Construction Inspection

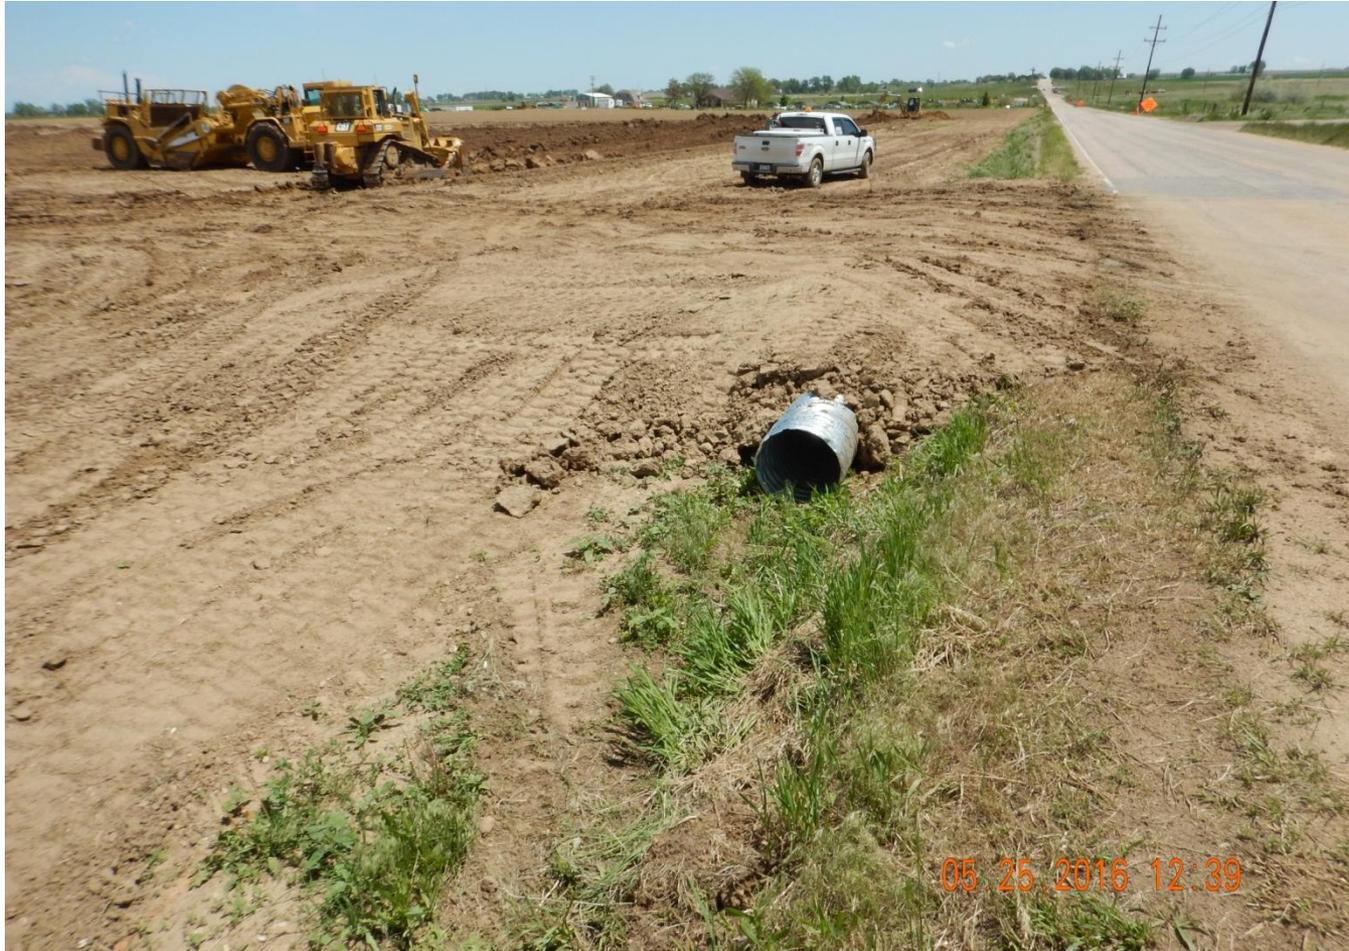
Photo 1. Photo taken from entrance of location, facing East. Culvert installed at entrance.

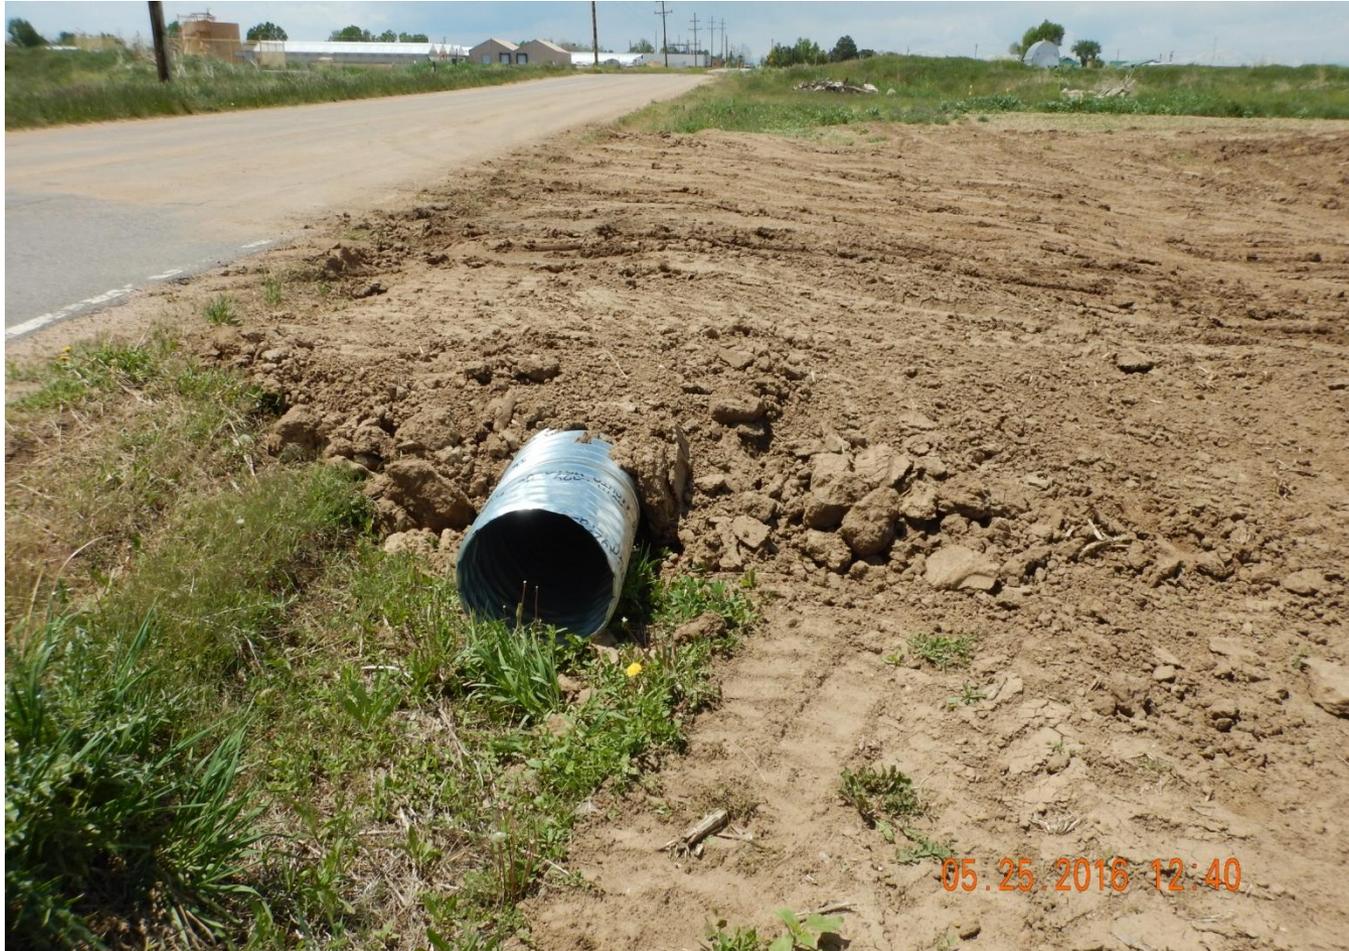
Photo 2. Photo taken from entrance of location, facing West. Culvert installed at entrance.

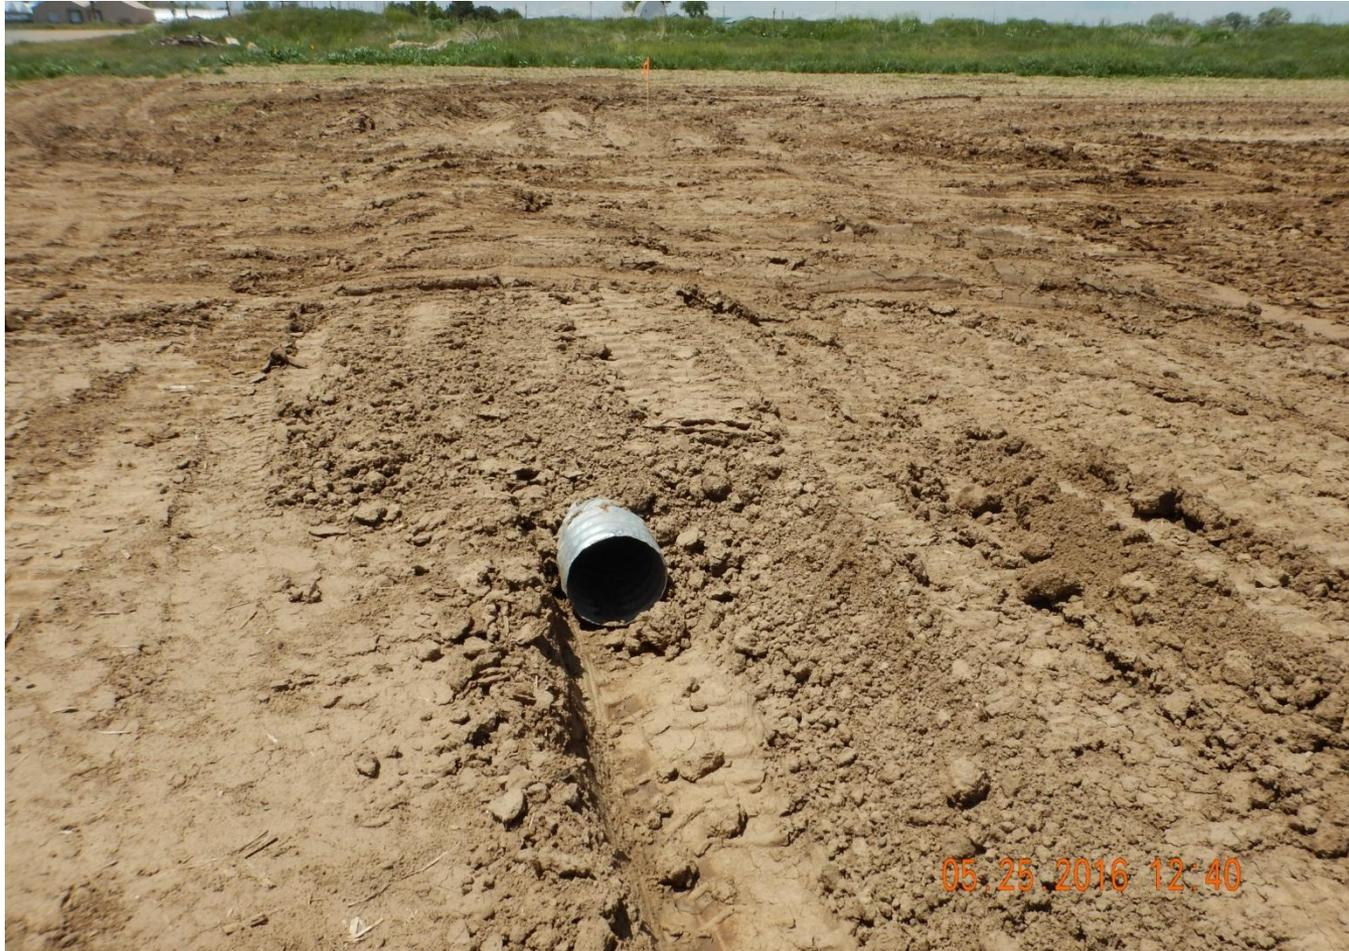
Photo 3. Photo taken from entrance of location, facing West. Second culvert installed along stormwater ditch.

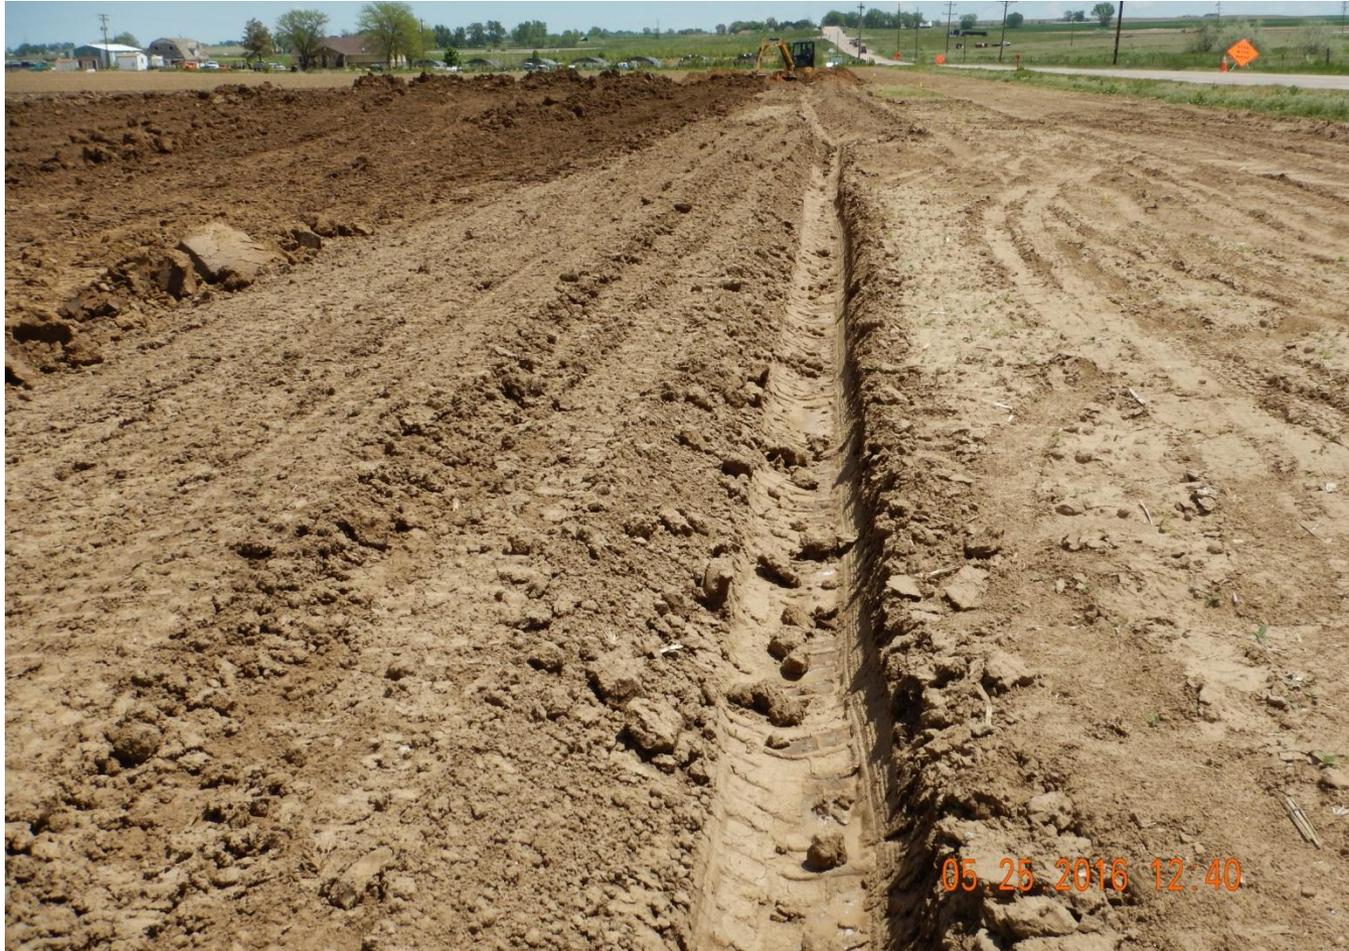
Photo 4. Photo taken from southern location, facing East. Stormwater BMP installed in center of photo.

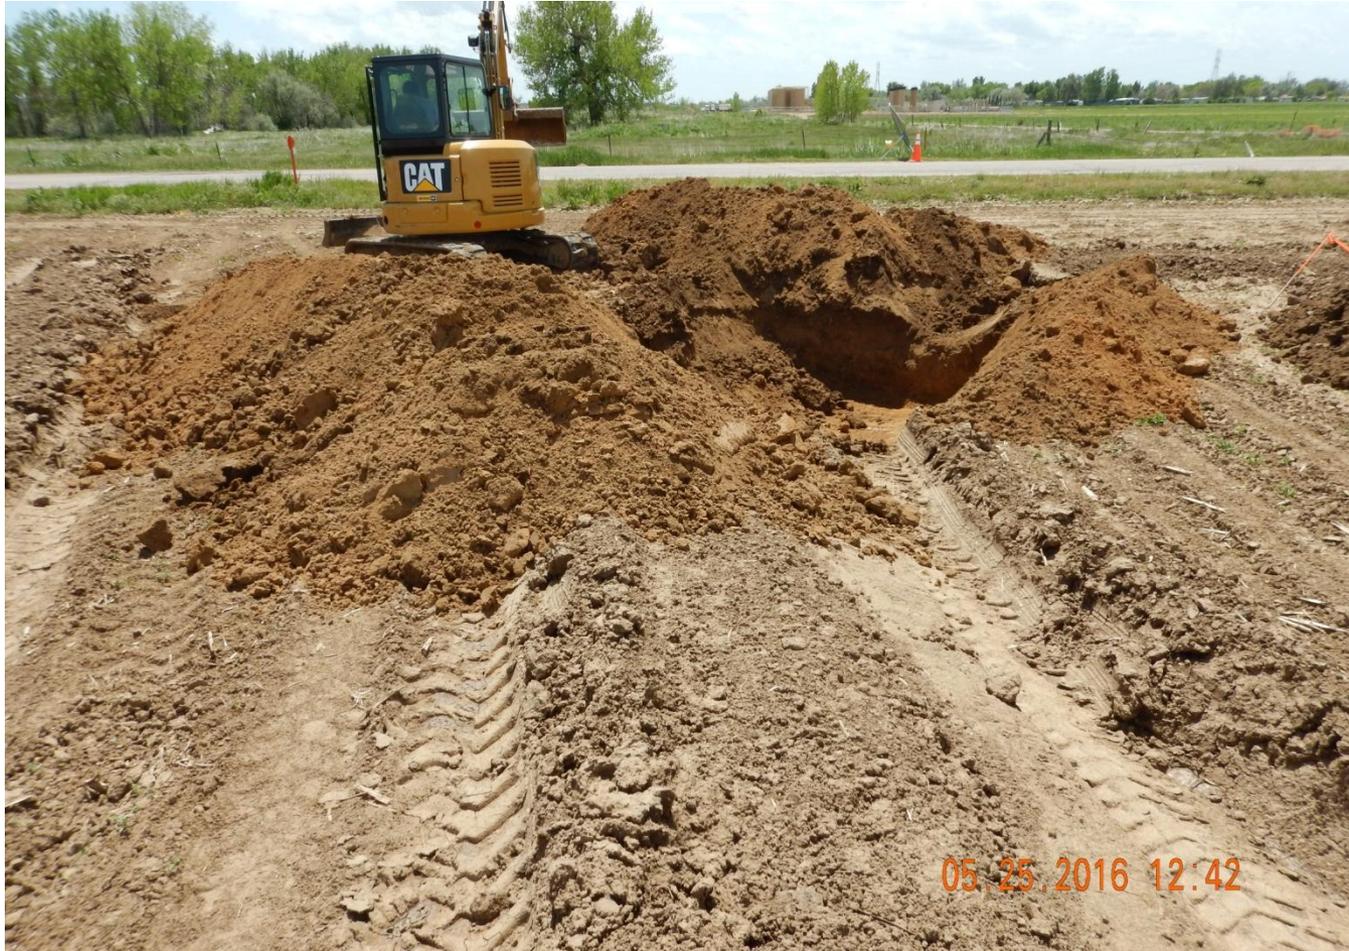
Photo 5. Photo taken from southeast location, facing South. Sediment trap being constructed.

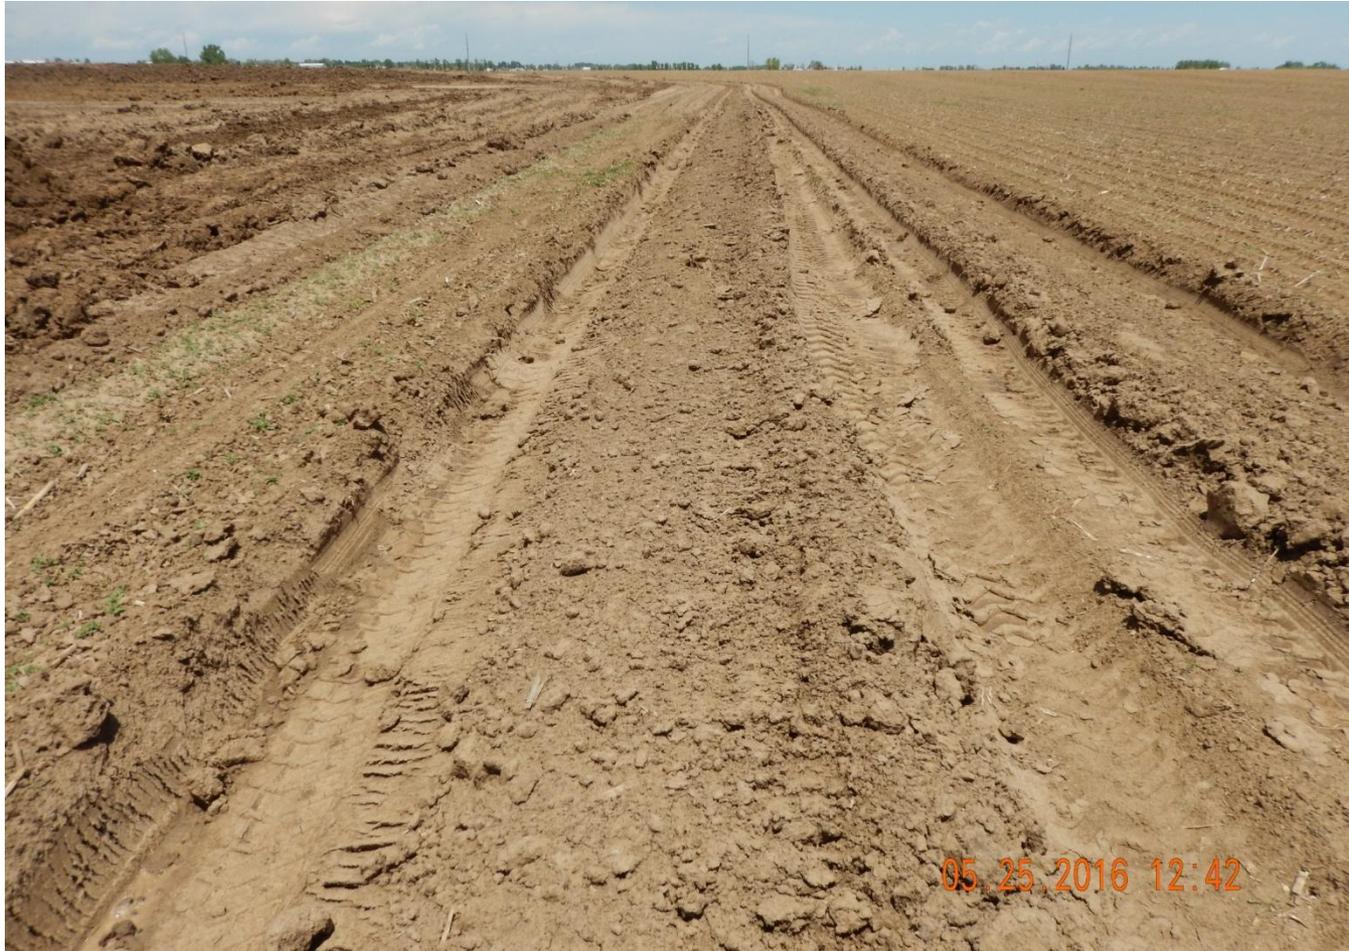
Photo 6. Photo taken from southeast location, facing North. 2-sets of stormwater BMPs installed to control run-on from flood irrigation.

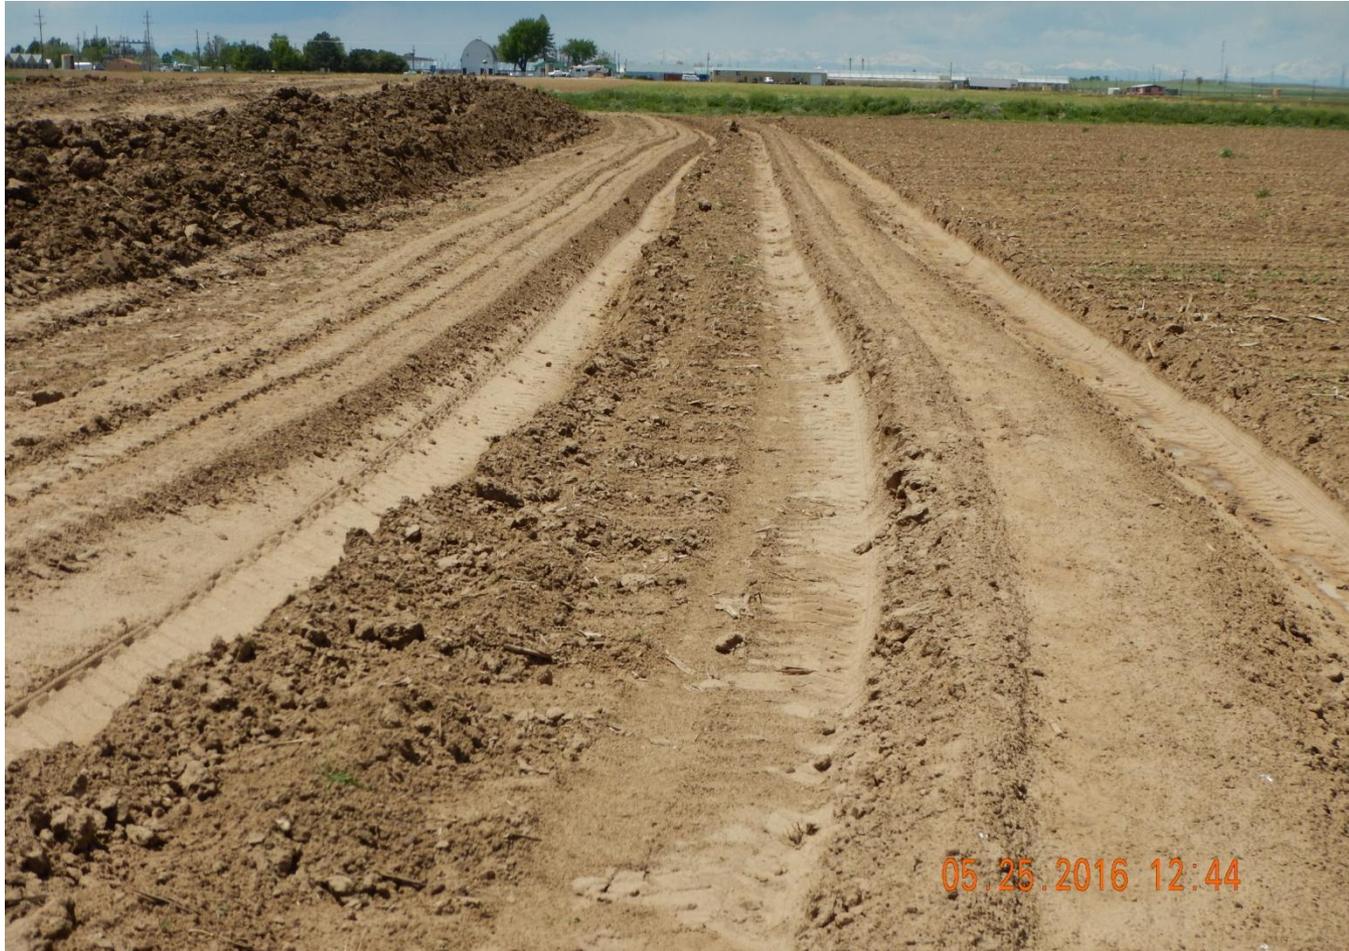
Photo 7. Photo taken from northeast location, facing West. 2-sets of stormwater BMPs installed to control run-on from flood irrigation.

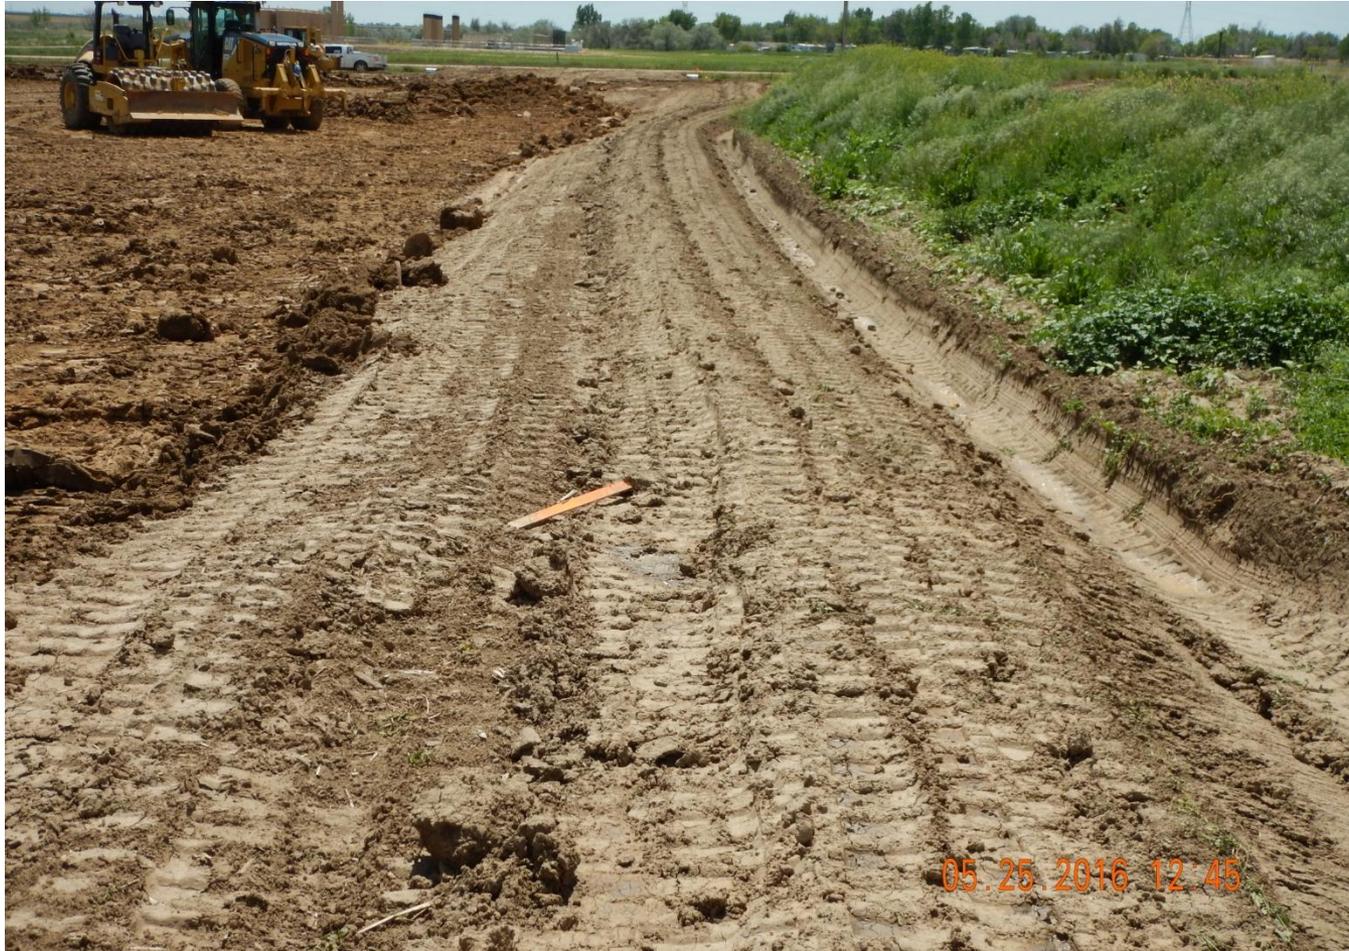
Photo 8. Photo taken from northwest location, facing South. Stormwater BMPs installed in center of photo.

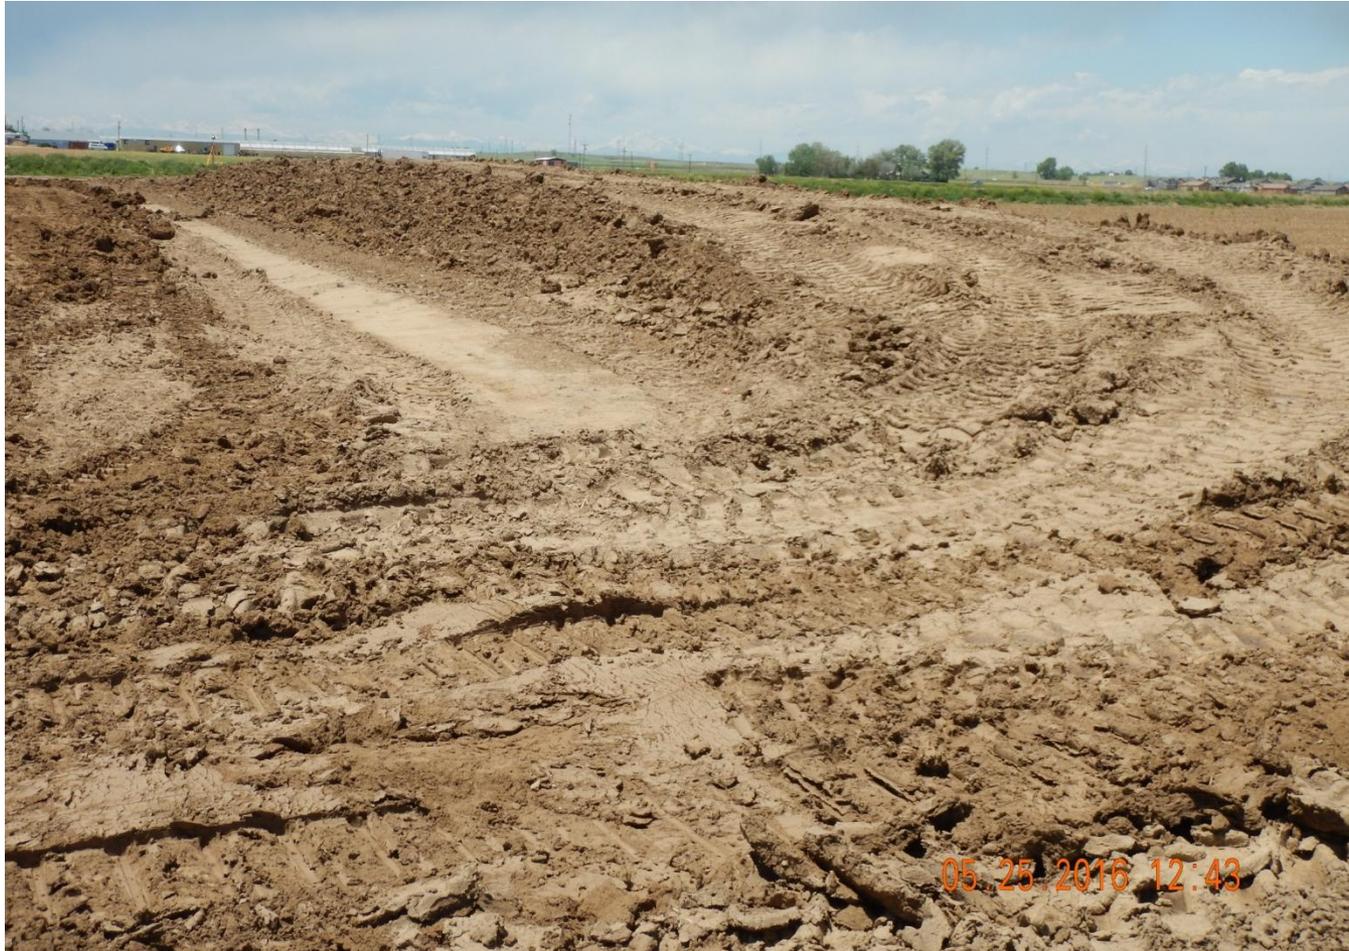
Photo 9. Photo taken from eastern location, facing West. Topsoil stockpile in center of photo. Topsoil stockpile needs to be stabilized upon completion of salvage process.
