June 2, 2016

Inspection Photos: OXY PA Cascade Creek Loc# 383339

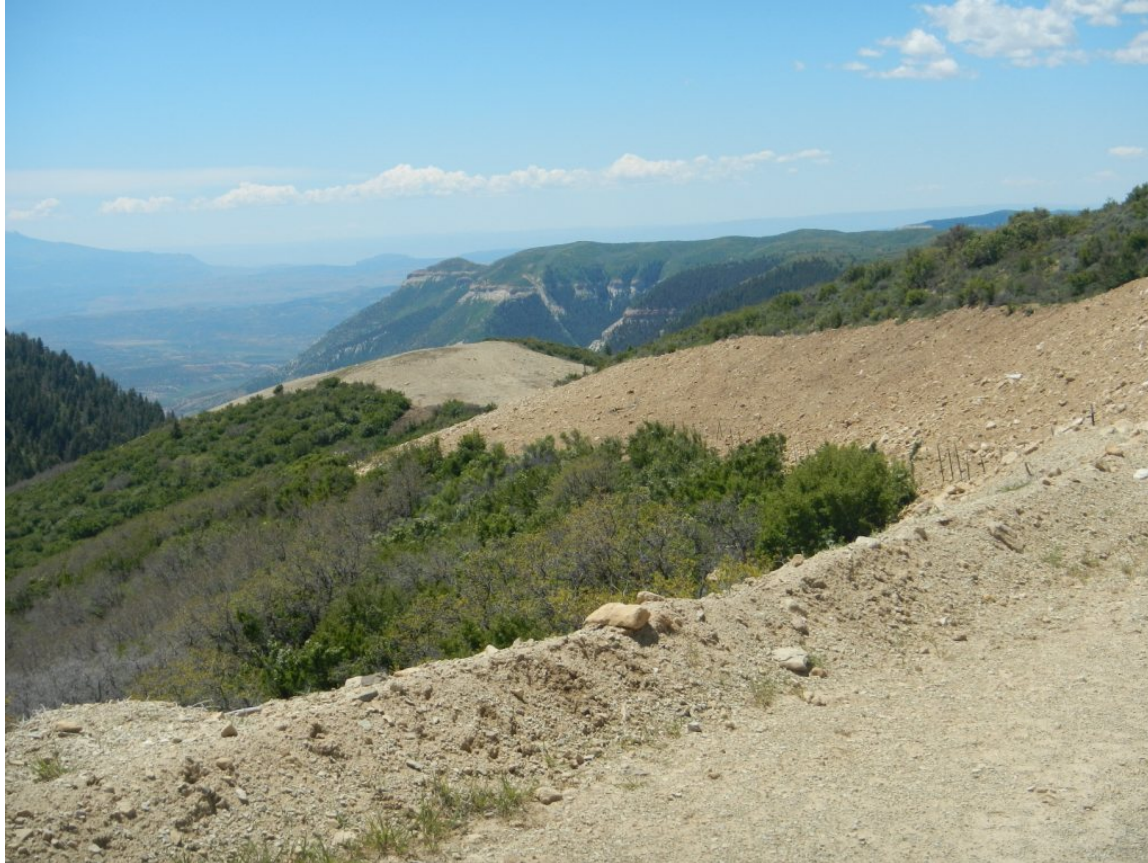
Photo#1: Access Road into Location in process of reclamation.

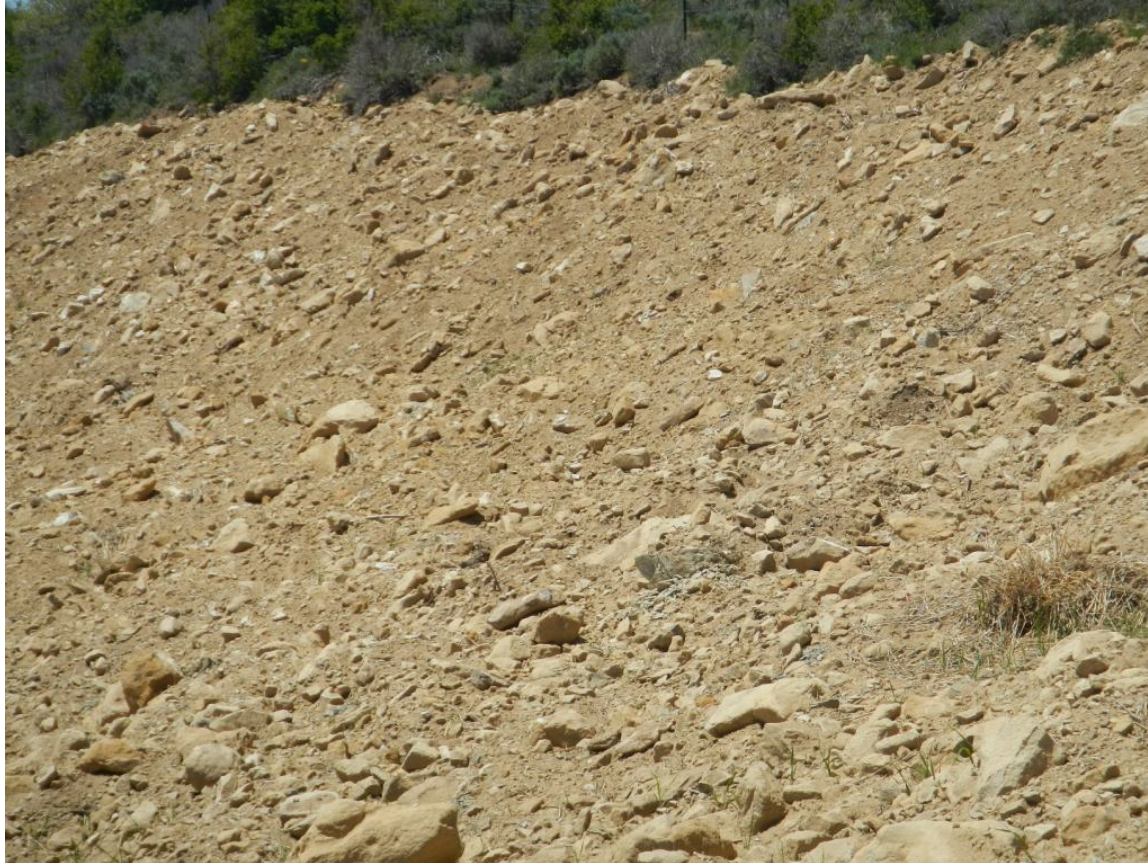
Photo#2: De-compaction has occurred.

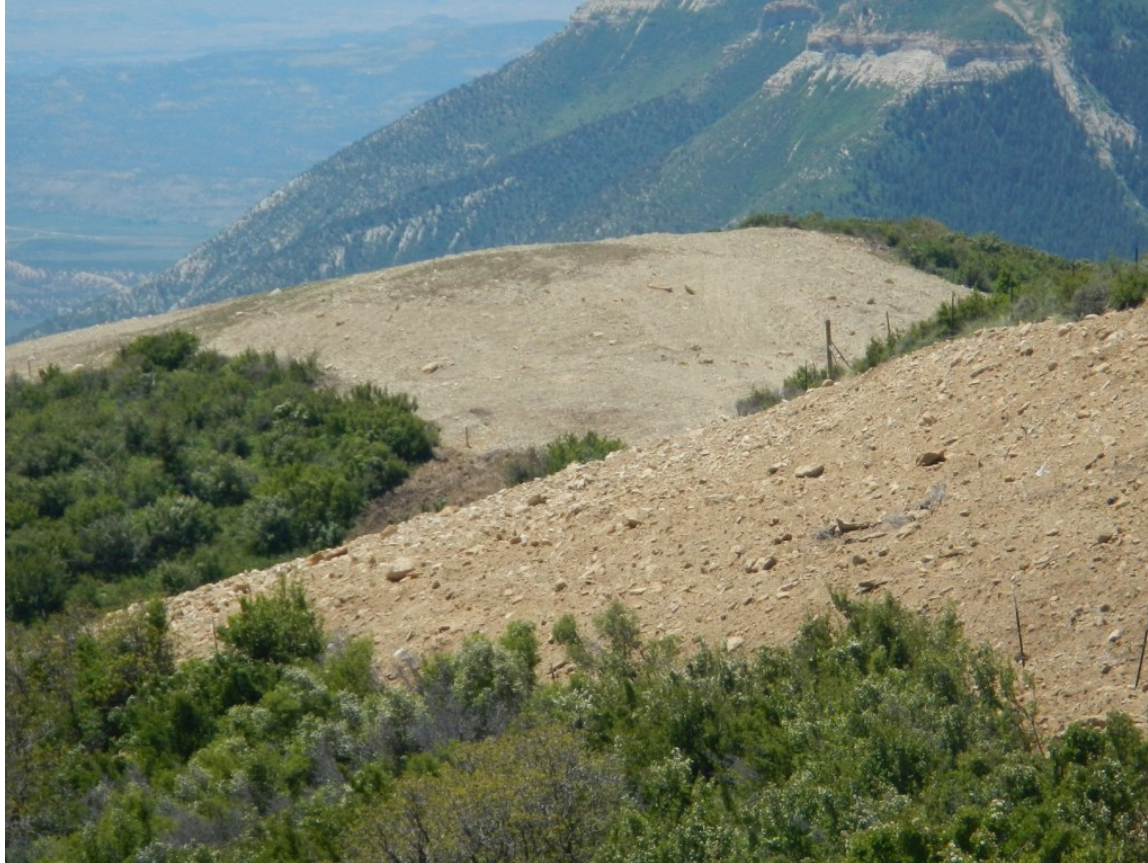
Photo#3: Steep Slopes will need monitoring to assess need for SW BMP's to stabilize Location until Vegetation establishes.
