June 2, 2016

Inspection Photos: Laramie Energy Loc#335203

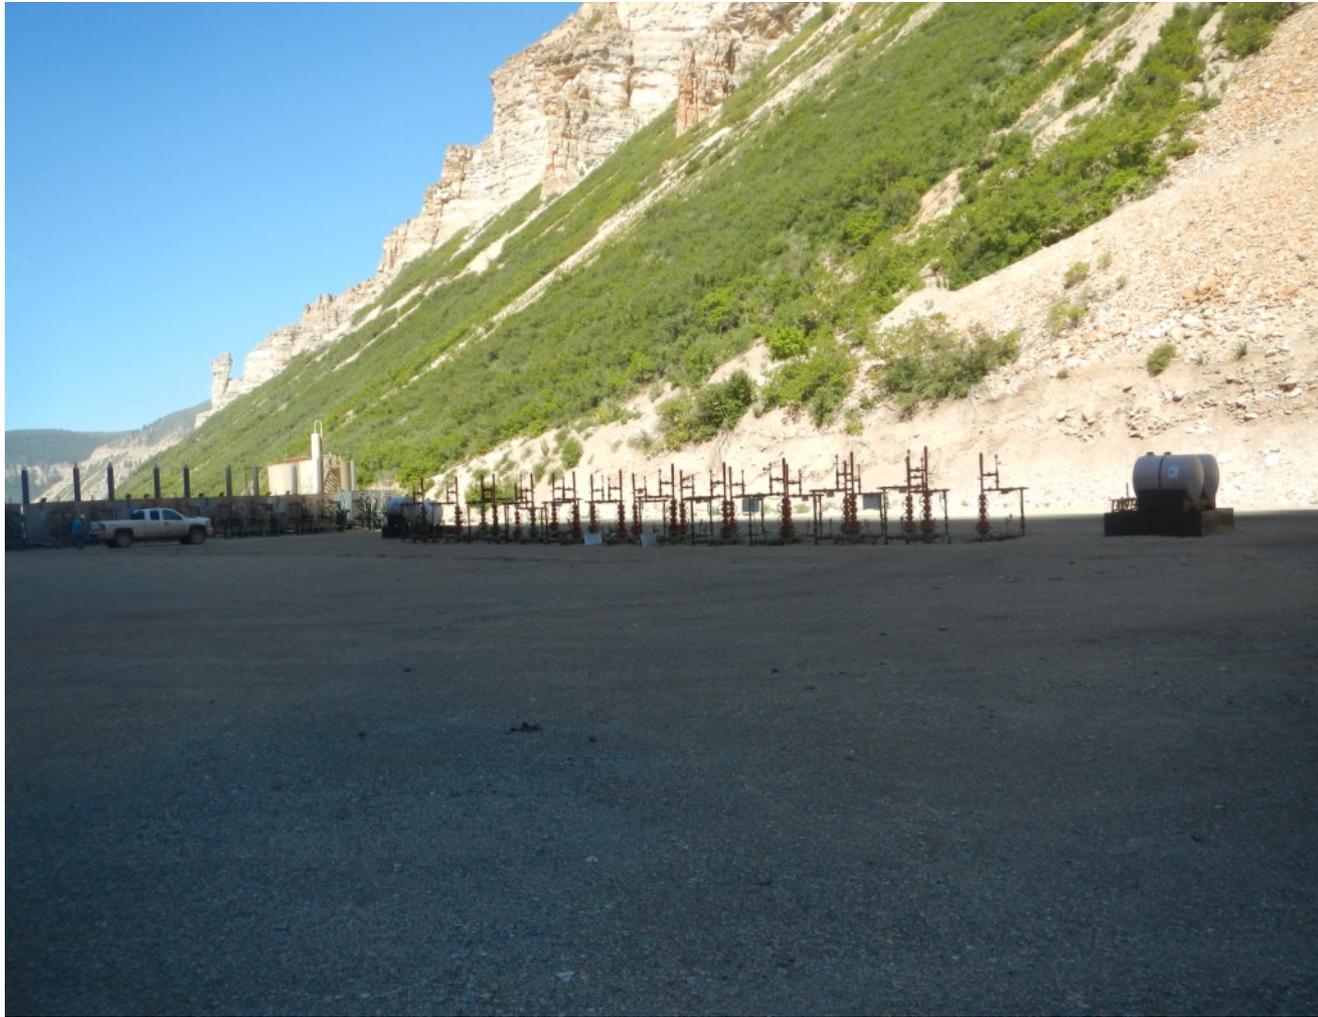
Photo#1: Overview of Location to SW.

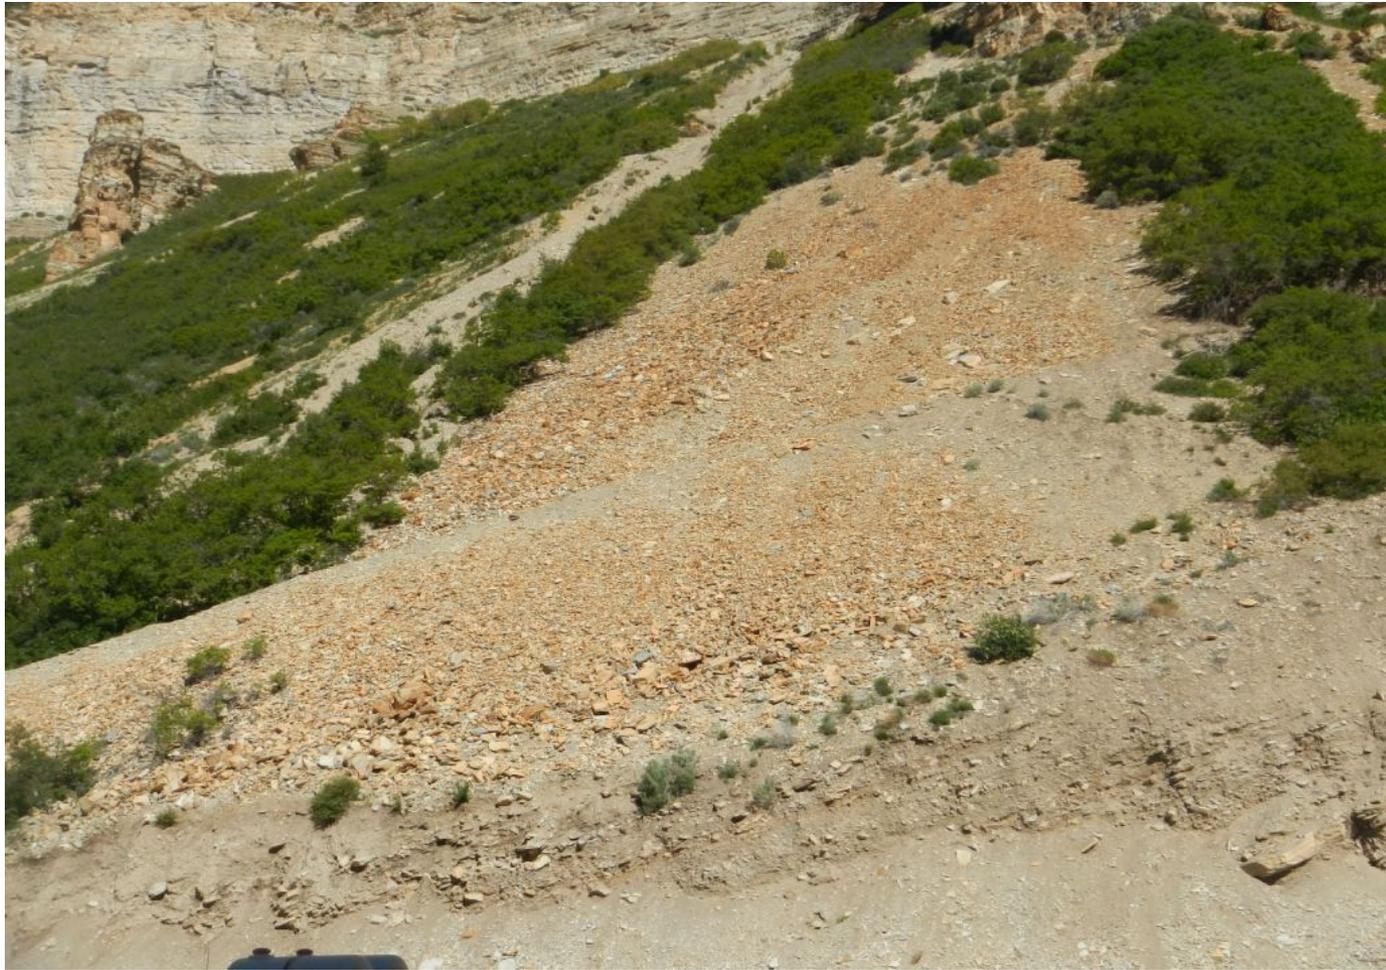
Photo#2: Cut Slope and Disturbance associated with site need to be Stabilized

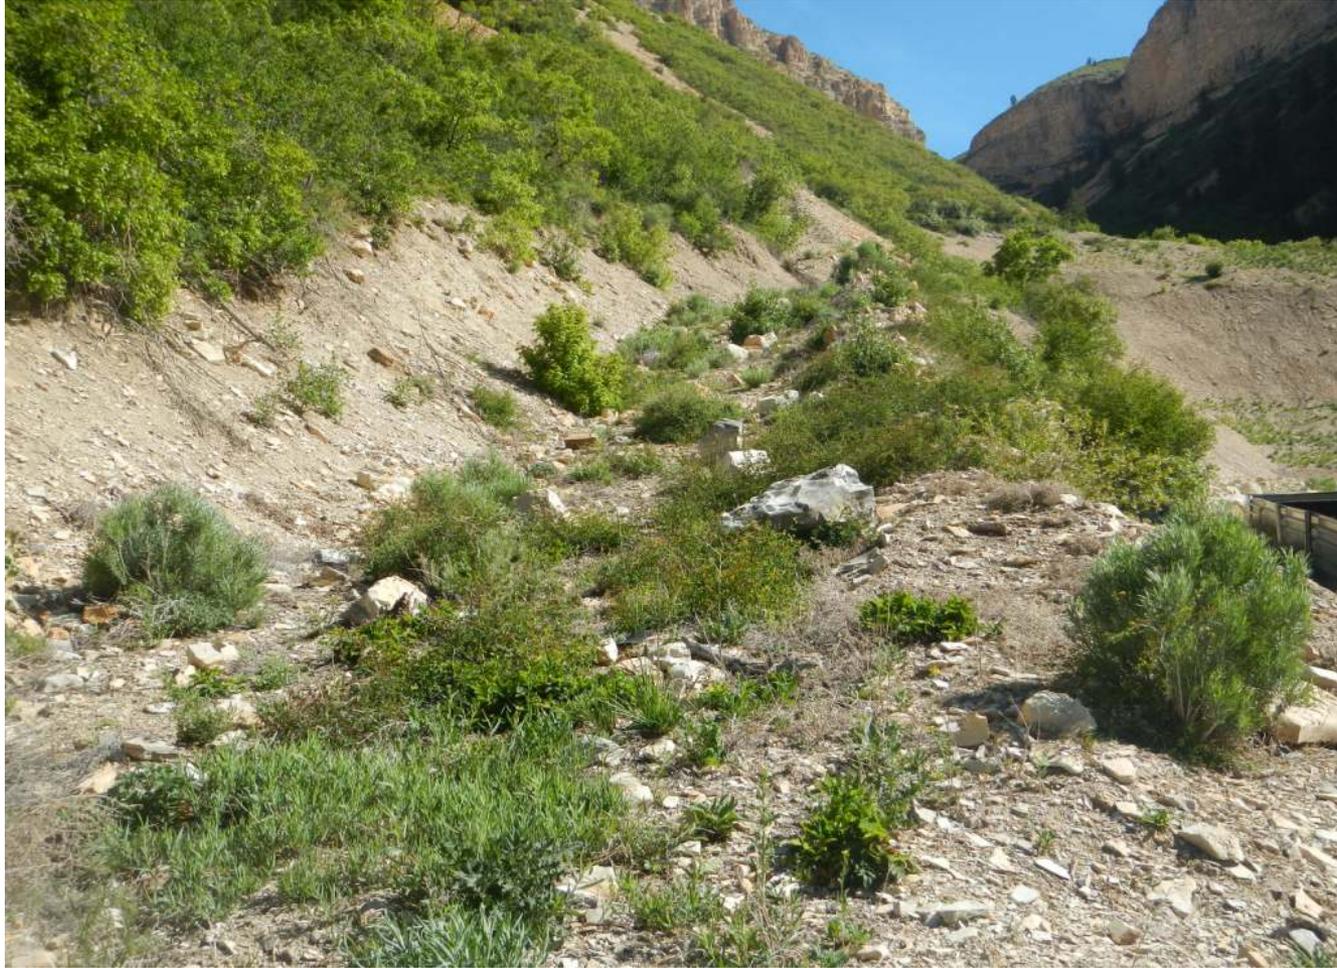
Photo#3: This Bench has been & is effective in stabilizing Slope behind Wells

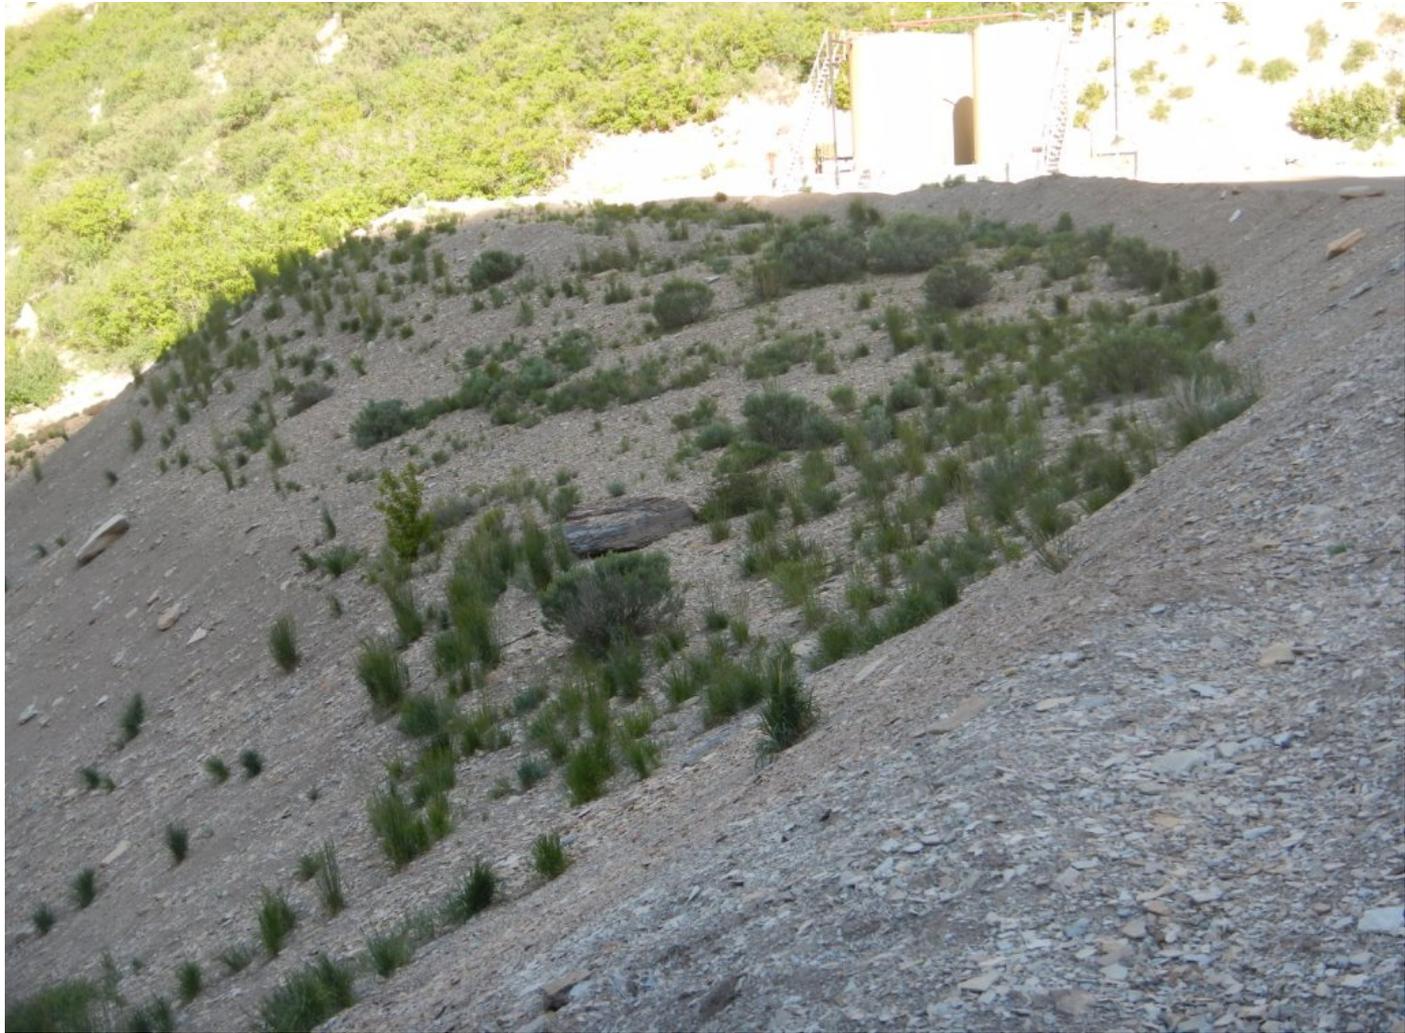
Photo#4: Upper Portions of Fill Slope have vegetation establishing, while Lower areas remain unstabilized .

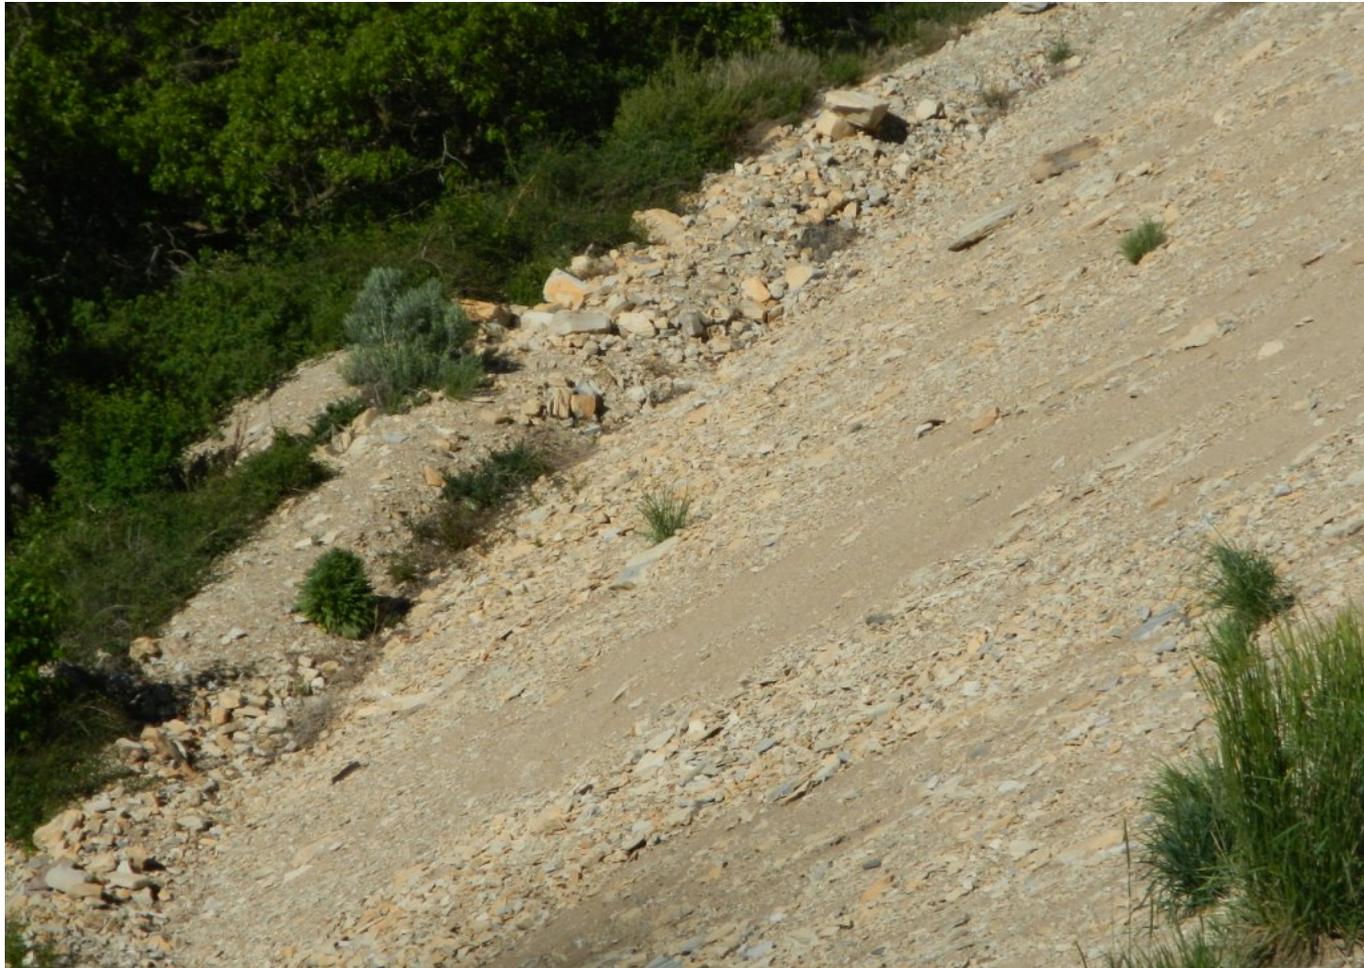
Photo#5:. Material/Sediment is Rattling/Migrating to Drainage at base and overwhelming Vegetation.

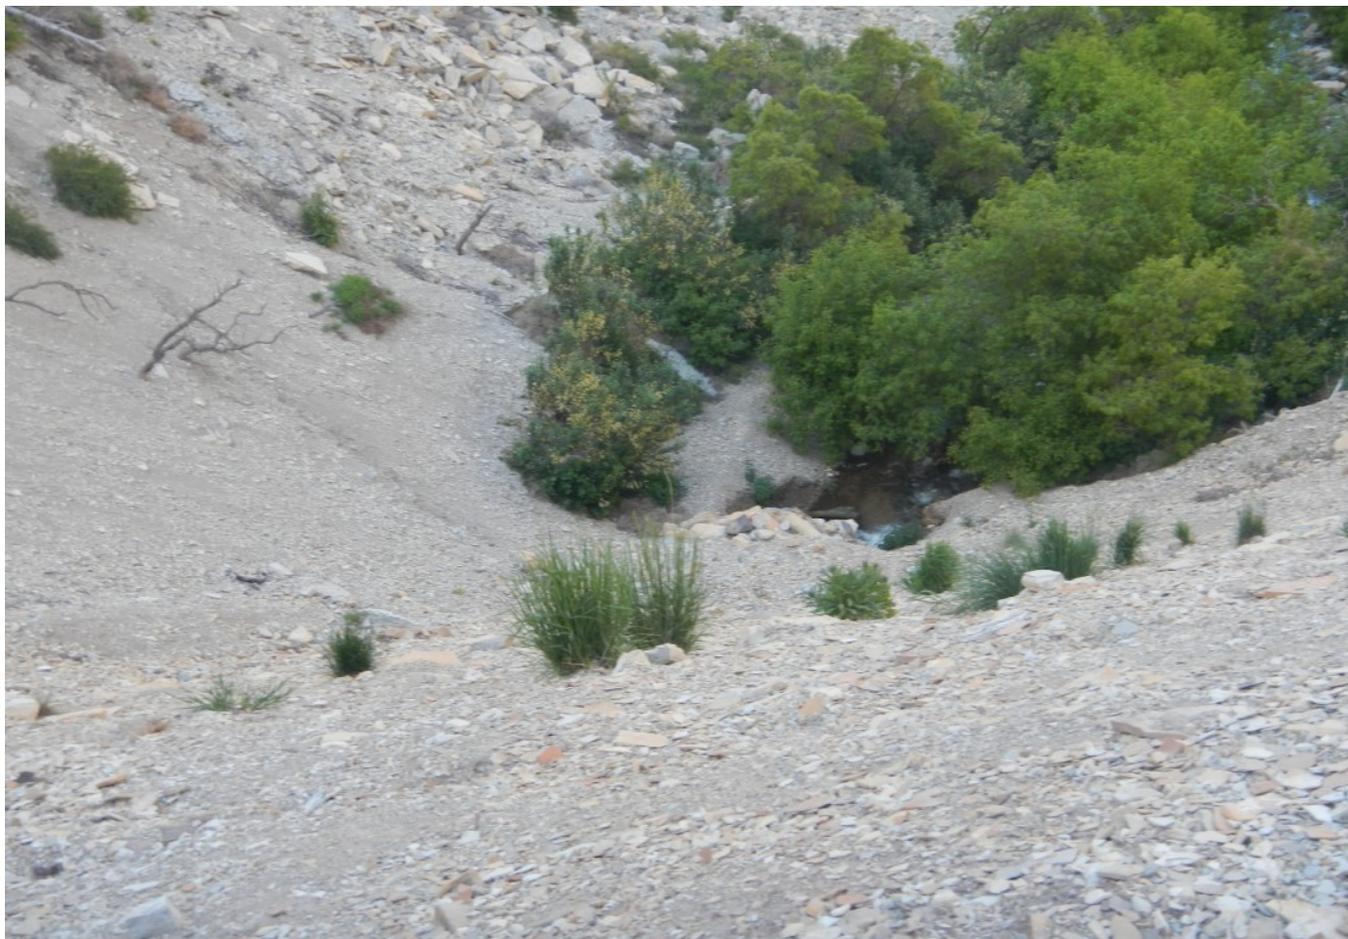
Photo#6:. Access Rd Slope Material is Migrating to Culvert and Creek

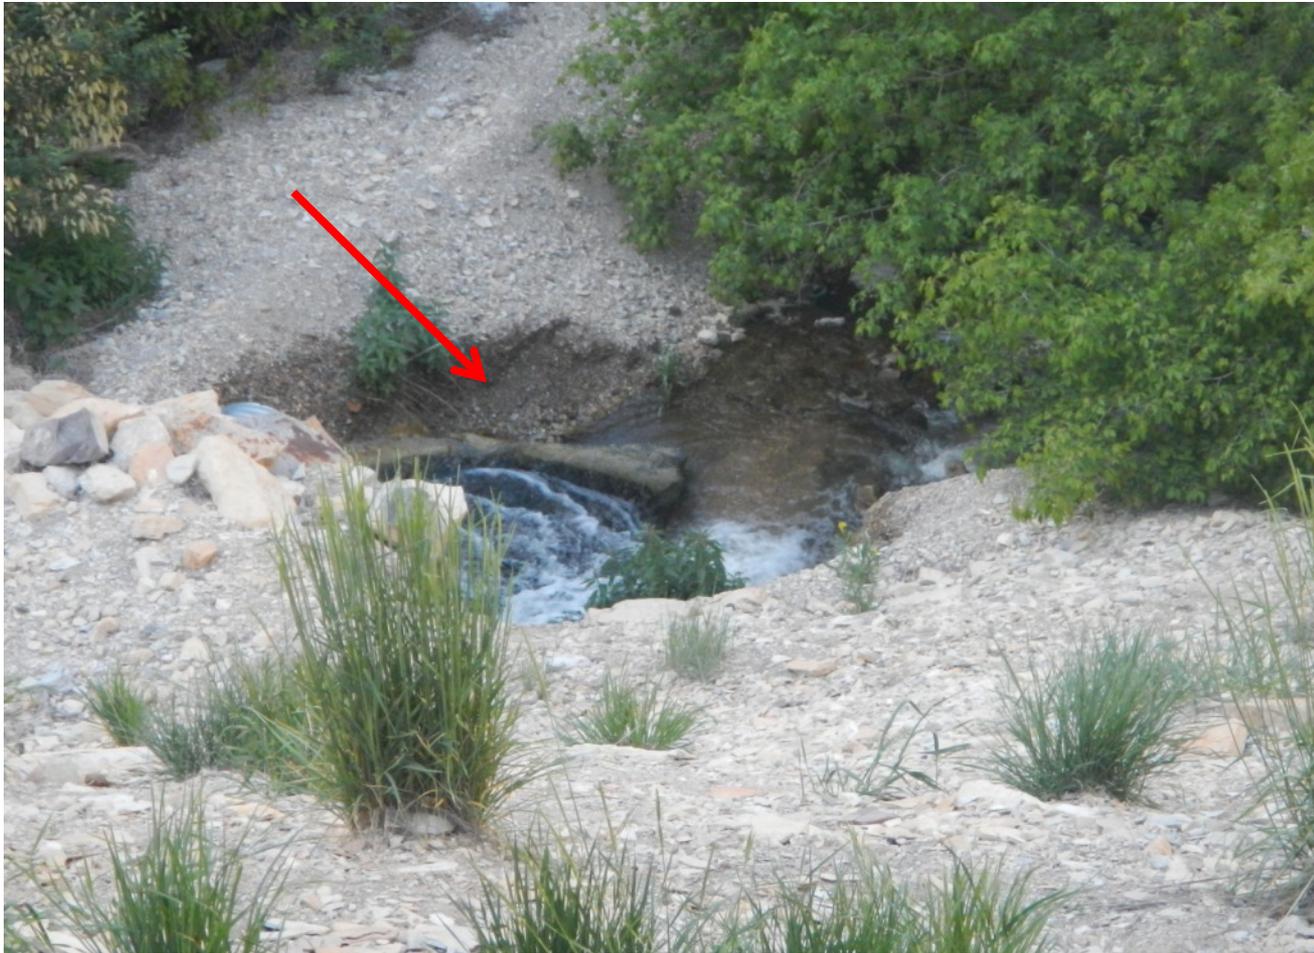
Photo#7: Close up of Culvert Creek Exit point at base of Access Rd Slope. Arrow indicates area where High Water has eroded Slope material that has Migrated down to Creek.

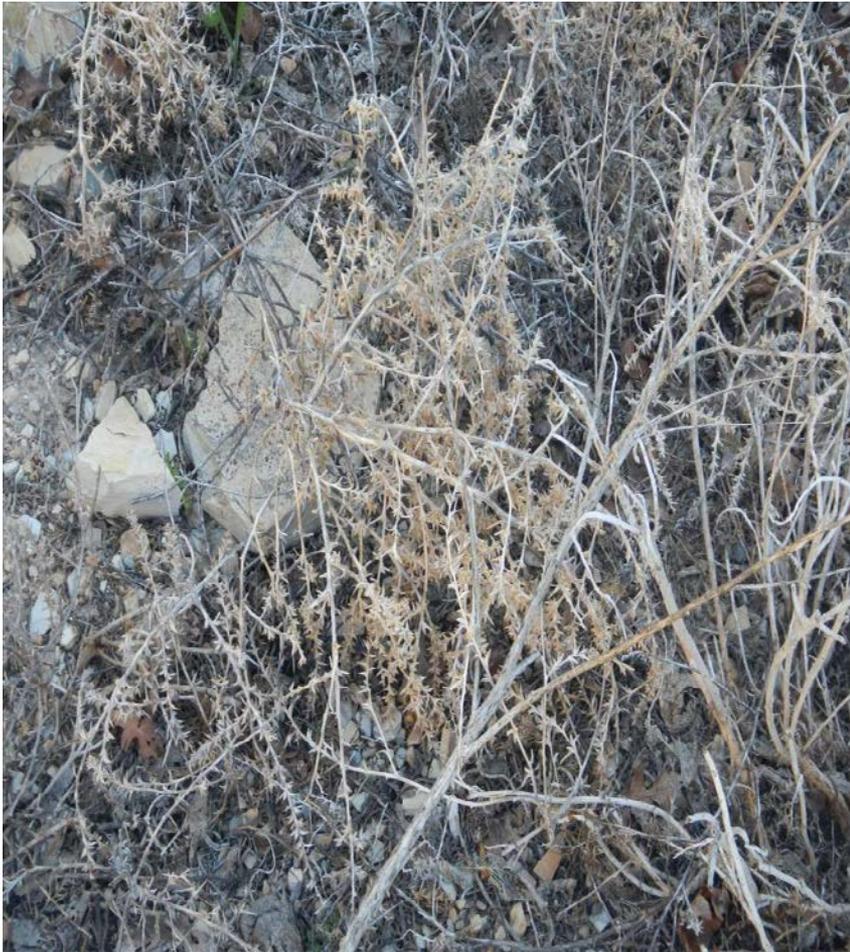
Photo#8:

Evidence of last years Noxious Weed, Thistle, infestation.
