Inspection Photos: Laramie Energy Cascade Creek Loc# 335844

June 2, 2016

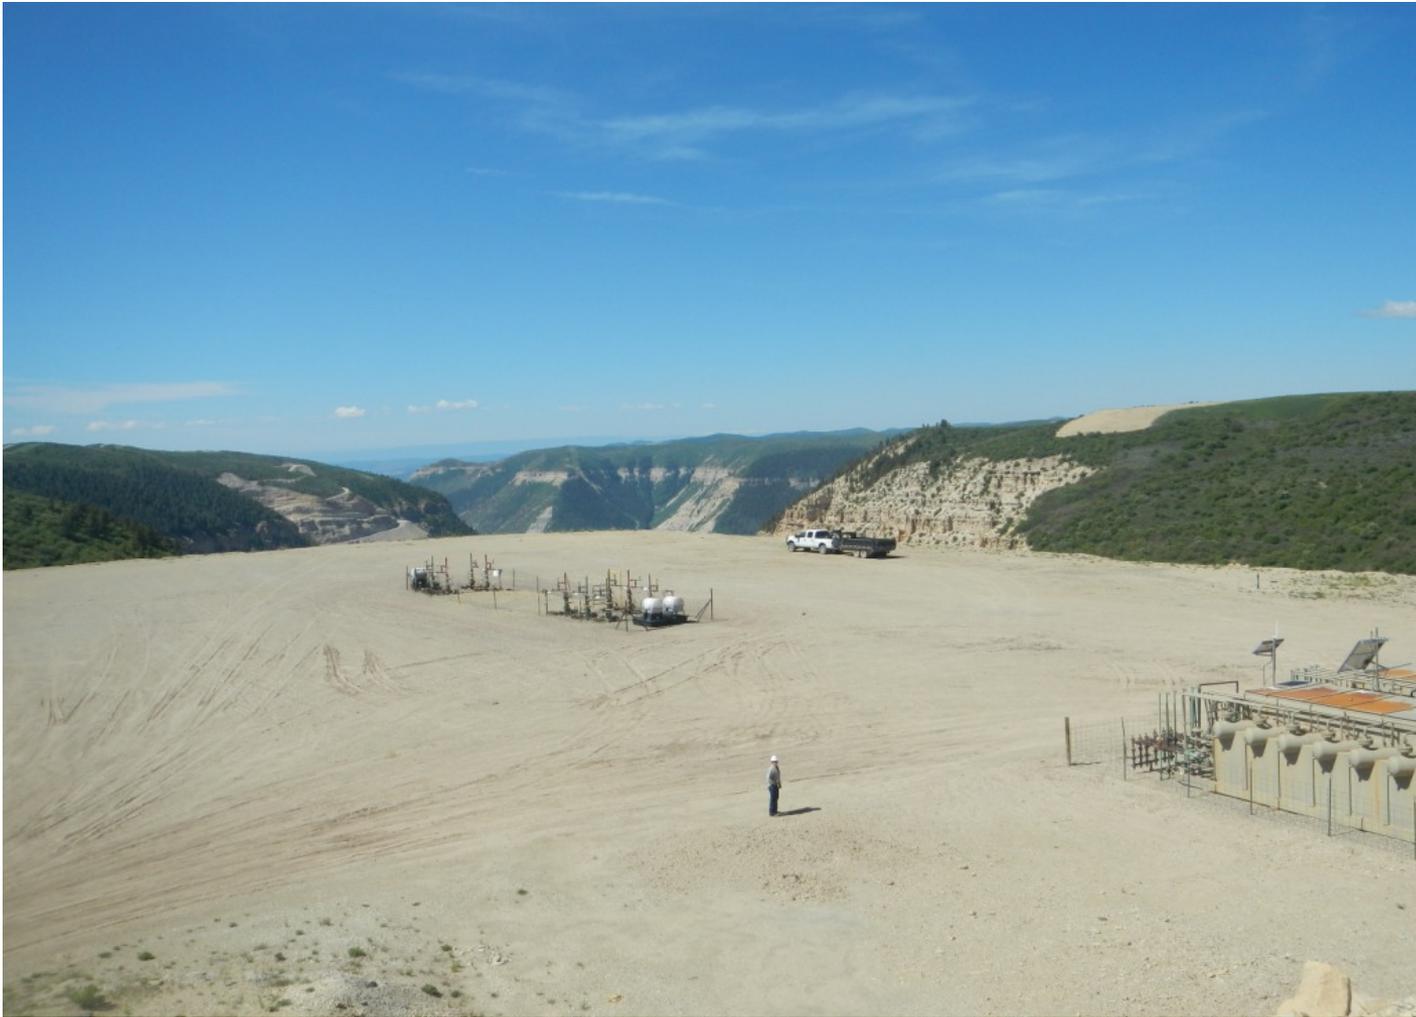
Photo#1: Overview of Location to SW.

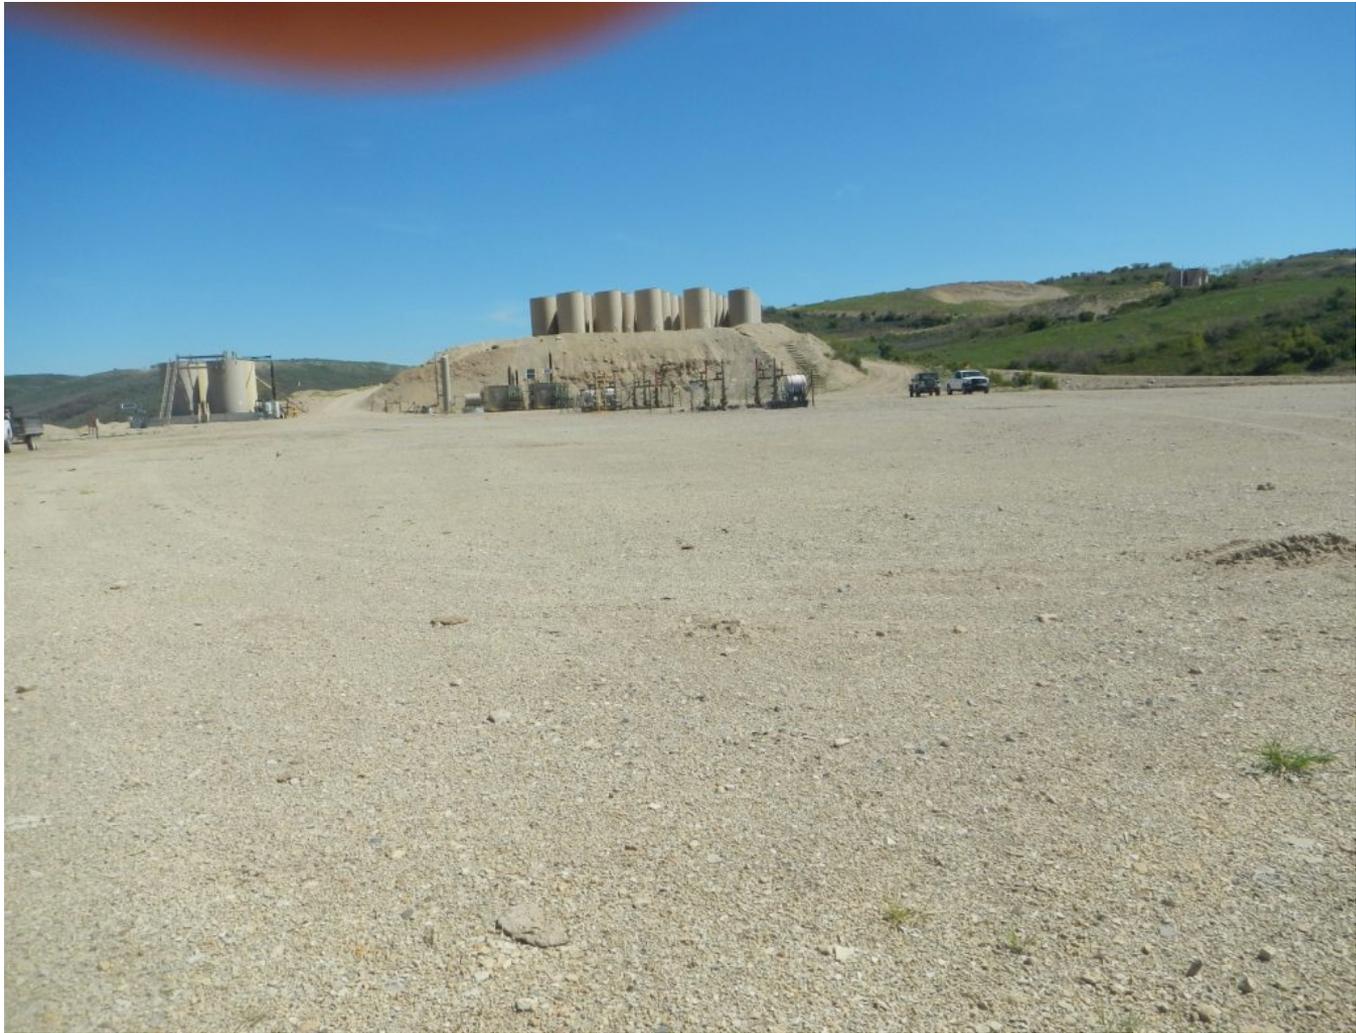
Photo#2: View of Location to NE.

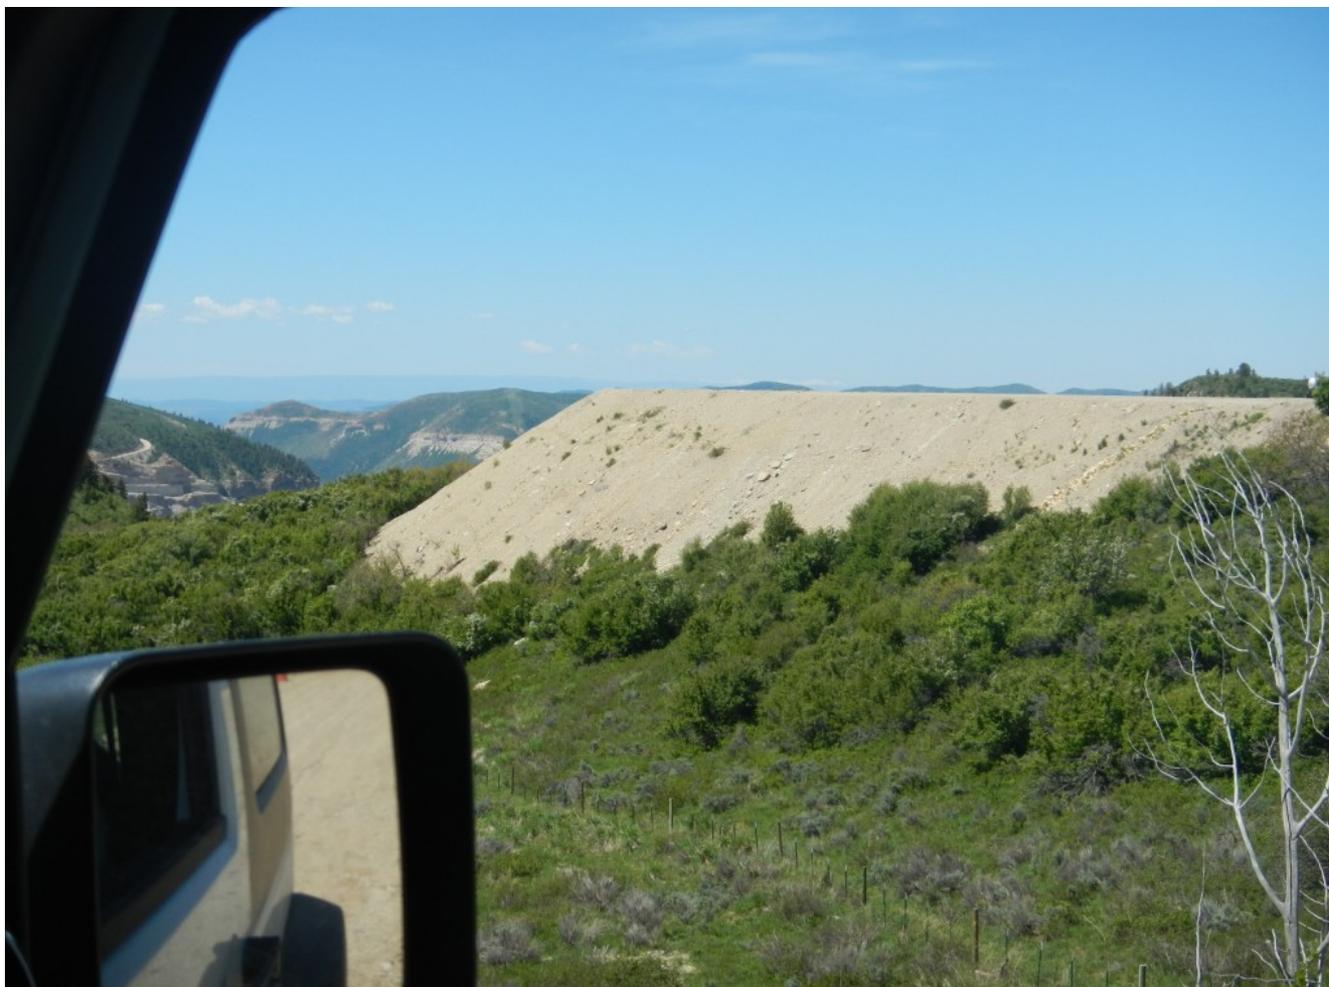
Photo#3:. View of Location Fill Slope to SW.

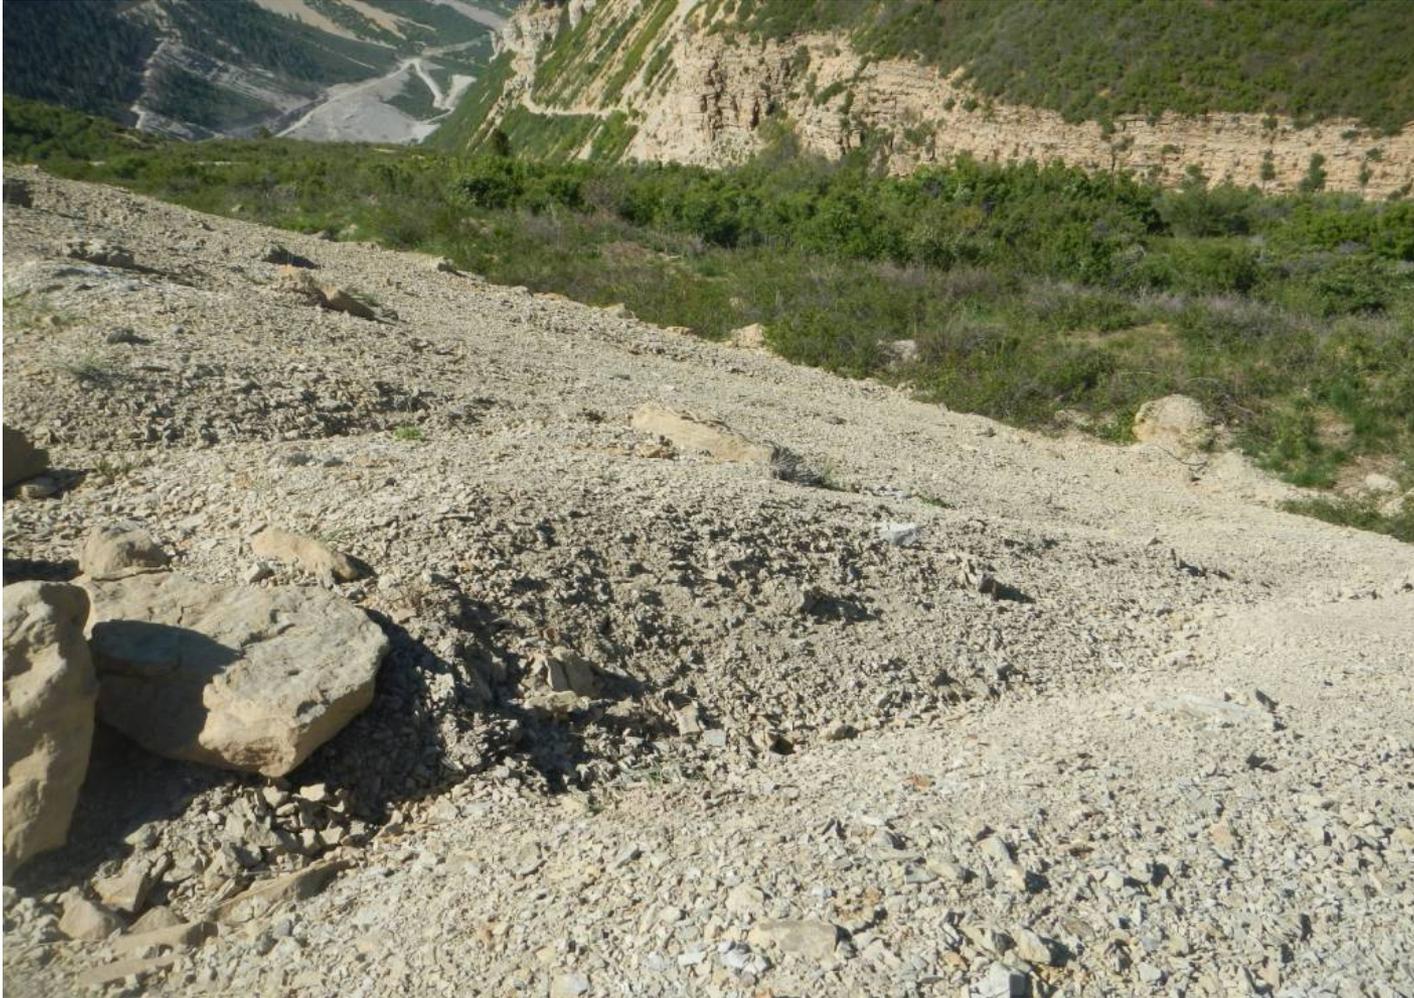
Photo#4:. Areas of Fill Slope where material begins to slough and Channel Down Slope.

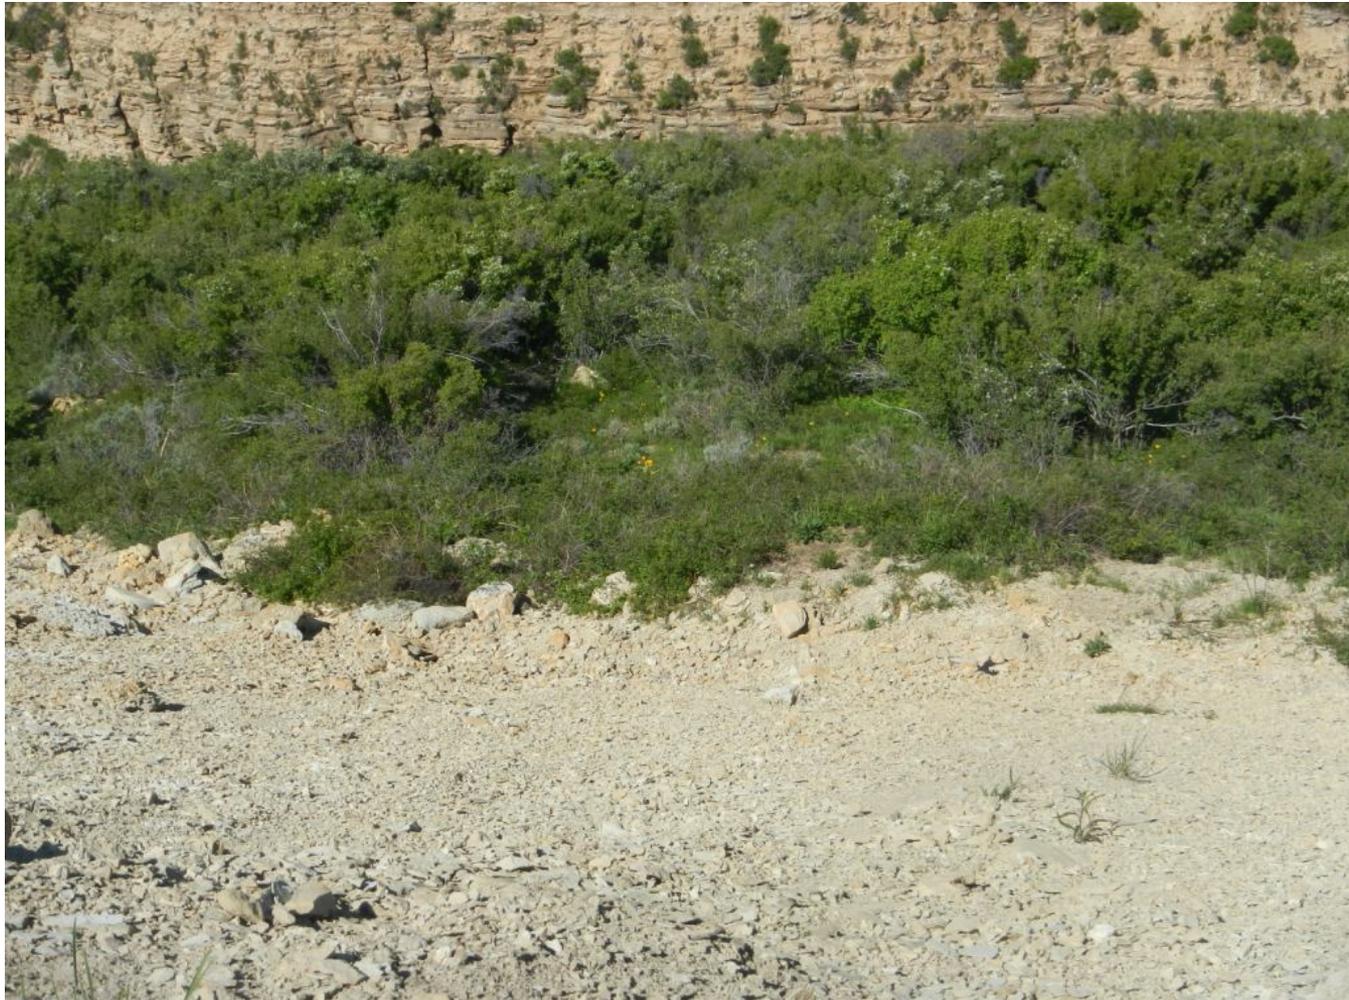
Photo#5: Fill Slope on West side of Location; Material is rattling, migrating into Vegetation.

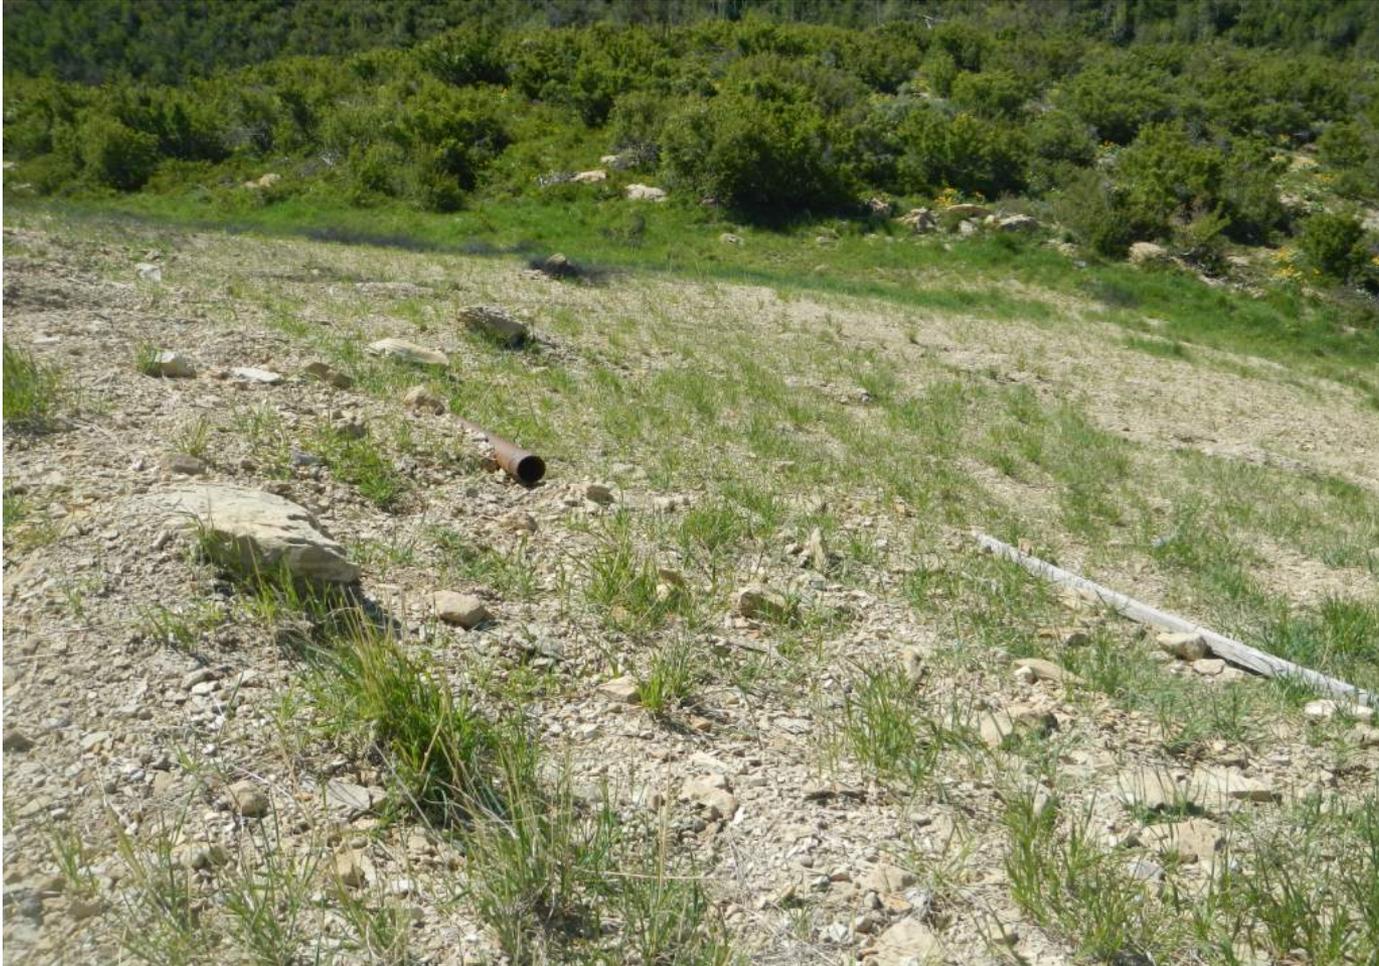
Photo#6:. Vegetation is establishing on South and SW areas of Fill Slope.

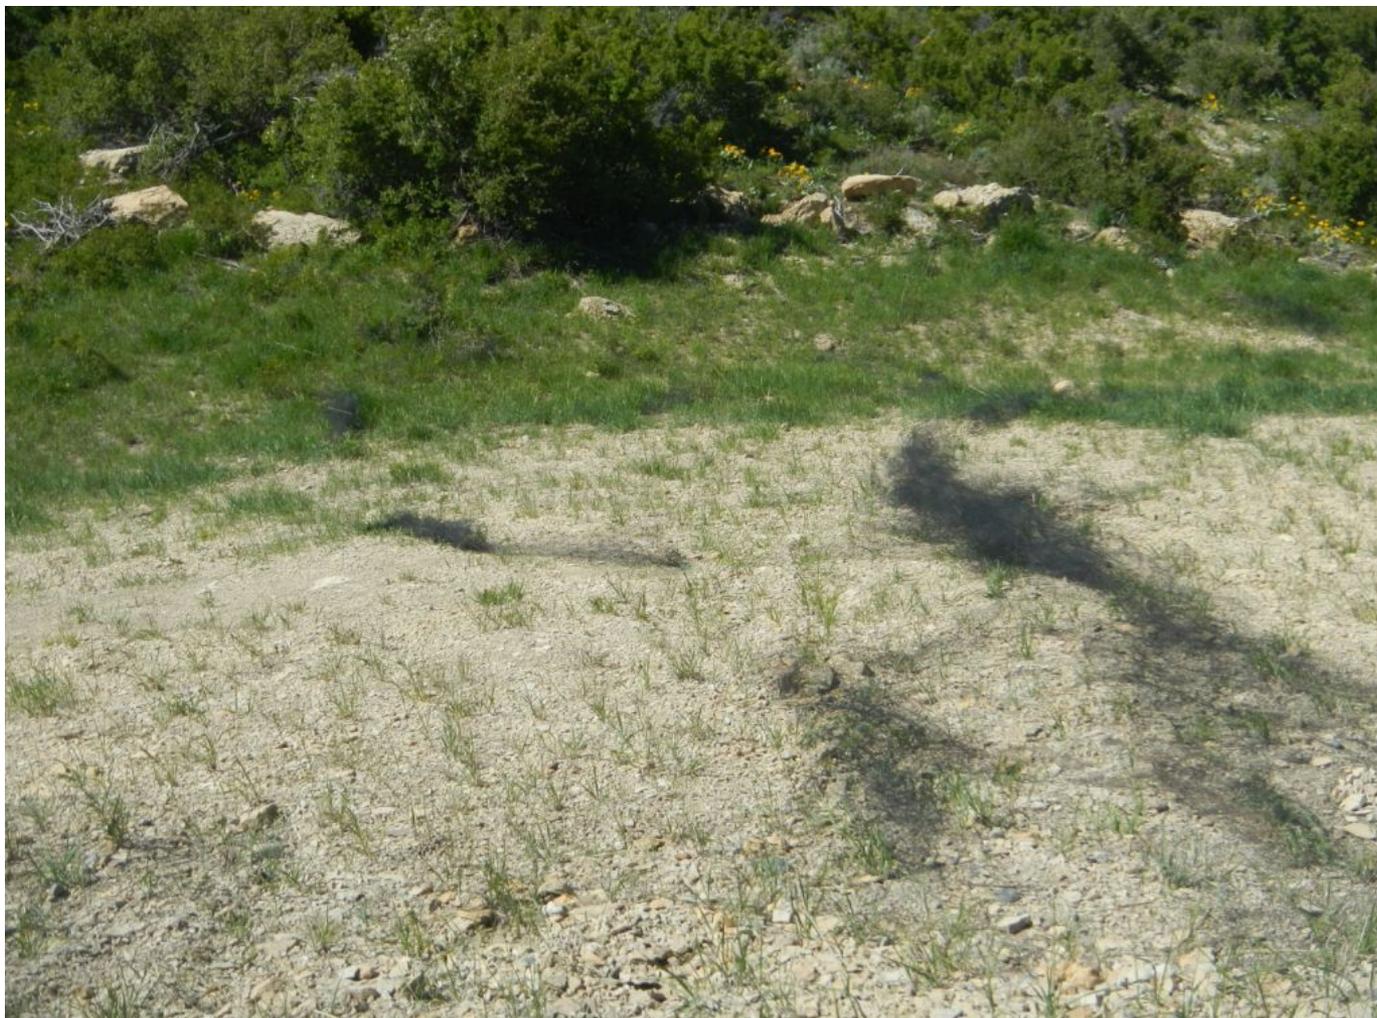
Photo#7: Deteriorated Blanket/netting has become Debris & could entangle Wildlife.

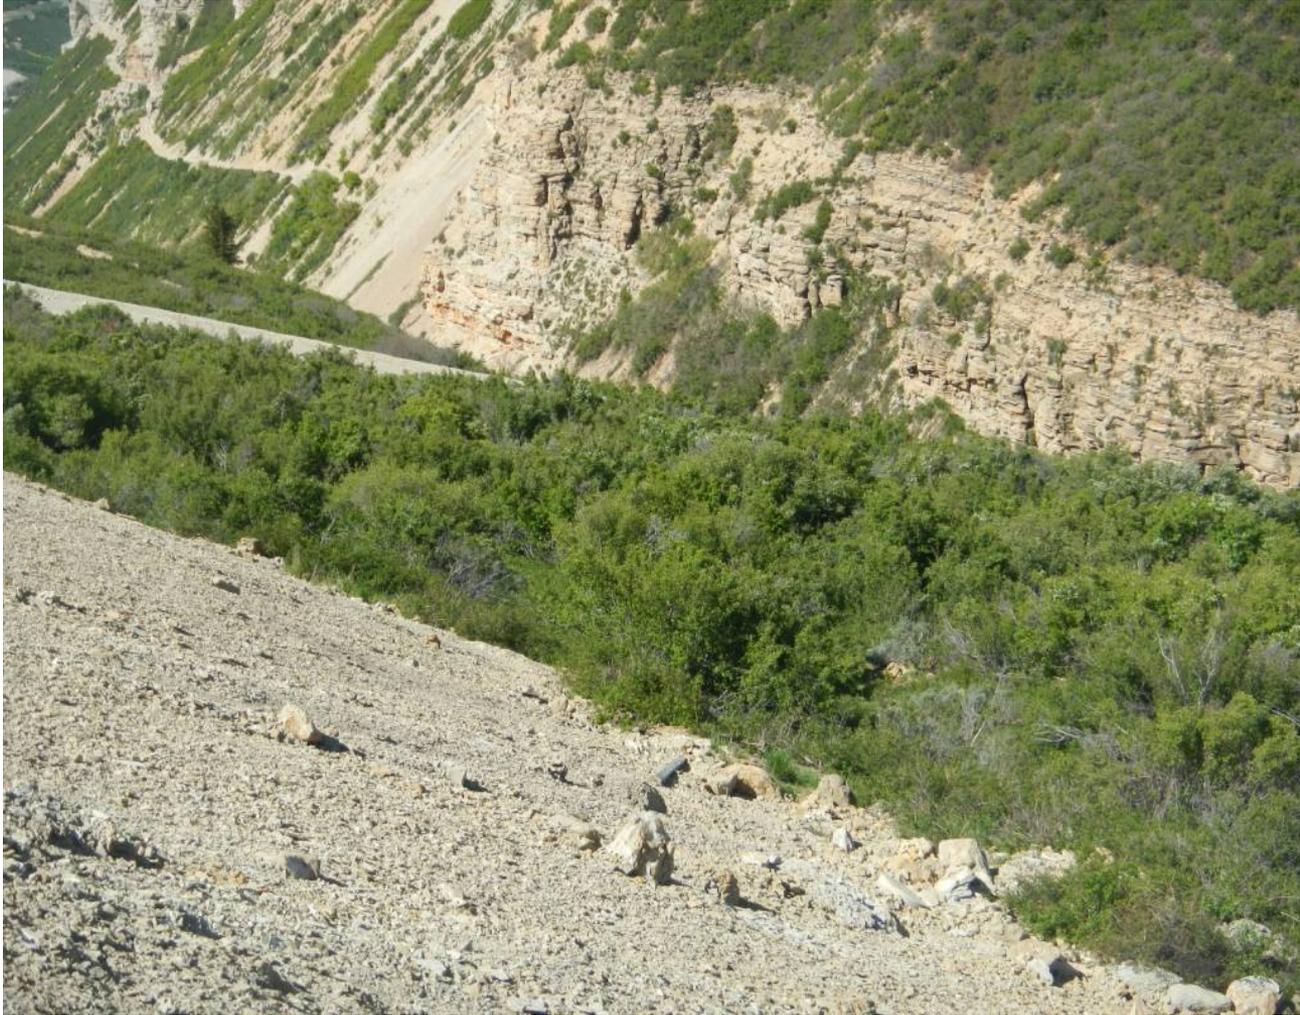
Photo#8: Unstabilized Fill slope Material again moving into Vegetation & lack of effective BMP at base of Slope.

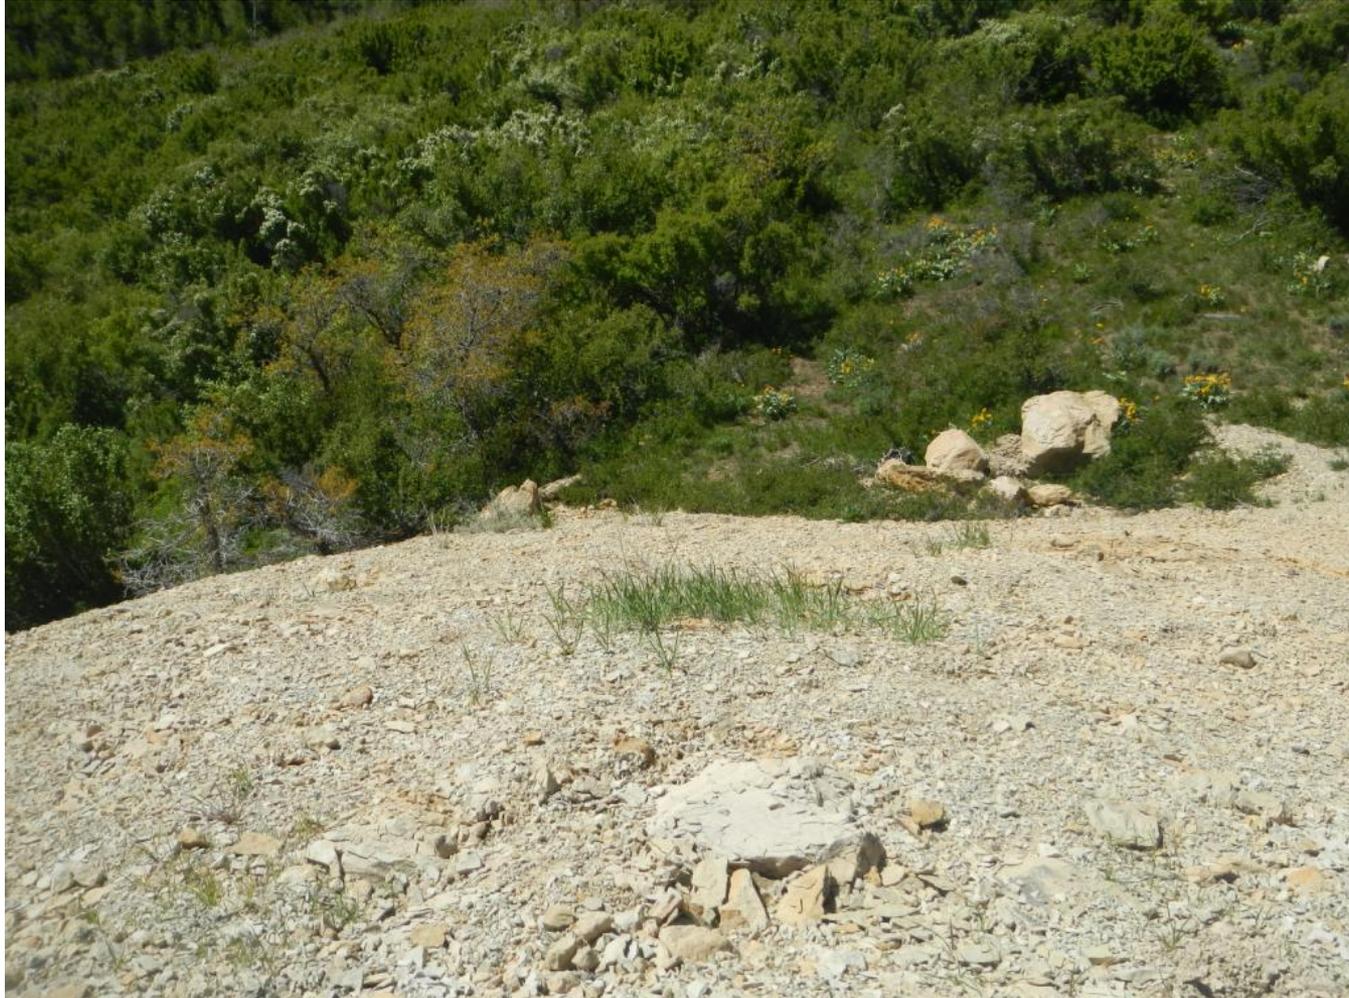
Photo#9: Fill Slope at East side of Location Bellies out; accelerating movement of Material off Location.

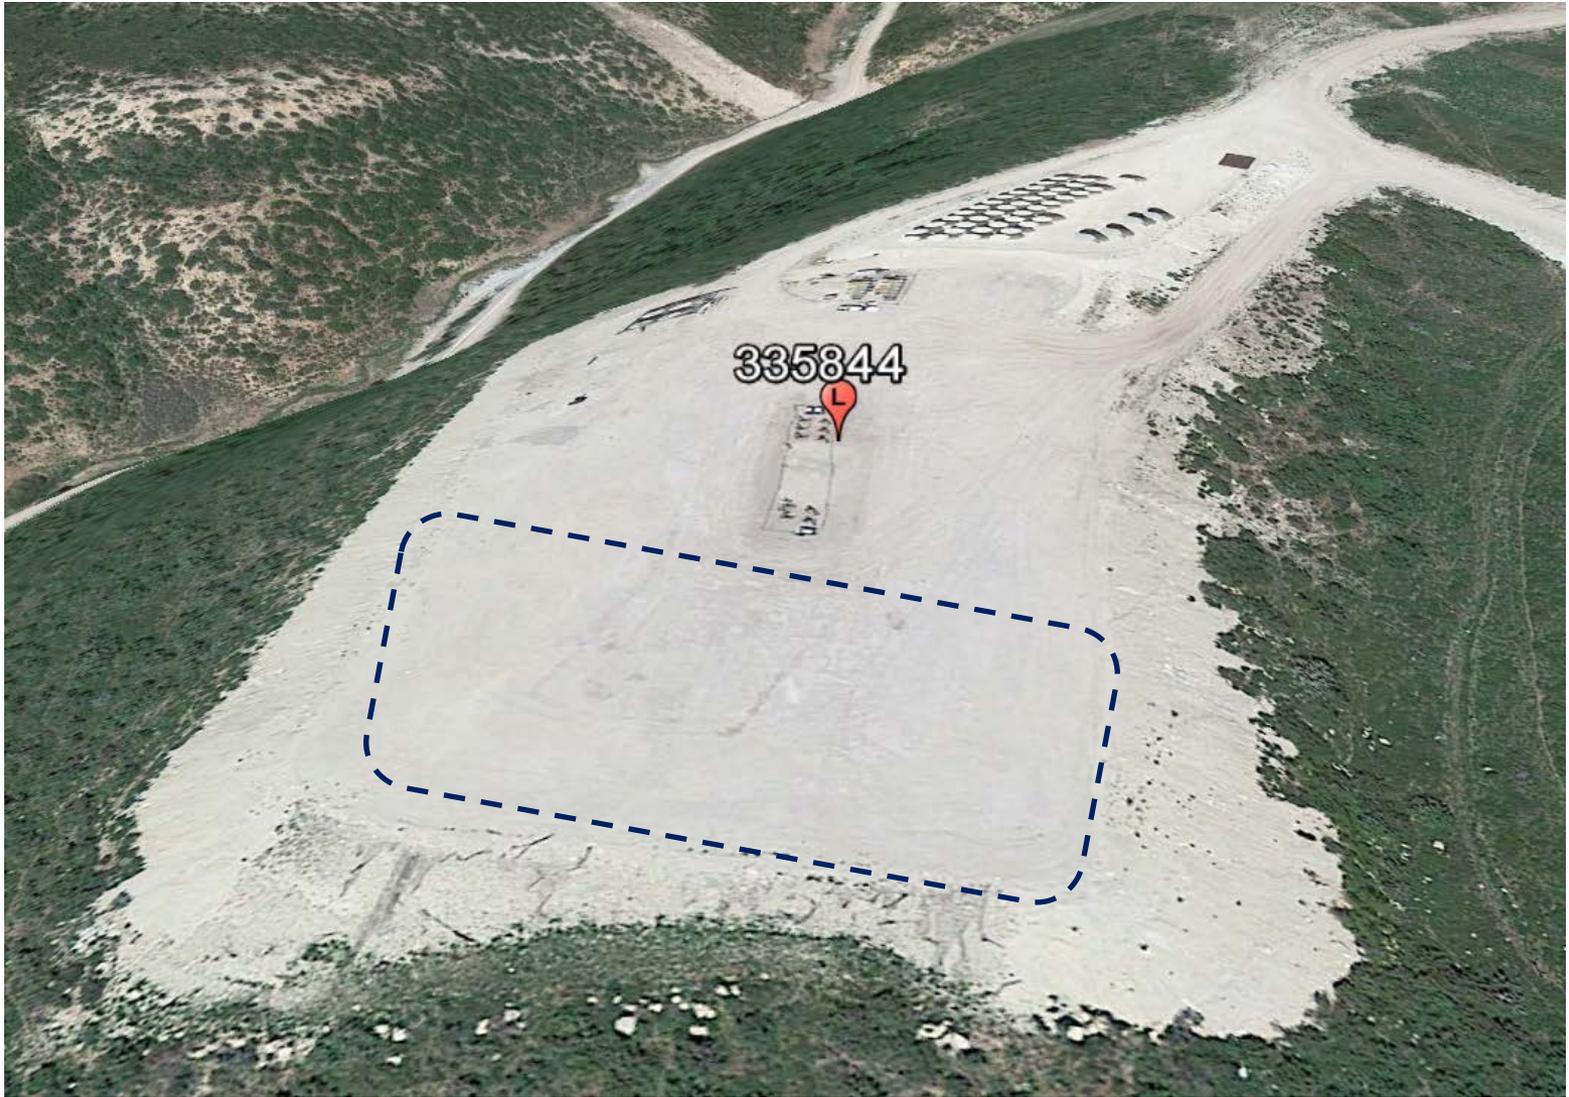
Photo#10: Aerial showing Areas no longer needed for foe Production or Use
