## Final Reclamation Inspection

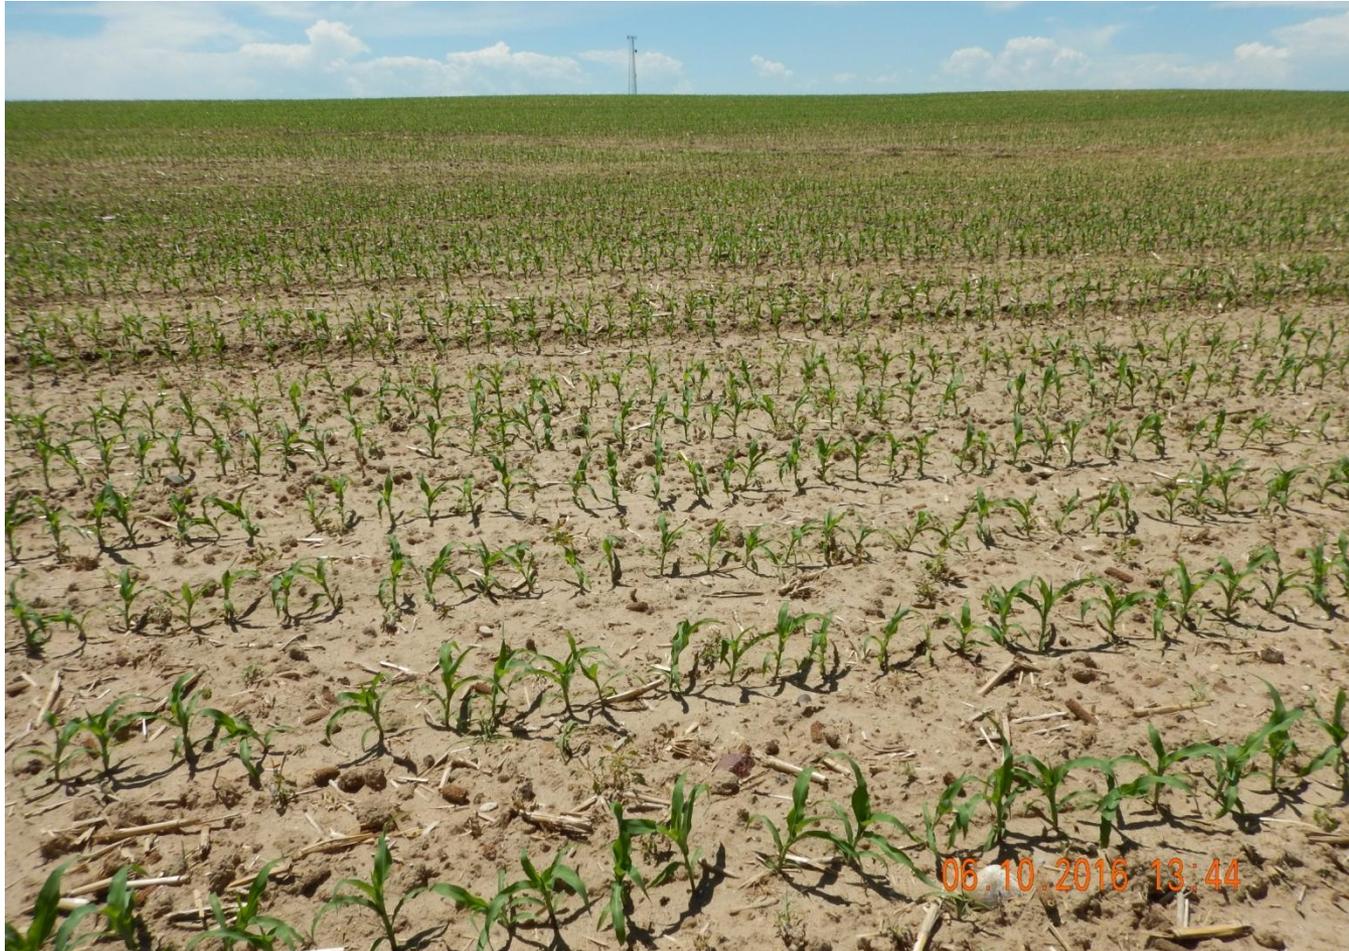
**Photo 1.** Photo taken from center of location, facing West. No evidence of wellbore. Appears to have uniform growth throughout location area. No evidence of noxious weeds present.

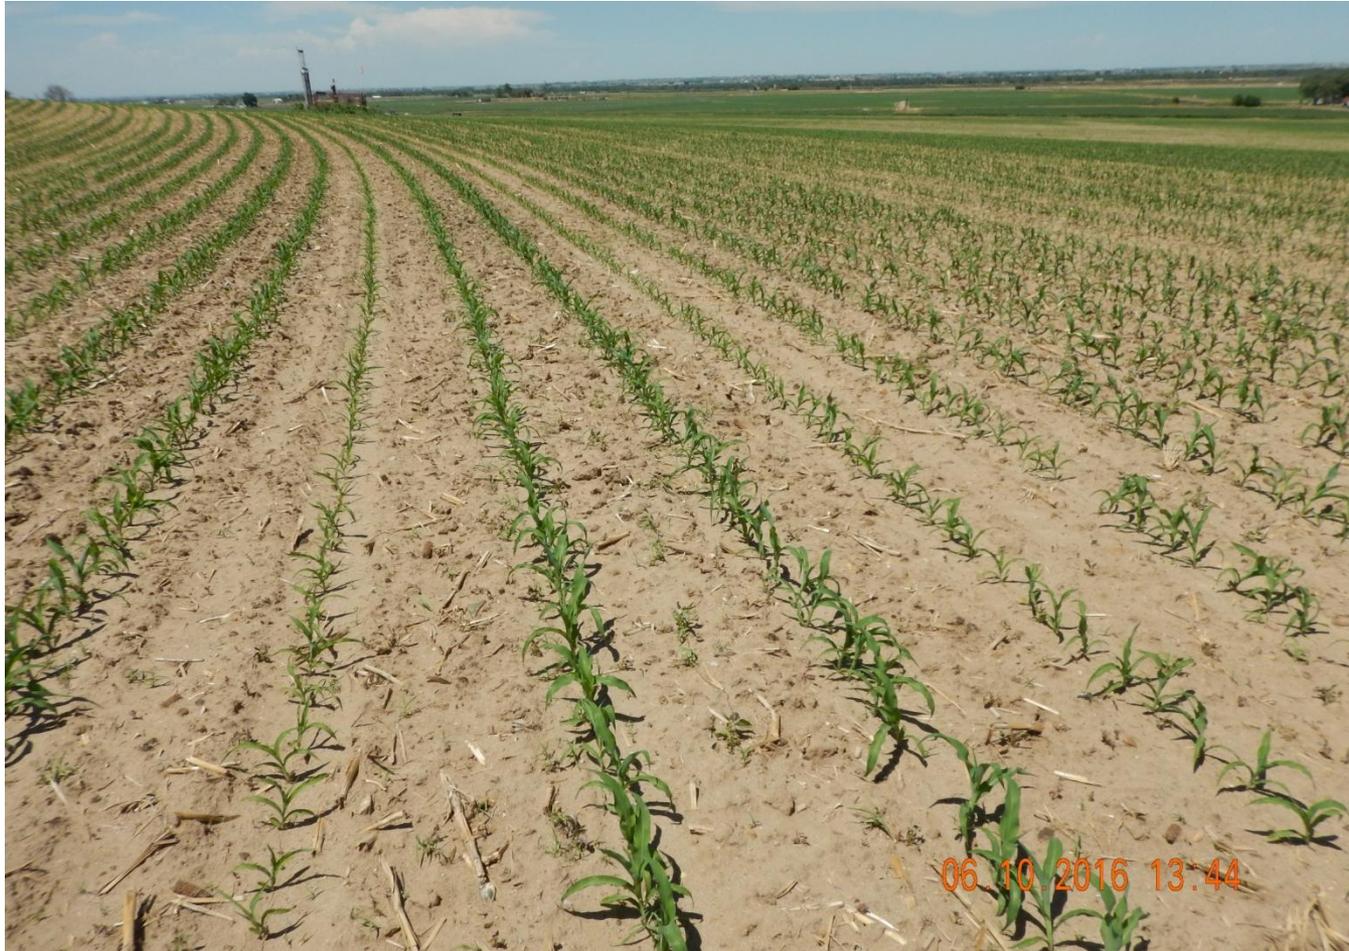
**Photo 2.** Photo taken from center of location, facing North. No evidence of wellbore. Appears to have uniform growth throughout location area. No evidence of noxious weeds present.

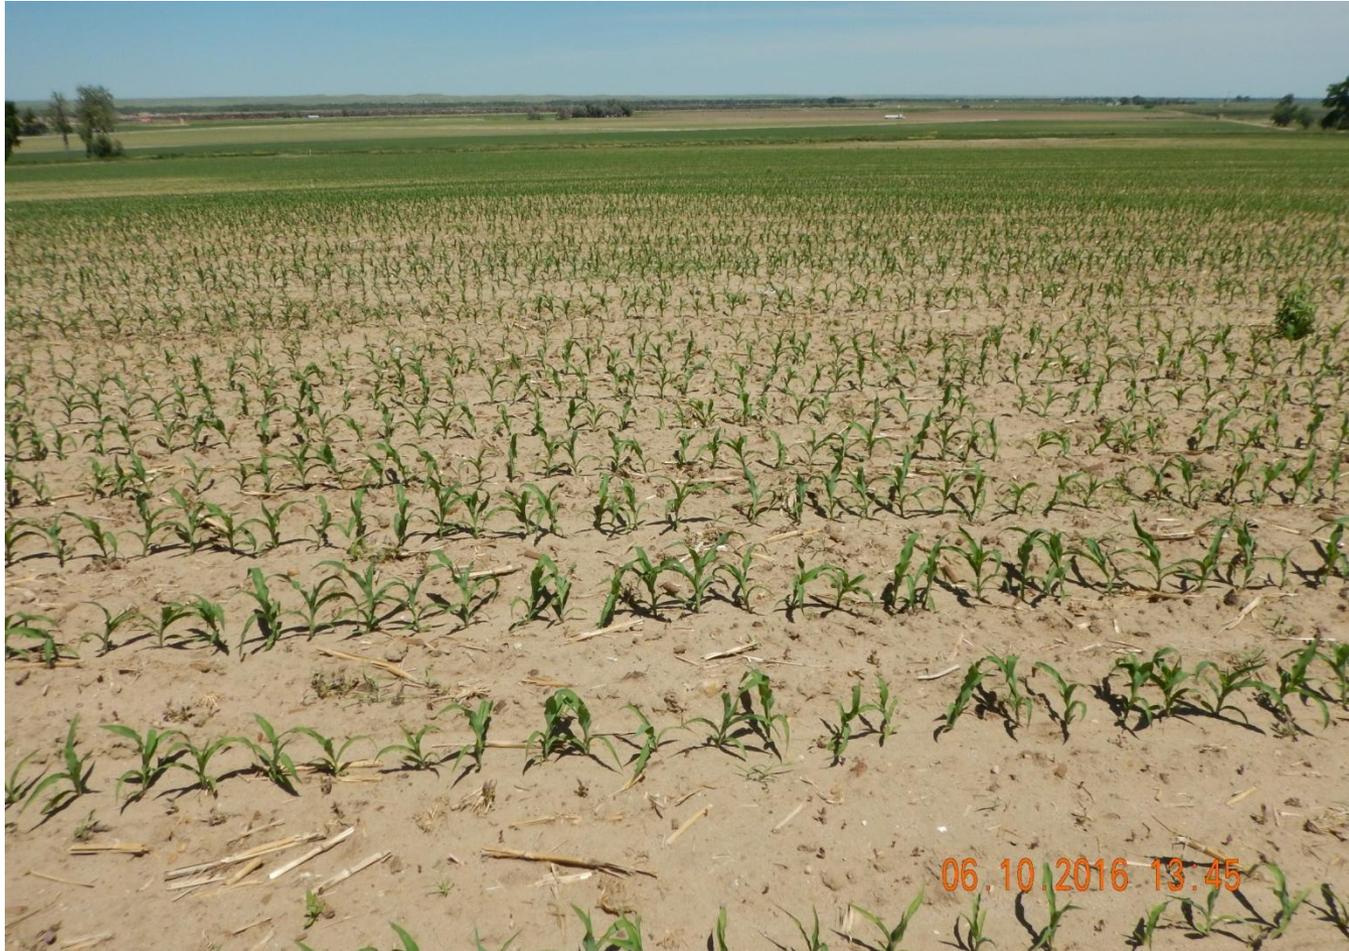
**Photo 3.** Photo taken from center of location, facing East. No evidence of wellbore. Appears to have uniform growth throughout location area. No evidence of noxious weeds present.

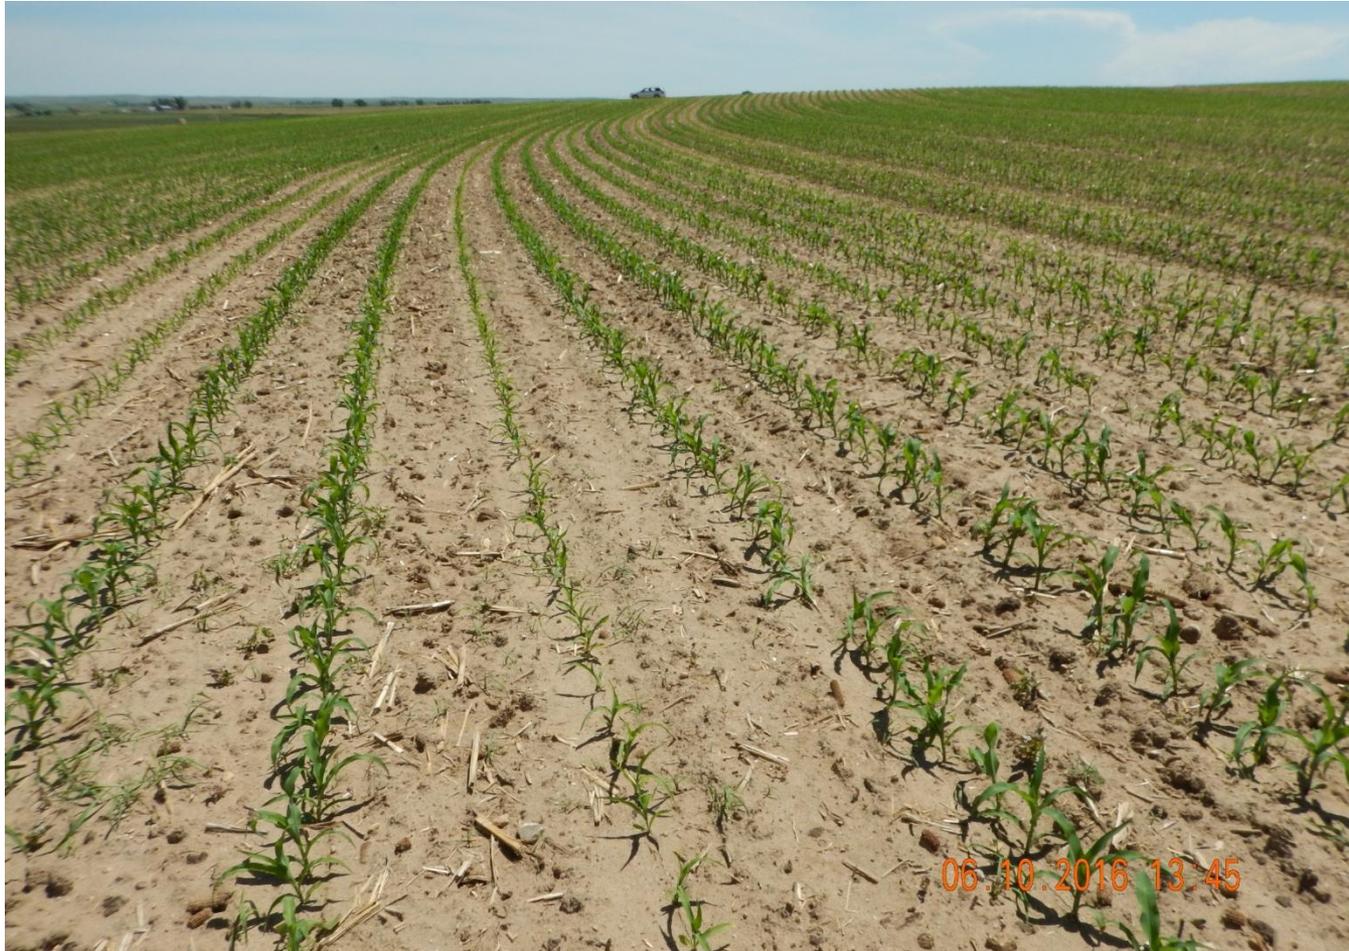
**Photo 4.** Photo taken from center of location, facing South. No evidence of wellbore. Appears to have uniform growth throughout location area. No evidence of noxious weeds present.

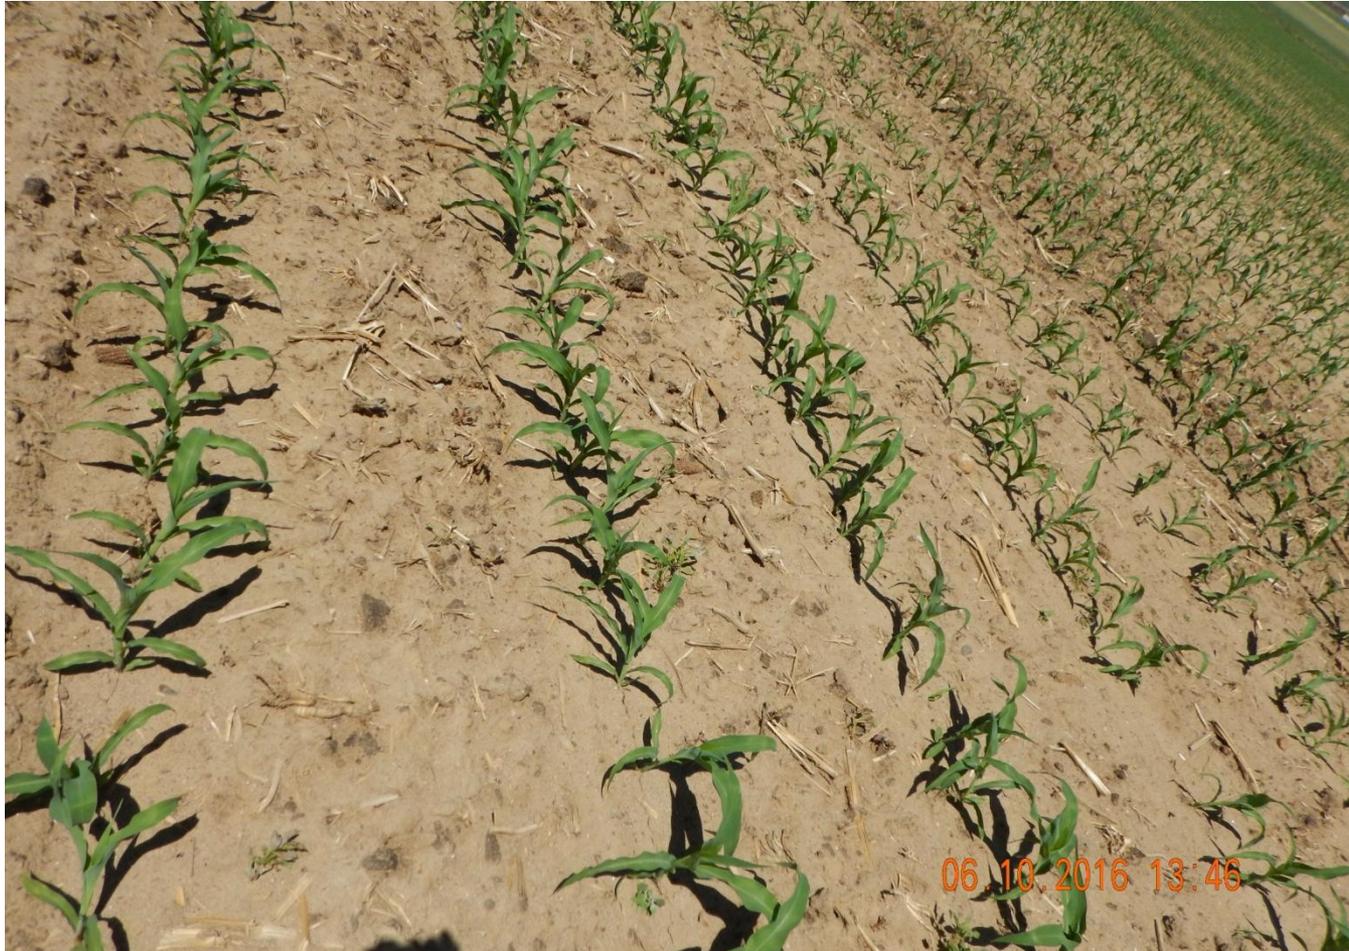
**Photo 7.** Close-up reference photo illustrating comparable vegetative growth from the disturbed area in relation to the reference area
