Final Reclamation Inspection

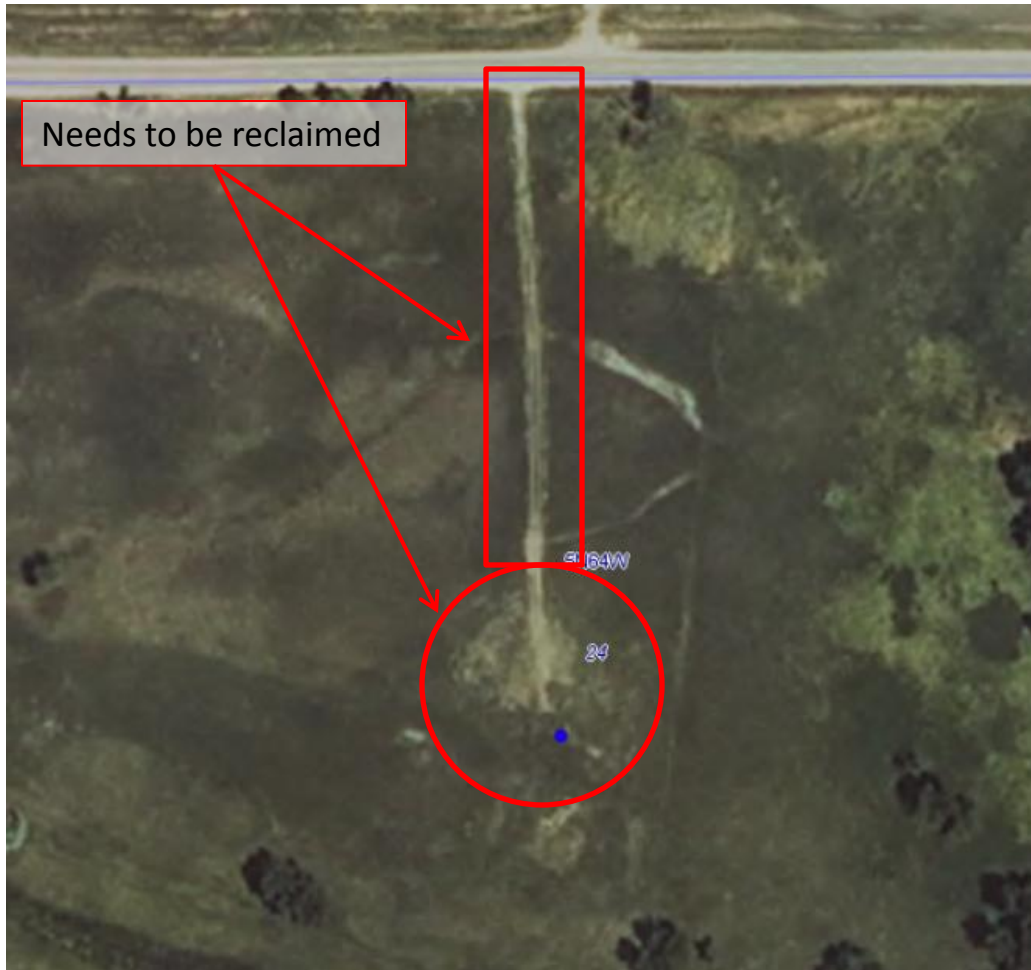
Photo 1. Aerial imagery taken 2013 using COGCC GISOnline illustrating total disturbance that needs to be reclaimed per Rule 1004. Refer to the following pictures.

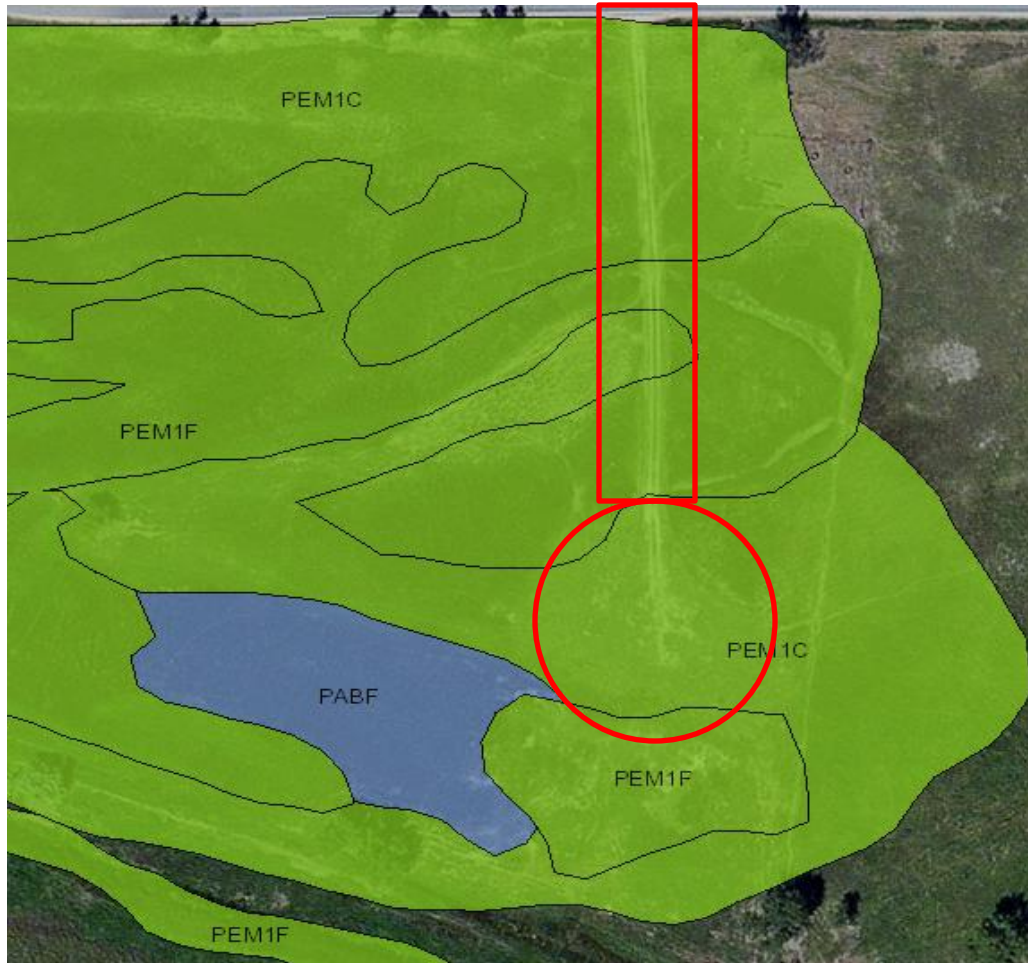
Photo 2. Aerial imagery using the U.S. Fish and Wildlife Service National Wetlands Inventory database. This area is designated to be a Freshwater Emergent Wetland.

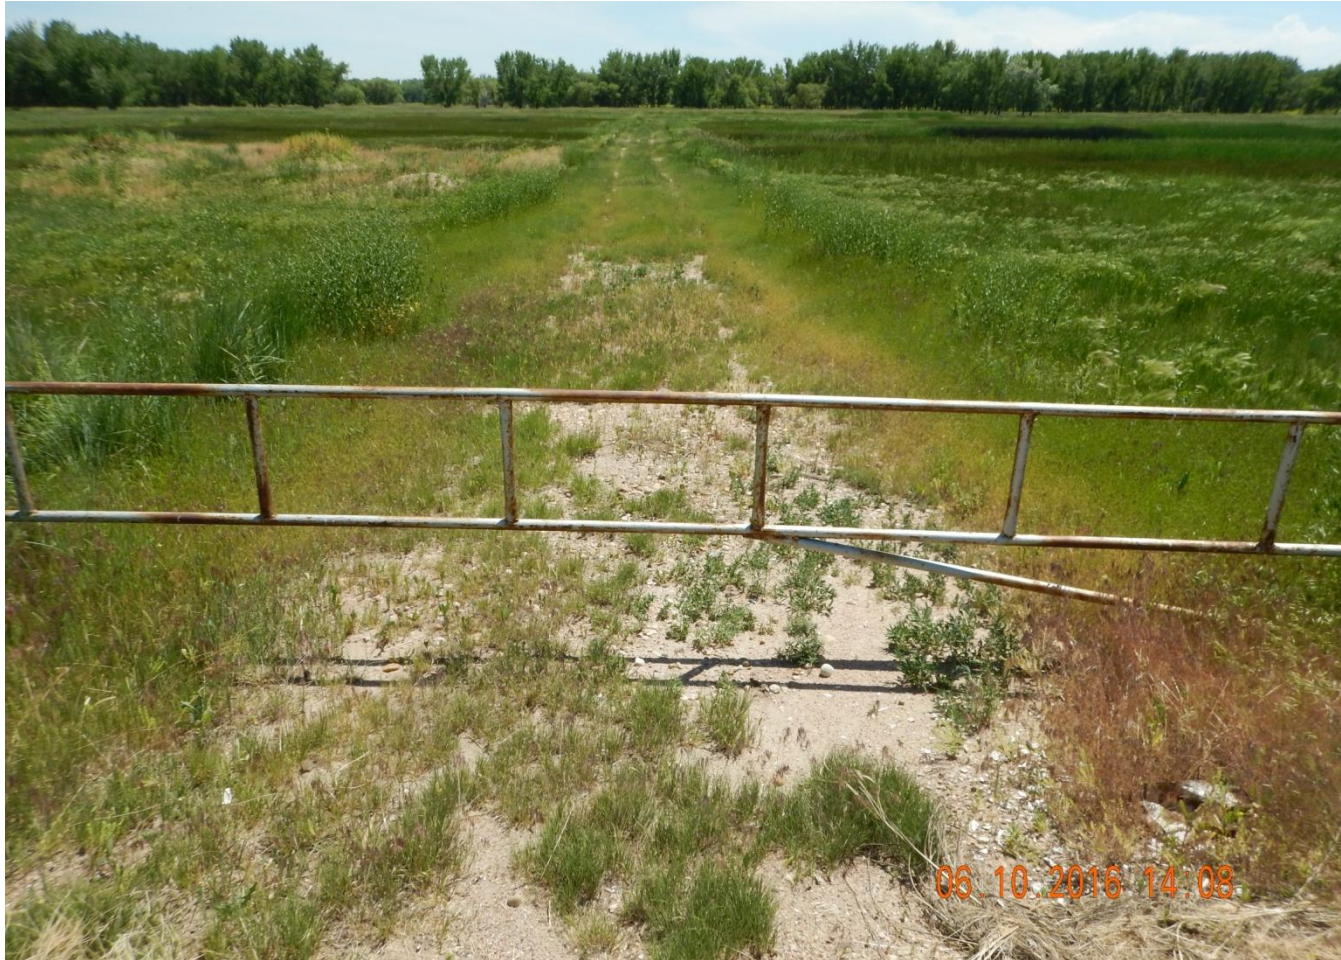
Photo 3. Photo taken from location entrance, facing South. Access road remains and has not been reclaimed per Rule 1004.

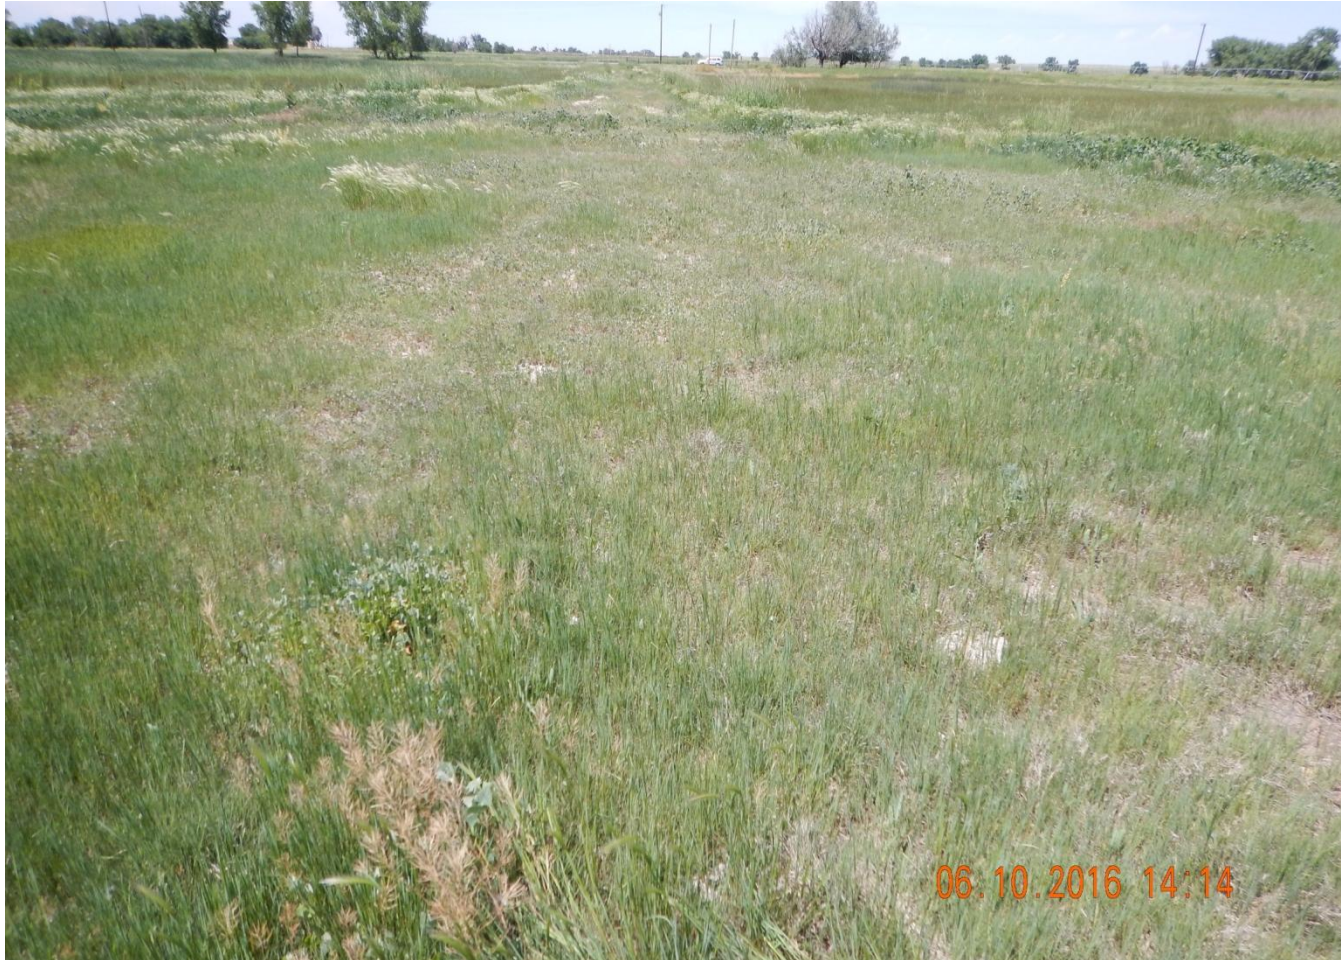
Photo 4. Photo taken from southern location, facing North. Location does not reflect reference area conditions and noxious weeds are present along access road.

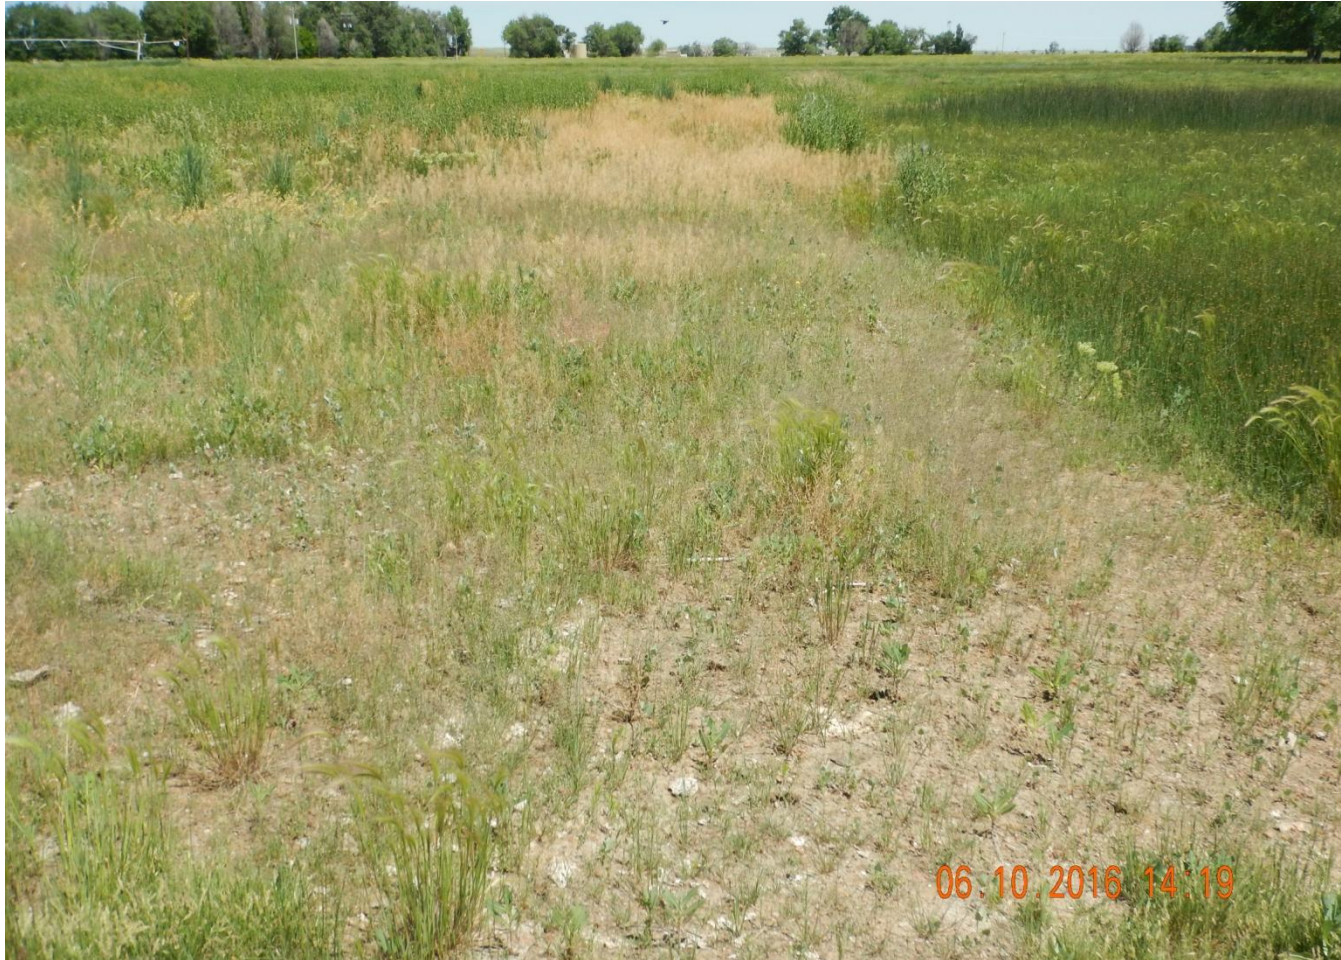
Photo 5. Photo taken from northern access road, facing East. Location does not reflect reference area conditions.

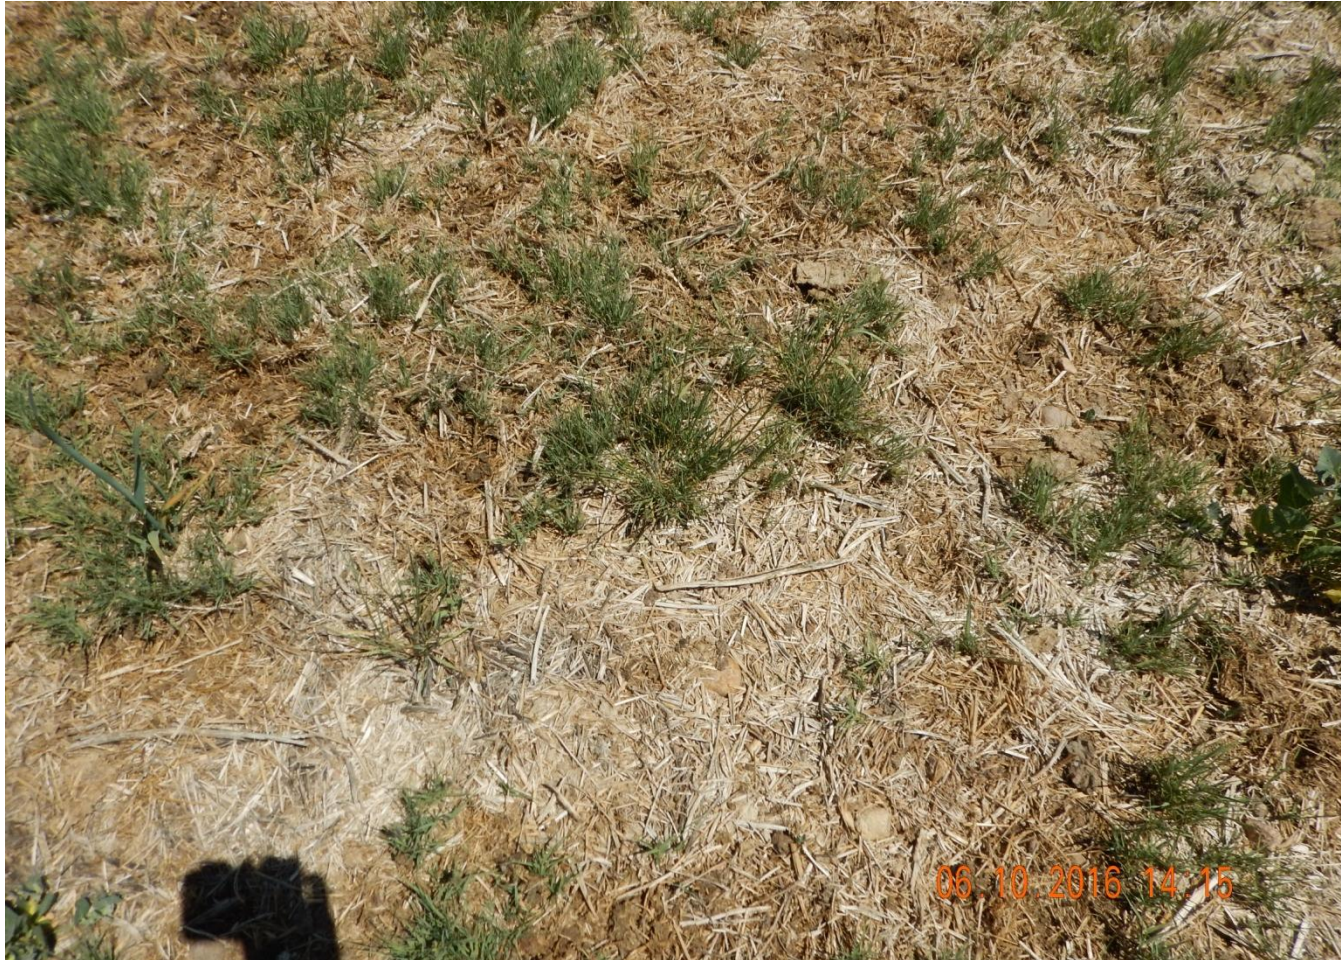
Photo 6. Photo taken from approximate center of location. It appears a seeding attempt was made.

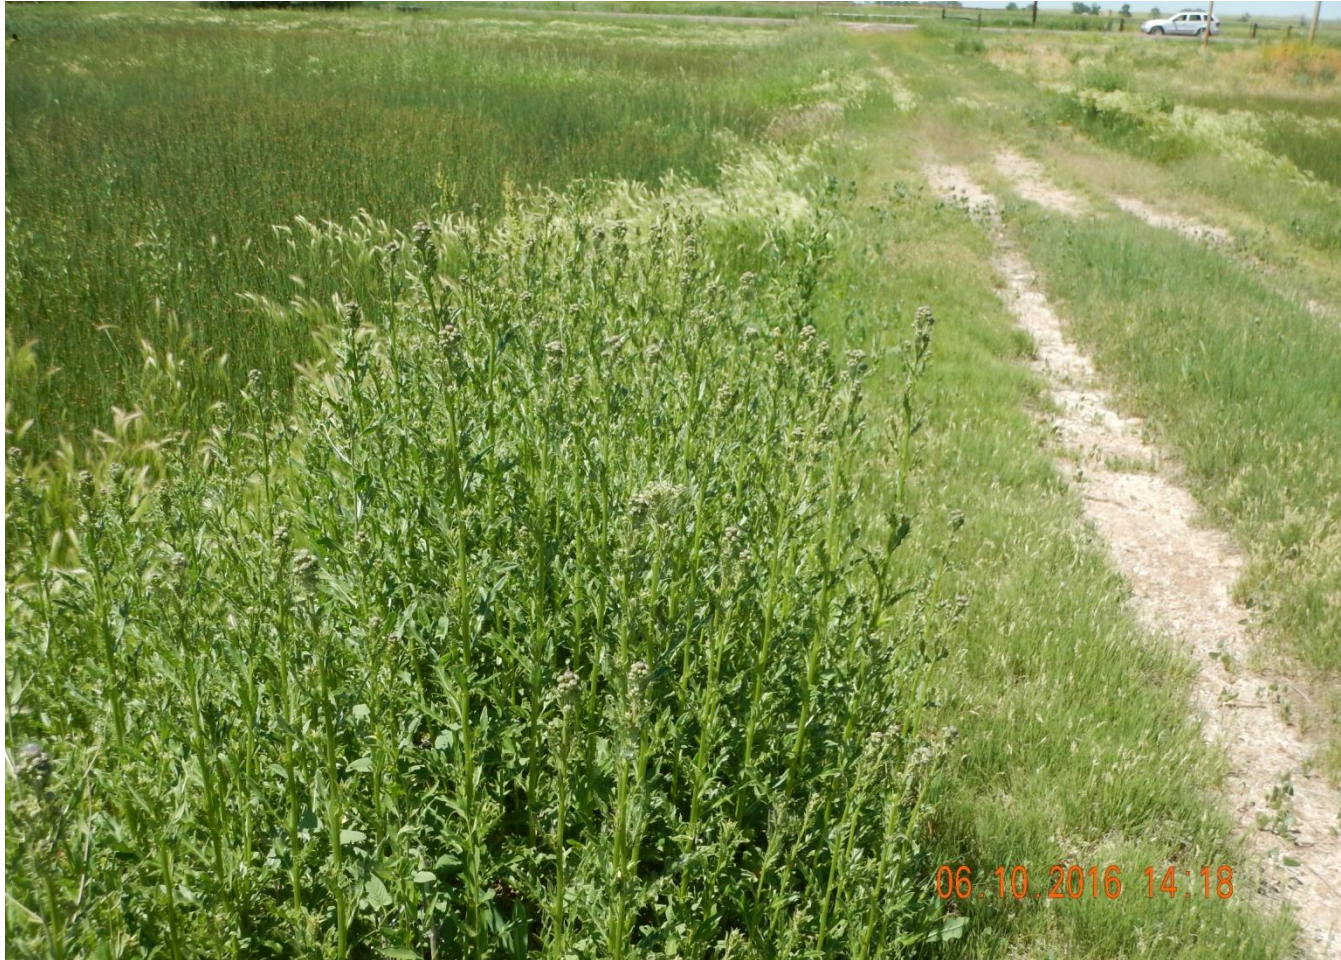
Photo 7. Photo taken along access road, facing North. List B Colorado Noxious weed species, Canada thistle (*Cirsium arvense*), exists along access road.

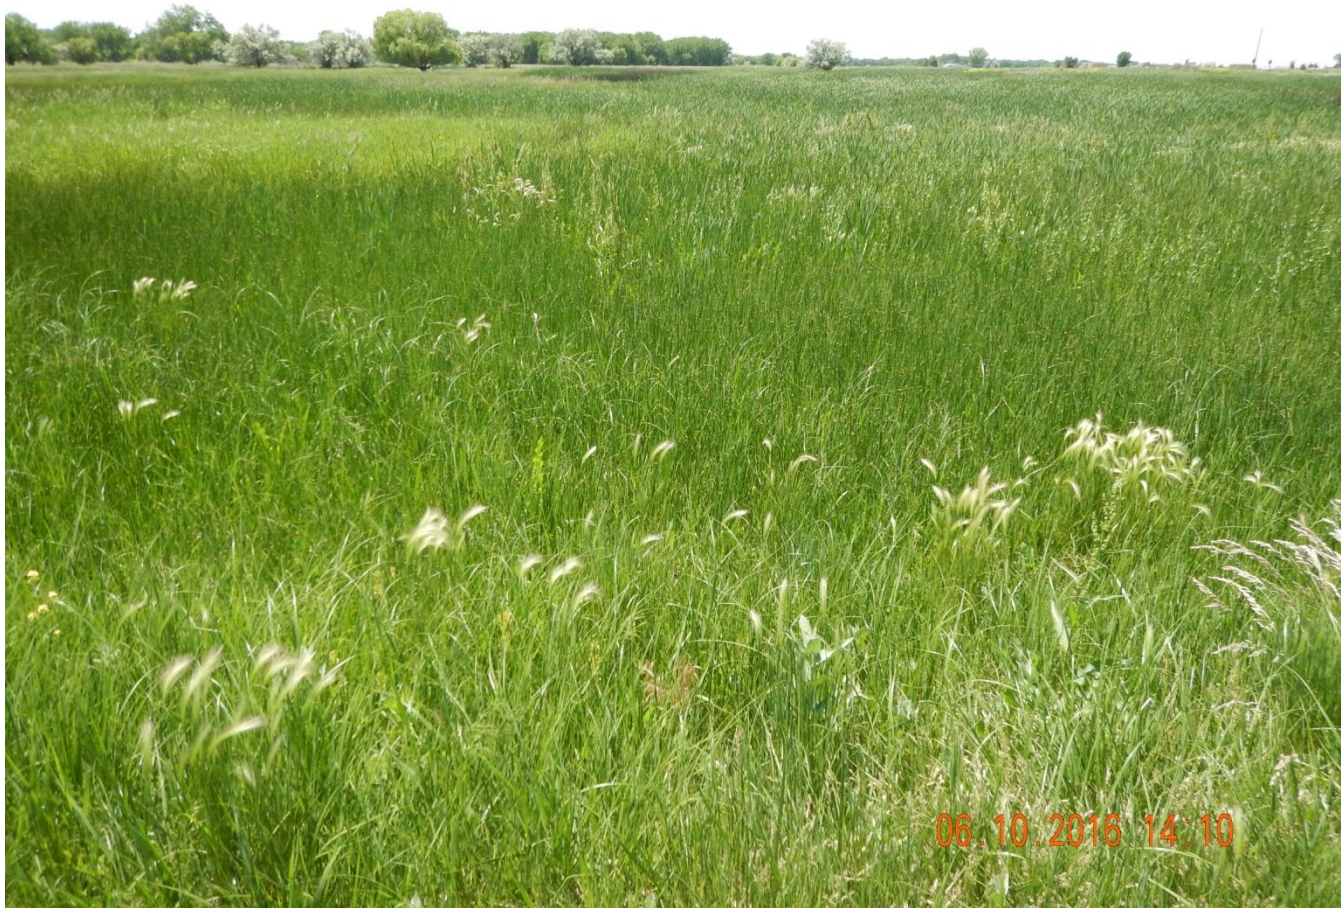
Photo 8. Reference photo illustrating vegetative composition that is not reflective throughout the location.
