Final Reclamation Inspection

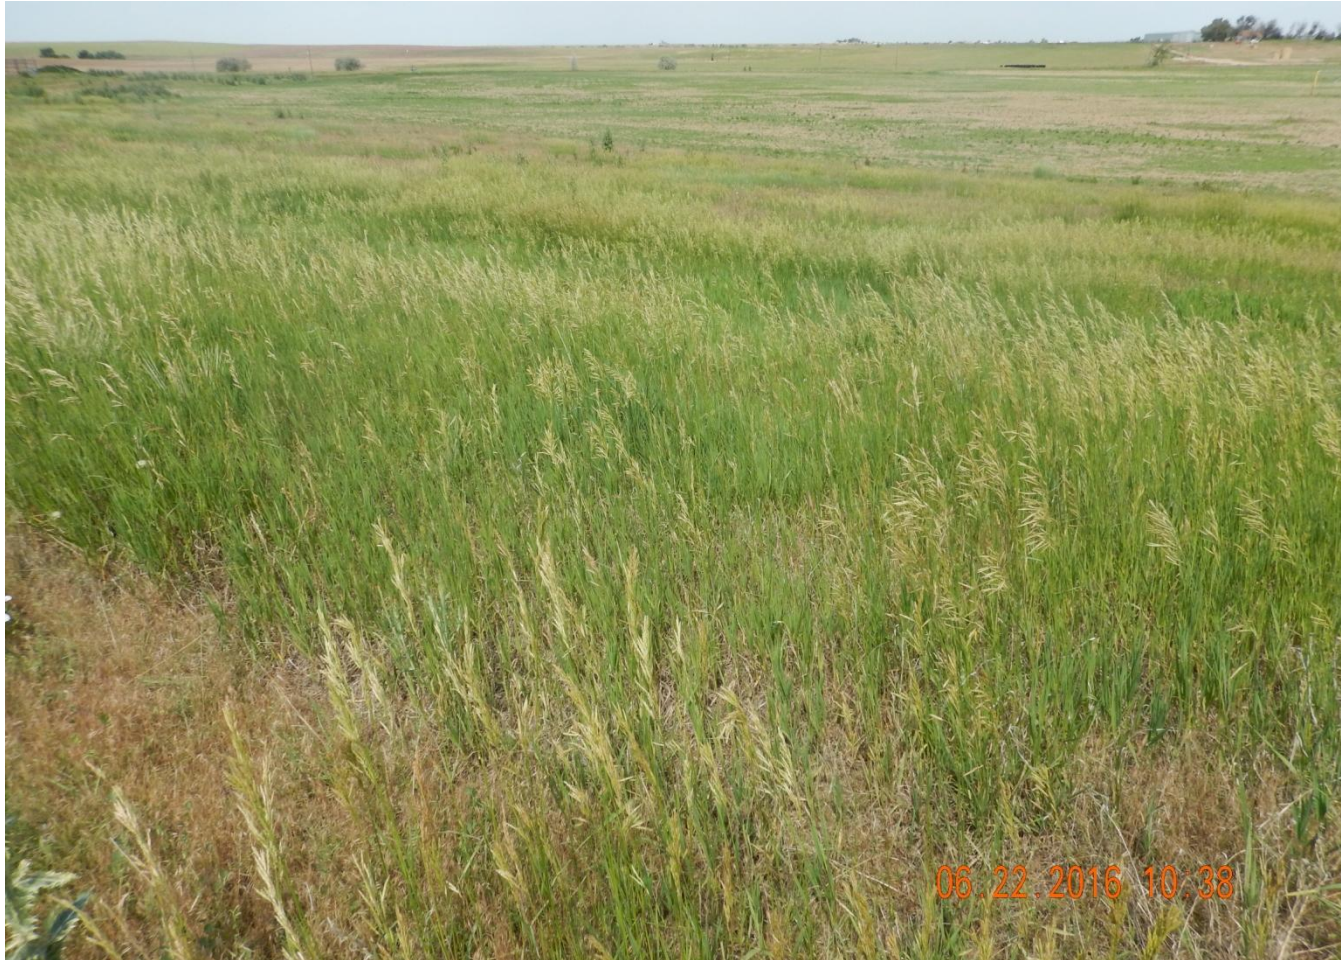
Photo 1. Photo taken from center of location, facing West. No evidence of disturbance. Uniform vegetative growth throughout location.

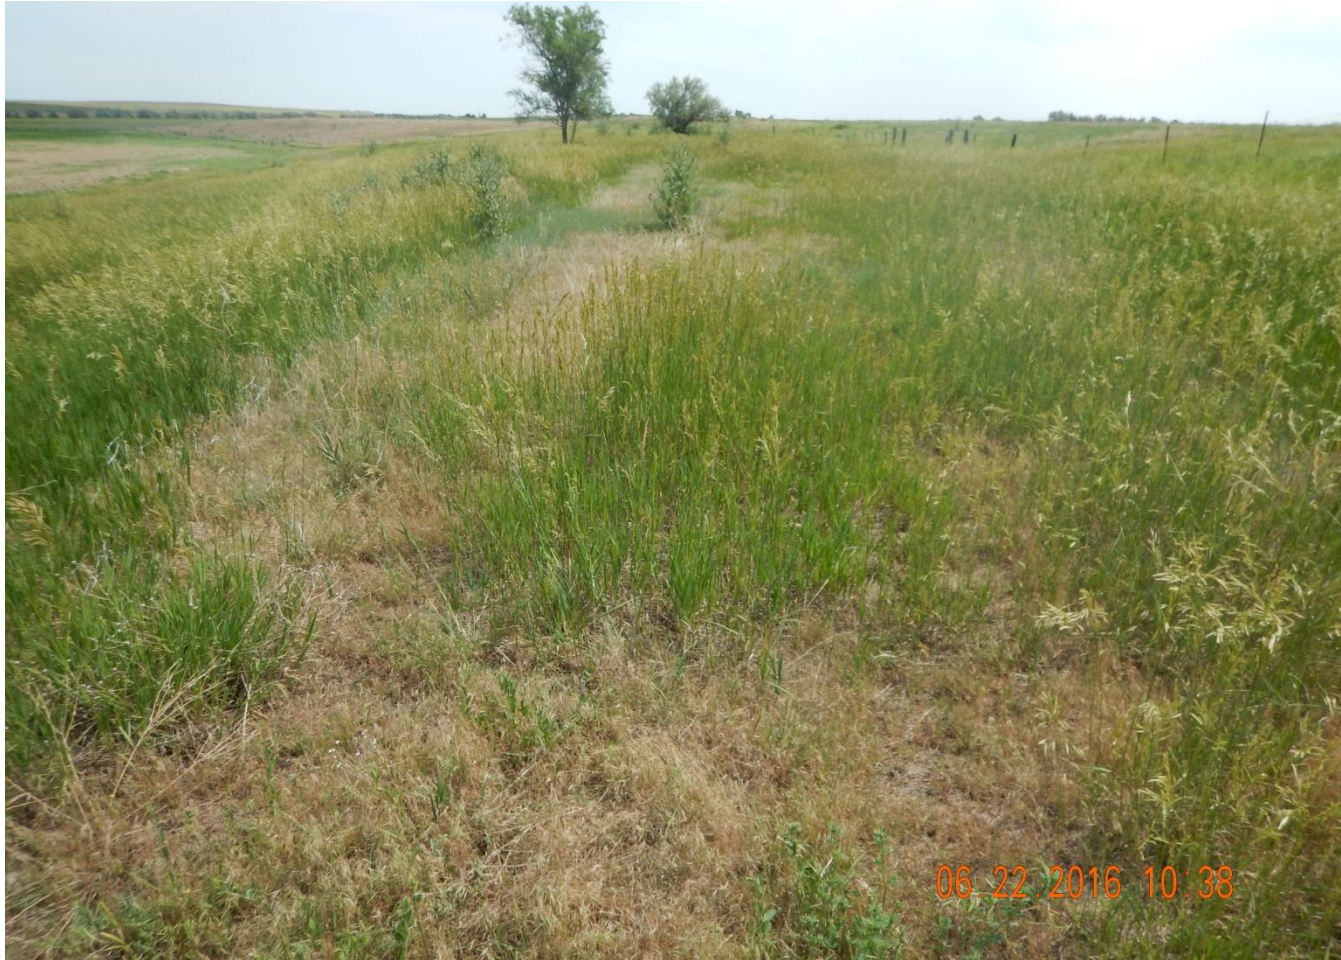
Photo 2. Photo taken from center of location, facing North. No evidence of disturbance. Uniform vegetative growth throughout location.

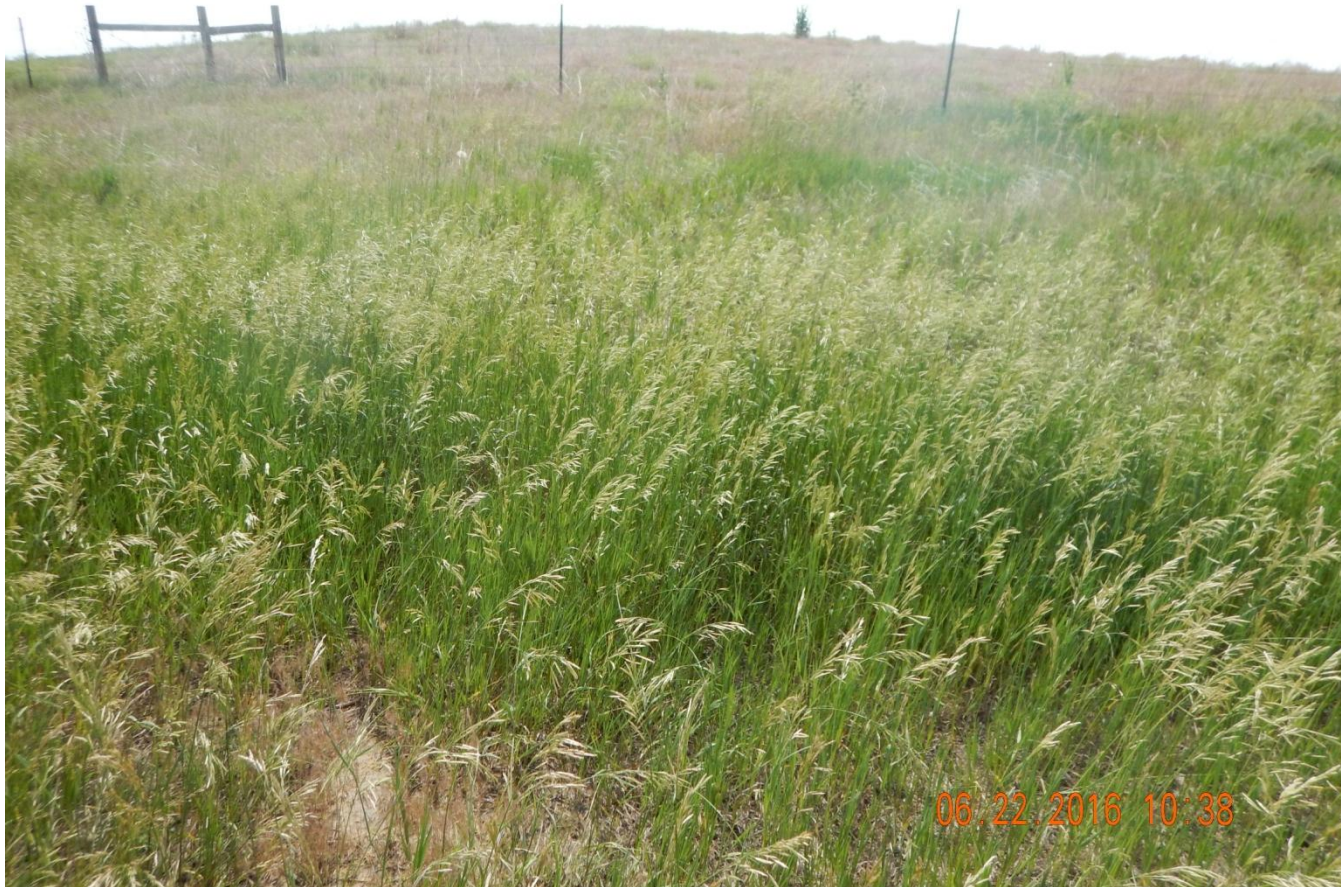
Photo 3. Photo taken from center of location, facing East. No evidence of disturbance. Uniform vegetative growth throughout location.

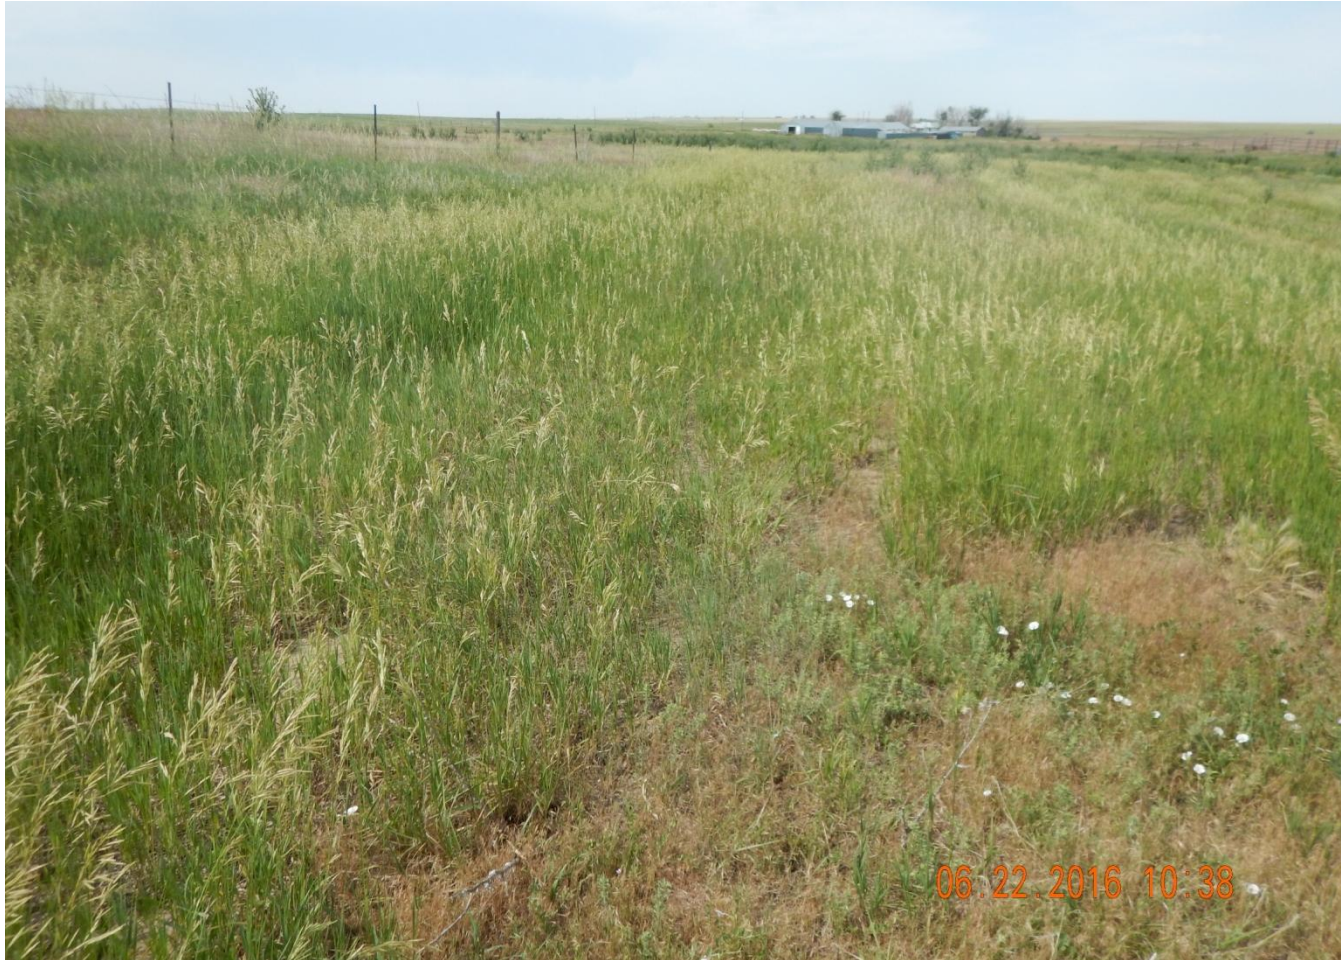
Photo 4. Photo taken from center of location, facing South. No evidence of disturbance. Uniform vegetative growth throughout location.

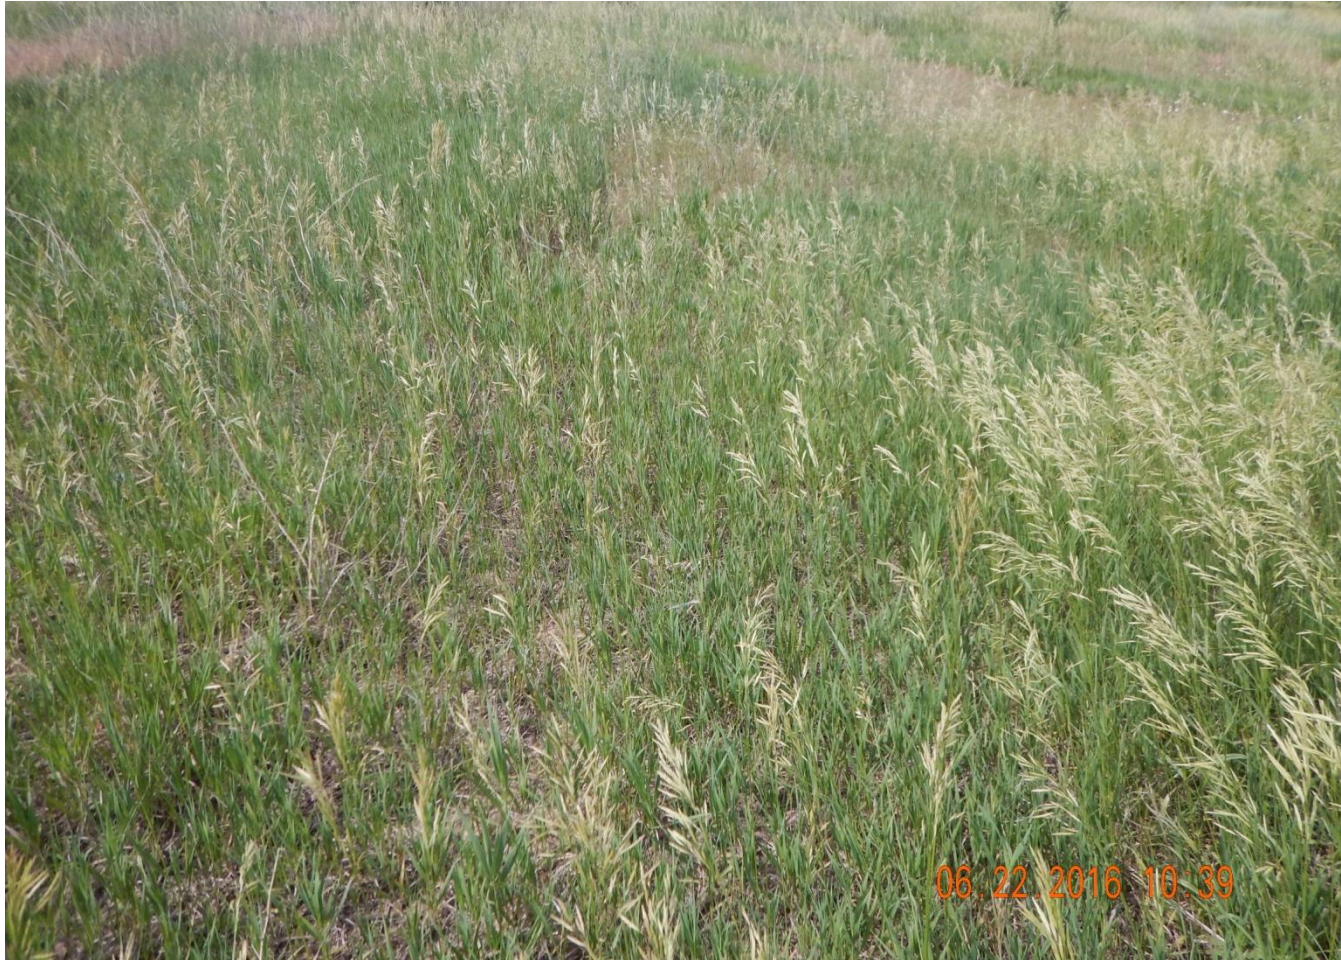
Photo 5. Reference photo taken west of location. Location appears to be reflective of the reference area.
