Final Reclamation Inspection

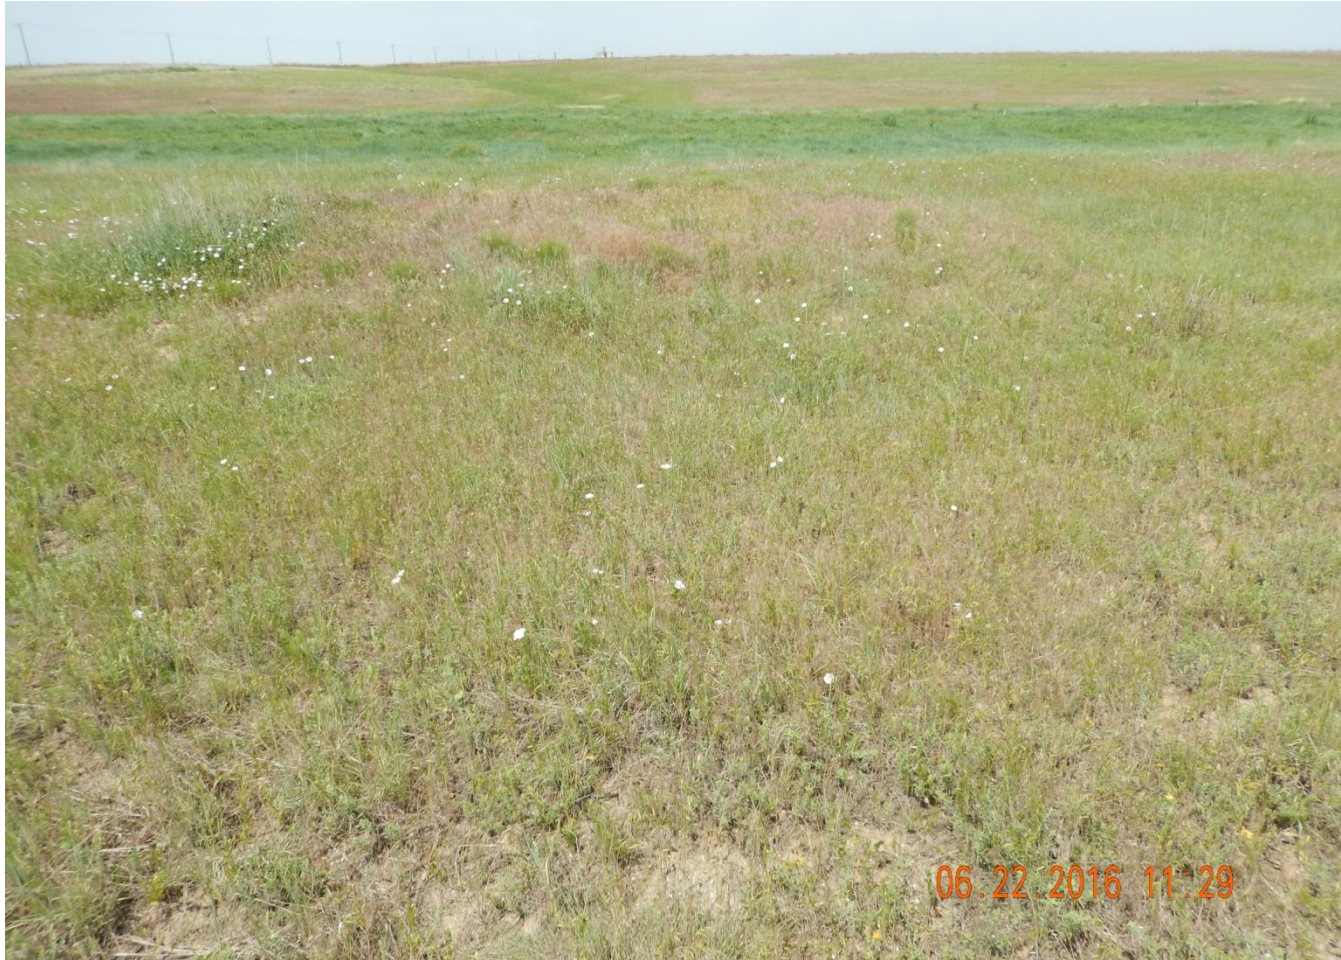
Photo 1. Photo taken from center of location, facing West. No evidence of disturbance. Uniform vegetative growth throughout location.

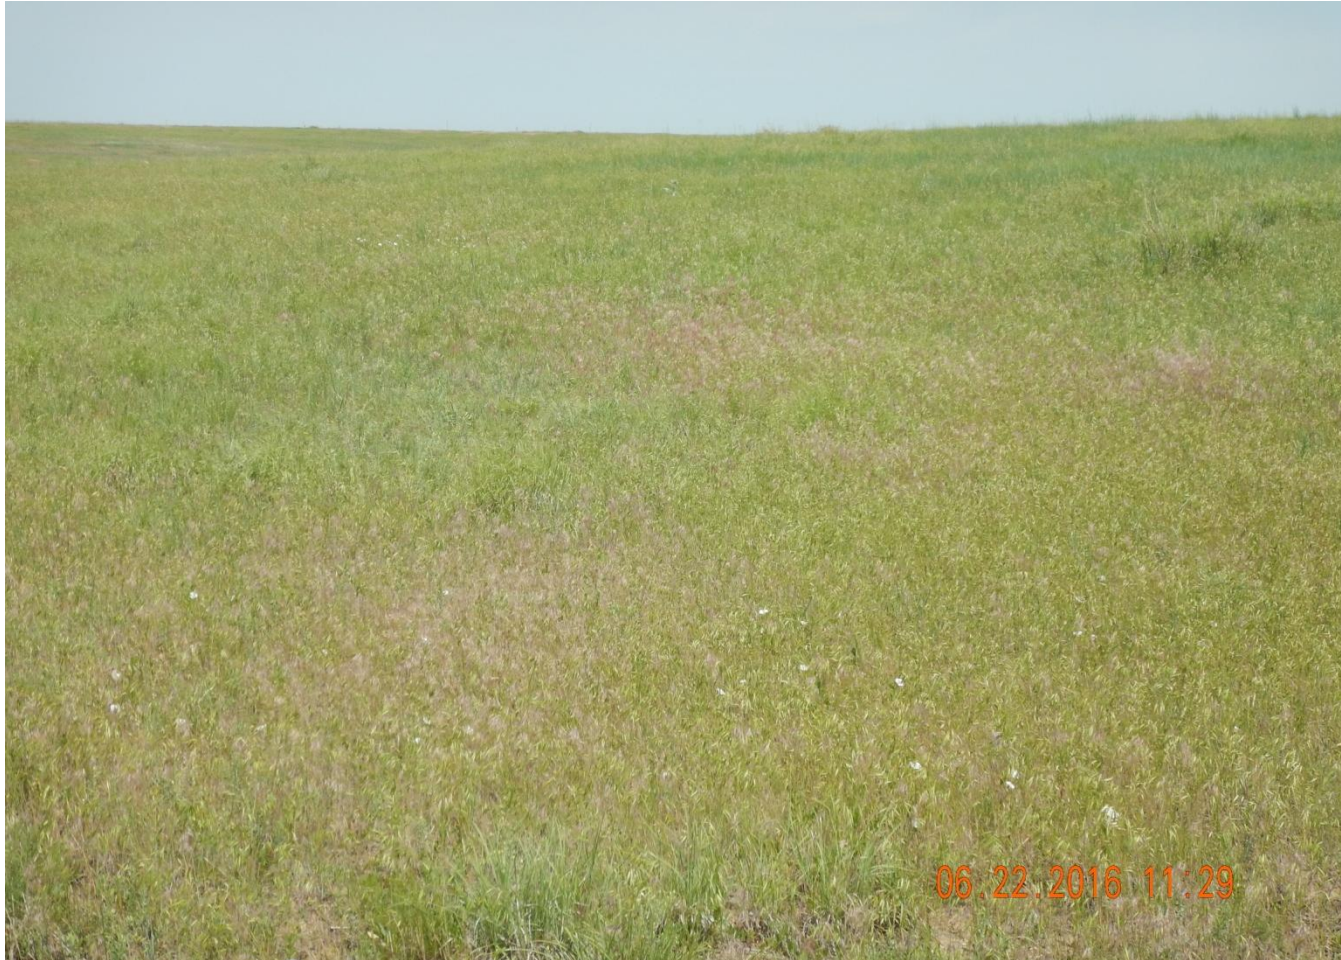
Photo 2. Photo taken from center of location, facing North. No evidence of disturbance. Uniform vegetative growth throughout location.

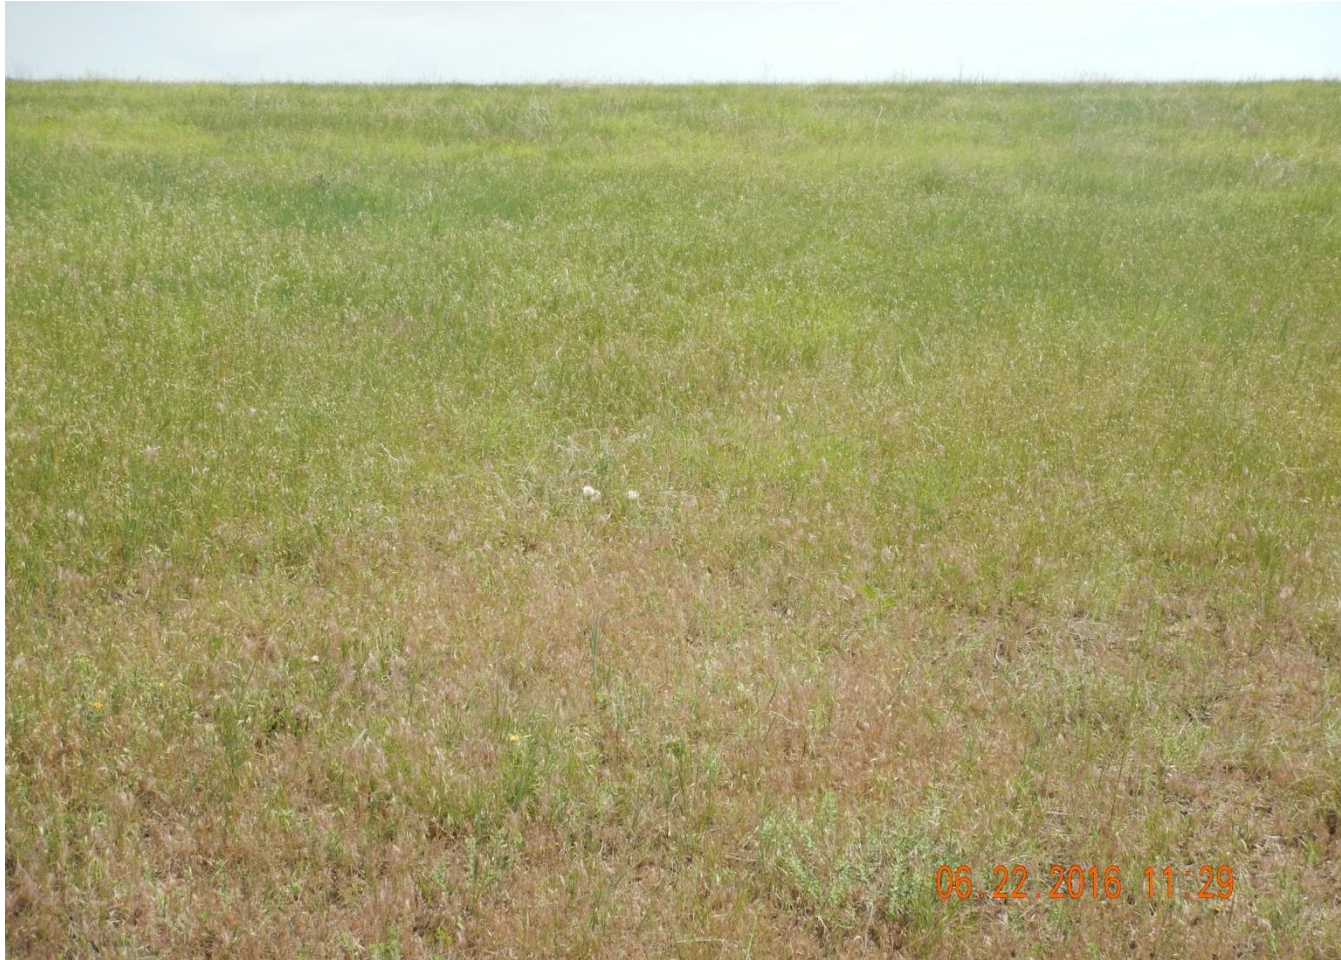
Photo 3. Photo taken from center of location, facing East. No evidence of disturbance. Uniform vegetative growth throughout location.

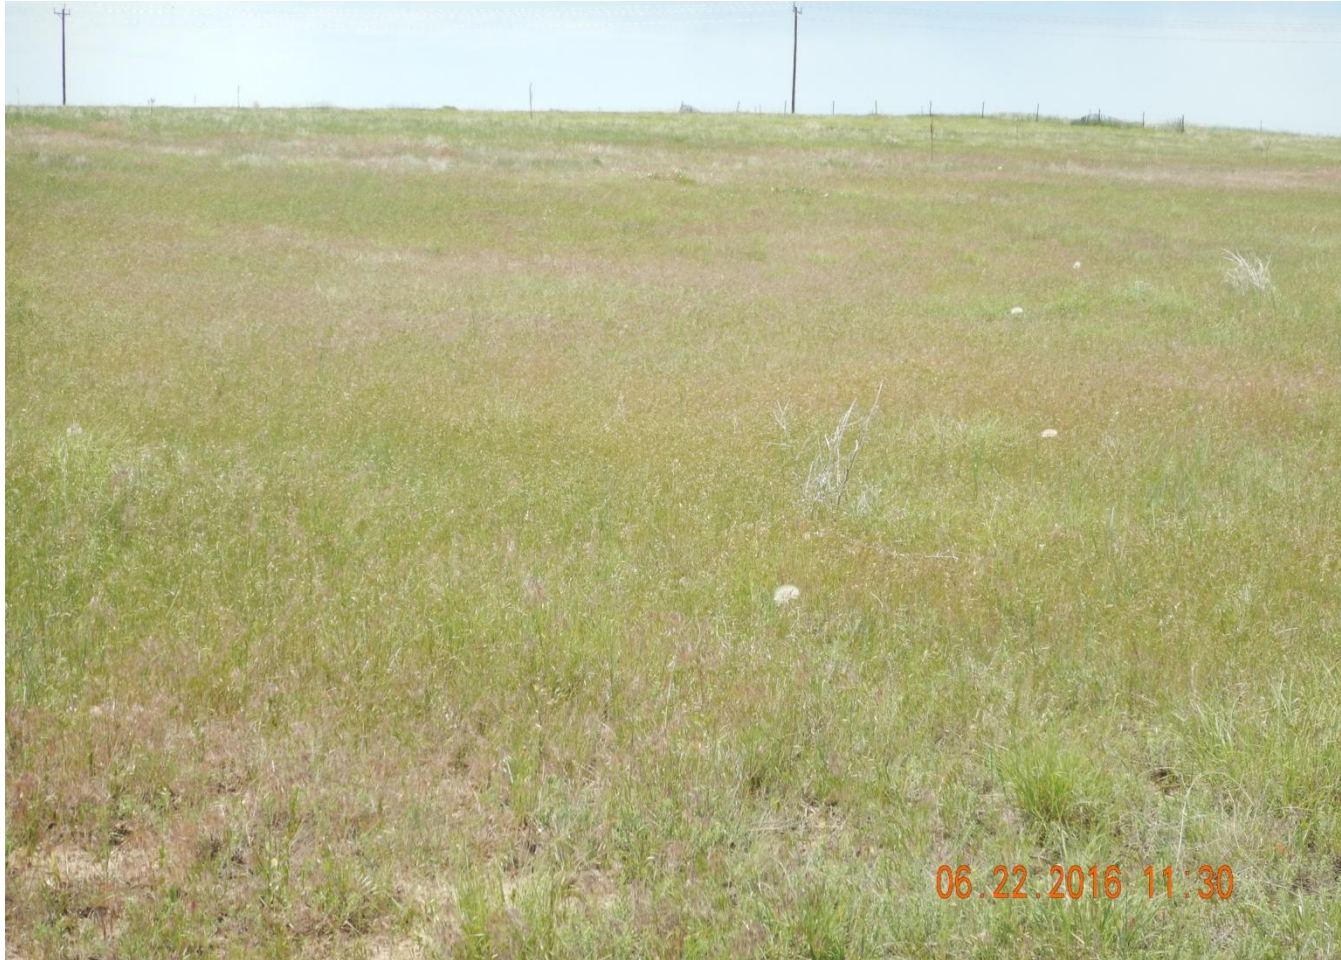
Photo 4. Photo taken from center of location, facing South. No evidence of disturbance. Uniform vegetative growth throughout location.

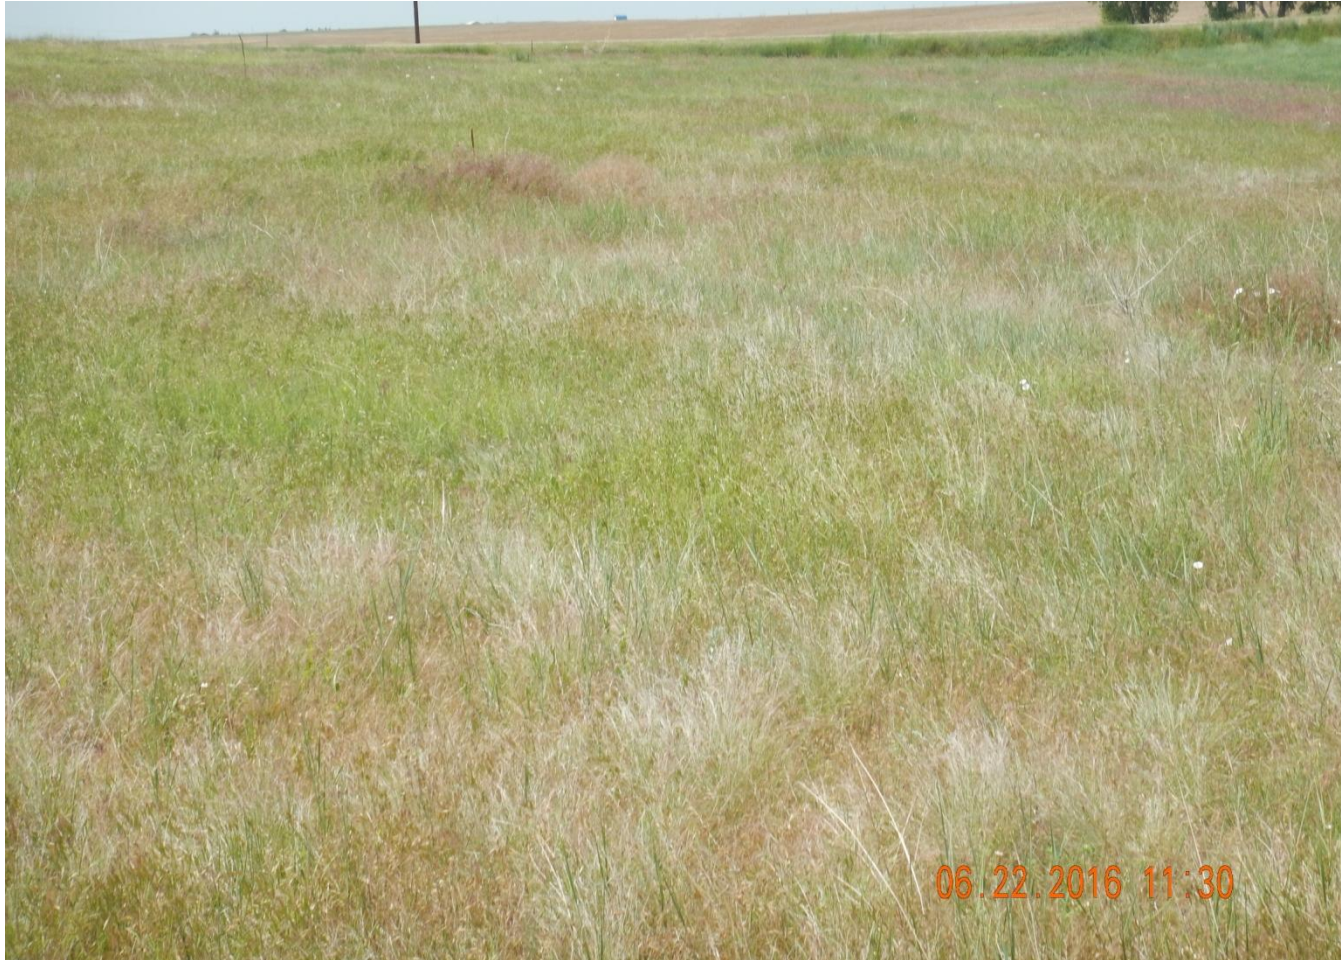
Photo 5. Reference photo taken southwest of location, facing South. Location appears to be reflective of the reference area.
