# Final Reclamation Inspection

06/28/2016

Operator: Petro-Canada

Location ID: 311680

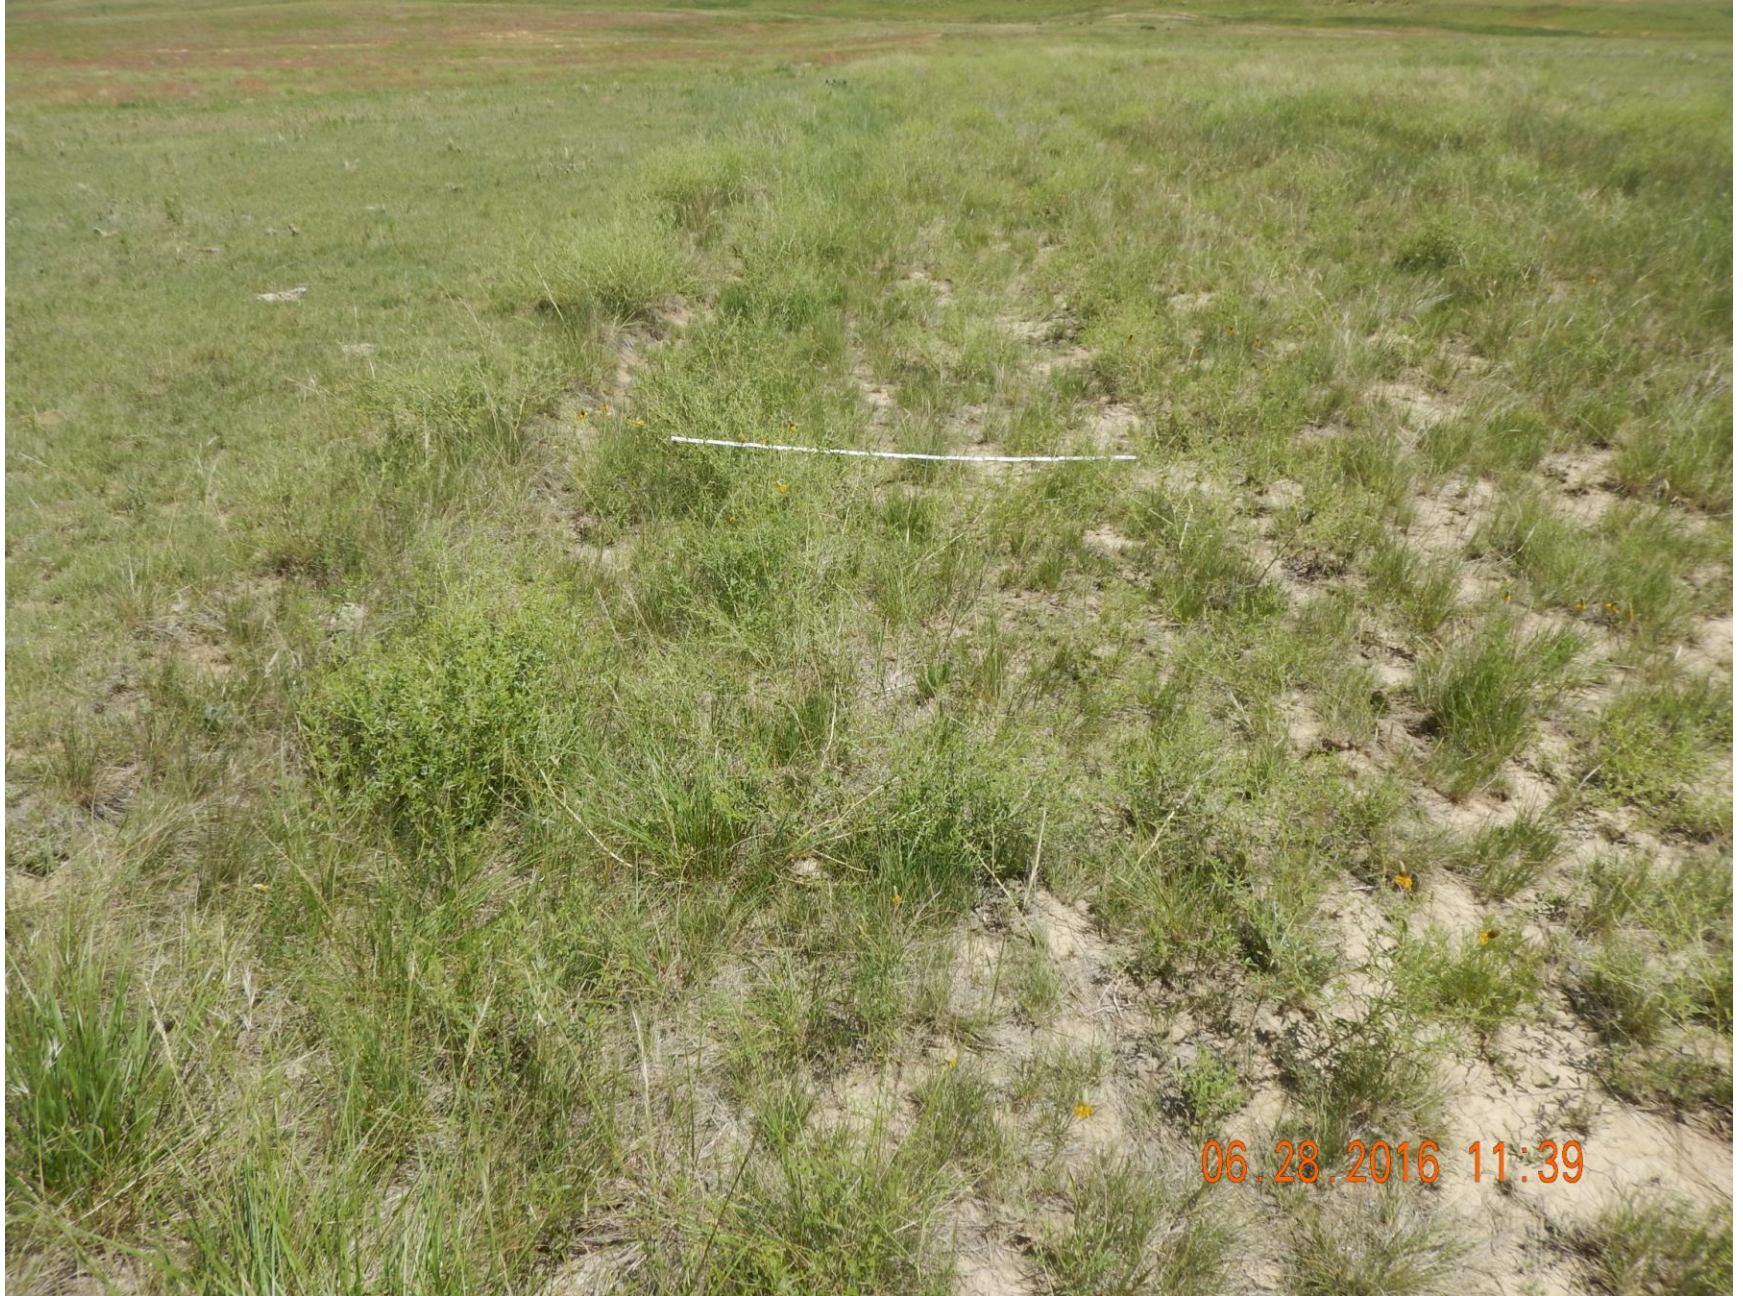
**Figure 1:** Photo taken from access road southeast of the location, facing north. Photo shows access road had not been recontoured, vegetation has not achieved 80% to reference. 6' measuring stick for reference.

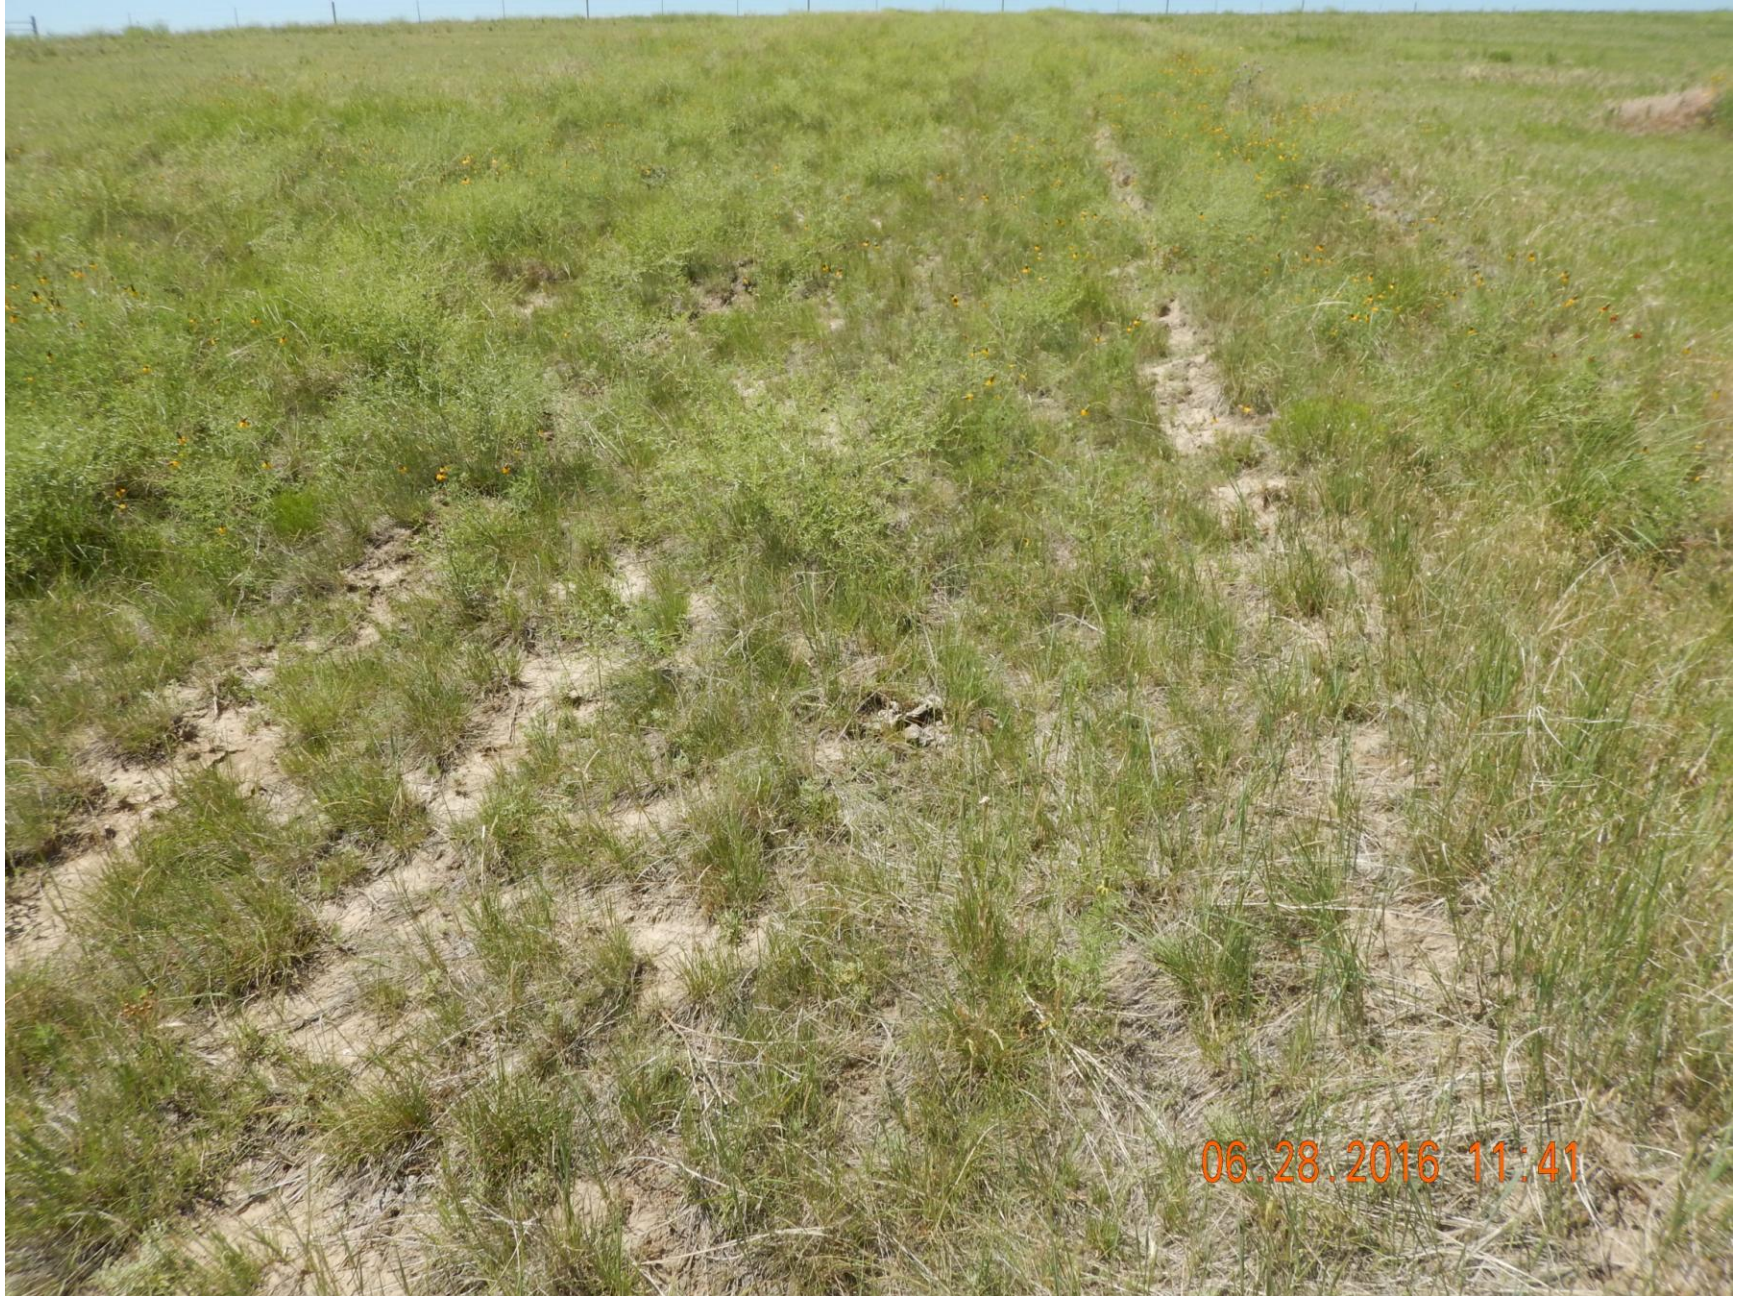
**Figure 2:** Photo taken from access road southeast of the location, facing south. Photo shows access road had not been recontoured, vegetation has not achieved 80% to reference.

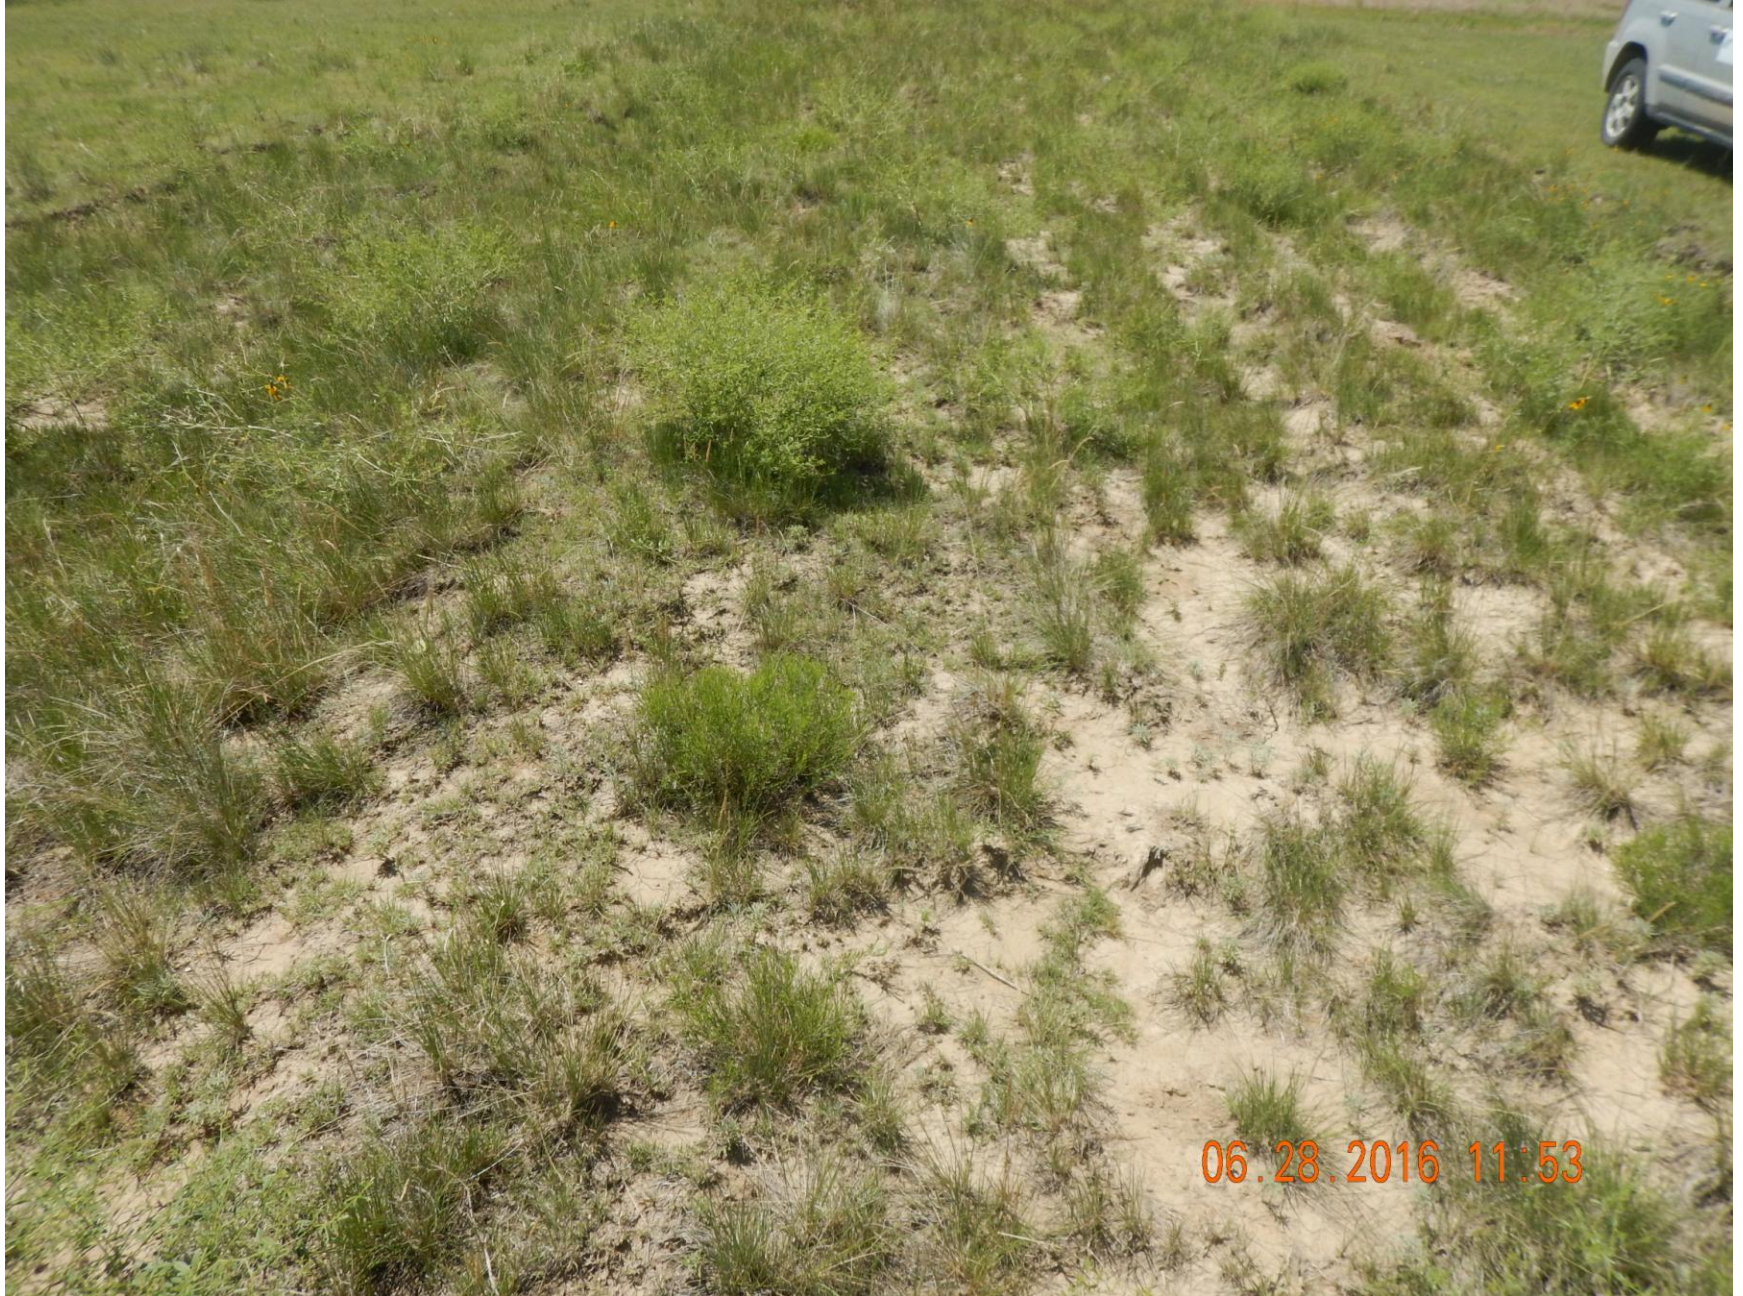
**Figure 3:** Photo taken from access road southeast of the location, facing south. Photo shows access road had not been recontoured, vegetation has not achieved 80% to reference.

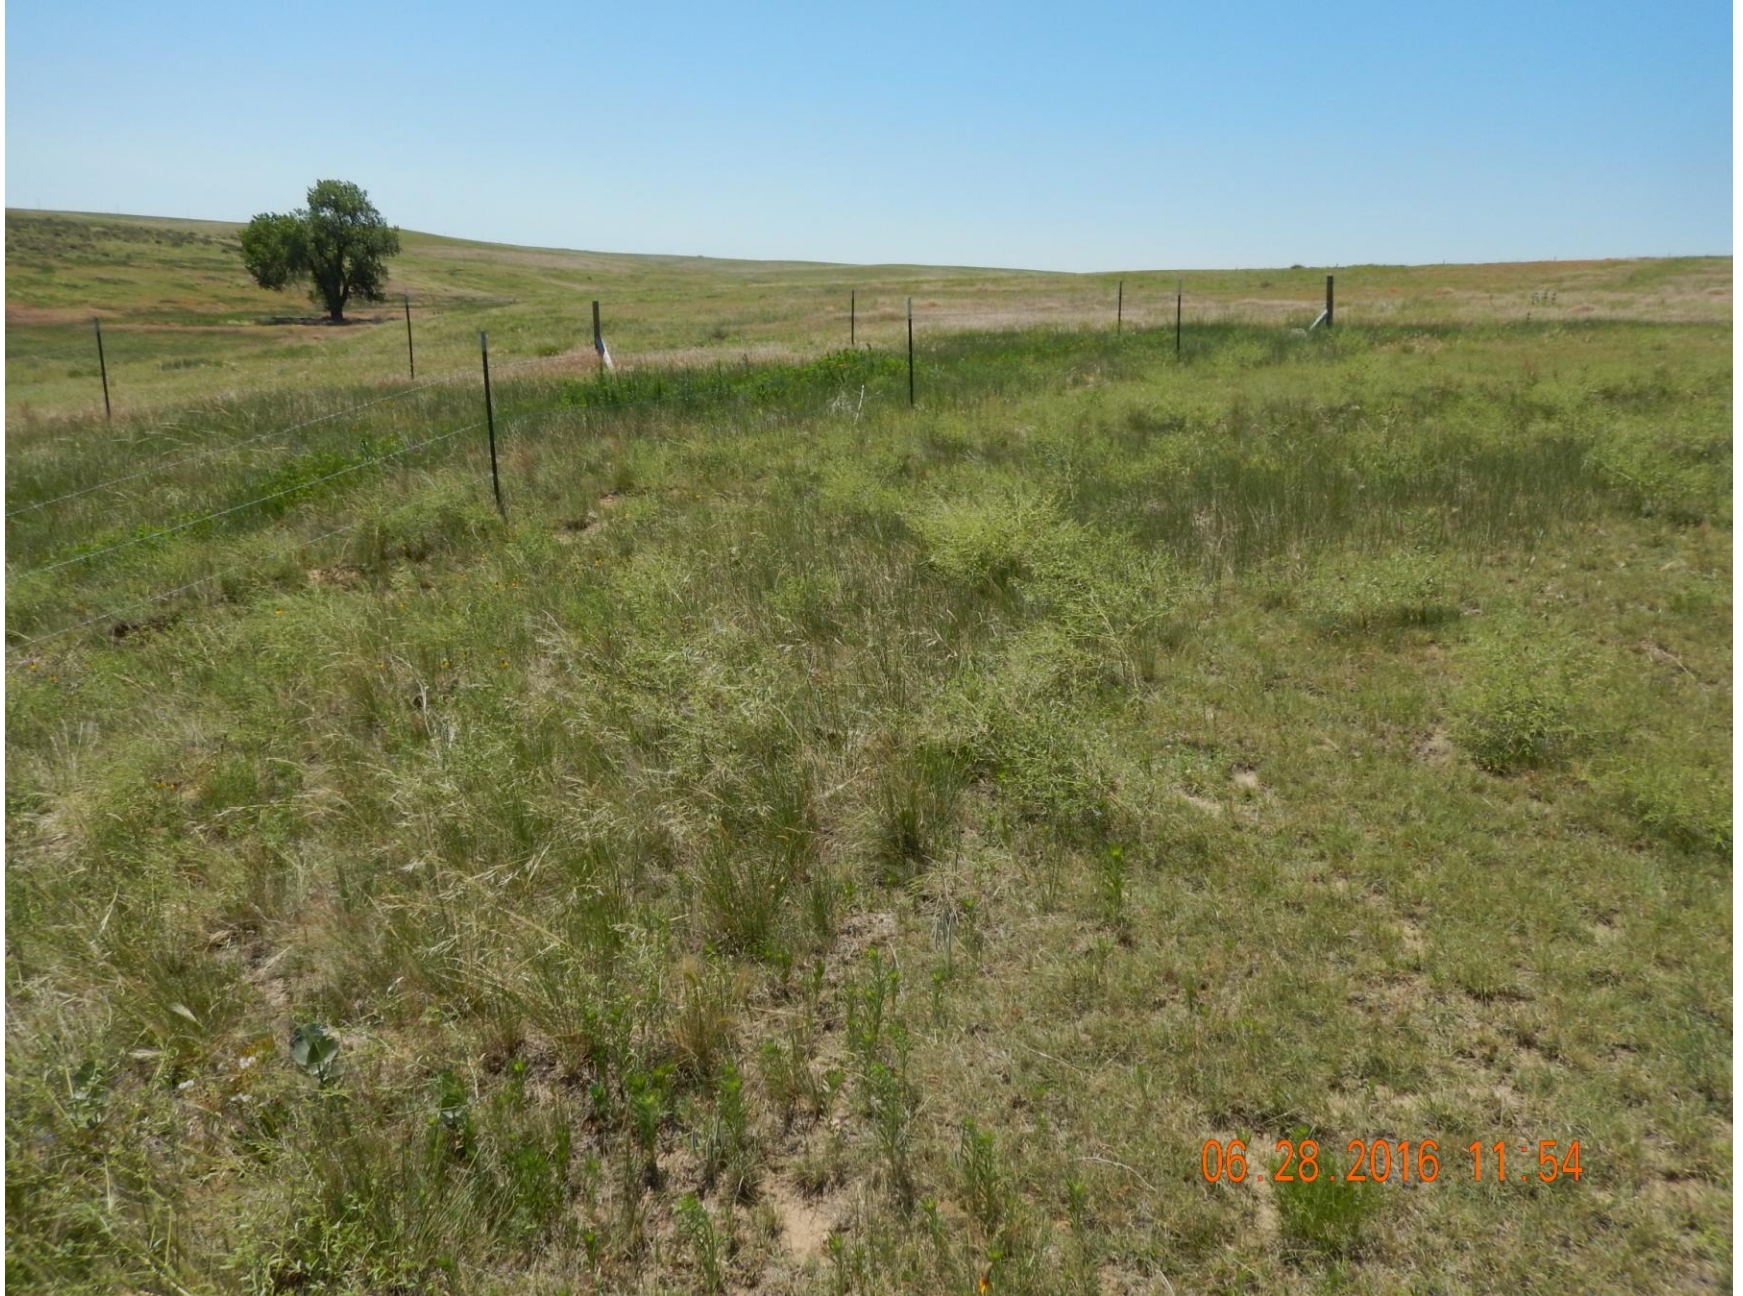
**Figure 4:** Photo taken from the southwest corner of the location, facing southeast. Photo shows portion of the reclamation area fenced off.

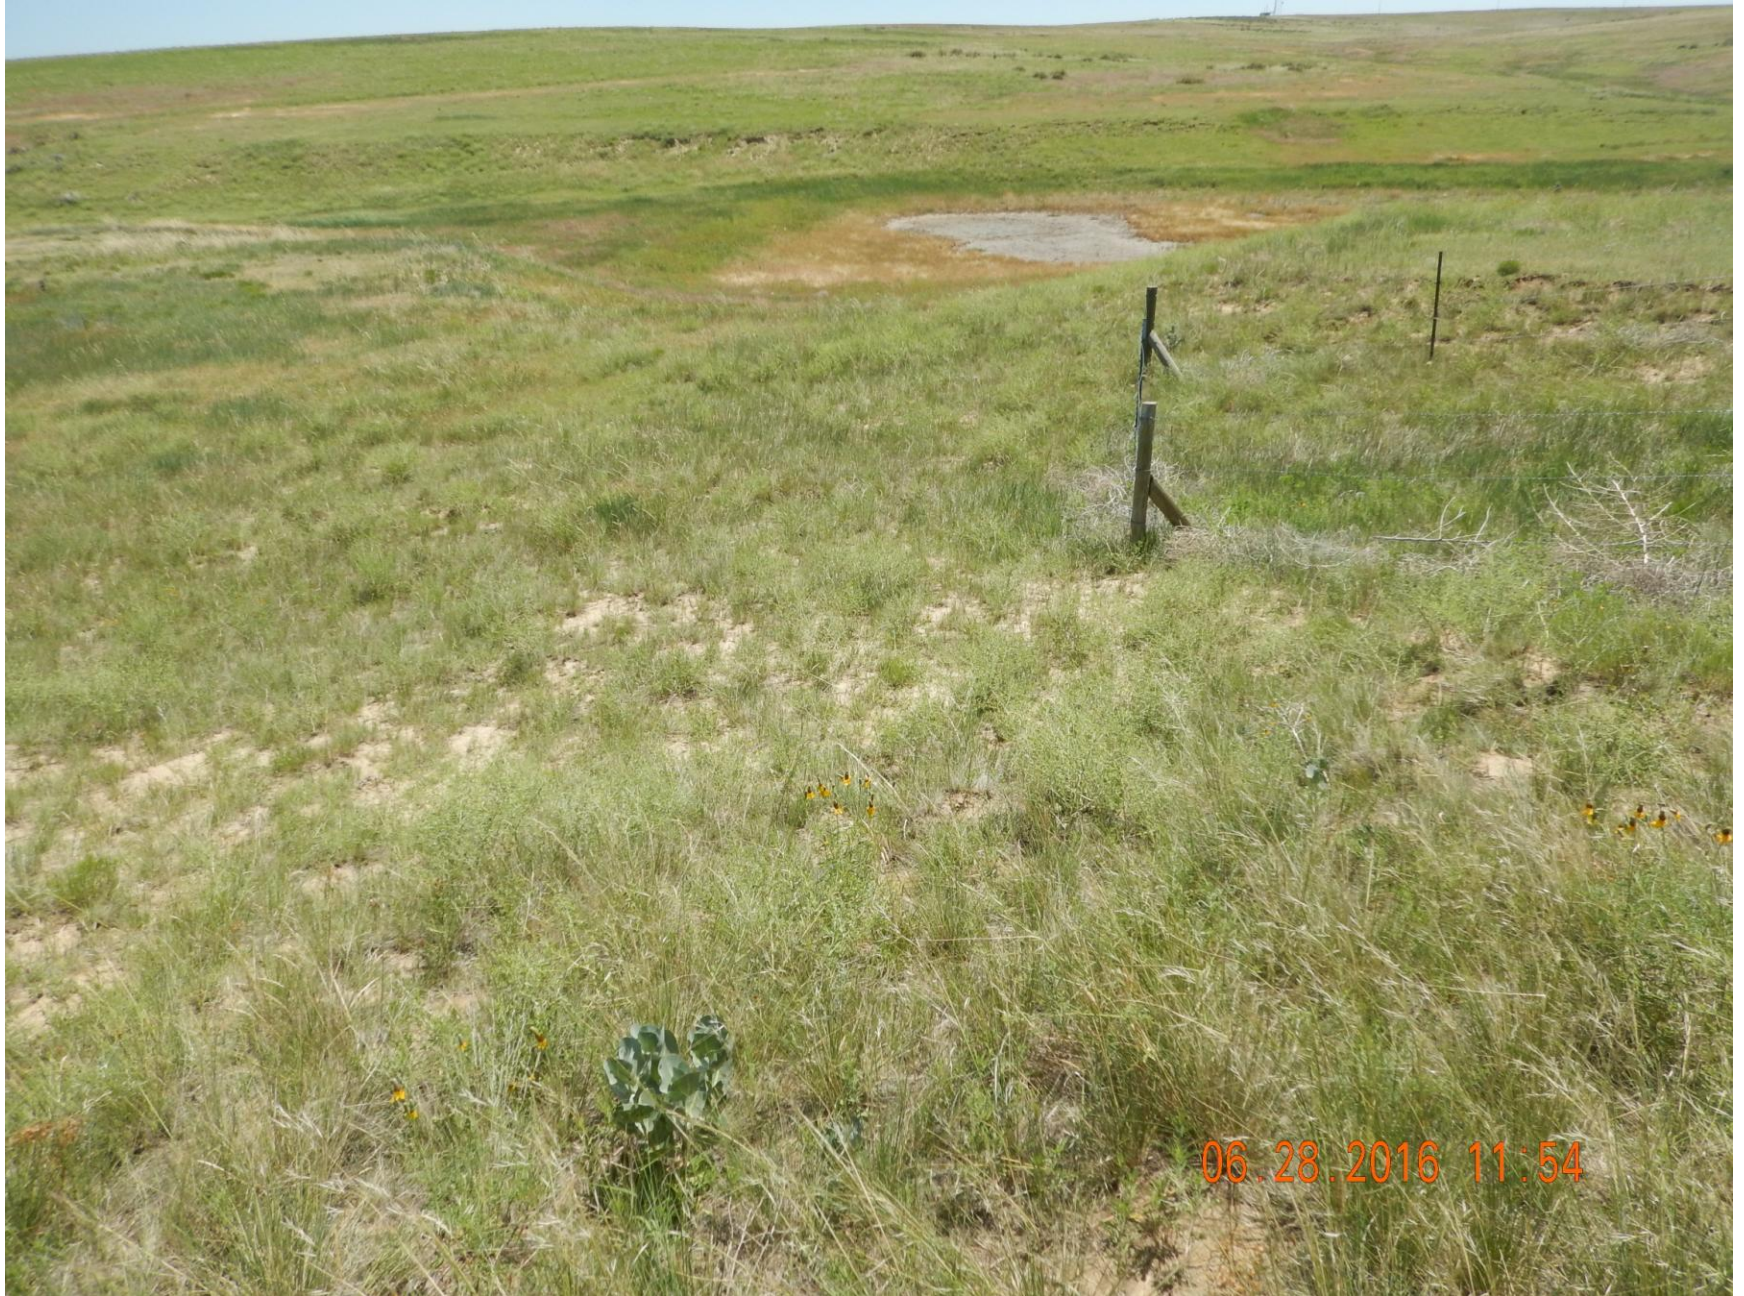
**Figure 5:** Photo taken from the southwest corner of the location, facing east. Photo shows vegetation over the reclamation area.

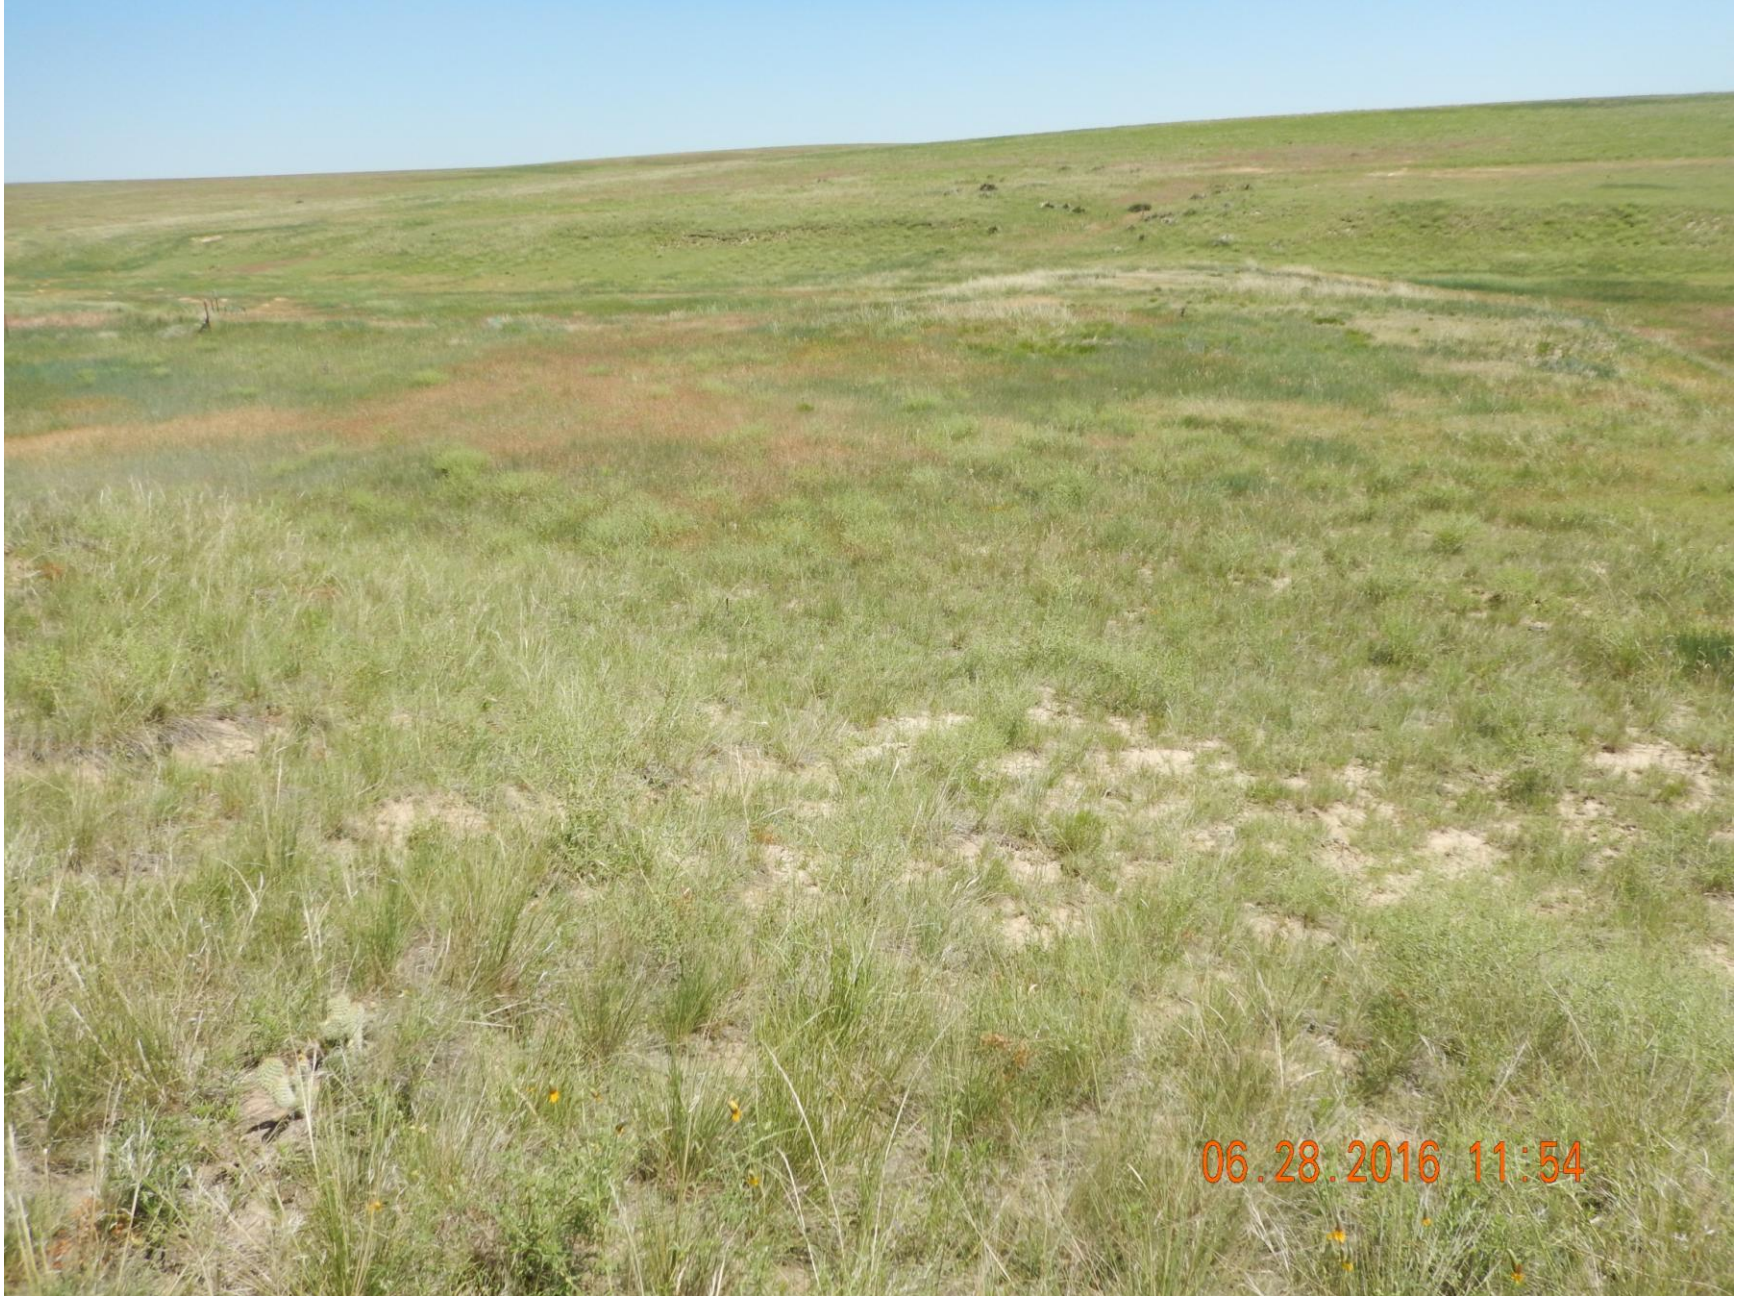
**Figure 6:** Photo taken from the southwest corner of the location, facing northeast. Photo shows vegetation over the reclamation area.

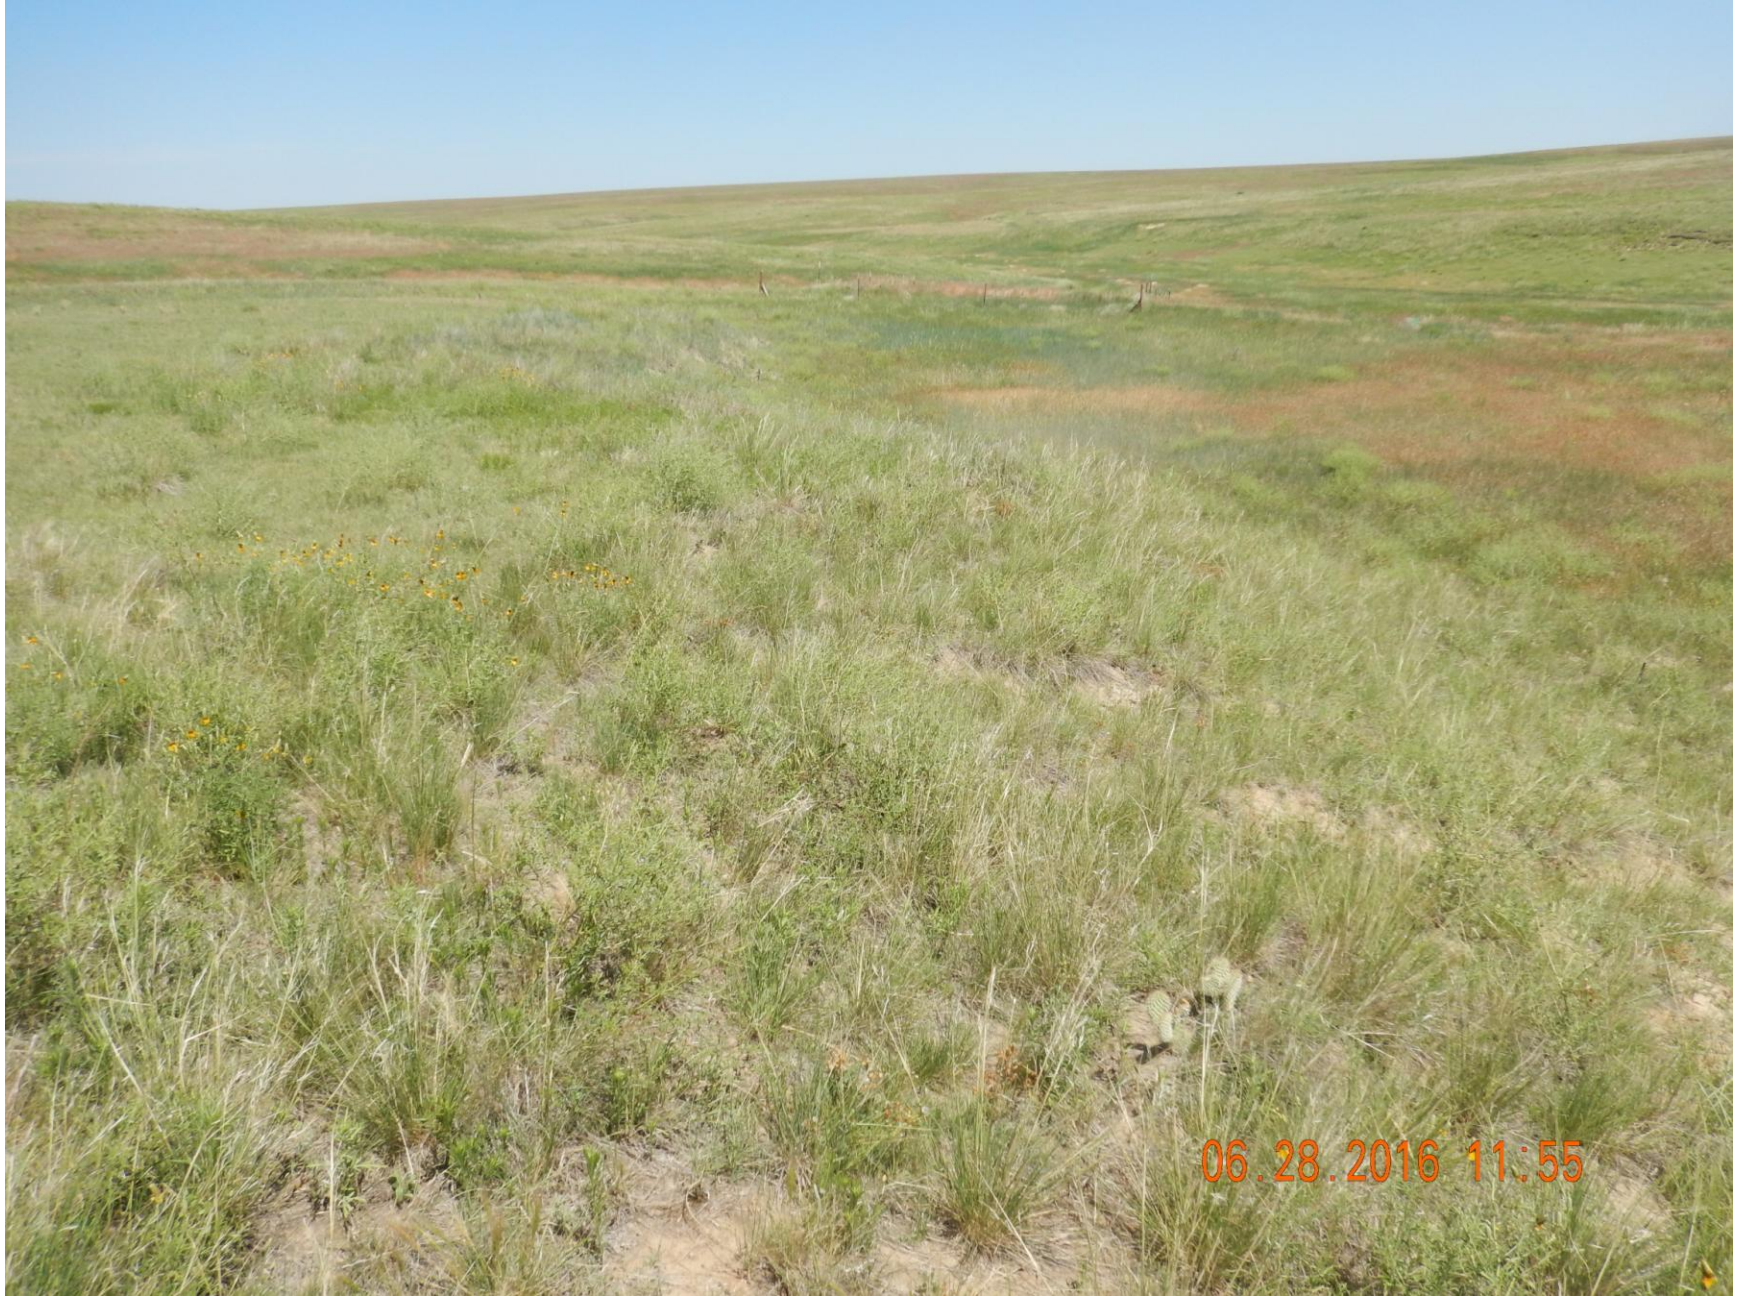
**Figure 7:** Photo taken from the southwest corner of the location, facing north. Photo shows vegetation over the reclamation area.

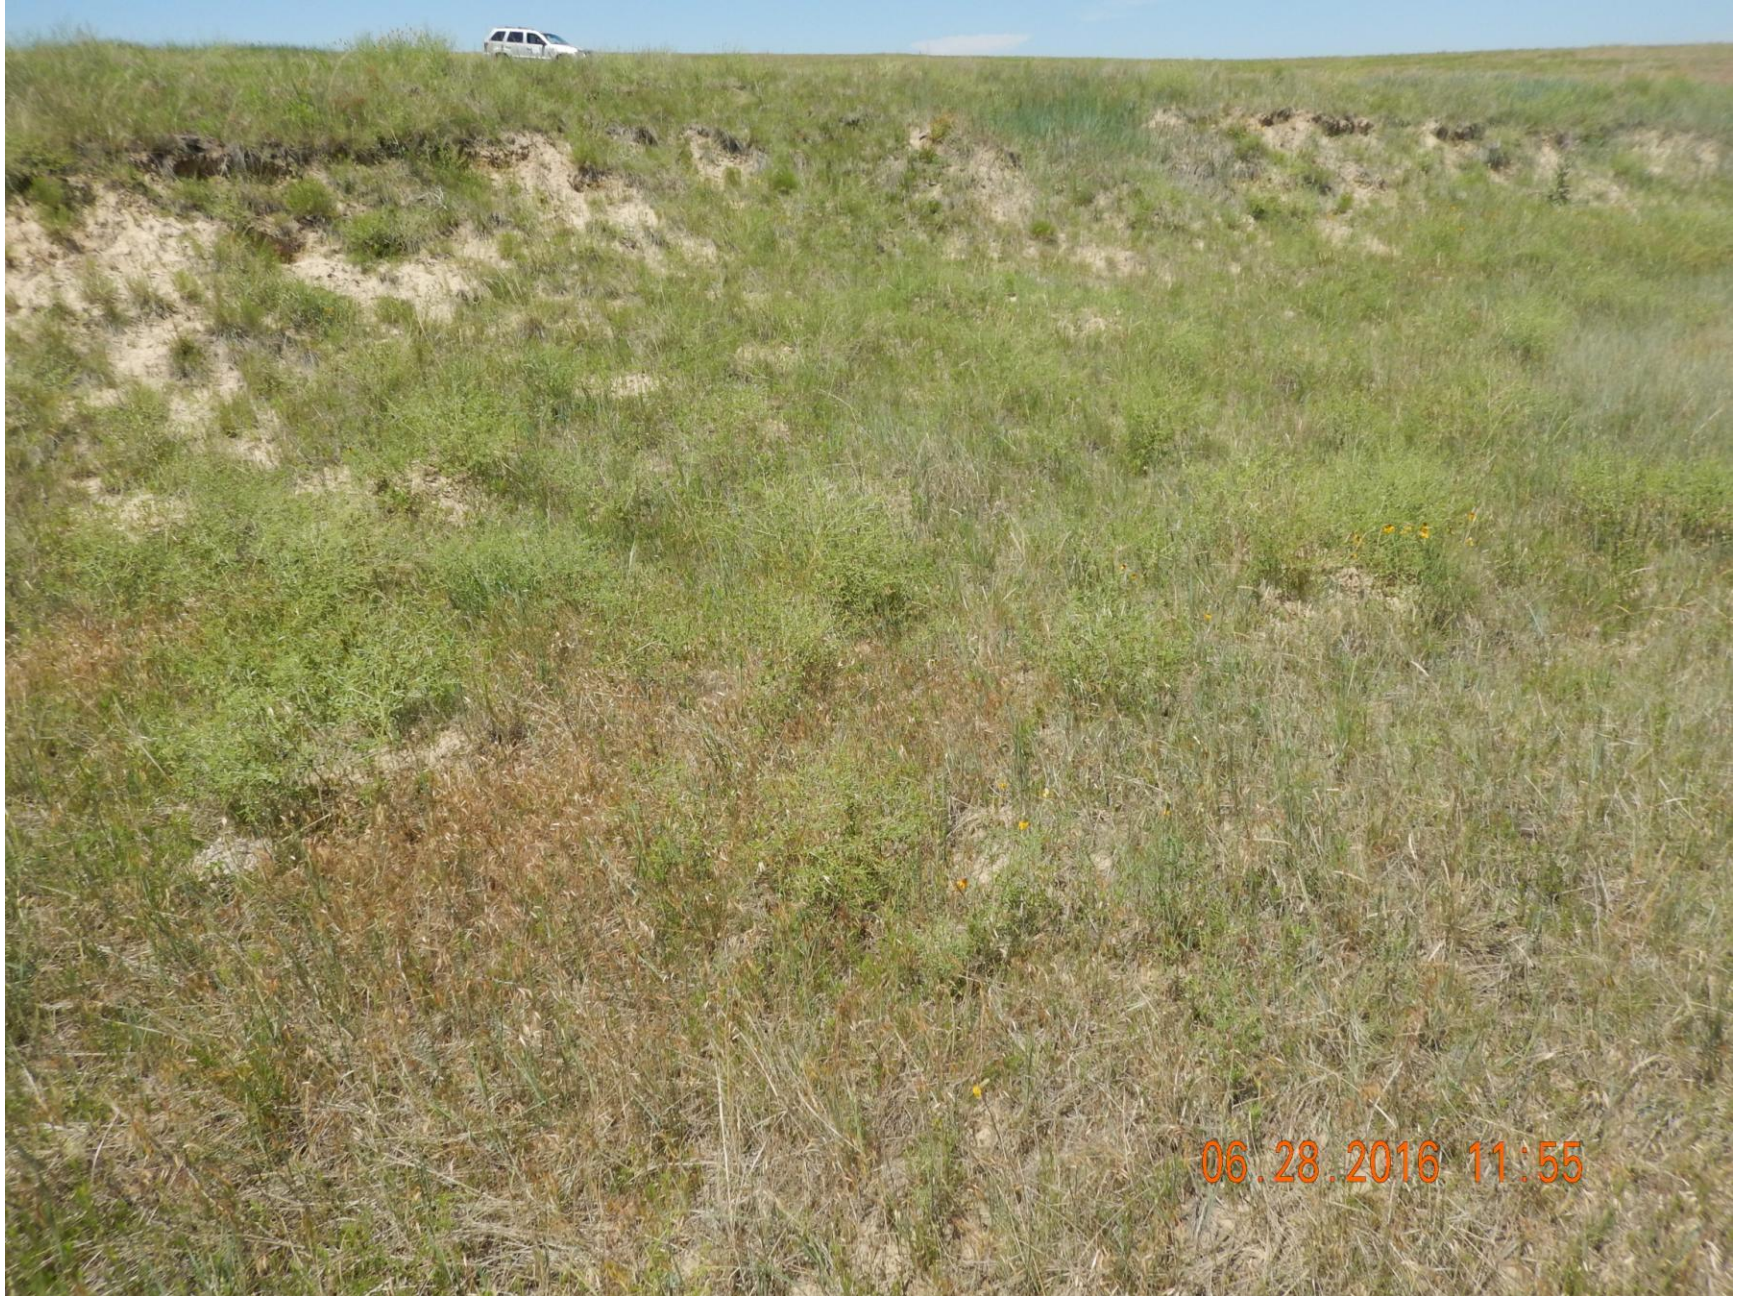
**Figure 8:** Photo taken from the southwest corner of the location, facing west. Photo shows erosion on cut bank. Photo shows location had not been recontoured.

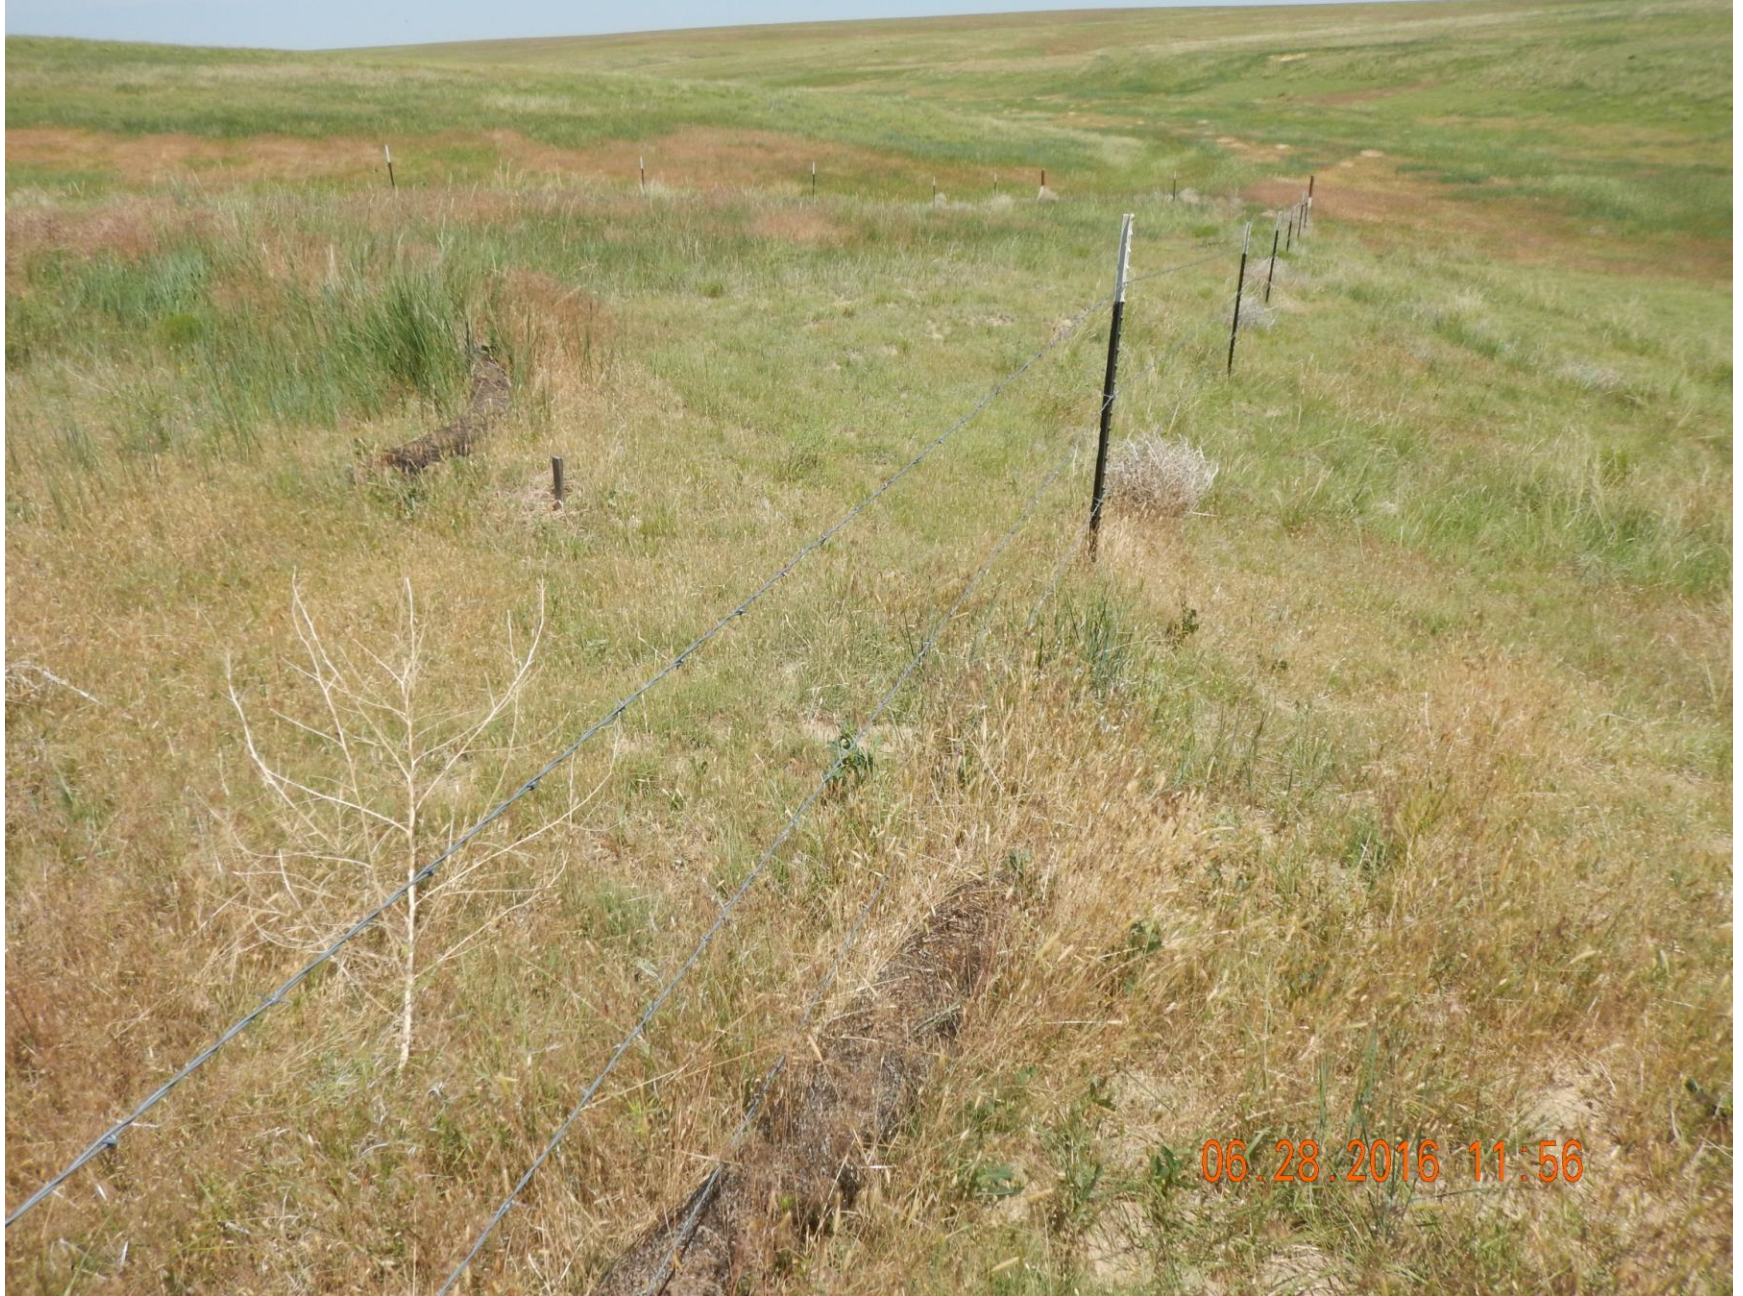
**Figure 9:** Photo taken from the north end of the location, facing north. Photo shows portion of the reclamation area fenced off.

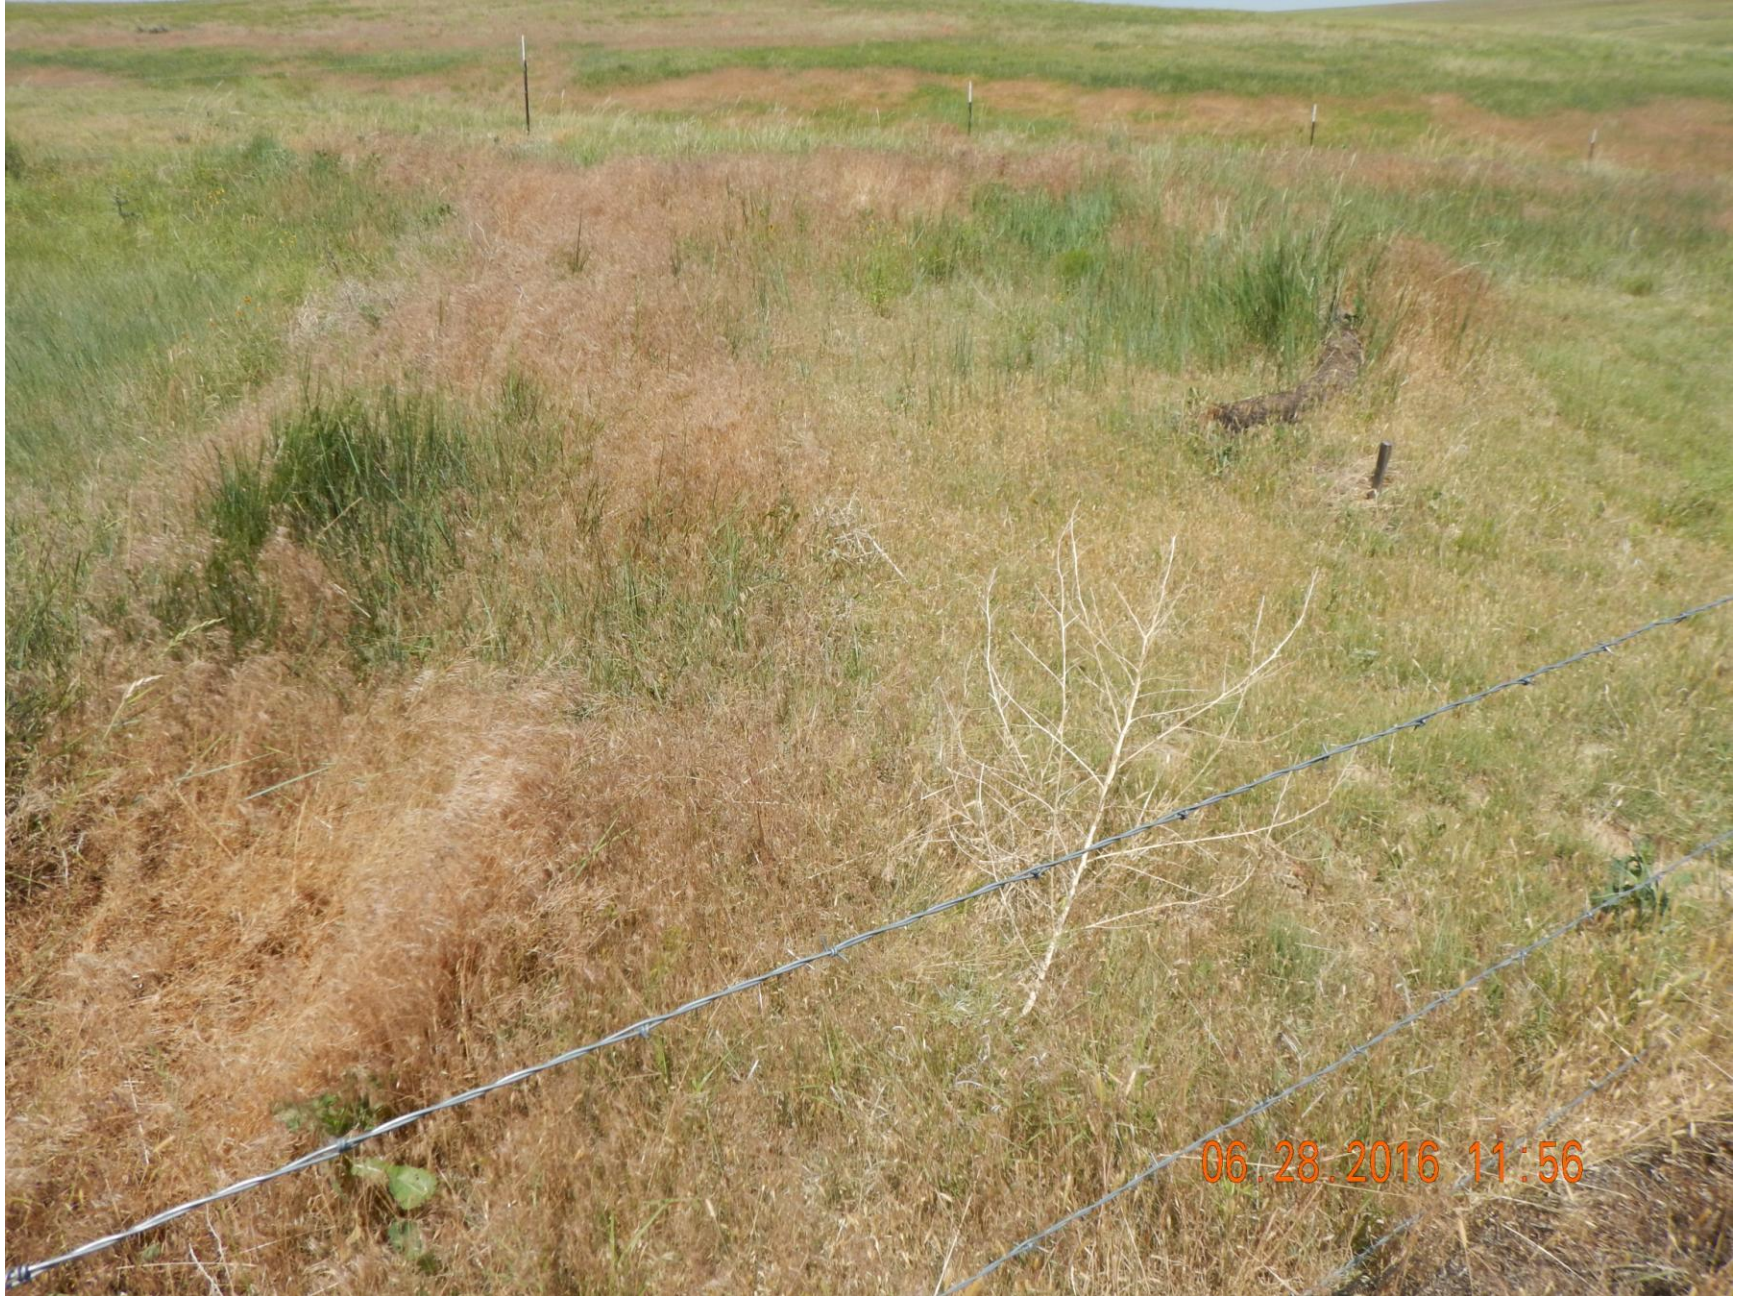
**Figure 10:** Photo taken from the north end of the location, facing west. Photo shows portion of the reclamation area fenced off.
