# Final Reclamation Inspection

06/28/2016

Operator: Petro-Canada

Location ID: 311680

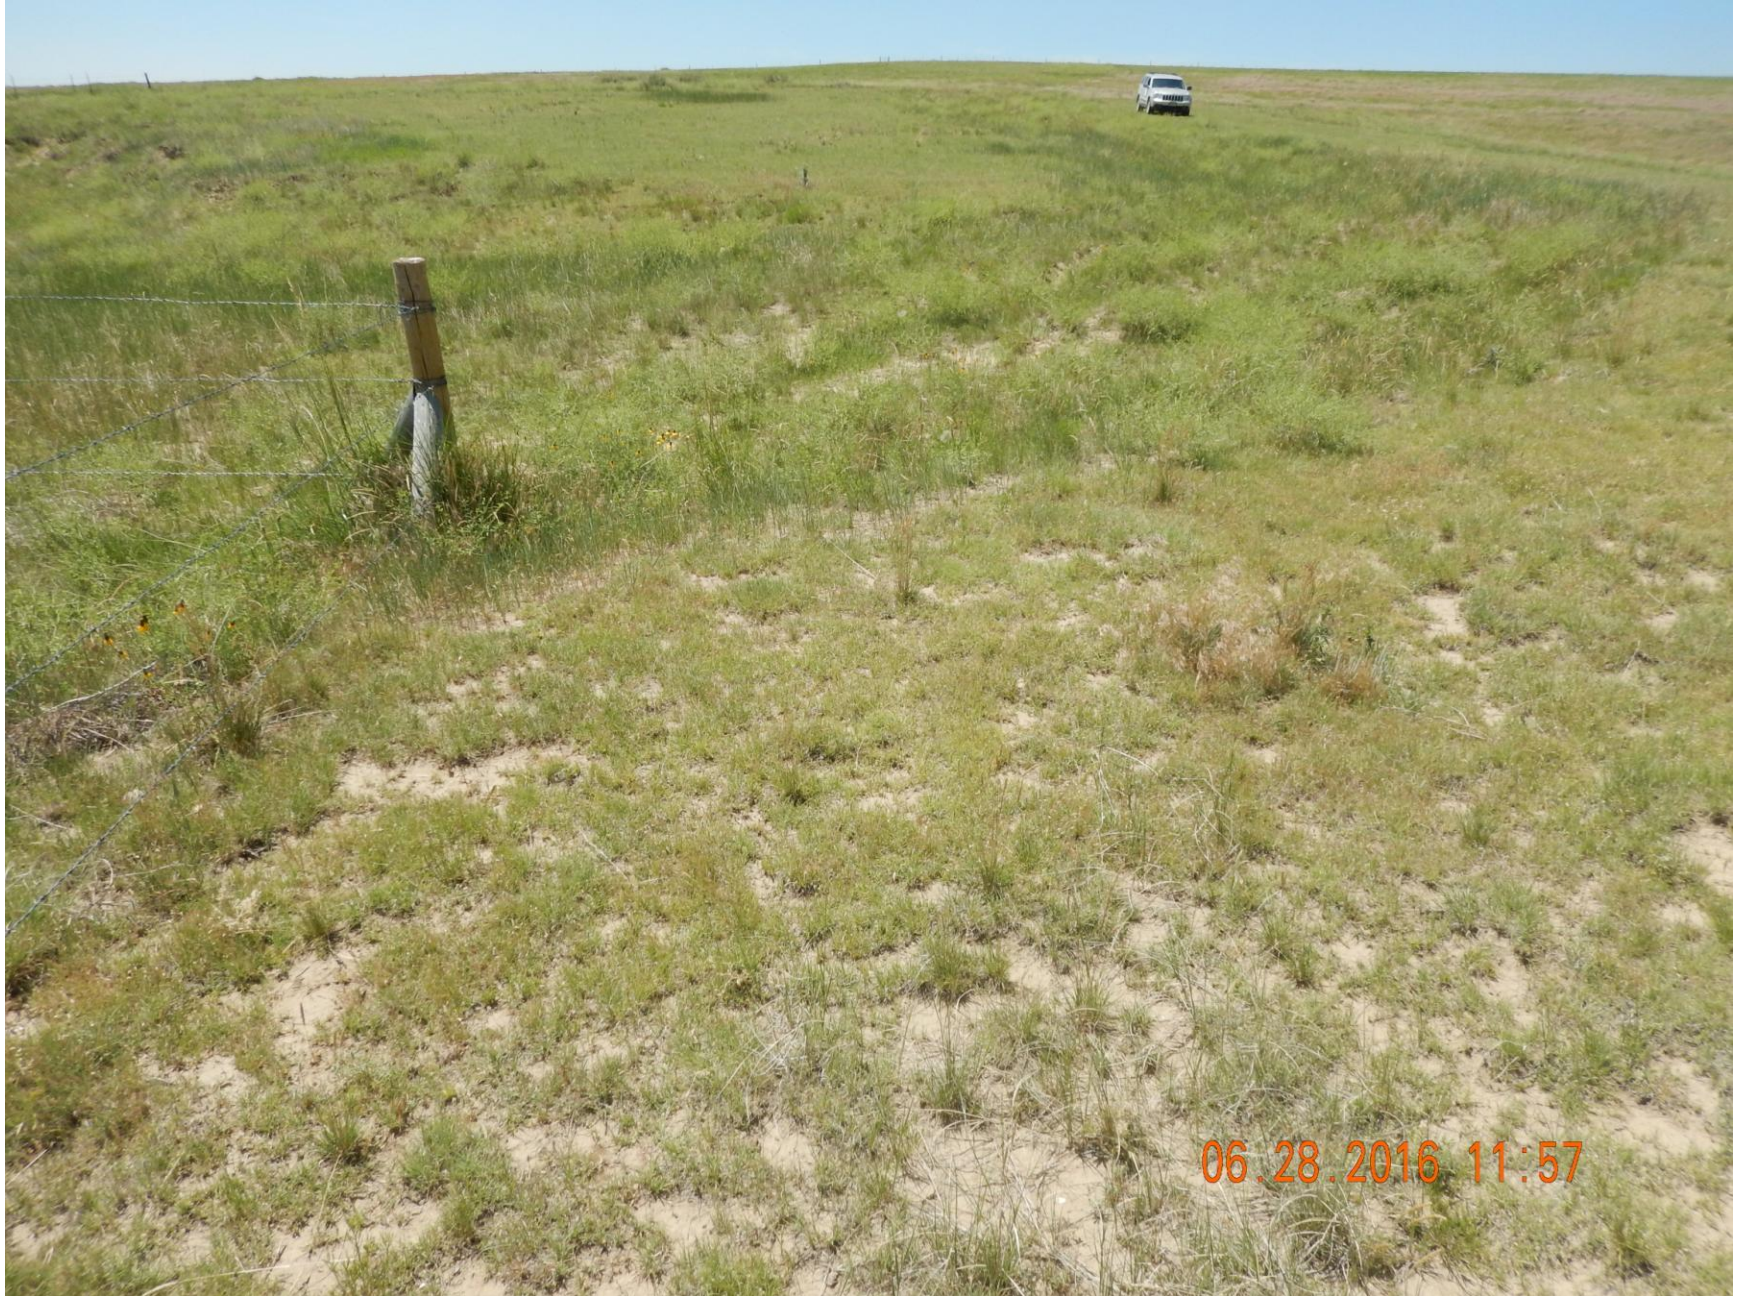
**Figure 11:** Photo taken from the northwest corner of the location, facing south. Photo shows access road had not been recontoured and vegetation has not achieved 80% of reference.

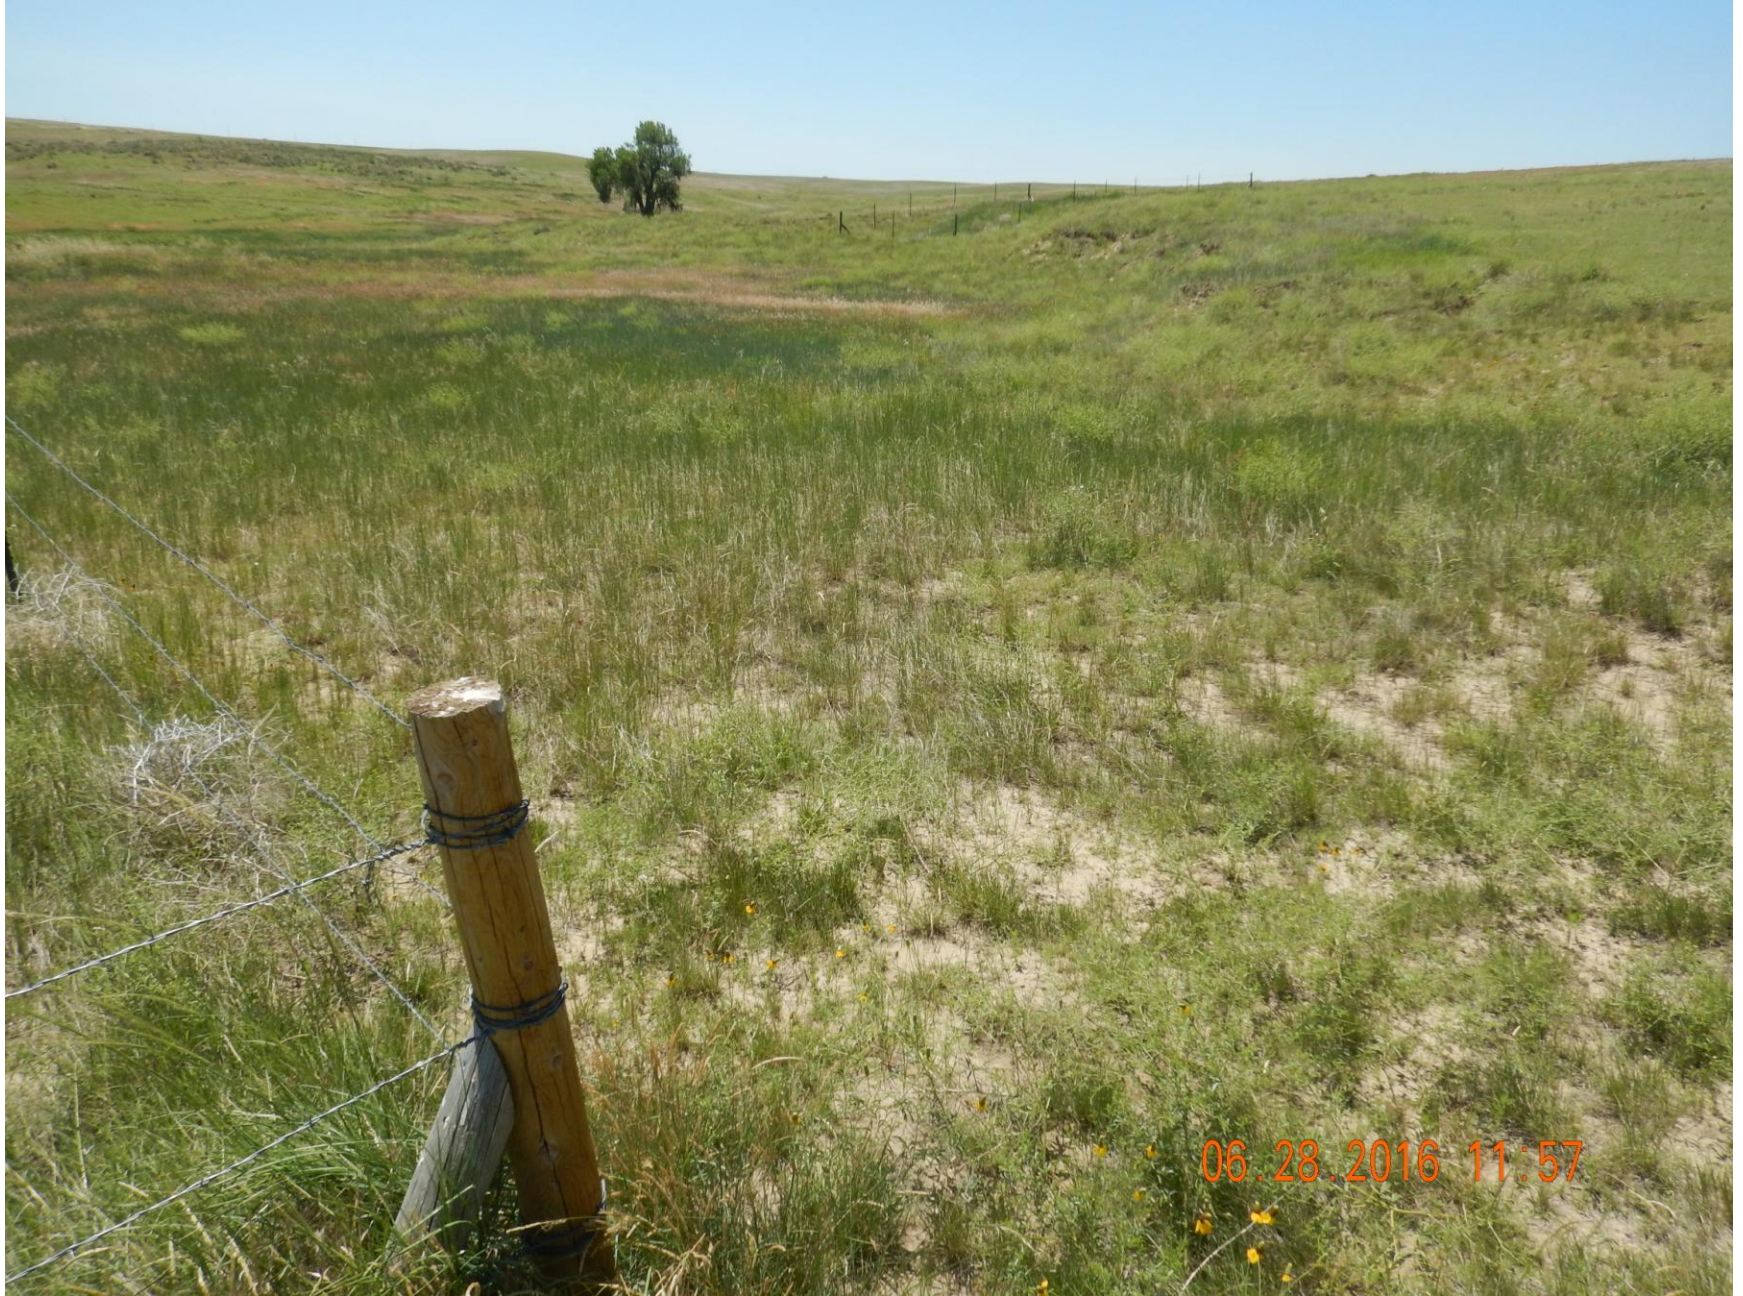
**Figure 12:** Photo taken from the northwest corner of the location, facing south. Photo shows erosion on cut bank (right of photo). Photo shows location had not been recontoured.
