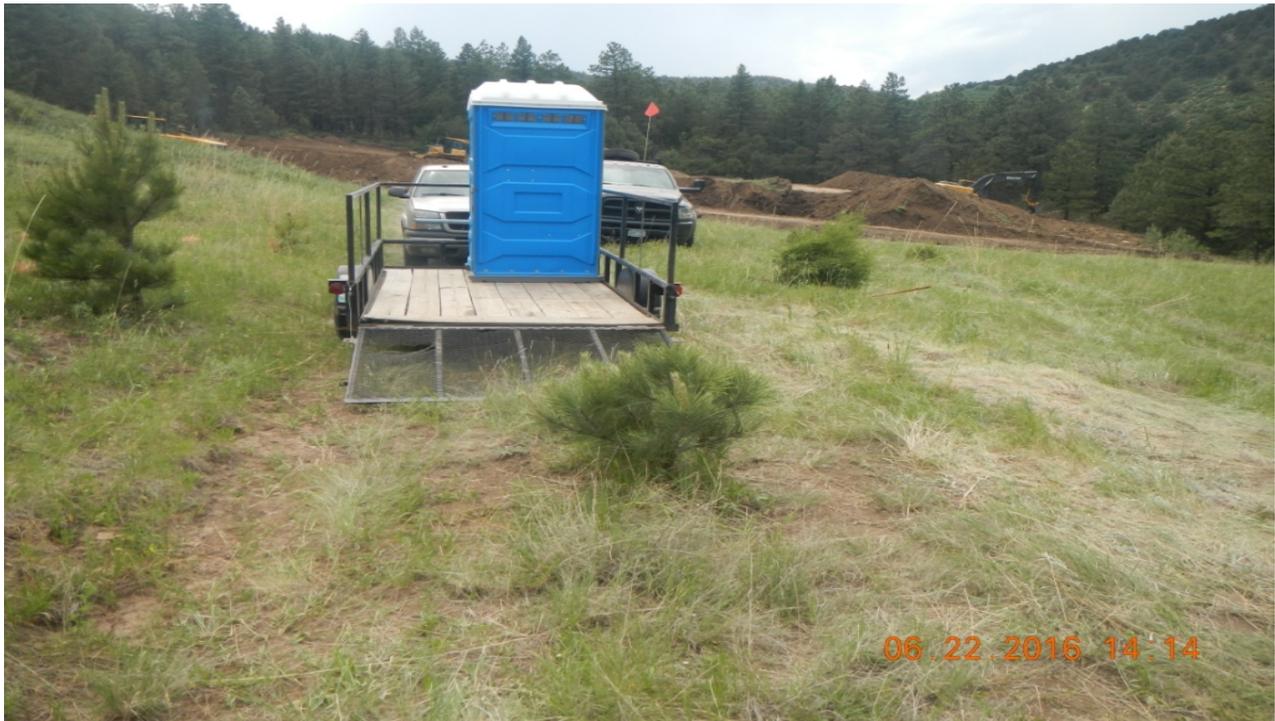
**photo 1:** Facing west toward the location. Work underway on recontouring the location.

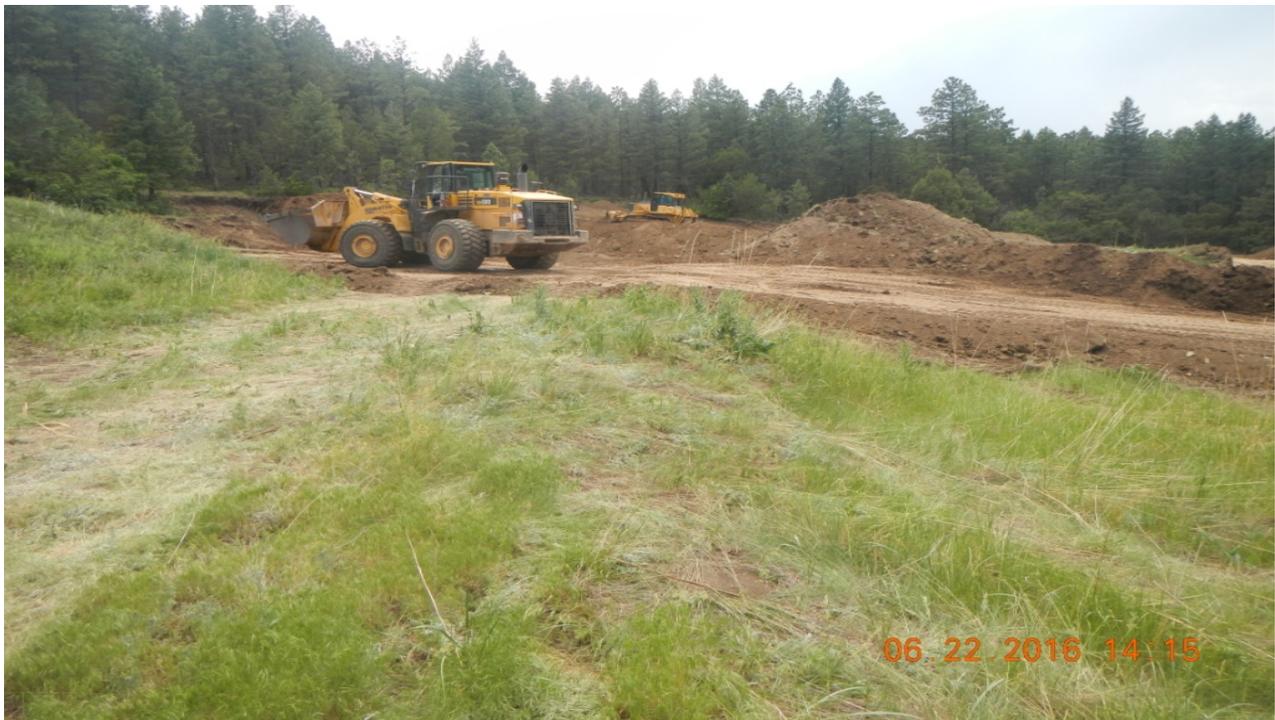
**photo 2:** Equipment in process of recontouring the location.

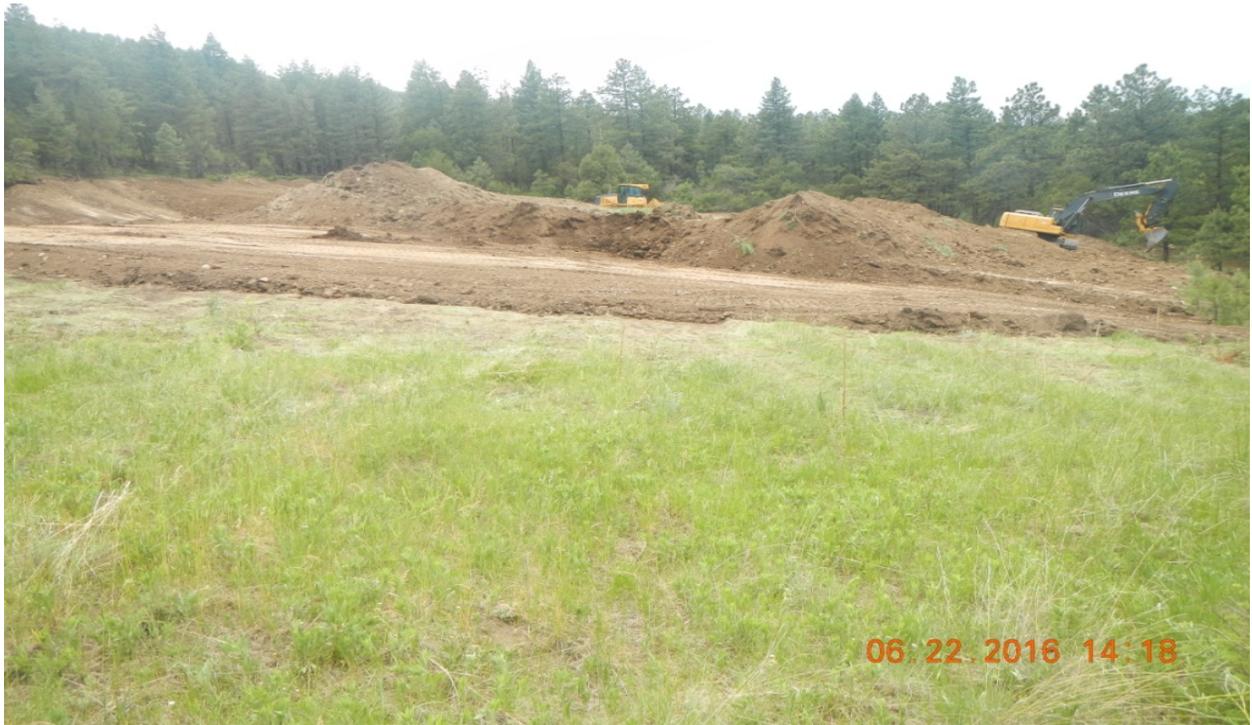
**photo 3:** East side of the location facing west.

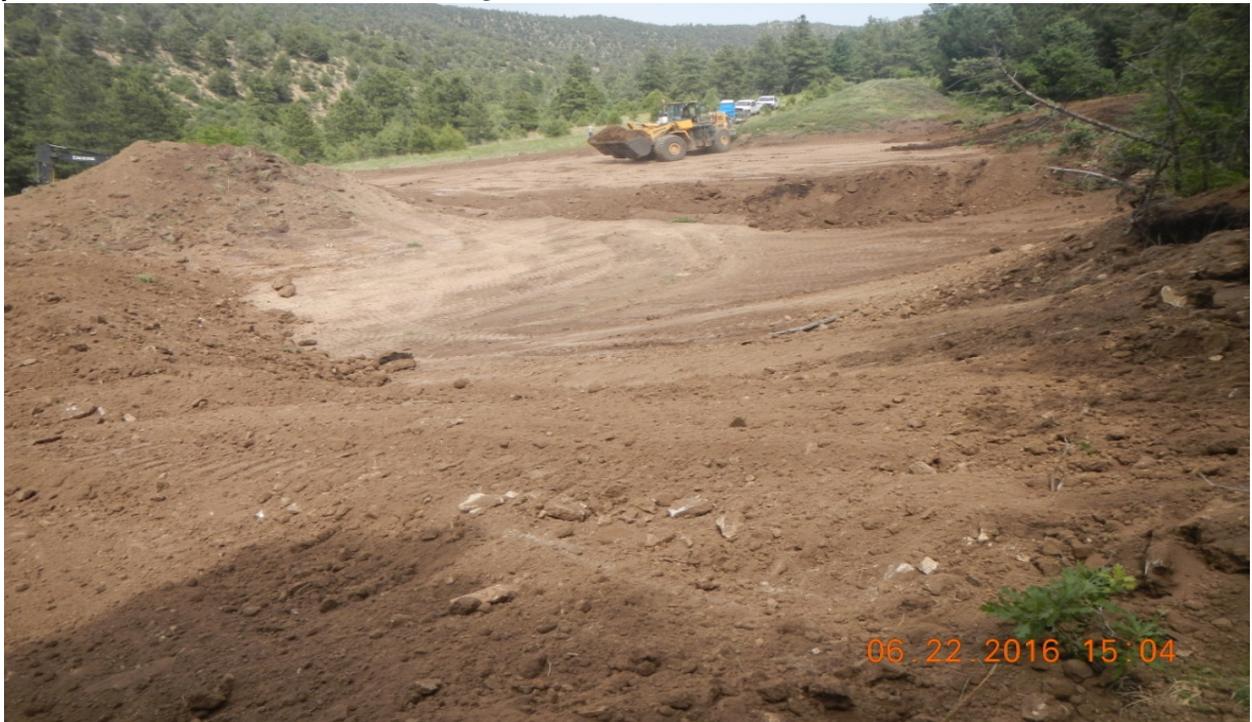
**photo 4:** South side of the location facing northeast..

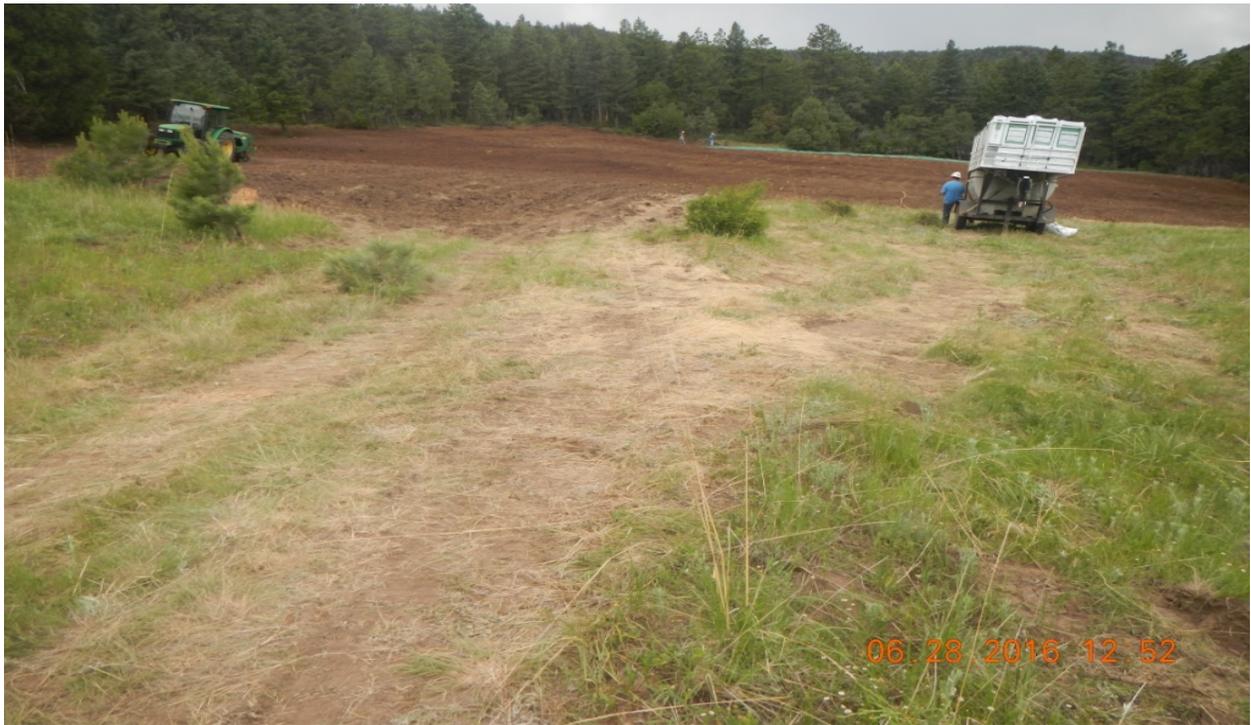
**photo 5:** Returned to inspect the work during following week. Location was recontoured and reclamation was being performed.

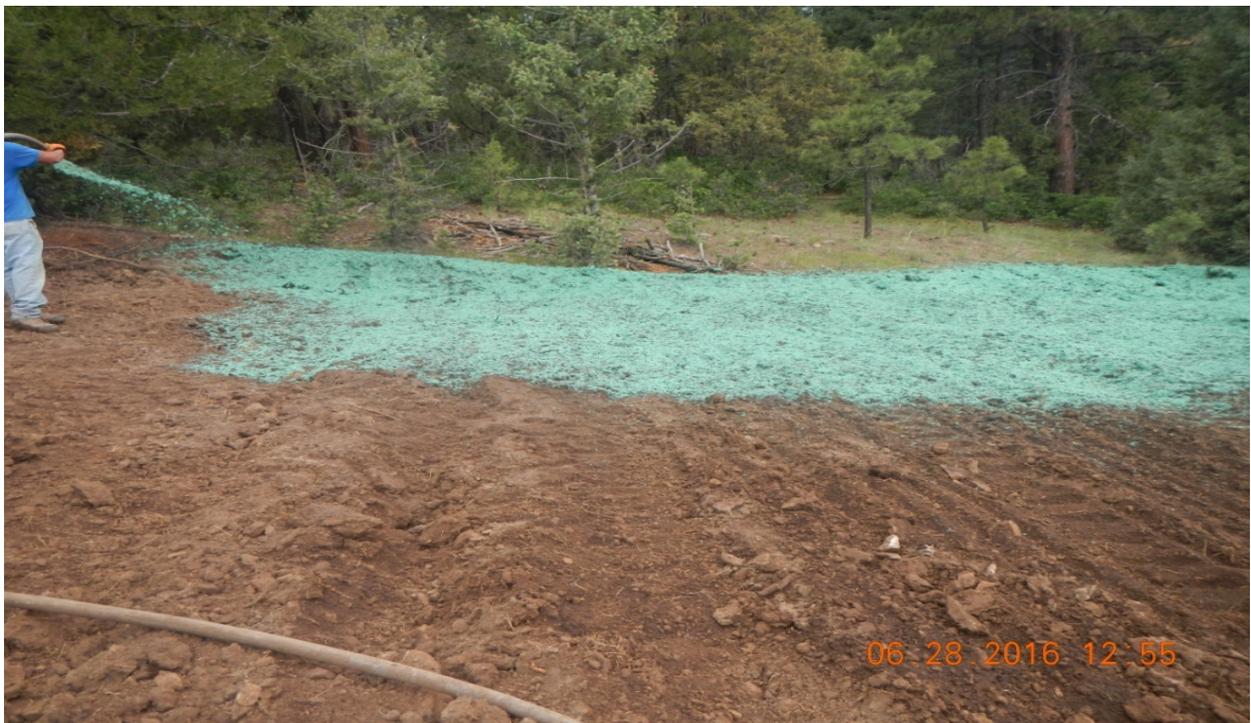
**photo 6:** A hydro mulch was in the process of being applied at the time of this inspection.

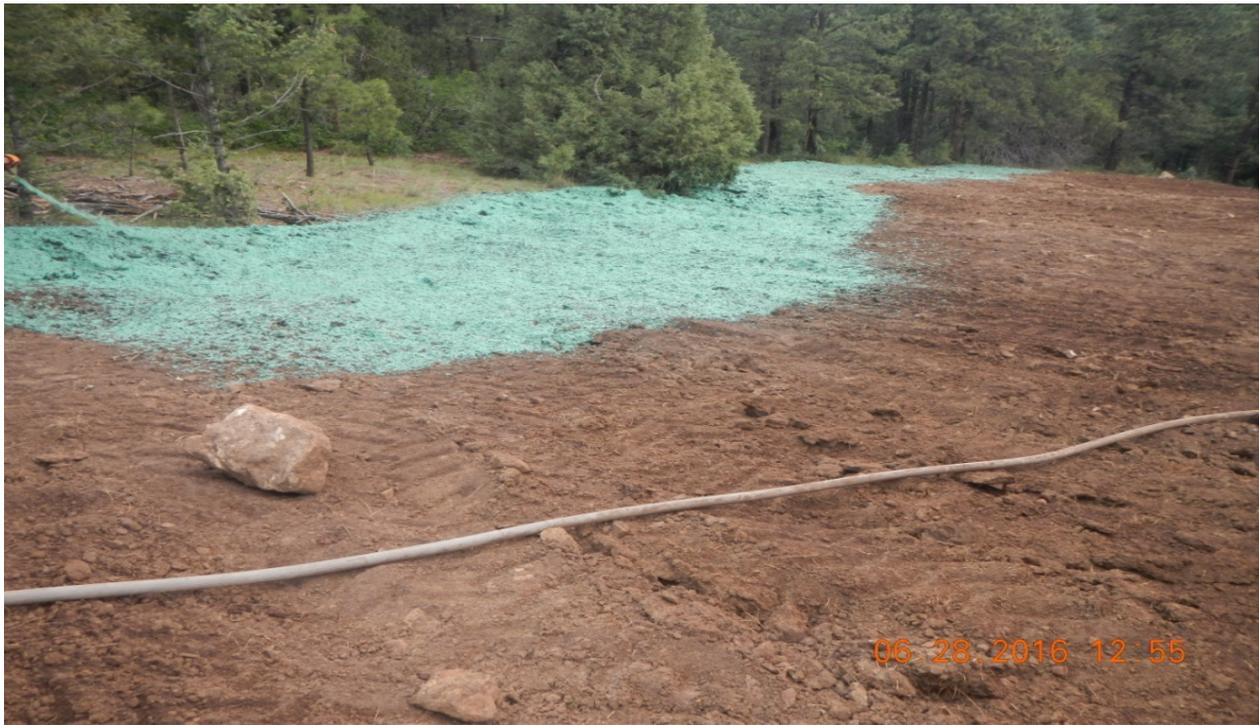
**photo 7:** Facing toward the northwest side of the location.

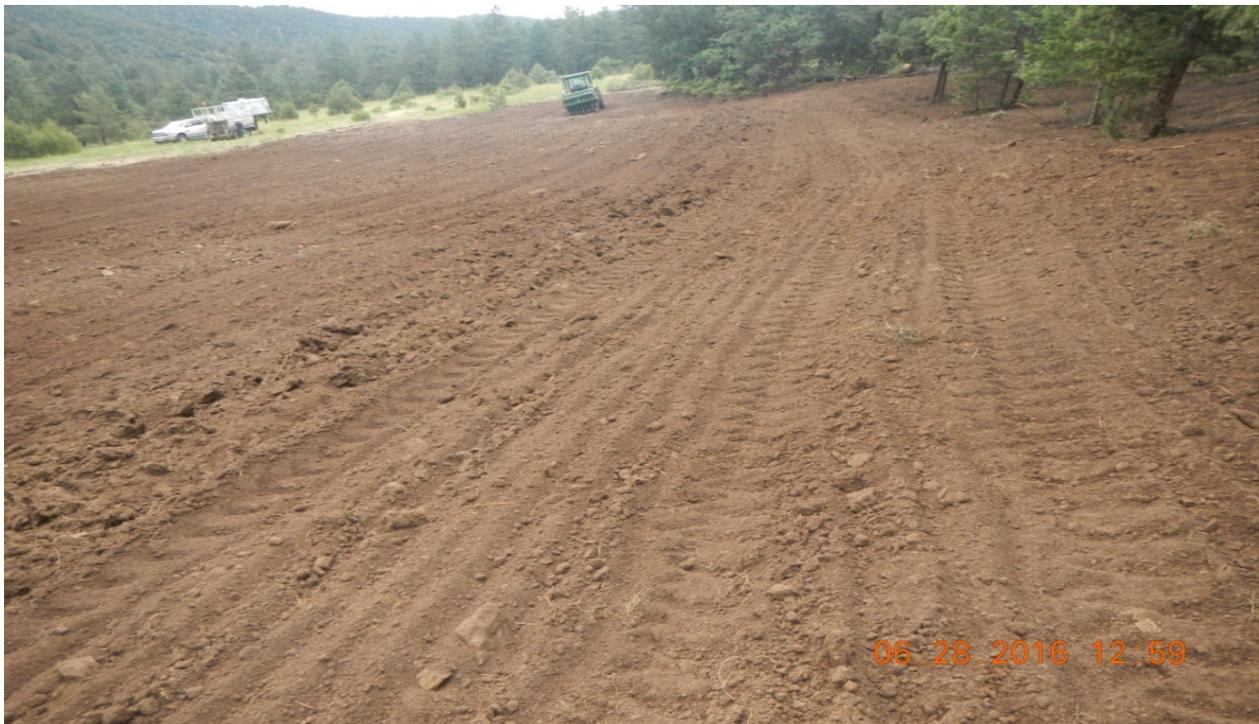
**photo 8:** Southwest side facing east. The location was drill seeded along the contour.

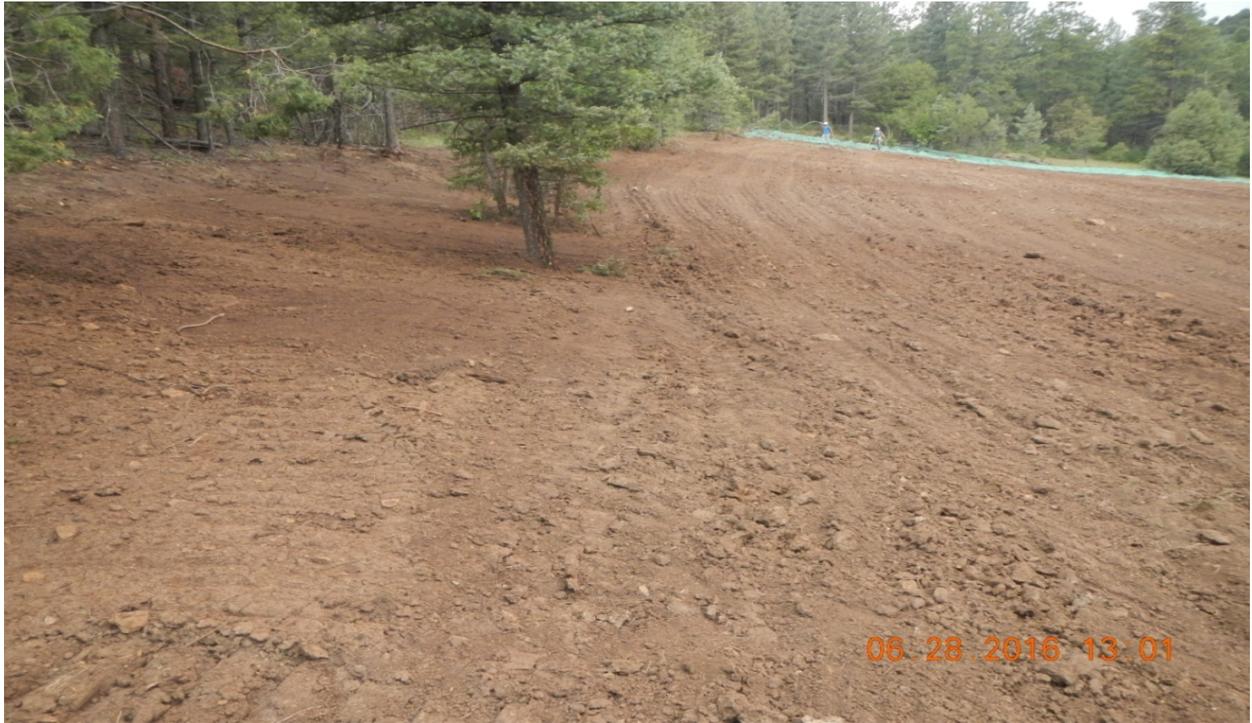
**photo 9:** Southeast side of the location facing west.

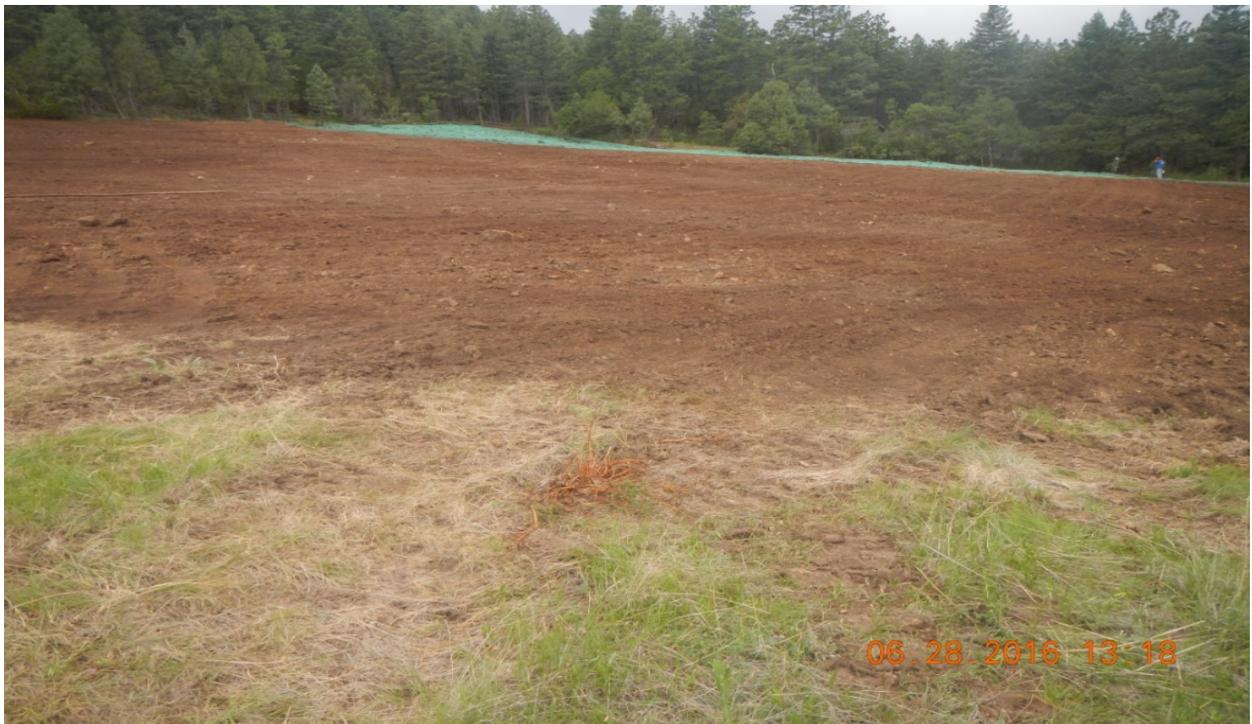
**photo 10:** Northeast side of the location facing southwest.

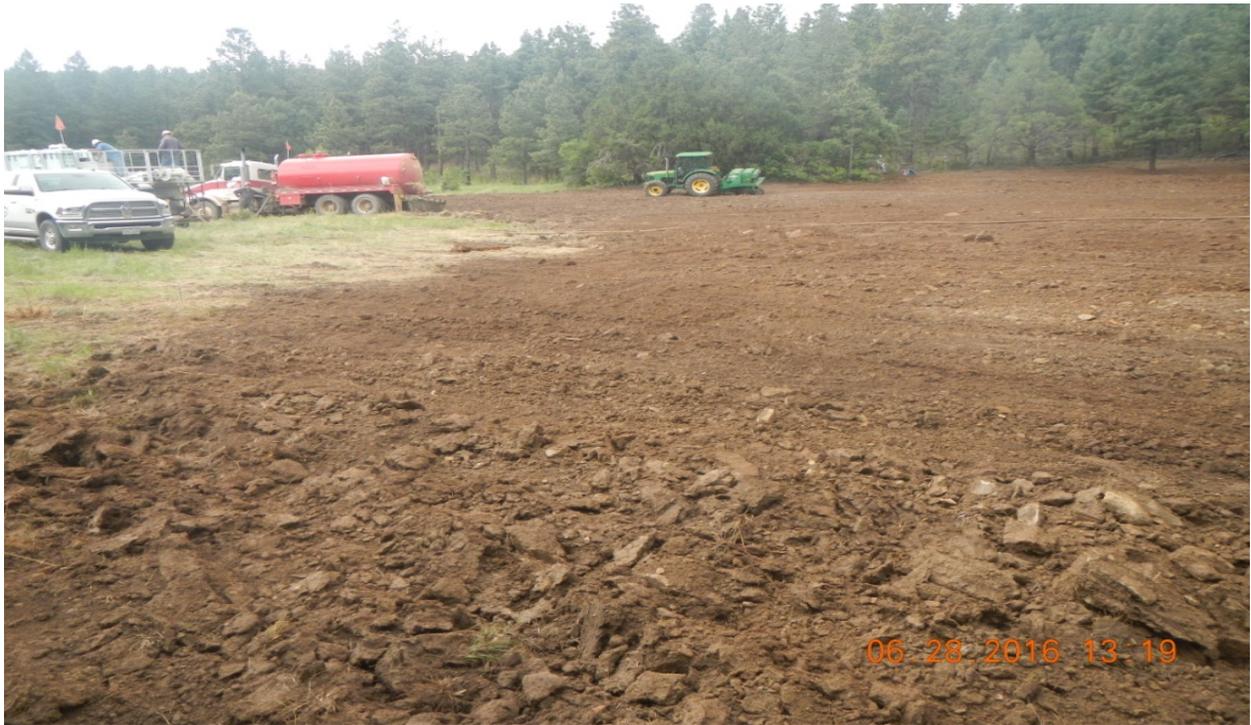
photo 11: Northeast side of the location facing south.

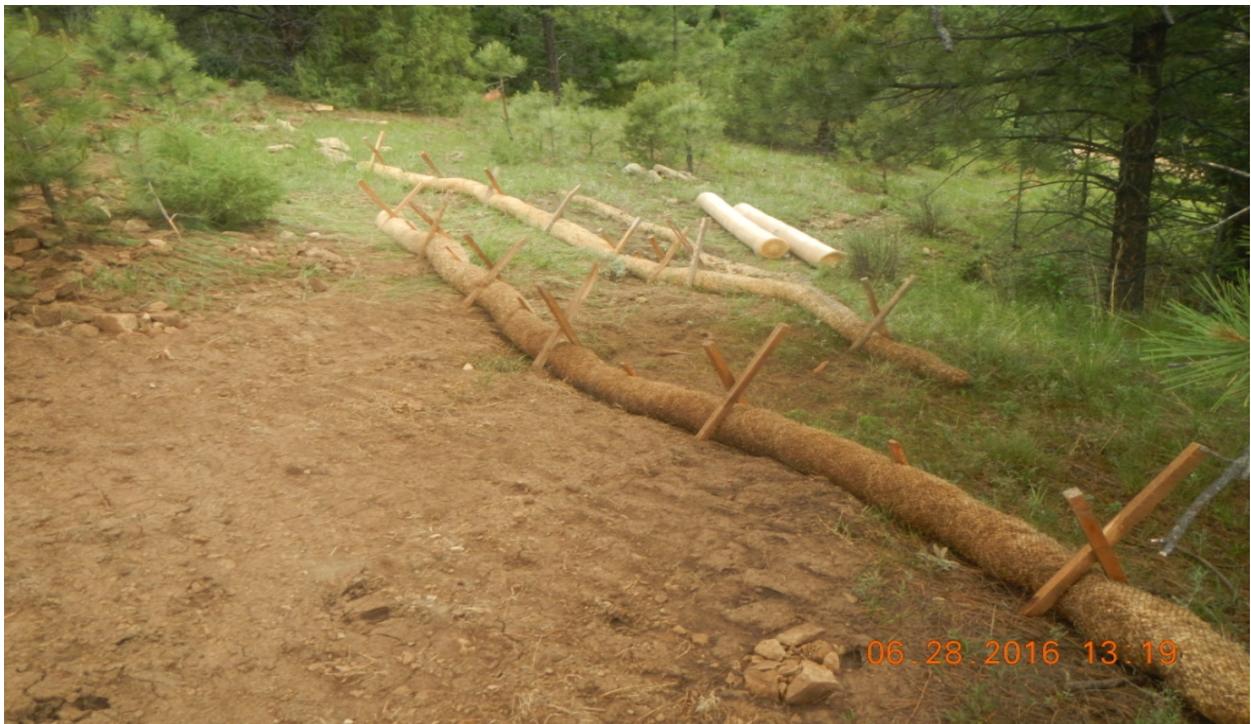
photo 12: There were excelsior wattles installed at the north perimeter of the location.
