June 9, 2016

Inspection Photos 051-06098

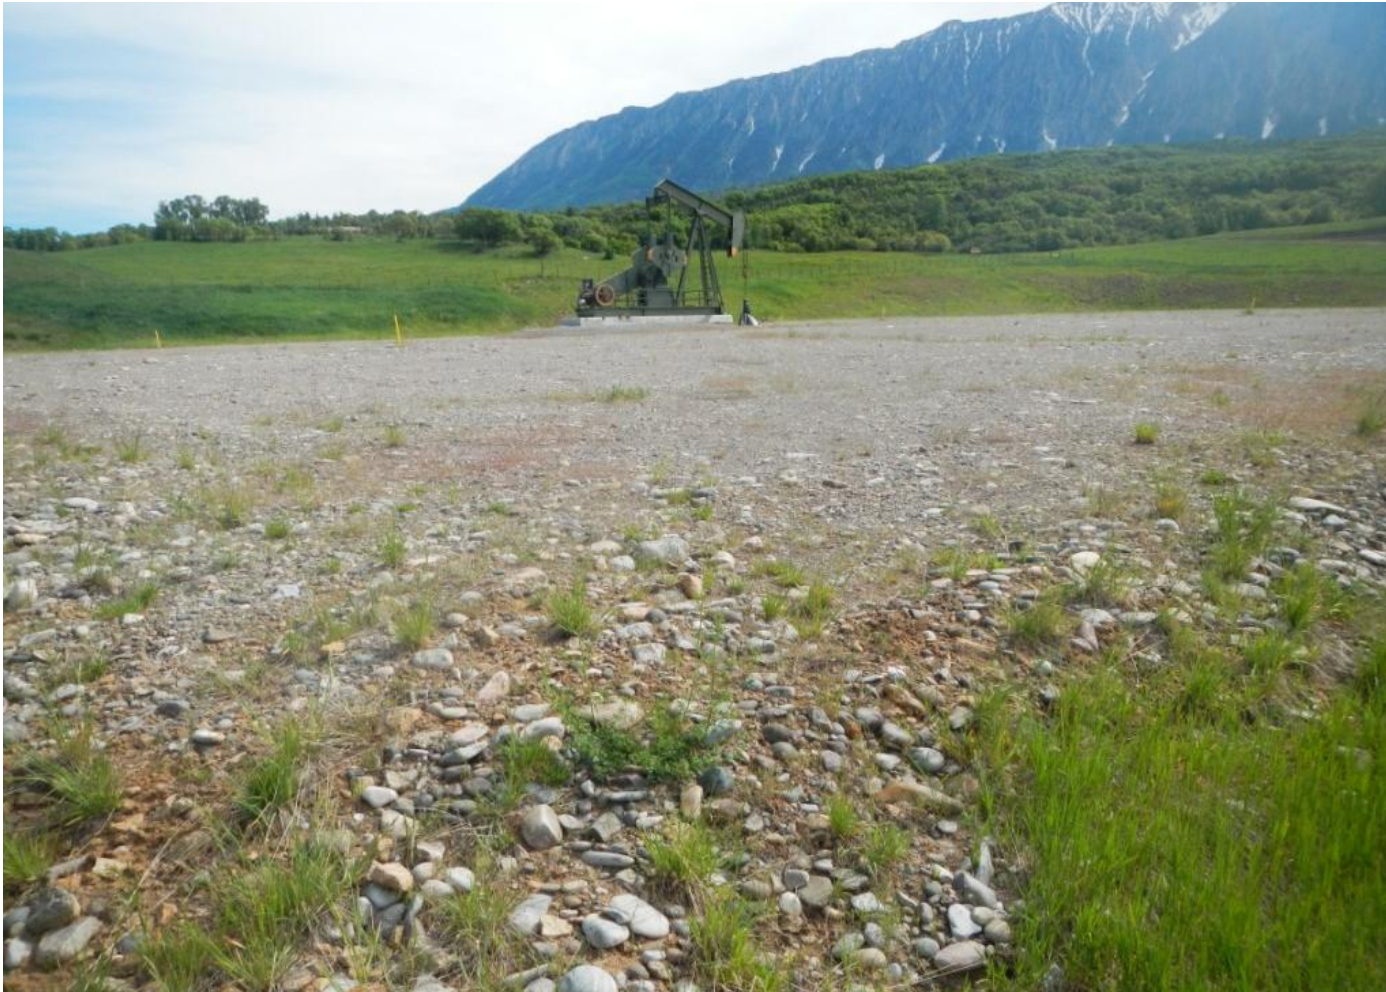
Photo 1. View of project area from the southwestern corner facing center. Interim reclamation has not been conducted. Outer cut and fill slopes are revegetated.

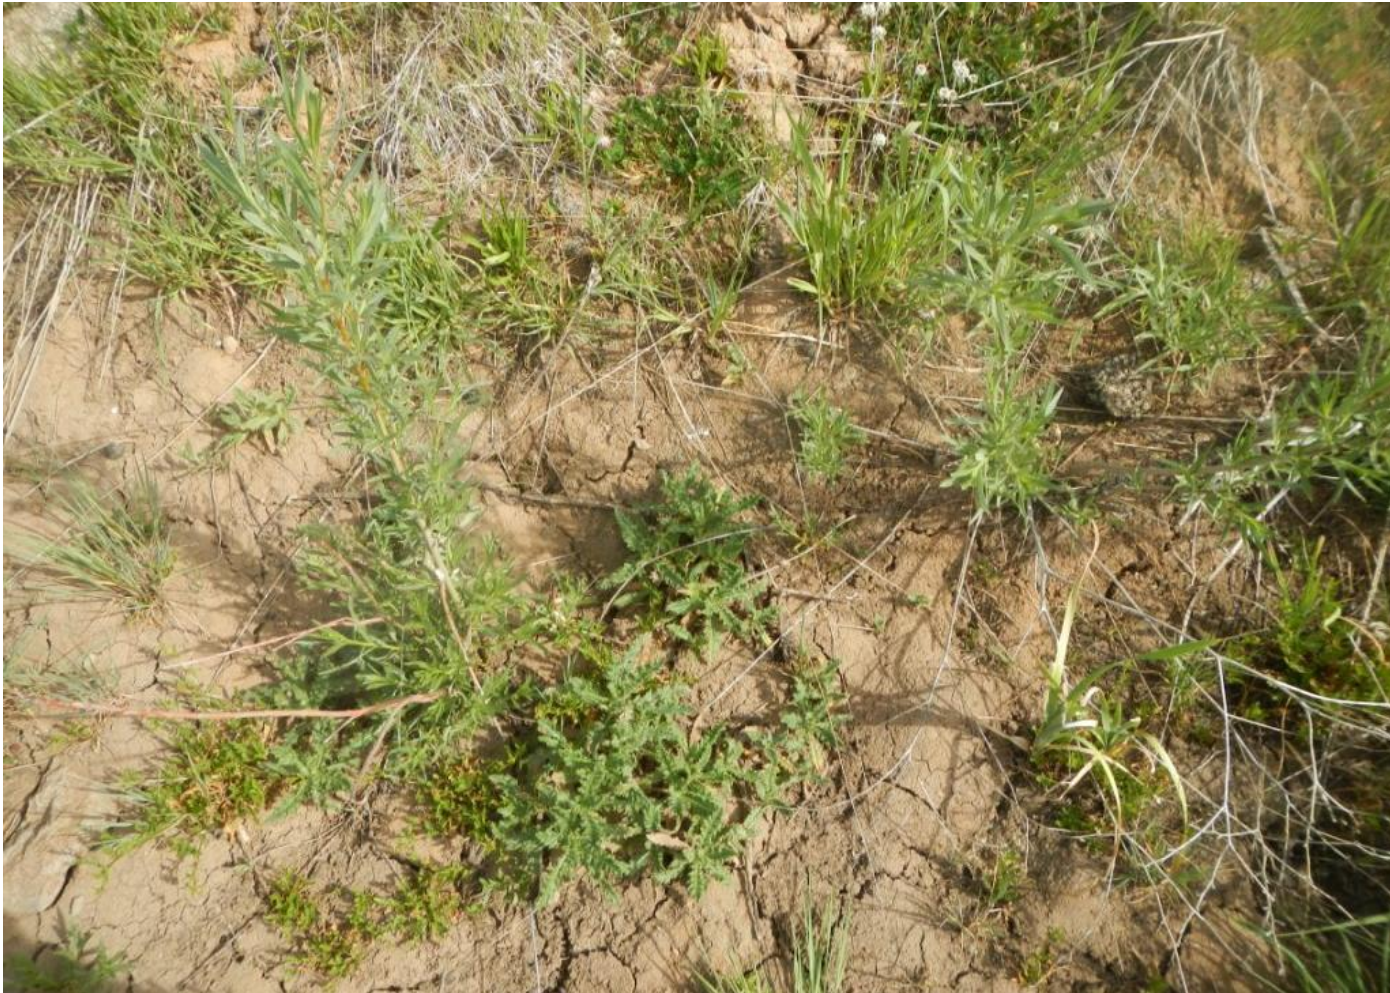
Photo 5. View of Canada thistle (*Cirsium arvense*) plants in the northern portion of the project area.

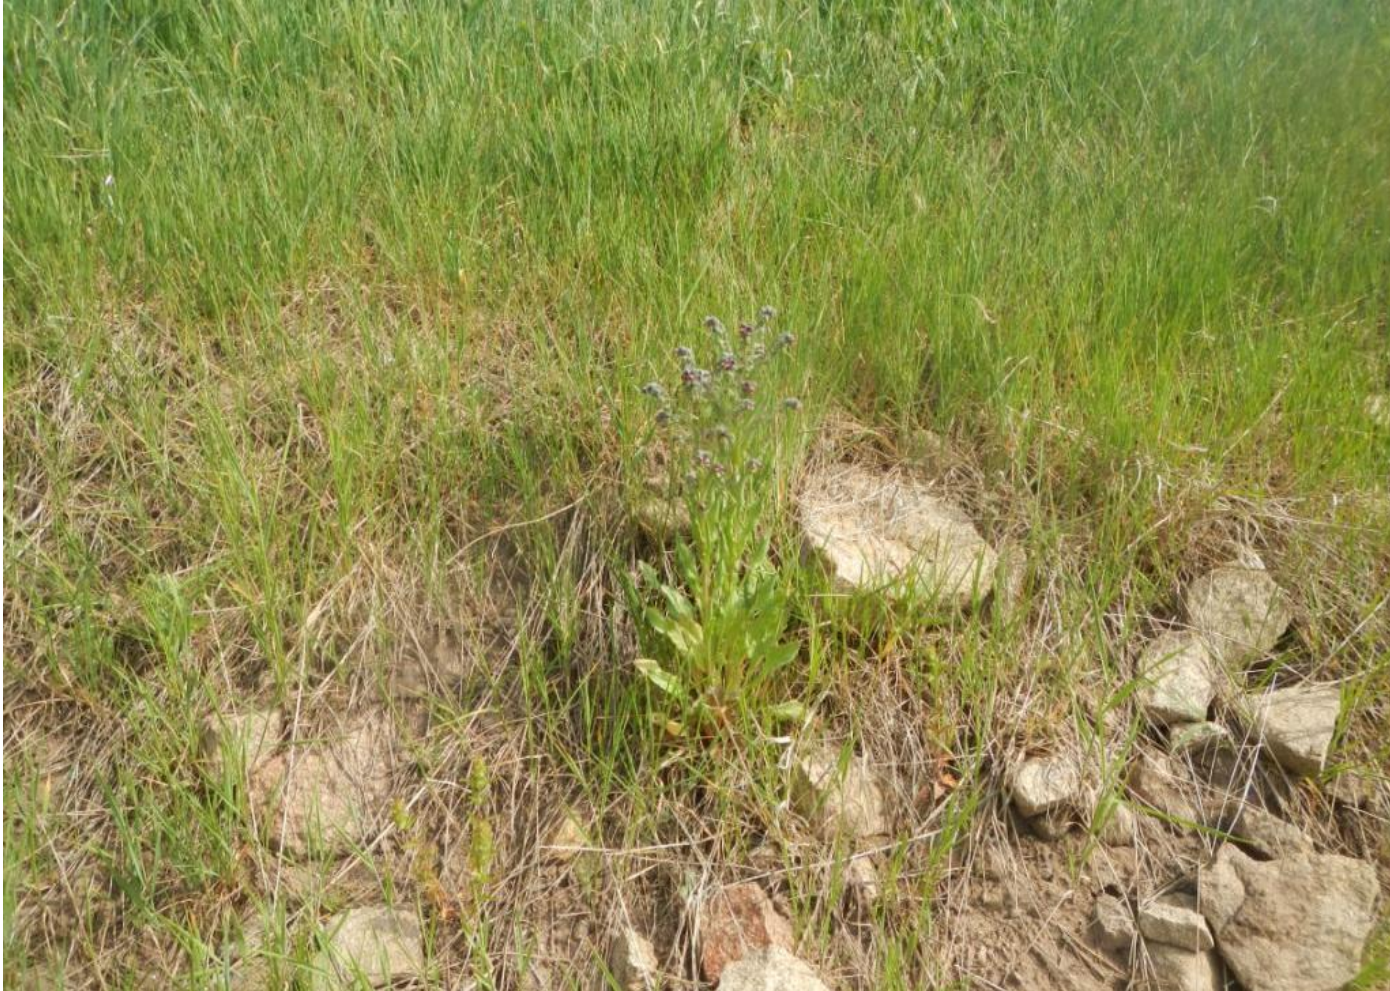
Photo 6. View of flowering houndstongue (*Cynoglossum officinale*) in the northern portion of the project area.

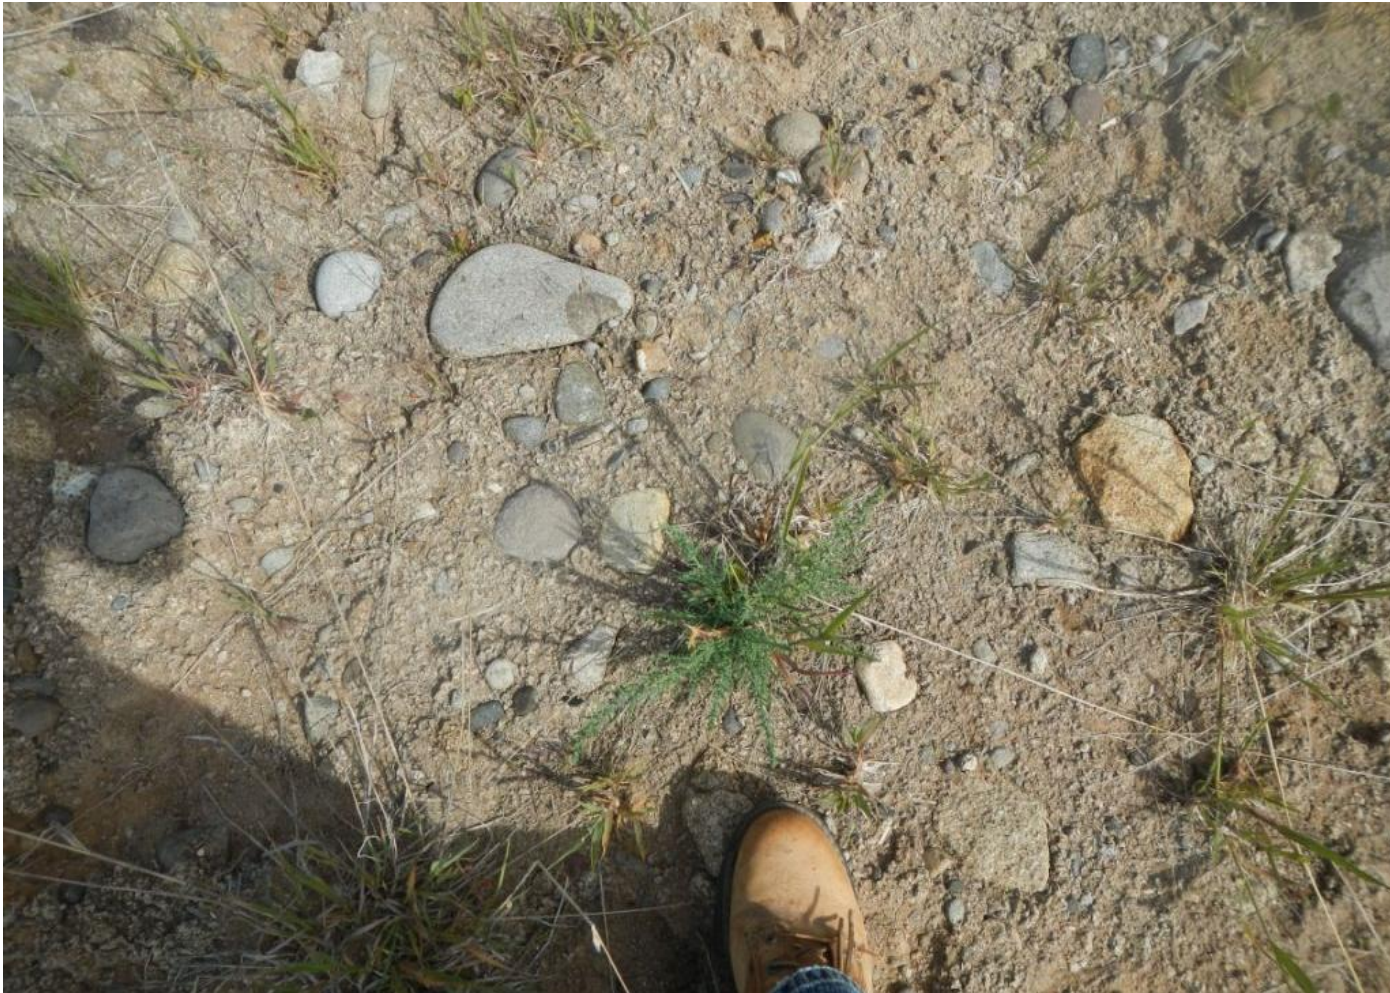
Photo 7. View of salt cedar (*Tamarix* sp.) in the northeastern portion of the project area.

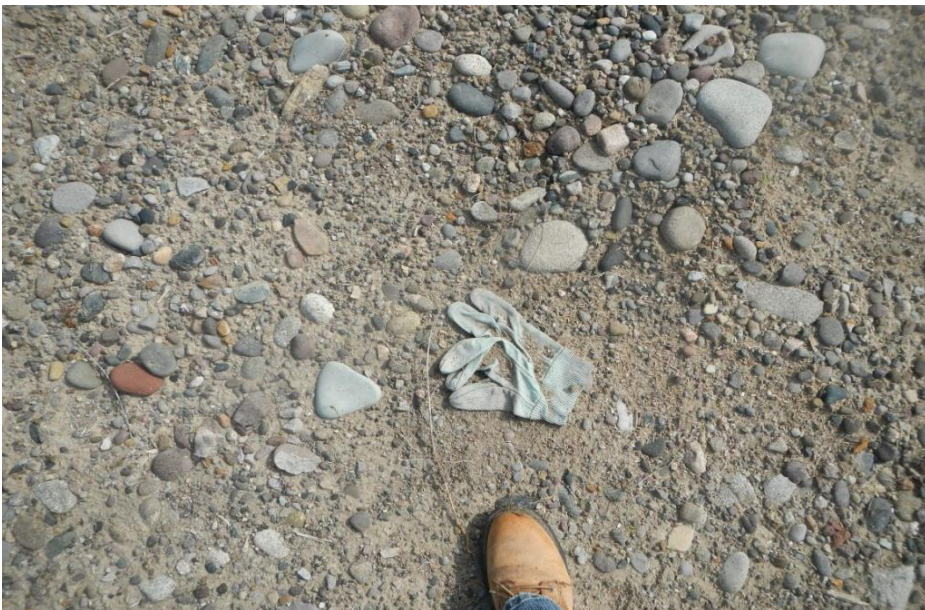
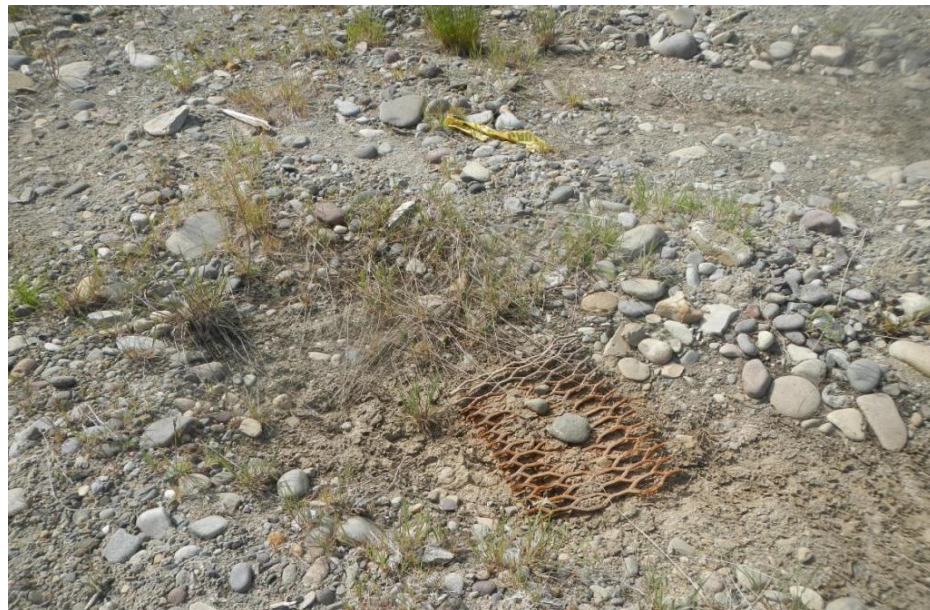
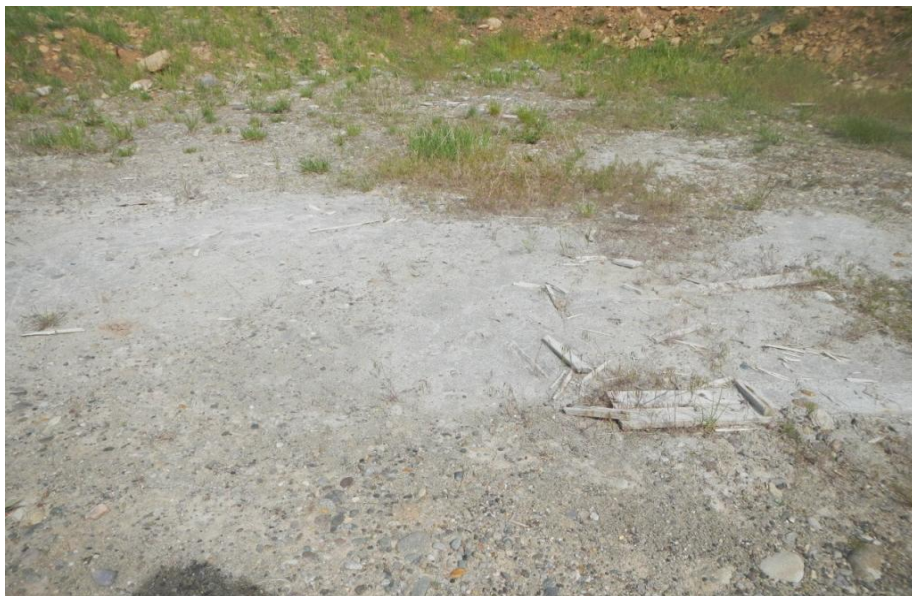
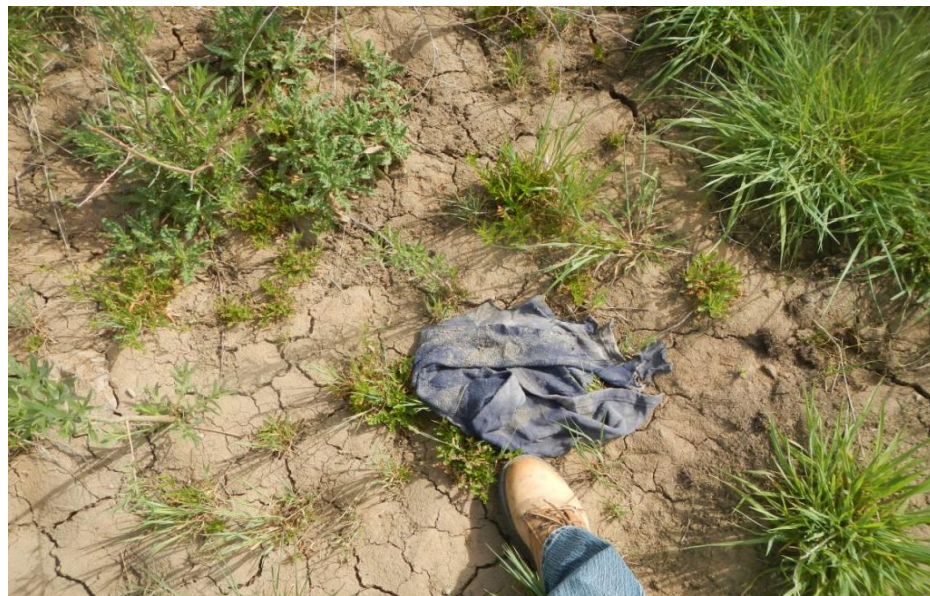
Photo 8-11. View of several pieces of trash and debris scattered around well pad area.
