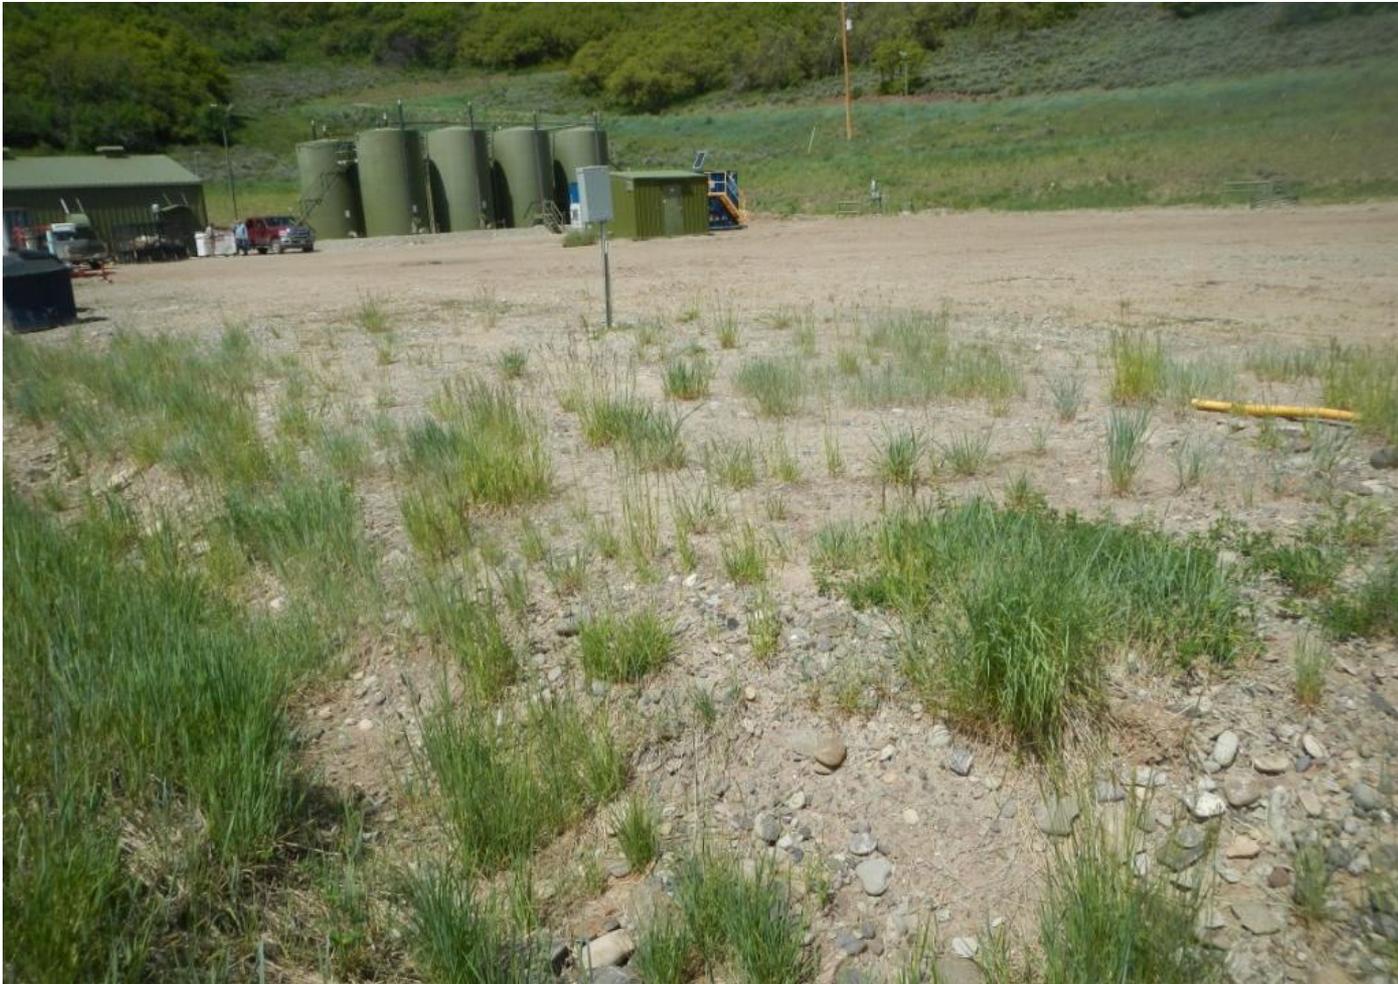
Photo 1. View of the project area from the eastern corner facing center.

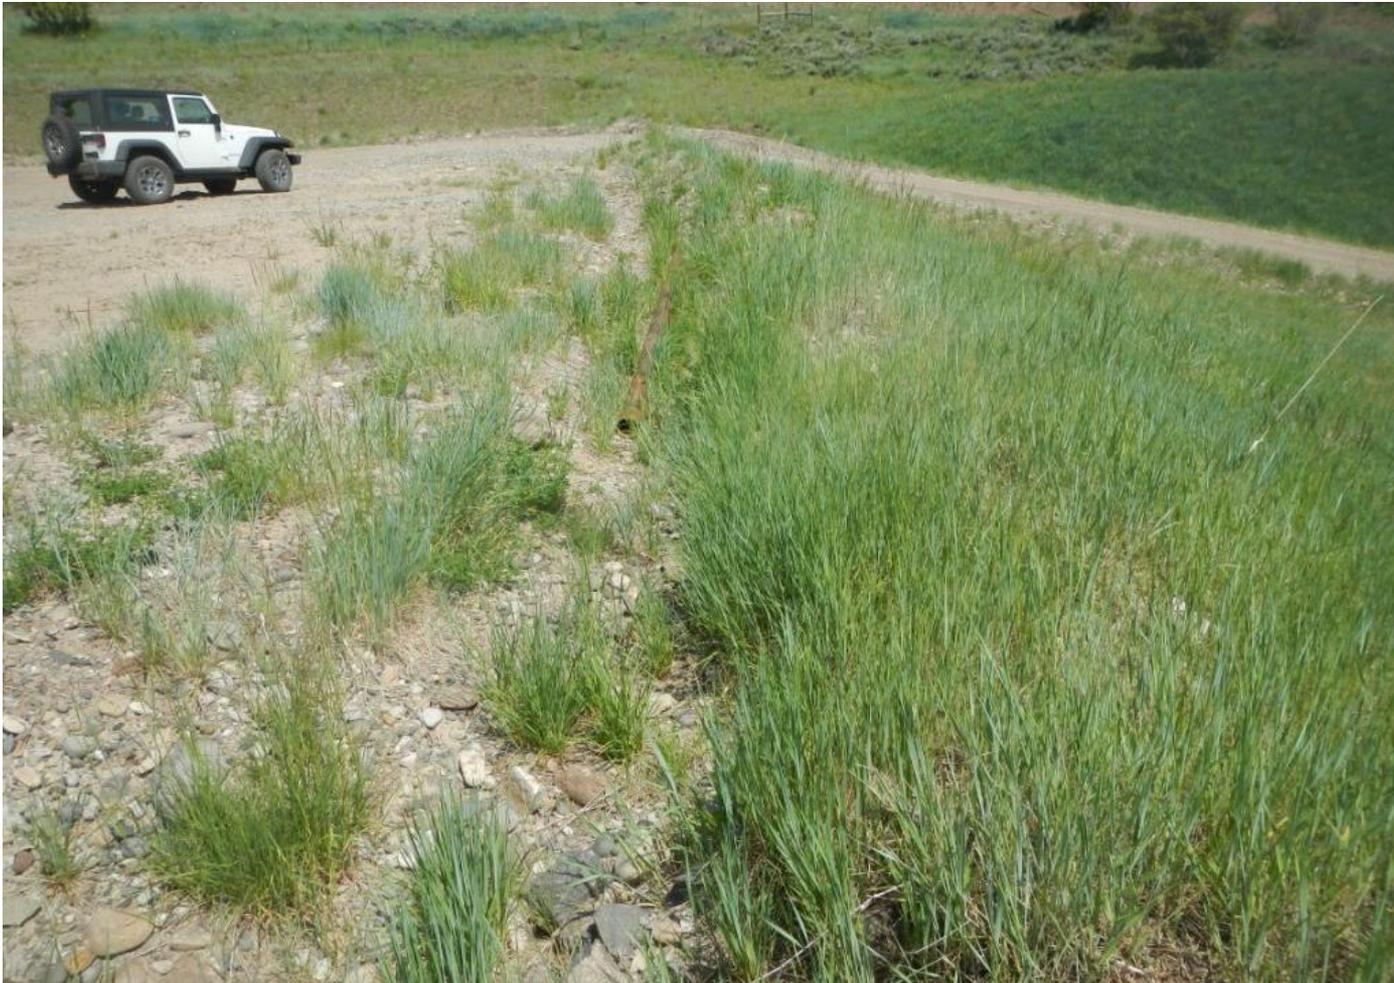
Photo 2. View of the northeastern portion of the project area from the eastern corner facing northward. Pipe in mid ground needs to be removed.

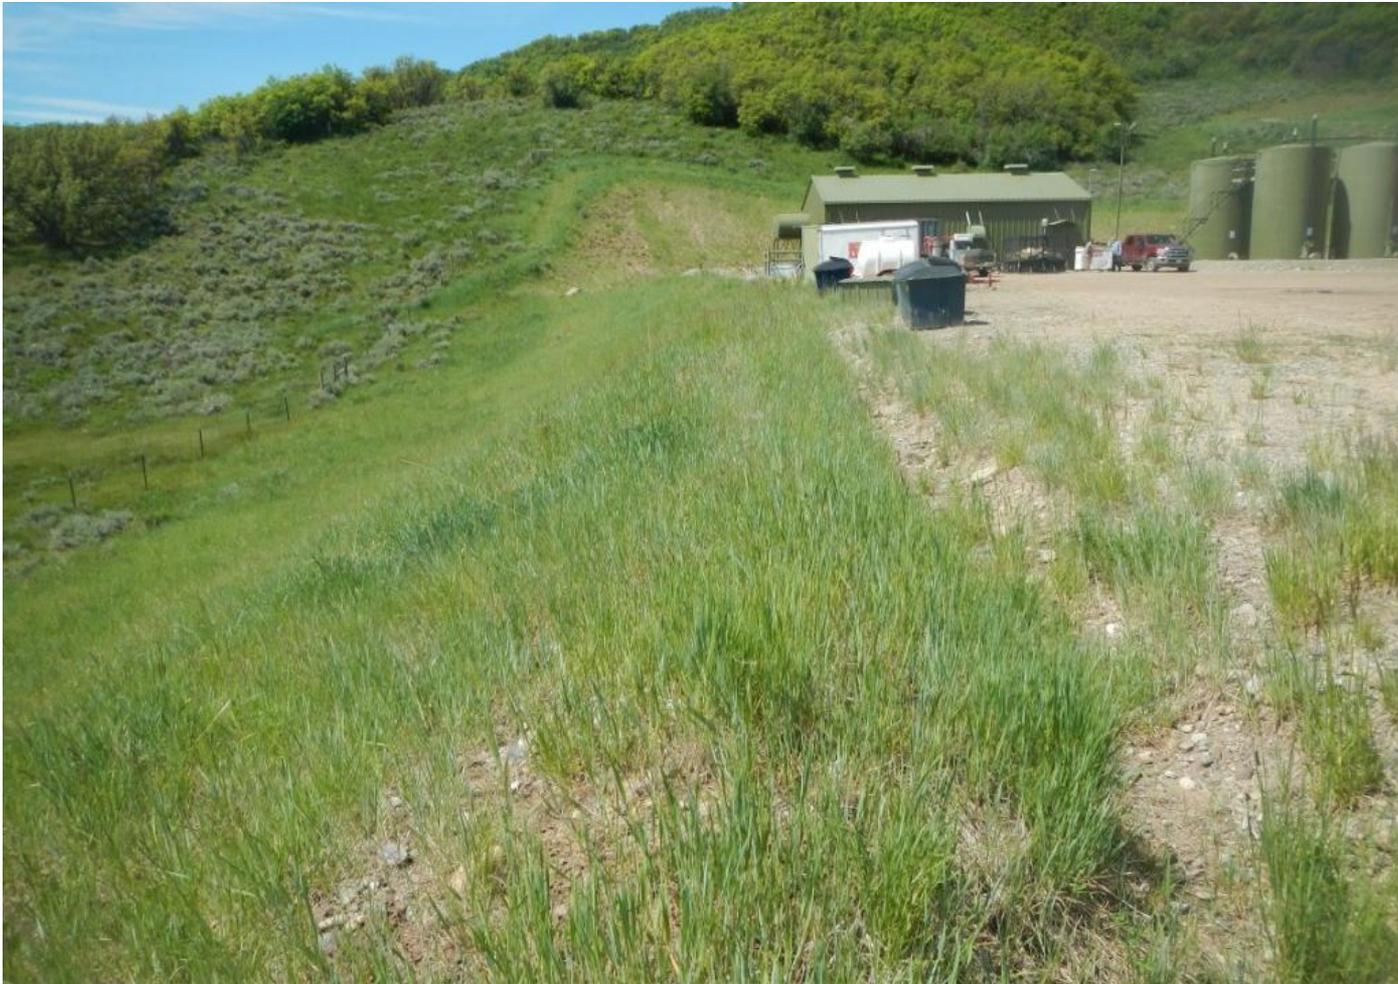
Photo 3. View of the southeastern portion of the project area from the eastern corner facing southwestward.

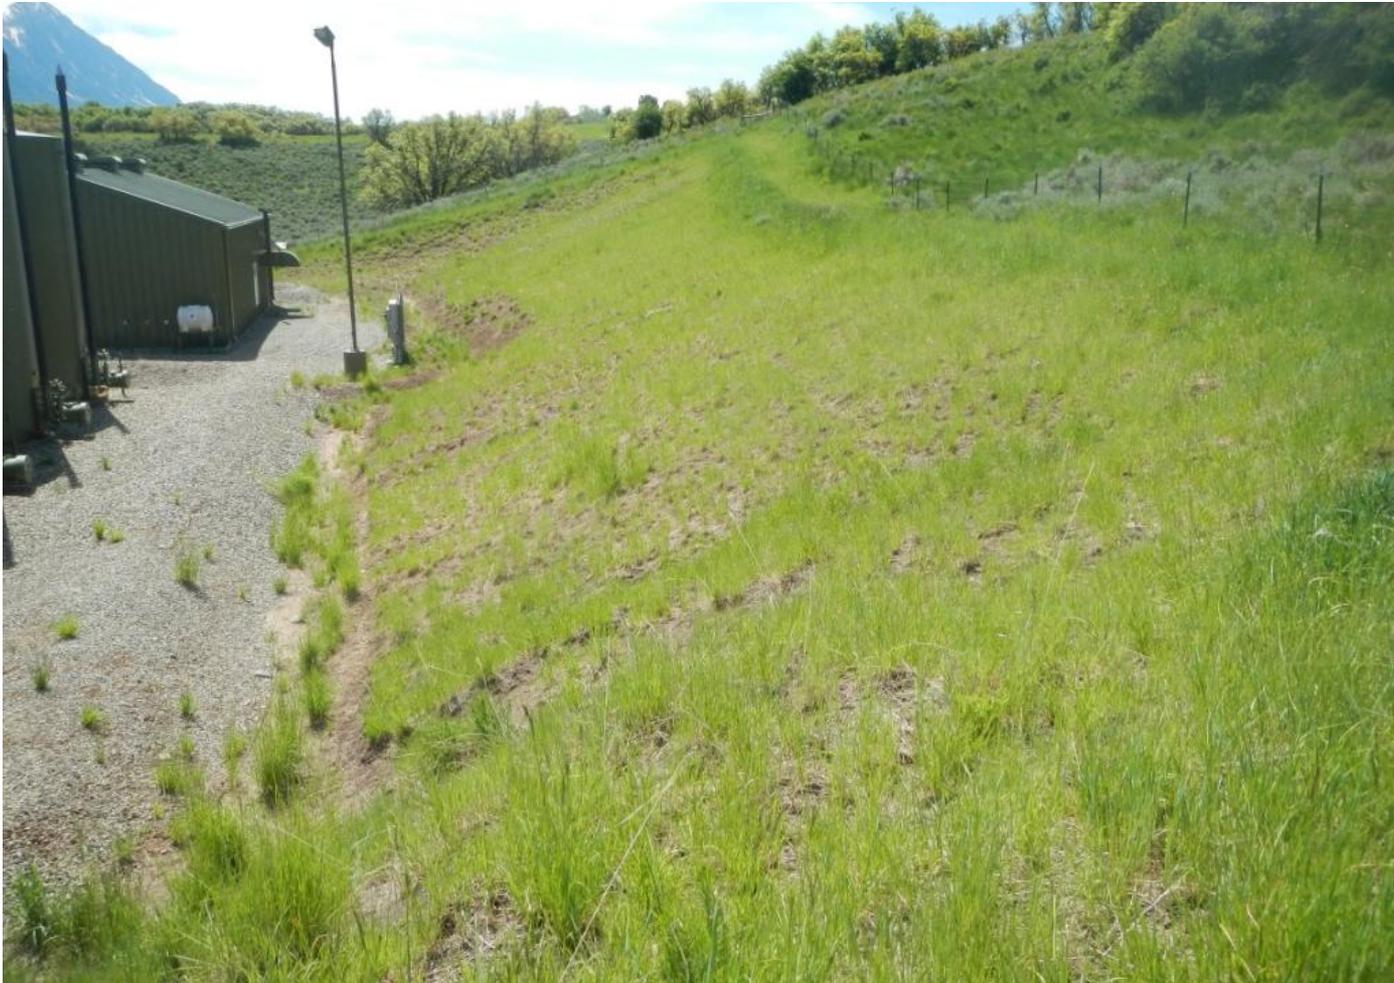
Photo 4. View of the southwestern portion of the project area from the northwestern corner facing southward. Revegetation is progressing on cut-slope largely with smooth brome (*Bromus inermis*) and western wheatgrass (*Pascopyrum smithii*).

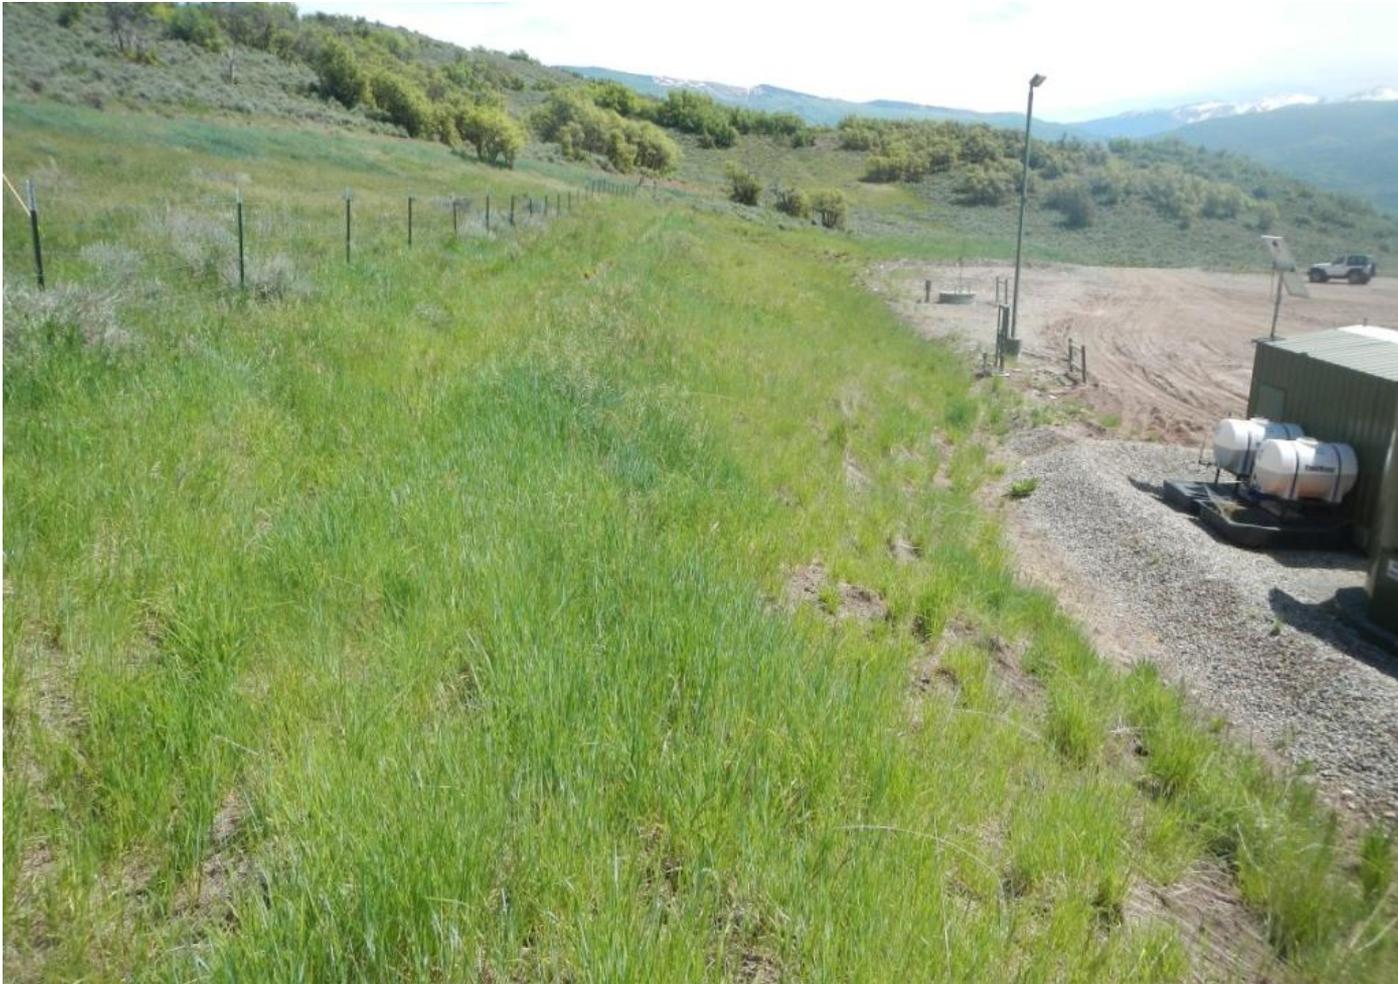
Photo 5. View of the northwestern portion of the project area from the southwestern corner facing northeastward.

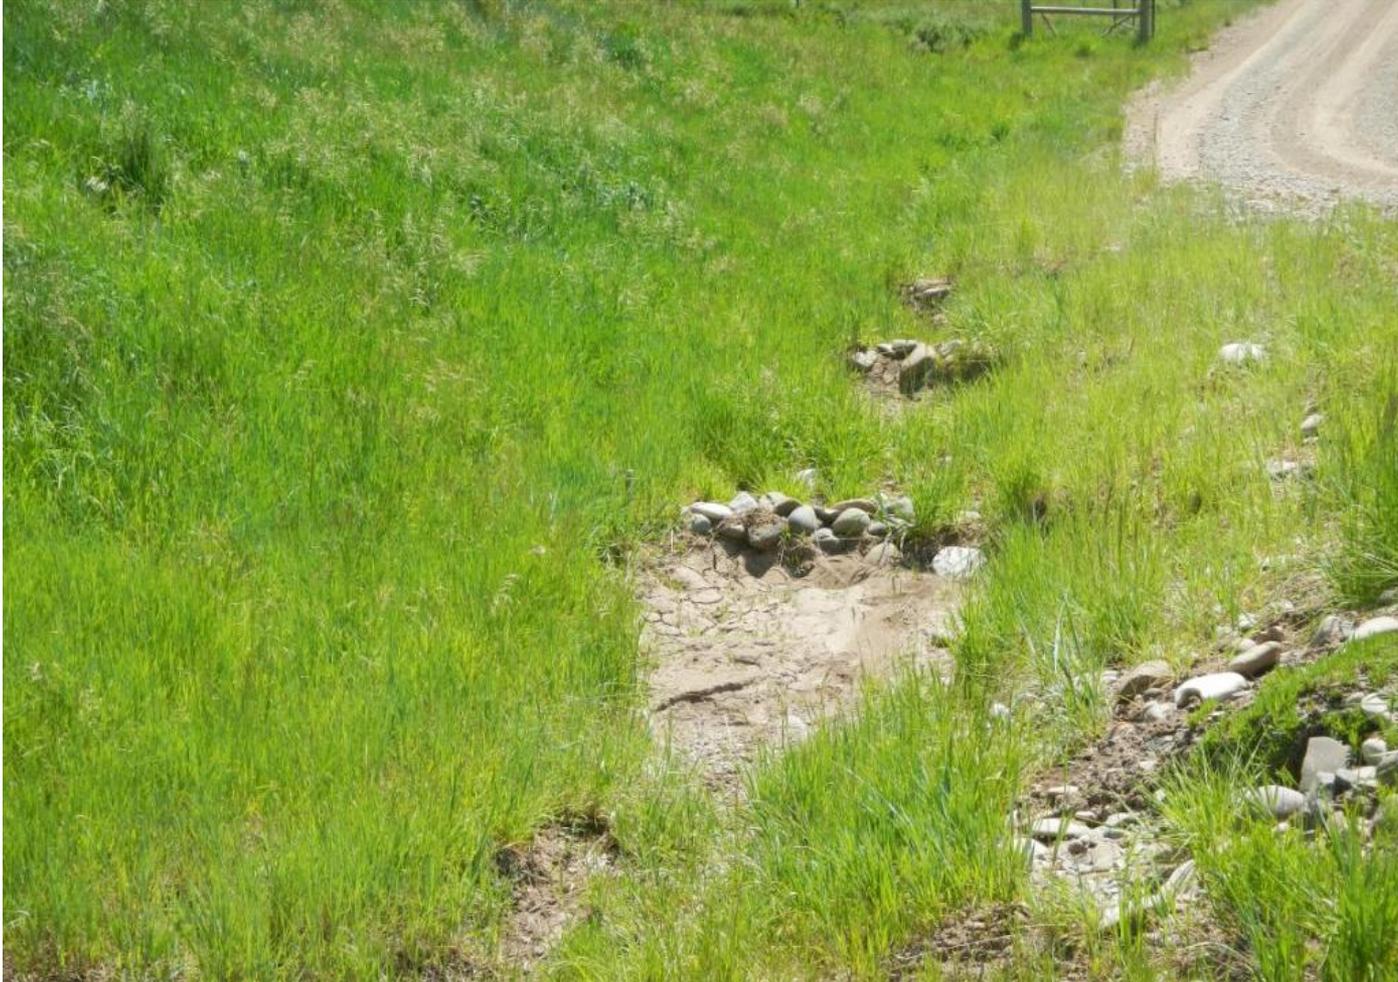
Photo 6. View of stormwater controls along the access road. Cobble check dams are used to de-energize flows. These are largely filled with sediment and need to be cleaned.

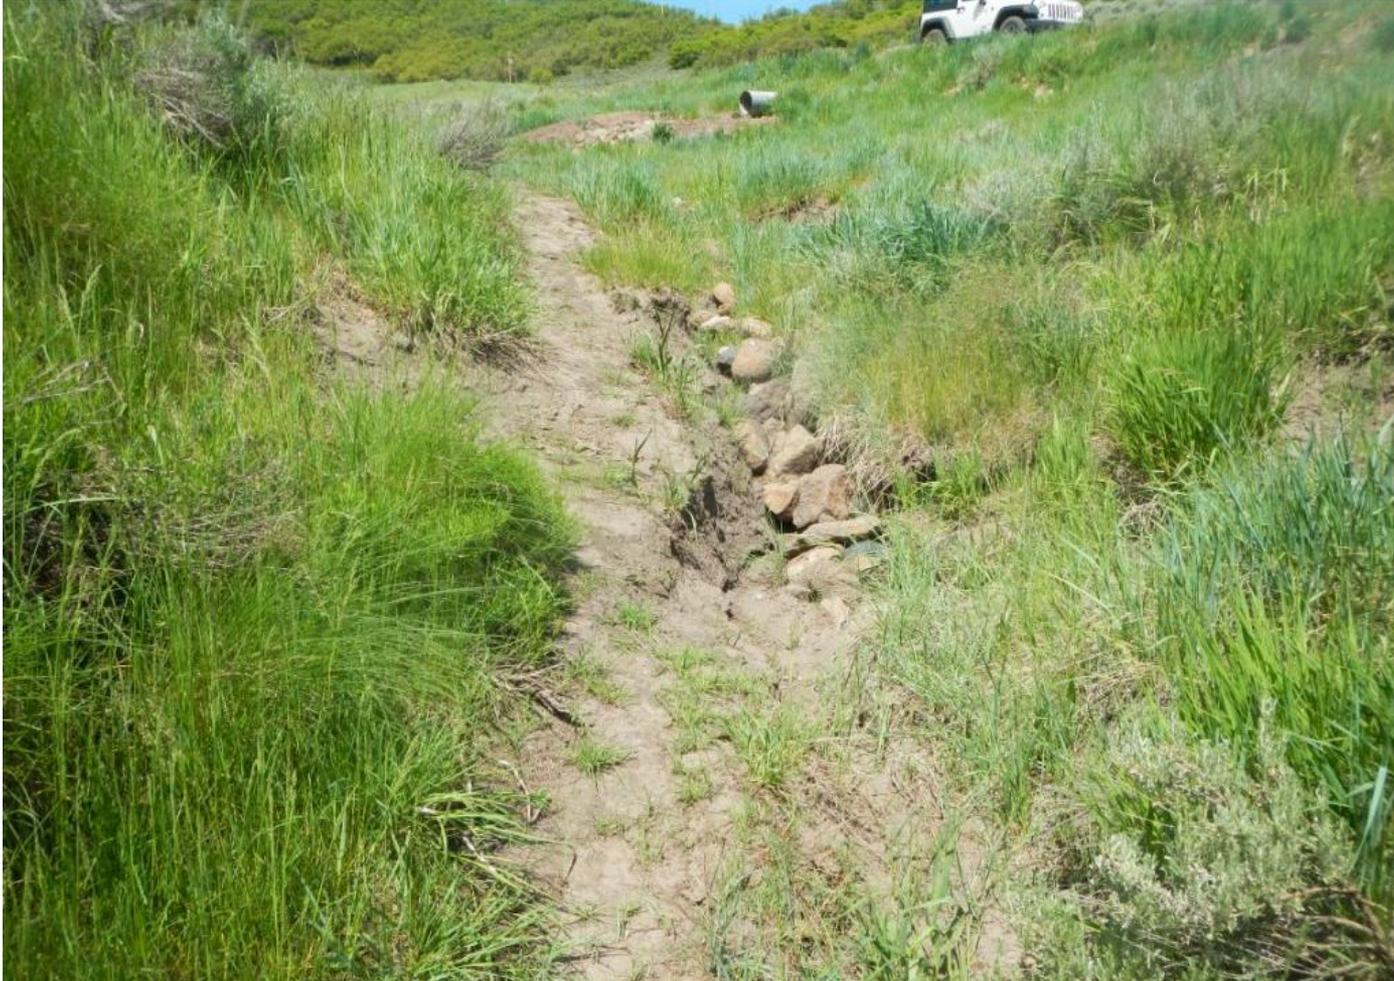
Photo 7. View of erosional channel on south side of access road. Stormwater BMPs are not functioning and stormwater is eroding the slope. Photo facing upslope toward where stormwater flows exit culvert on access road.

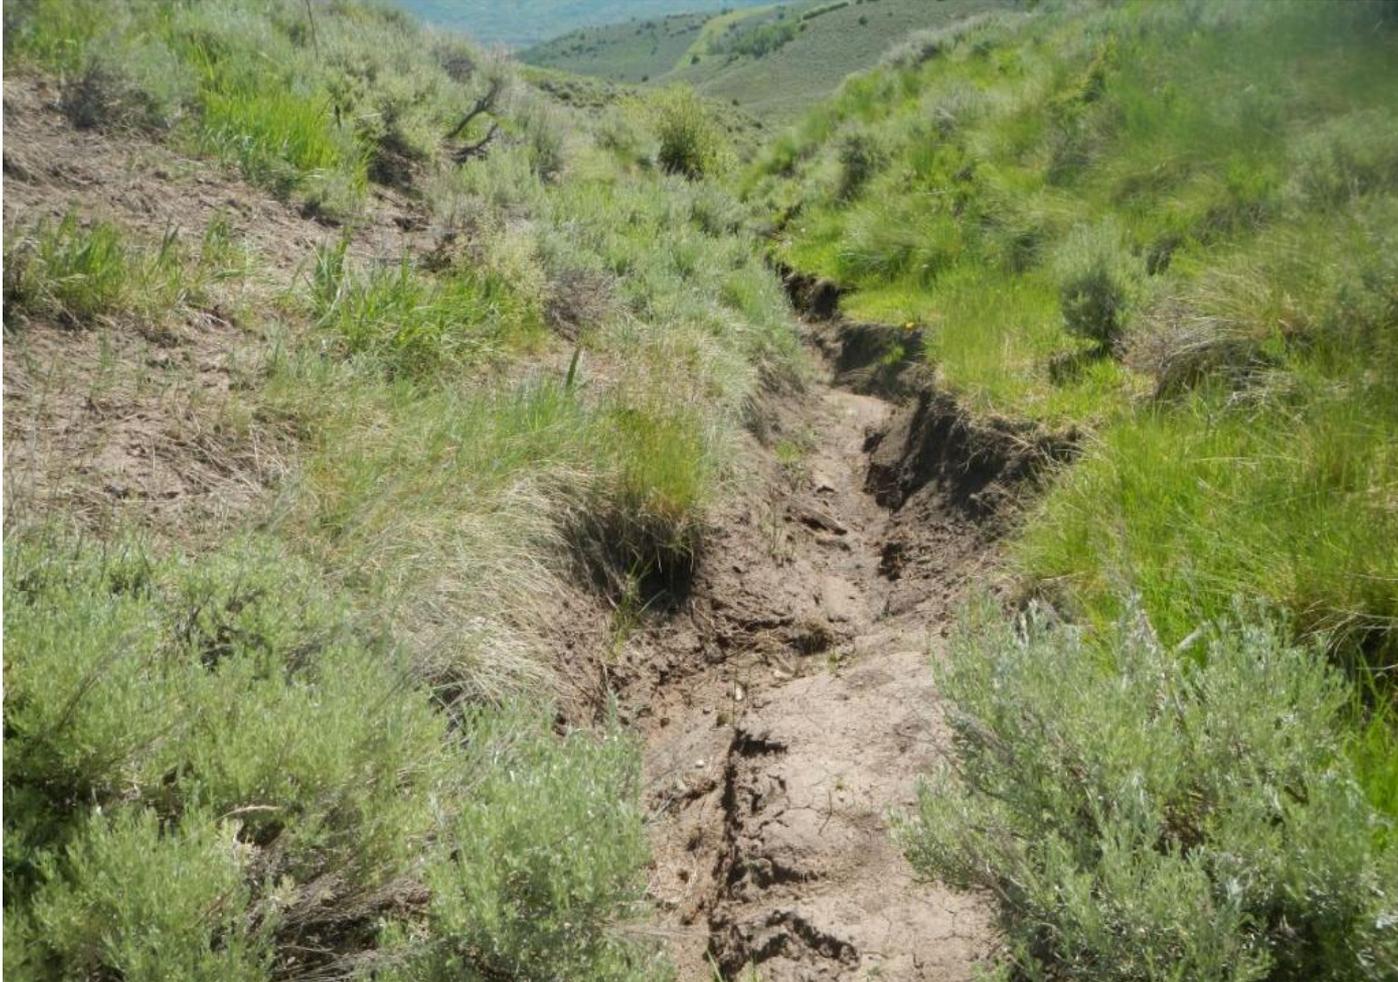
Photo 8. View of erosional channel that has formed on the south side of the access road where concentrated flows from the well pad and access road are eroding the drainage. Channel is approximately 3 feet wide and deep. Stormwater controls are needed stabilize erosion along this drainage.

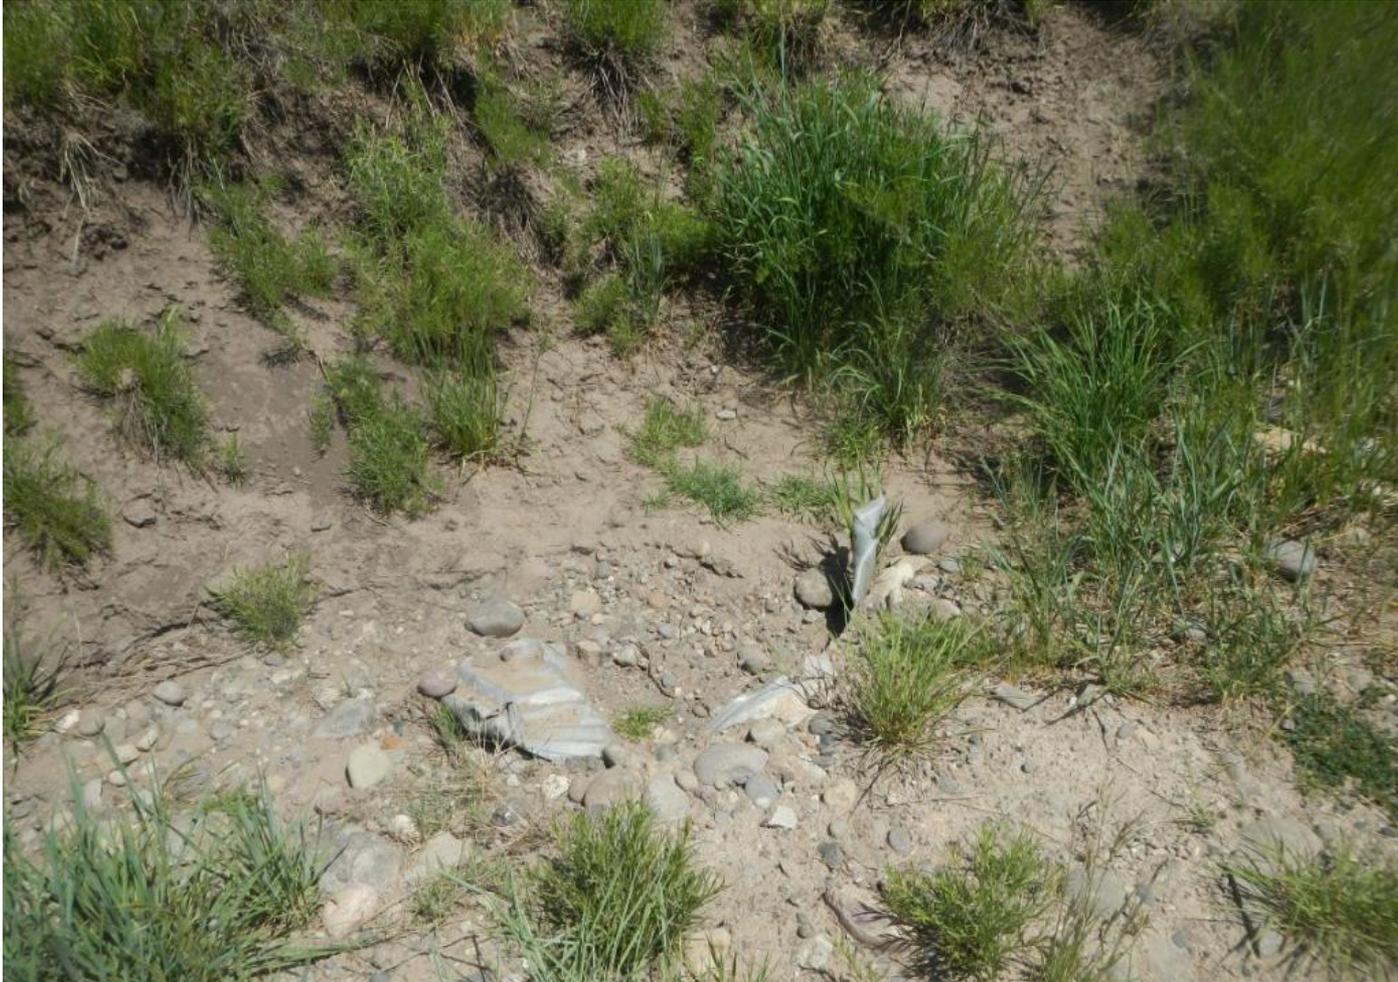
Photo 9. View of damaged culvert at the entrance to the access road.

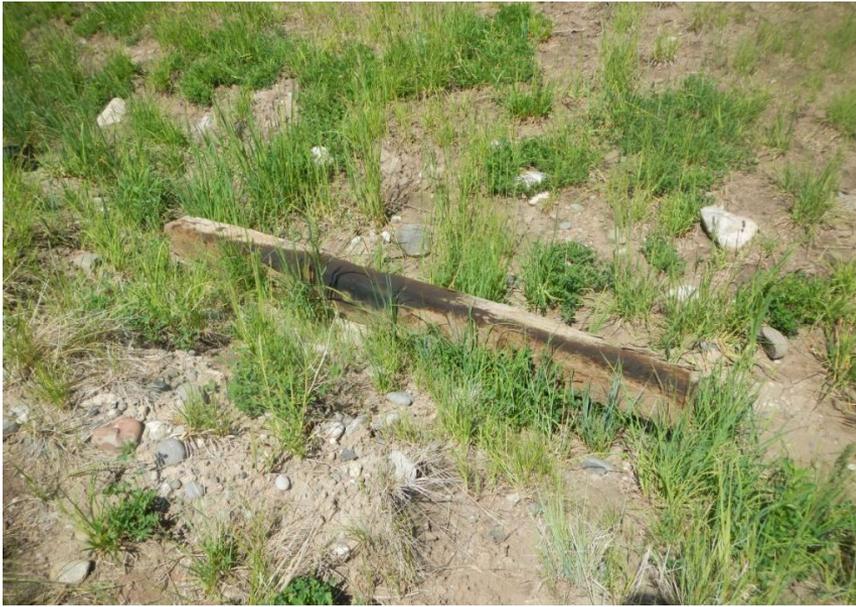
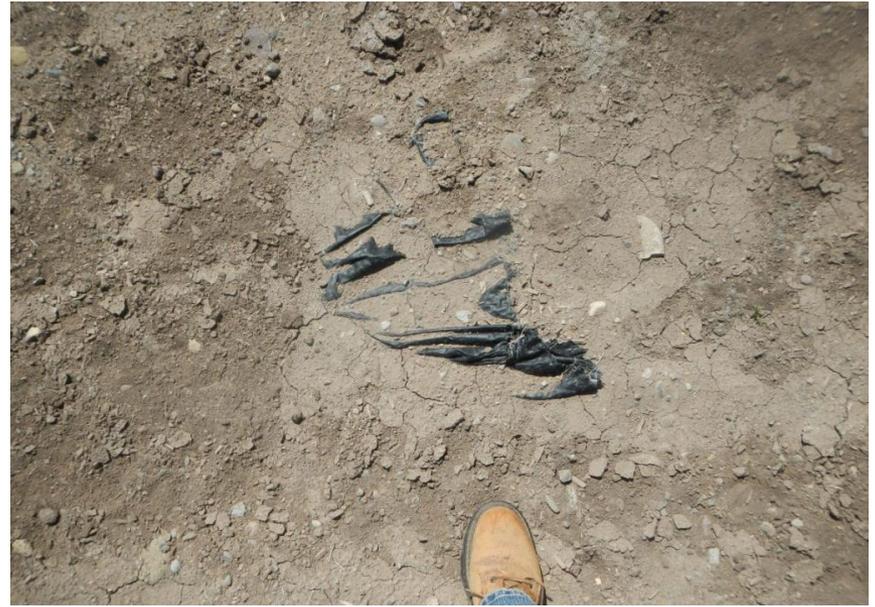
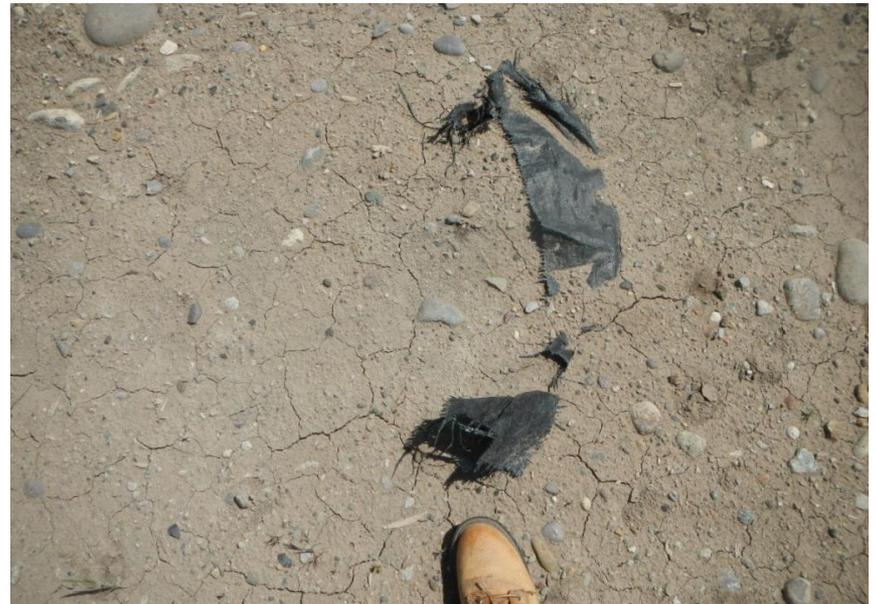
Photo 10-12. View of woody debris and liner debris observed scattered around well pad area.
