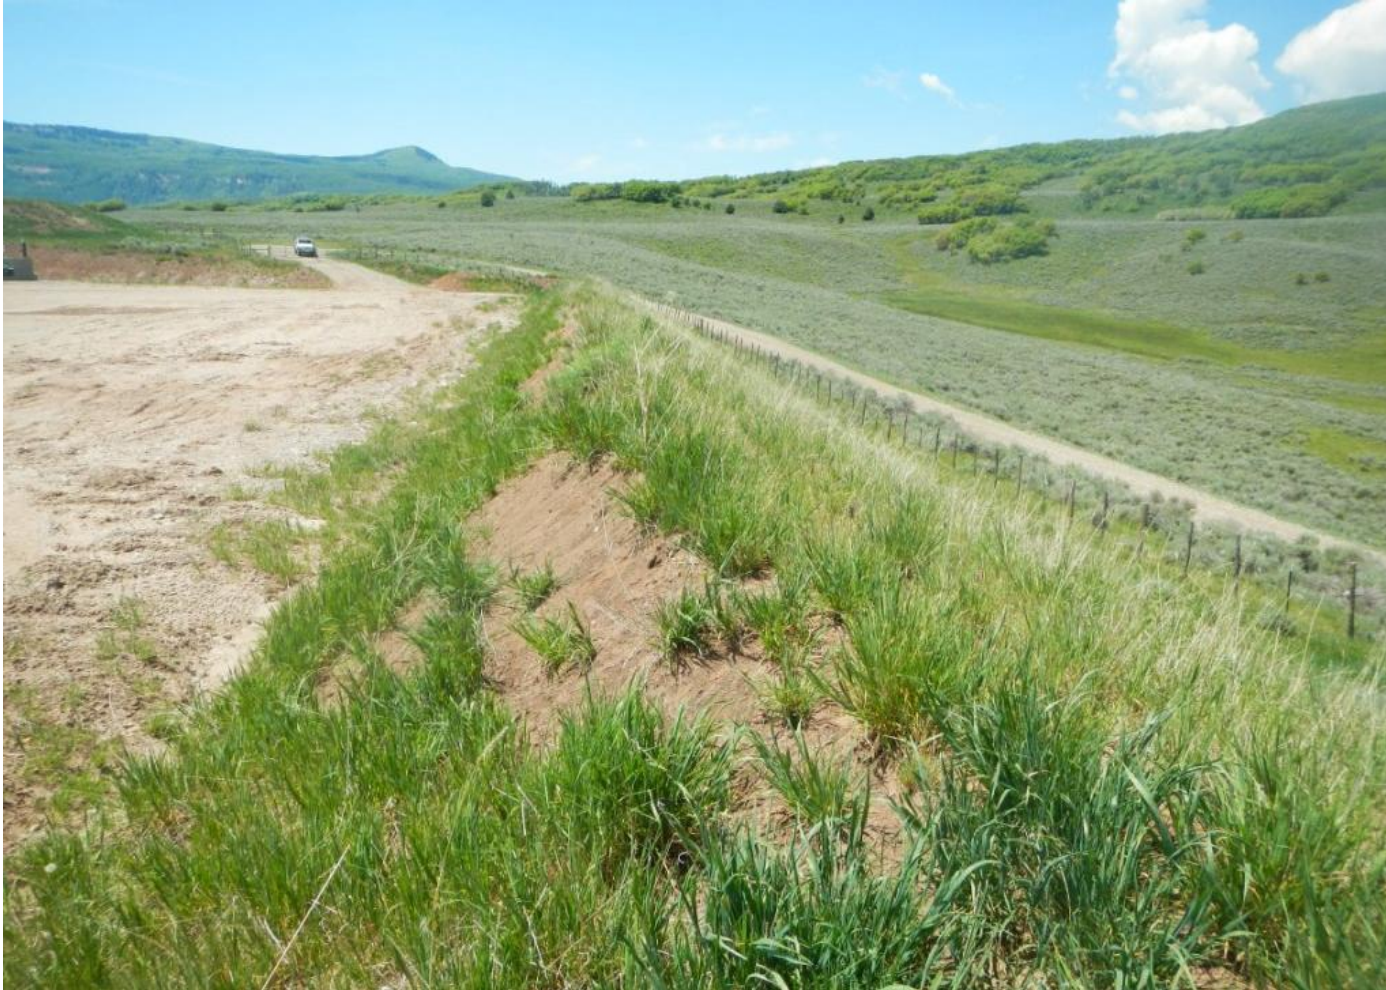
Photo 1. View of the northwestern portion of the project area from the northern corner facing southwestward. Cut and fill slopes are revegetating.

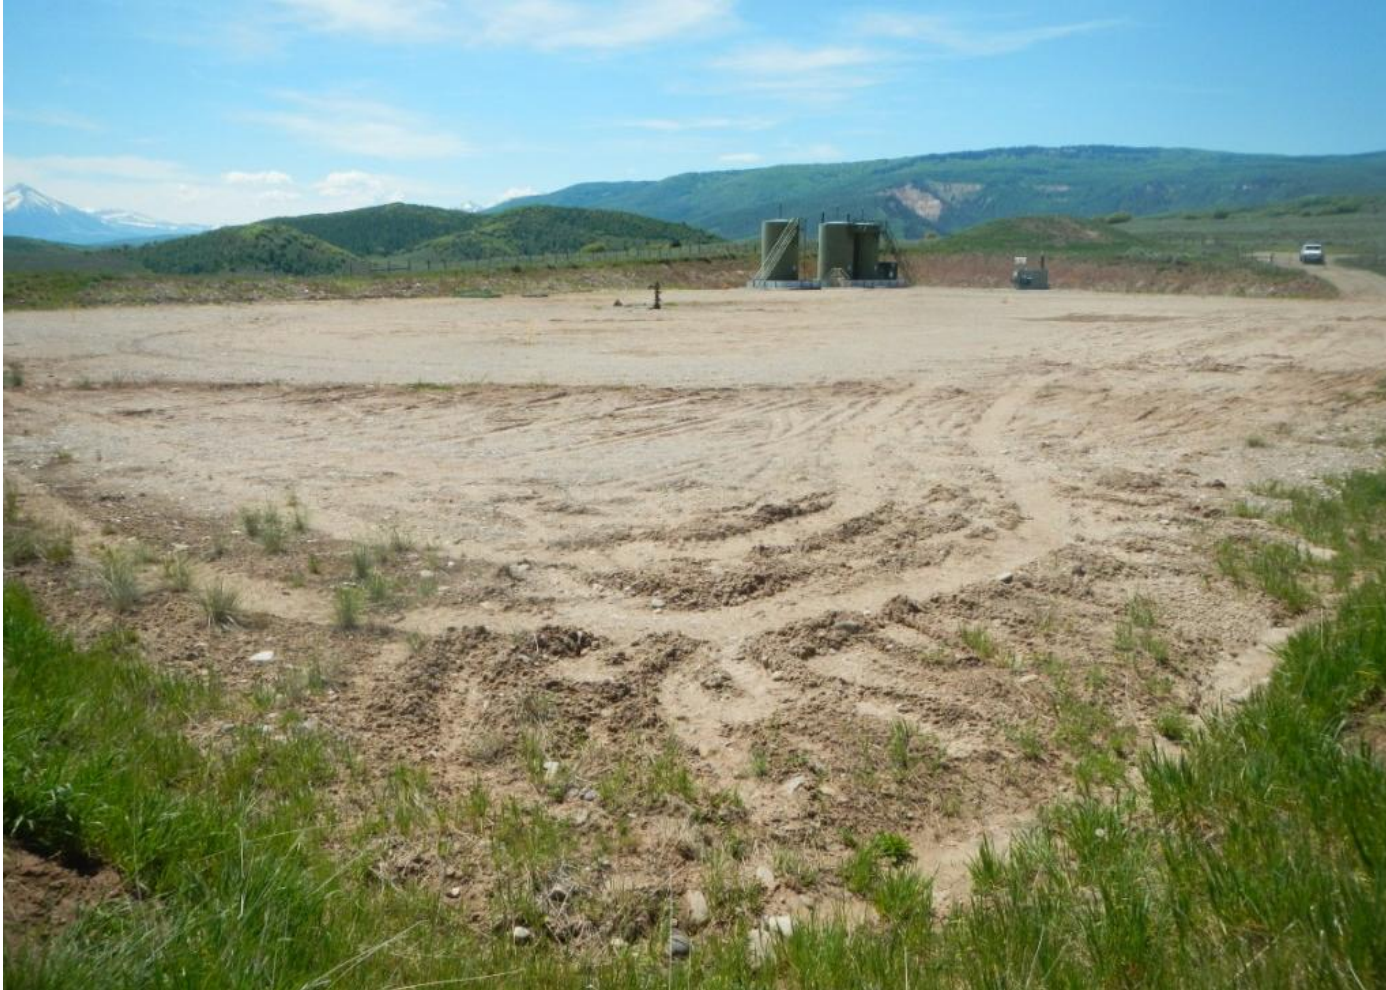
Photo 2. View of the project area from the northern corner facing center. Interim reclamation has not been conducted.

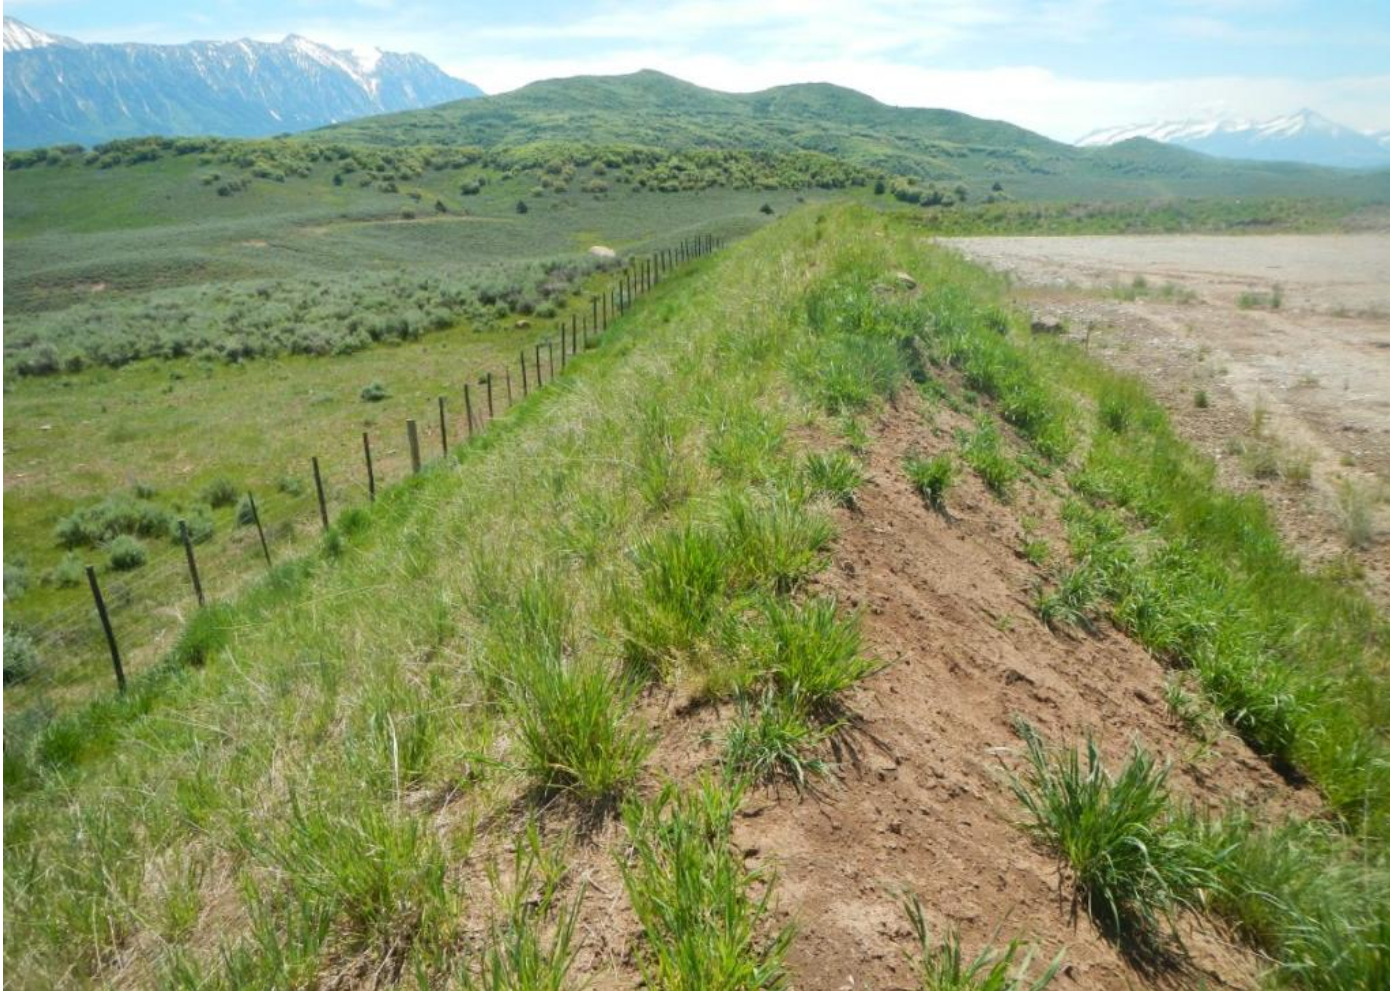
Photo 3. View of the northern portion of the project area from the northern corner facing eastward.

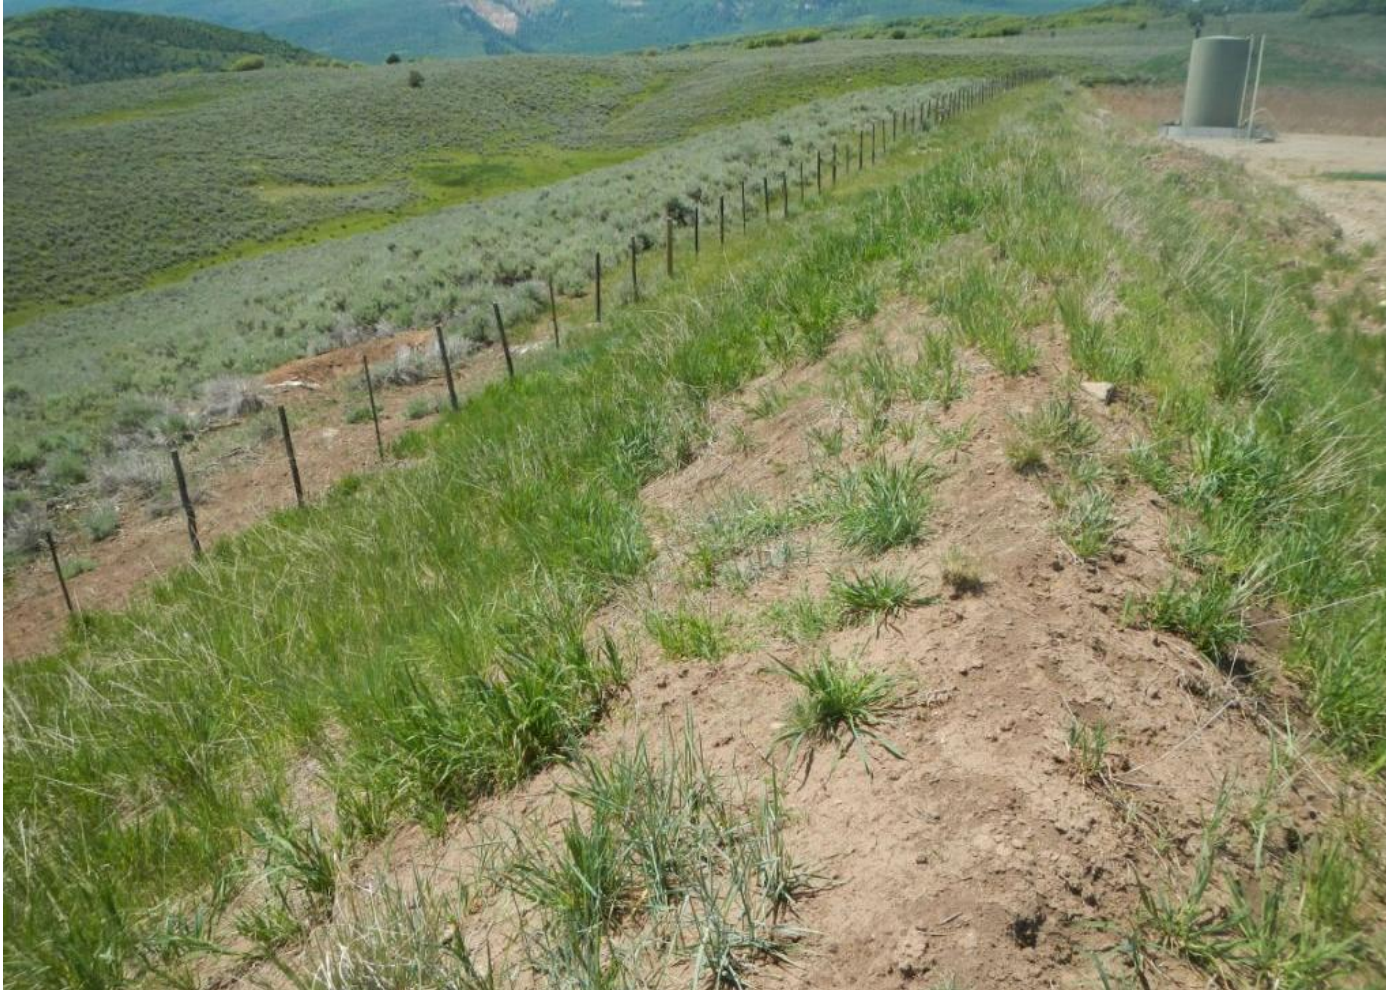
Photo 4. View of the southeastern portion of the project area from the eastern corner facing southwestward.

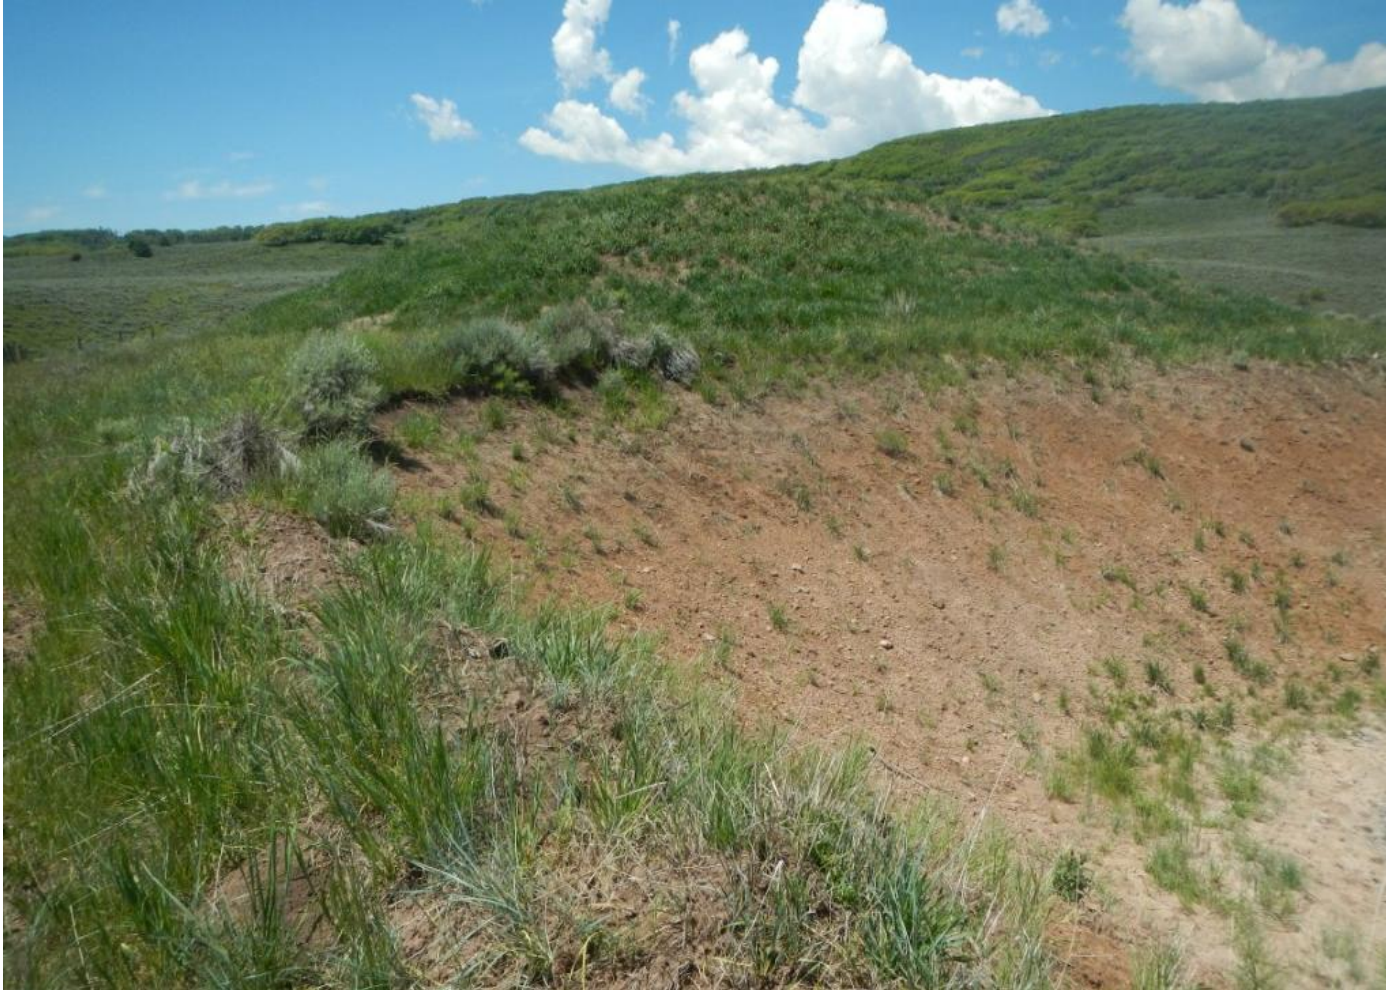
Photo 5. View of the southwestern corner of the project area. It appears that topsoil is stockpiled here and is revegetating.

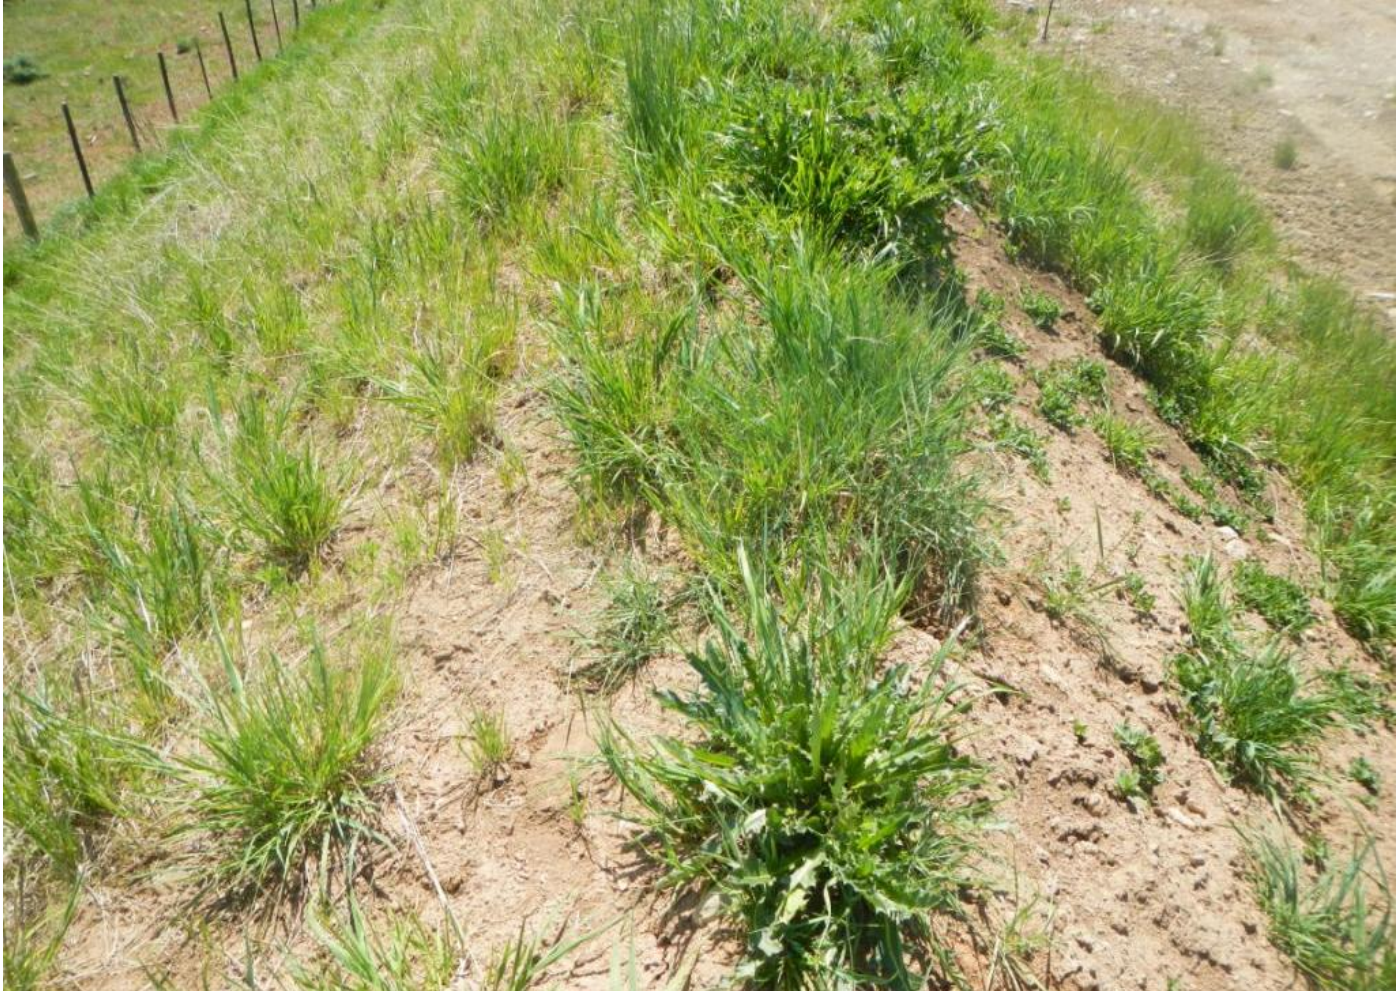
Photo 6. View of musk thistles in northern portion of the project area.

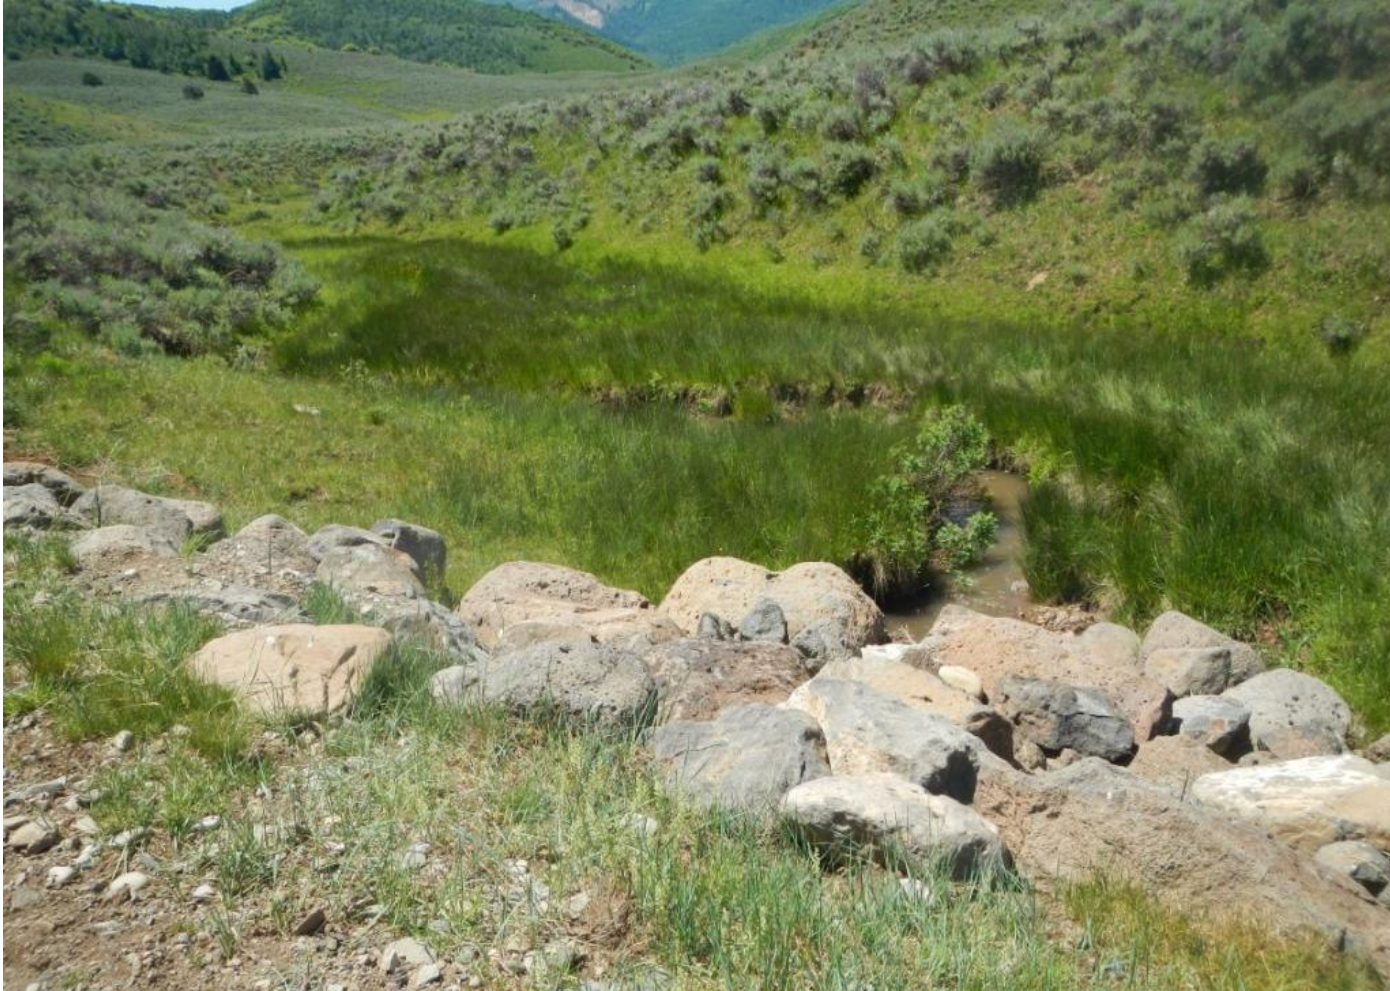
Photo 7. View of armoring at culvert along access road. Appears to be in good condition.

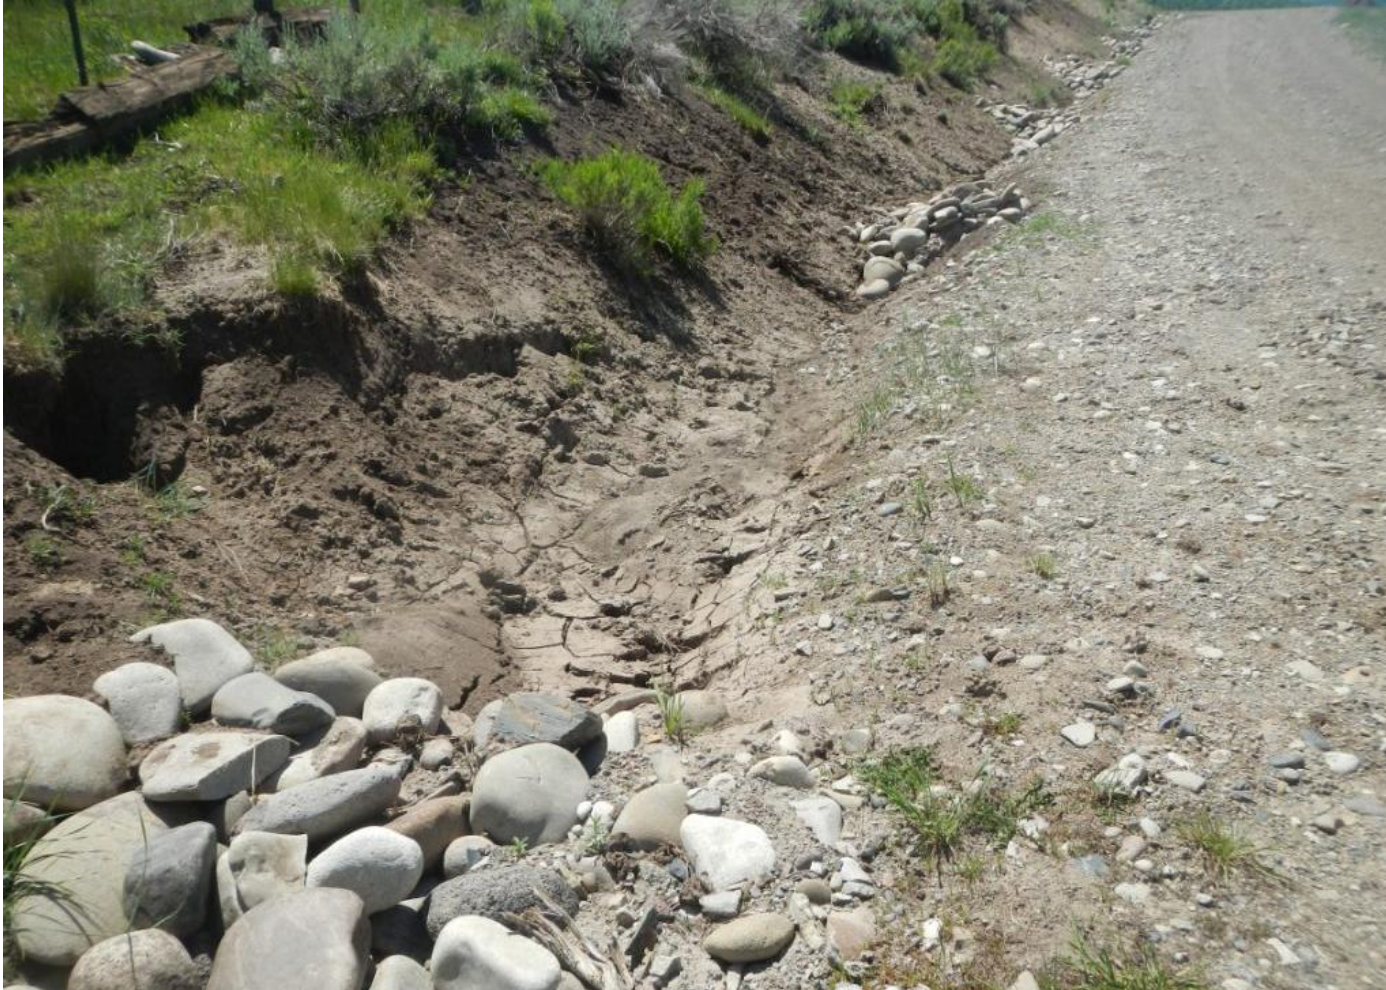
Photo 8. View of rock check dams placed along access road. Appear to be functioning at this time, but will soon need maintenance.
