Reference Area Photographs

Inspection Conducted on June 15, 2016

Hunter Ridge Energy Services

Spill/Release Point ID #446199

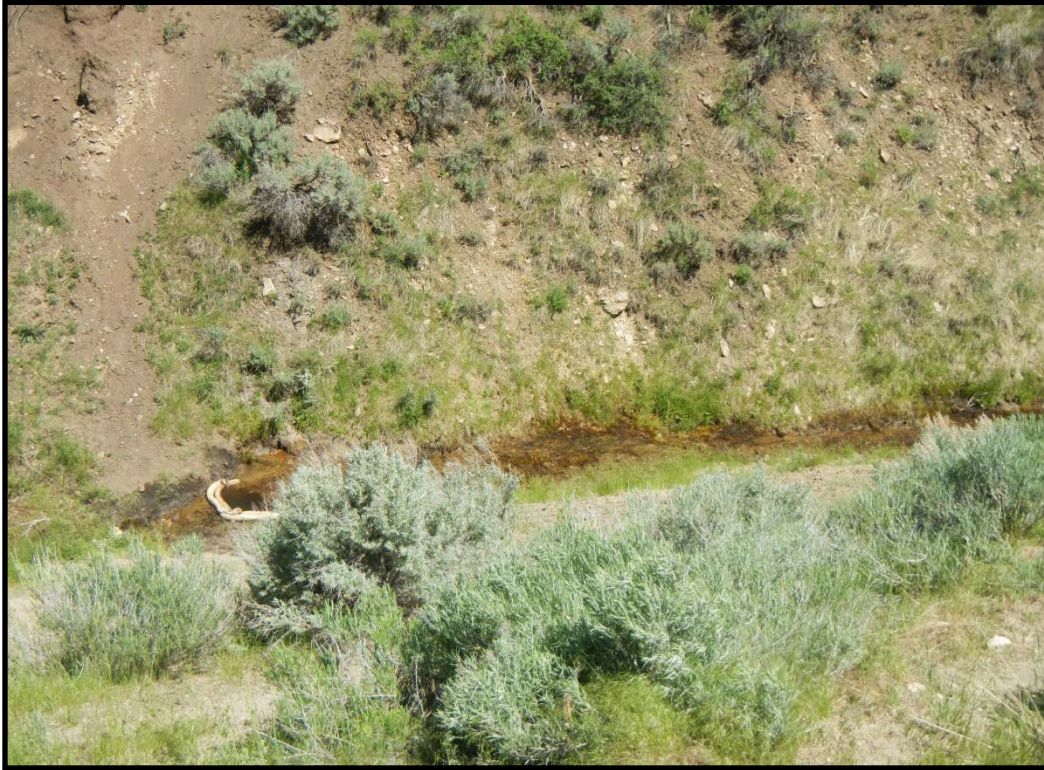
About three Springs in this location, approximately ½ mile north and downgradient of Pipelines crossing the natural drainage (A27 CDP location).

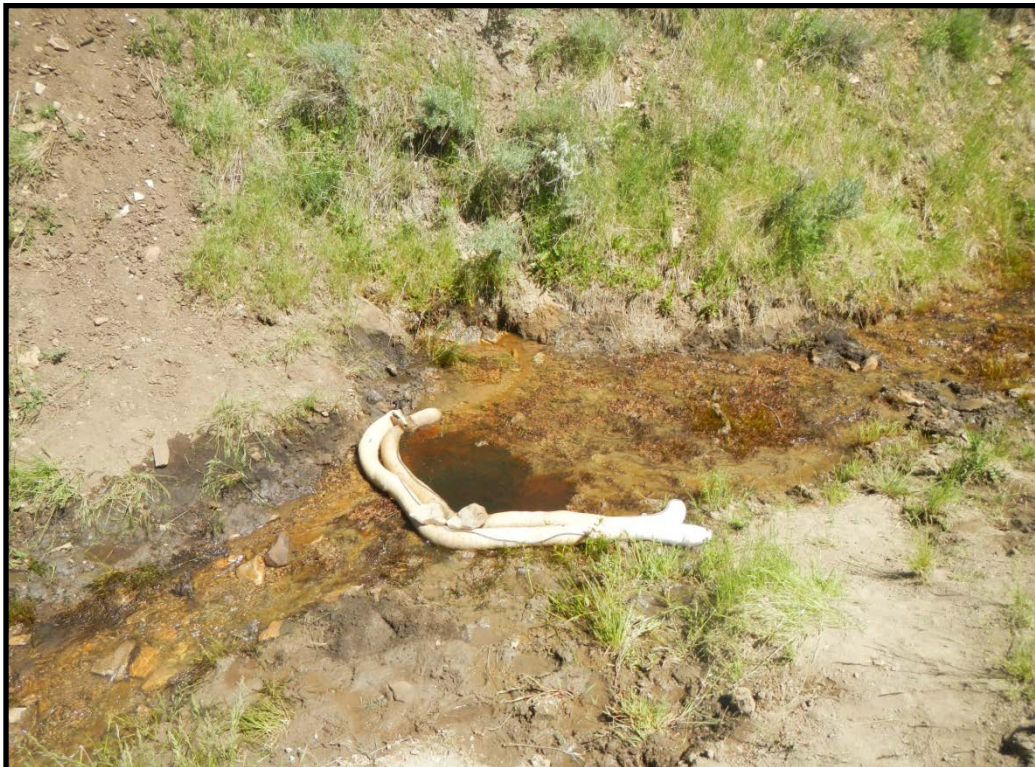
Close-up showing one of the Springs and free-product retained by booms. Natural drainage is dry upgradient of Springs. Continuous flow downgradient. Approximately one mile to stock pond.

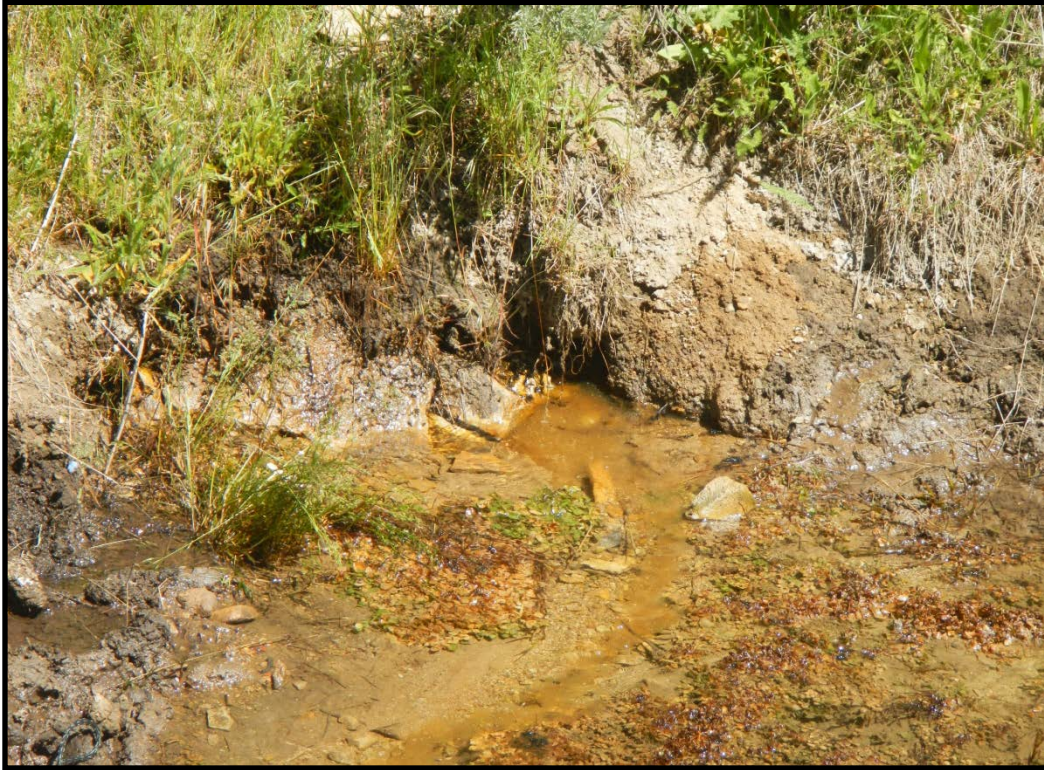
Close-up of one of the Springs. Observe sheen coming from the Spring.

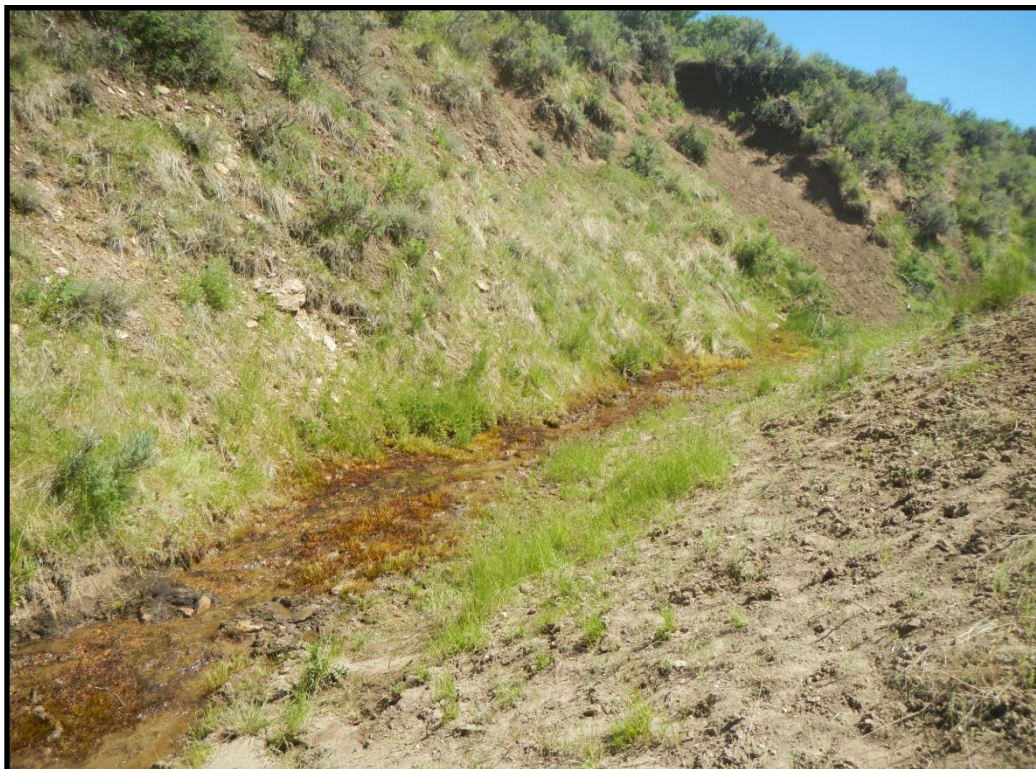
Looking upstream (south). Springs are near and on the same side of landslide.

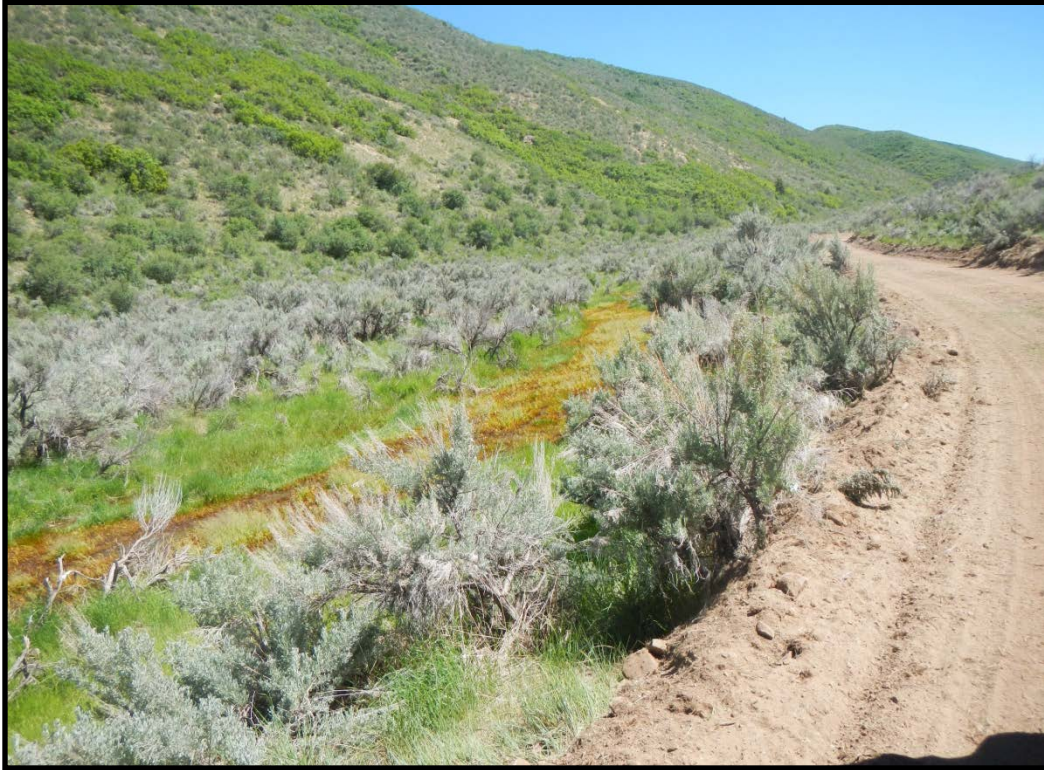
Approximately midway between Springs and stock pond. Looking upstream (south). Observe change of color in vegetation.

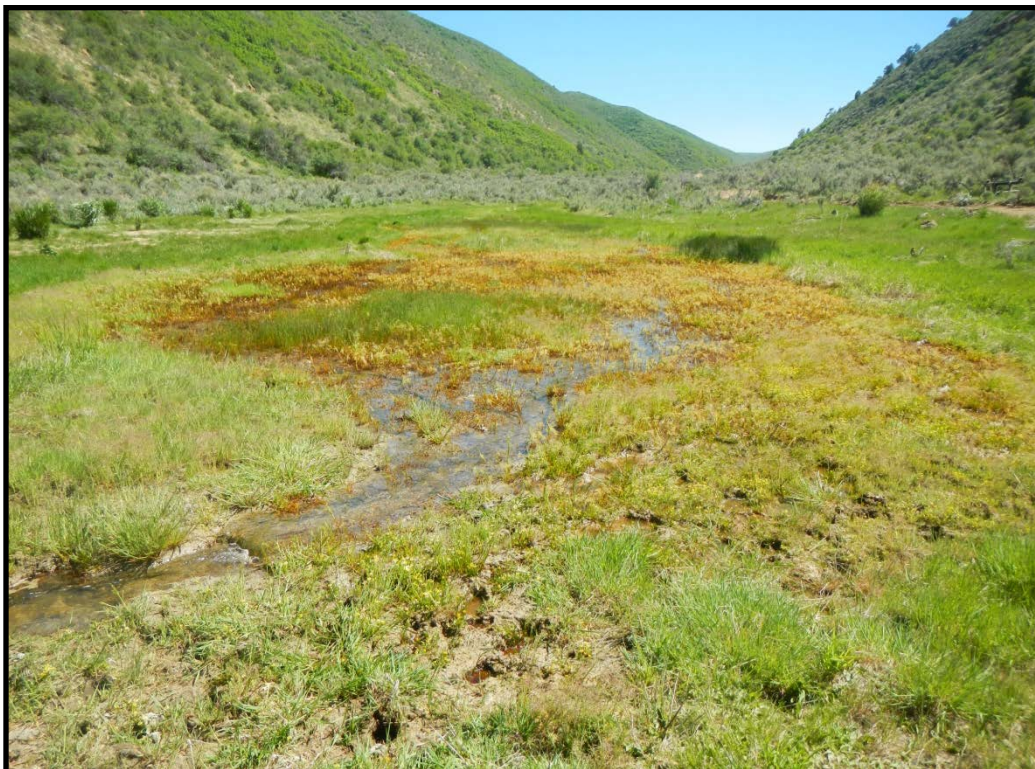
Near the stock pond, looking upstream. Stressed vegetation, change of color.

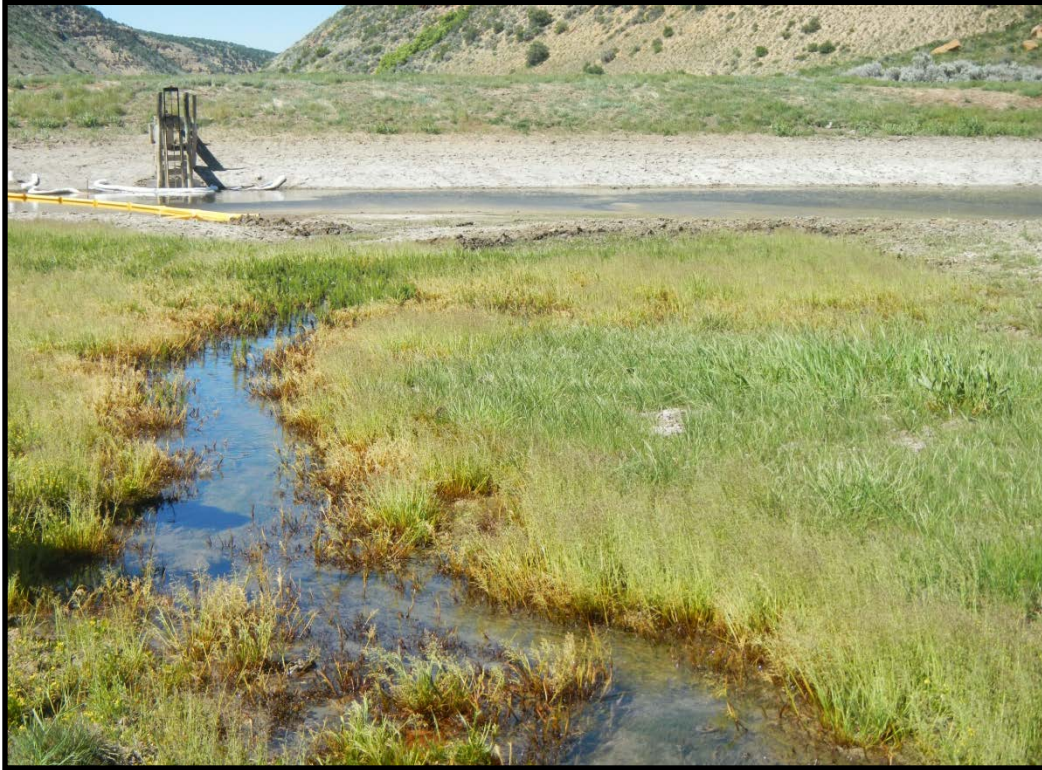
Stream reaching the stock pond. Looking downstream (north). Some free product on vegetation.

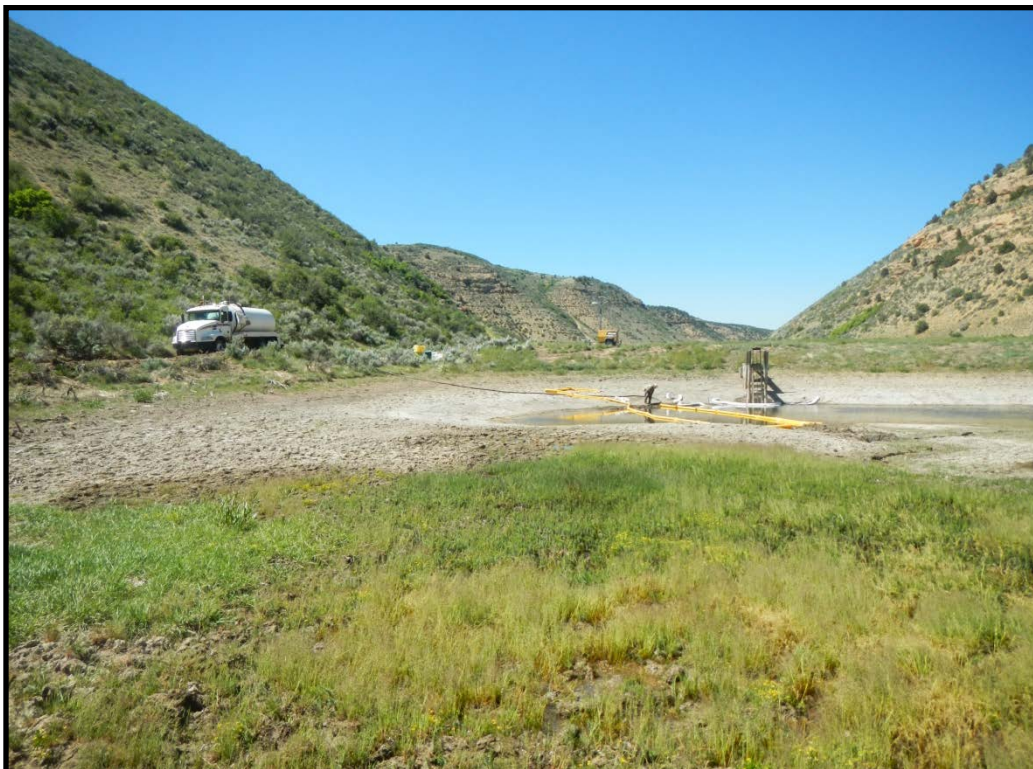
Stock pond. Skimming system pumping free-product and impacted water to truck. Gate could not be completely closed. Some flow continues downstream beyond pond.

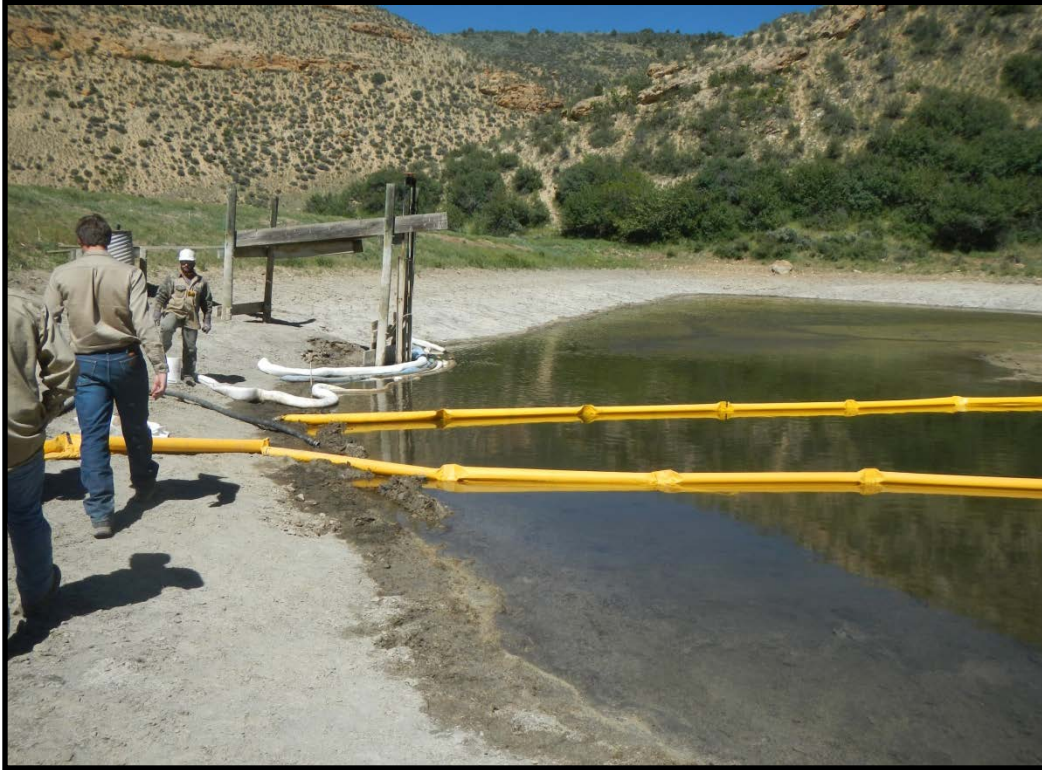
Skimming activities

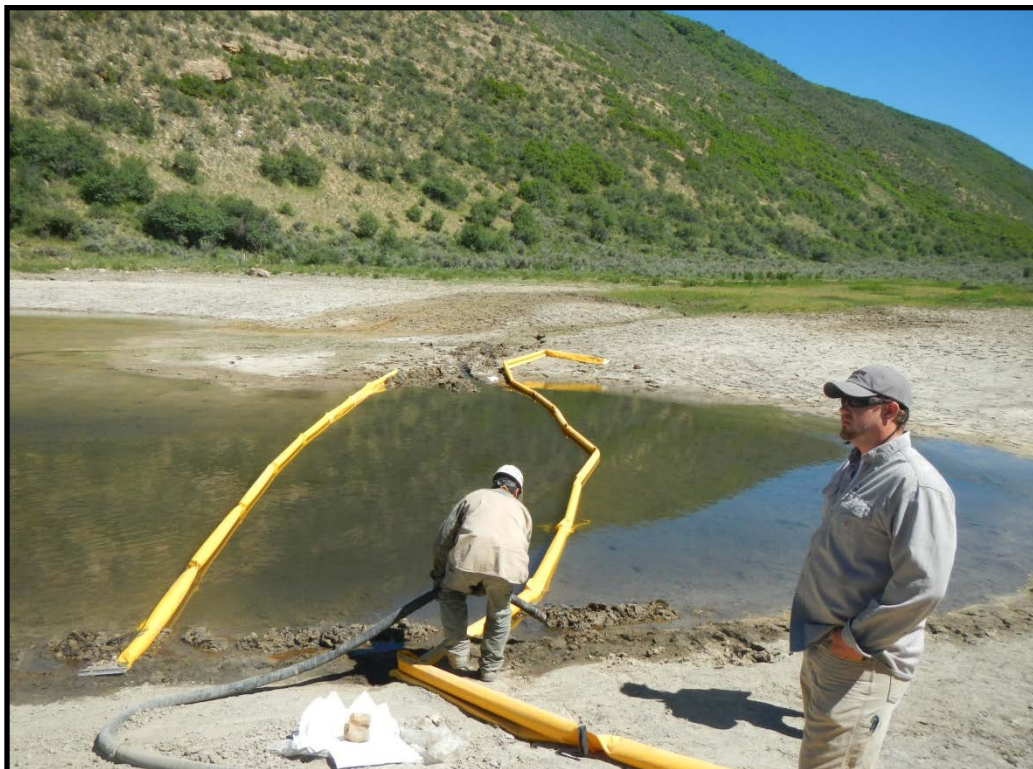
Stream channeled to concentrate free-product between yellow tubing. Skimming operation in process.

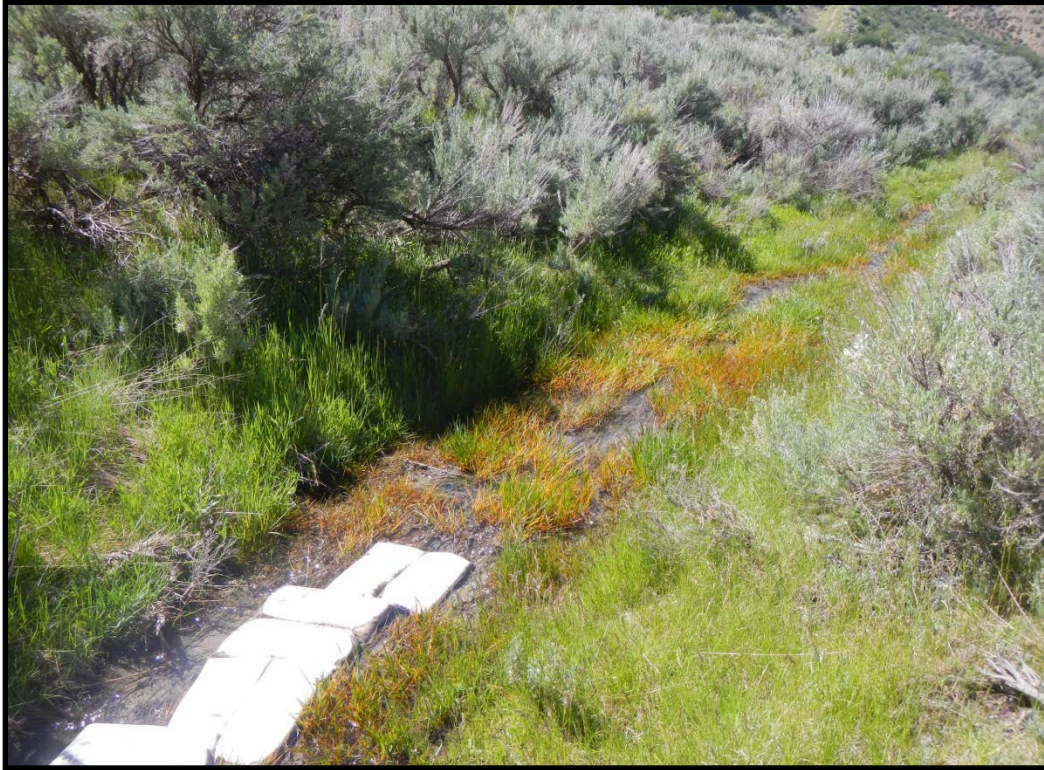
Downstream of stock pond. Impacted water flows for about 1,500 feet and dries out.

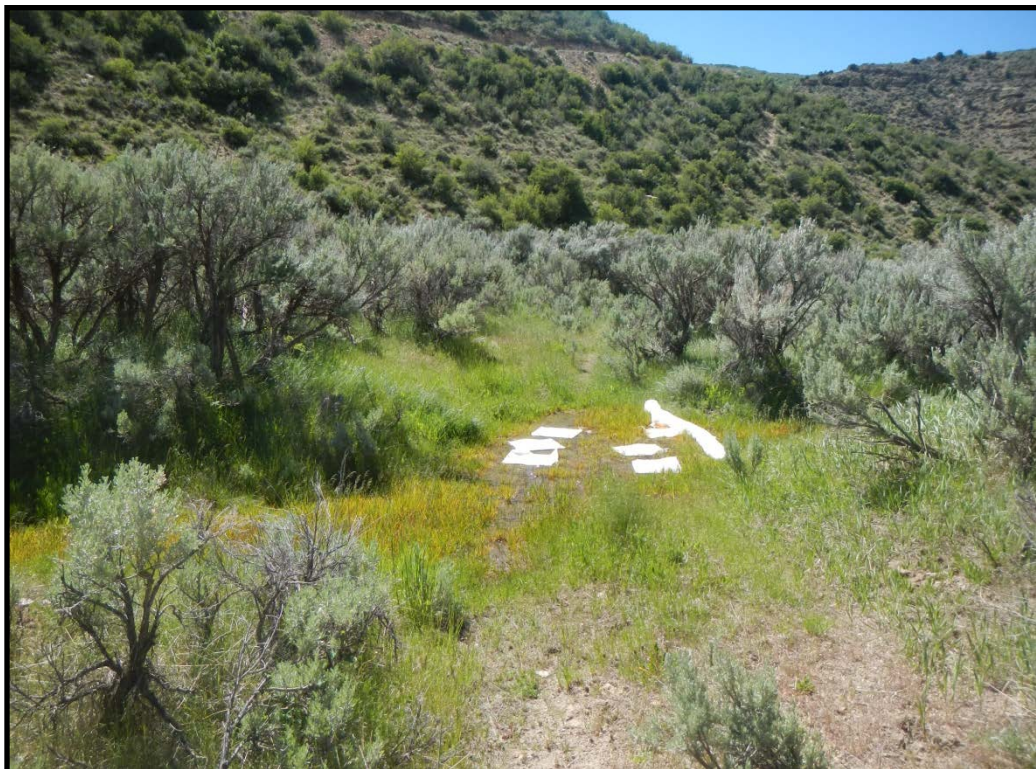
Flow dries out. No stressed vegetation observed beyond this point.
