Final Reclamation Inspection

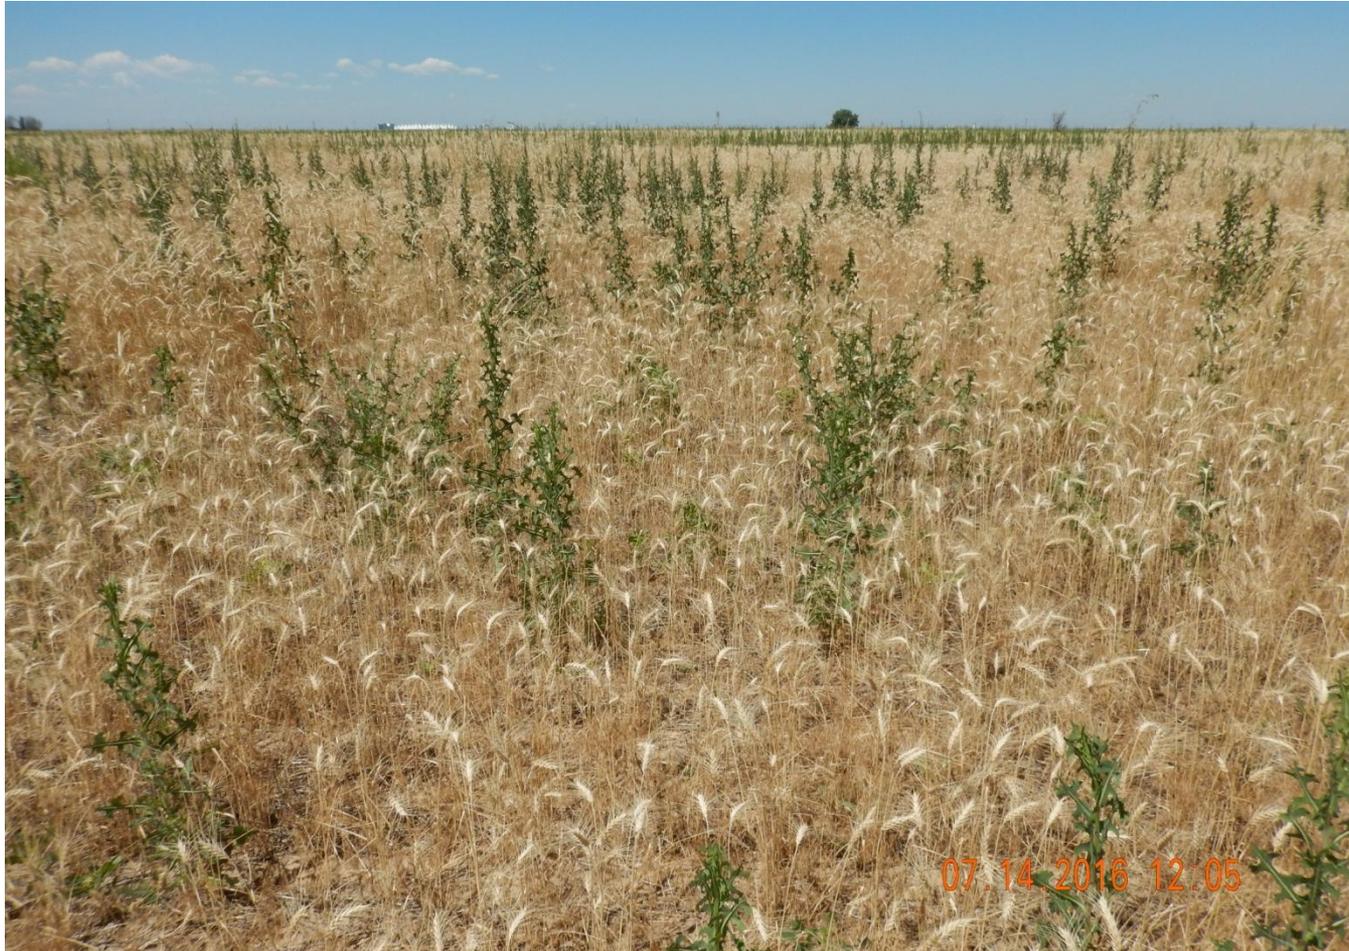
Photo 1. Photo taken from center of location, facing West. No evidence of disturbance. Uniform, vegetative crop growth throughout location.

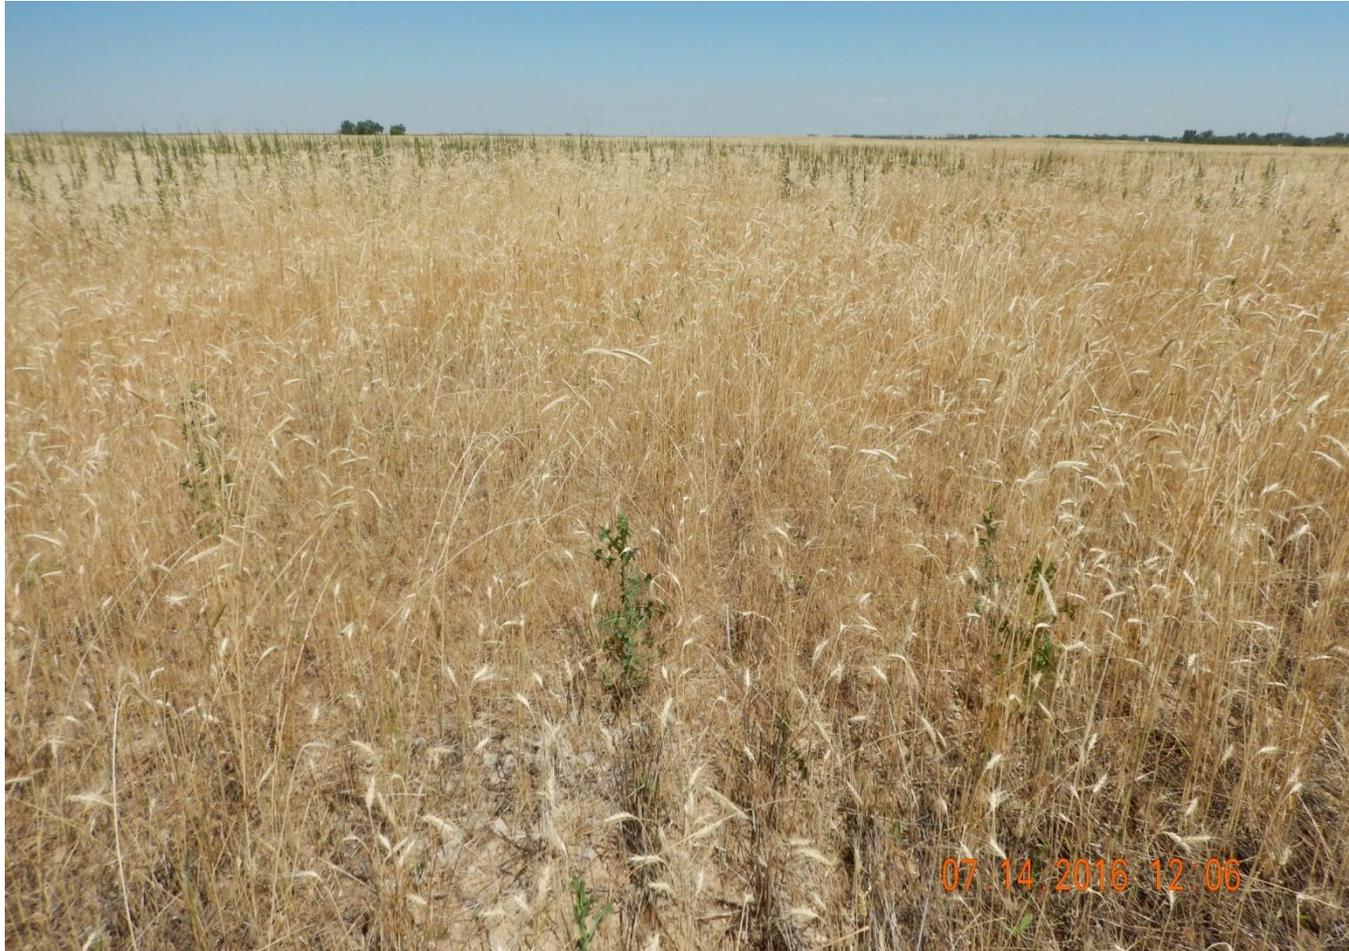
Photo 2. Photo taken from center of location, facing North. No evidence of disturbance. Uniform, vegetative crop growth throughout location.

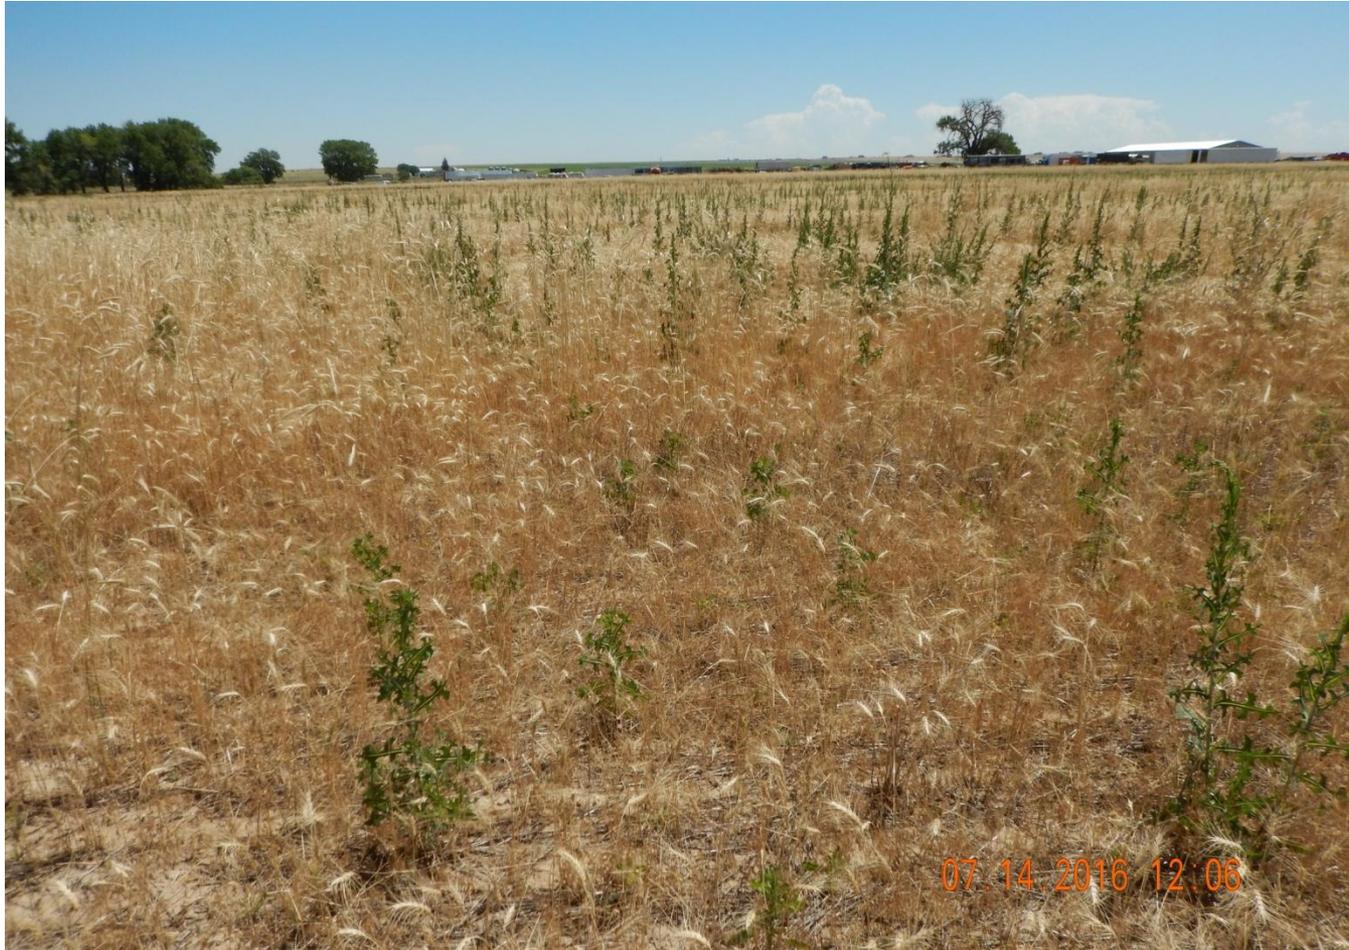
Photo 3. Photo taken from center of location, facing East. No evidence of disturbance. Uniform, vegetative crop growth throughout location.

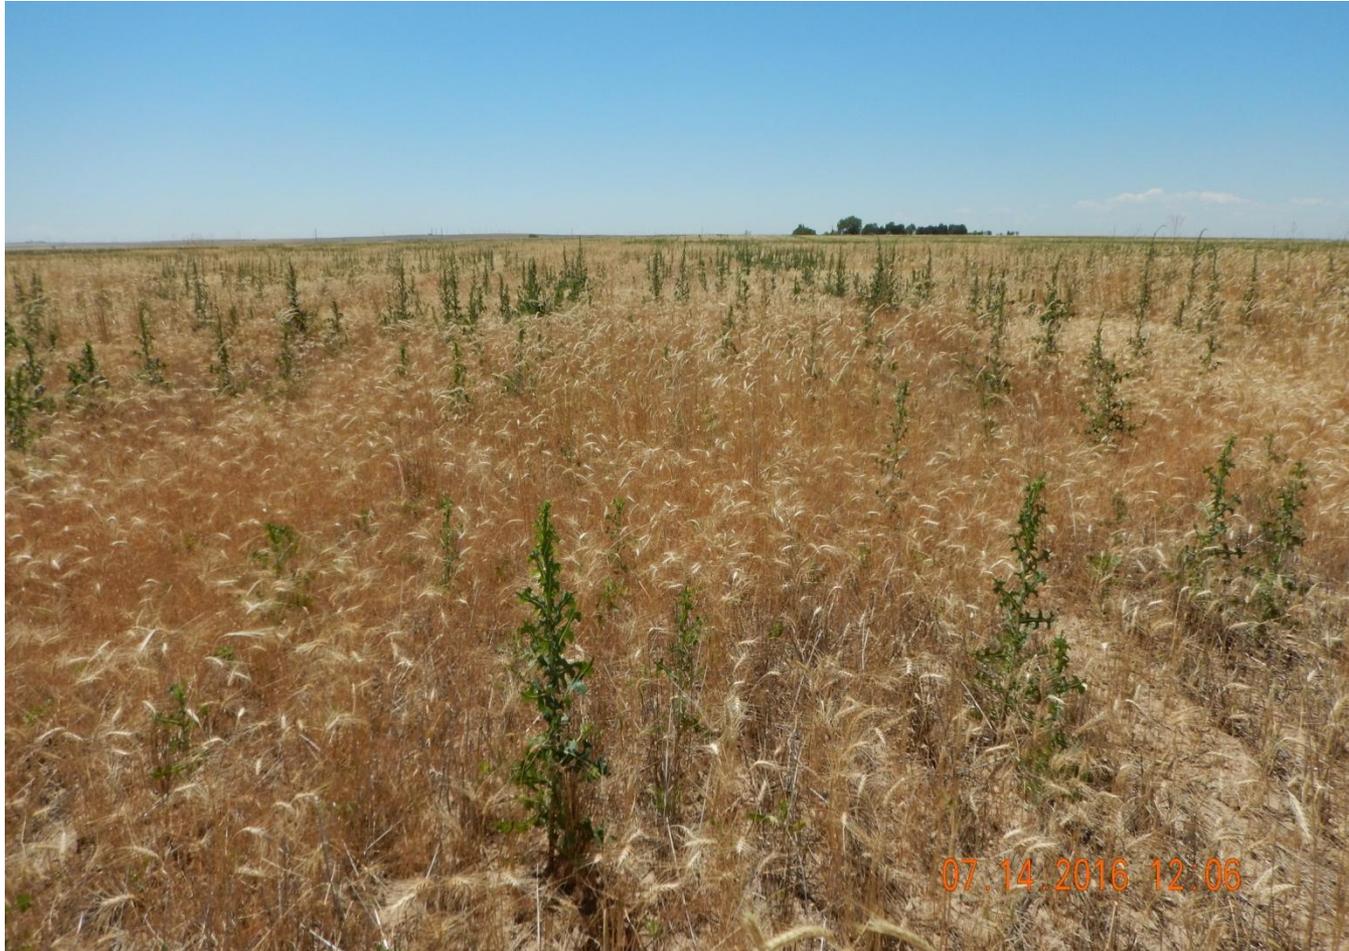
Photo 4. Photo taken from center of location, facing South. No evidence of disturbance. Uniform, vegetative crop growth throughout location.

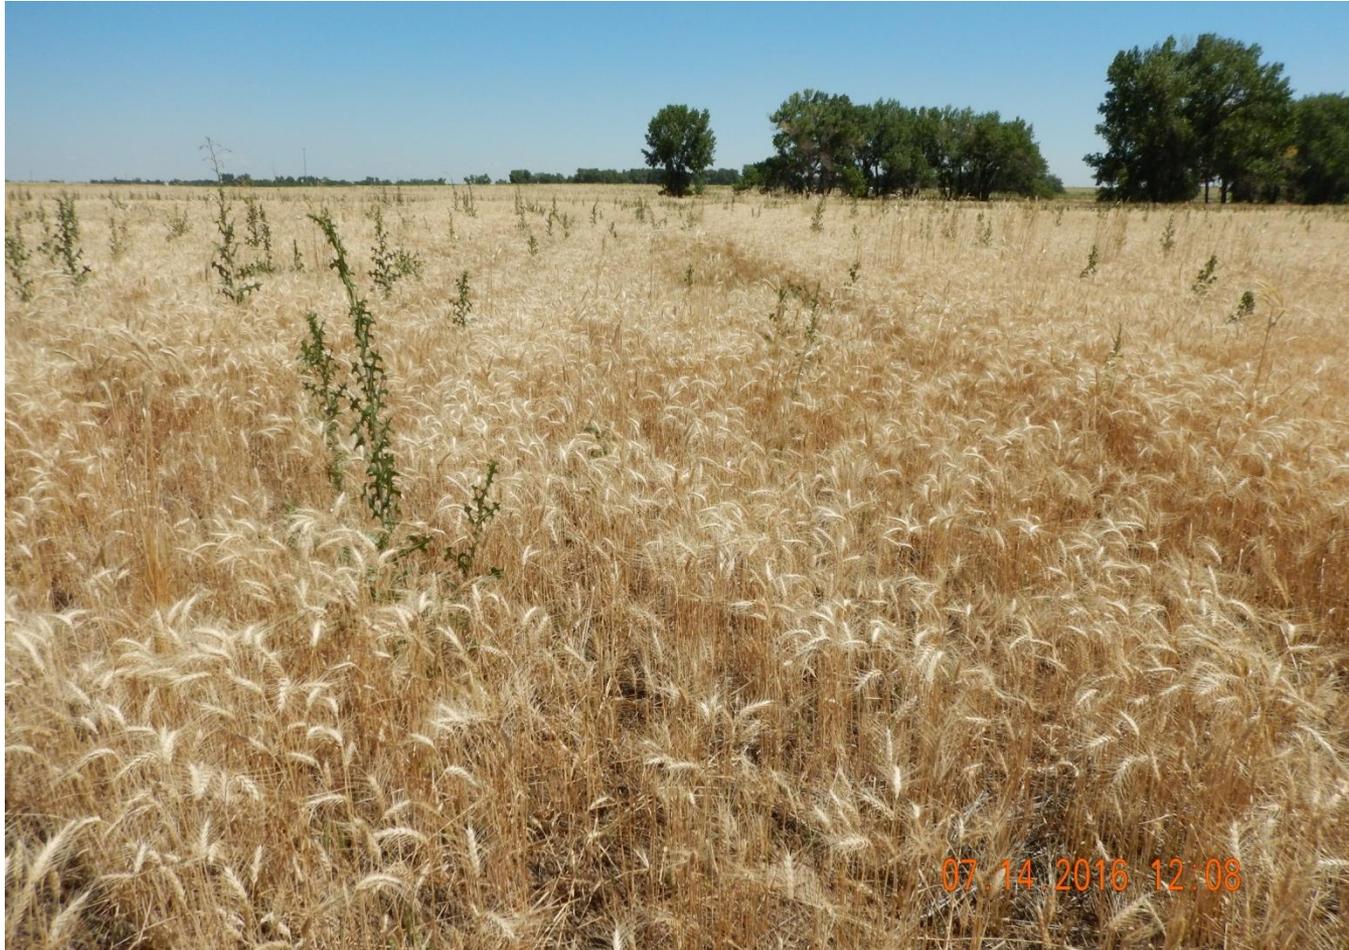
Photo 5. Photo taken along access road, east of well location, facing East. A slight growth height difference but above 80% of the reference areas.

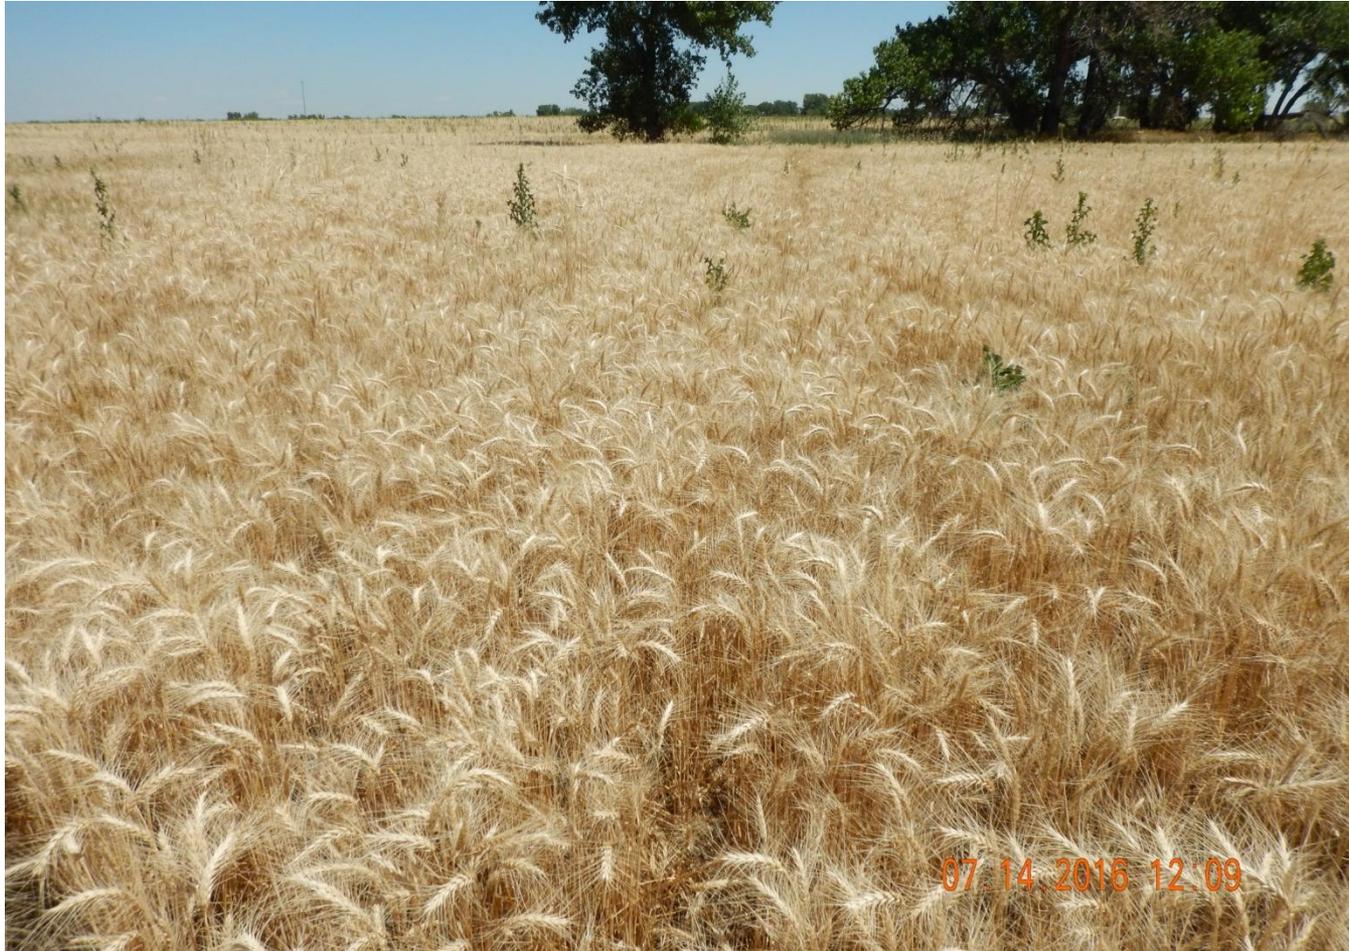
Photo 6. Photo taken along access road, east of well location, facing East. Crop height is very similar in height, as shown here.

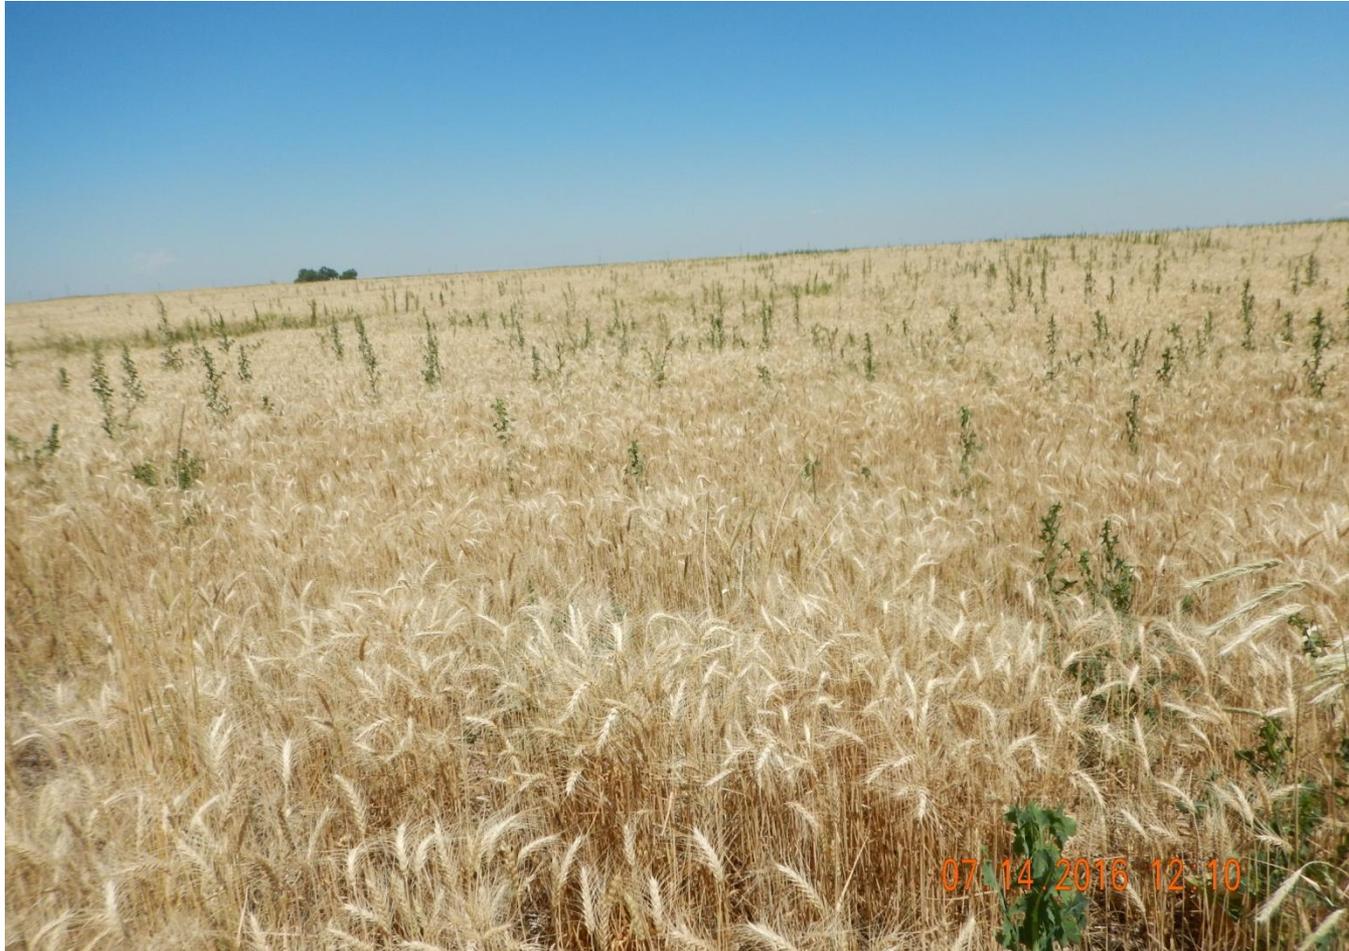
Photo 7. Reference photo taken north of the midpoint along the access road. Location and access road appears to be reflective of the reference area.
