Final Reclamation Inspection-Sandau East Land Application Area

COLORADO
Oil & Gas Conservation
Commission
Department of Natural Resources

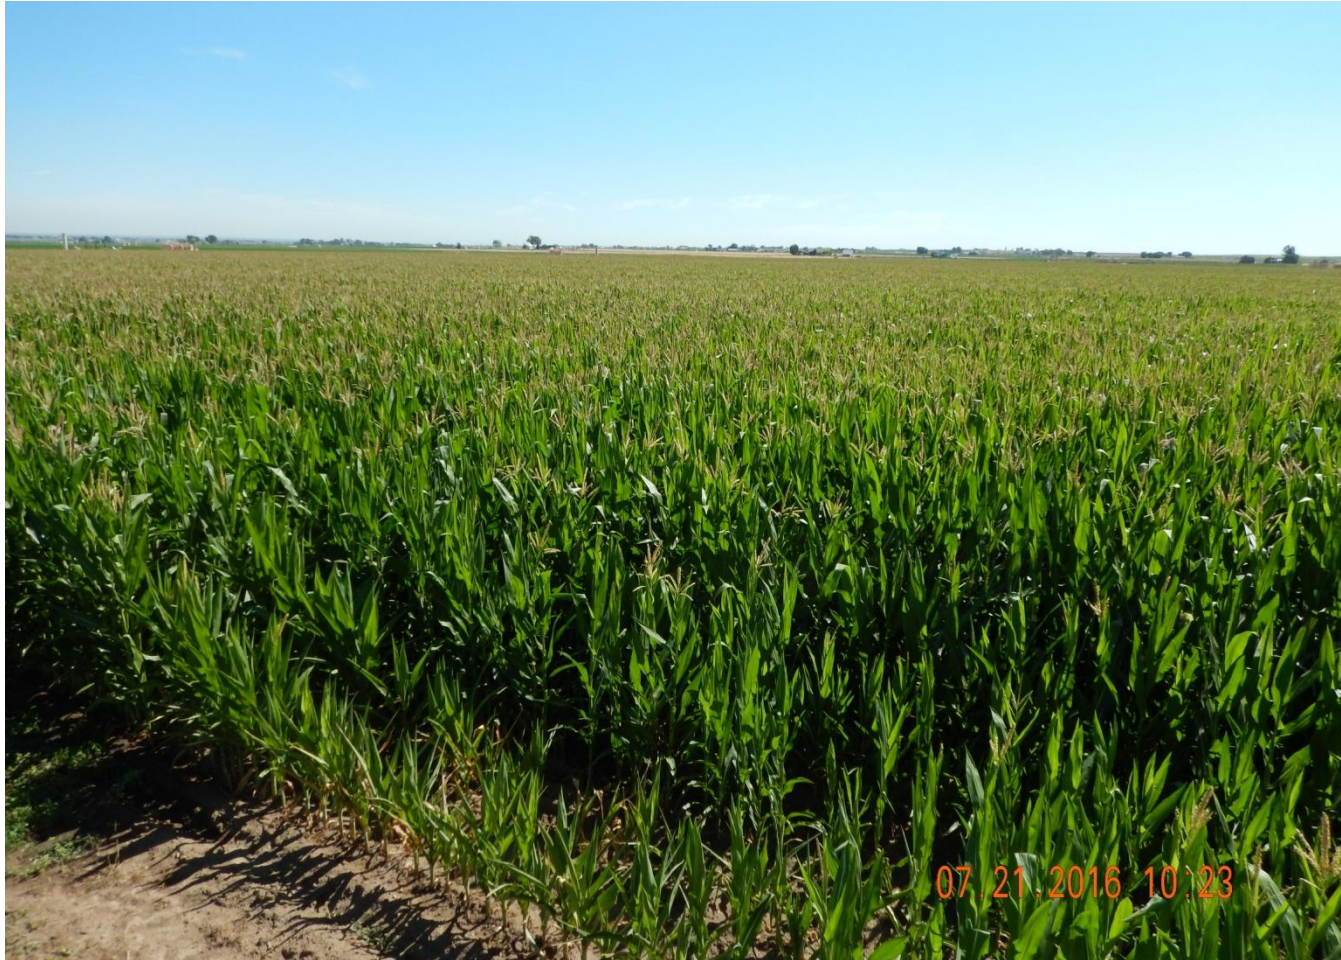
Photo 1. Photo taken from the central irrigation pivot, facing Northeast. Uniform vegetative crop growth throughout location.

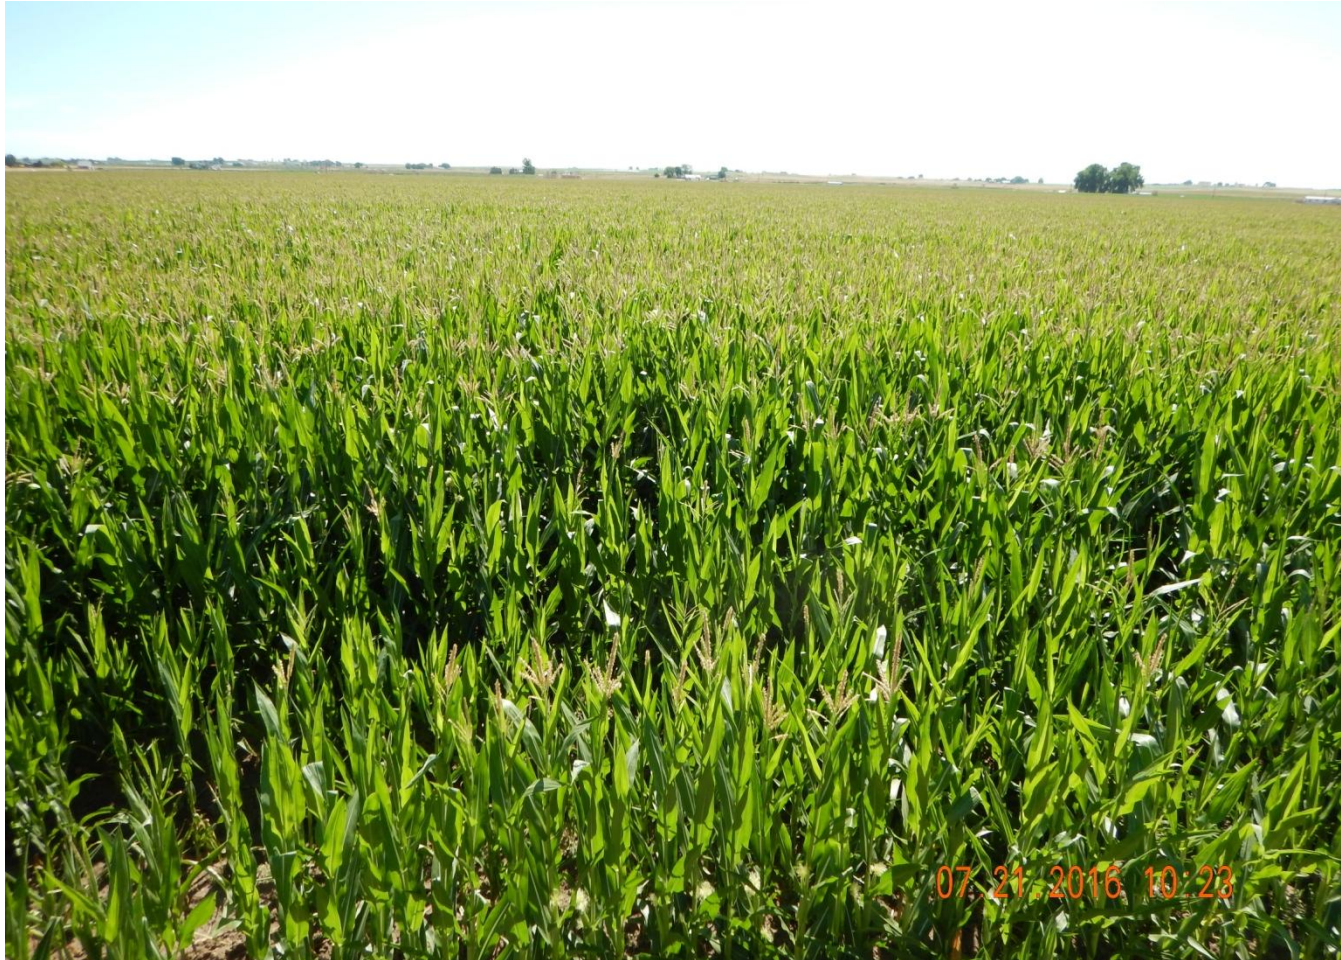
Photo 2. Photo taken from the central irrigation pivot, facing East. Uniform vegetative crop growth throughout location.

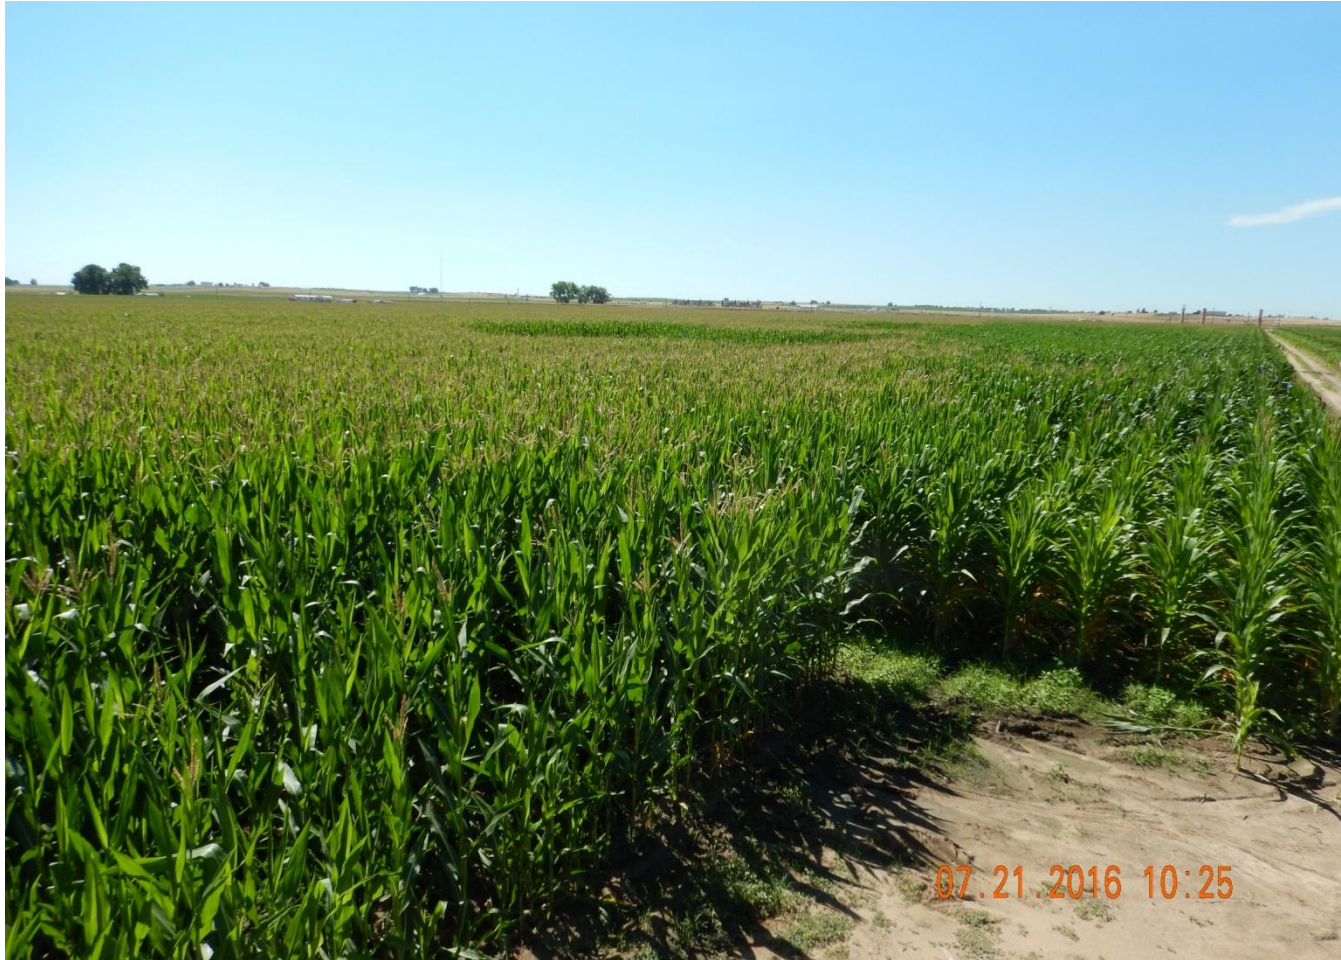
Photo 3. Photo taken from the central irrigation pivot, facing Southeast. Uniform vegetative crop growth throughout location.
