Final Reclamation Inspection

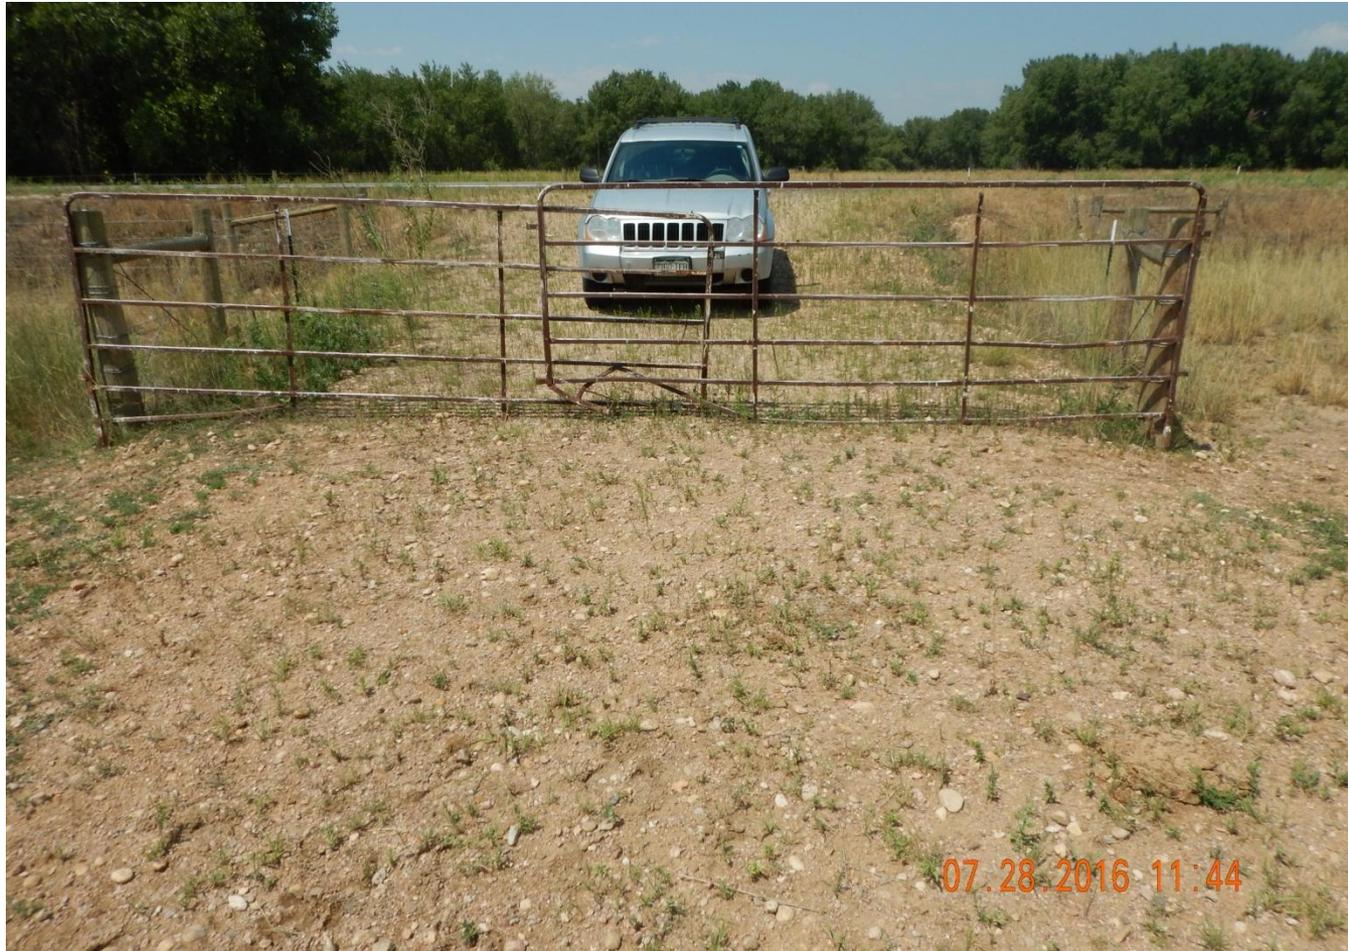
Photo 1. Photo taken from location entrance, facing West. Access road has not been reclaimed and equipment (i.e., gate) has not been removed per Rule 1004.

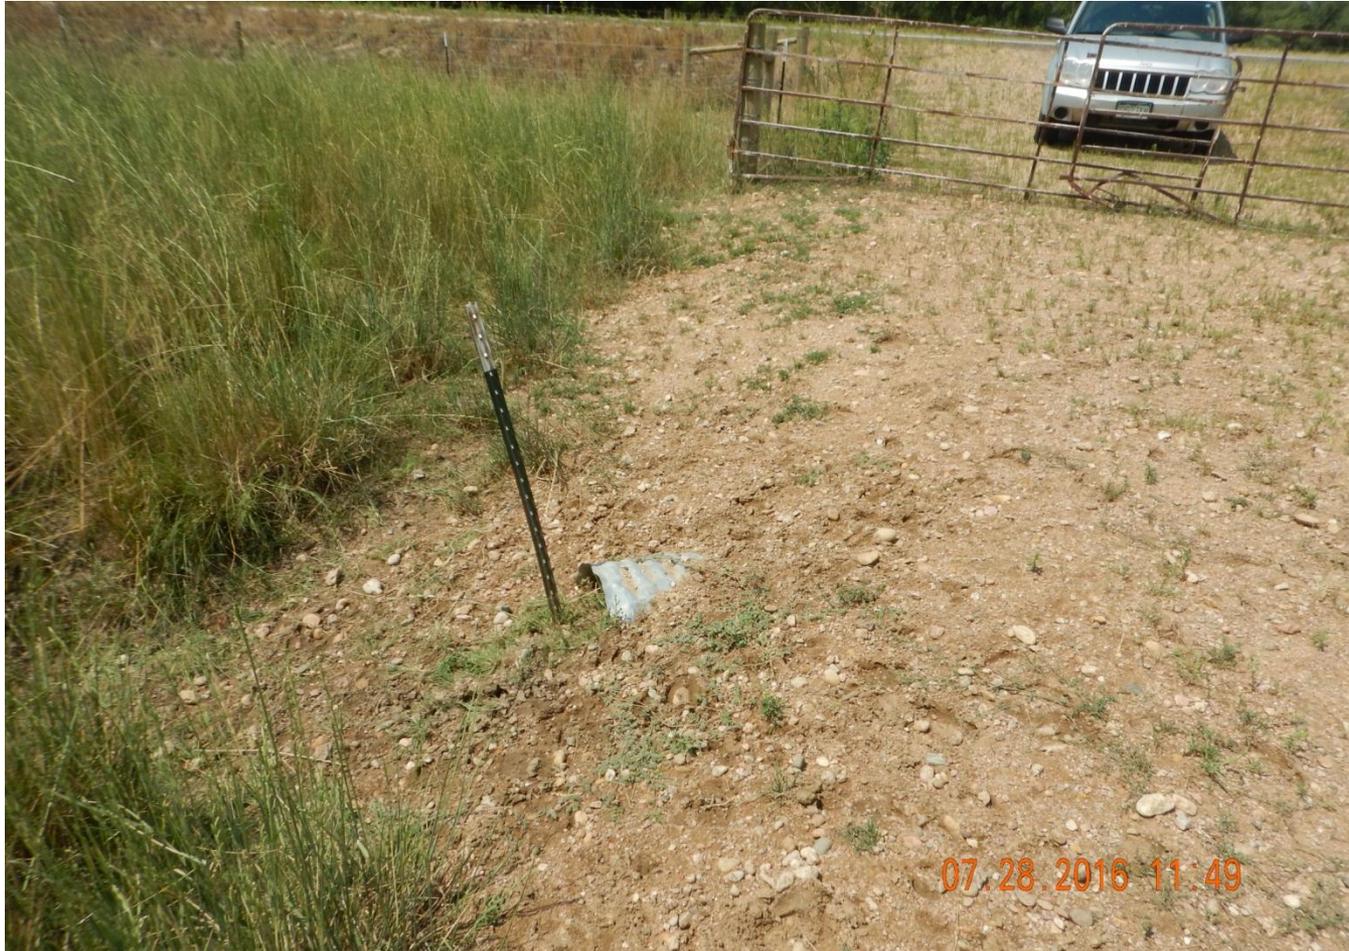
Photo 2. Photo taken from location entrance, facing West. Surface equipment (i.e., culvert) has not been removed per Rule 1004.

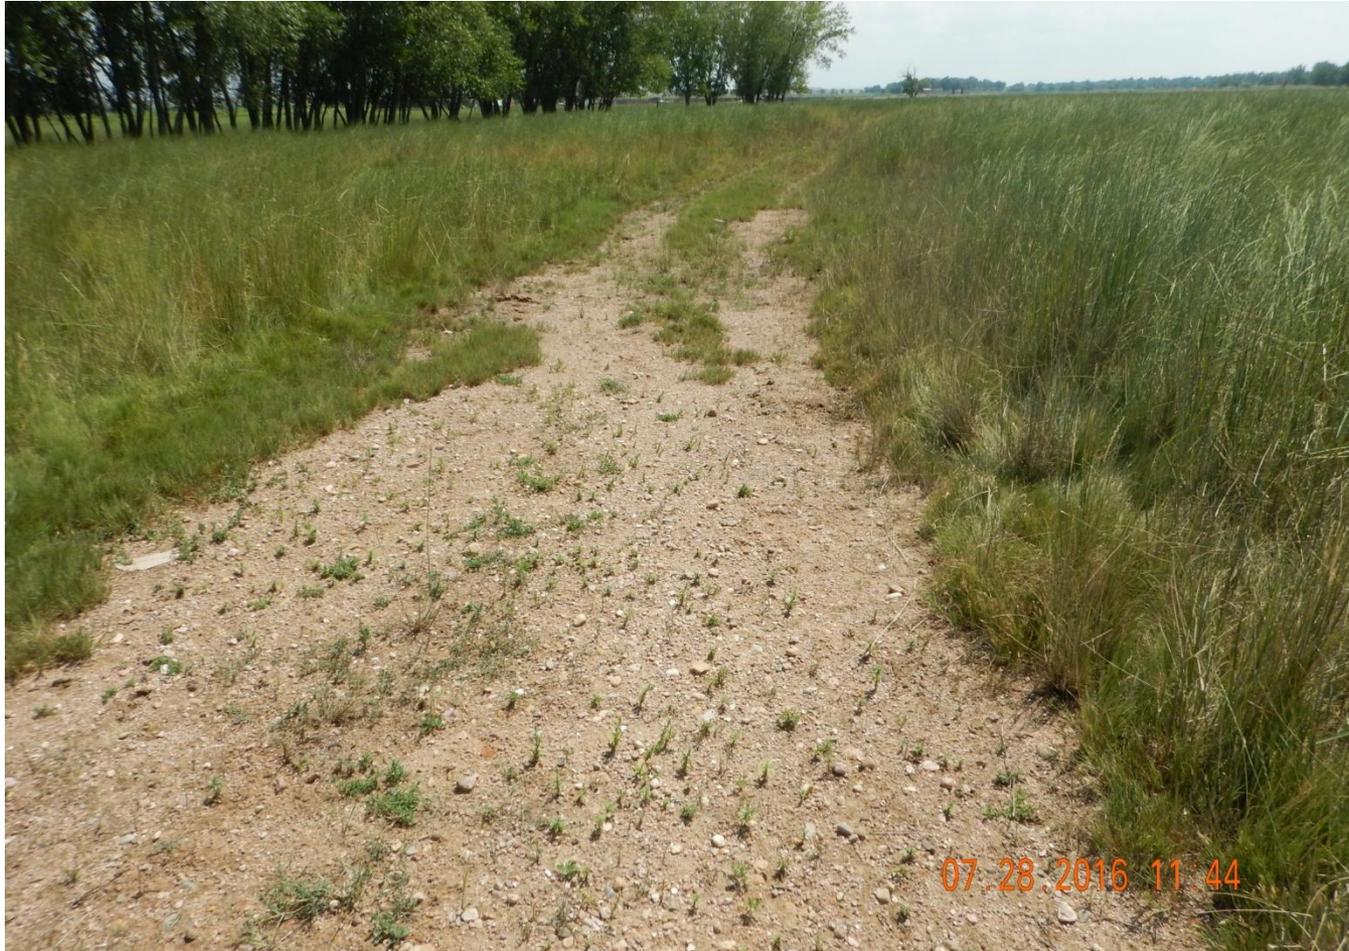
Photo 3. Photo taken from location entrance, facing East. Access road has not been reclaimed per Rule 1004.

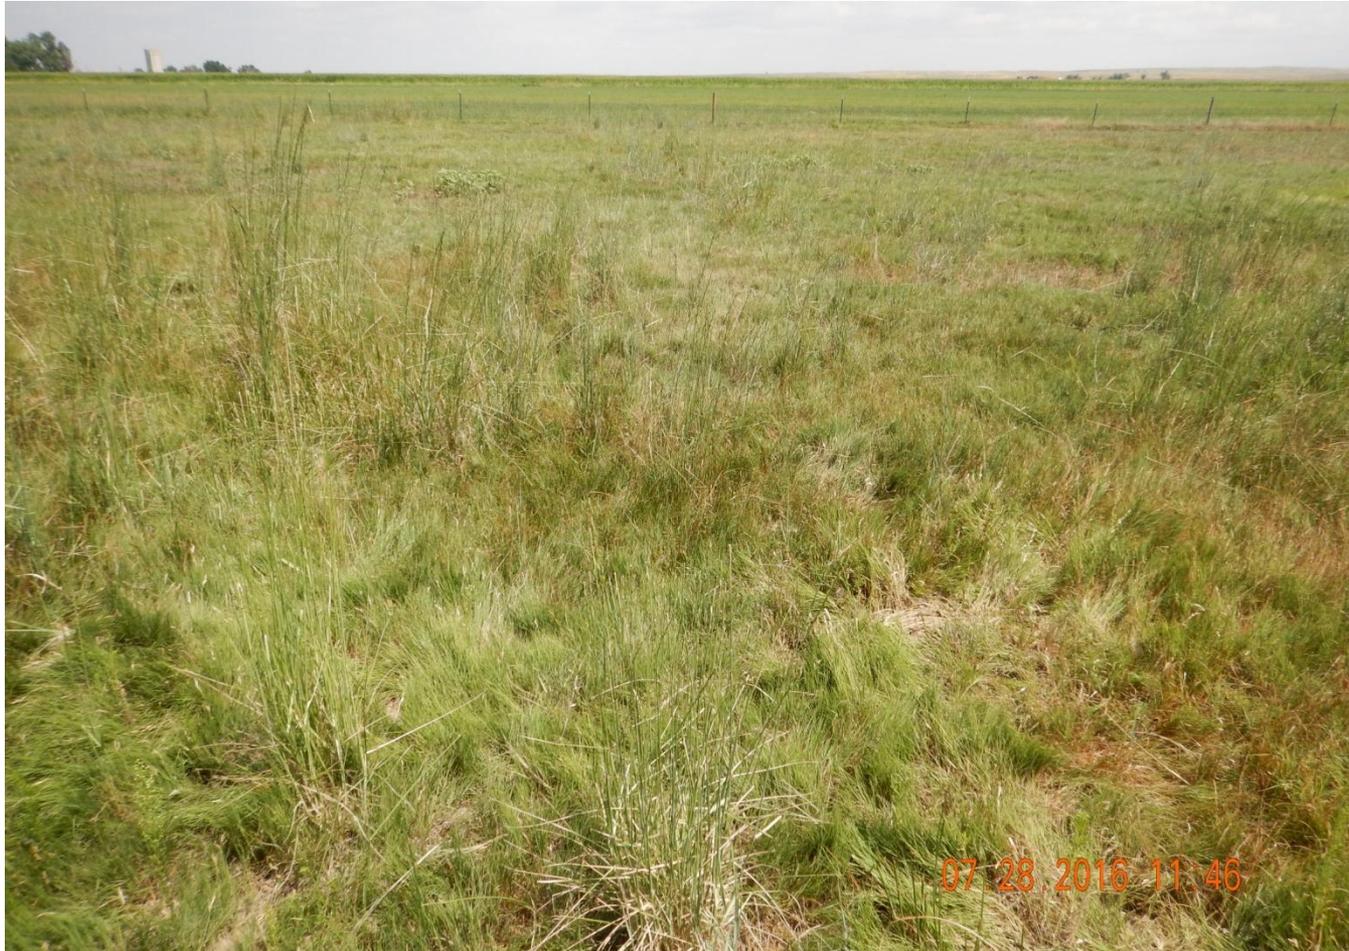
Photo 4. Photo taken from center of location, facing North. Vegetative growth appears to be reflective of reference areas. Location is currently used for cattle.
