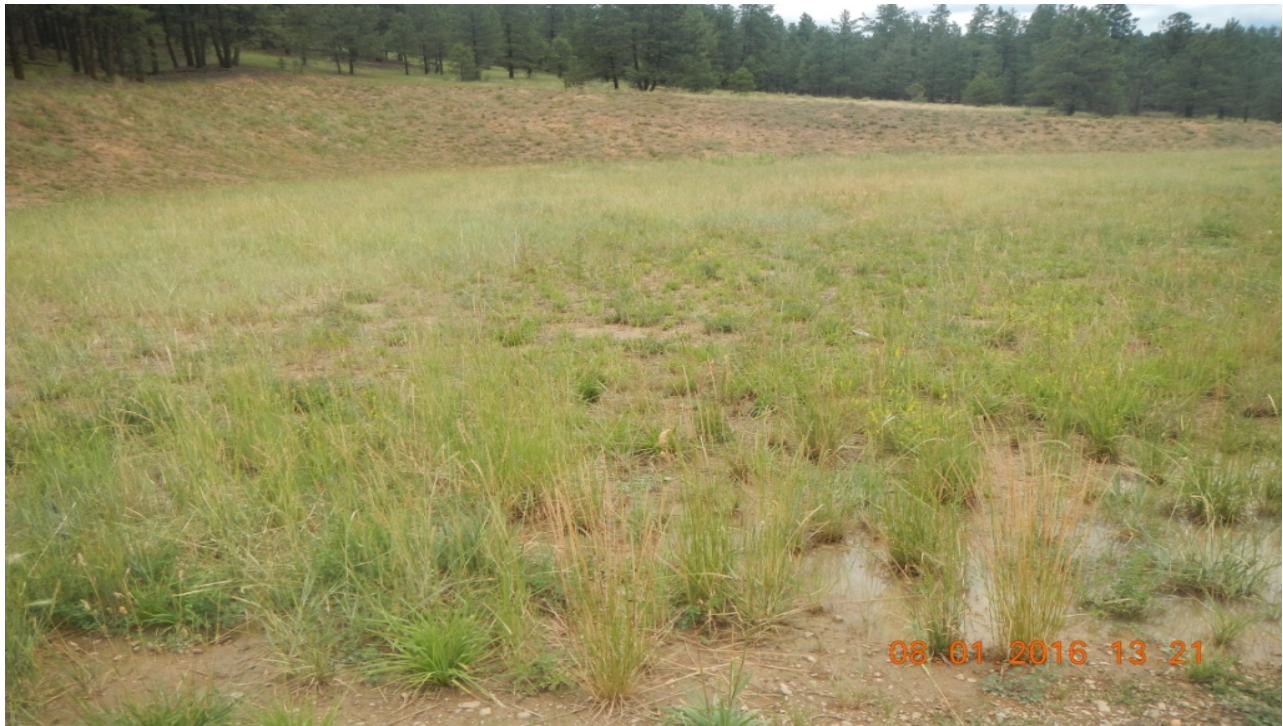
**photo 1:** Facing northwest toward the location.

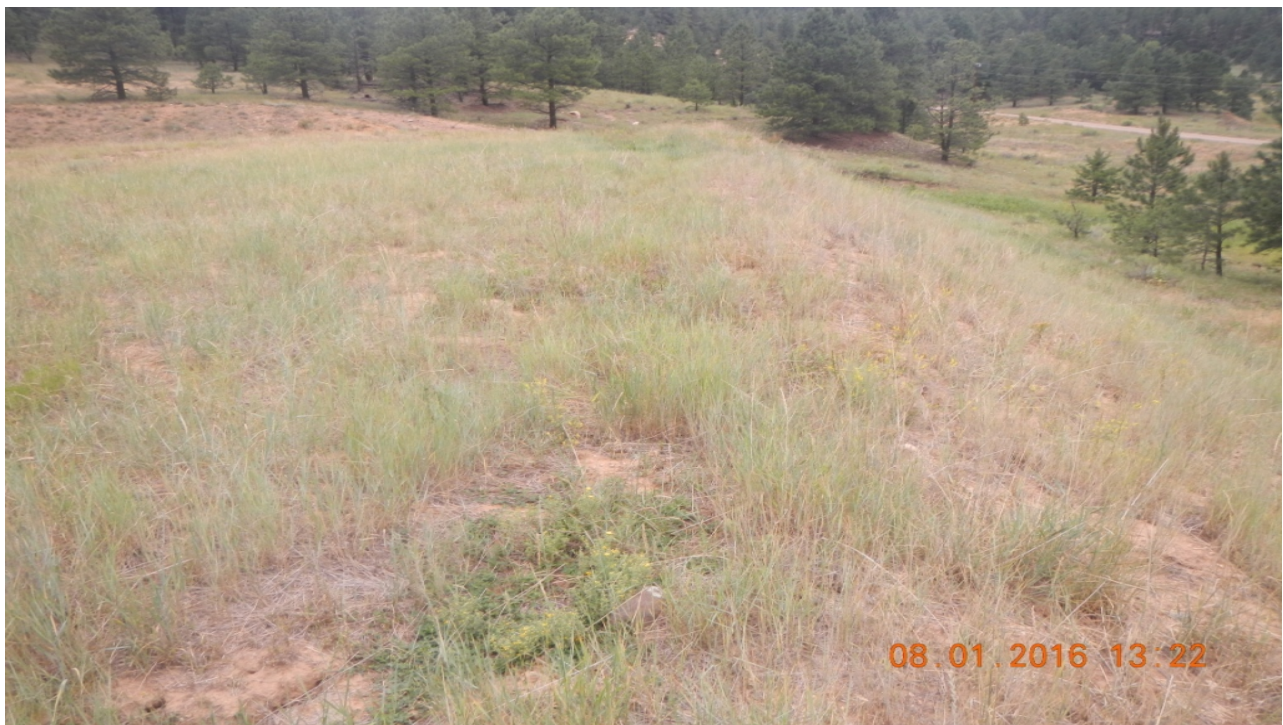
**photo 2:** Facing northwest along the fill slope of the location.

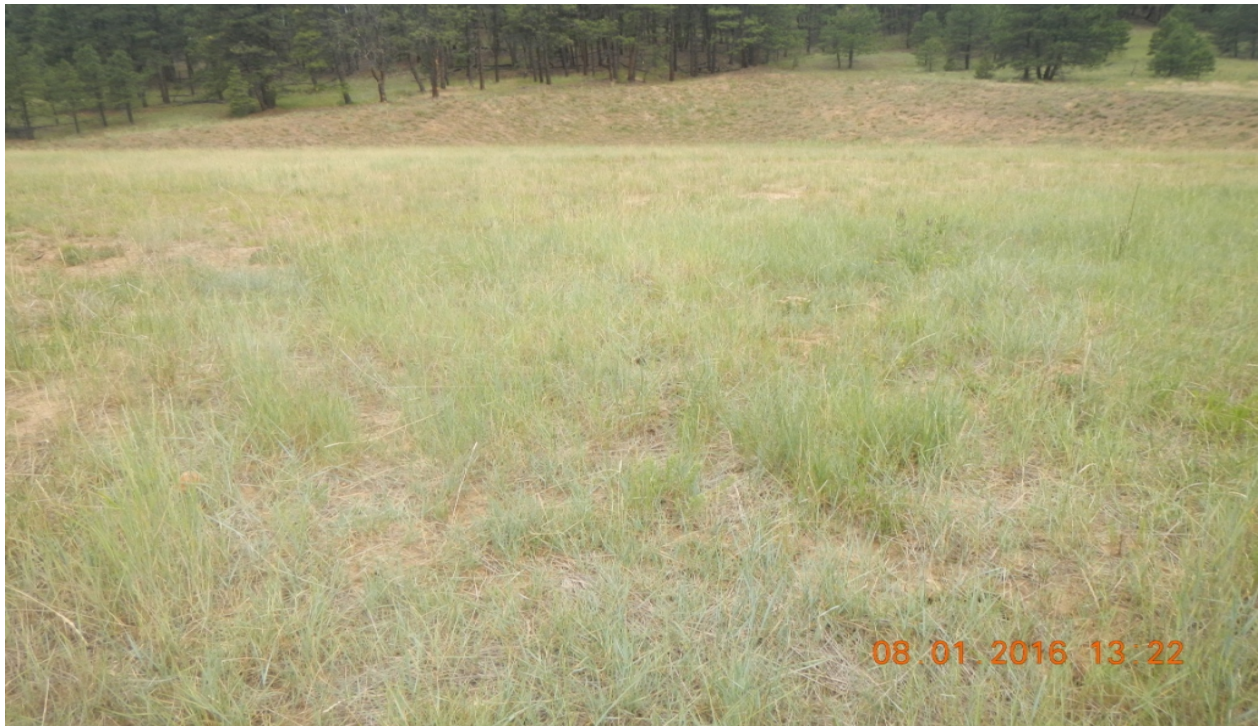
**photo 3:** Facing southwest toward the location.

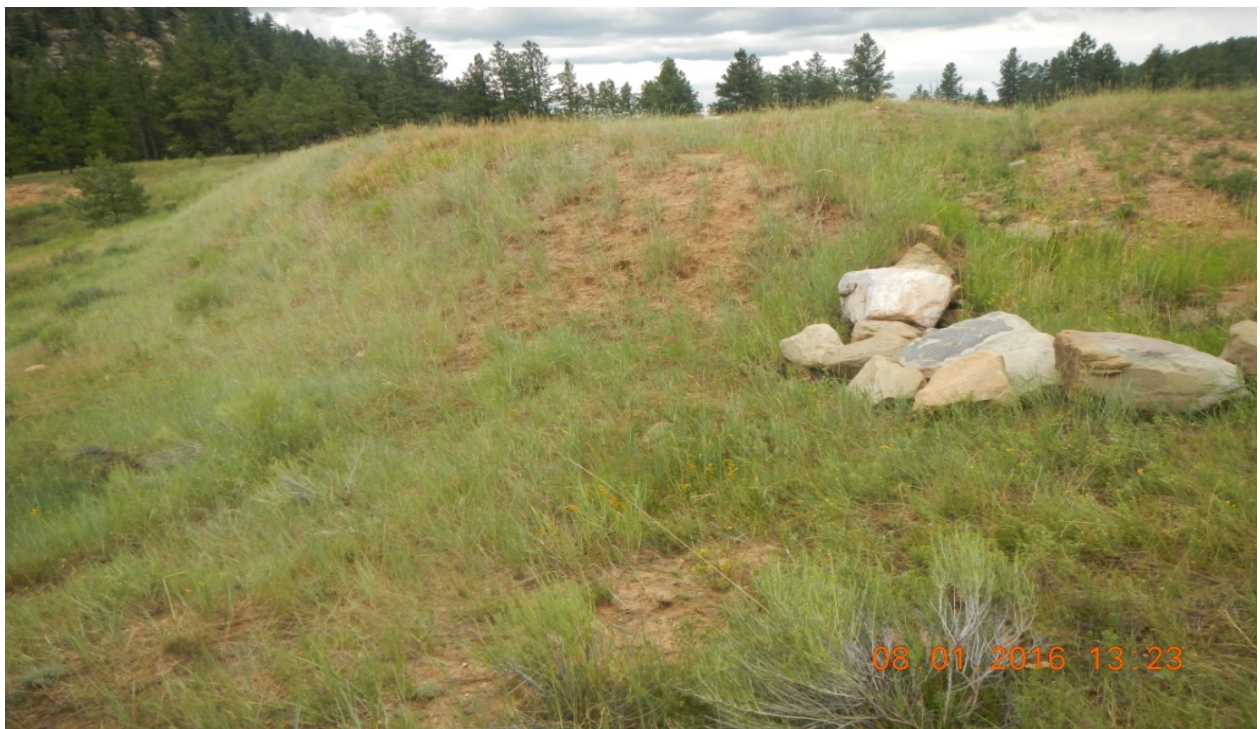
**photo 4:** North side of the location facing southeast.

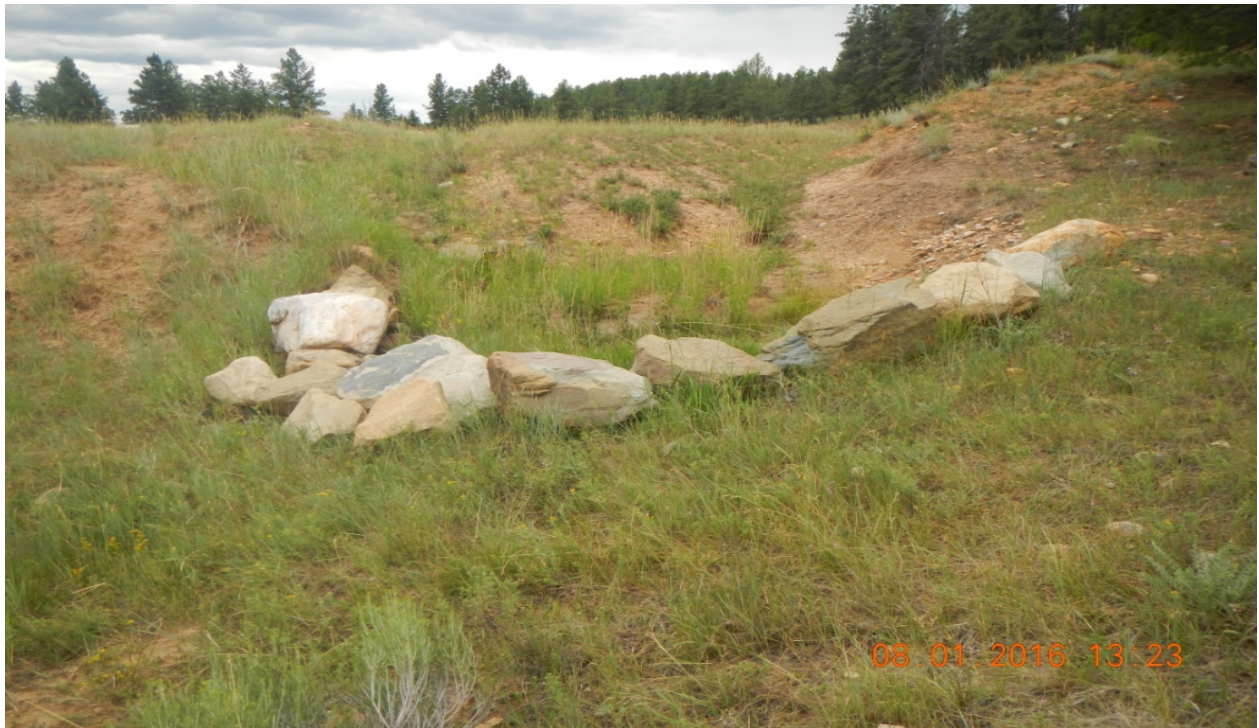
**photo 5:** North side of the location facing southwest.

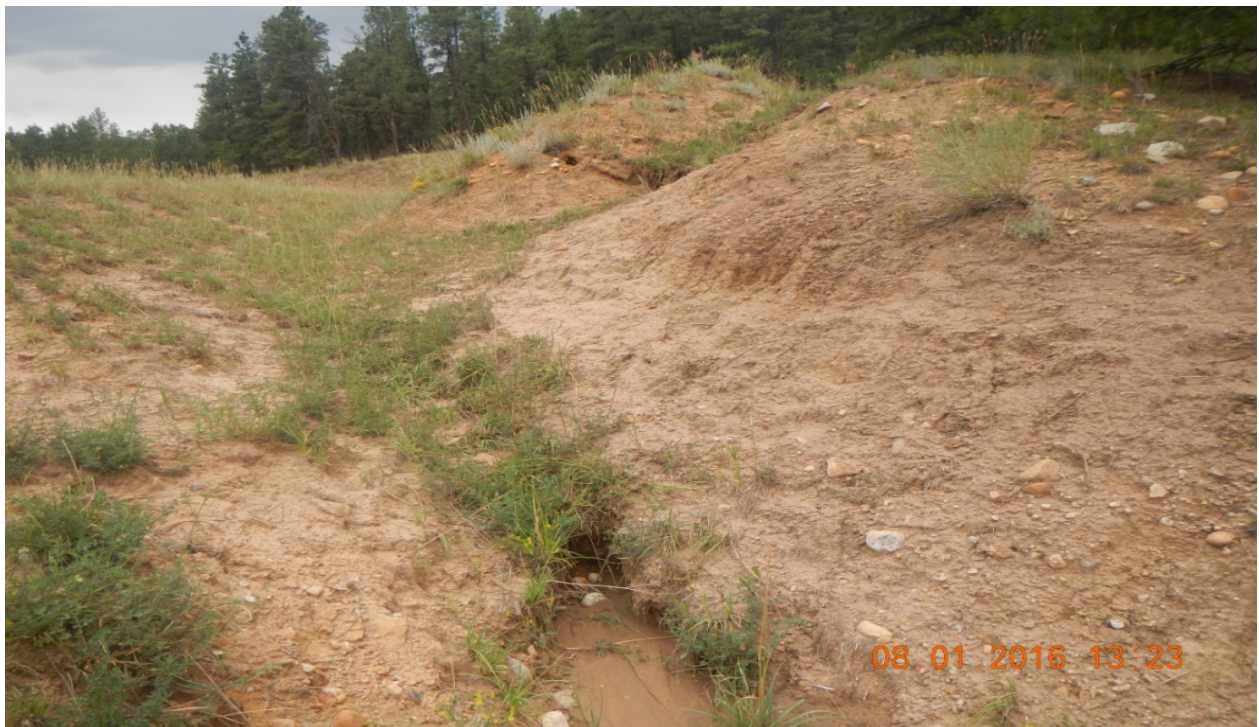
**photo 6:** North side of the location facing southwest. Diversion ditch is directing stormwater to the north side of the location.

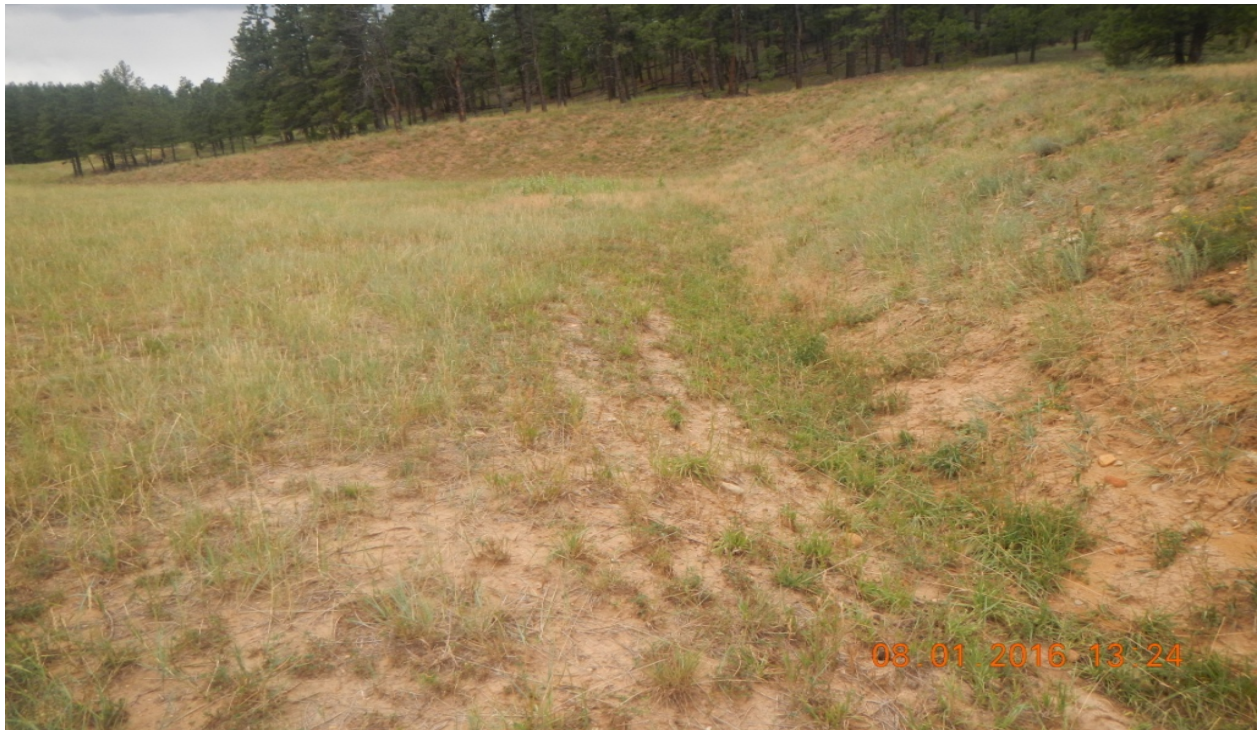
**photo 7:** Facing southwest along the cut slope.

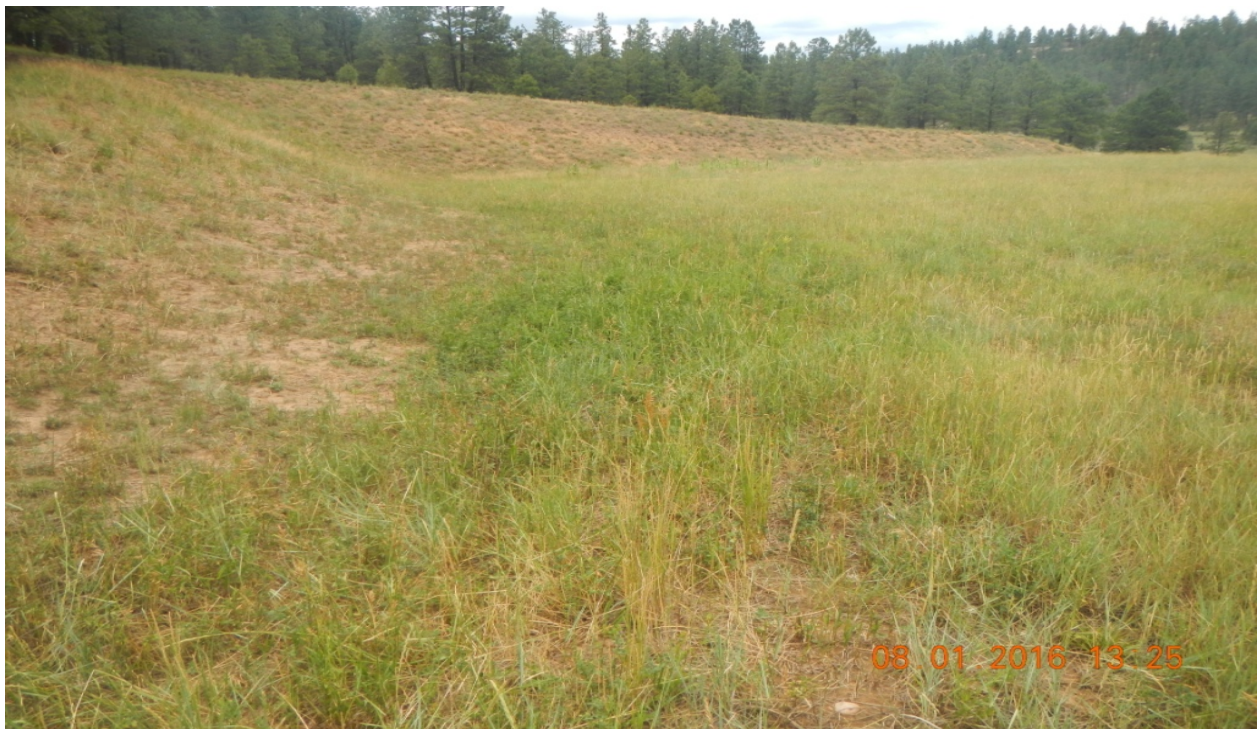
**photo 8:** Facing northwest along the cut slope.
