# Final Reclamation Inspection- Bond Release

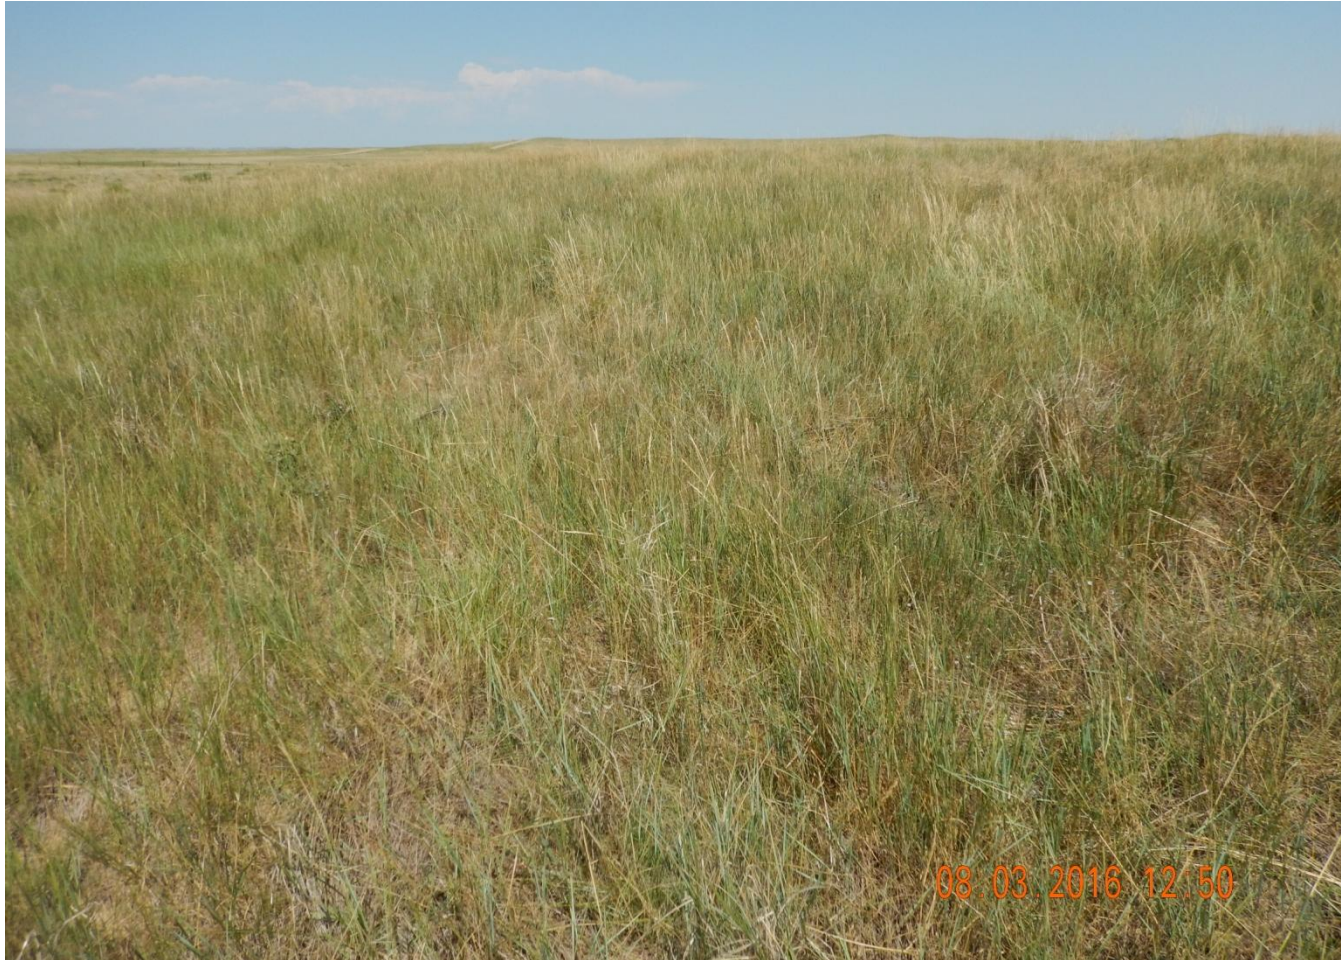
**Photo 1.** Photo taken from approximate center of location, facing North. Uniform vegetative growth throughout location. Area appears to be grazed with cattle.

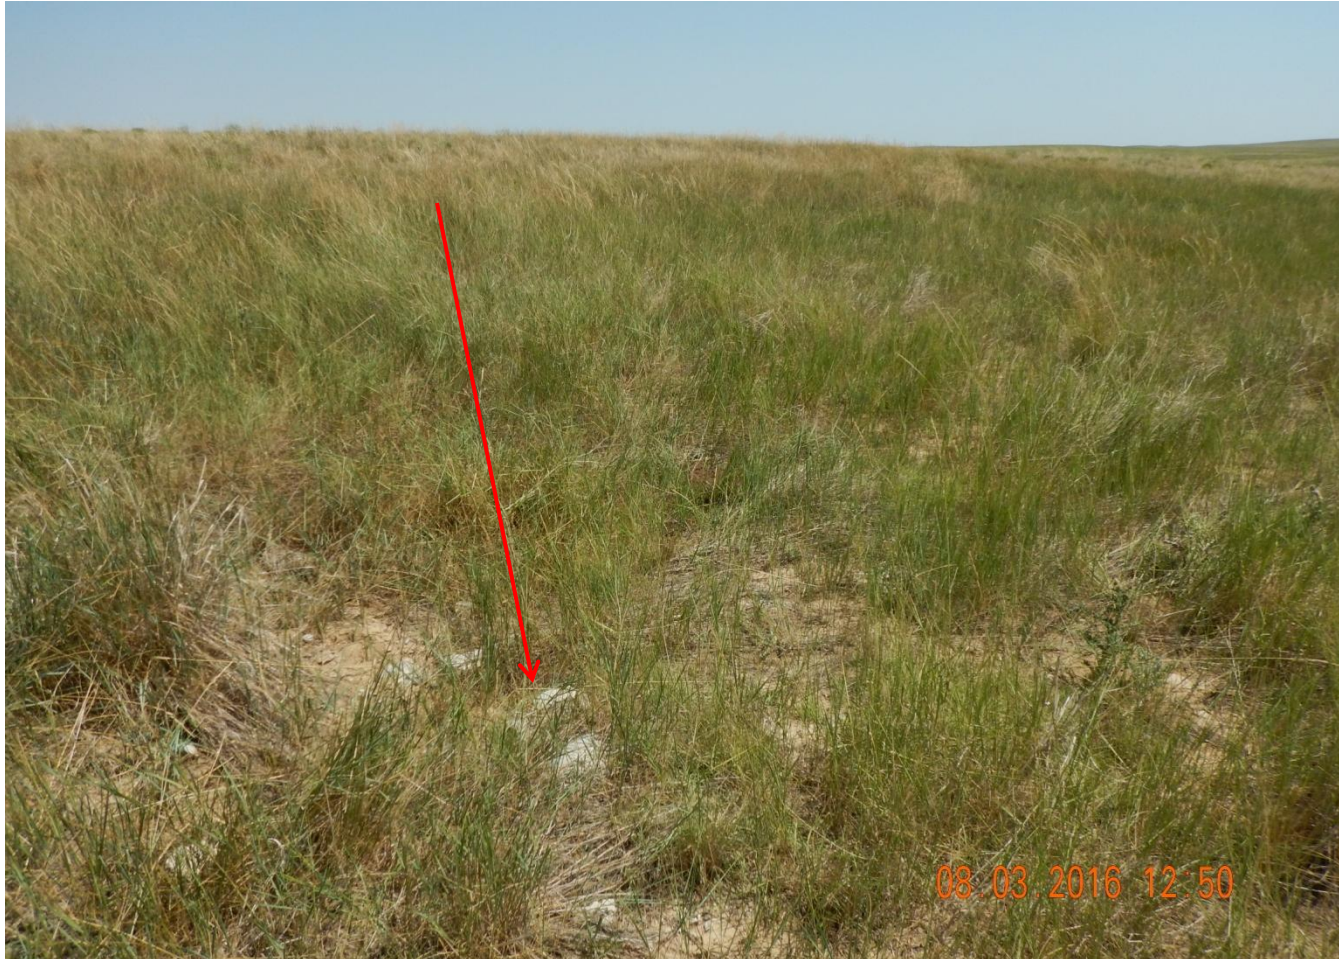
**Photo 2.** Photo taken from approximate center of location, facing East. Uniform vegetative growth throughout location. Area appears to be grazed with cattle. Debris (i.e., casing) left behind needs to be removed. See following photos.

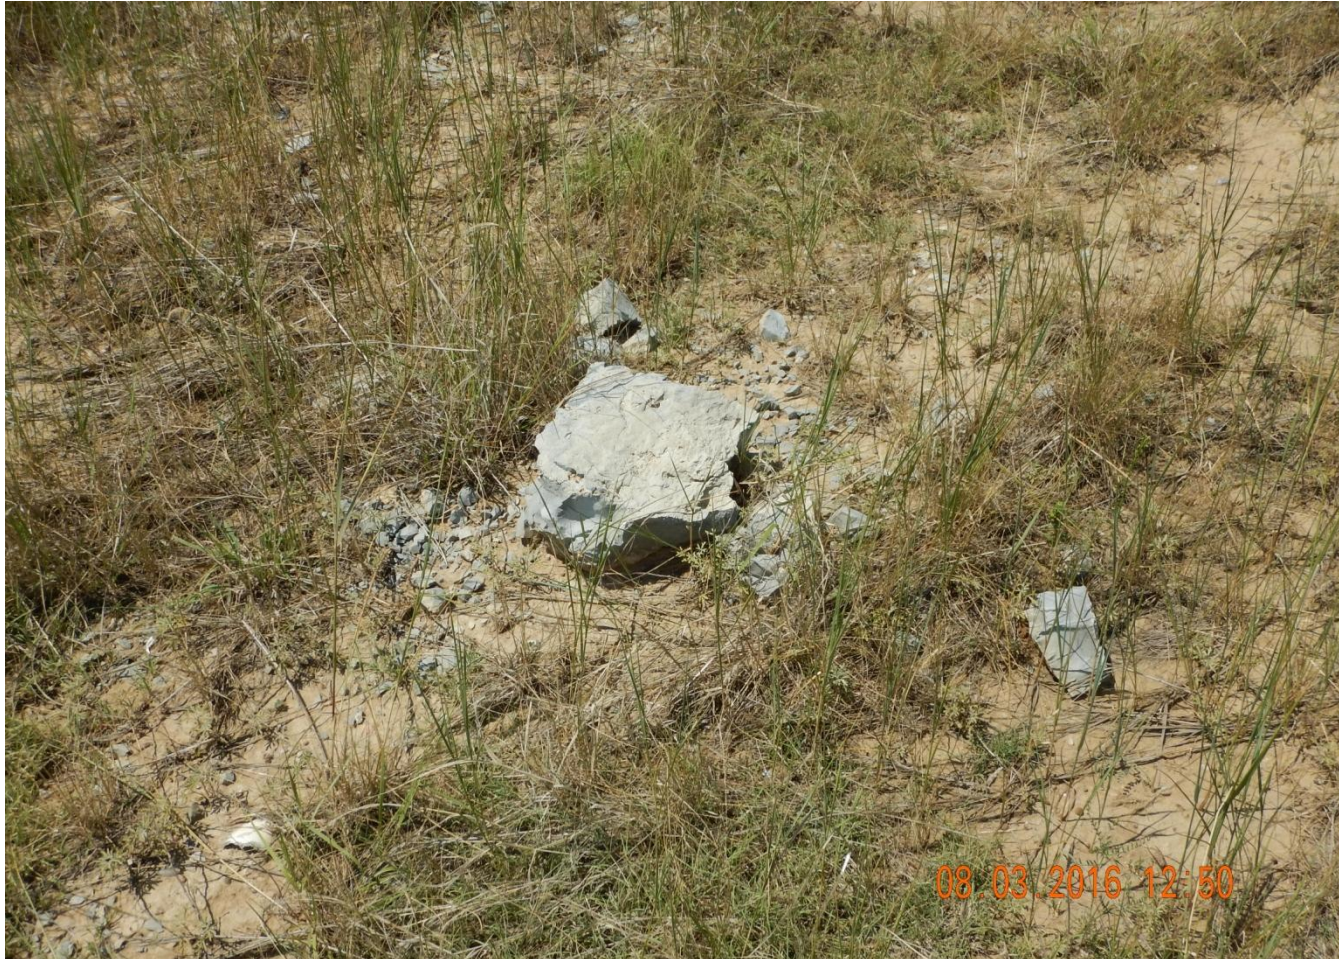
**Photo 3.** Photo taken from approximate center of location. Debris (i.e., casing) left behind needs to be removed.

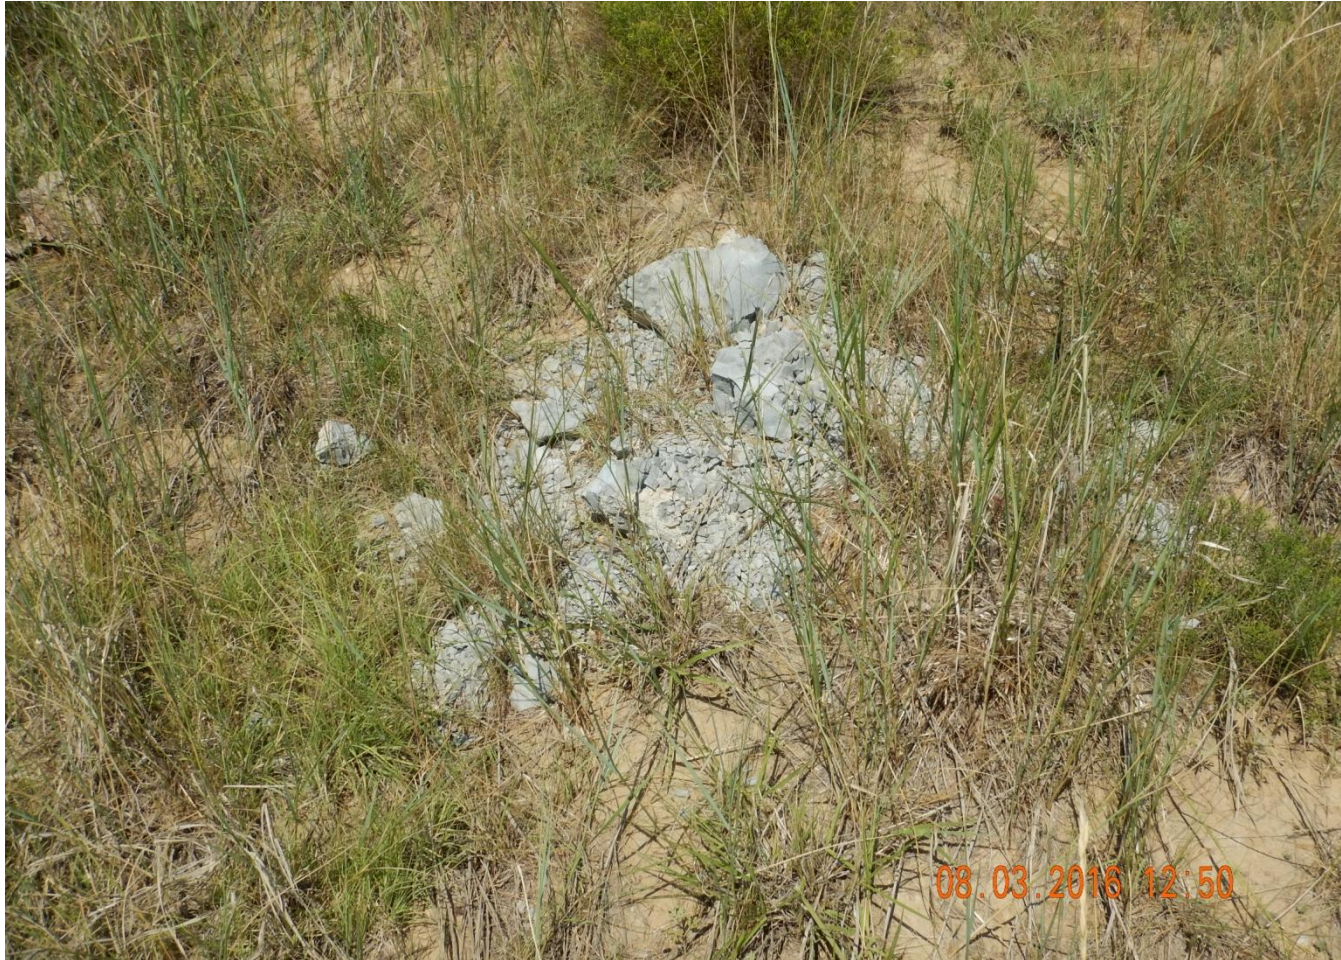
**Photo 4.** Photo taken from approximate center of location. Debris (i.e., casing) left behind needs to be removed.
