Reclamation Inspection

08/15/2016

Operator: Diversified Operating Corp

Location ID: 408171

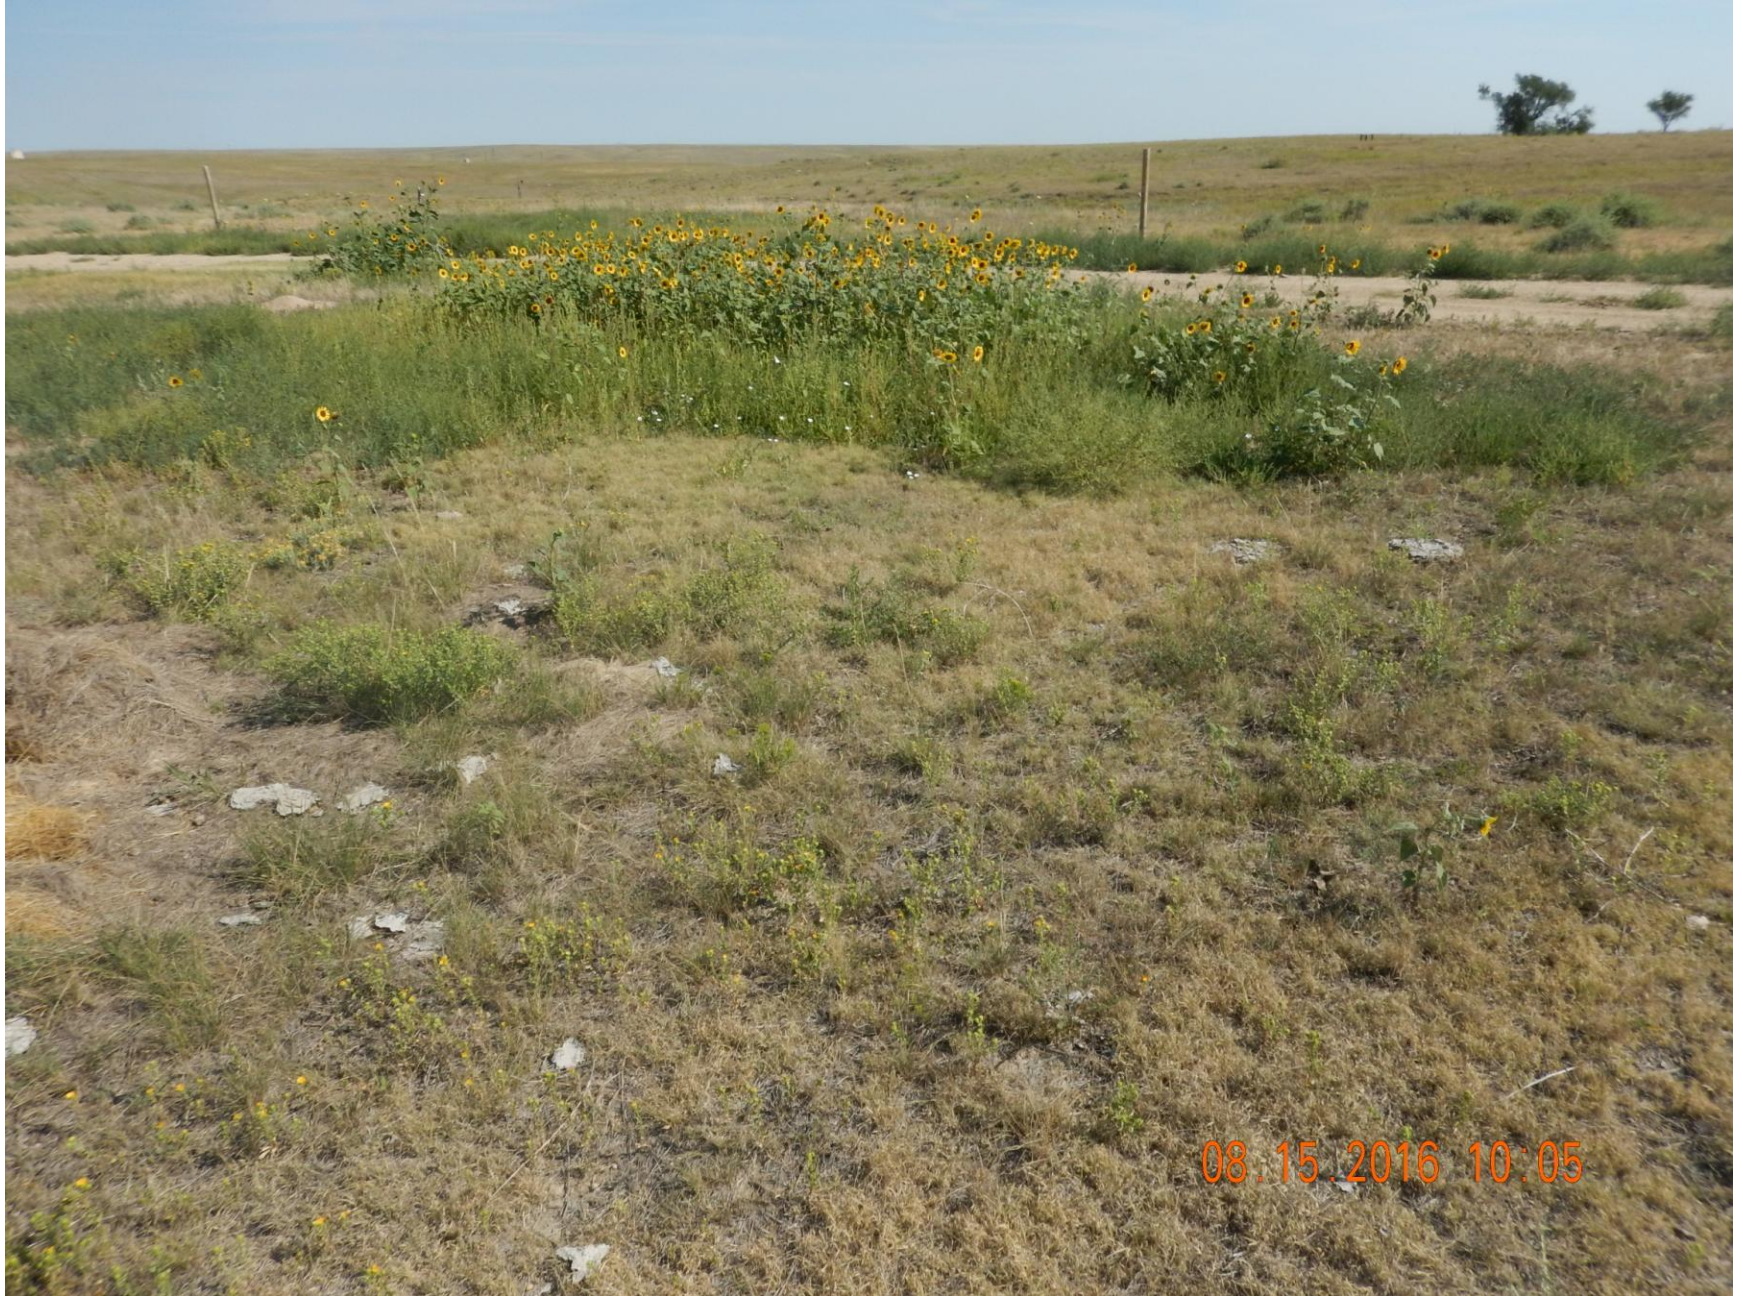
Figure 2: Photo taken from the southeast end of the well site, facing north. Photo shows vegetation over the reclamation area. Note vegetation predominantly undesirable weedy species.

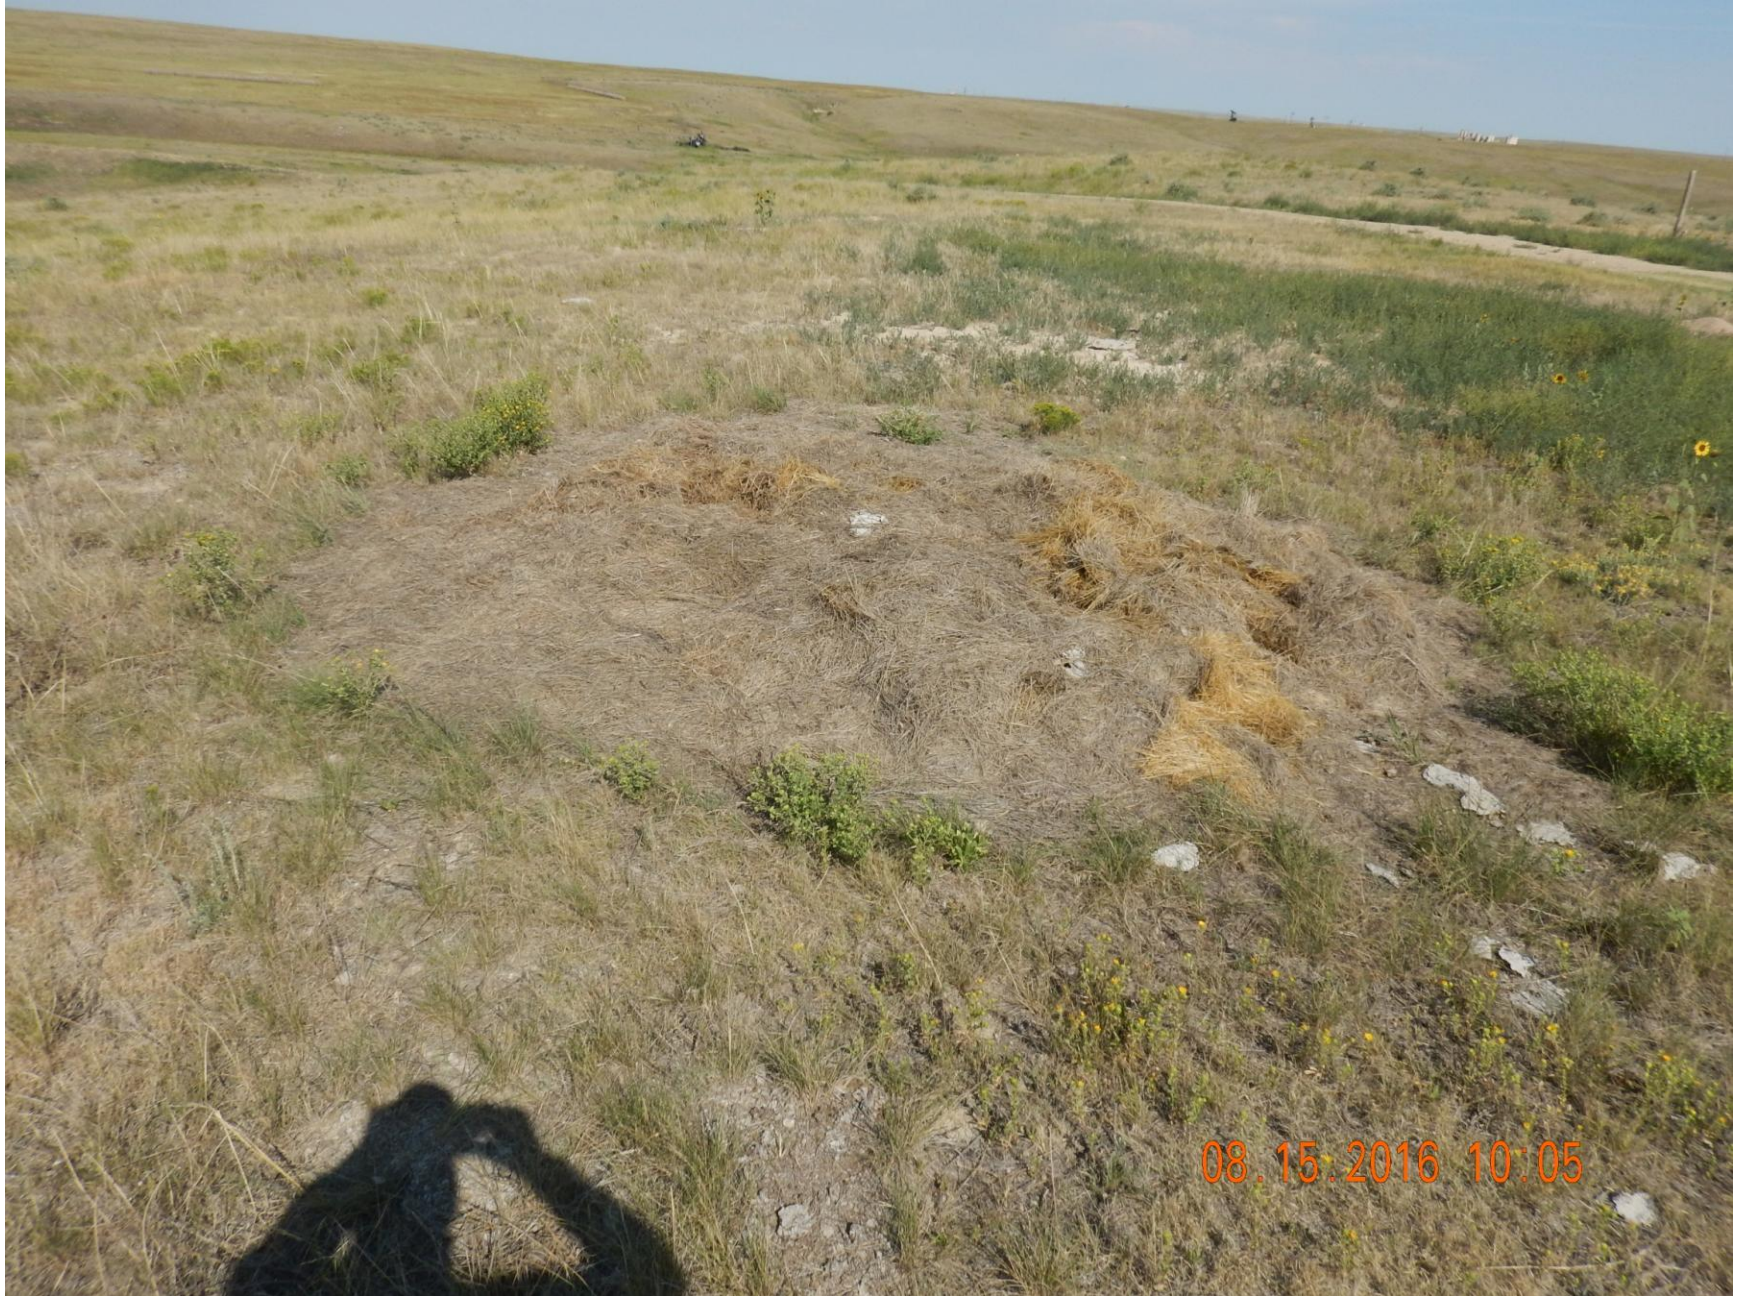
Figure 3: Photo taken from the southeast end of the well site, facing north. Photo shows vegetation over the reclamation area. Note large pile of straw debris and bare areas.

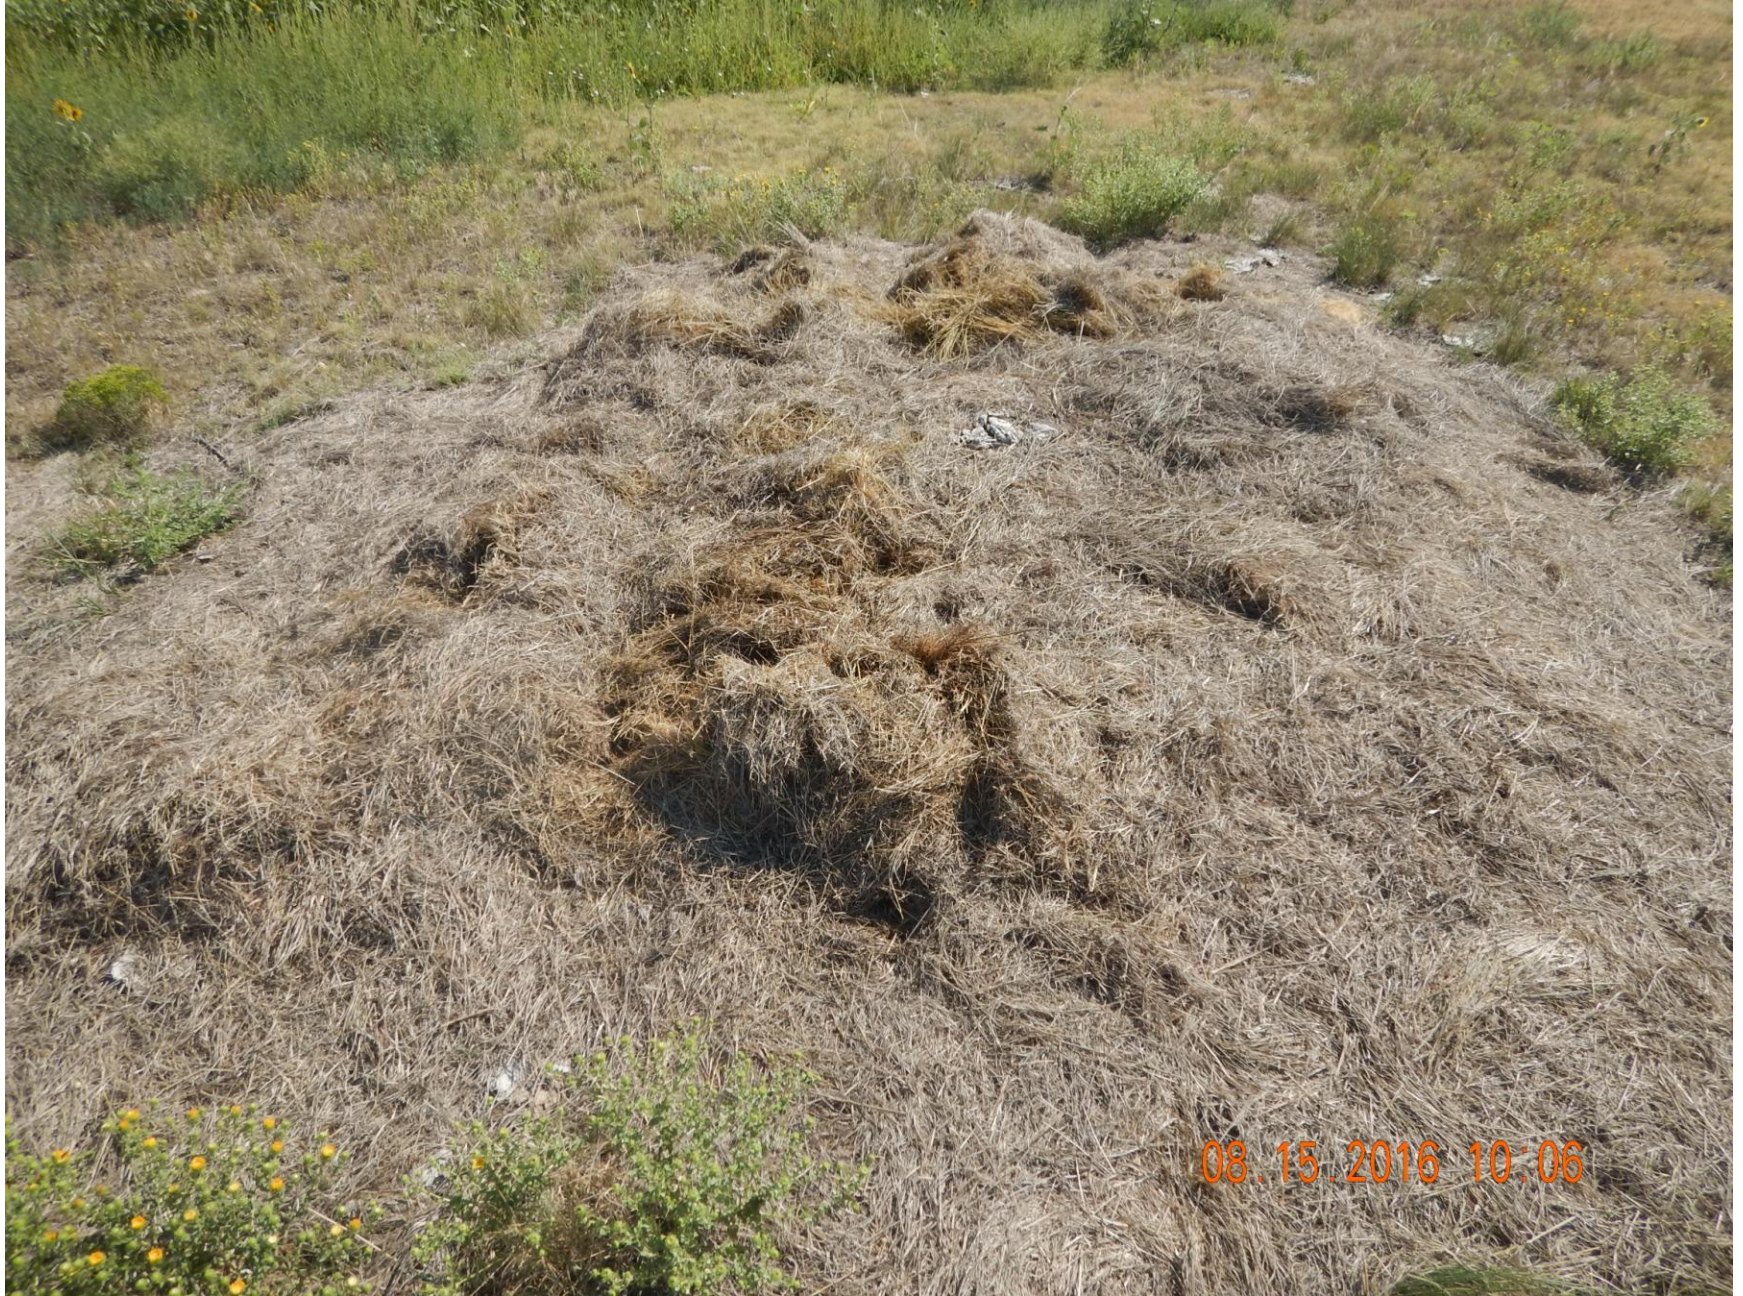
Figure 4: Photo taken from the south end of the well site. Photo shows large pile of straw debris found on location. Debris has smothered vegetation on location thus hindering reclamation and achieving 80% desirable, uniform perennial vegetative cover and needs to be removed.

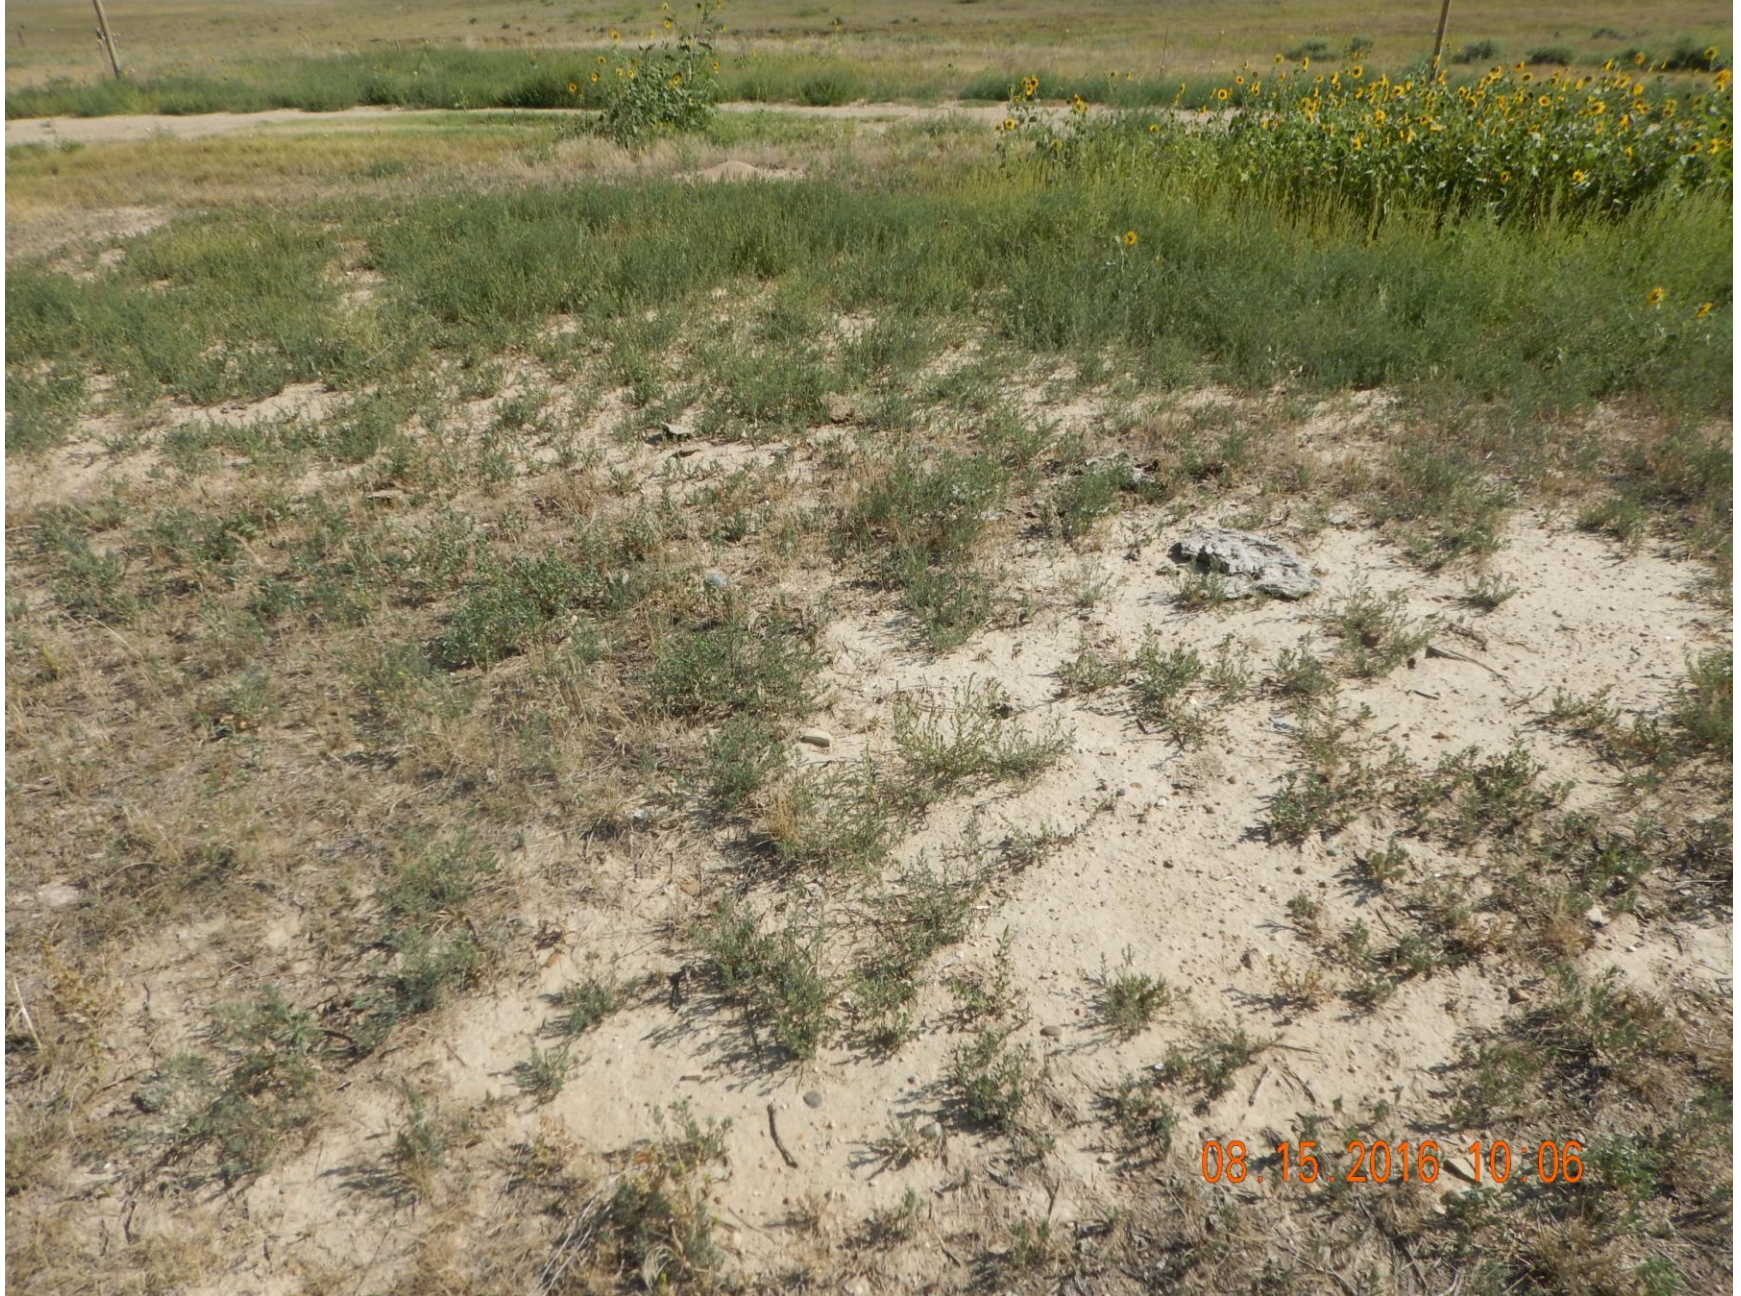
Figure 5: Photo taken from the south end of the well site, facing north. Photo shows vegetation has not achieved uniform cover, and is predominantly undesirable weedy plant species.

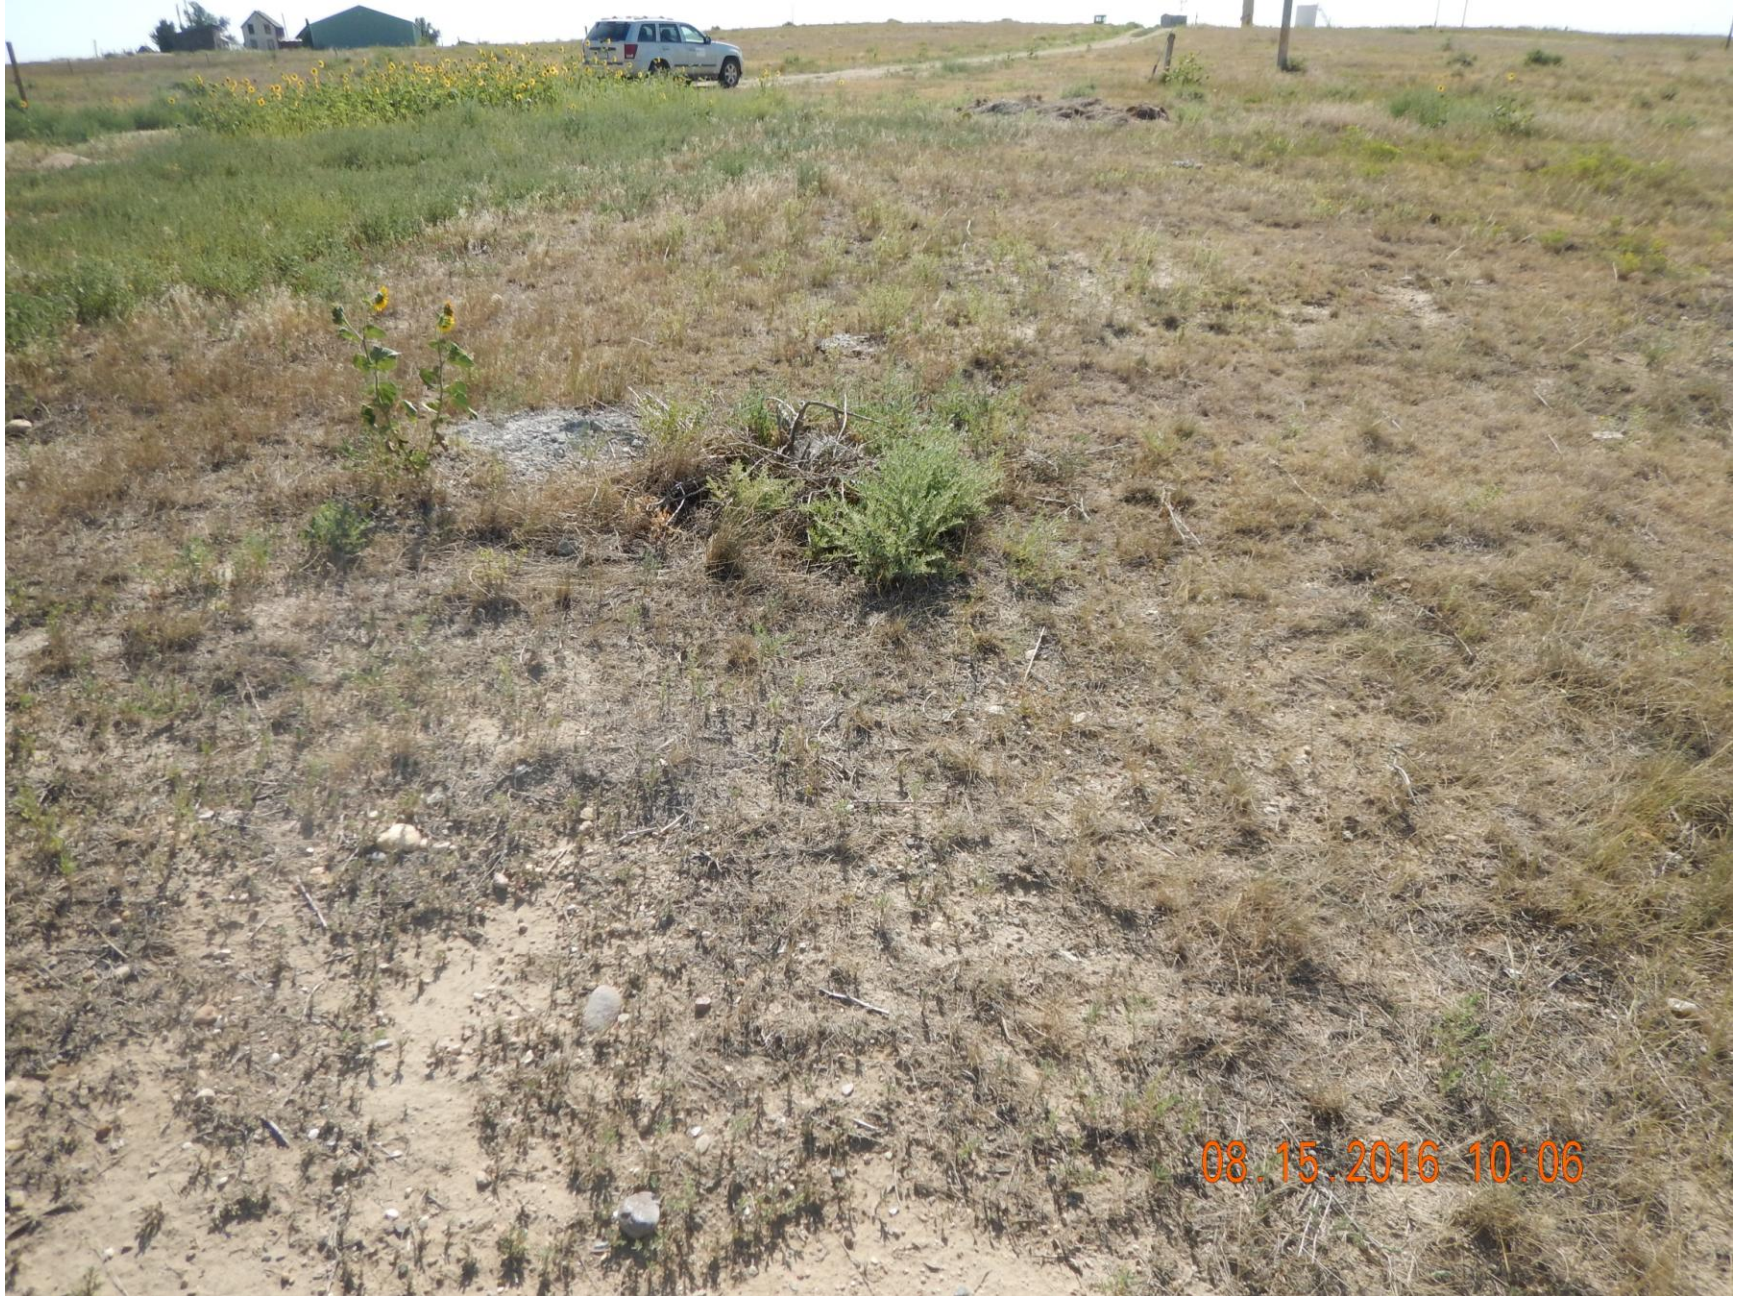
Figure 6: Photo taken from the southwest end of the well site, facing east. Photo shows vegetation has not achieved uniform cover, and is predominantly undesirable weedy plant species.

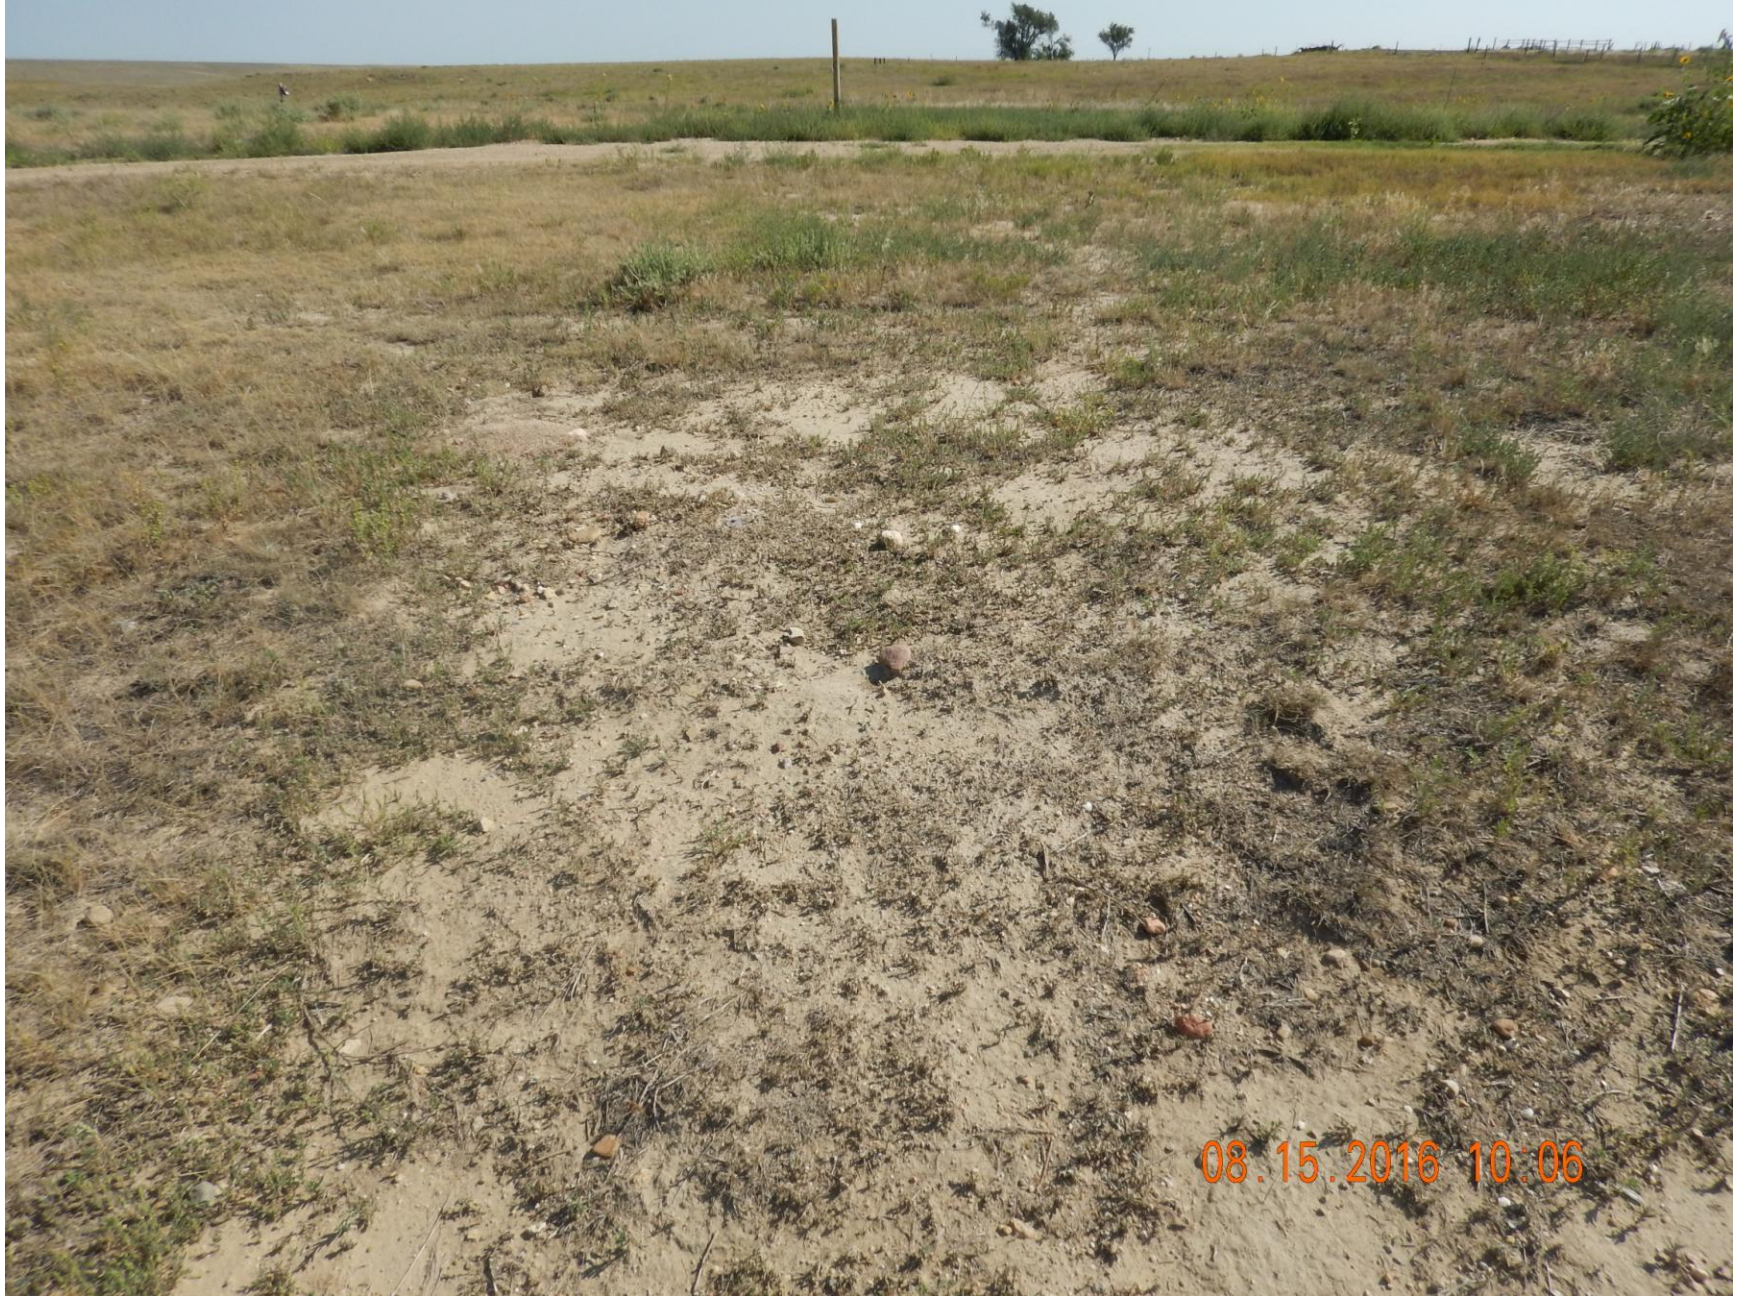
Figure 7: Photo taken from the southwest end of the well site, facing north. Photo shows vegetation has not achieved uniform cover, and is predominantly undesirable weedy plant species.

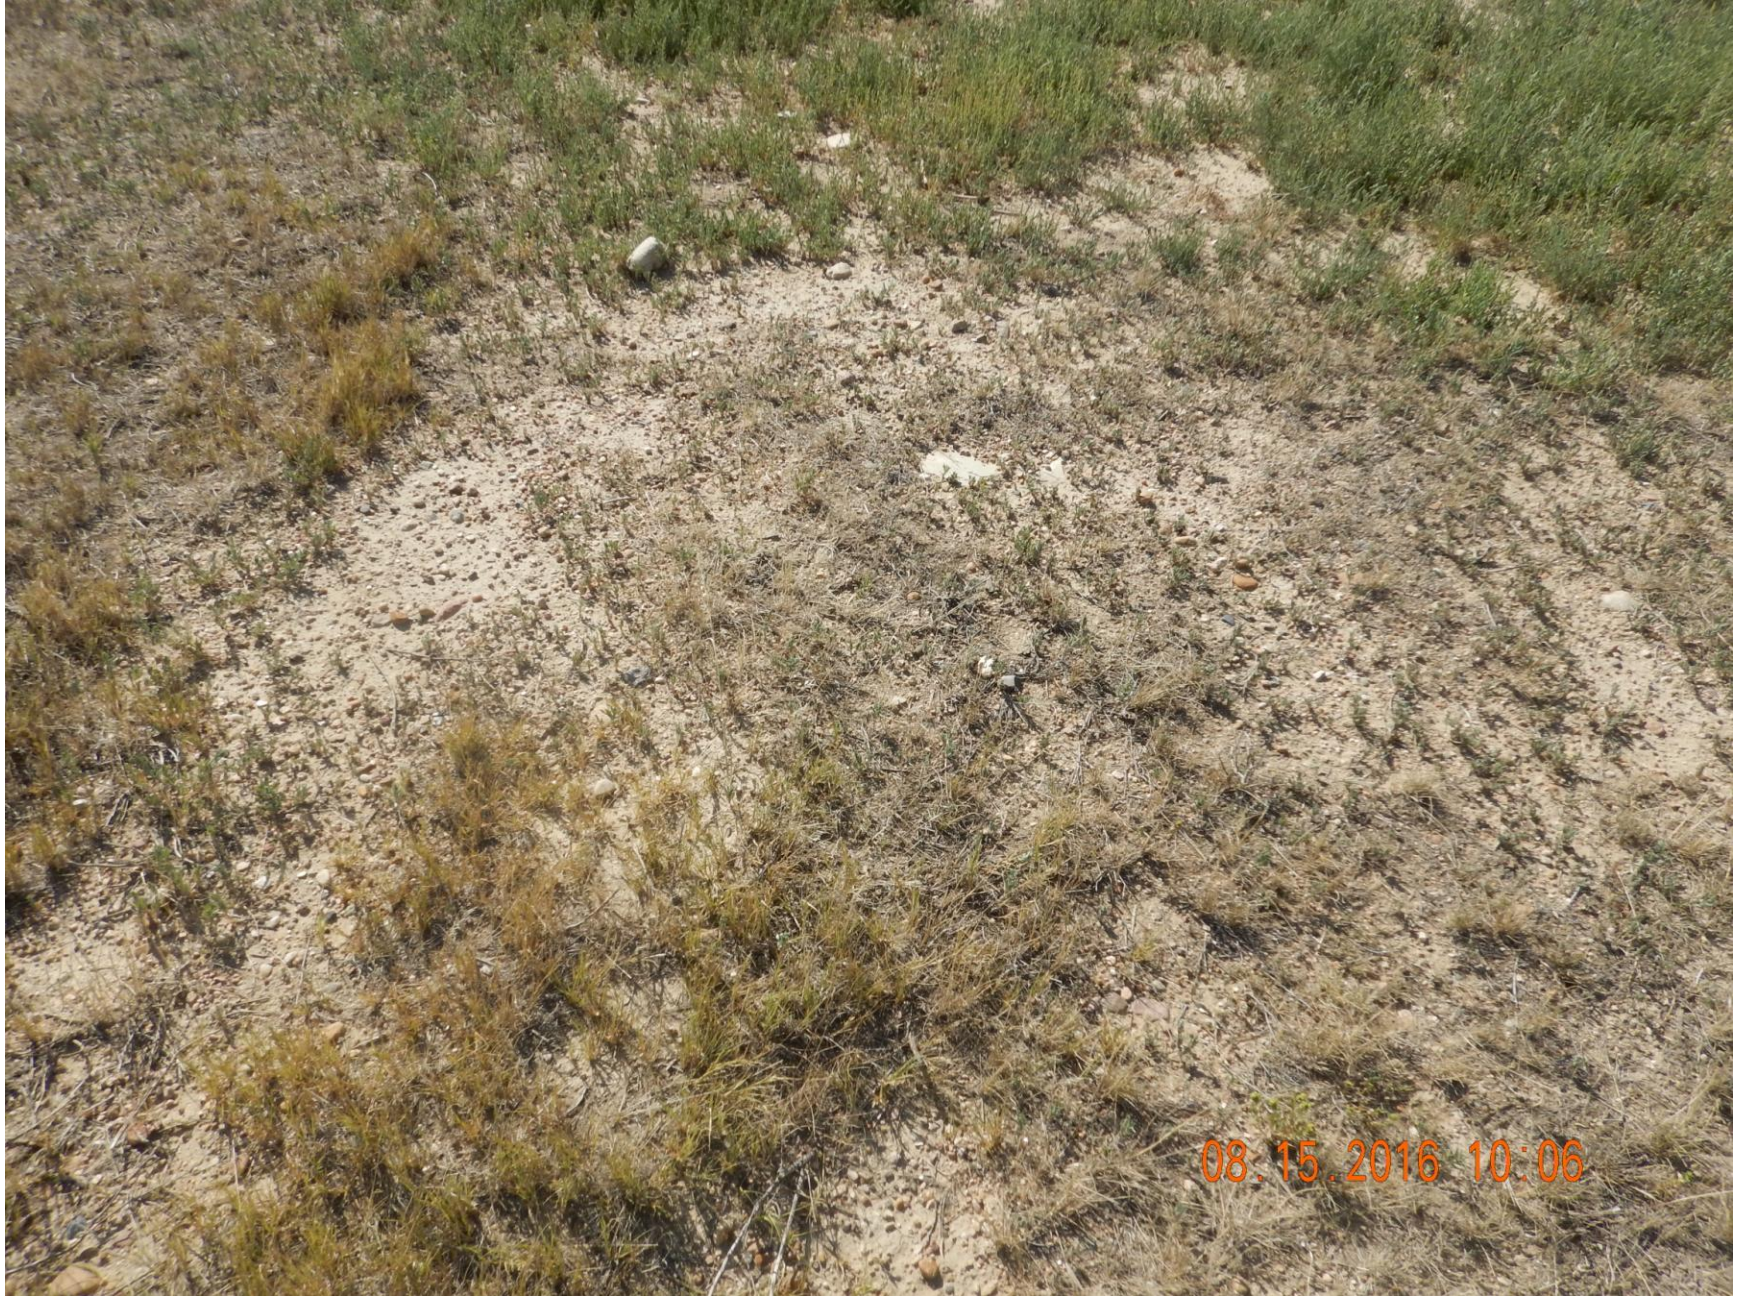
Figure 8: Photo taken from the well site. Photo shows large bare areas and what appears to be gravel remaining on location.

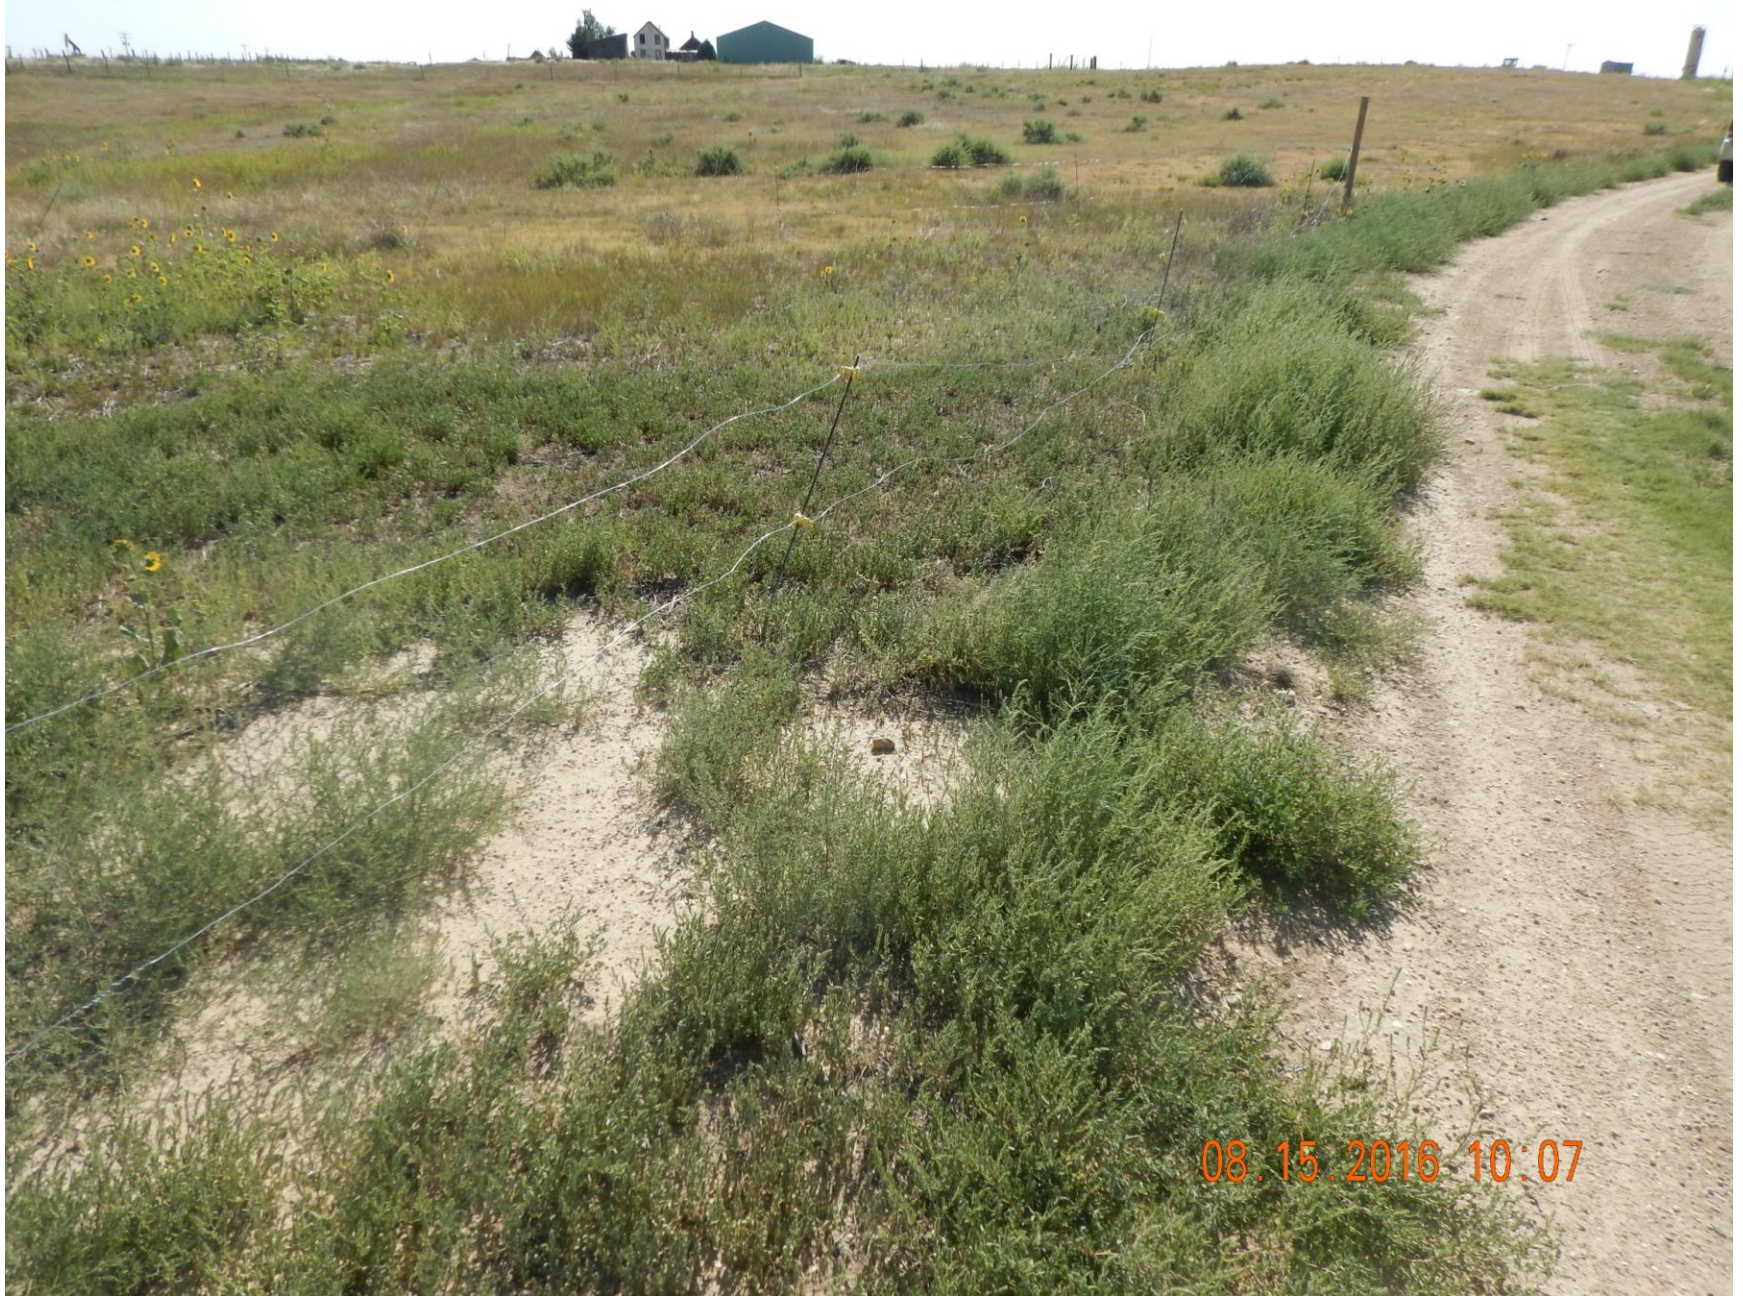
Figure 9: Photo taken from the southwest corner of the fenced off area, facing east. Fenced area appears to have been the site of a spill. Photo shows vegetation over the reclamation area.

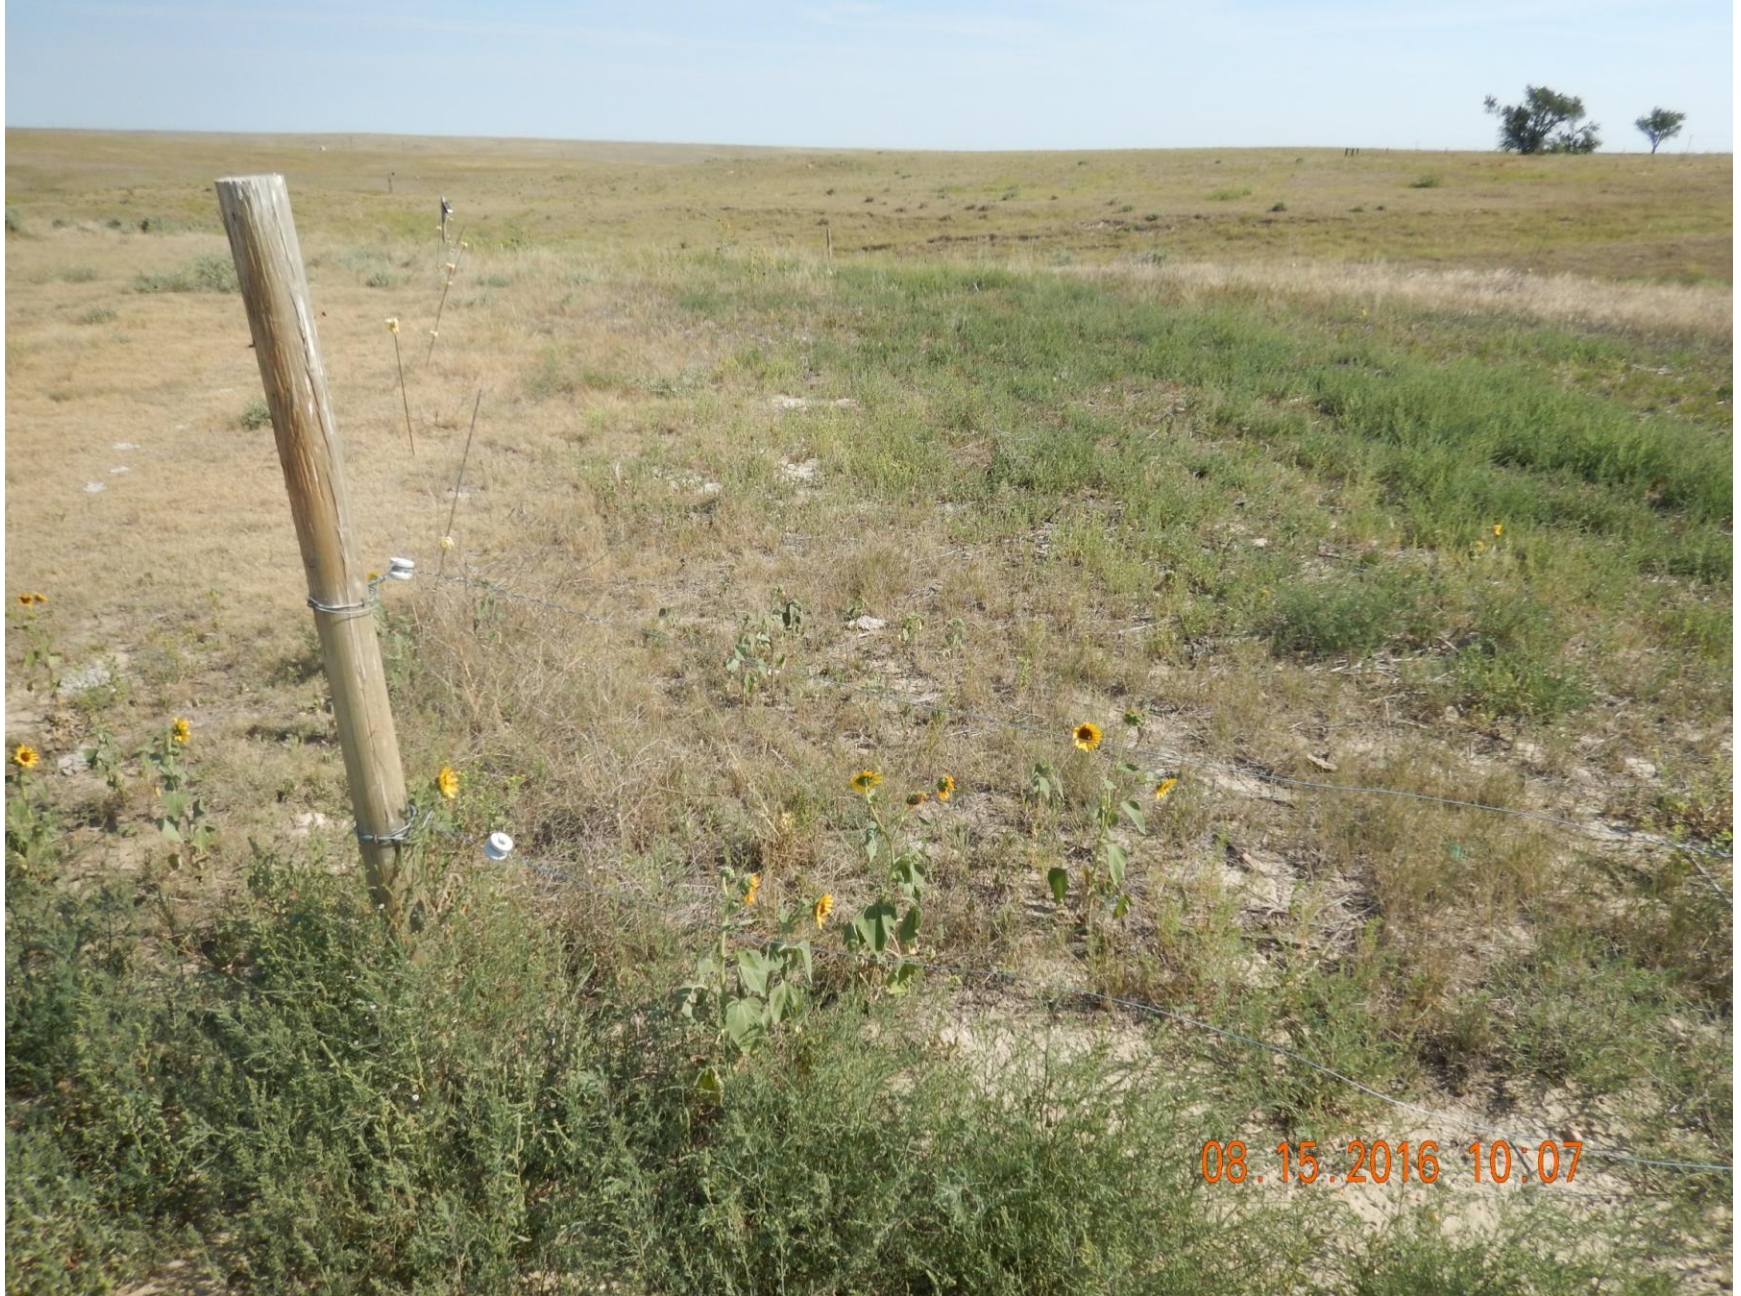
Figure 10: Photo taken from the southwest corner of the fenced off area, facing north. Fenced area appears to have been the site of a spill. Photo shows vegetation over the reclamation area.

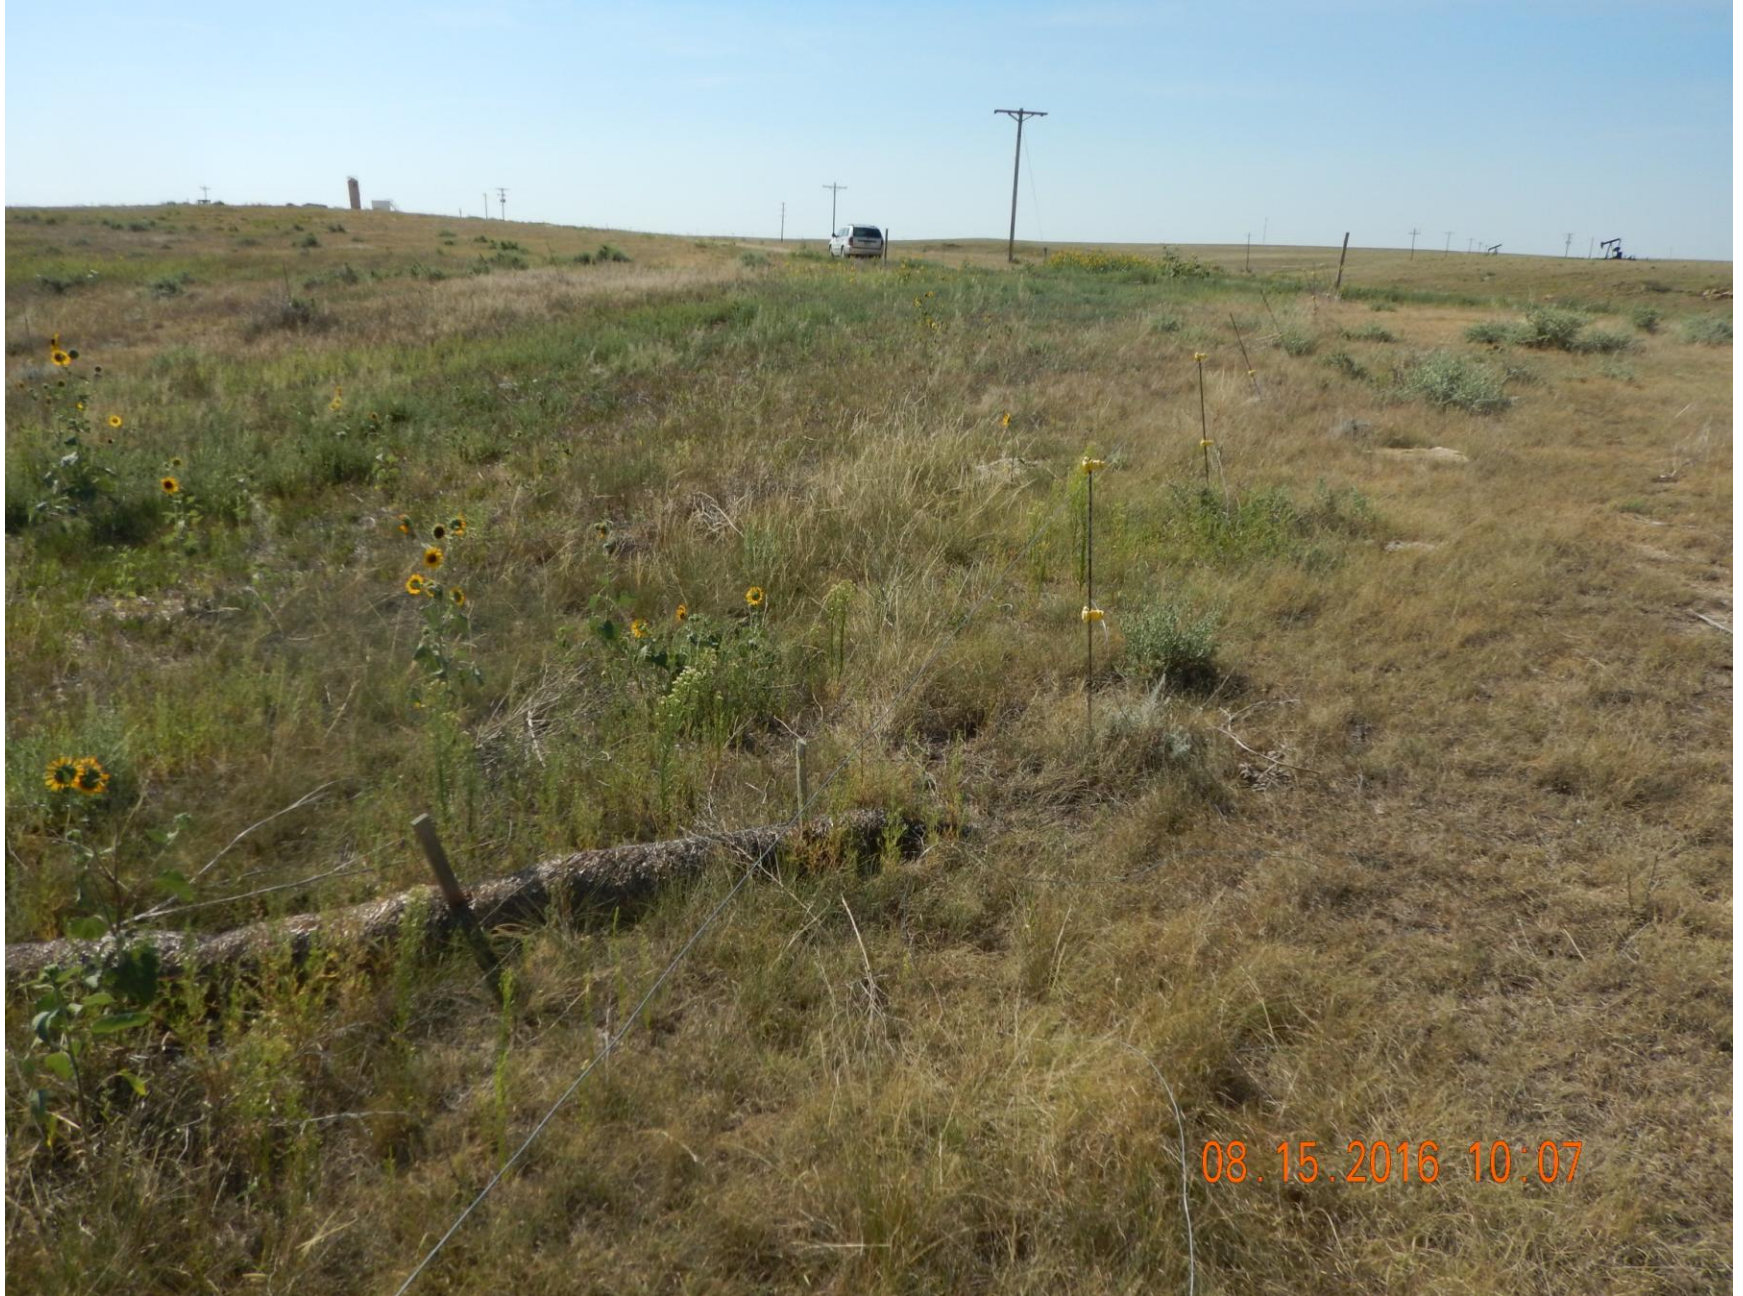
Figure 11: Photo taken from the northwest corner of the fenced off area, facing south. Fenced area appears to have been the site of a spill. Photo shows vegetation over the reclamation area.
