Reclamation Inspection

08/15/2016

Operator: Diversified Operating Corp

Location ID: 408171

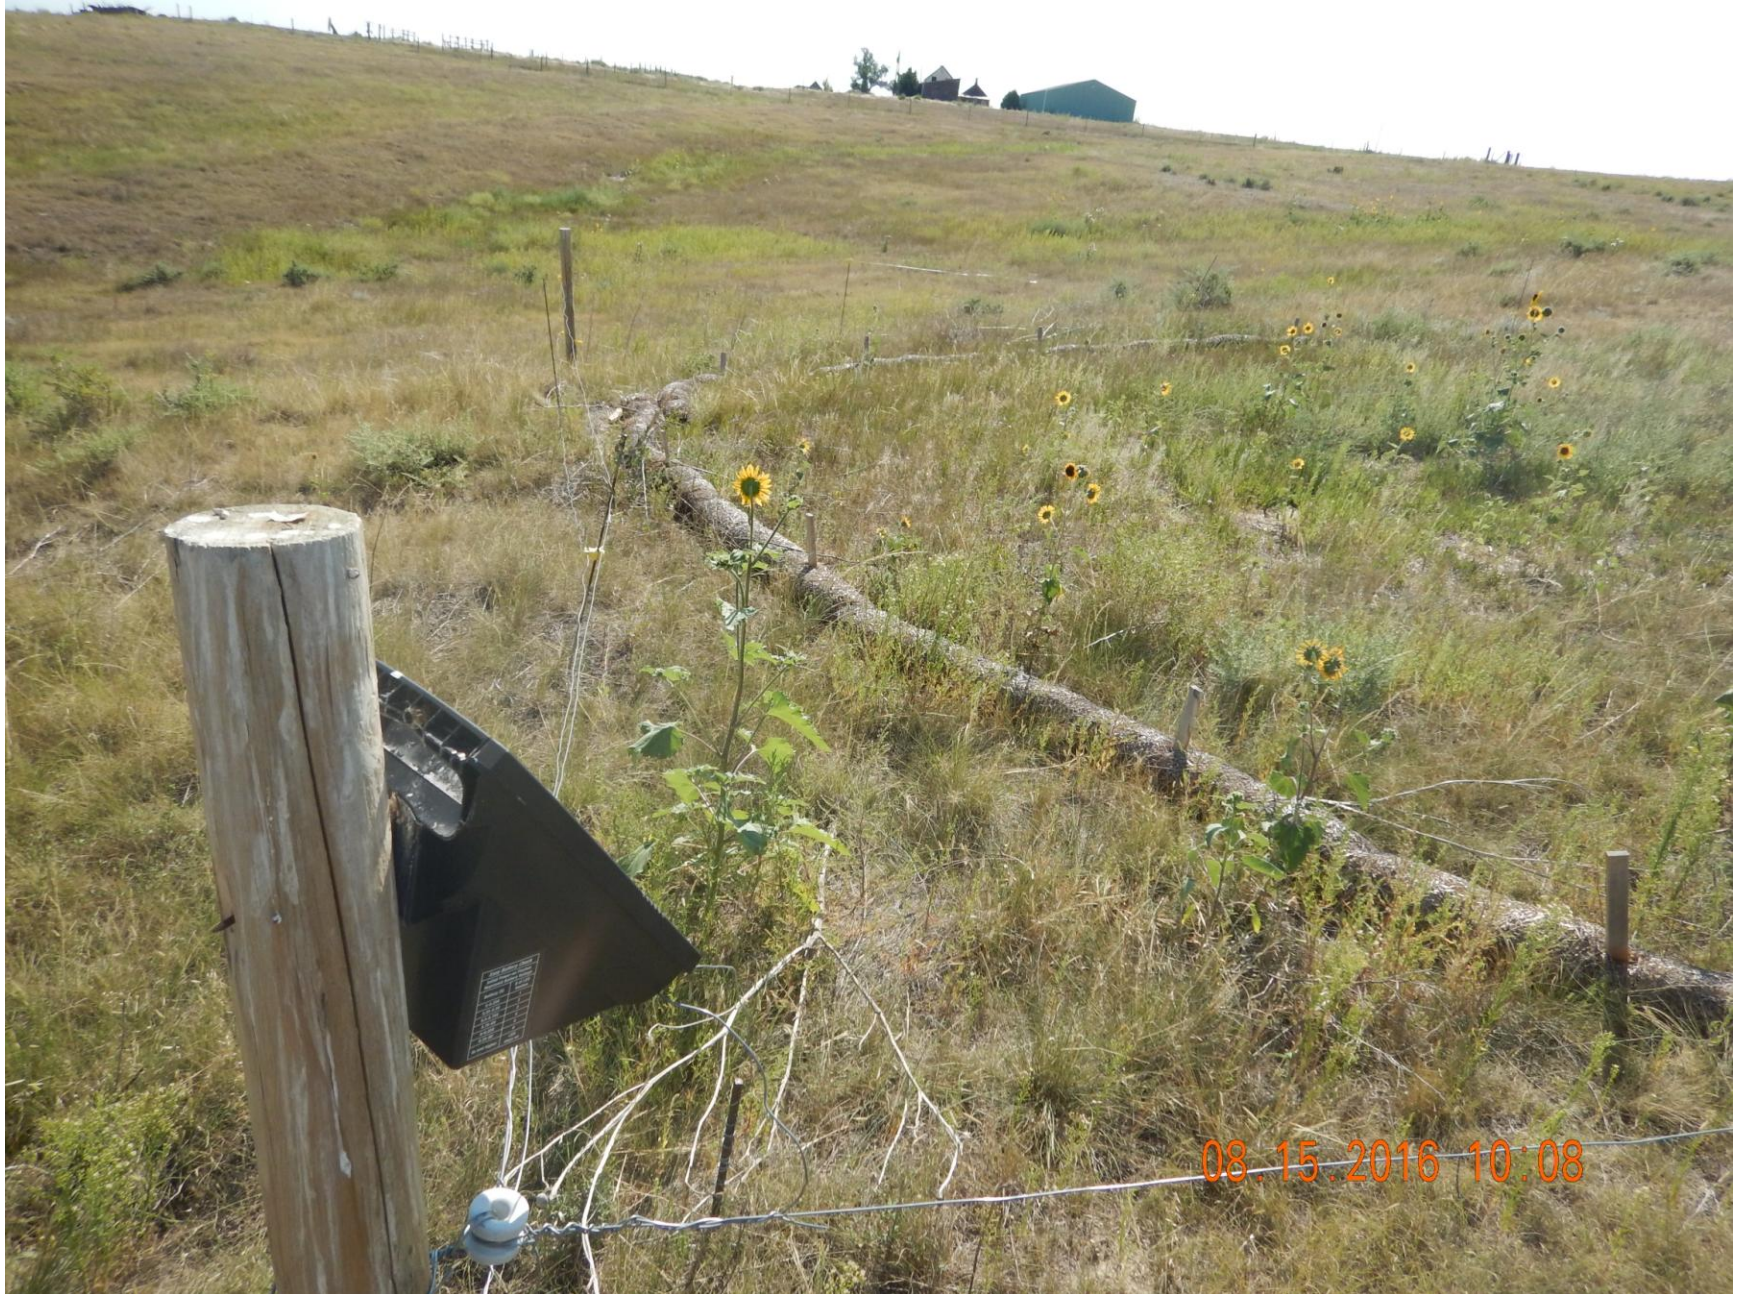
Figure 12: Photo taken from the northwest corner of the fenced off area, facing east. Fenced area appears to have been the site of a spill. Photo shows vegetation over the reclamation area.

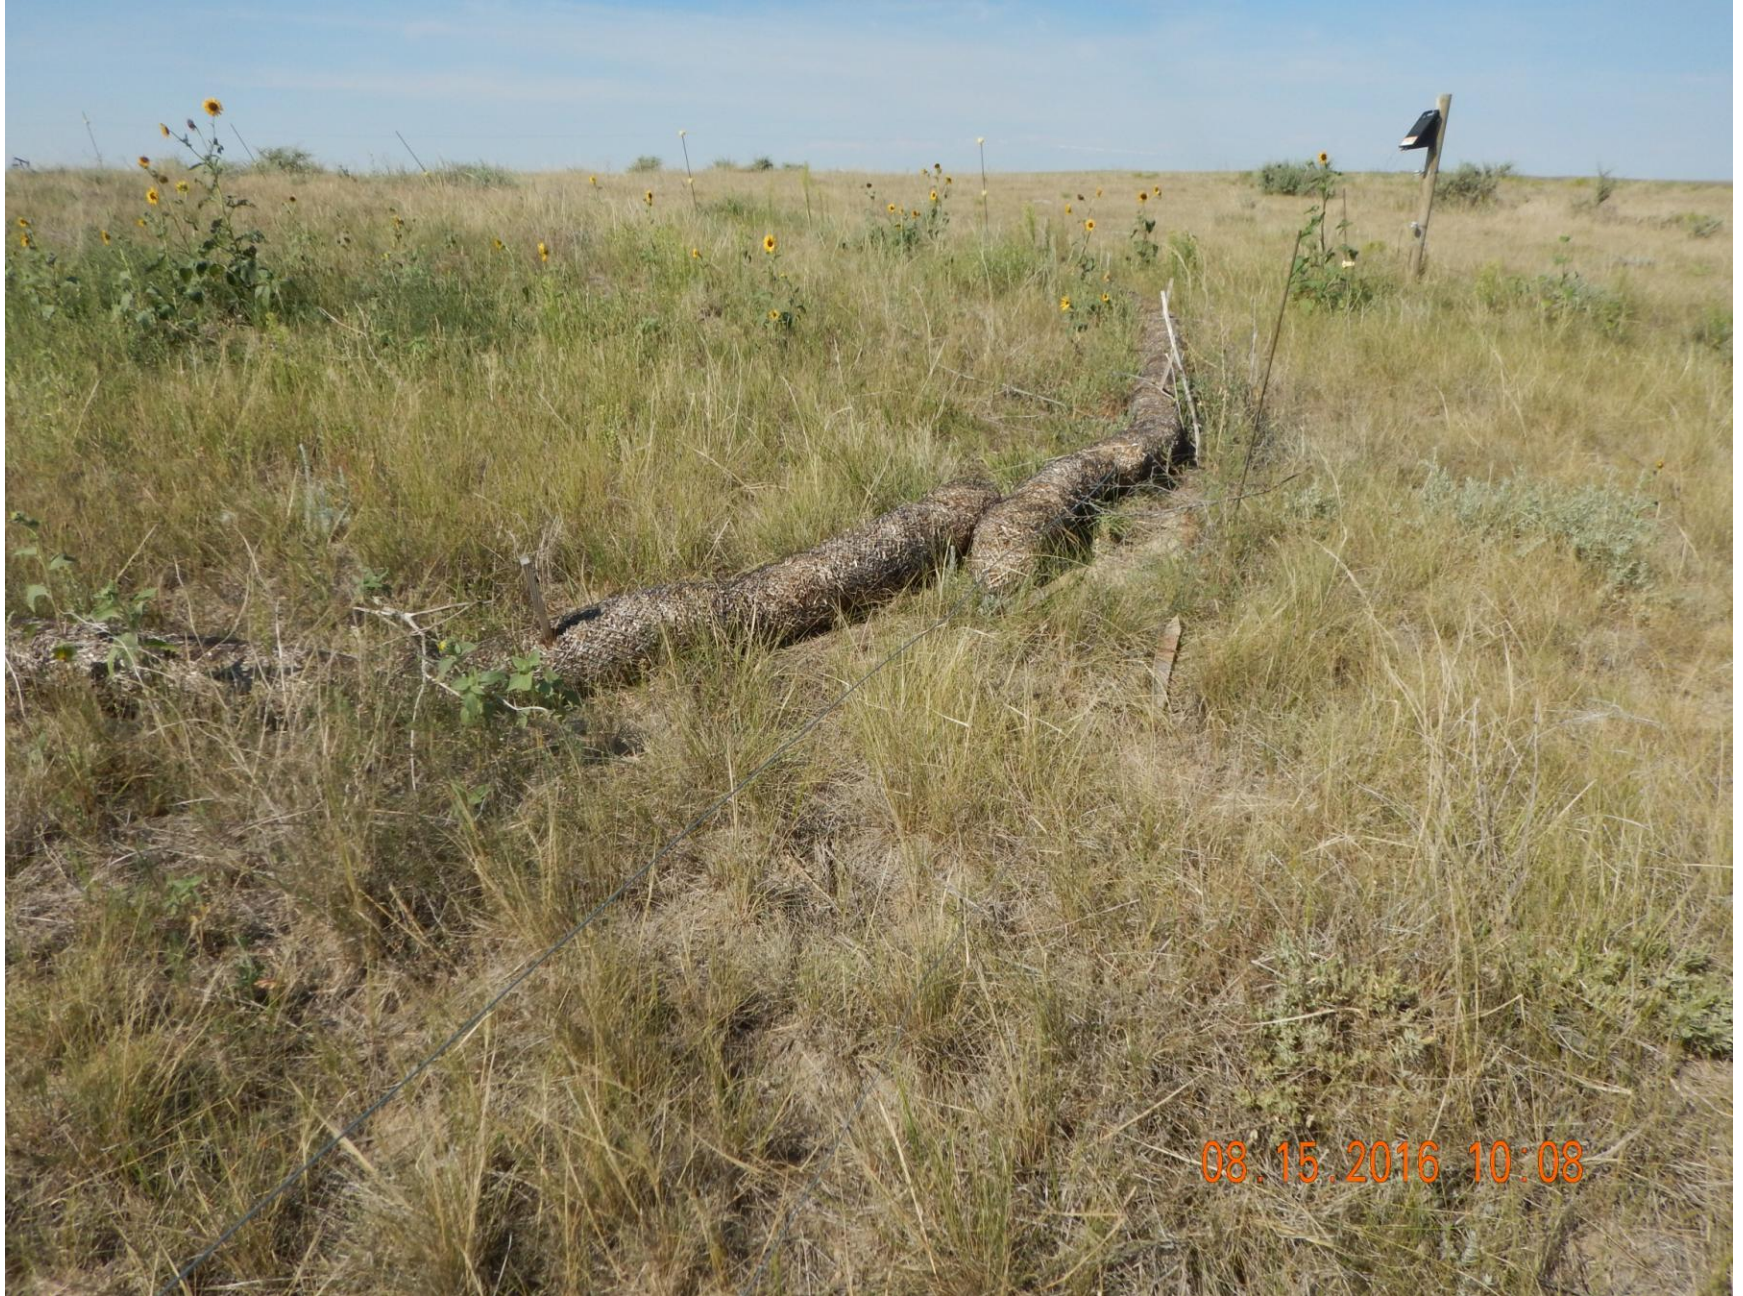
Figure 13: Photo taken from the northeast corner of the fenced off area, facing west. Fenced area appears to have been the site of a spill. Photo shows vegetation over the reclamation area

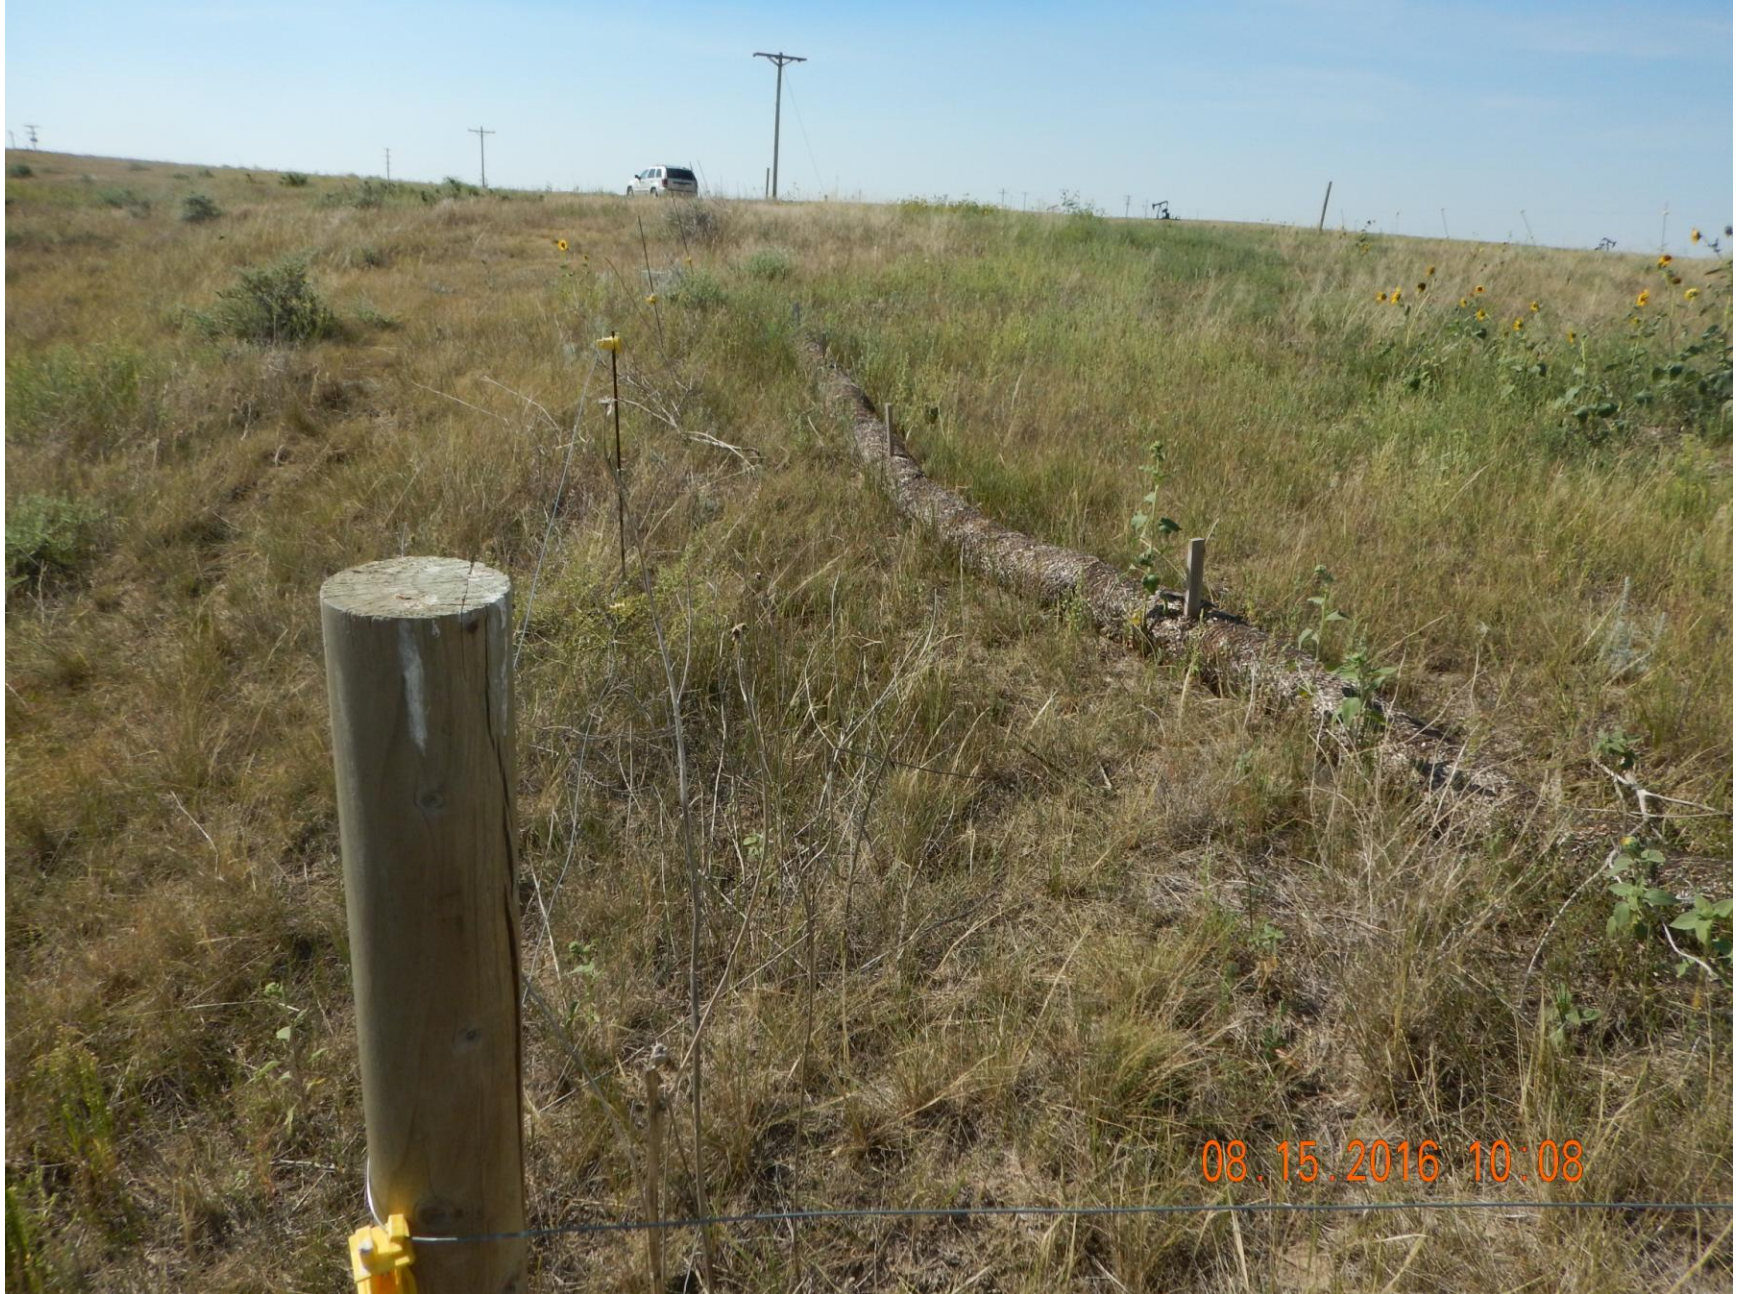
Figure 14: Photo taken from the northeast corner of the fenced off area, facing south. Fenced area appears to have been the site of a spill. Photo shows vegetation over the reclamation area

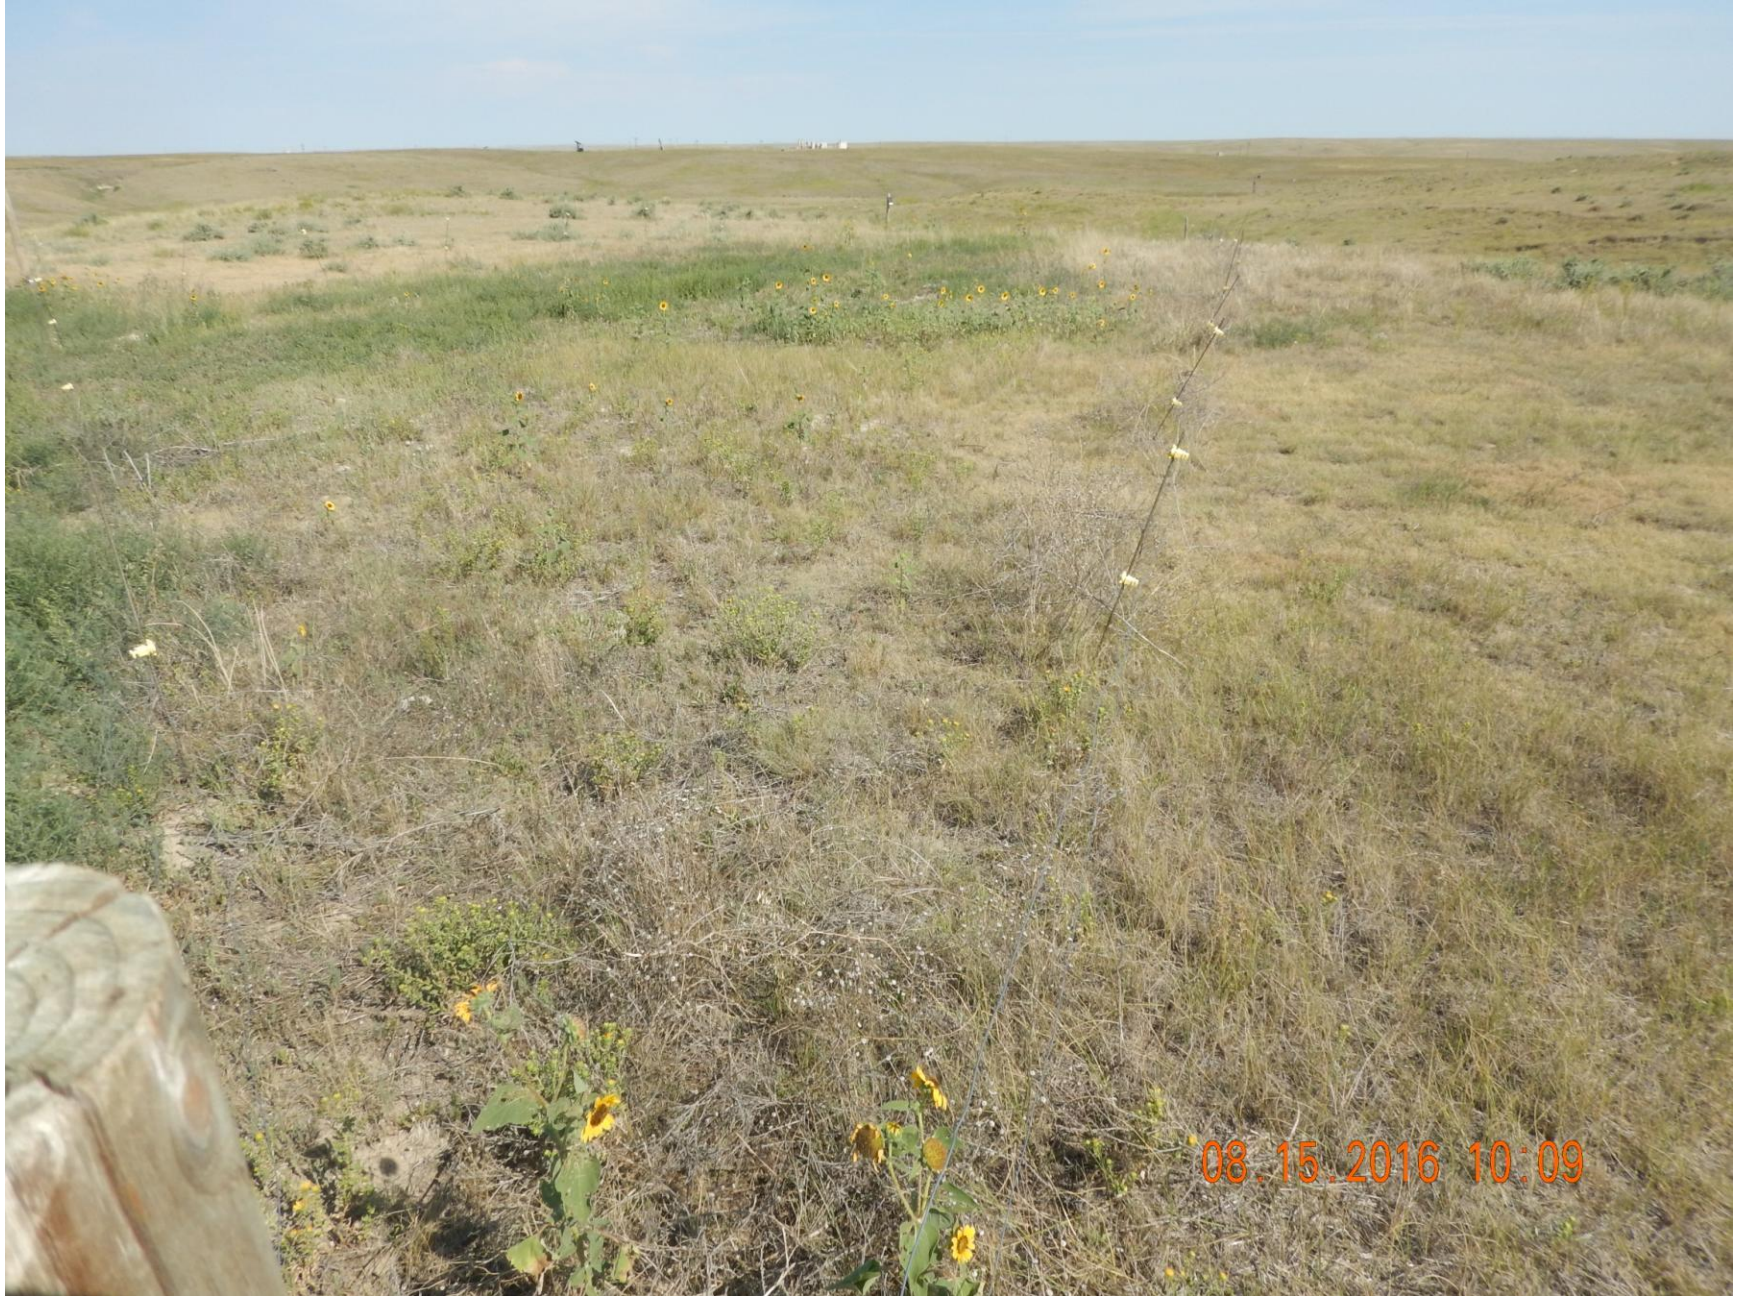
Figure 15: Photo taken from the southeast corner of the fenced off area, facing north. Fenced area appears to have been the site of a spill. Photo shows vegetation over the reclamation area.

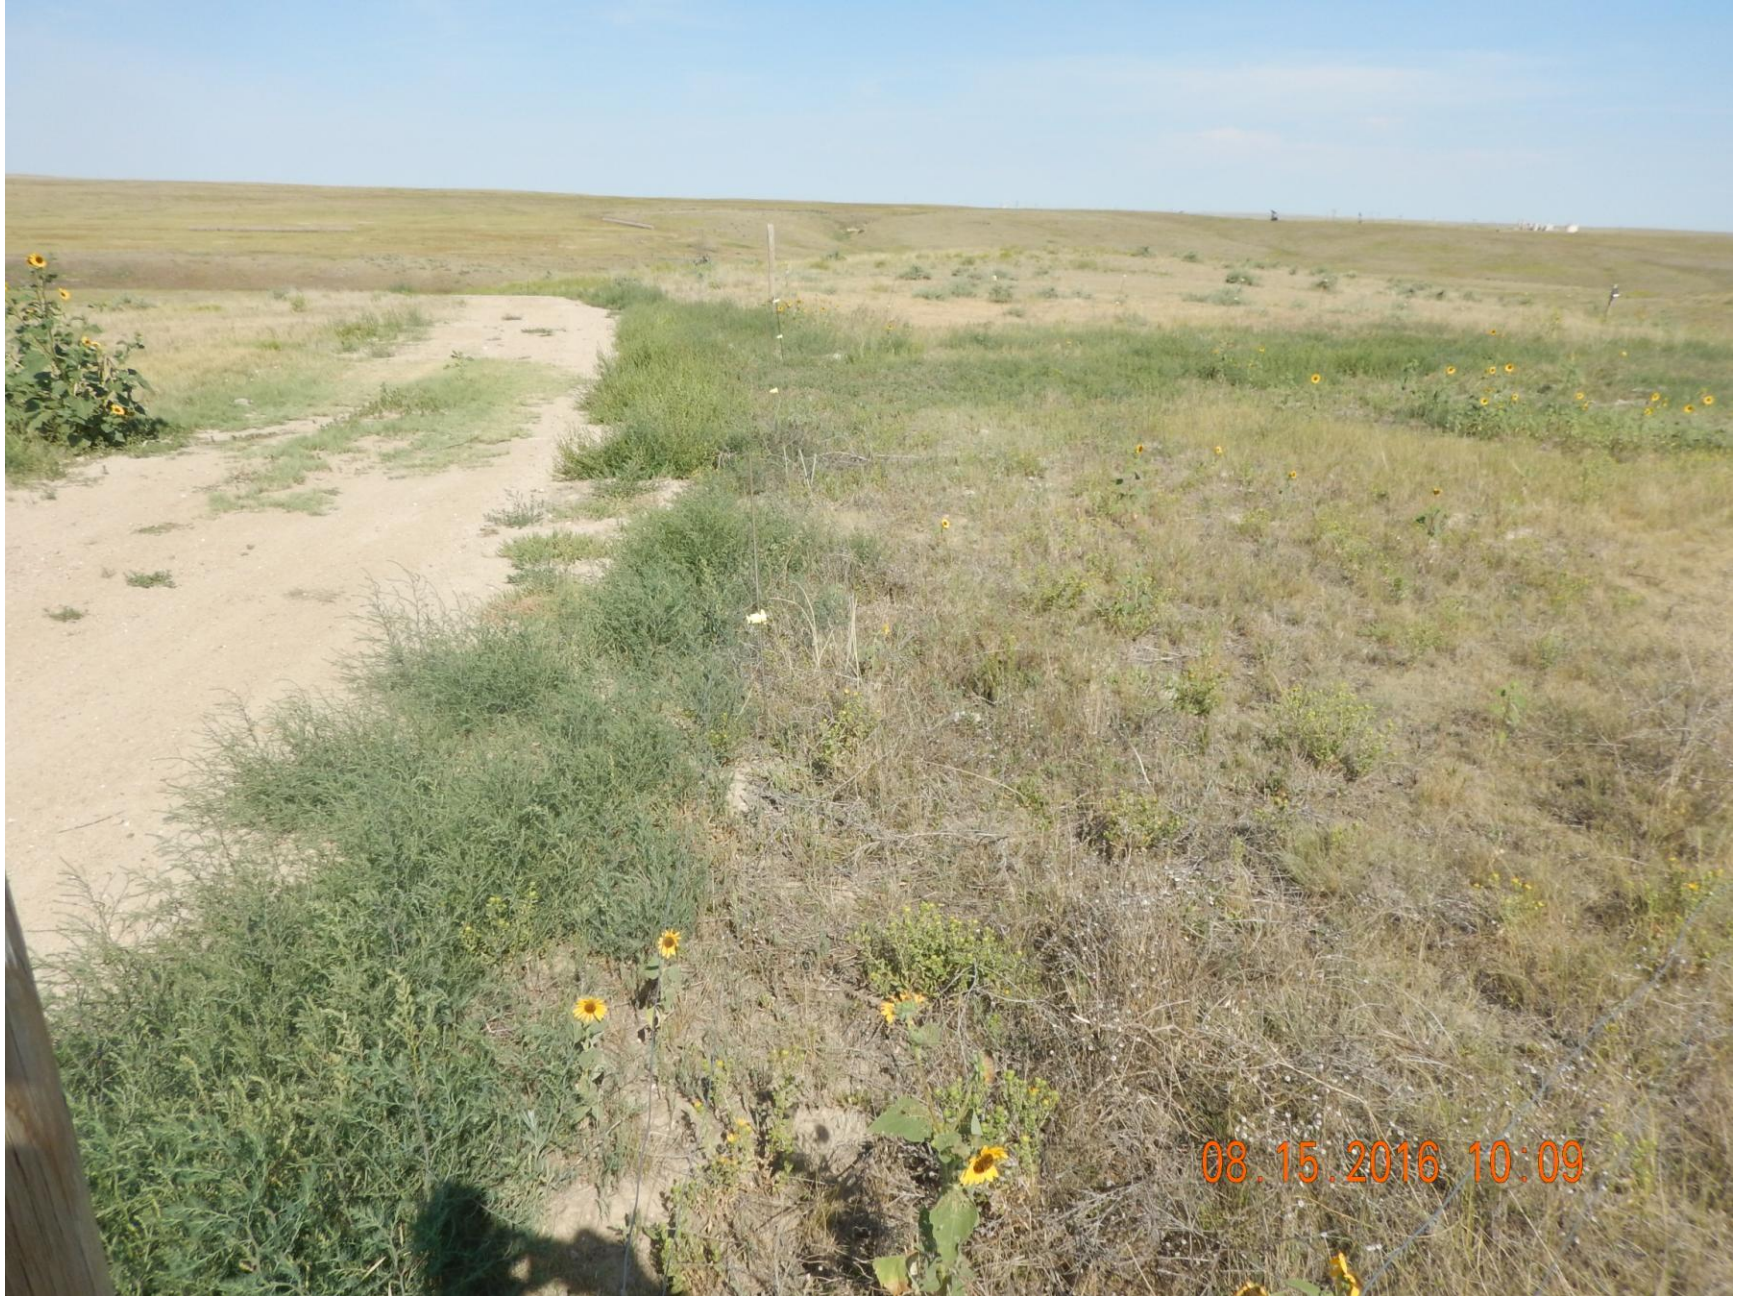
Figure 16: Photo taken from the southeast corner of the fenced off area, facing west. Fenced area appears to have been the site of a spill. Photo shows vegetation over the reclamation area.

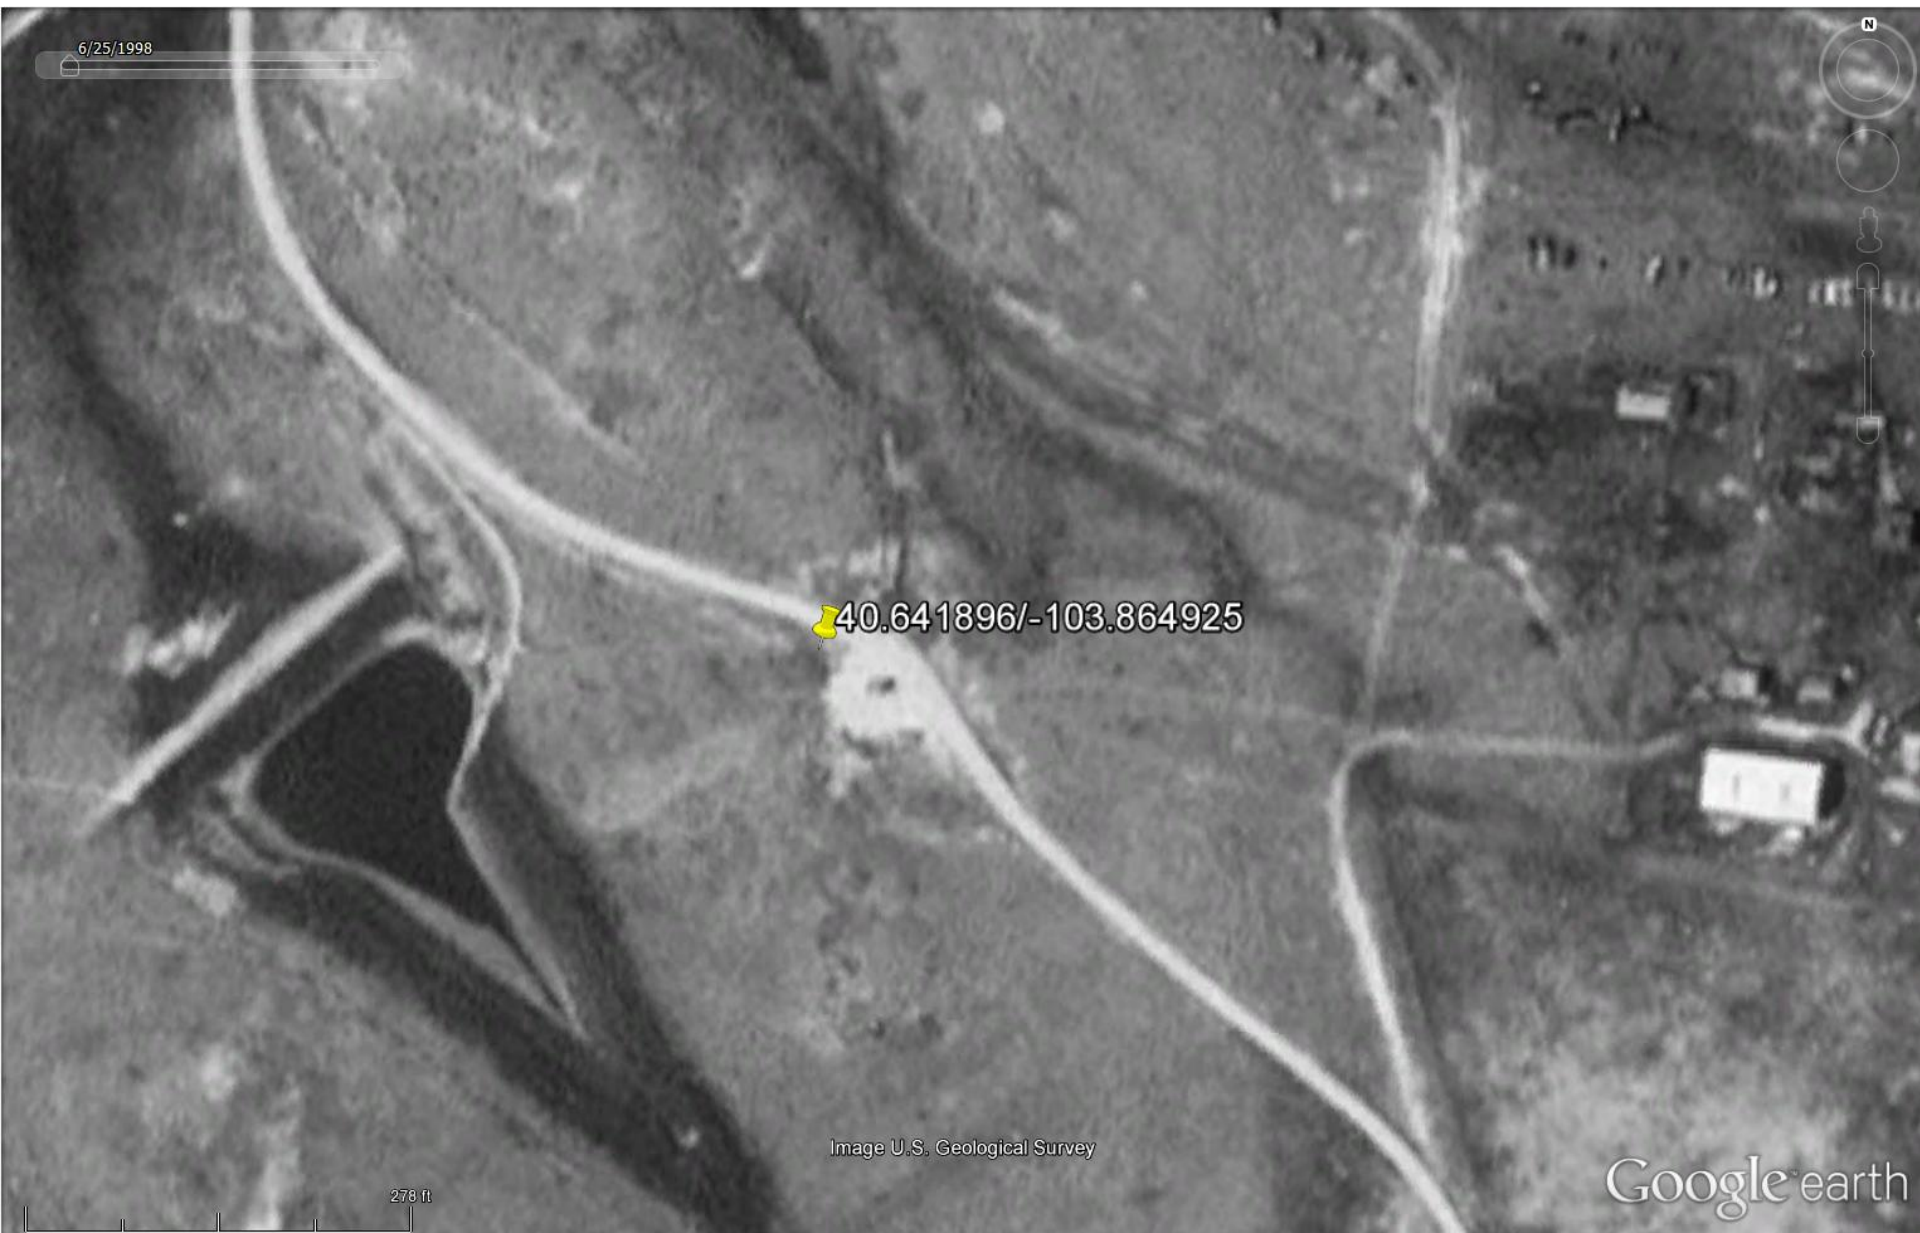
Figure 27: 1998 aerial imagery. Image shows well site existed on the southern side of the access road.

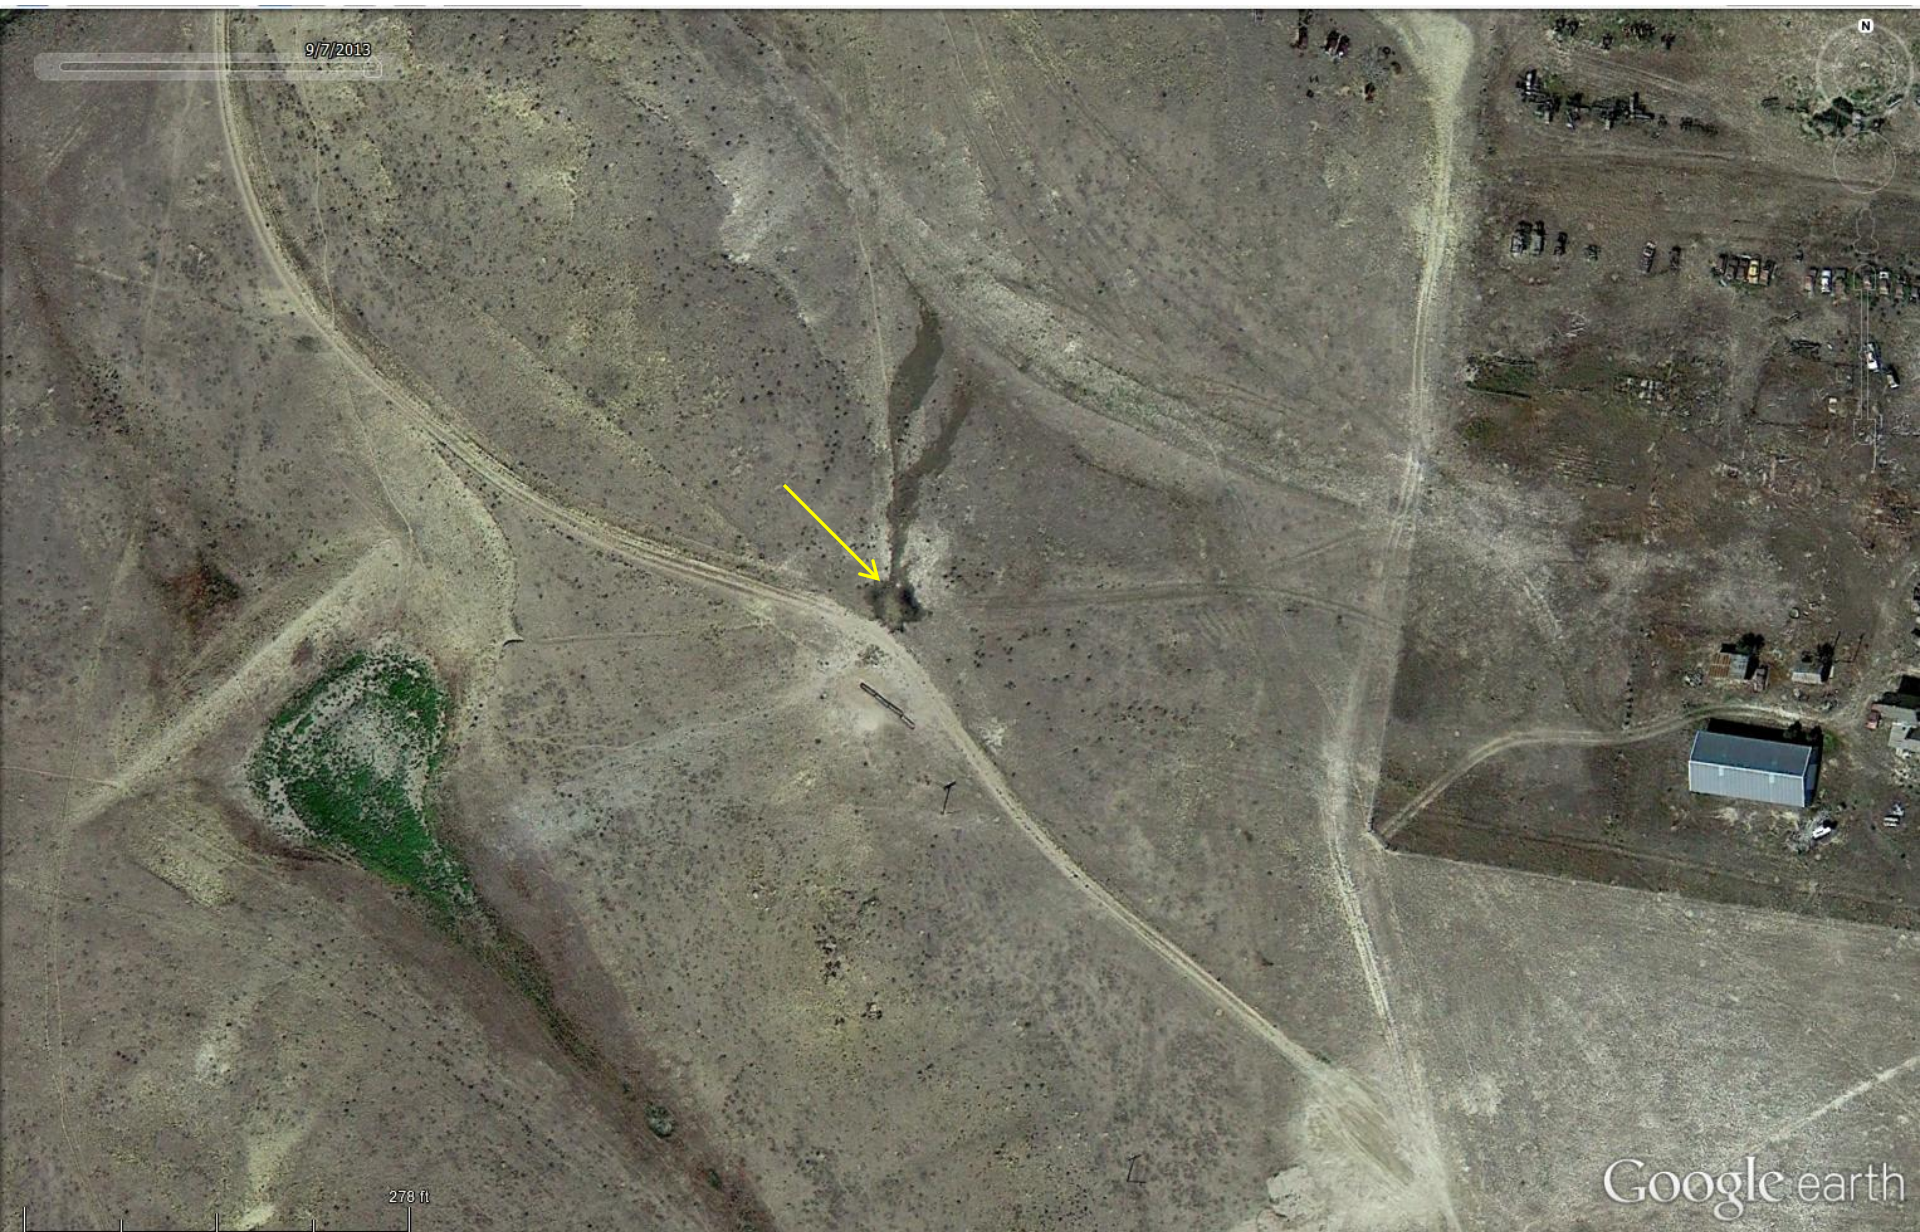
Figure 28: 2013 Aerial imagery well and location. Records state spill had occurred on location, imagery shows spill had occurred to the north of the well/access road. This is the fenced off area (for reclamation) in figures 9-16.
