VERTEX ENERGY PARTNERS, LLC FOR  
LONGS PEAK RESOURCES, LLC  
RAIL AY 28-3-1CH  
API #05-123-39863  
NE NW SEC.28-T12N-R66W  
SHL: 180' FWL & 1980' FWL BHL: 310' FSL & 2080' FWL  
LAT: 40.98531 LONG: 104.78359  
WELD COUNTY, COLORADO  
CONTACT NO. 214-534-9569

Cirque Resources L.P.  
Railay 28-3-1CH  
N 40.98531 W 104.78359  
NE/NW Sec 28 T12N R66W

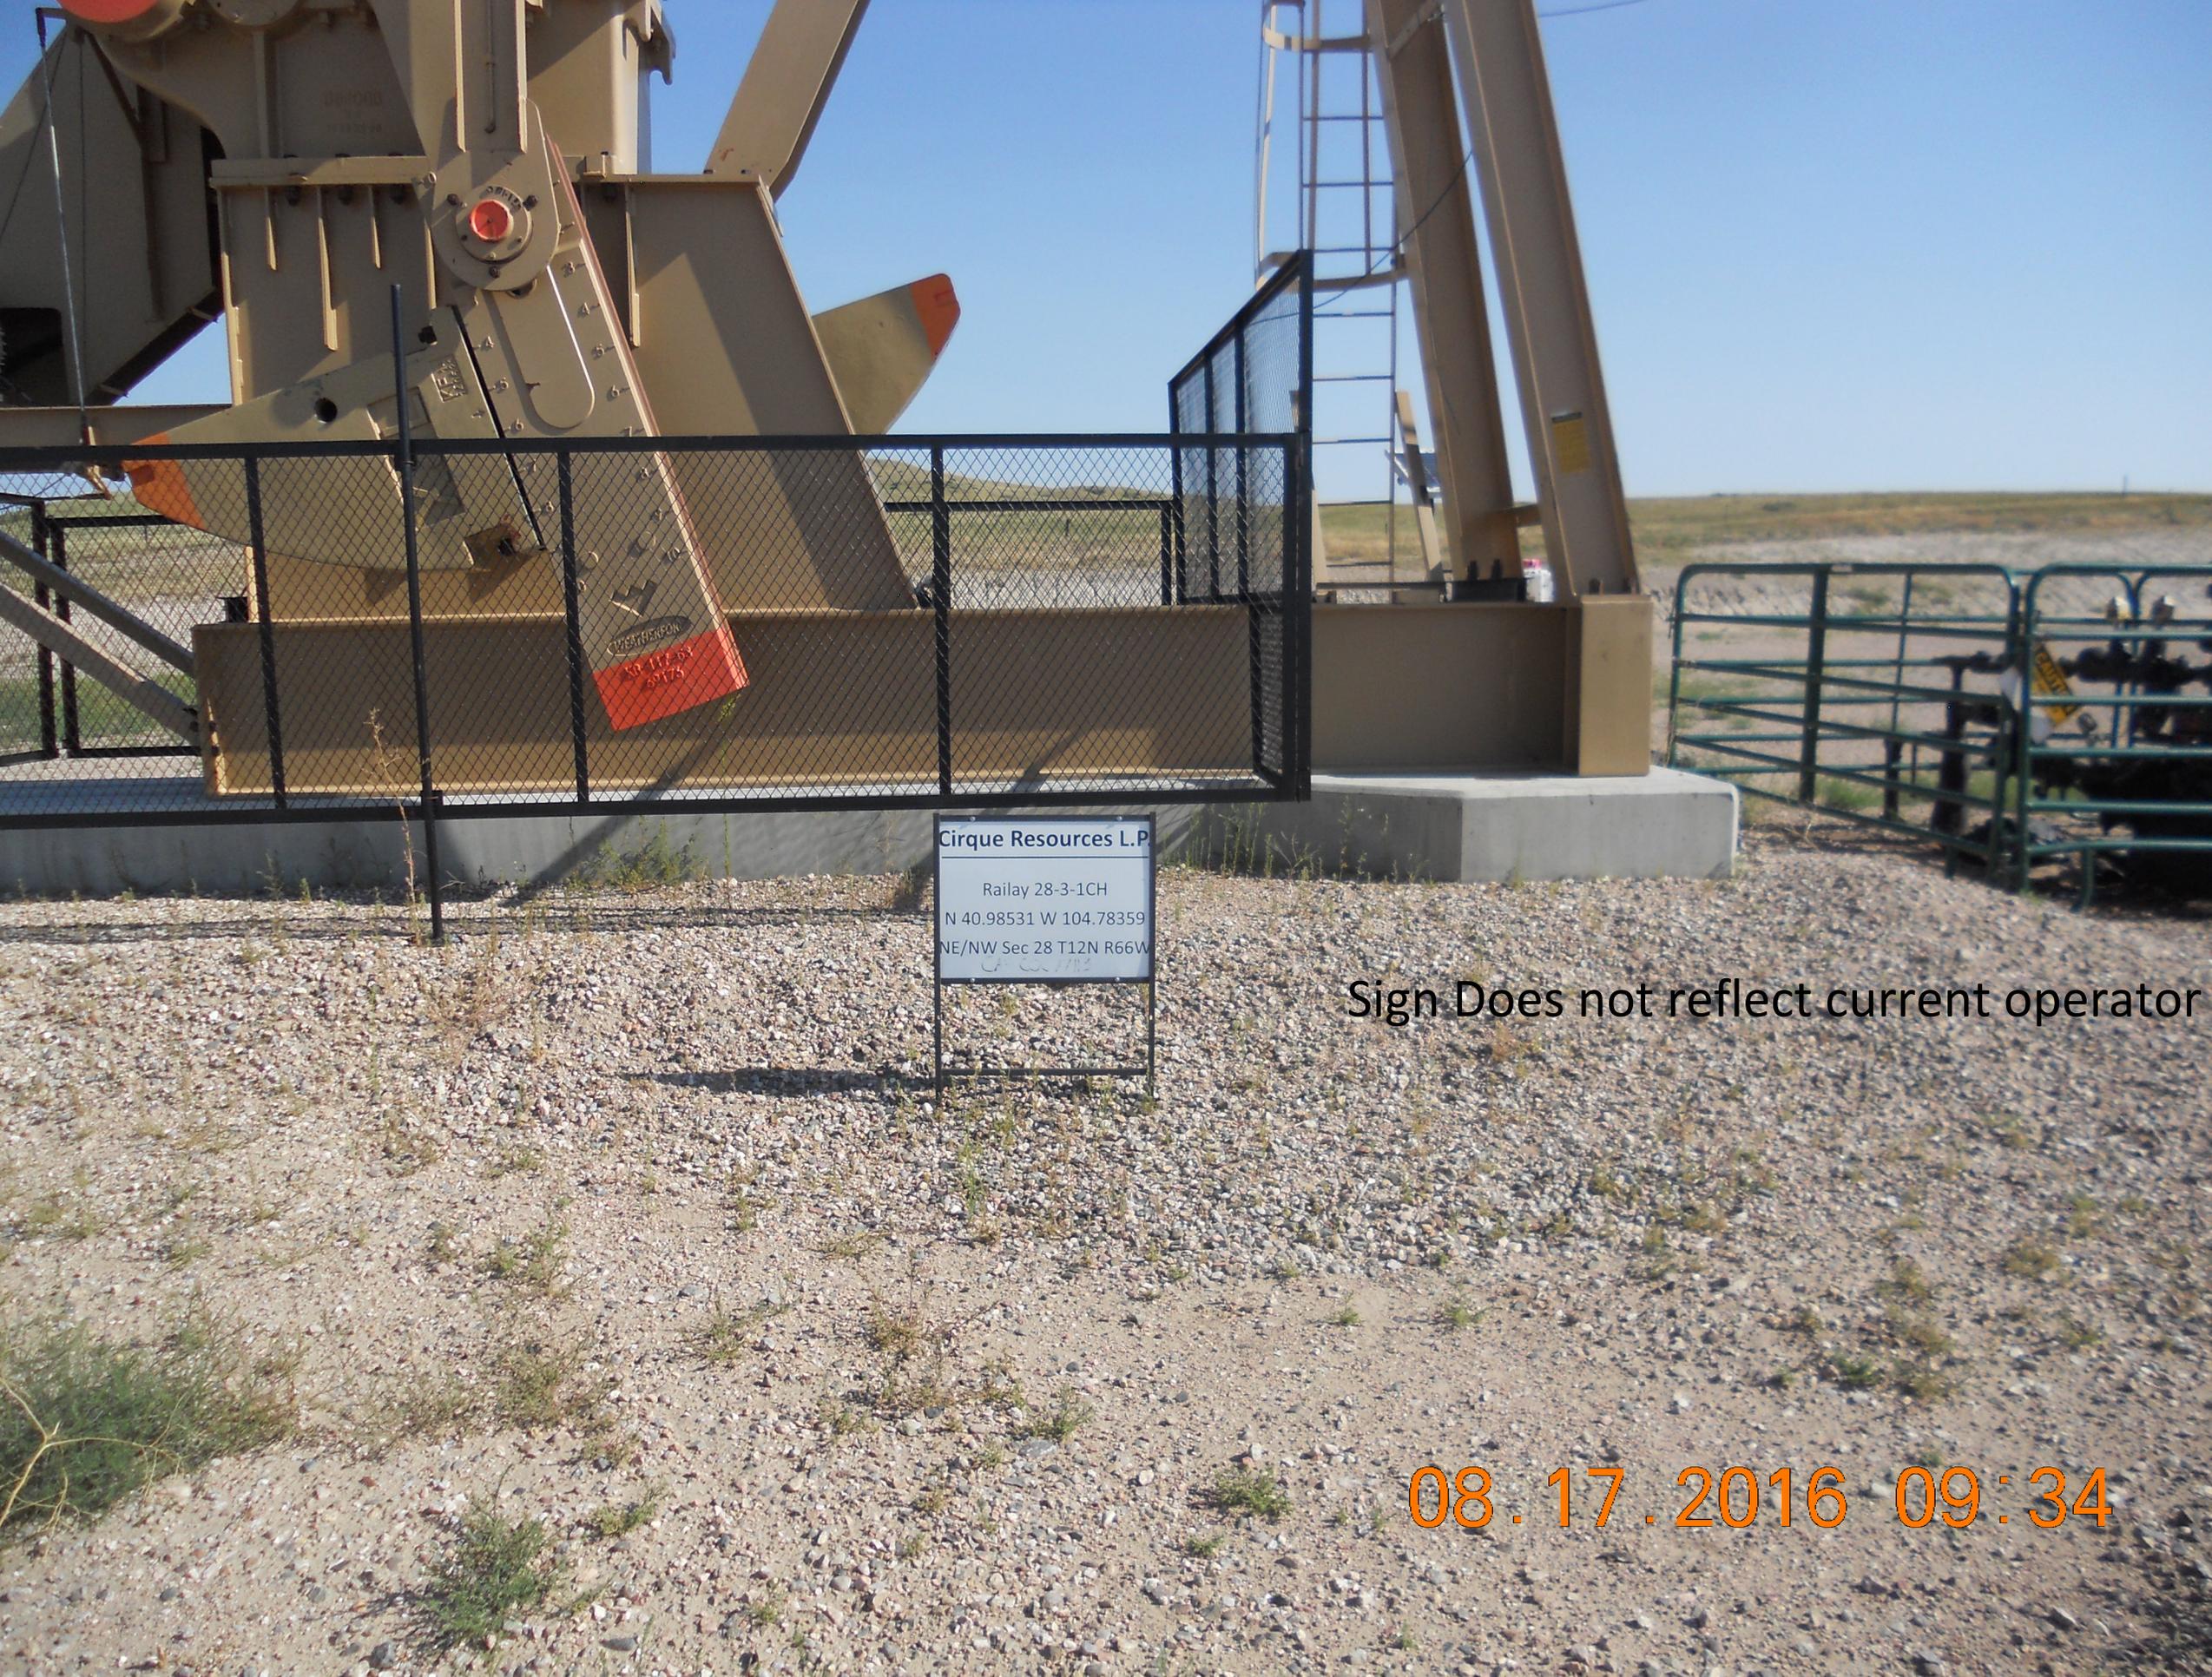
Sign Does not reflect current operator

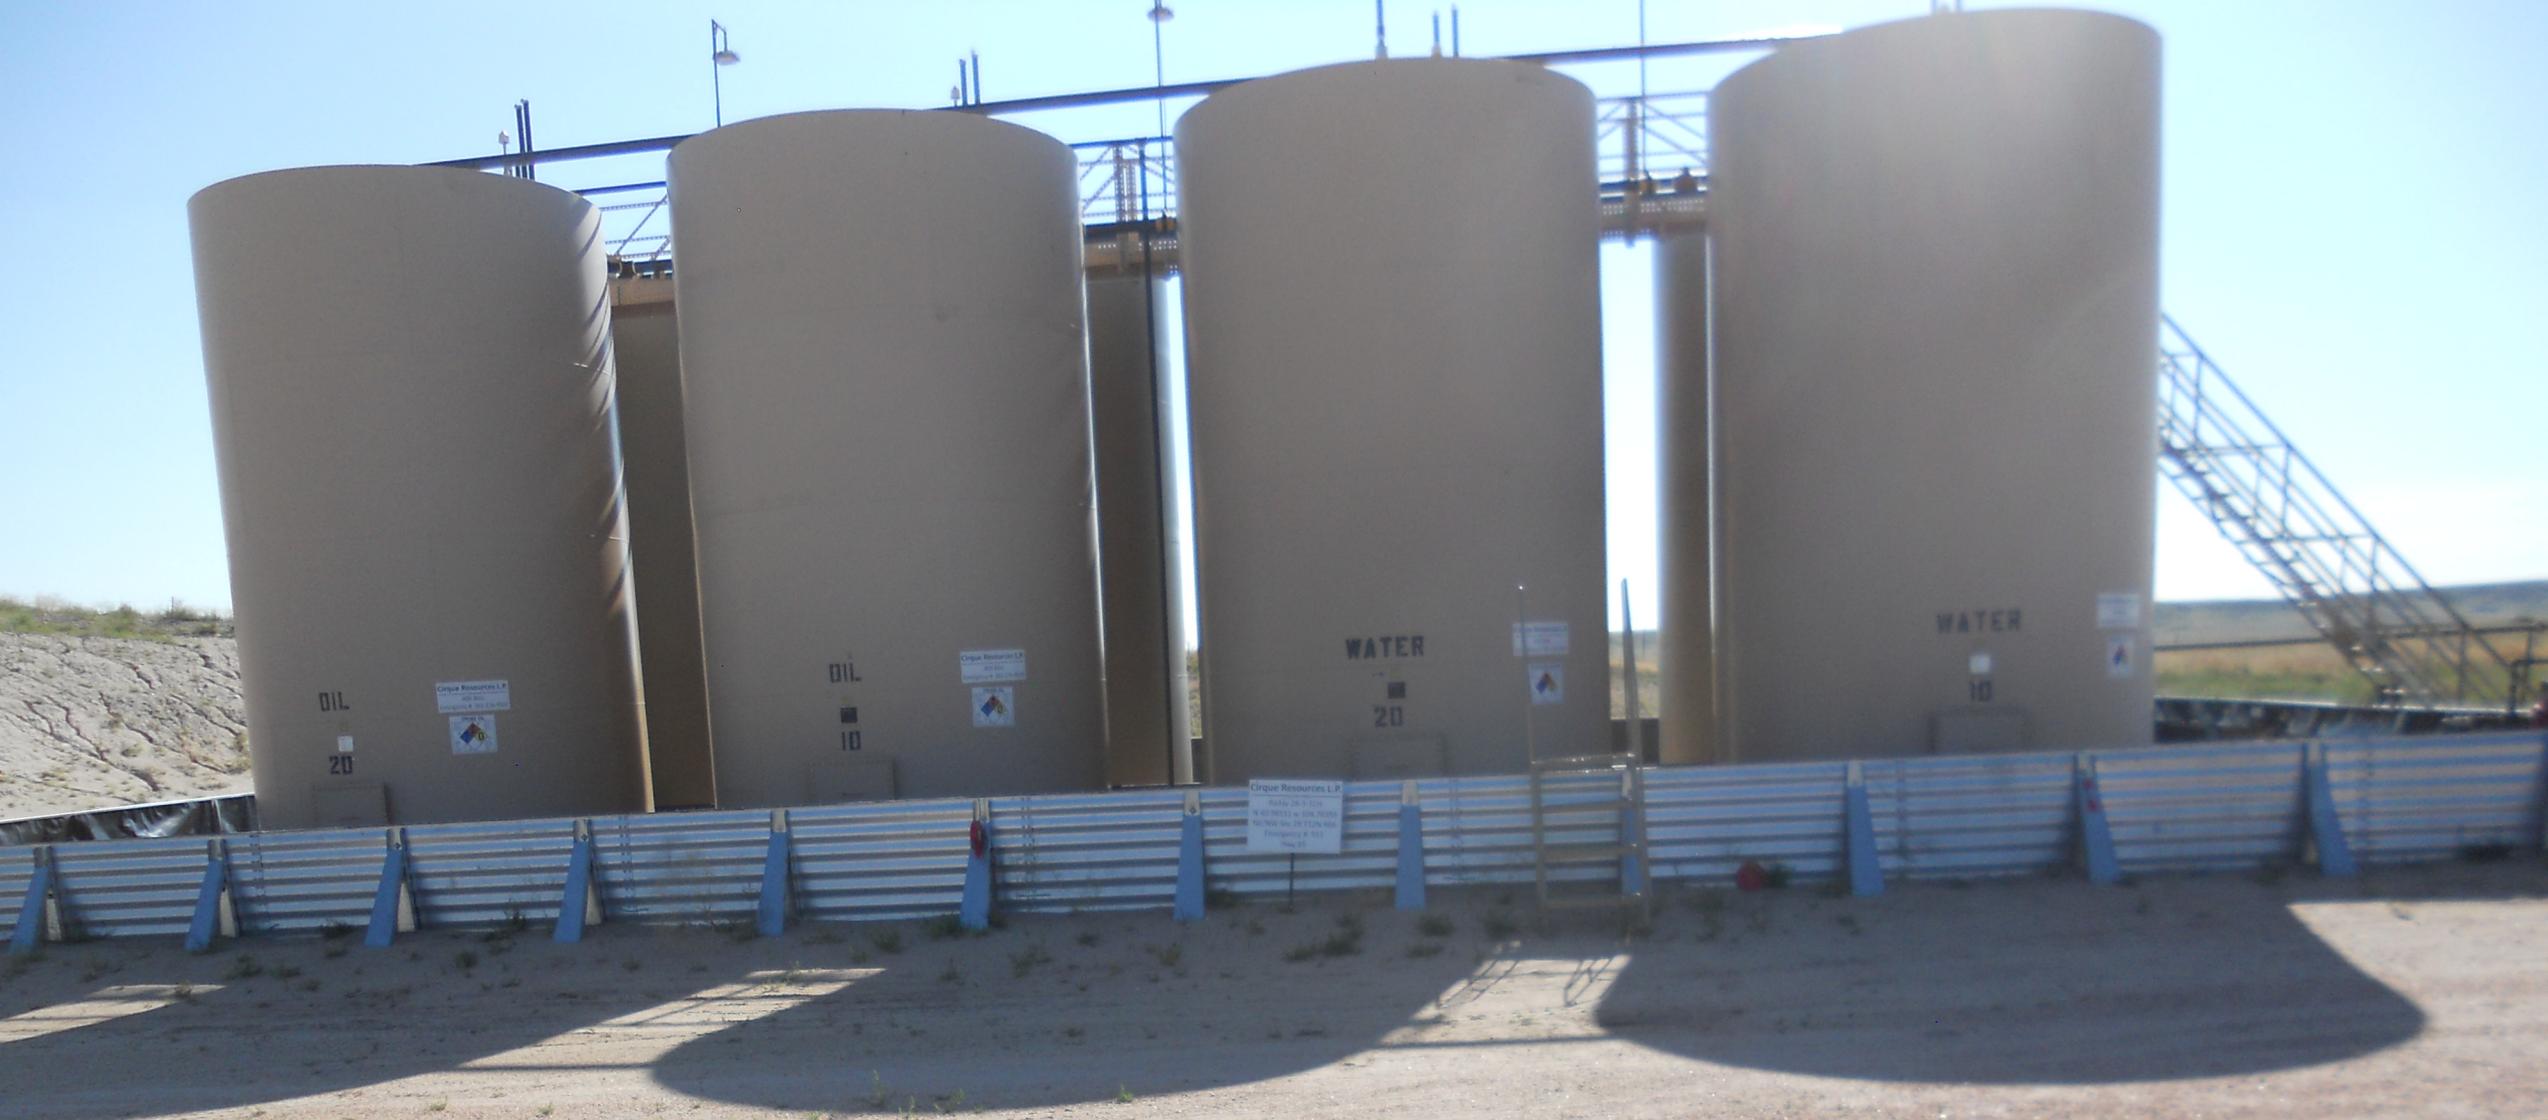
Signs do not reflect current operator

Emergency contact does not reflect current operator

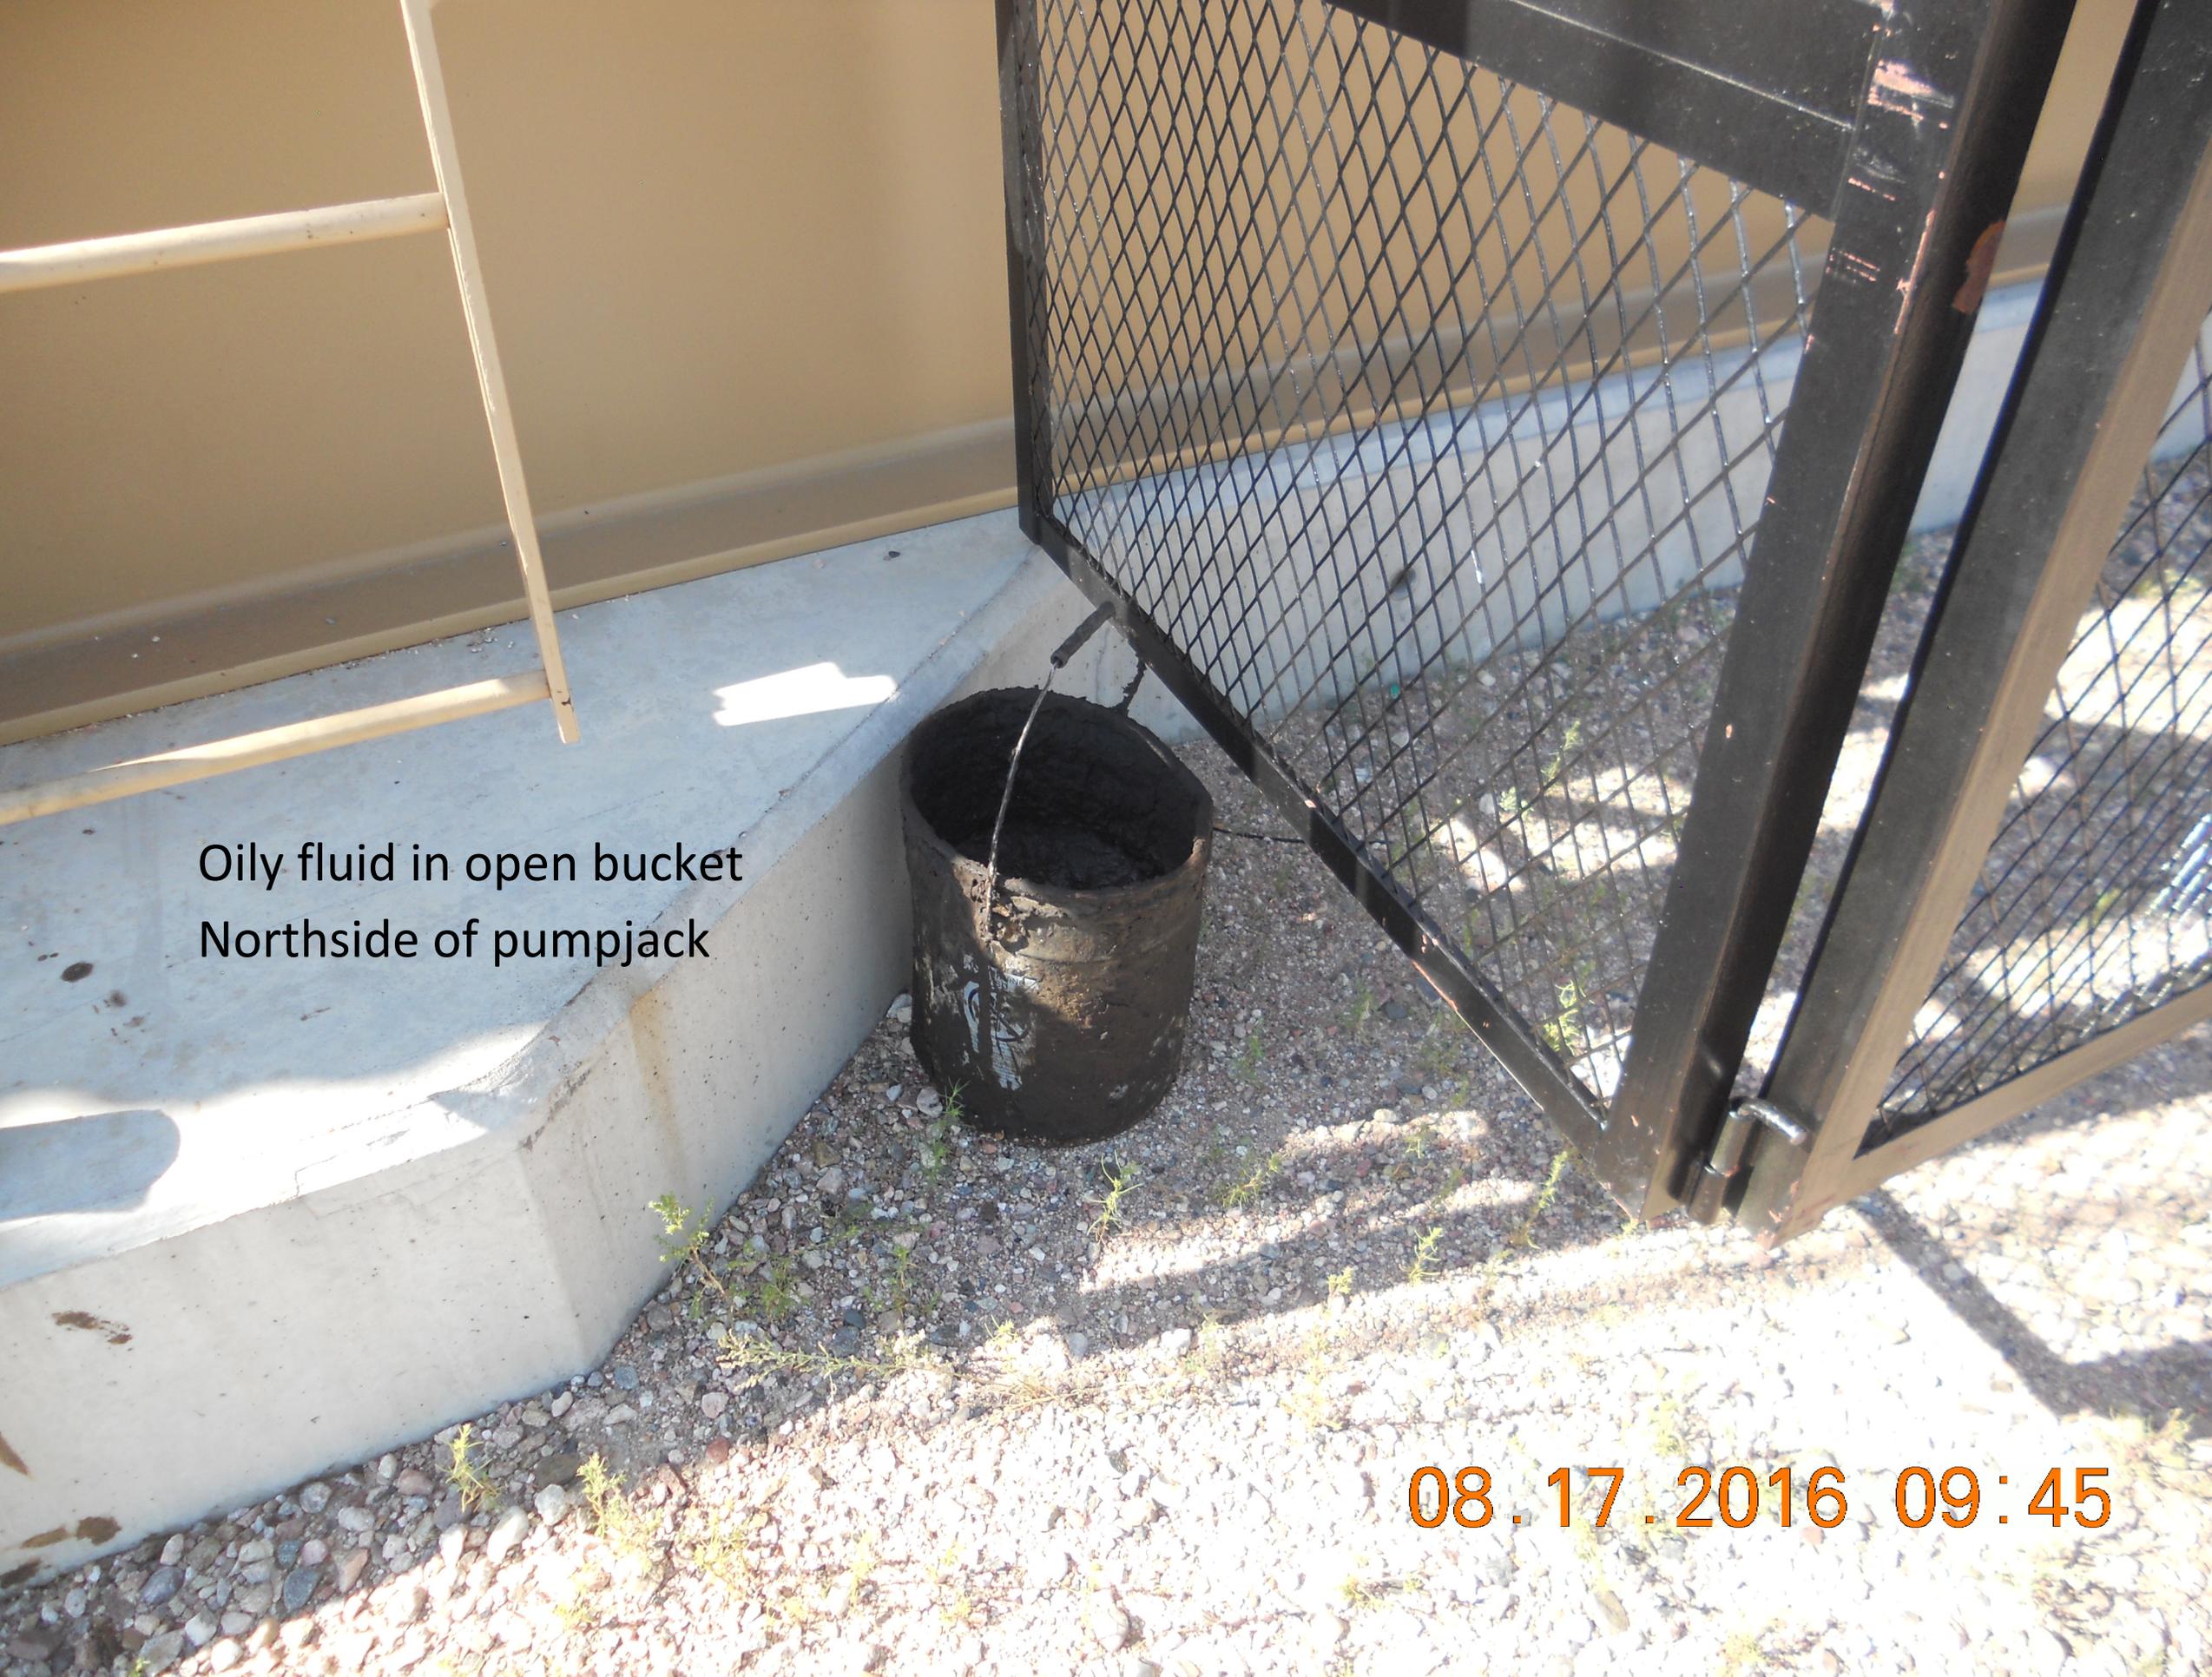
Oily fluid in open bucket  
Northside of pumpjack

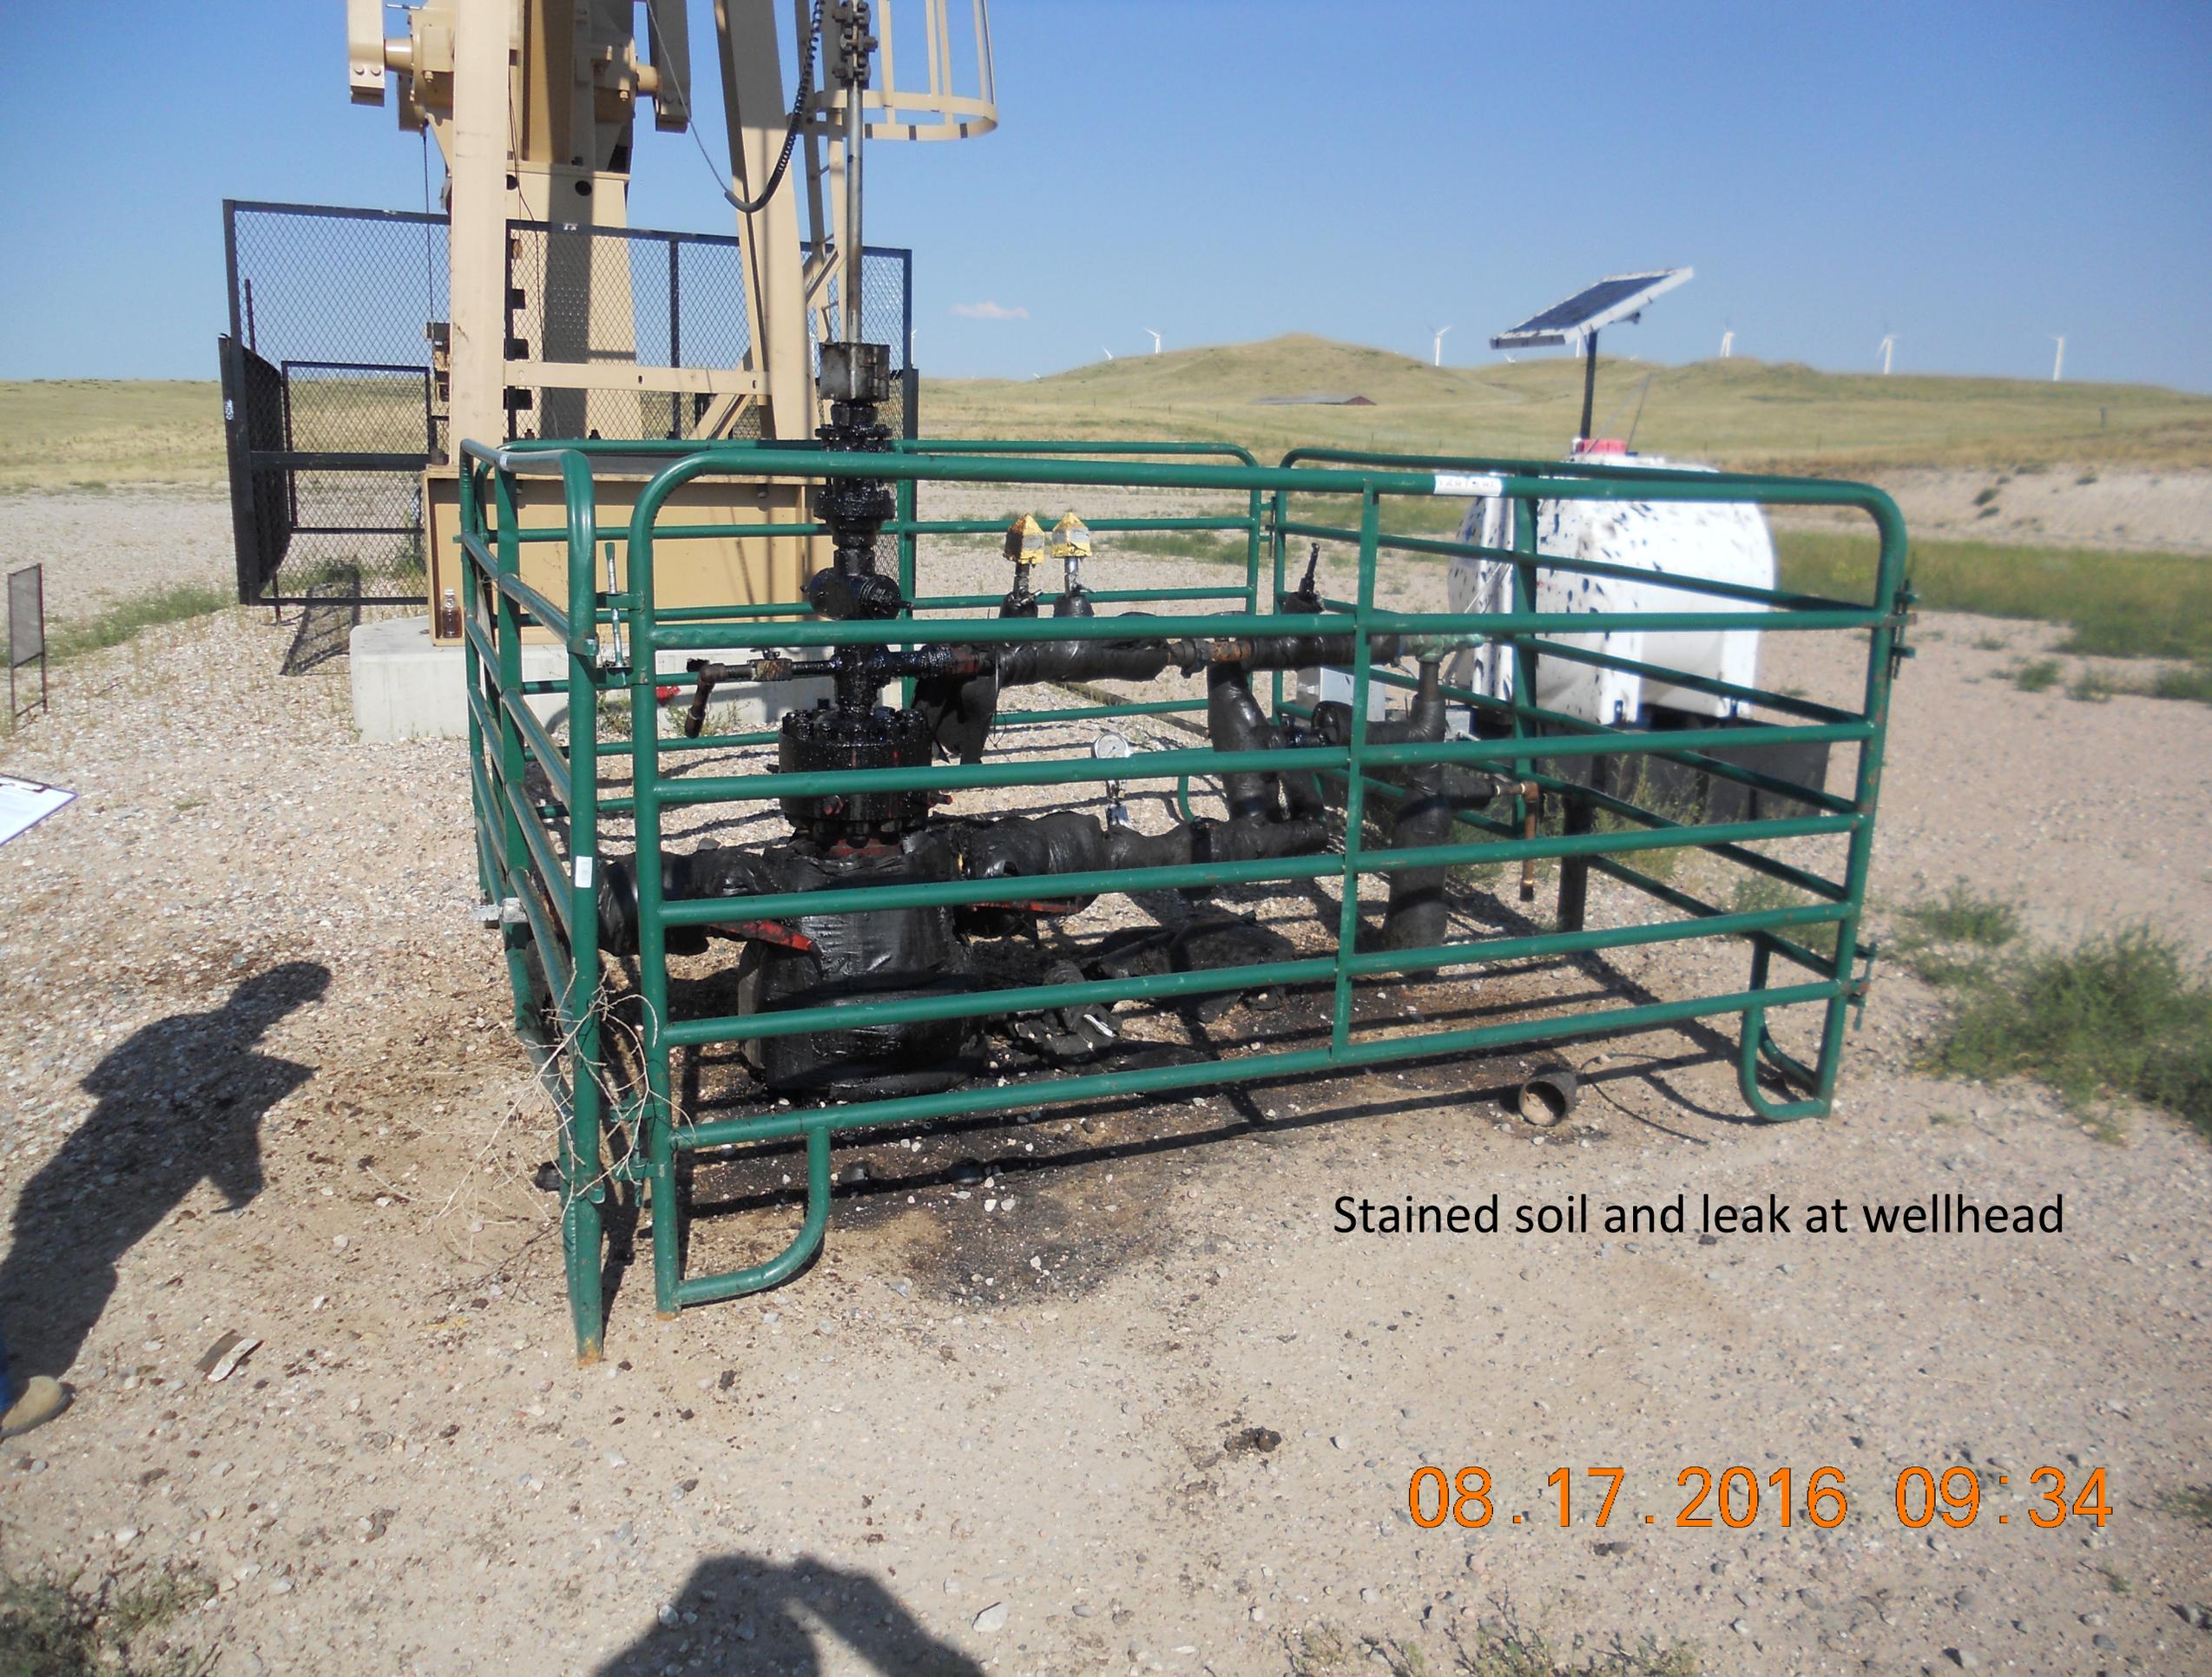
Stained soil and leak at wellhead

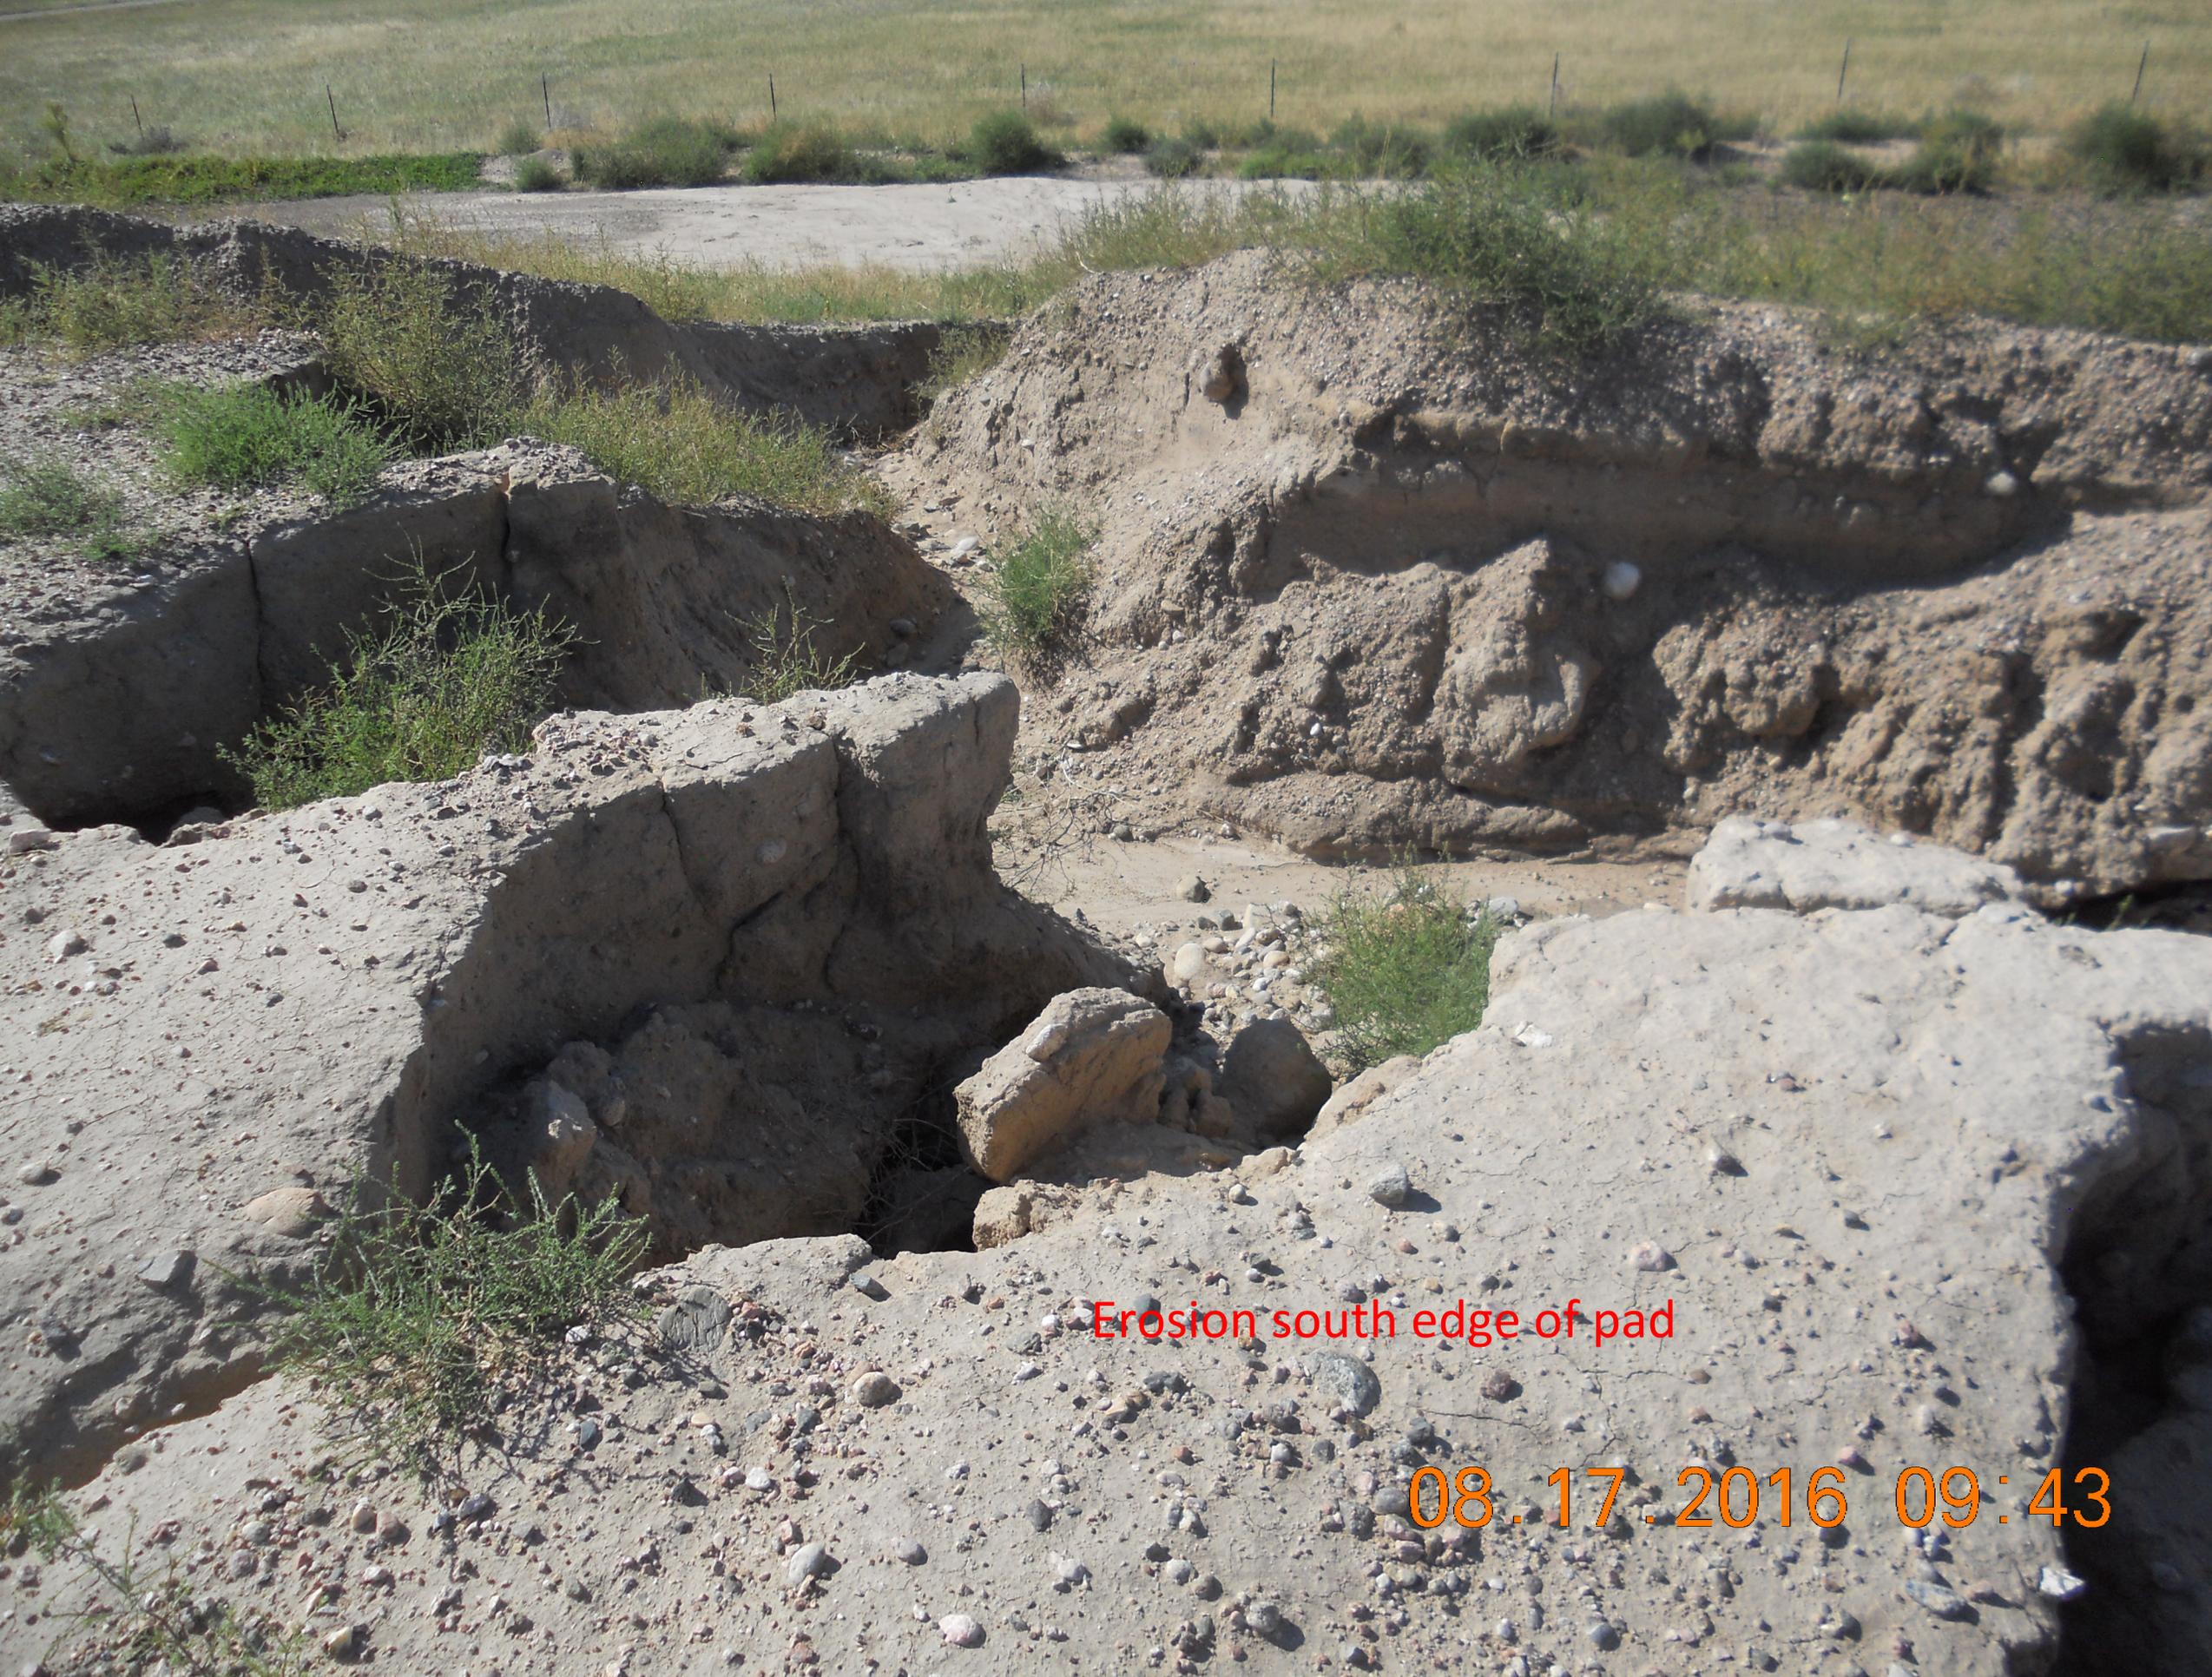
Erosion south edge of pad

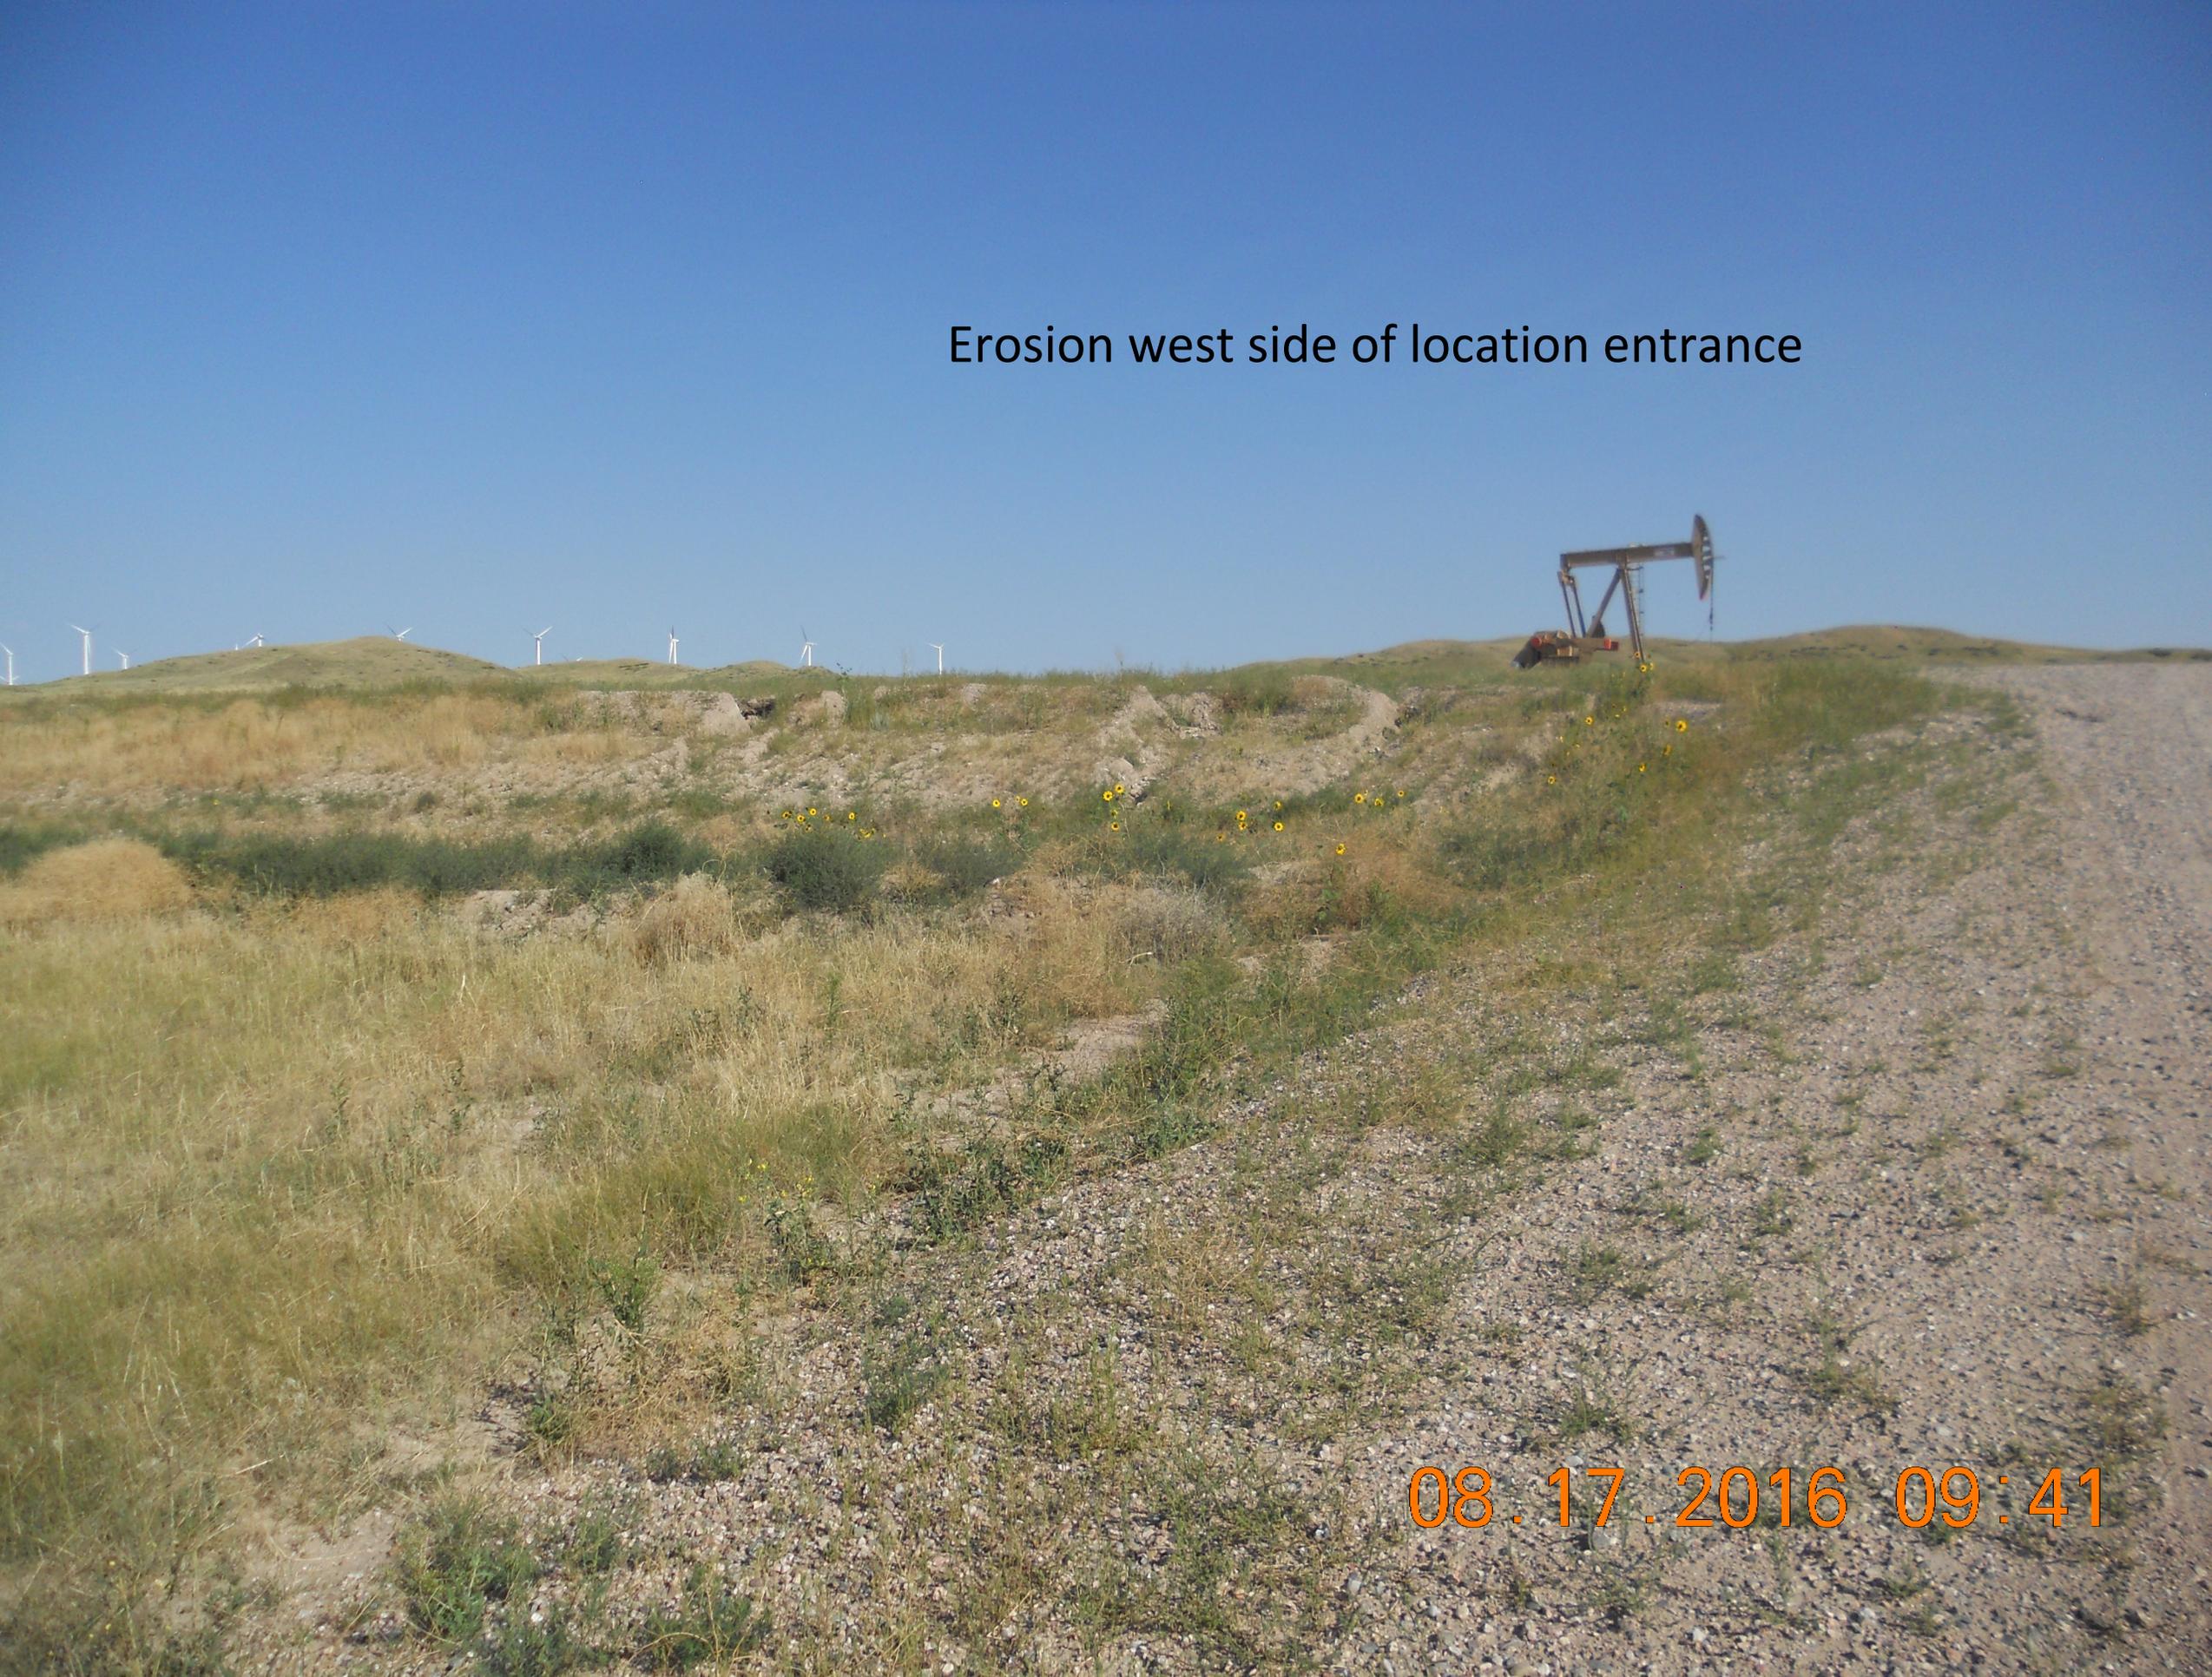
Erosion west side of location entrance
