VERTEX ENERGY PARTNERS, LLC FOR  
LONGS PEAK RESOURCES, LLC  
RAIL AY 28-3-1CH  
API #05-123-39863  
NE NW SEC.28-T12N-R66W  
SHL: 180' FWL & 1980' FWL BHL: 310' FSL & 2080' FWL  
LAT: 40.98531 LONG: 104.78359  
WELD COUNTY, COLORADO  
CONTACT NO. 214-534-9569

Cirque Resources L.P.  
Railay 28-3-1CH  
N 40.98531 W 104.78359  
NE/NW Sec 28 T12N R66W

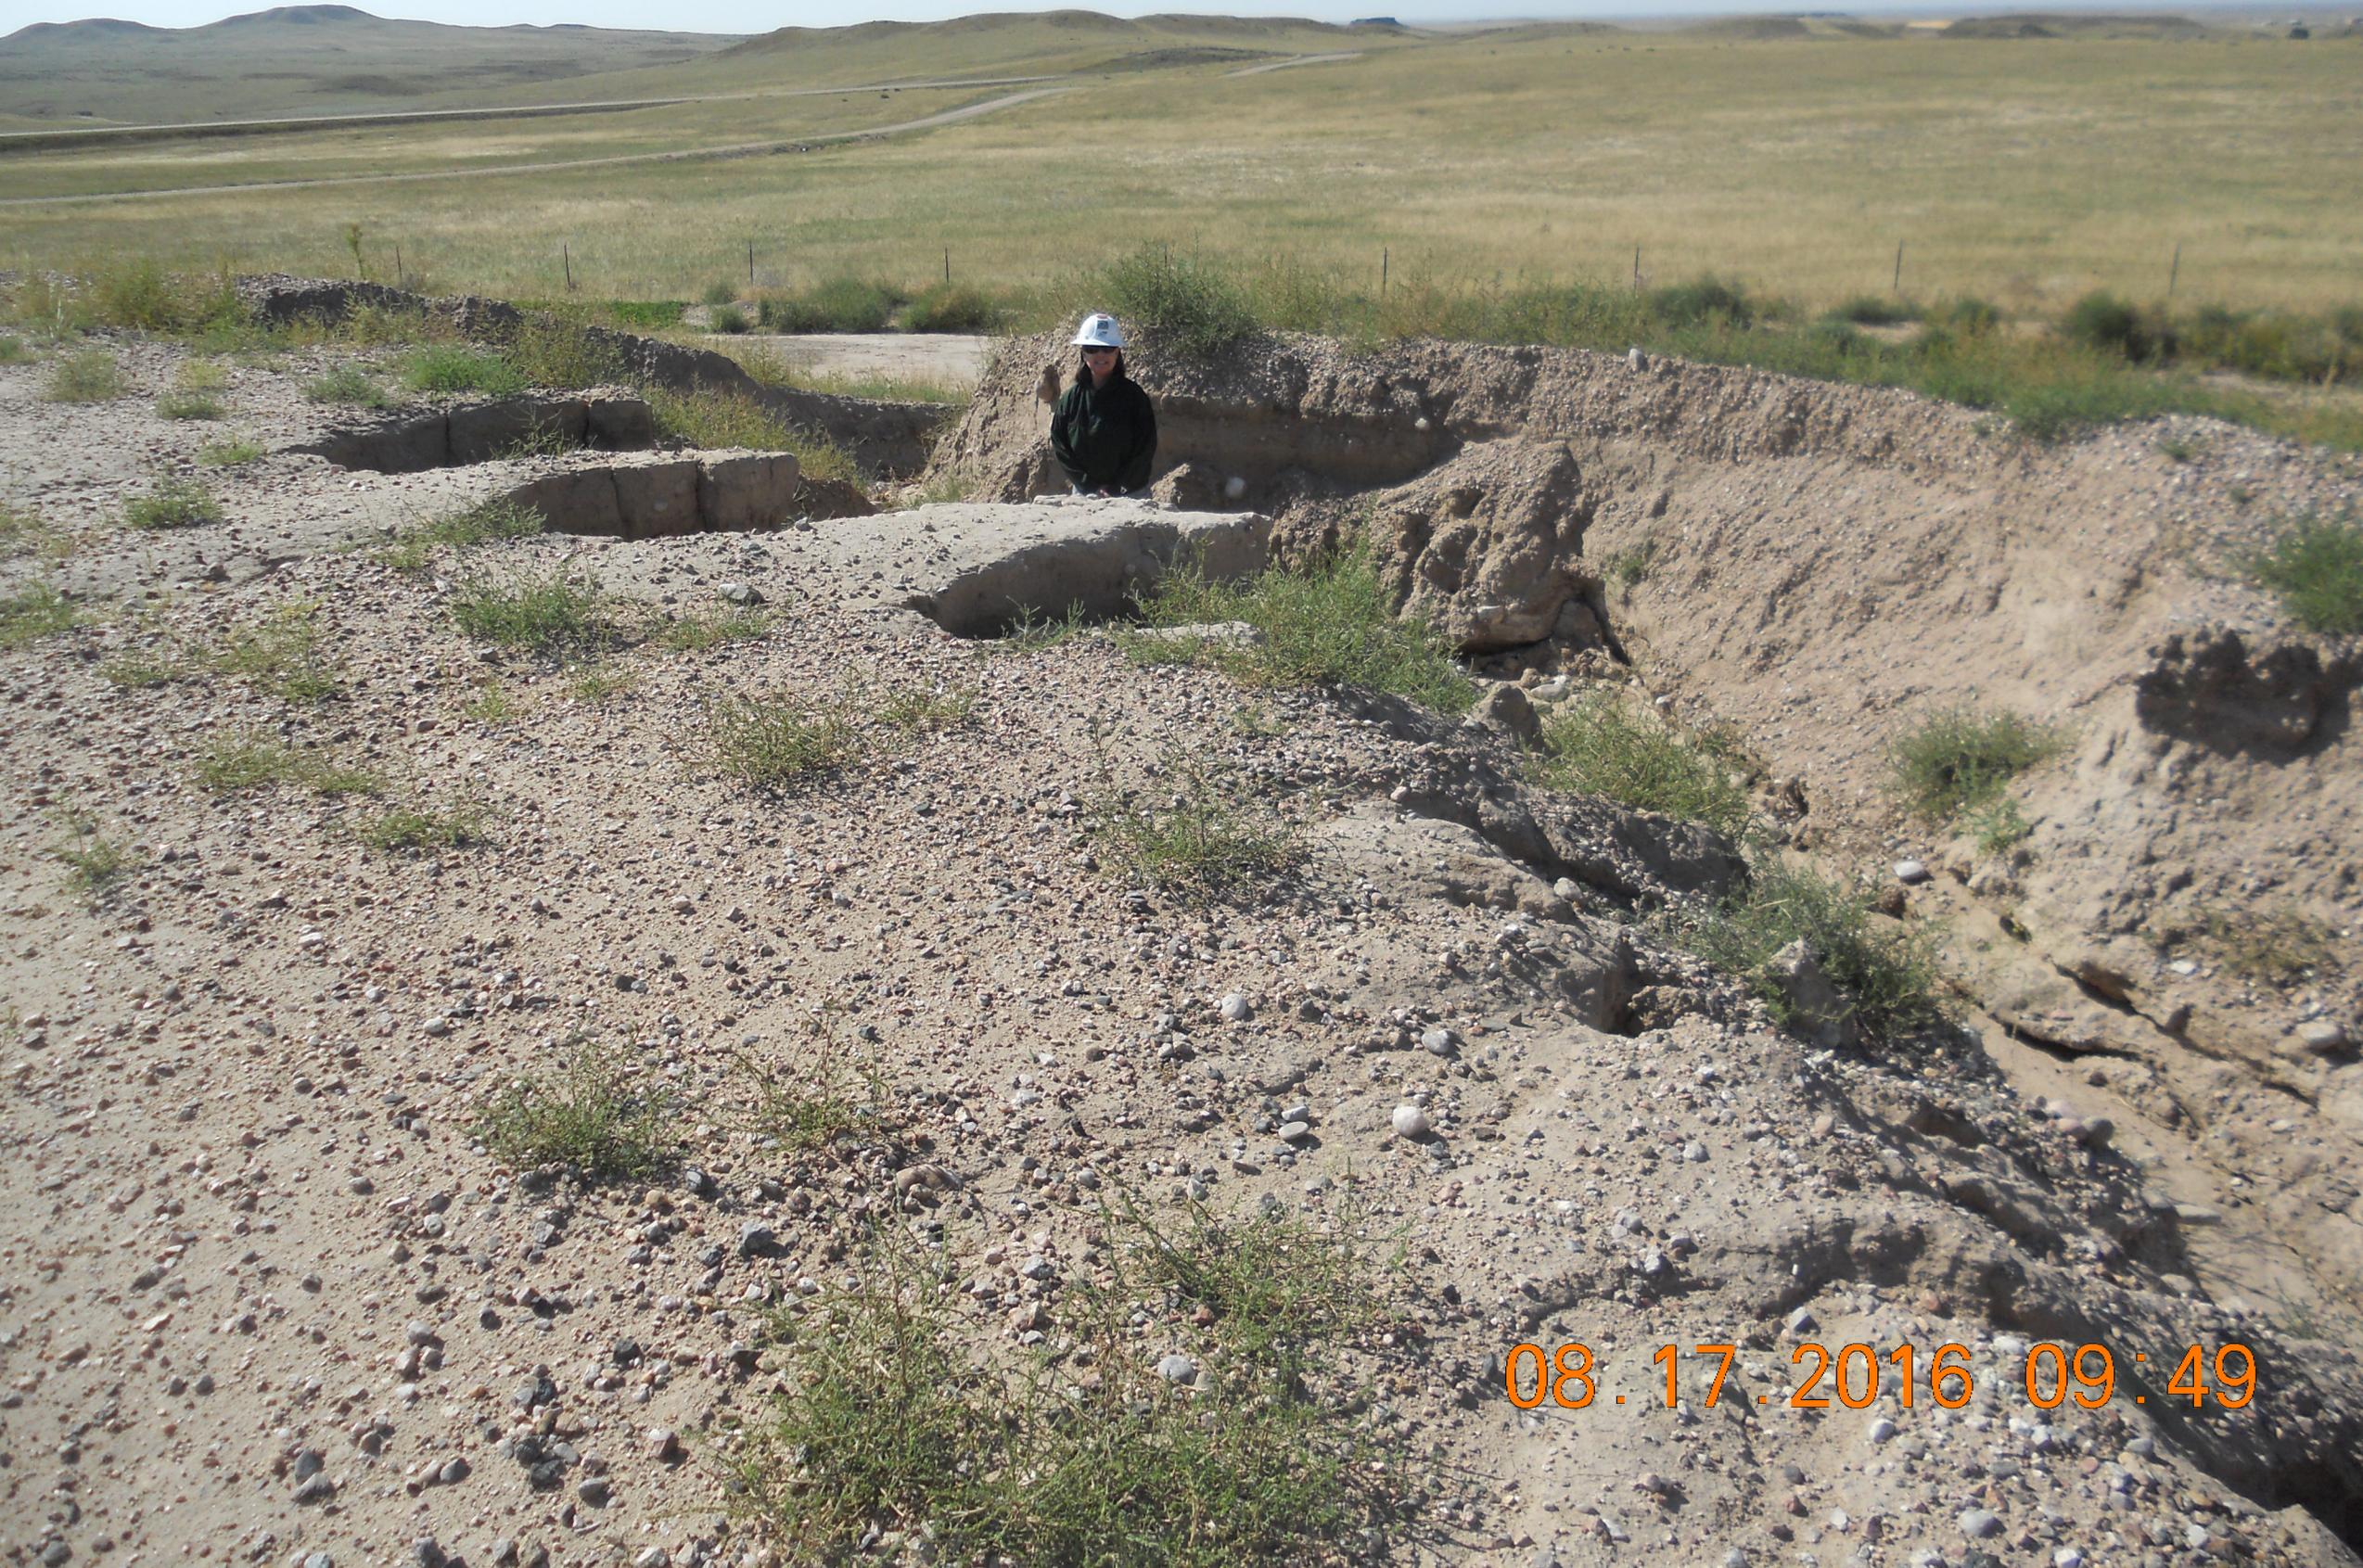
Extent of erosion at sw corner

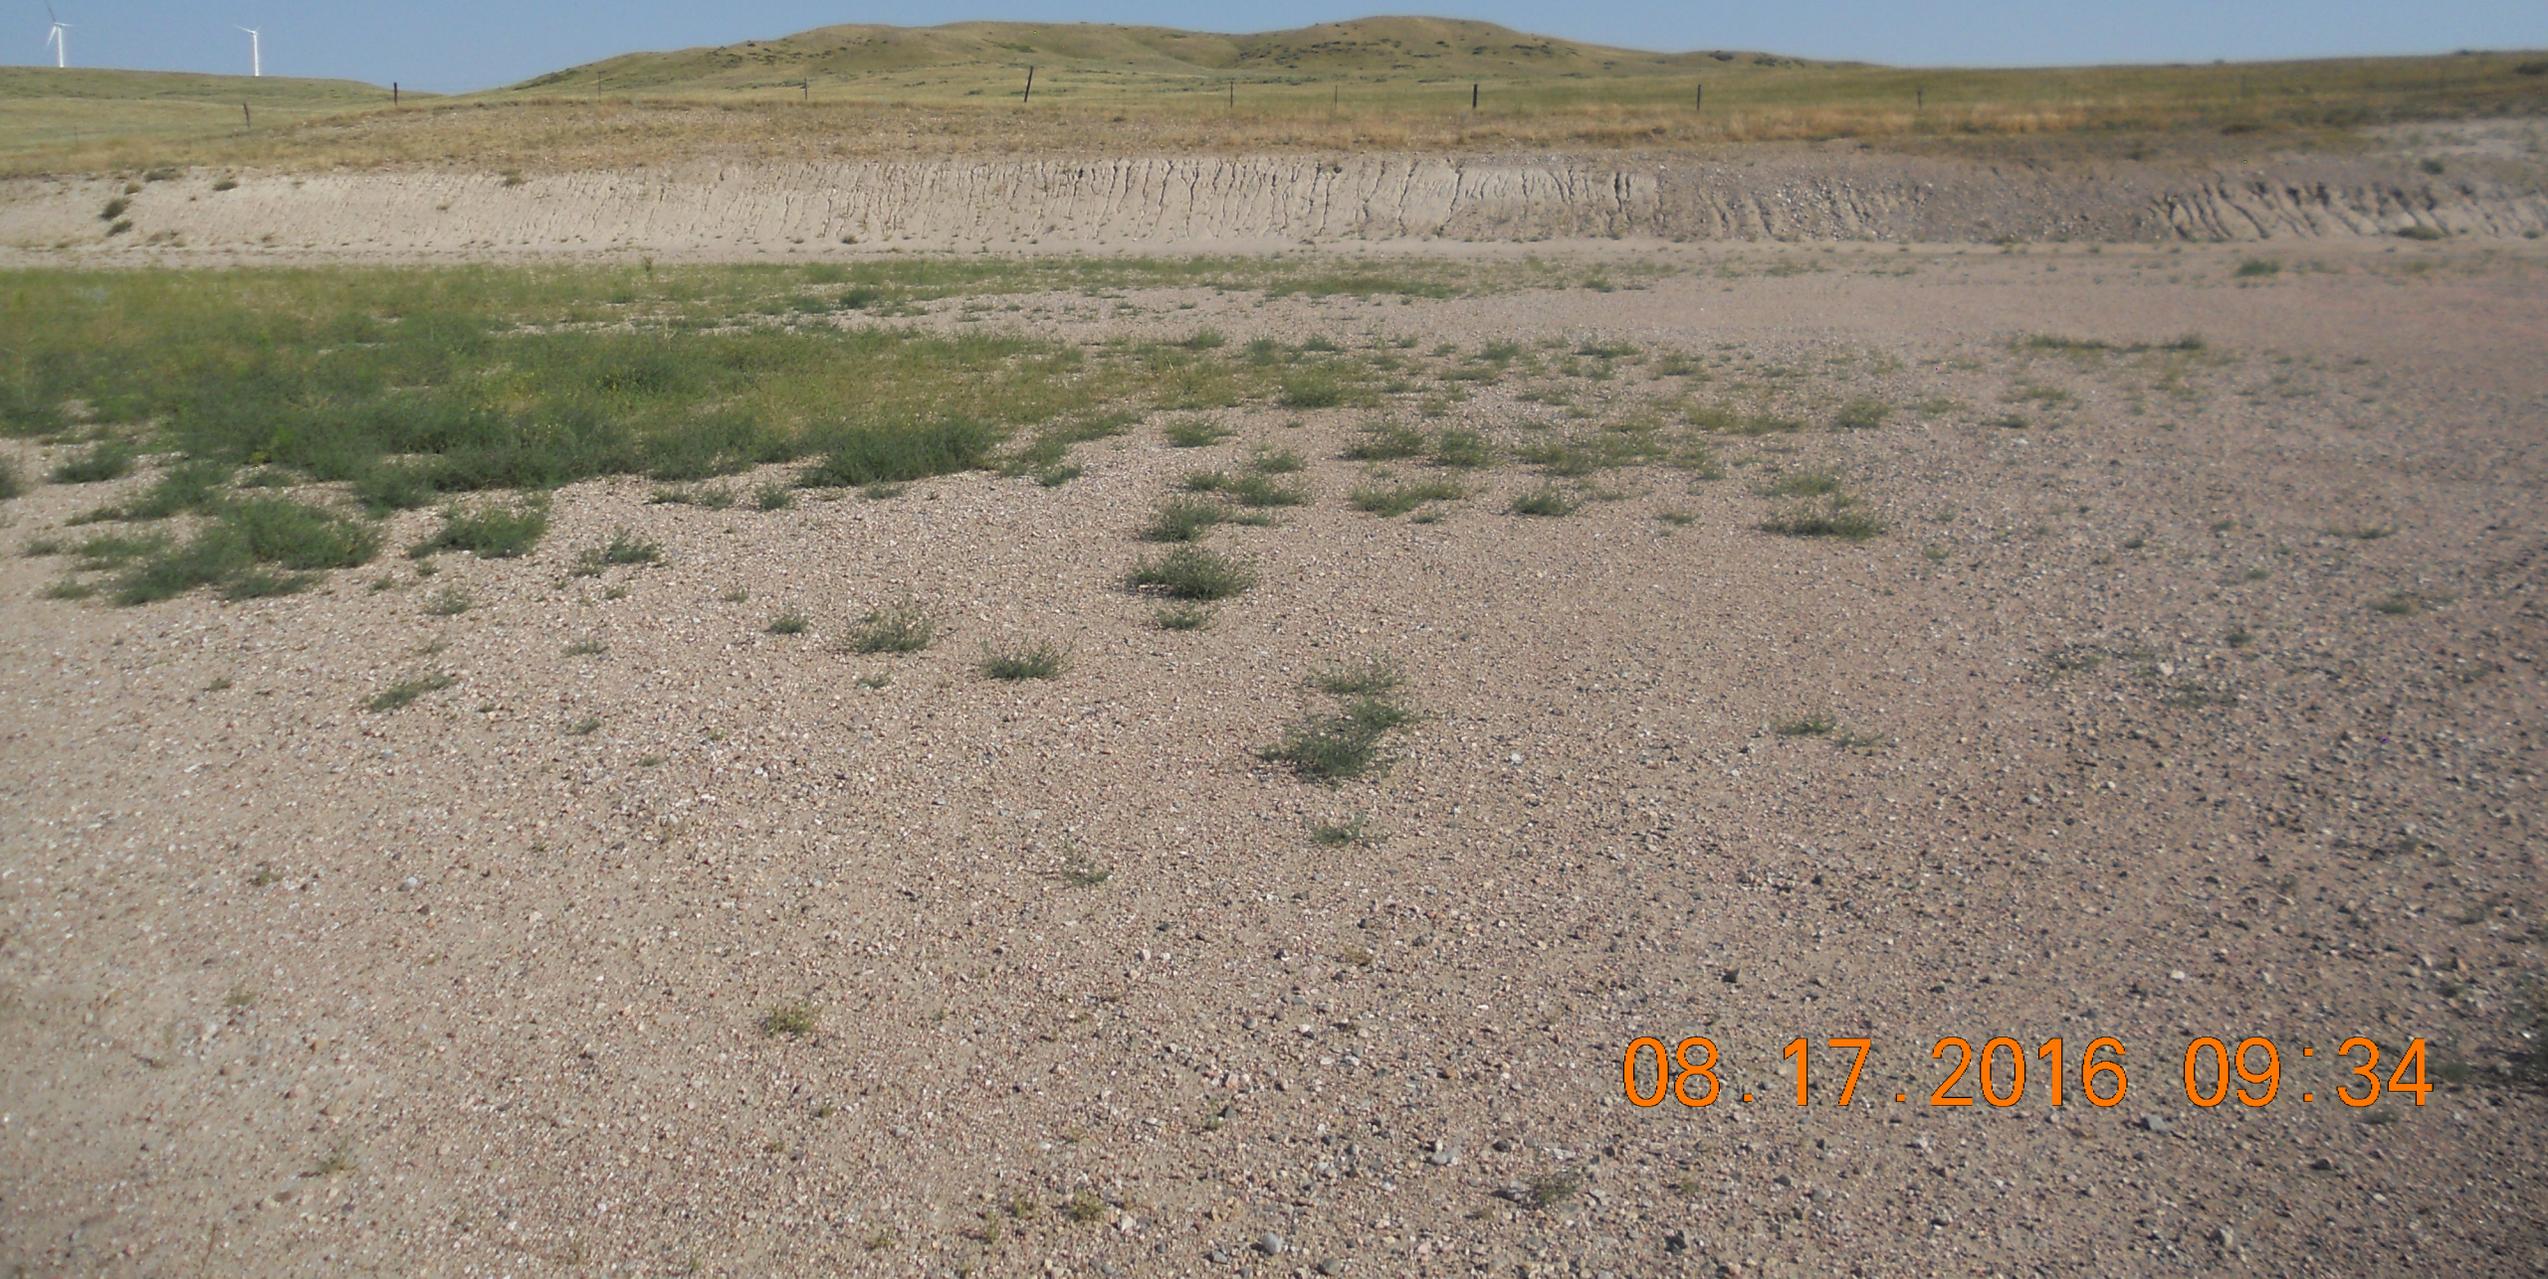
Rilling north cut slope

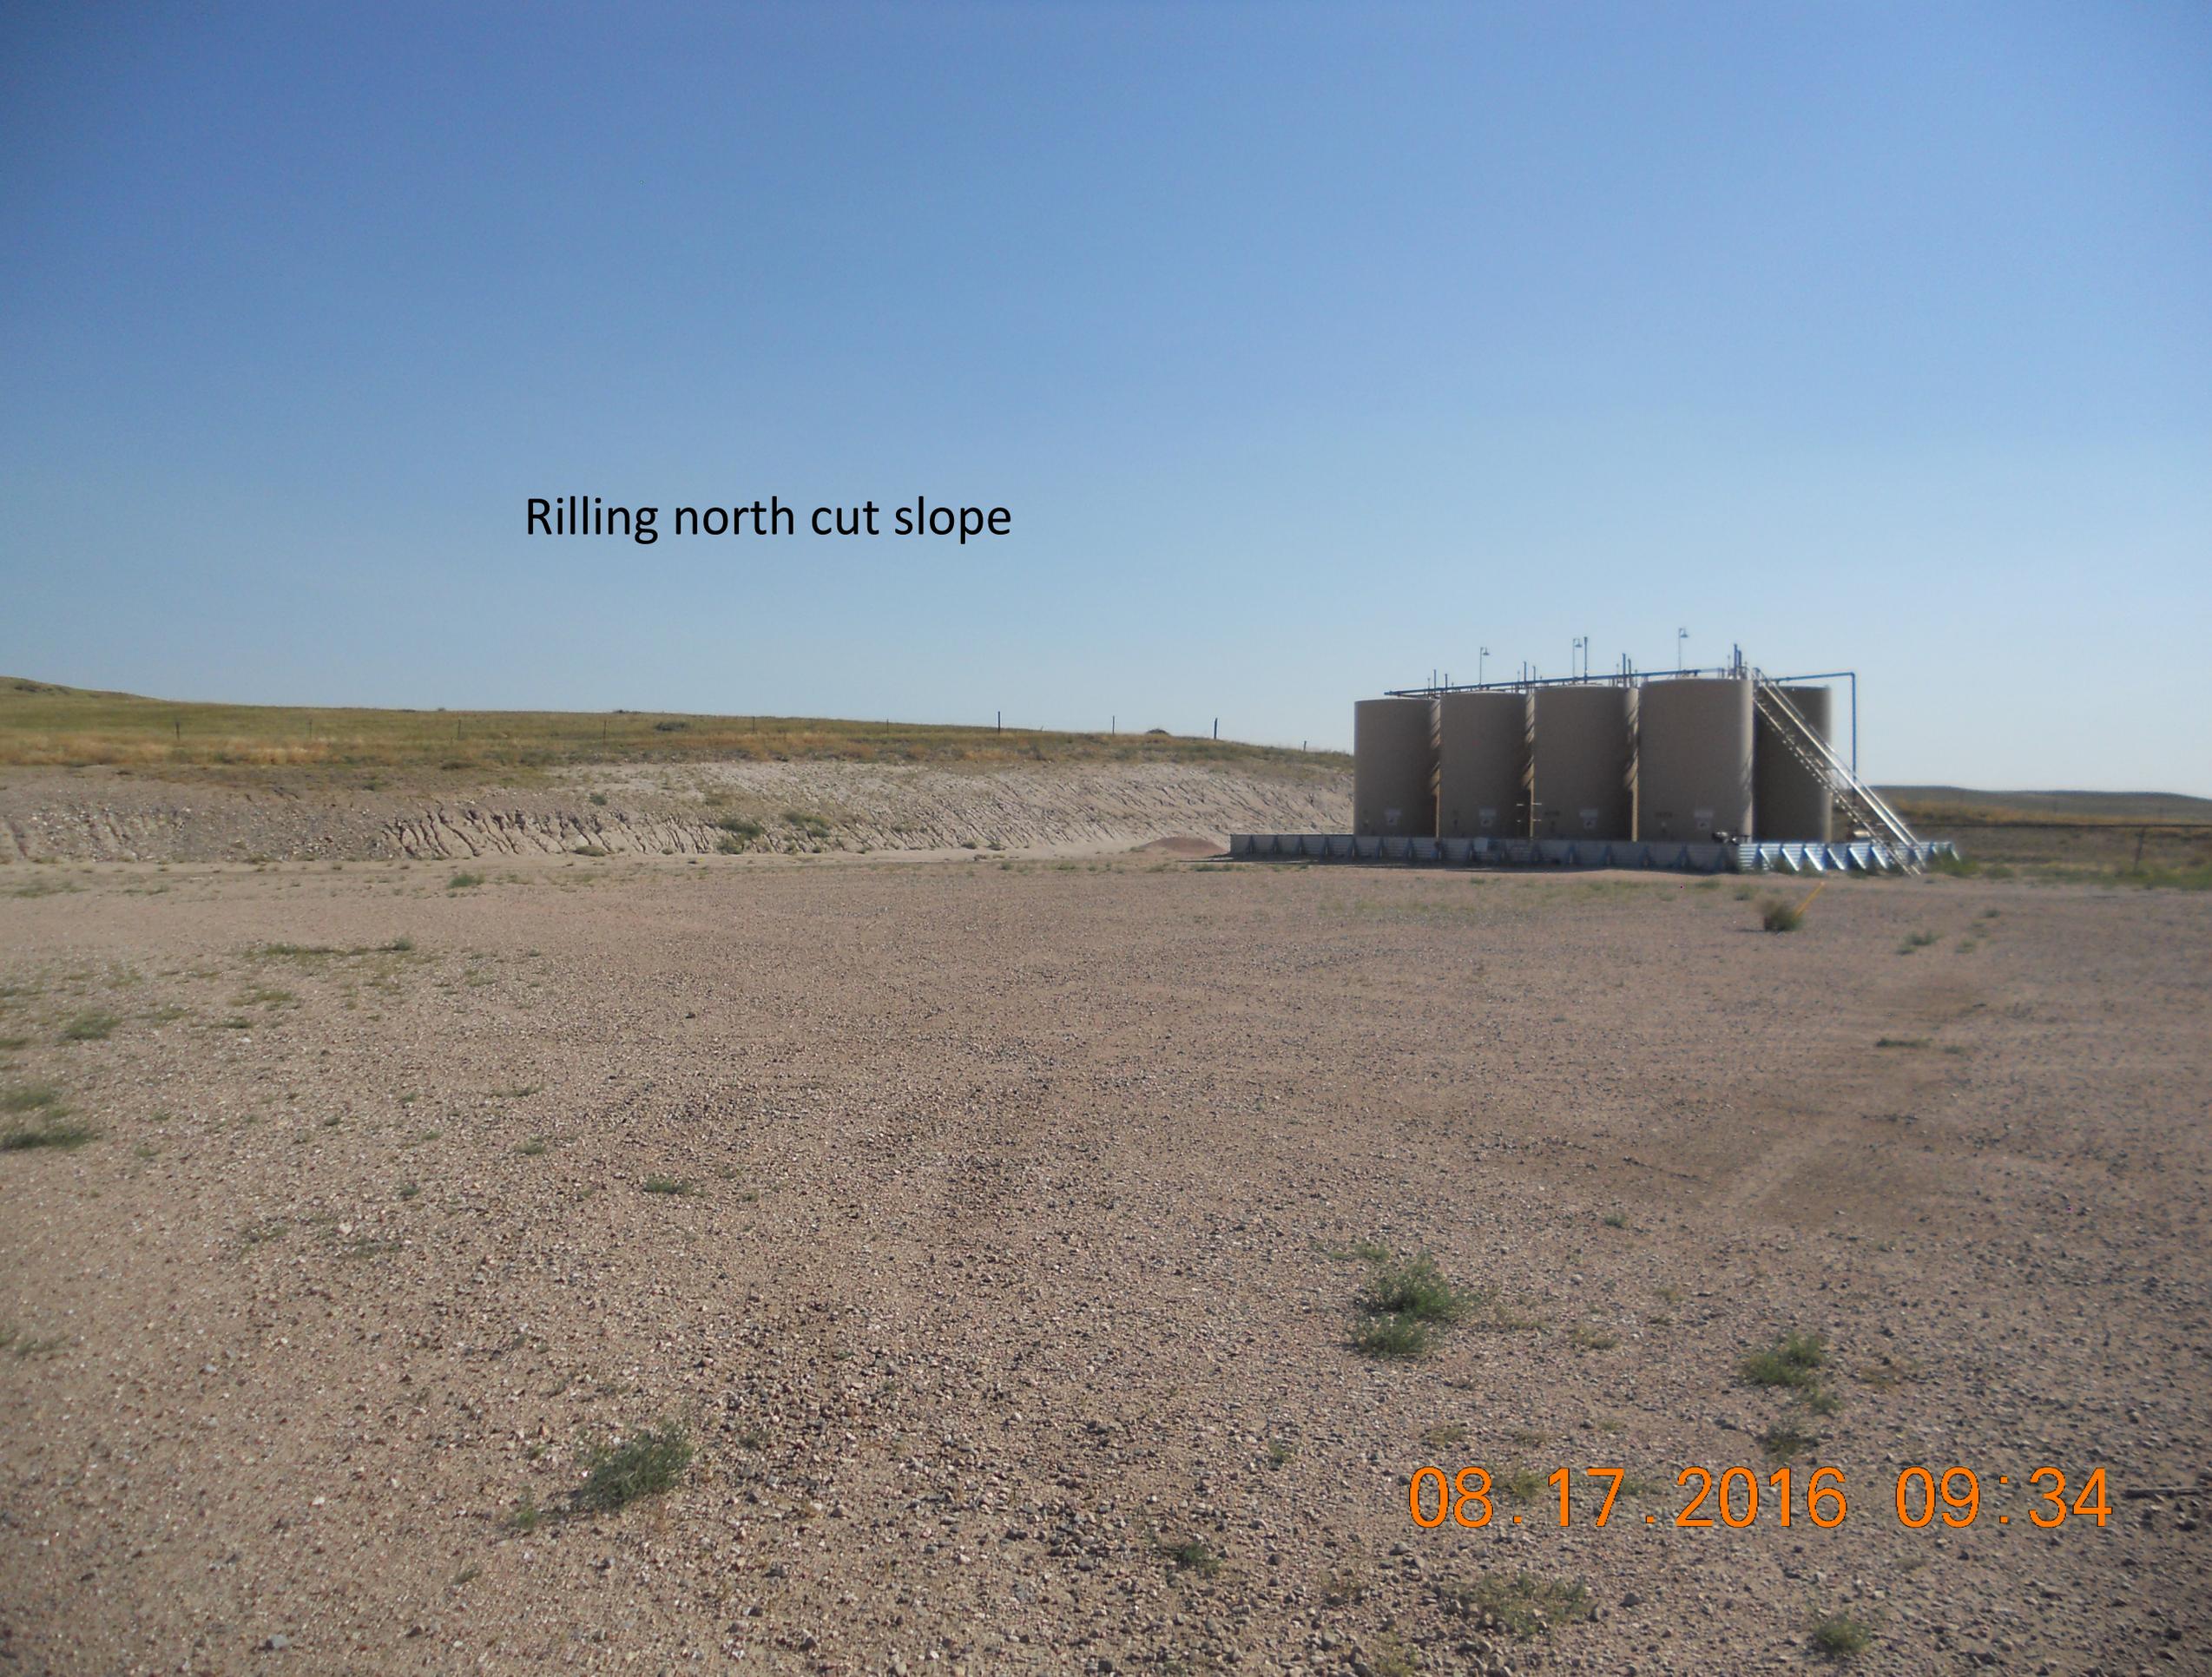
Rilling north cut slope
