Foundation Overview- Diffuse knapweed (*Centarea diffusa*)

3 Locations Inspected:

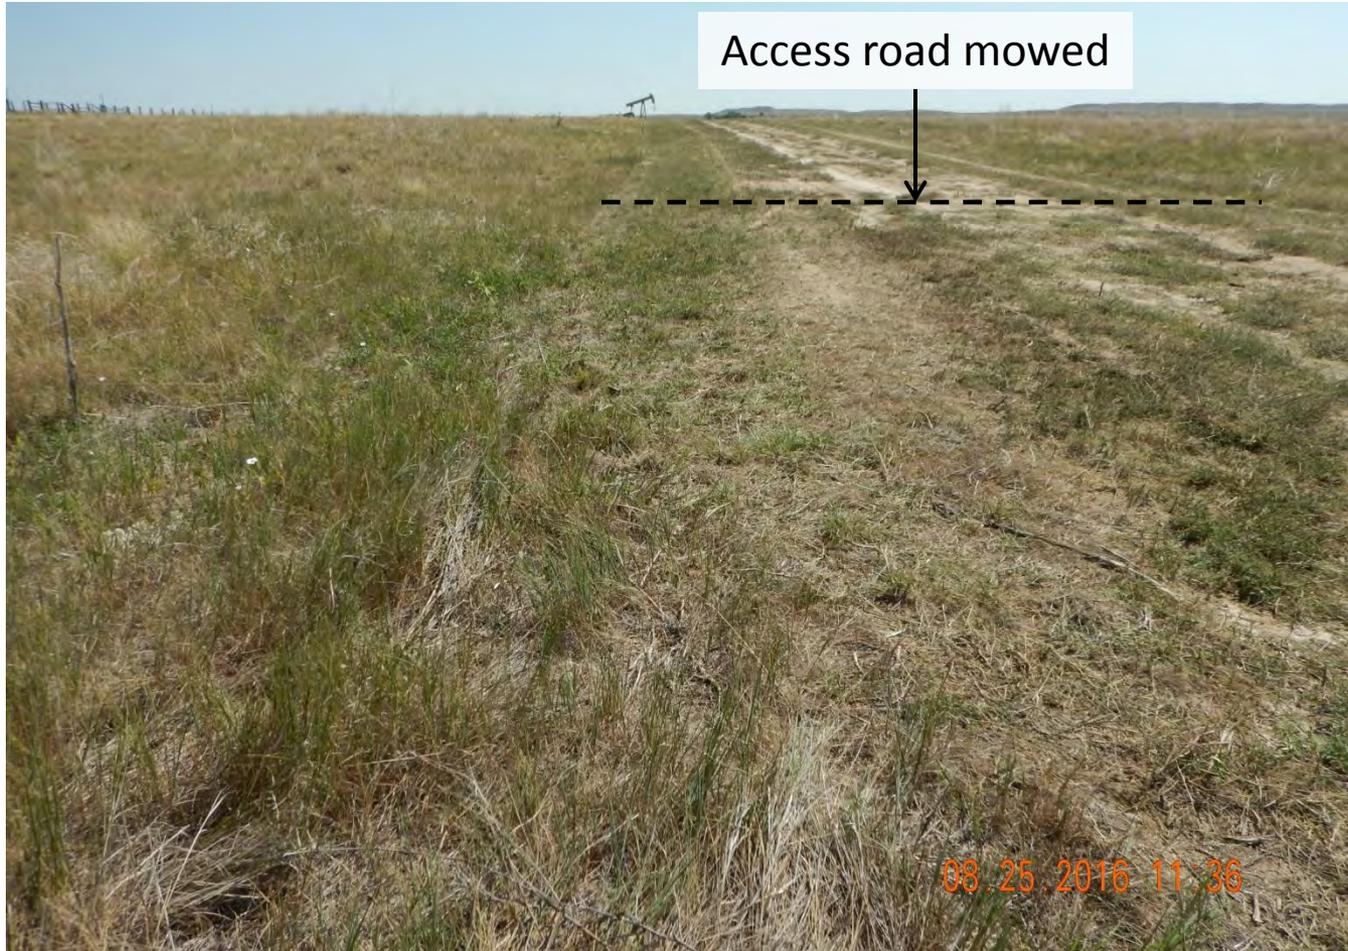
Krager Site- Well location (Location ID 331849)

Photo 1. Photo taken from entrance of location, facing East. Access road was mowed within the last 2 days based off conversations with other COGCC staff. No Diffuse knapweed or mowed seed heads were observed along access road.

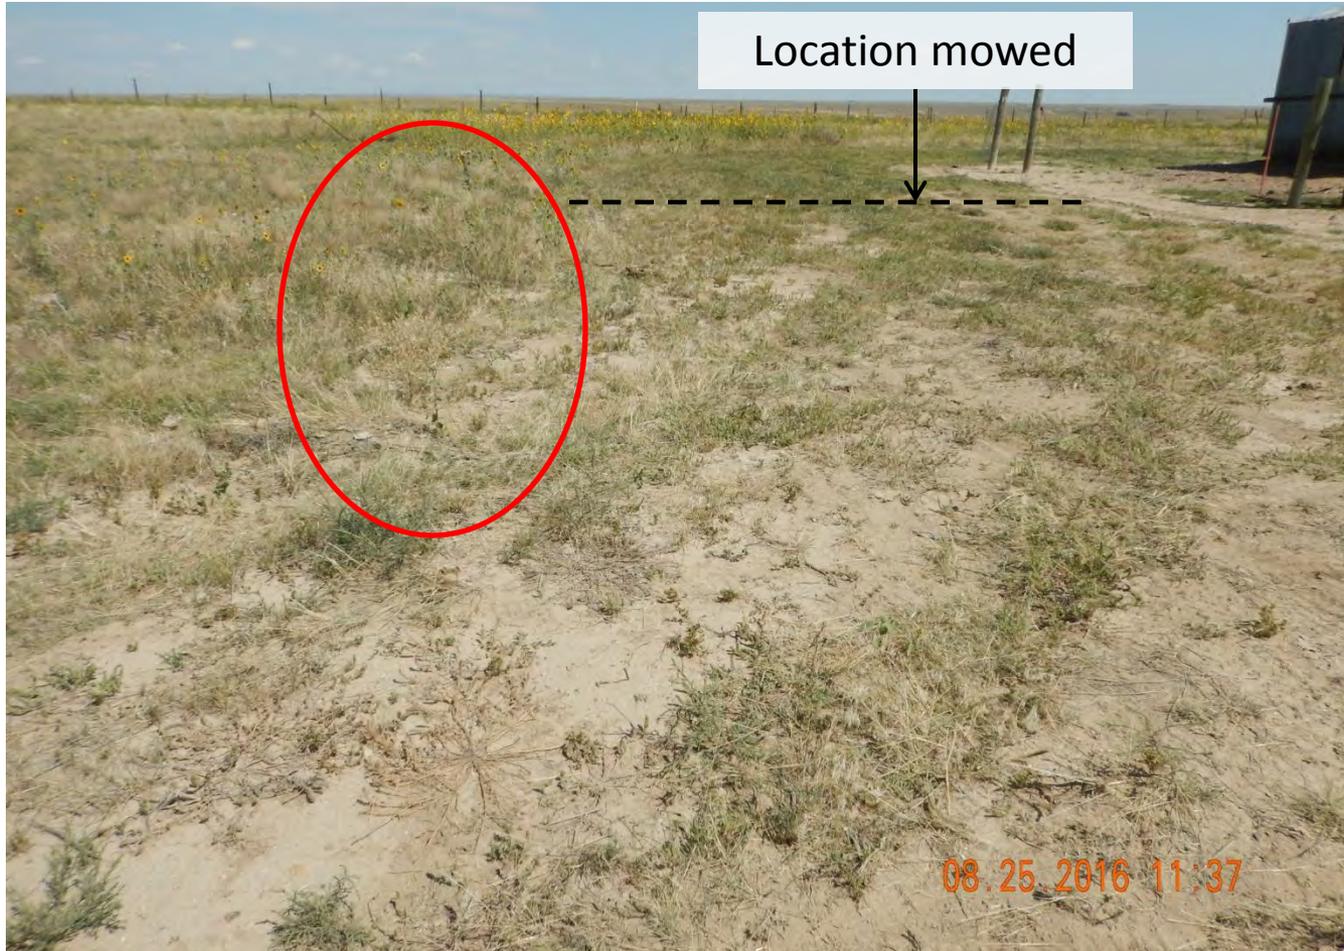
Krager Site- Well location (Location ID 331849)

- 1) Location 331849- Portions mowed and knapweed was observed in the cuttings and a handful of individual Diffuse knapweeds left behind. Foundation instructed on 8/25/16 to pull and bag remaining plants. Foundation instructed on 8/30/16 to collect, remove, and dispose weed debris and seed heads properly from areas that were mowed.
- 2) Tank battery/storage yard- Portions mowed and knapweed was observed in the cuttings and several patches, varying in size, of Diffuse knapweed left behind. Foundation instructed on 8/25/16 to pull and bag remaining plants. Foundation instructed on 8/30/16 to collect, remove, and dispose weed debris and seed heads properly from areas that were mowed.

Photo 2. Photo taken from western location, facing North. Location was mowed within the last 2 days based off conversations with other COGCC staff. A handful of individual Diffuse knapweeds left behind highlighted in the red circle. Diffuse knapweed seed heads were observed in the mowed cuttings.

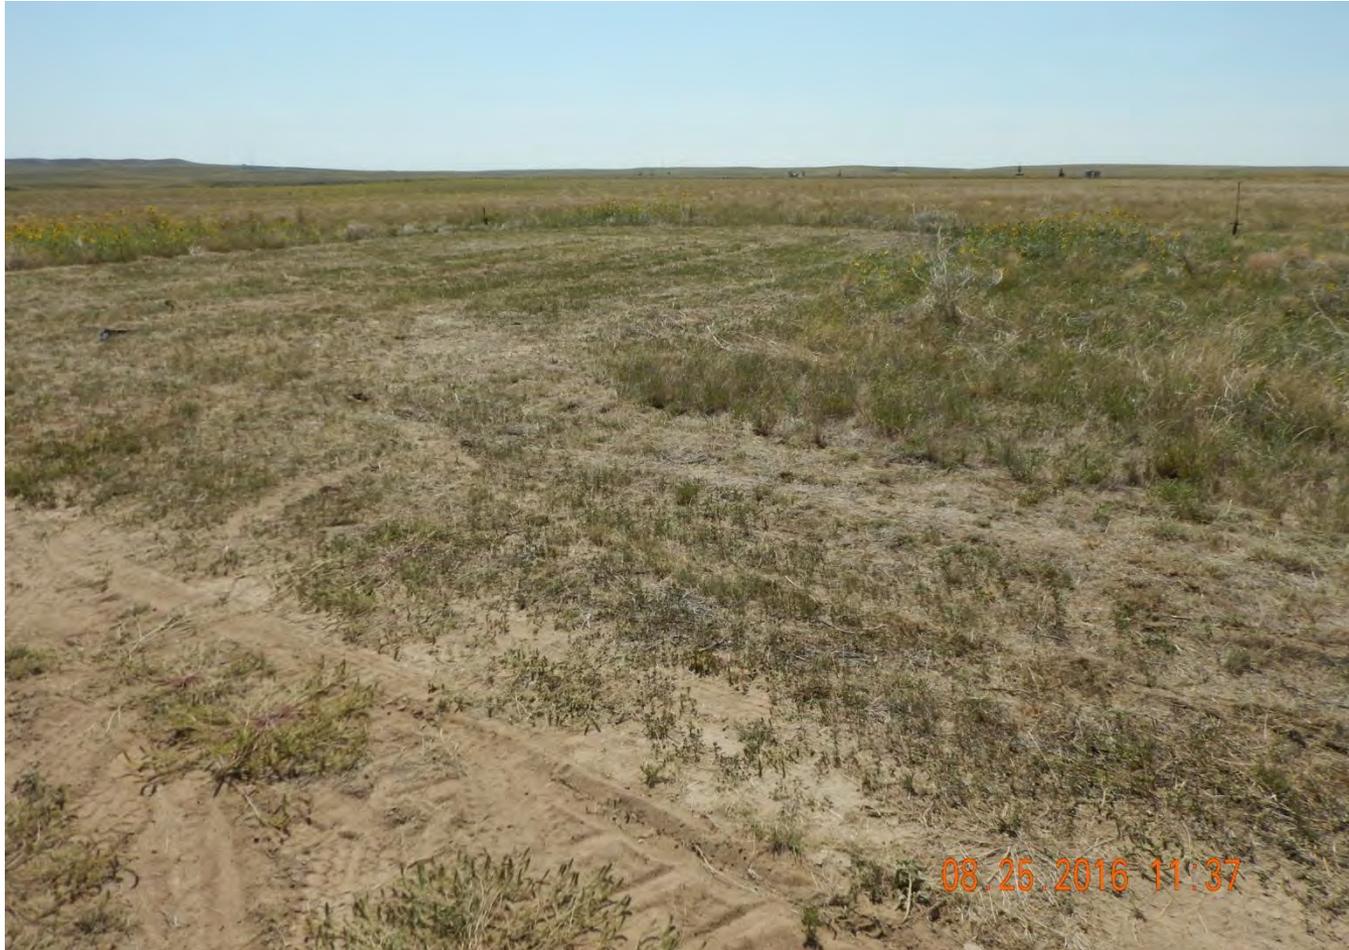
Krager Site- Well location (Location ID 331849)

Photo 3. Photo taken from western location, facing Southeast. Location was mowed within the last 2 days based off conversations with other COGCC staff. Diffuse knapweed seed heads were observed in the mowed cuttings.

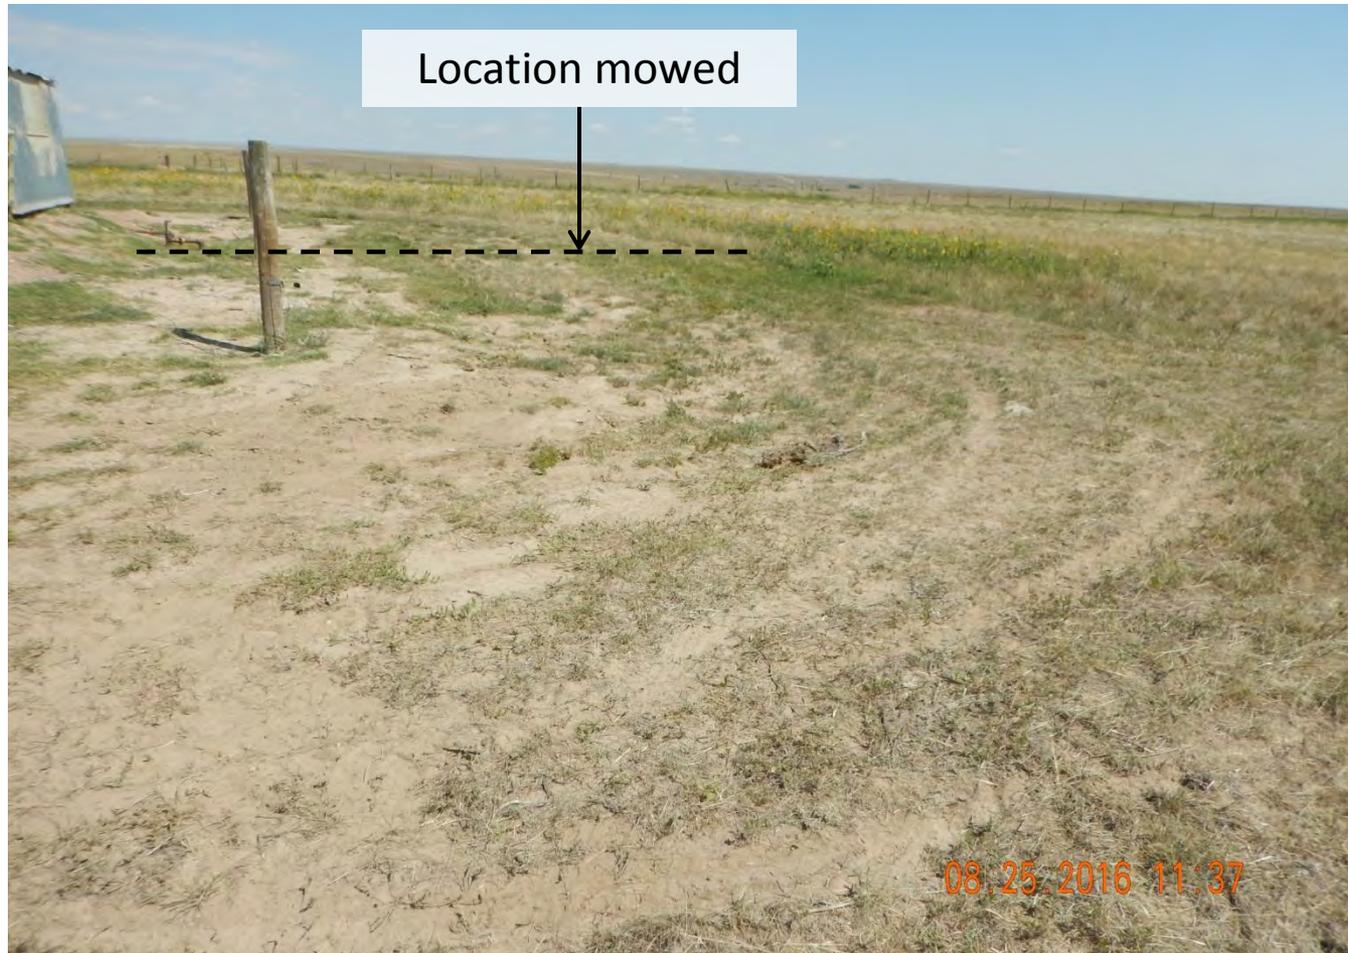
Krager Site- Well location (Location ID 331849)

Photo 4. Photo taken from western location, facing North. Location was mowed within the last 2 days based off conversations with other COGCC staff. Diffuse knapweed seed heads were observed in the mowed cuttings.

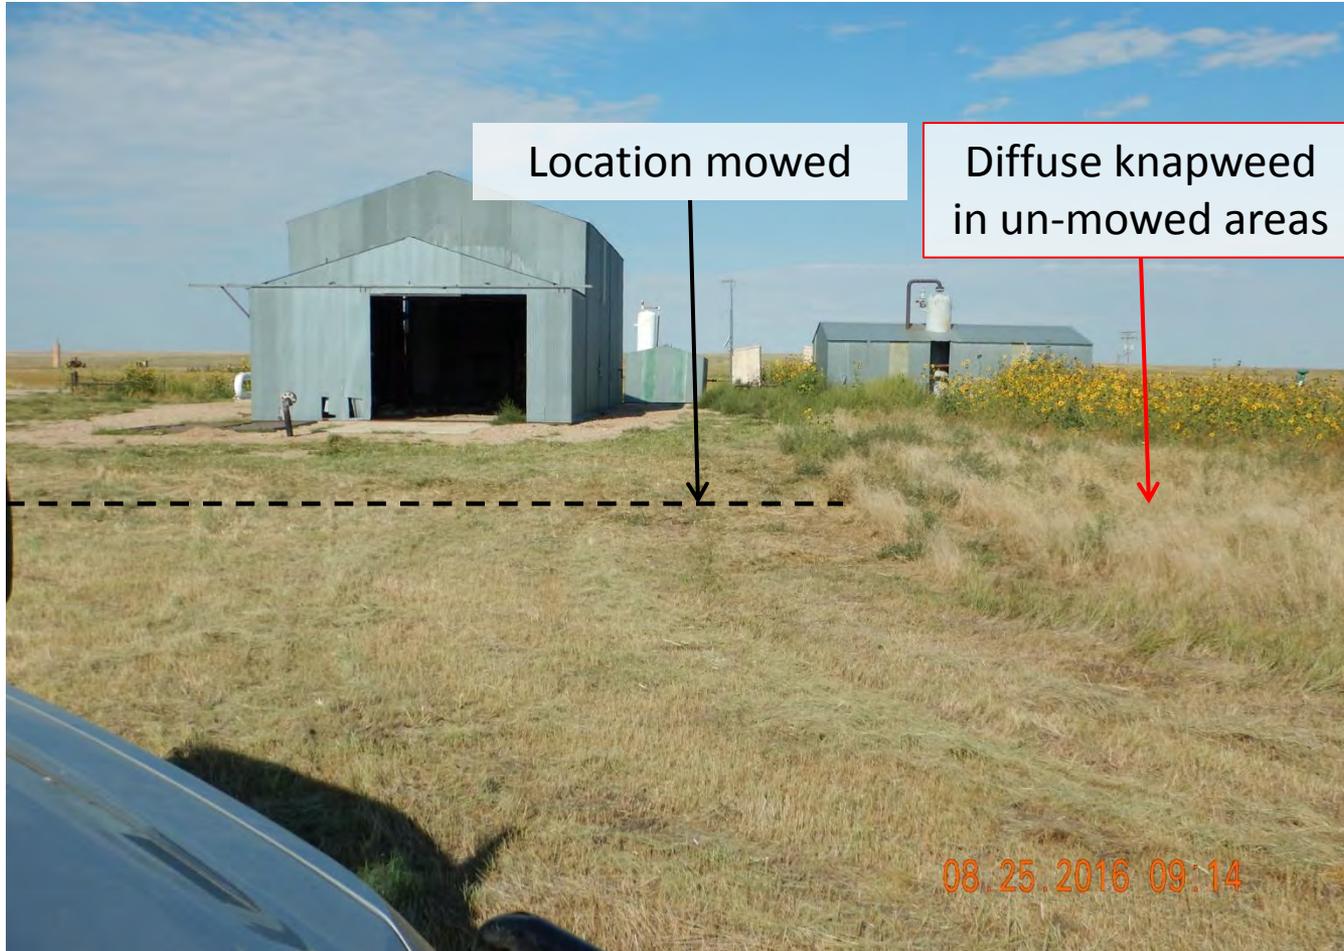
Krager Site- Tank battery/storage yard

Photo 5. Photo taken from central location, facing West. Location was mowed within the last 2 days based off conversations with other COGCC staff. Diffuse knapweed seed heads were observed in the mowed cuttings and mature knapweed individuals were observed anywhere it was not mowed.

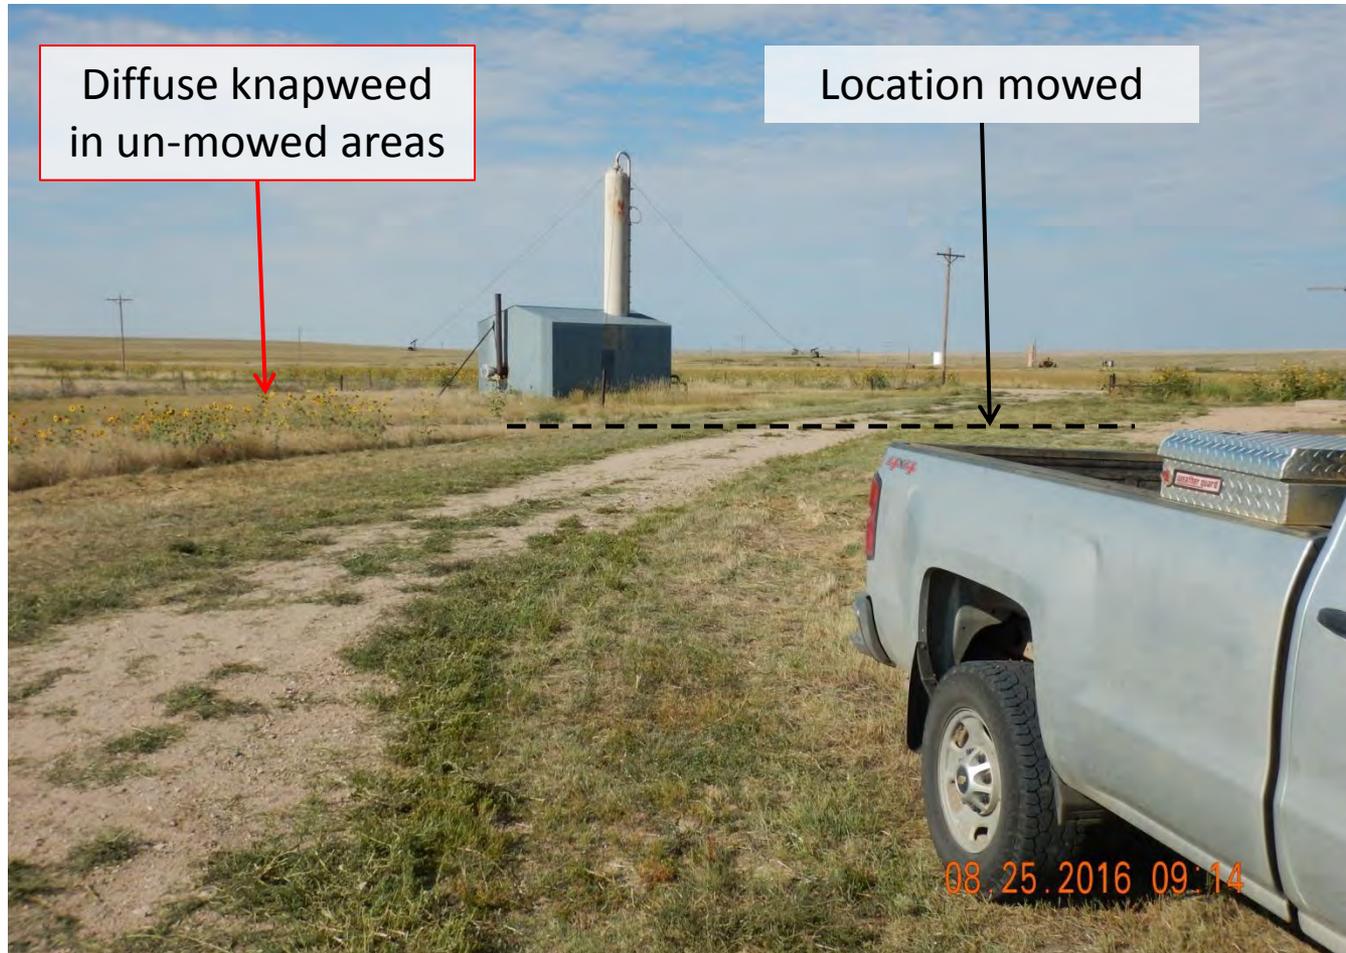
Krager Site- Tank battery/storage yard

Photo 6. Photo taken from central location, facing Southwest. Location was mowed within the last 2 days based off conversations with other COGCC staff. Diffuse knapweed seed heads were observed in the mowed cuttings and mature knapweed individuals were observed anywhere it was not mowed.

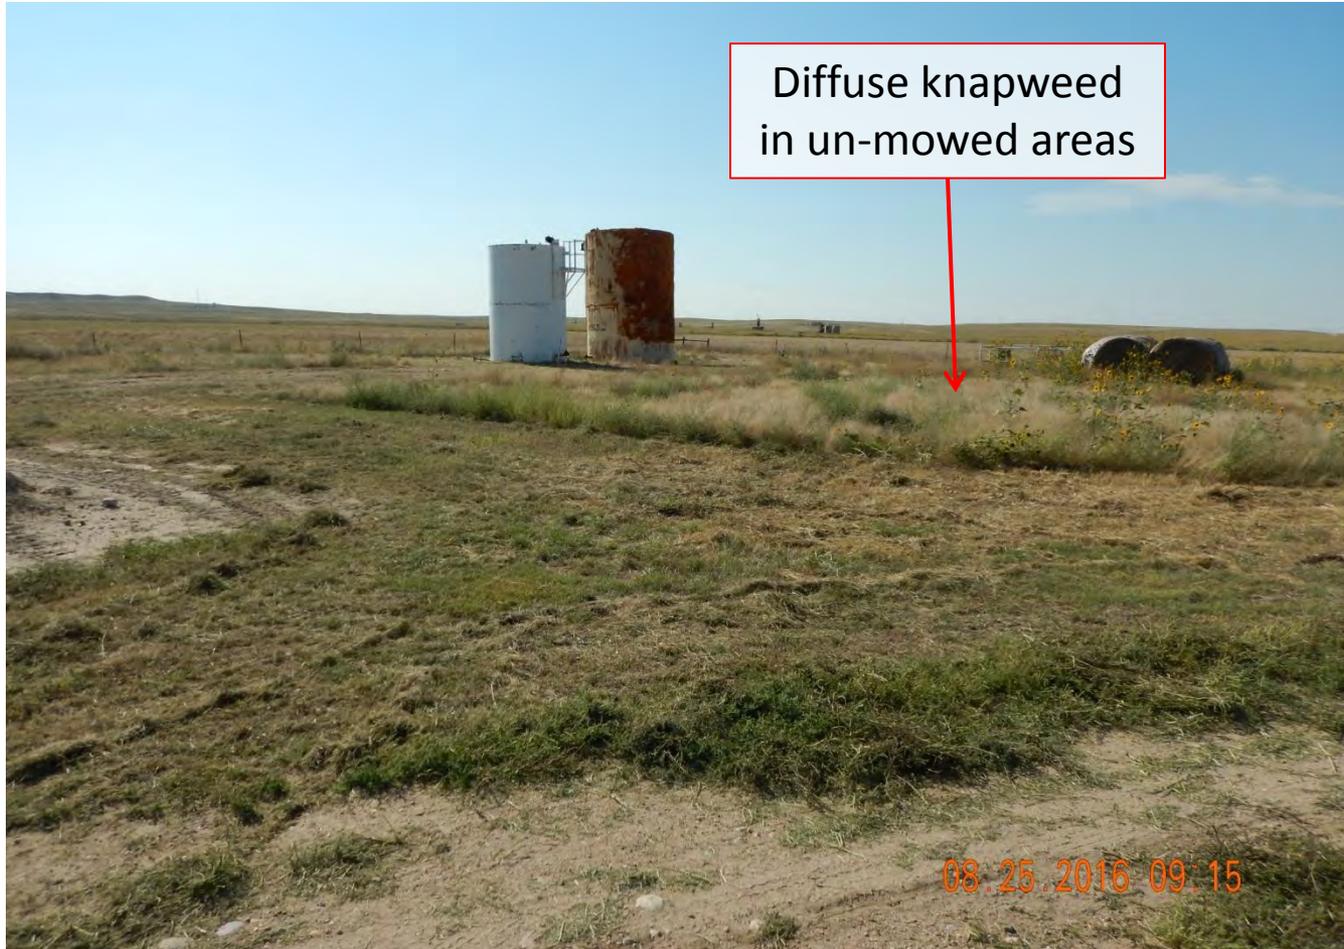
Krager Site- Tank battery/storage yard

Photo 7. Photo taken from central location, facing Southeast. Location was mowed within the last 2 days based off conversations with other COGCC staff. Diffuse knapweed seed heads were observed in the mowed cuttings and mature knapweed individuals were observed anywhere it was not mowed.

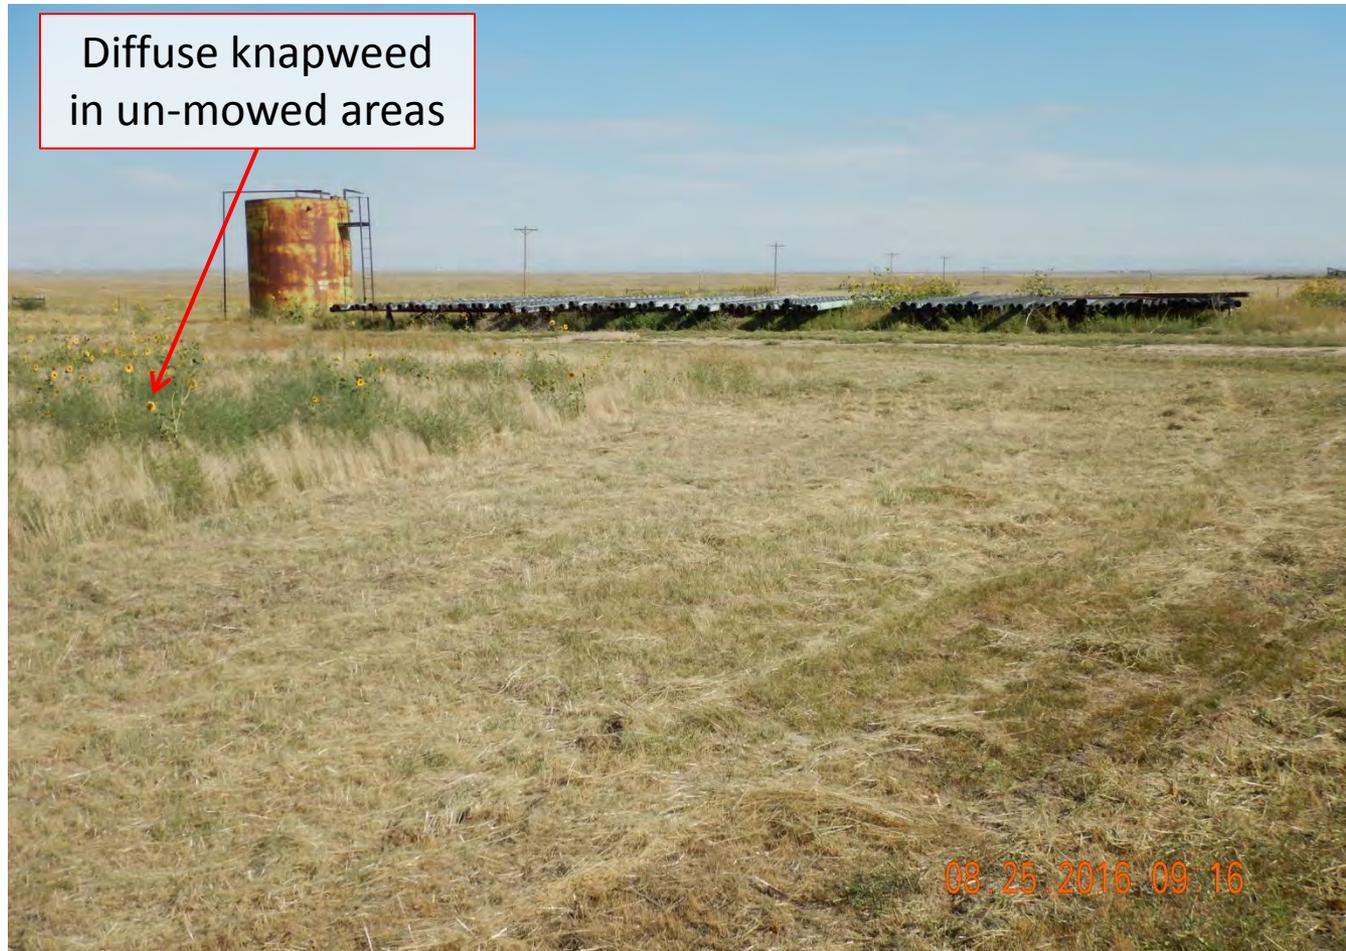
Krager Site- Tank battery/storage yard

Photo 8. Photo taken from central location, facing North. Location was mowed within the last 2 days based off conversations with other COGCC staff. Diffuse knapweed seed heads were observed in the mowed cuttings and mature knapweed individuals were observed anywhere it was not mowed.

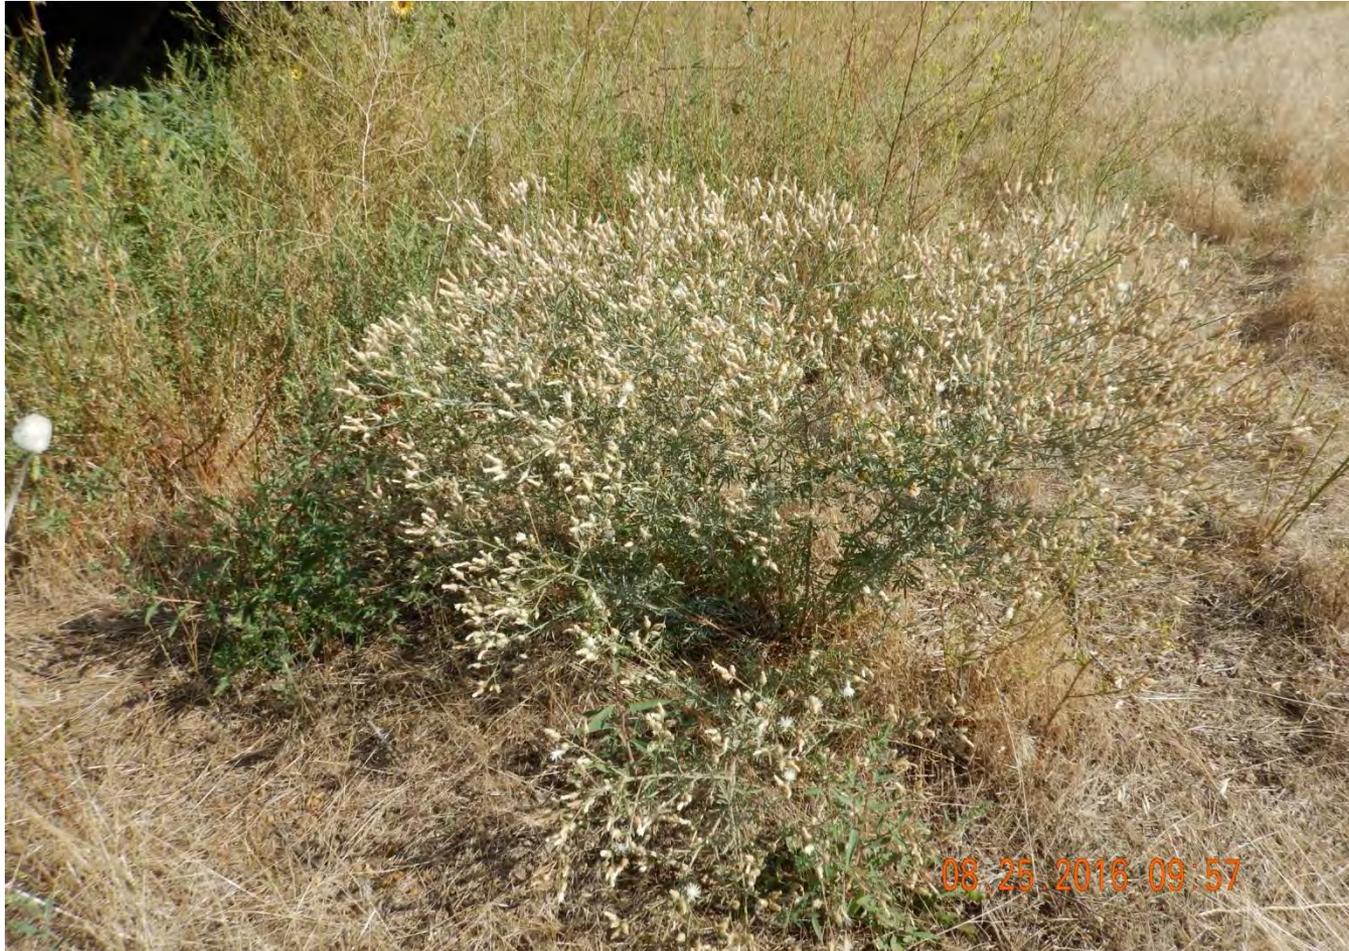
Krager Site- Tank battery/storage yard

Photo 9. Close-up photo of Diffuse knapweed (*Centarea diffusa*) found throughout un-mowed areas of location.
