## Reclamation Inspection Overview- Church Ranch #2W and #3W

## Reclamation Inspection- CHURCH RANCH #3W

**COLORADO**  
Oil & Gas Conservation  
Commission  
Department of Natural Resources

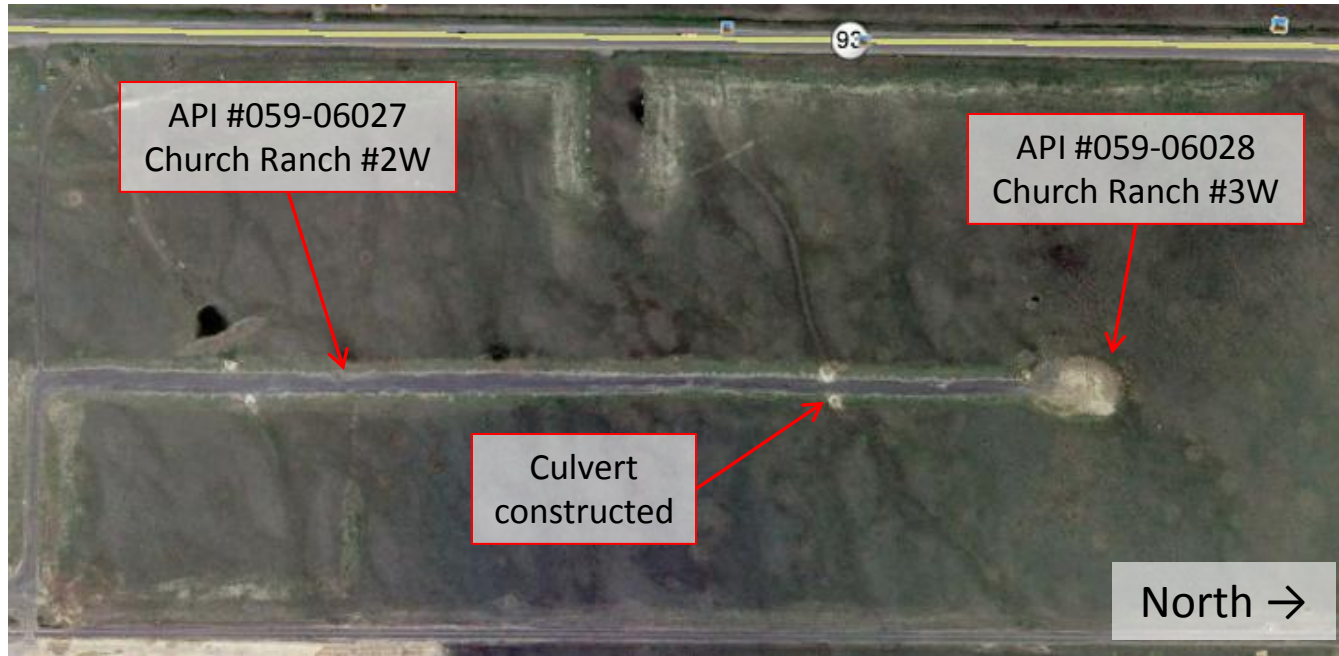
Google Earth aerial imagery taken 6/15/2010. This photo illustrates the construction of location API #059-06028 and the access road. Diffuse knapweed (*Centarea diffusa*), was observed at low densities at location (< 30 plants). Access road has been graveled and stabilized. No erosion was observed along the access road.

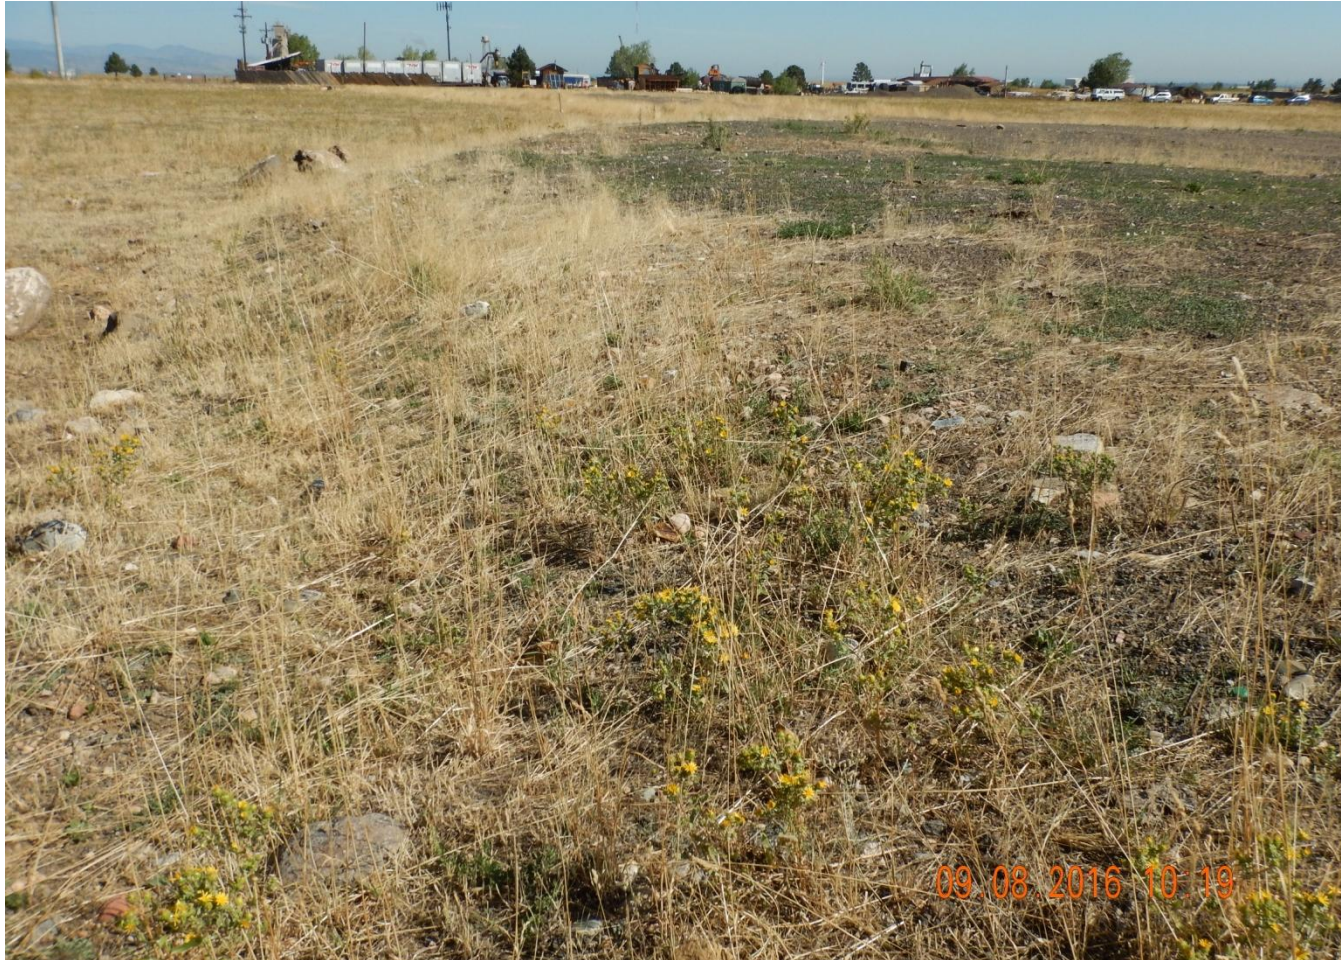
**Photo 1.** Photo taken from the western location, facing North. Evidence of location remains- location has not been re-contoured or reduced in size.

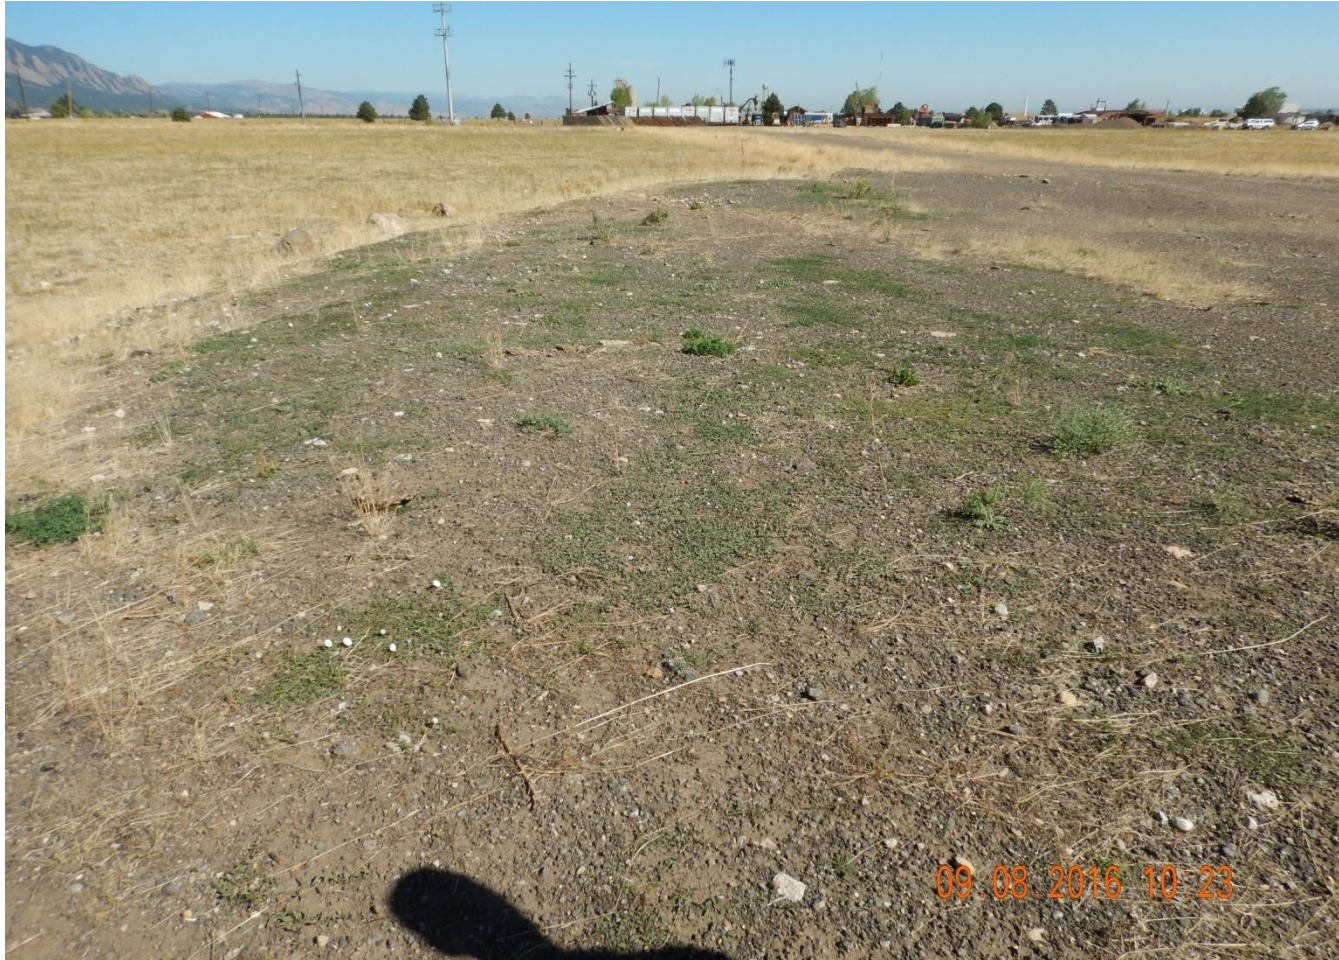
**Photo 2.** Photo taken from the western location, facing North. Evidence of location remains- location has not been re-contoured or reduced in size.

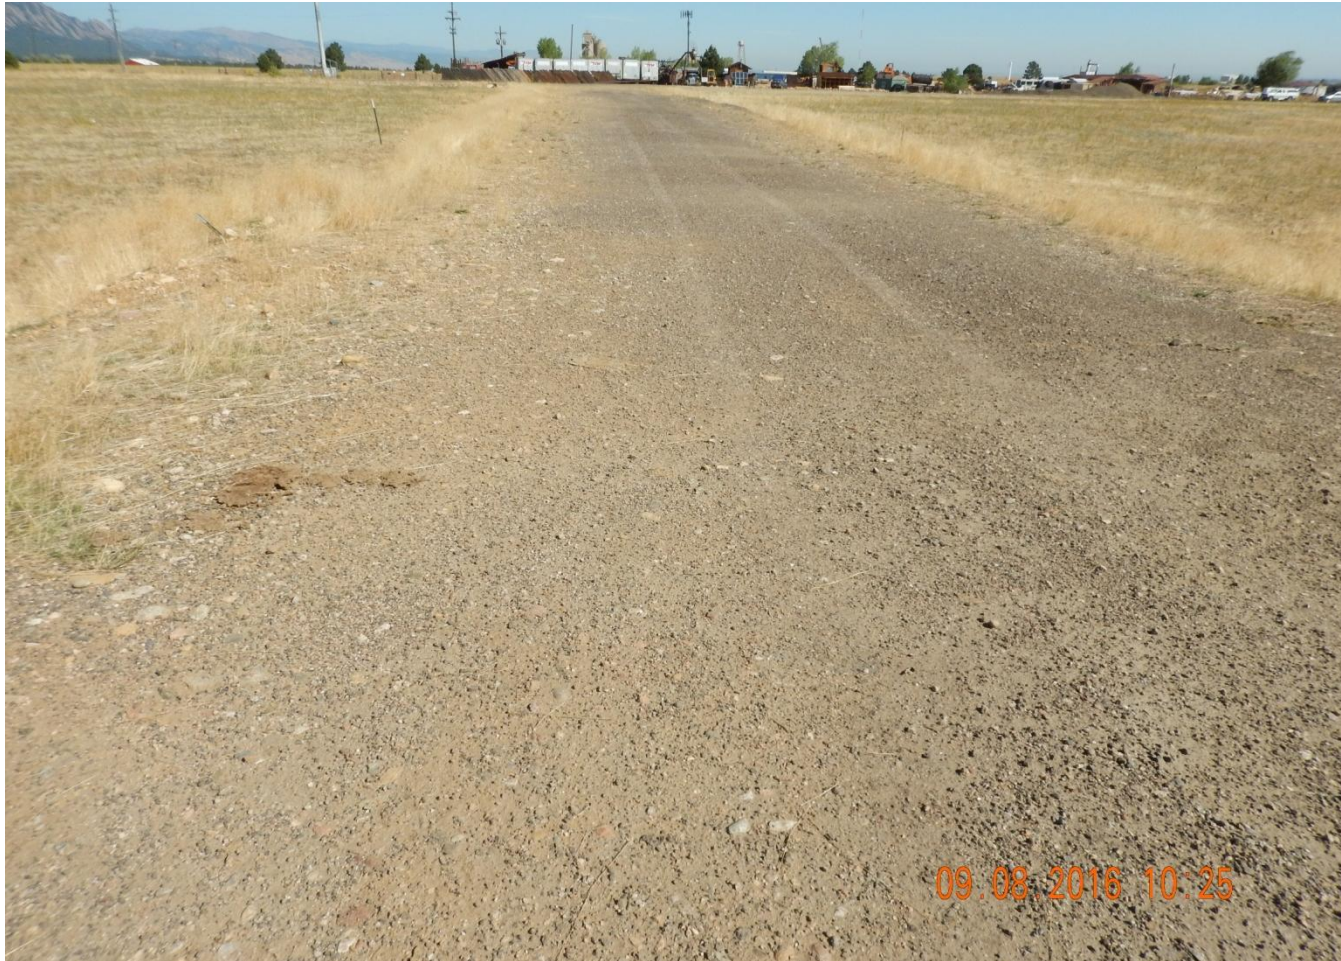
**Photo 3.** Photo taken from center of location, facing North. Access road, which extends north past the location, has been gravelled and stabilized. Access road is being used by private landowner. No erosion was observed along the access road.

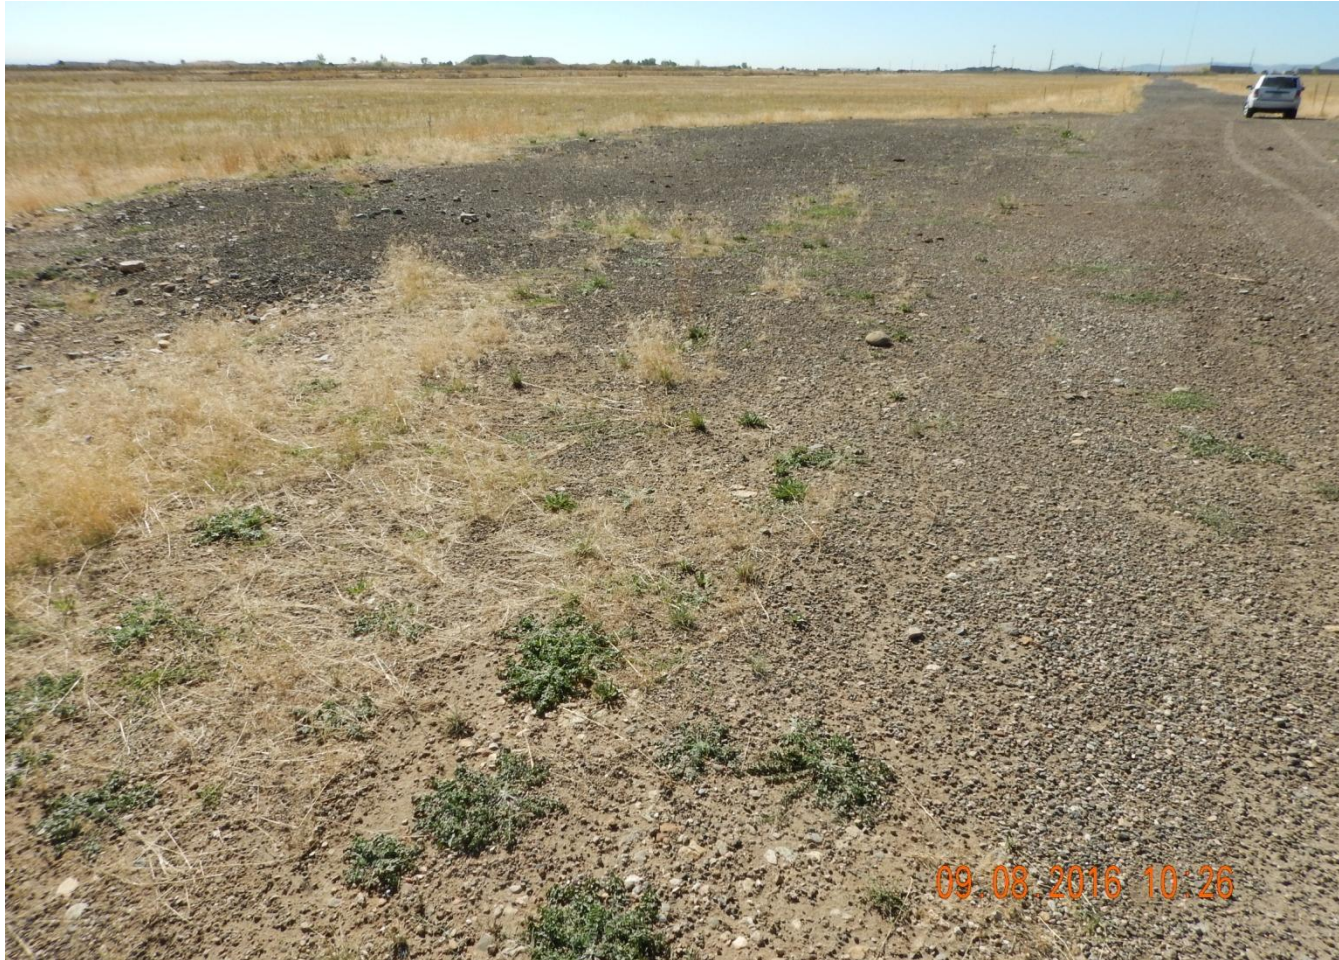
**Photo 4.** Photo taken from the eastern location, facing South. Evidence of location remains- location has not been re-contoured or reduced in size.

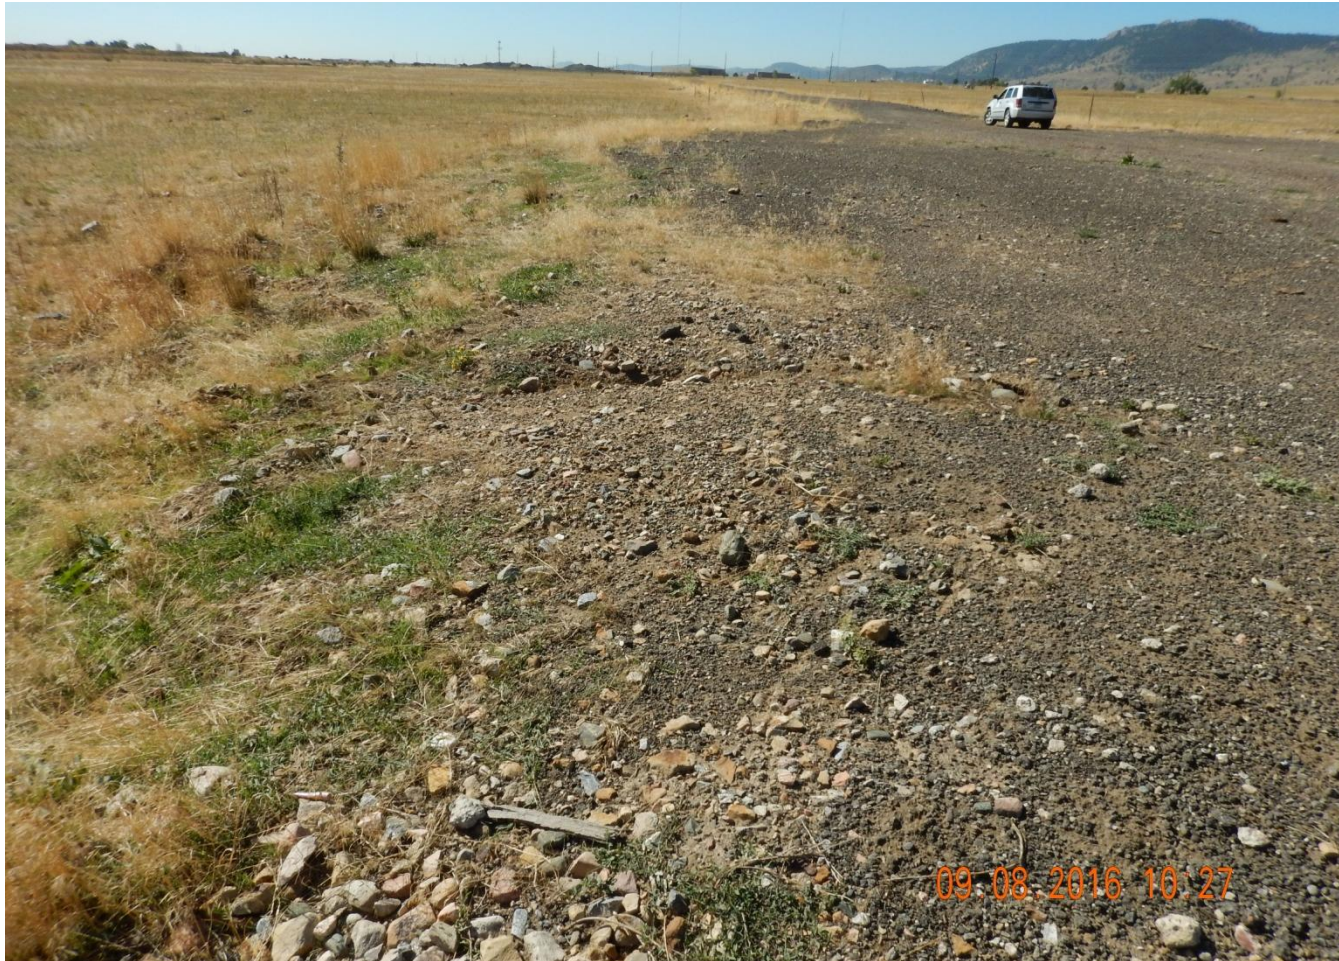
**Photo 5.** Photo taken from the eastern location, facing South. Evidence of location remains- location has not been re-contoured or reduced in size.

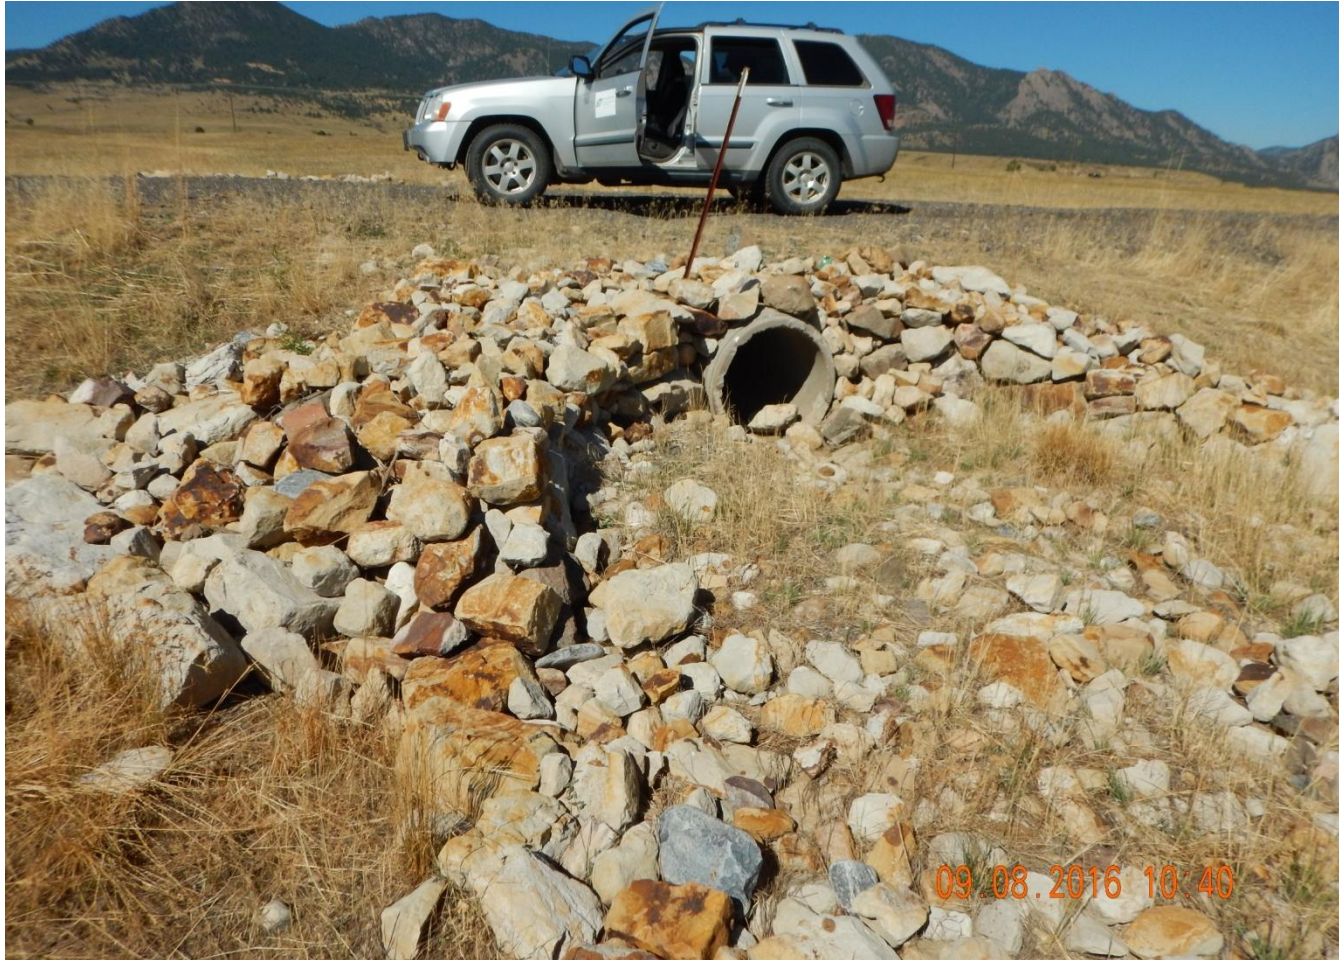
**Photo 6.** Photo taken along the eastern access road, facing West. Culvert was installed along a drainage point to control stormwater. Culvert is armored at both the inlet and outlet drainage areas.

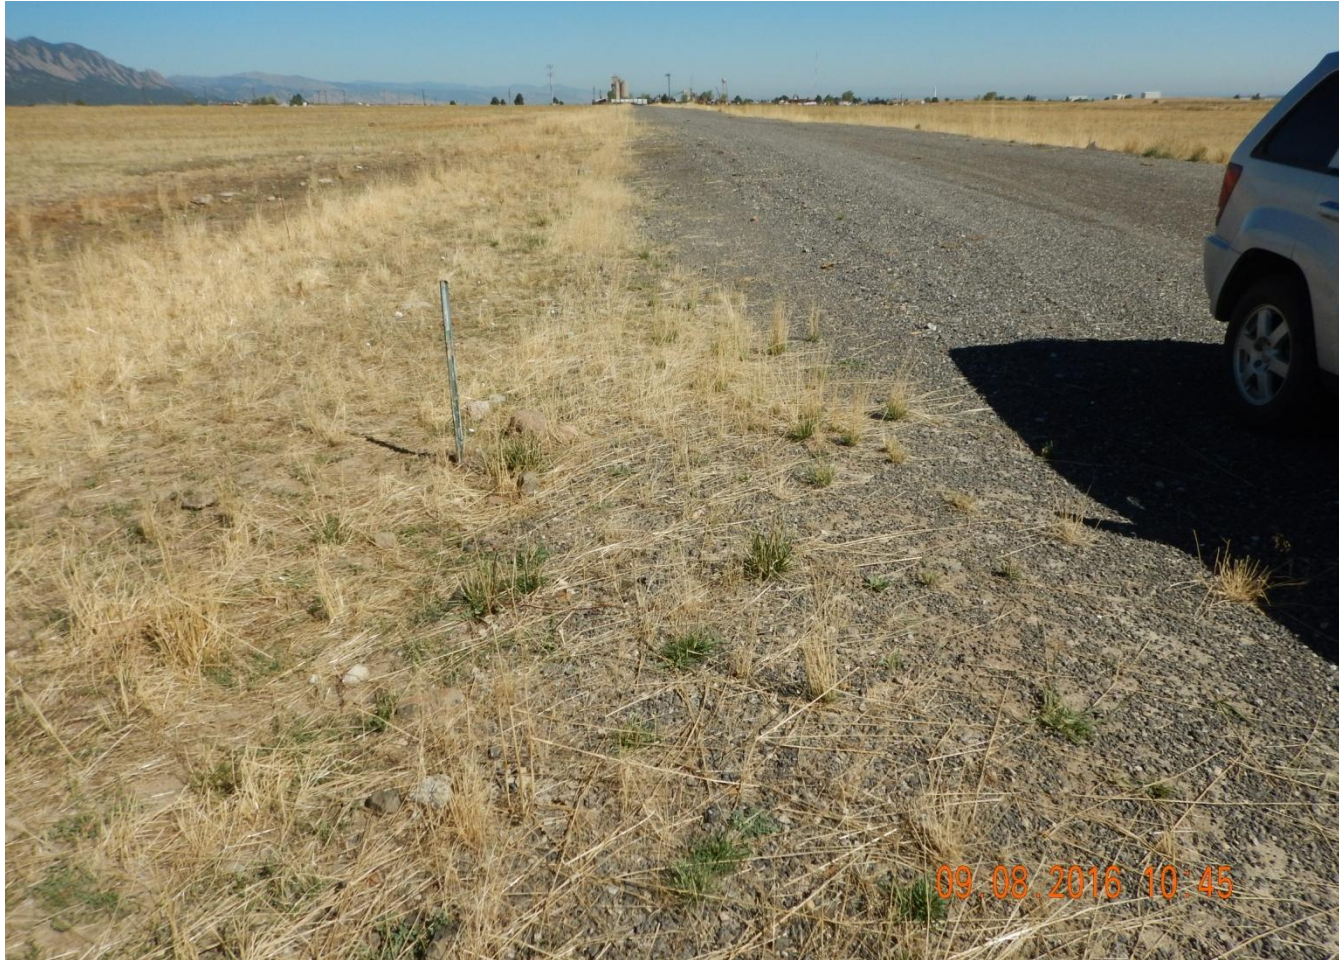
**Photo 5.** Photo taken from approximate center of location, facing North. Does not appear to have been built based off field observations. Access road is being used by private landowner. Access road has been graveled and stabilized. No erosion was observed along the access road.

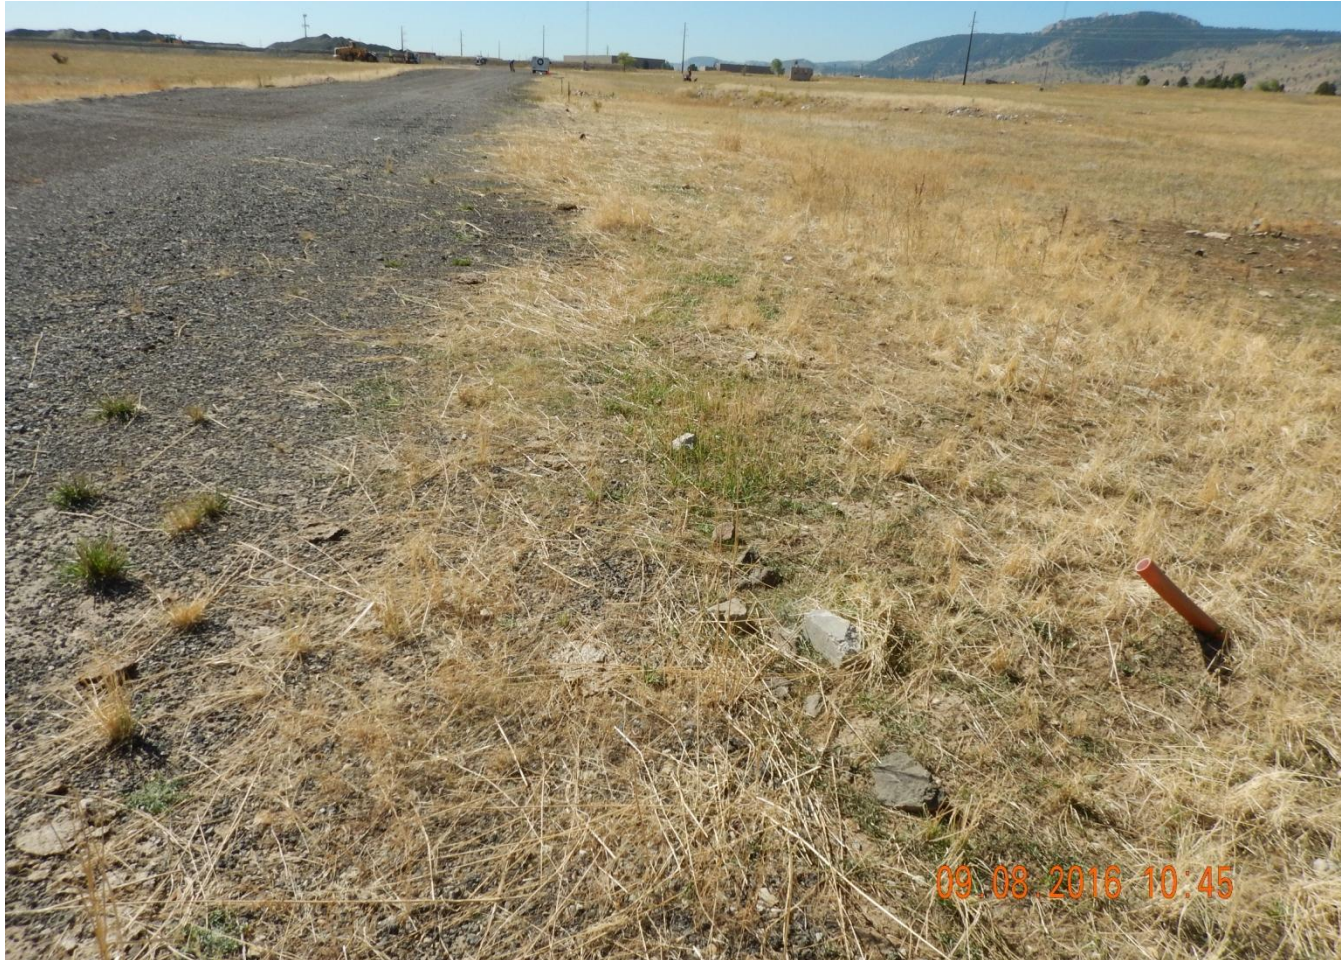
**Photo 6.** Photo taken from approximate center of location, facing South. Does not appear to have been built based off field observations. Access road is being used by private landowner. Access road has been graveled and stabilized. No erosion was observed along the access road.
