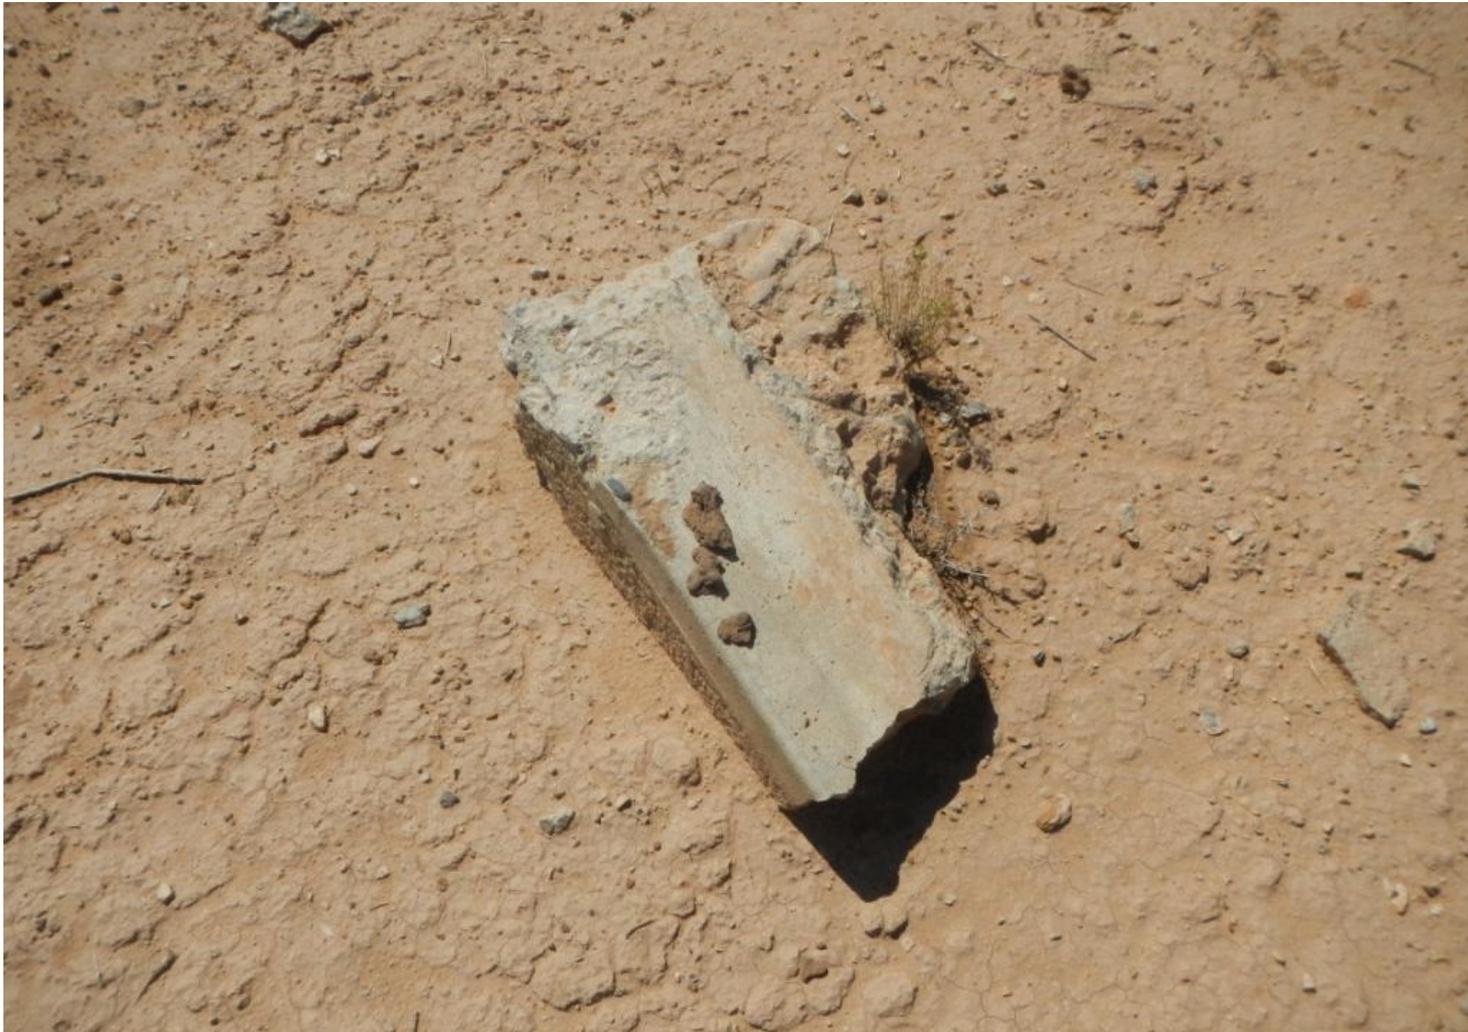
Photo 1. View of cement debris on the well pad.

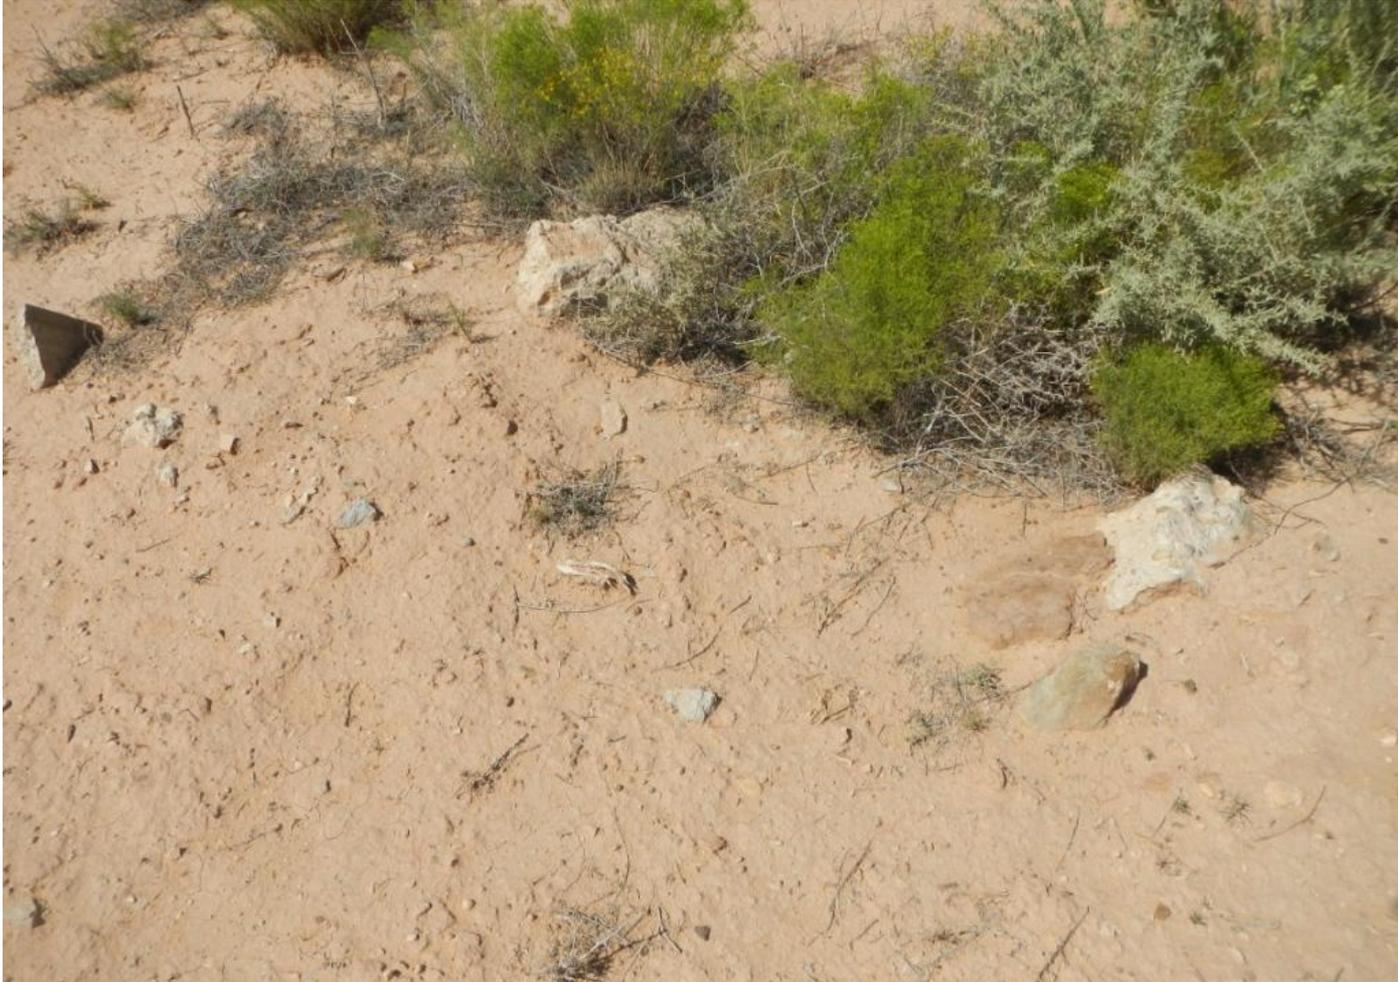
Photo 2. View of more cement debris on the well pad.

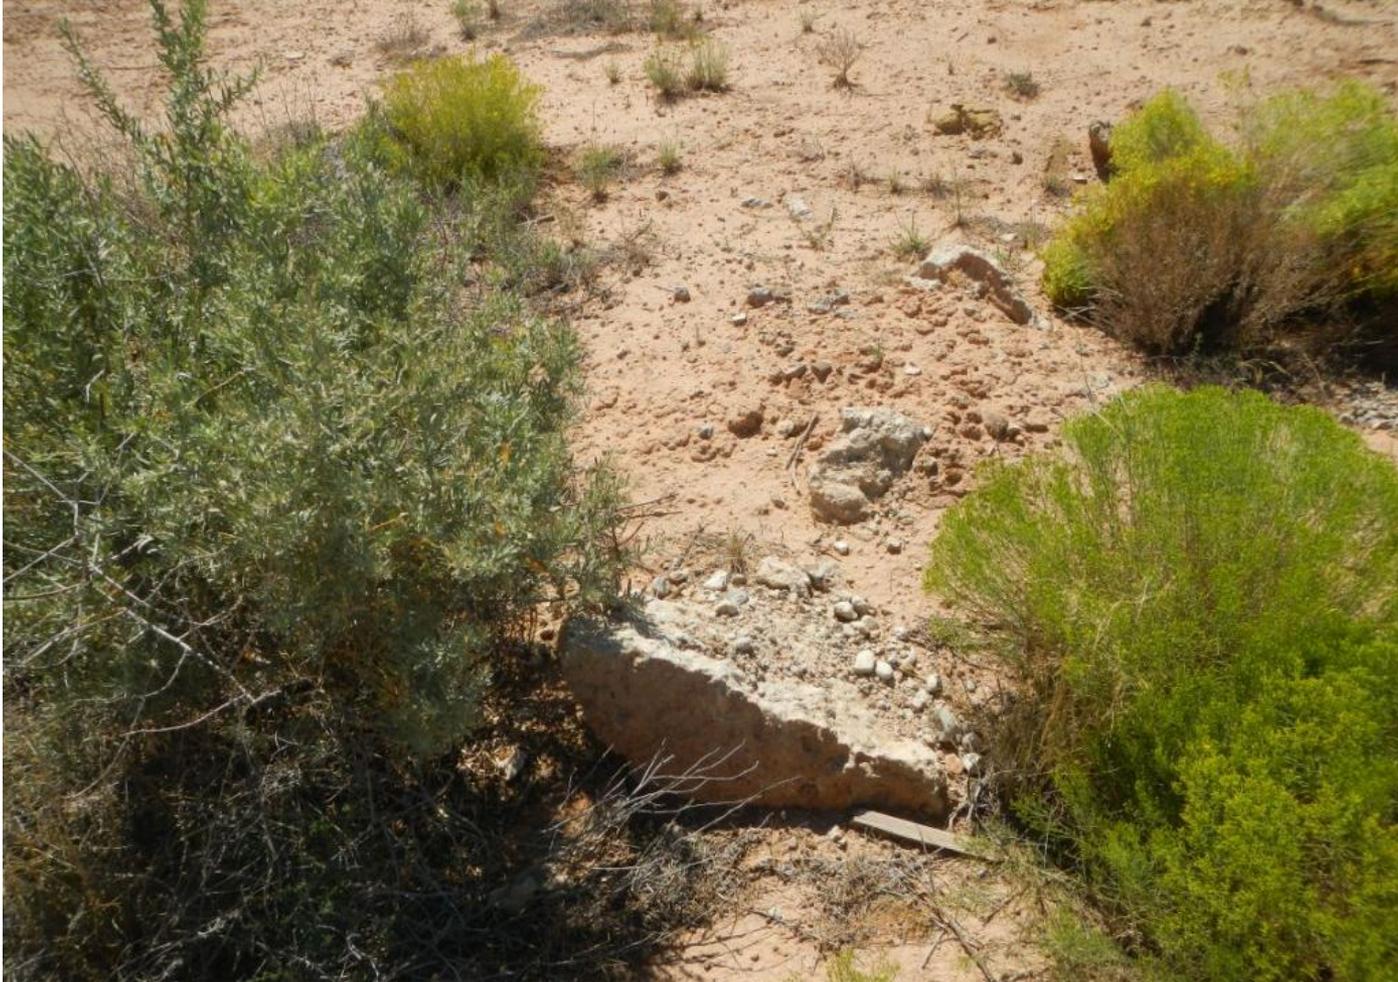
Photo 3. View of more cement debris on the well pad.

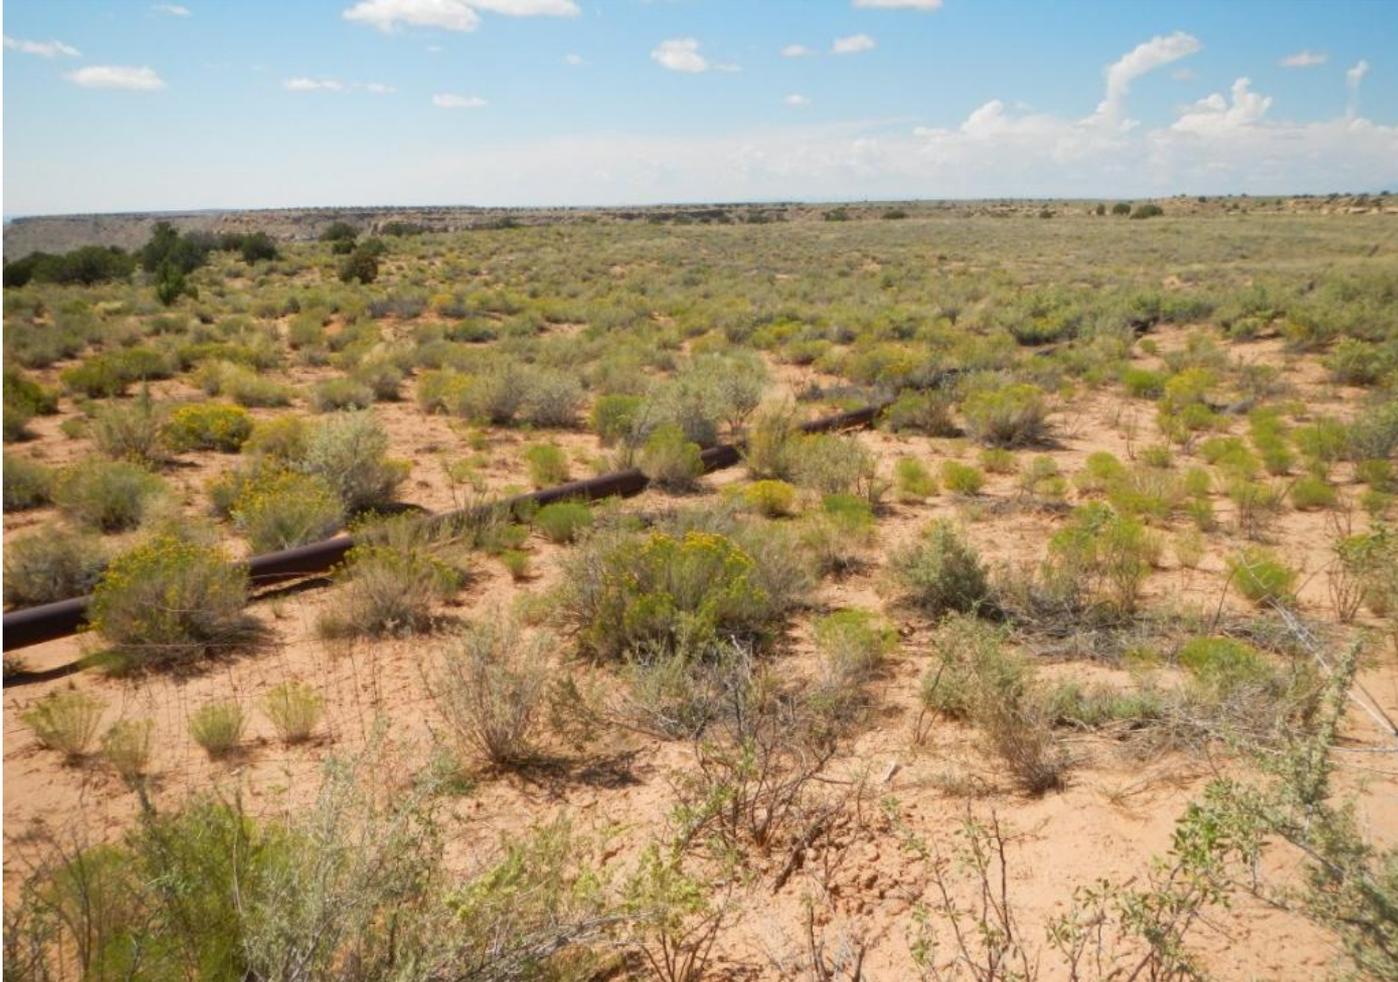
Photo 4. View of surface pipeline that does not appear to be in use and needs to be removed.

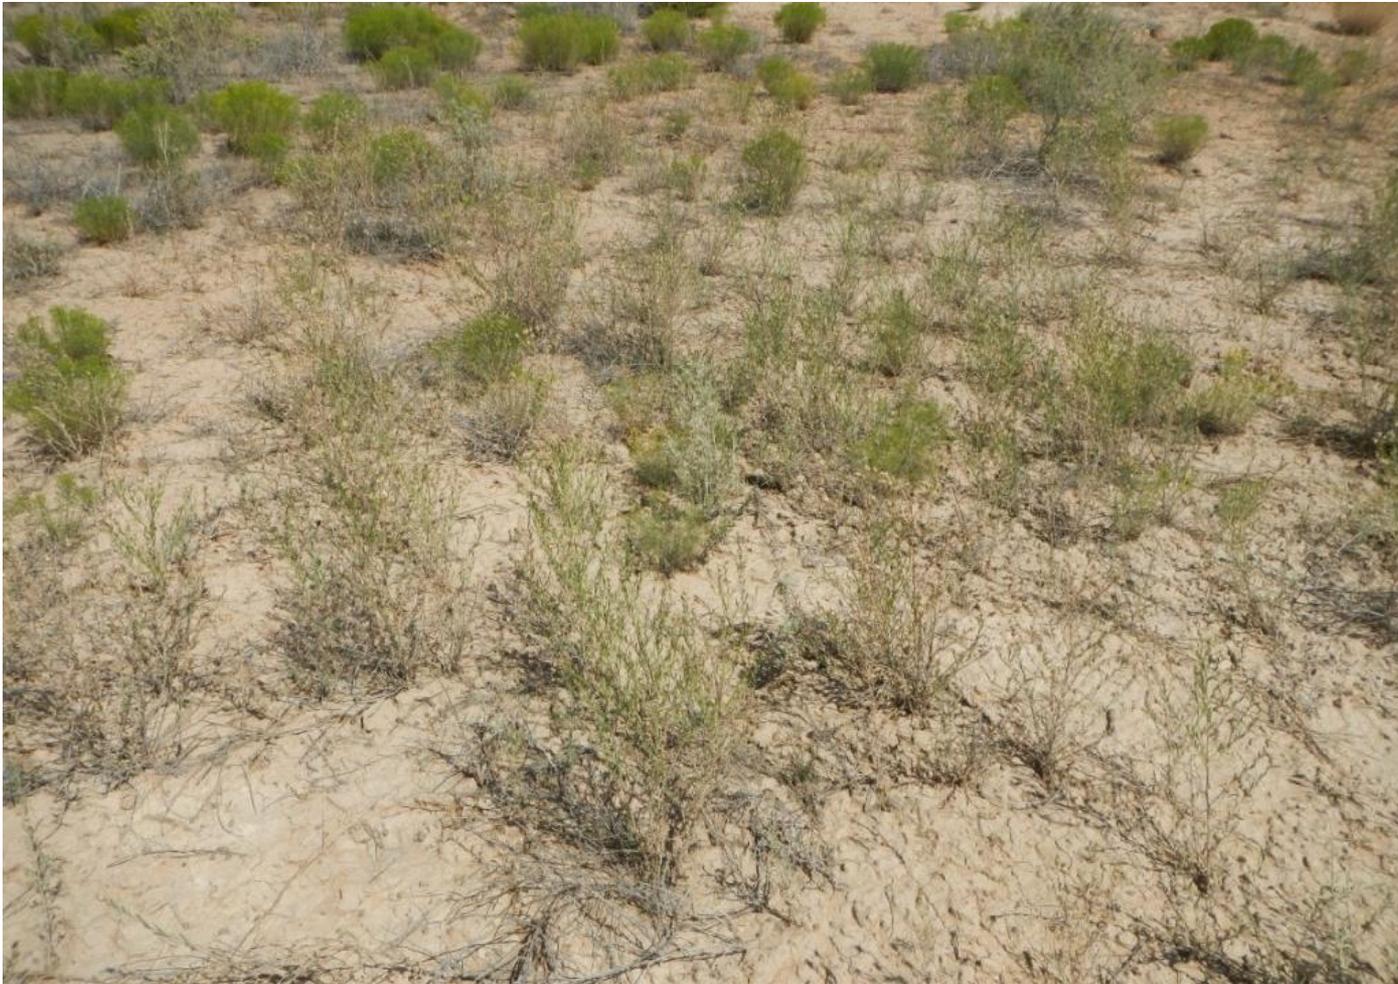
Photo 5. View of Russian knapweed (*Acroptilon repens*) infestation in the northeastern portion of the project area.
