Inspection Photos: PRAW API#081-07088

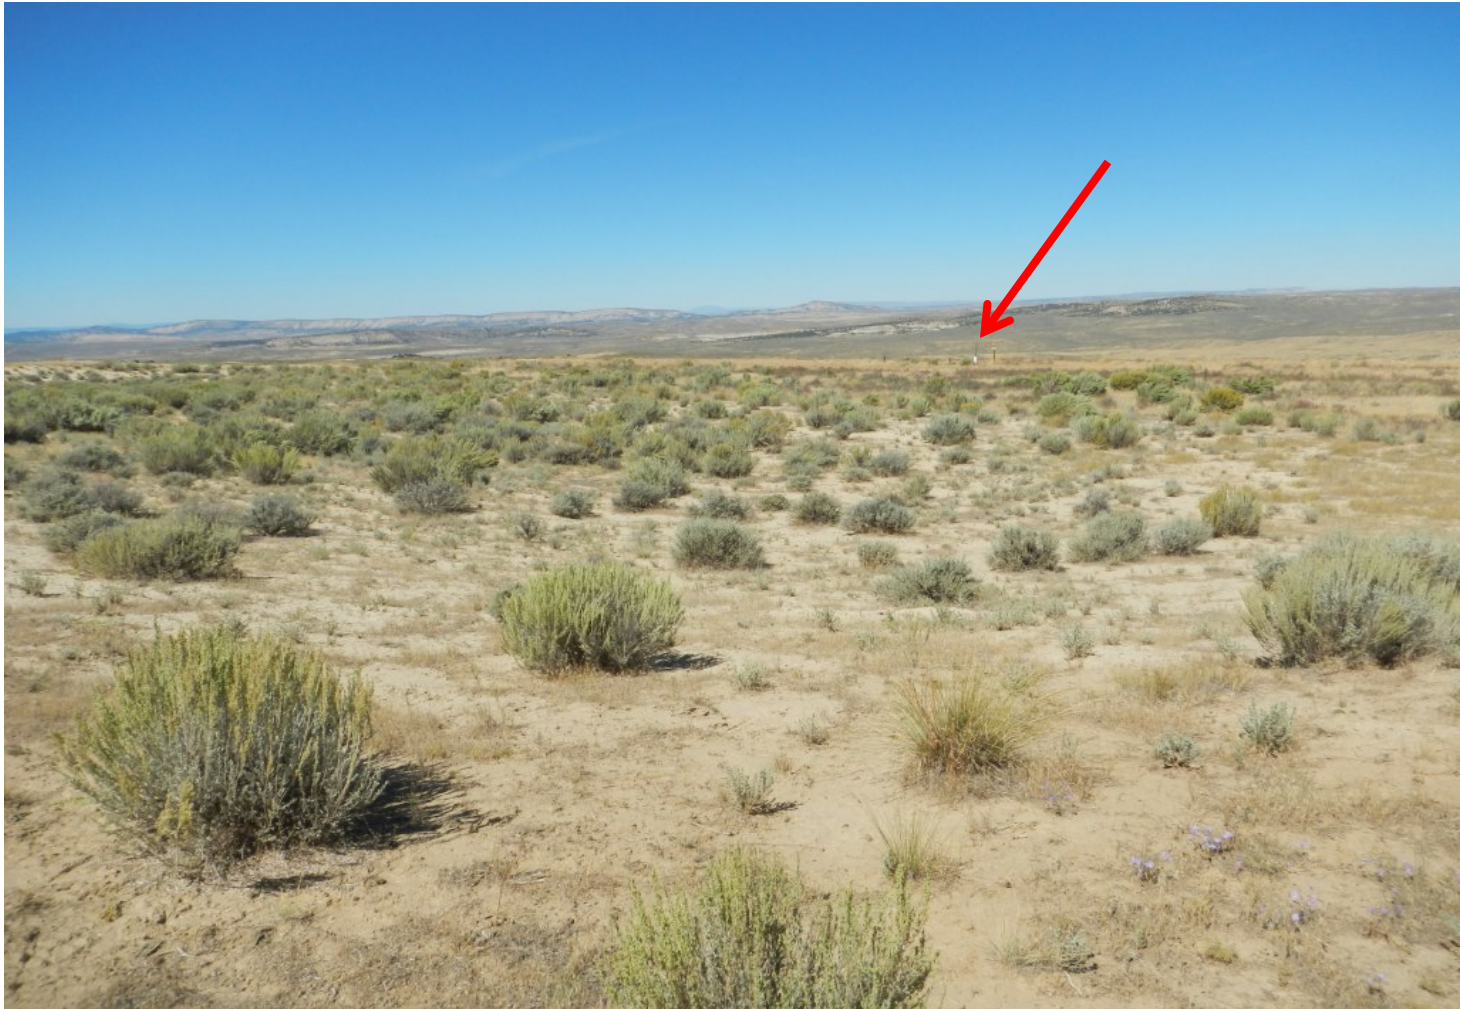
**Photo#1:** Overview of Location to NW. Arrow indicates Risers/Gas lines at NW side of Site.

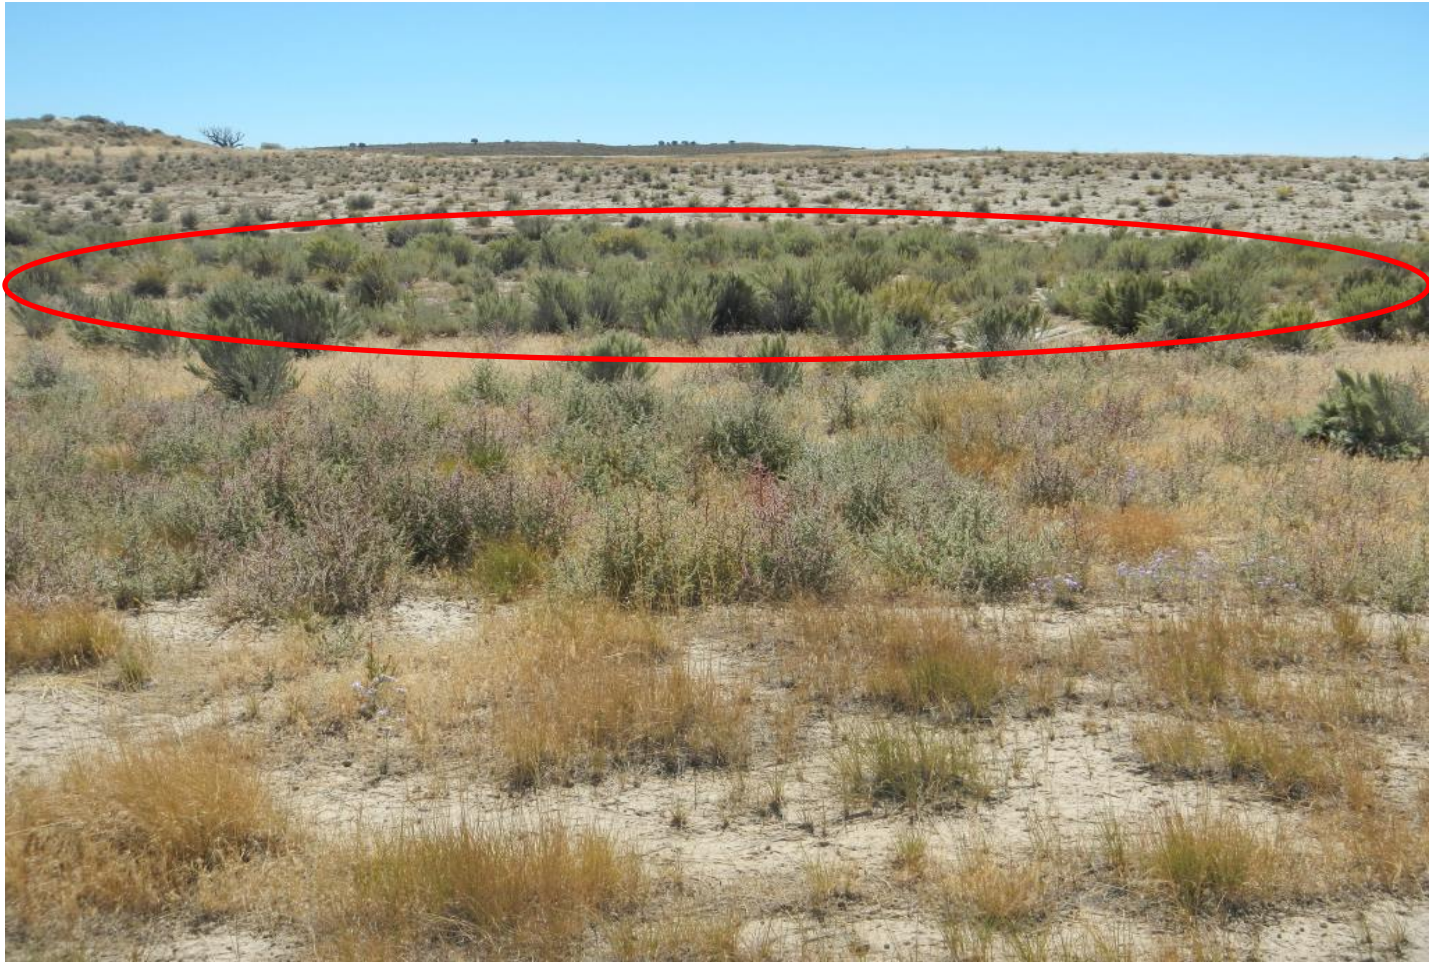
**Photo#2:** View to SW at Cut Slope. Area circled, running through center of Location is well revegetated

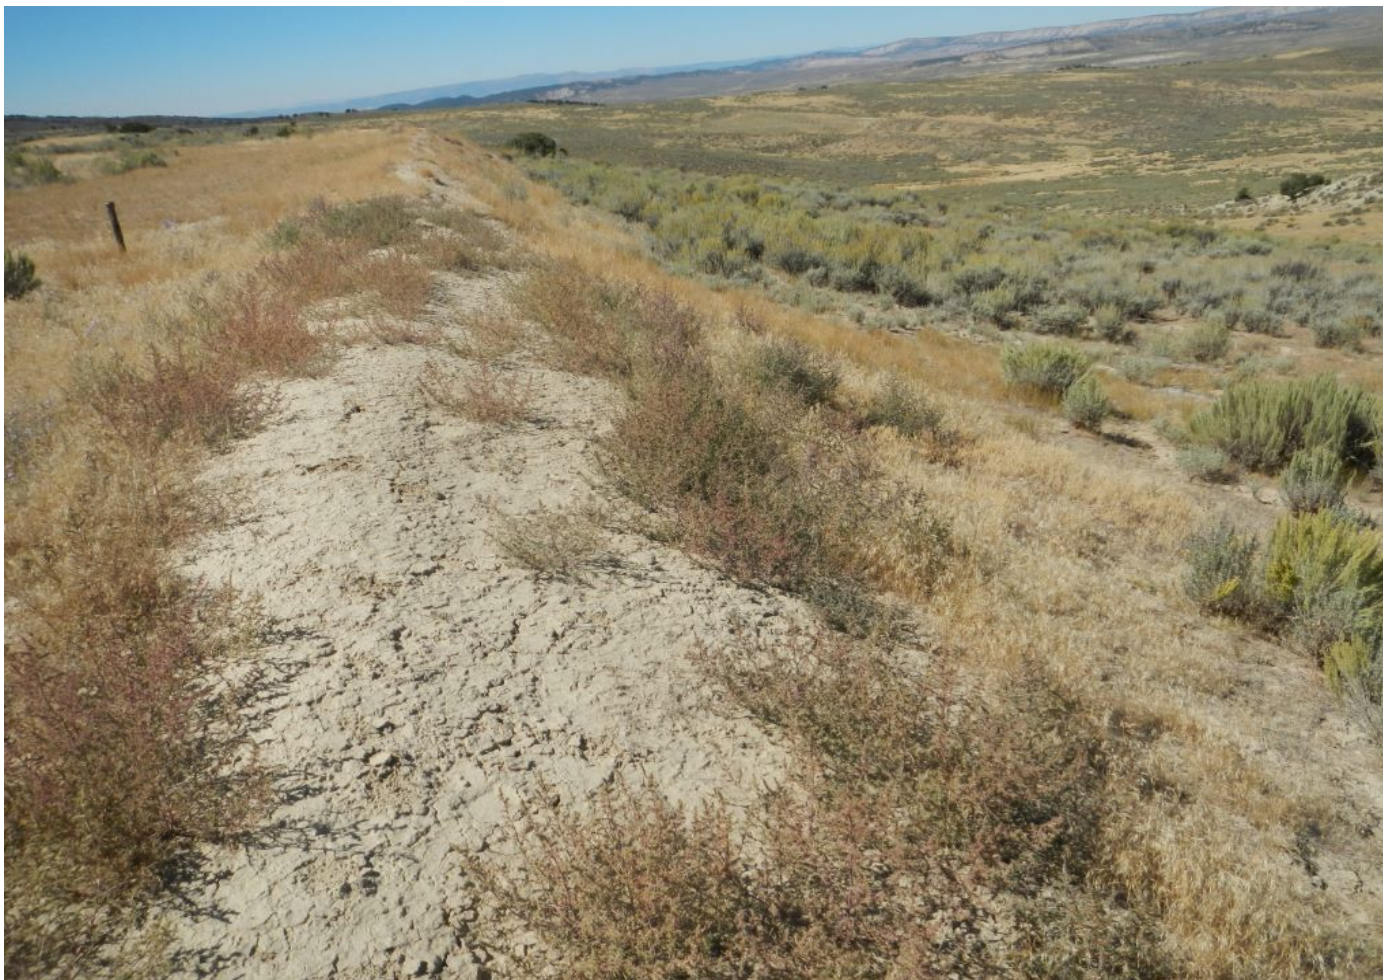
**Photo#3:** Fill slope is Weed infested

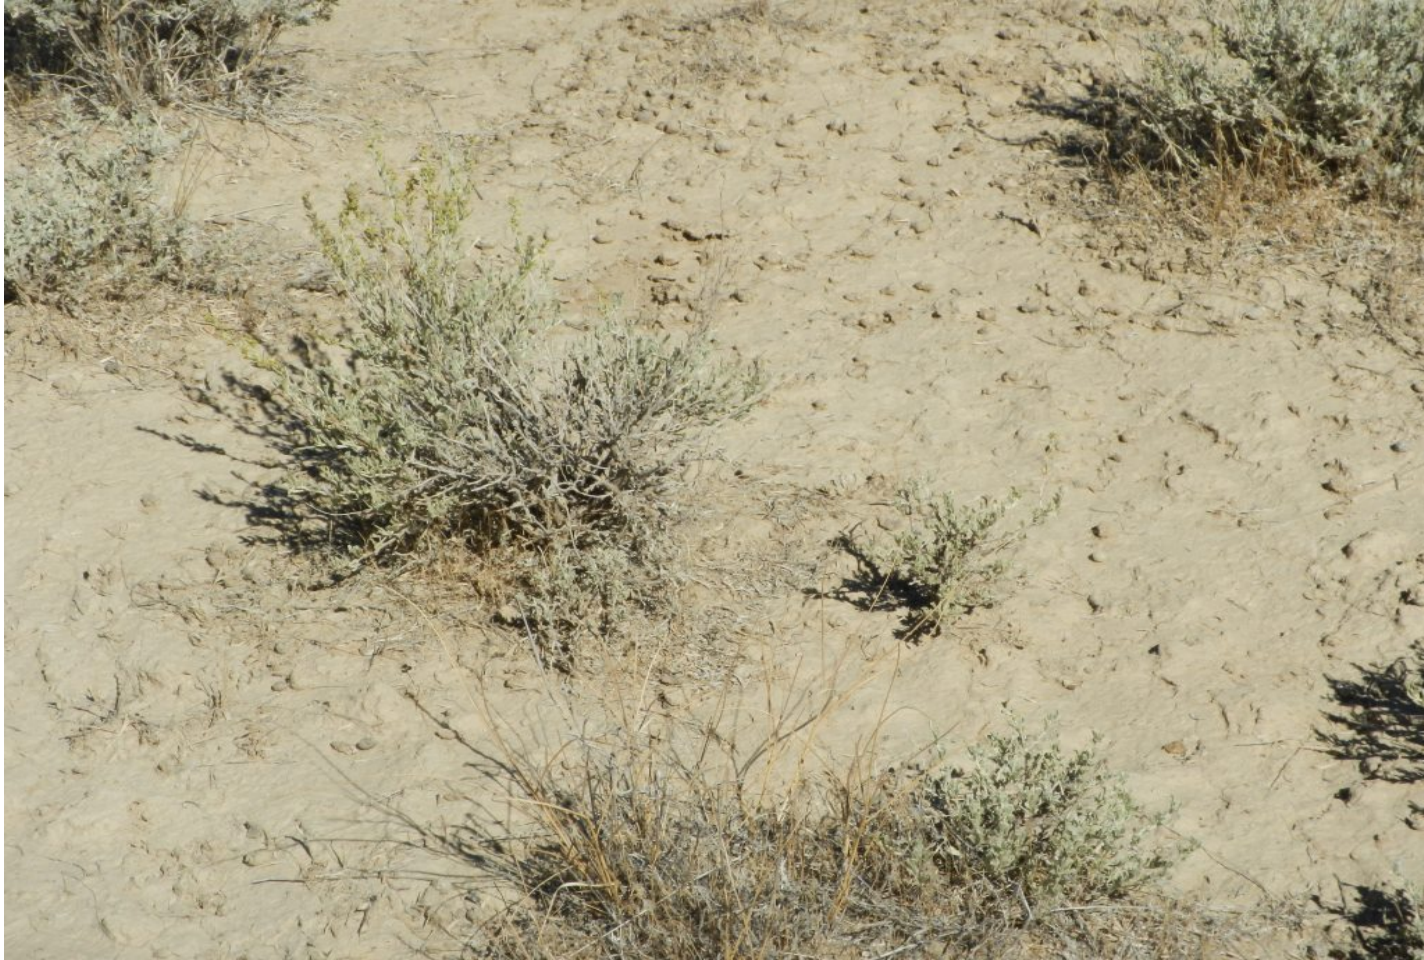
**Photo#4:** Ground Conditions on Flat.

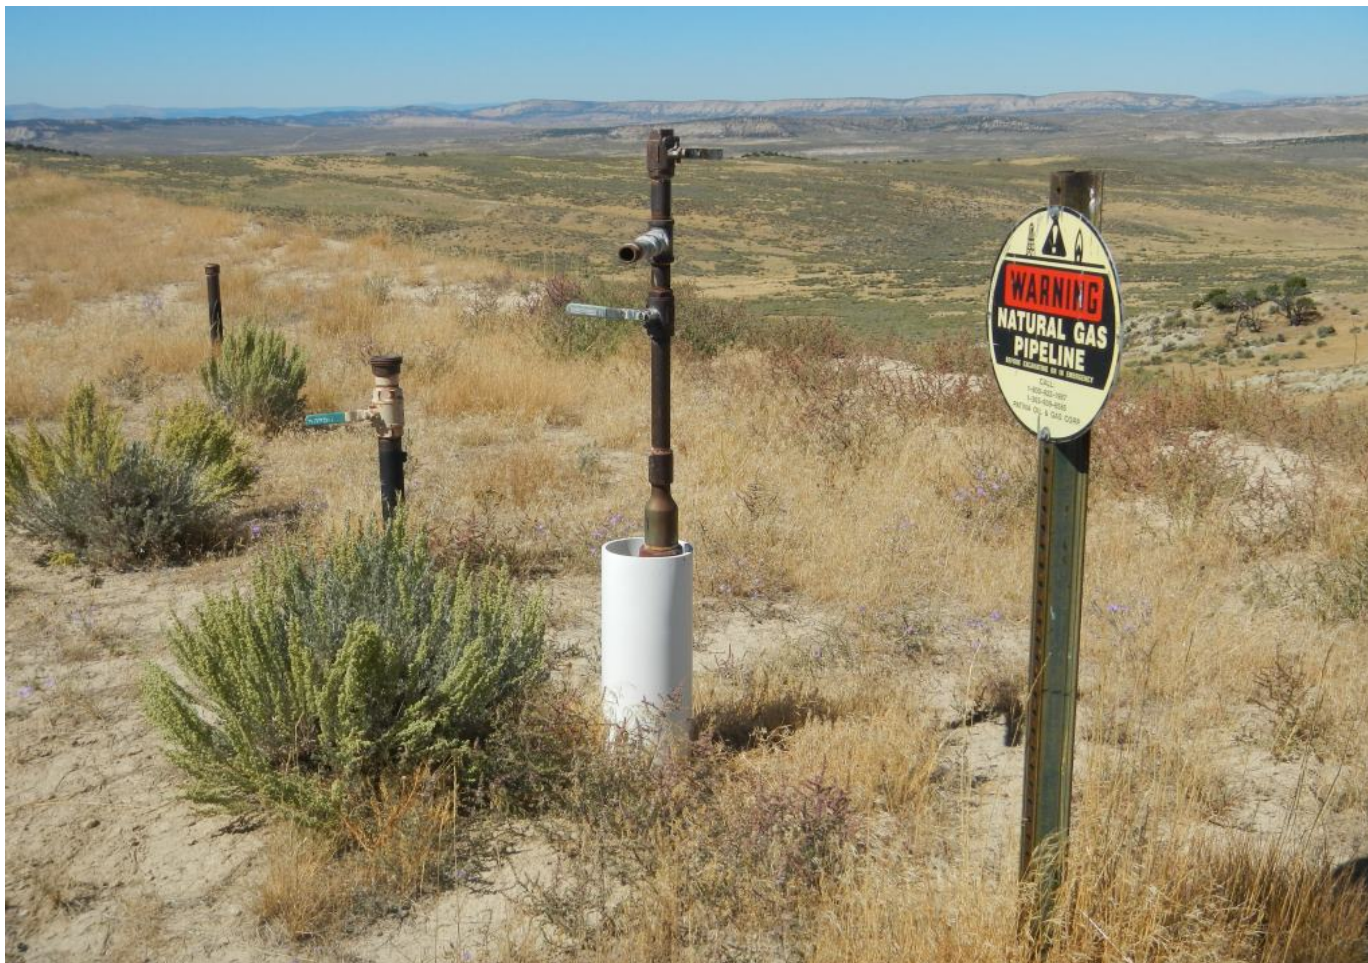
**Photo#5:** Risers/ lines remain on Location.

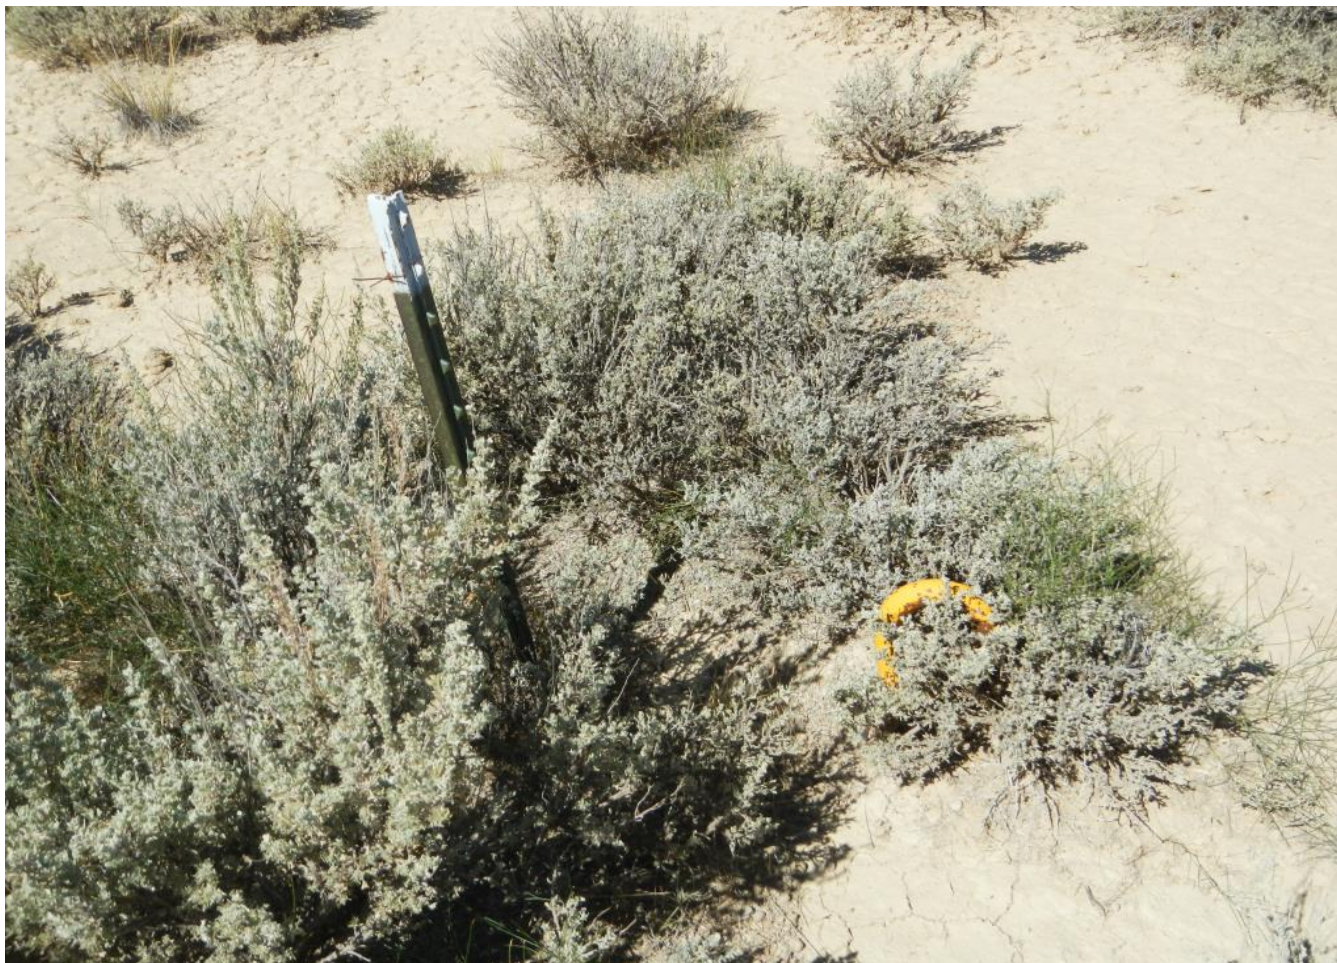
**Photo#6:** Guy Anchors remain.

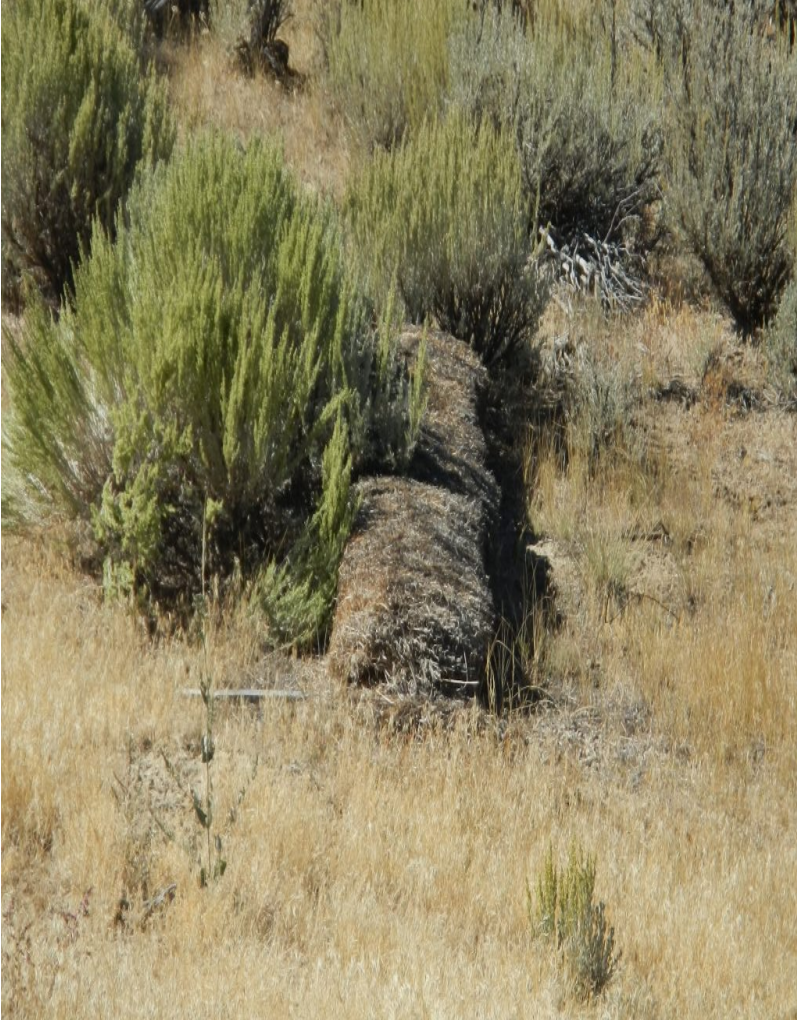
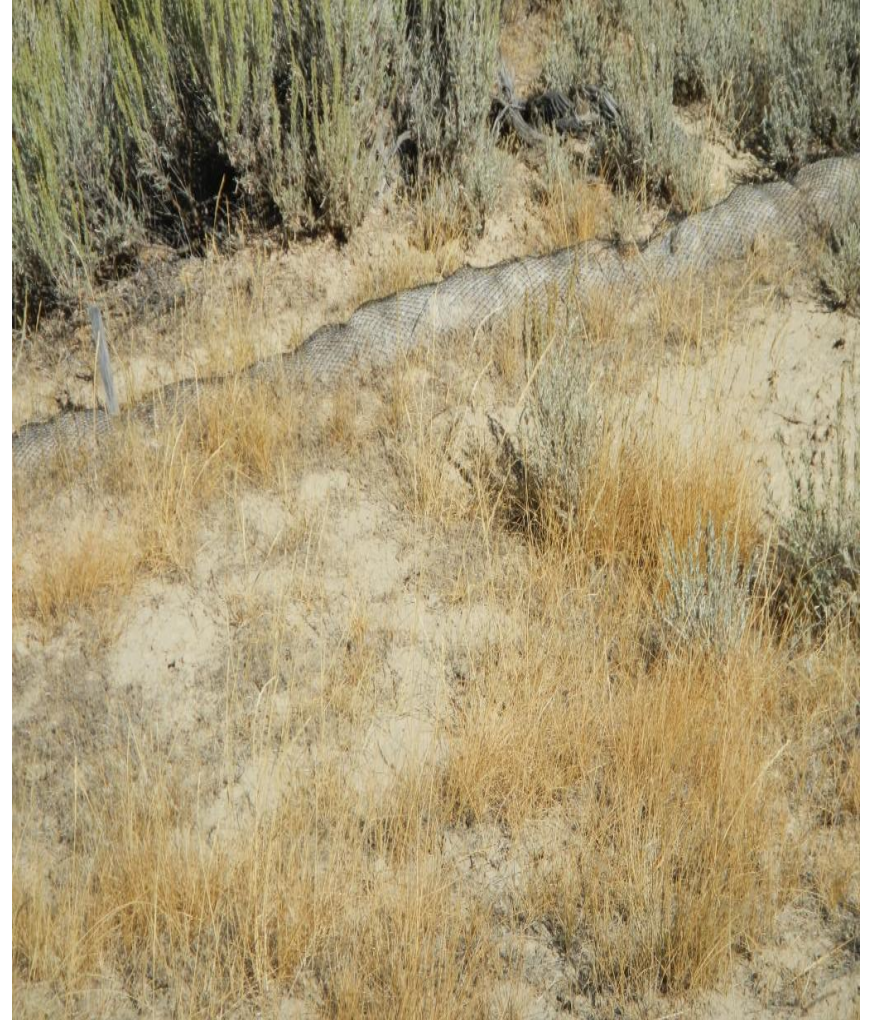
Photos 7 & 8: BMPs remain on Perimeter

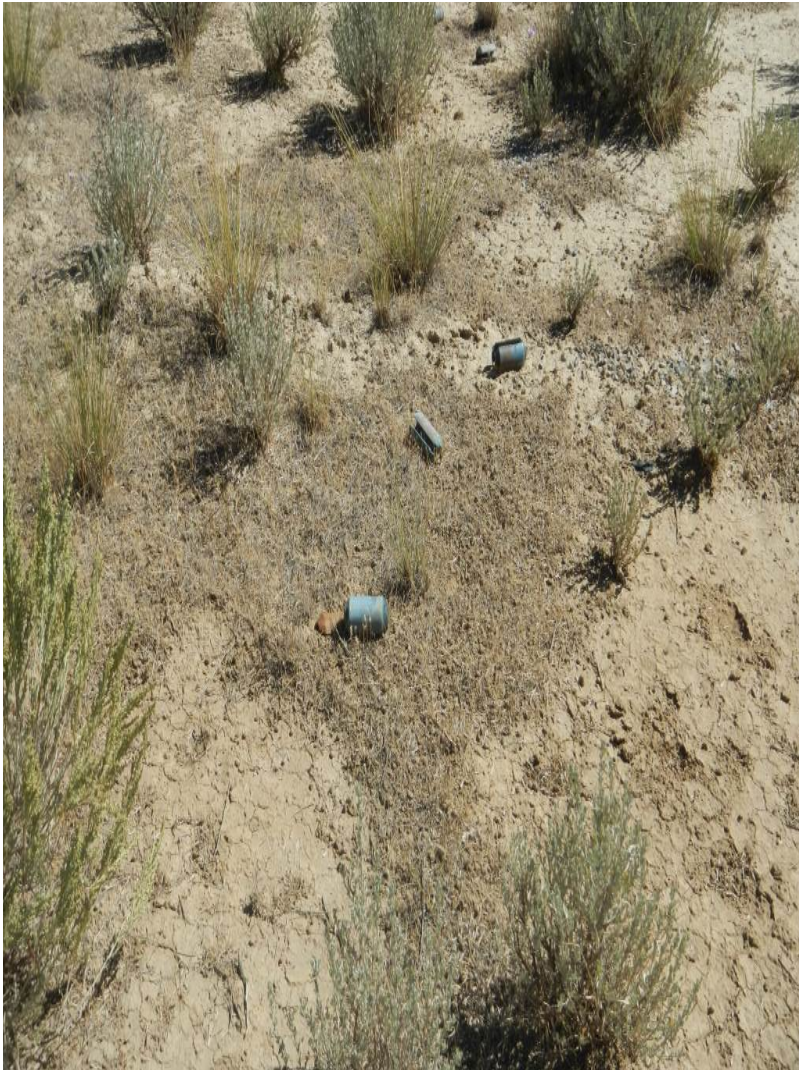
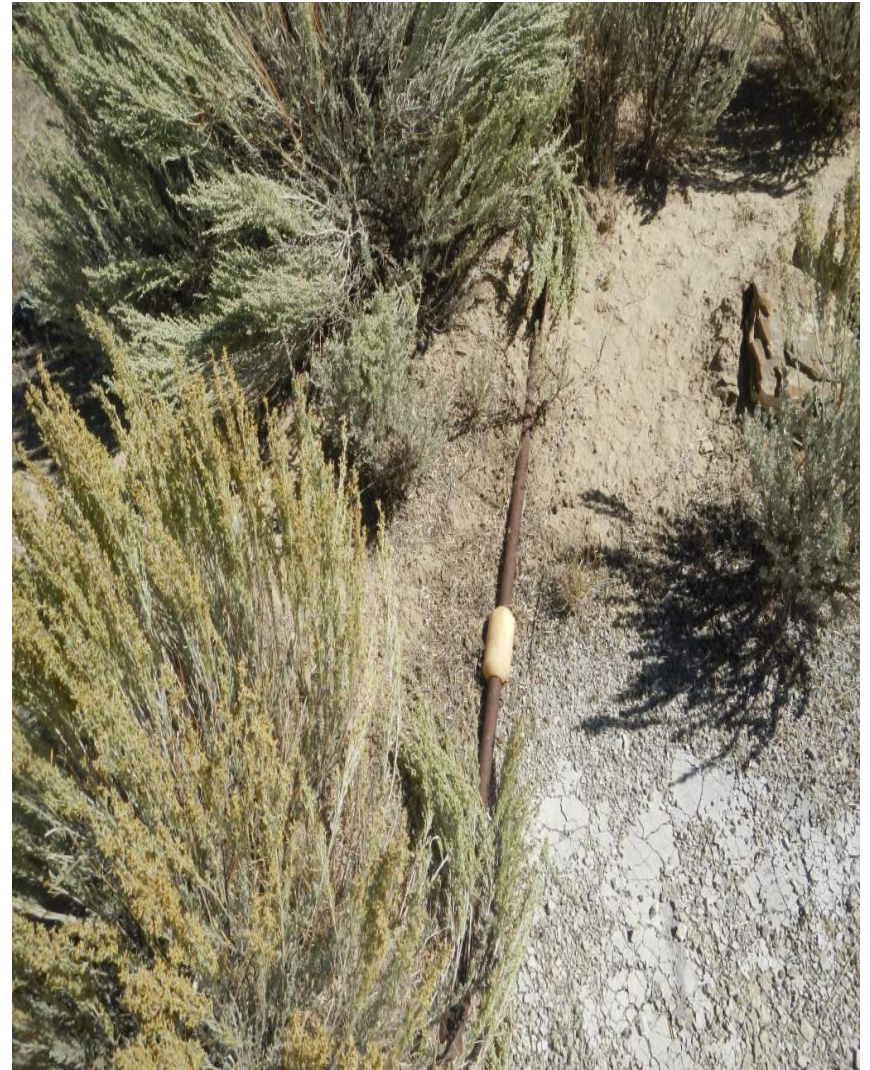
Photos 9 & 10: Debris remains on Location.

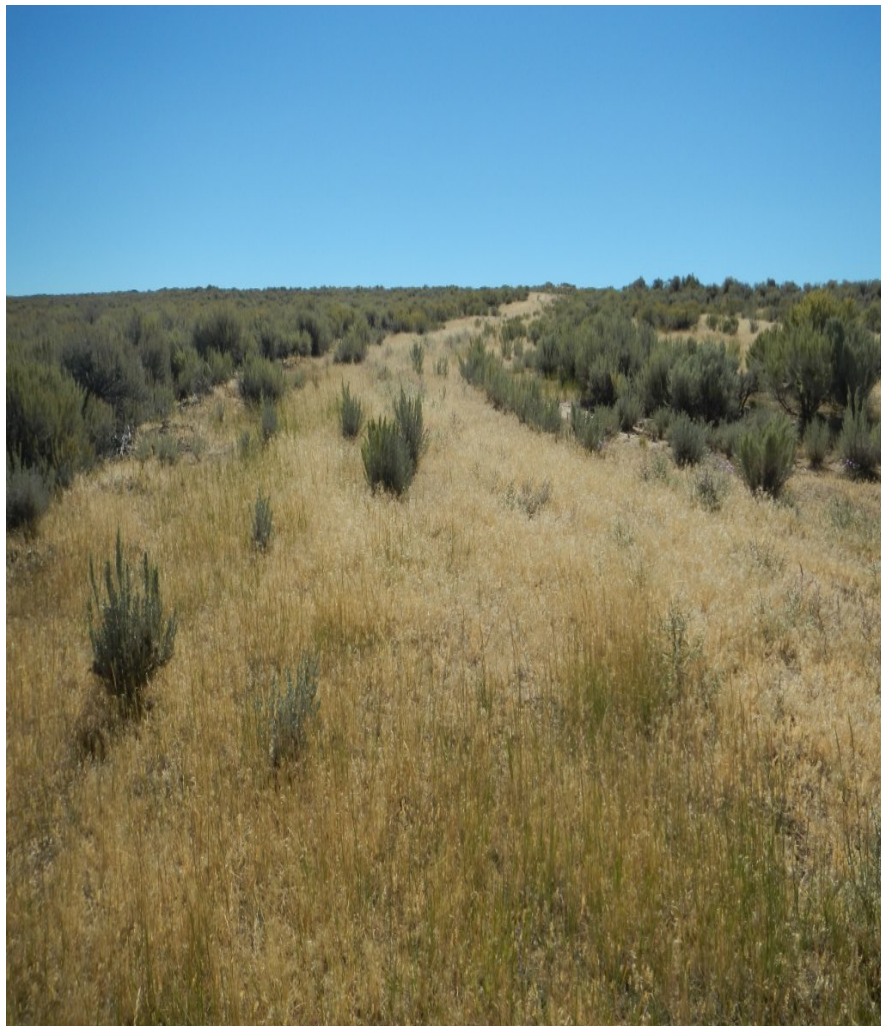
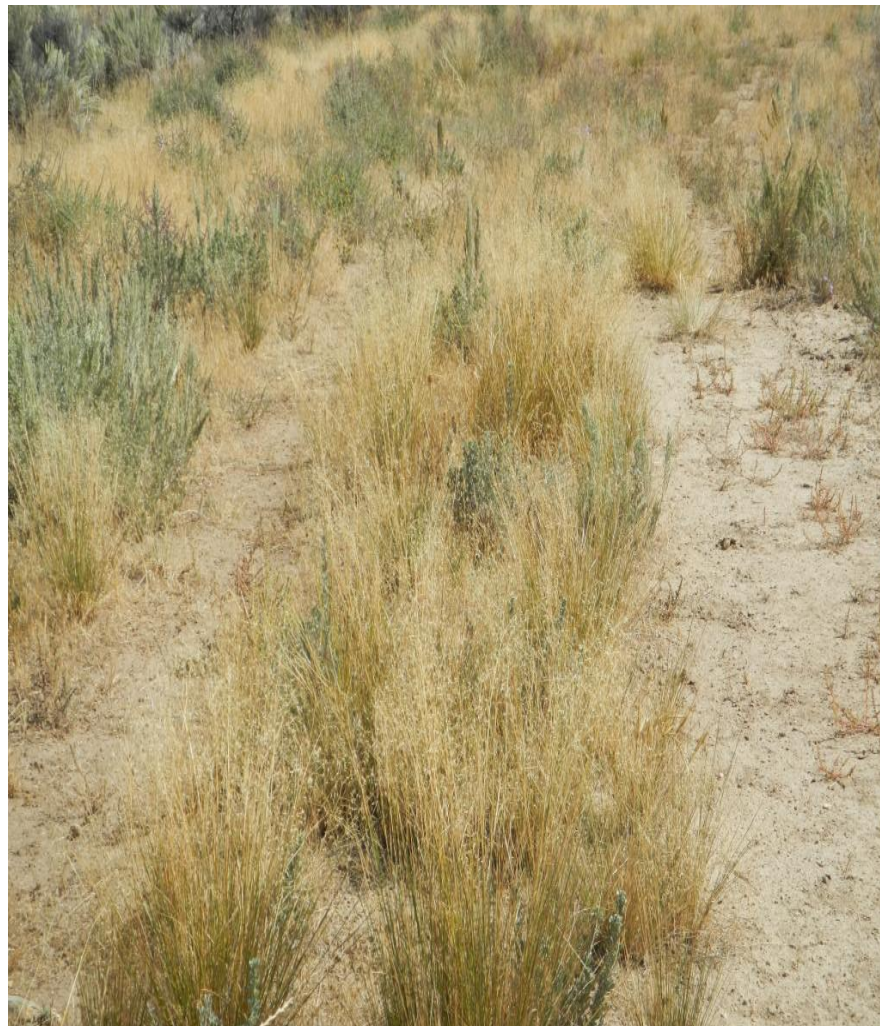
Photos 11 & 12: Access Road Leading out of Location **.7** Miles to Gate
