Stormwater Inspection

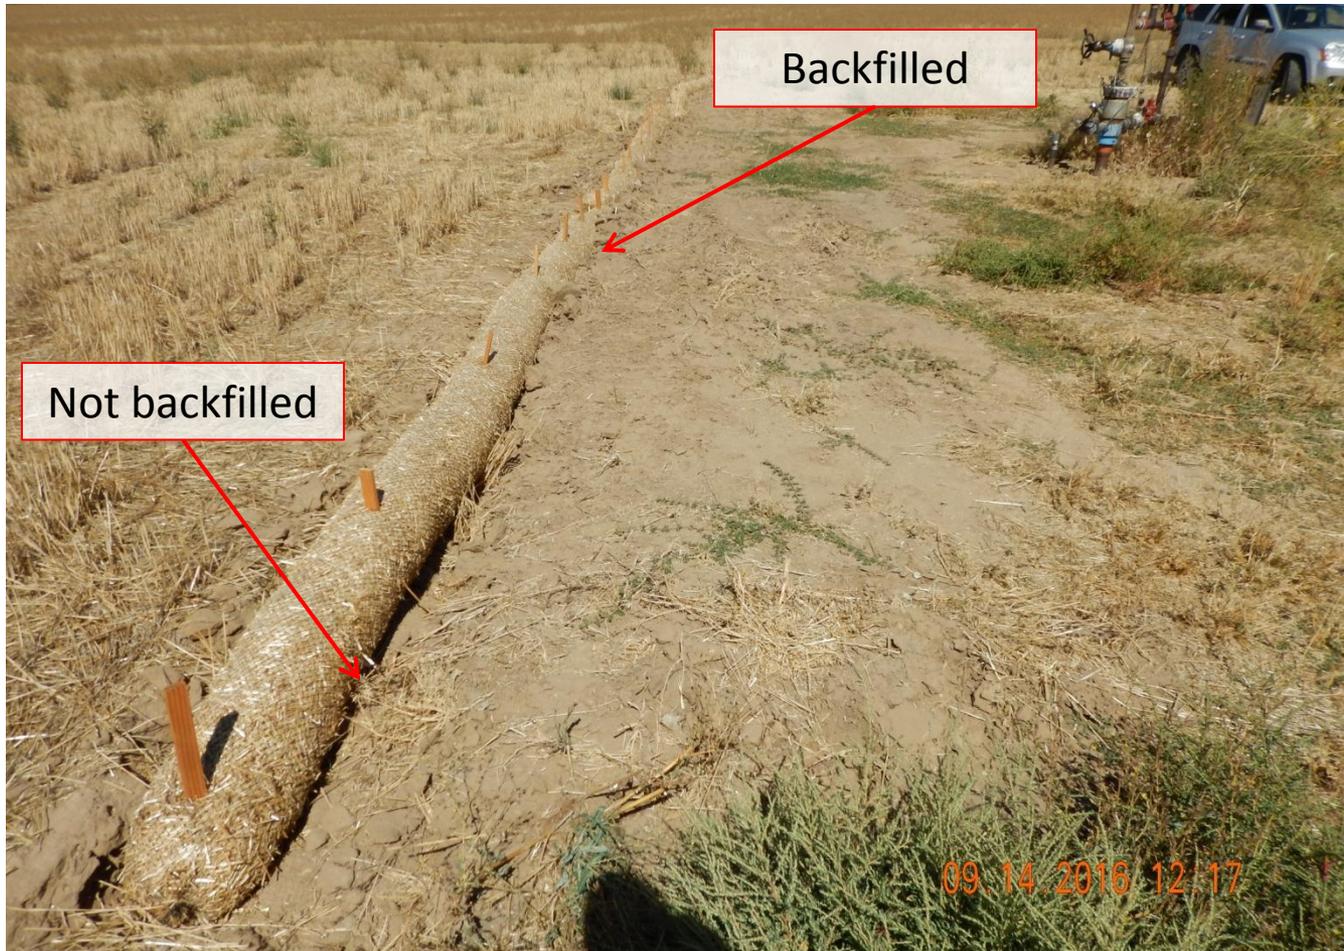
Photo 1. Photo taken southwest of the wellhead, facing North. Wattles were installed along the western perimeter. Wattle installation has some potential weak spots because areas were not properly backfilled and compacted.

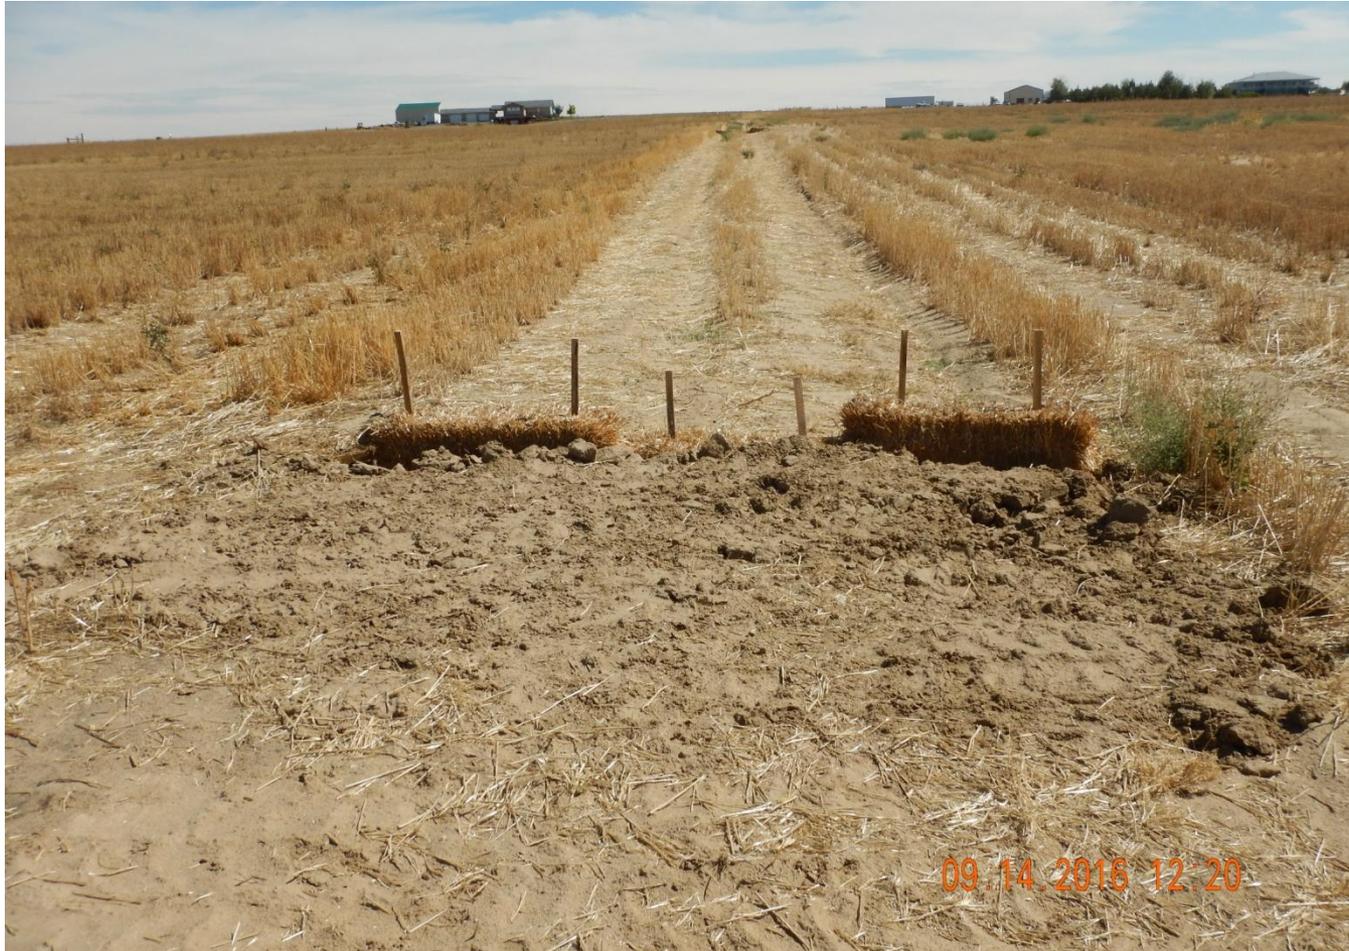
Photo 2. Photo taken east of wellhead along access, facing East, towards the first of two straw bale BMPs installed.

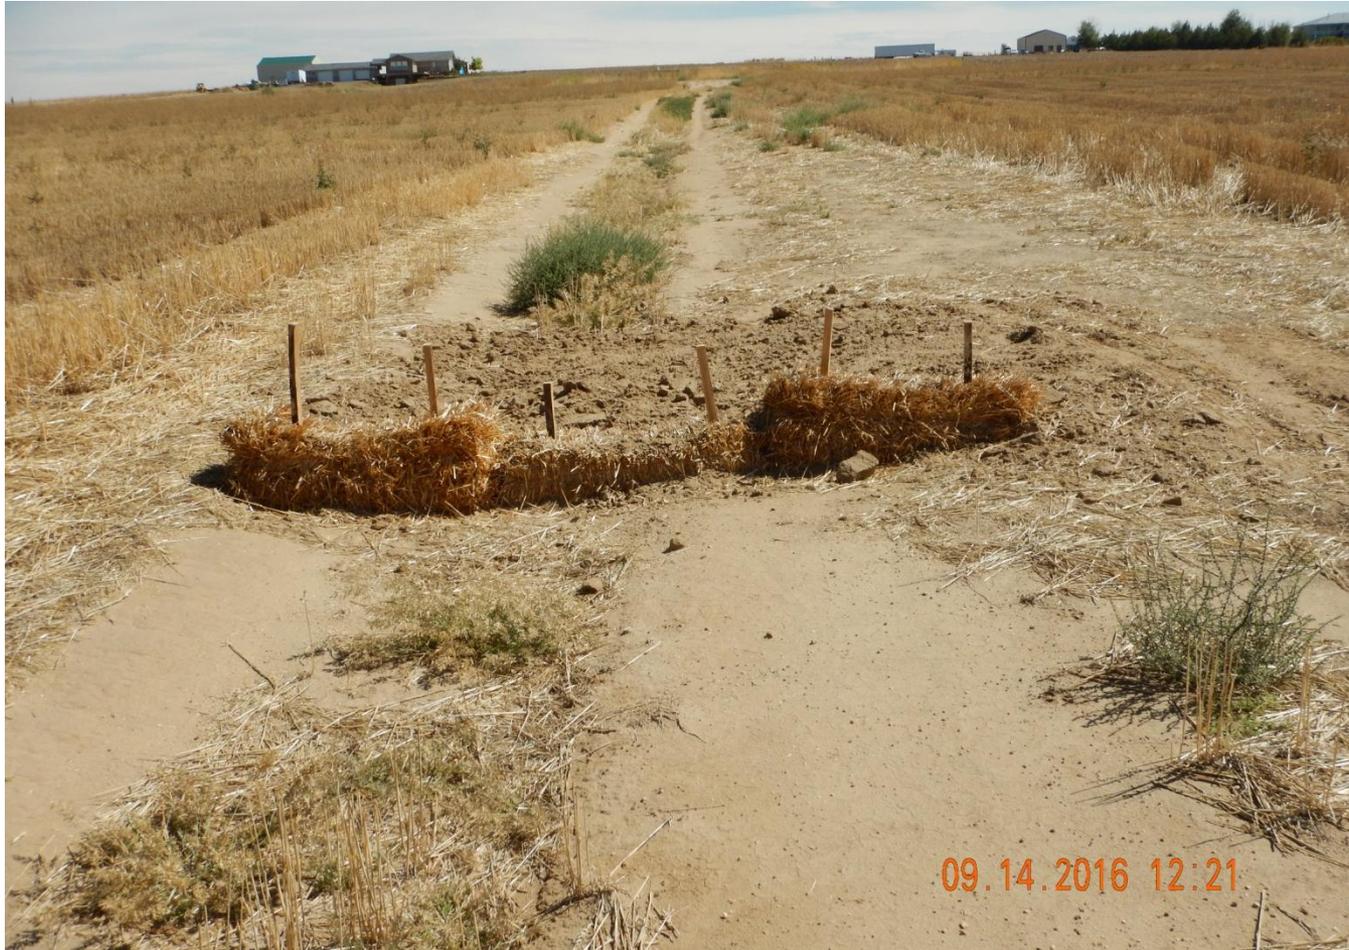
Photo 3. Photo taken east of the last BMP, facing East, towards the second straw bale BMP installed along the access road.
