Construction Inspection

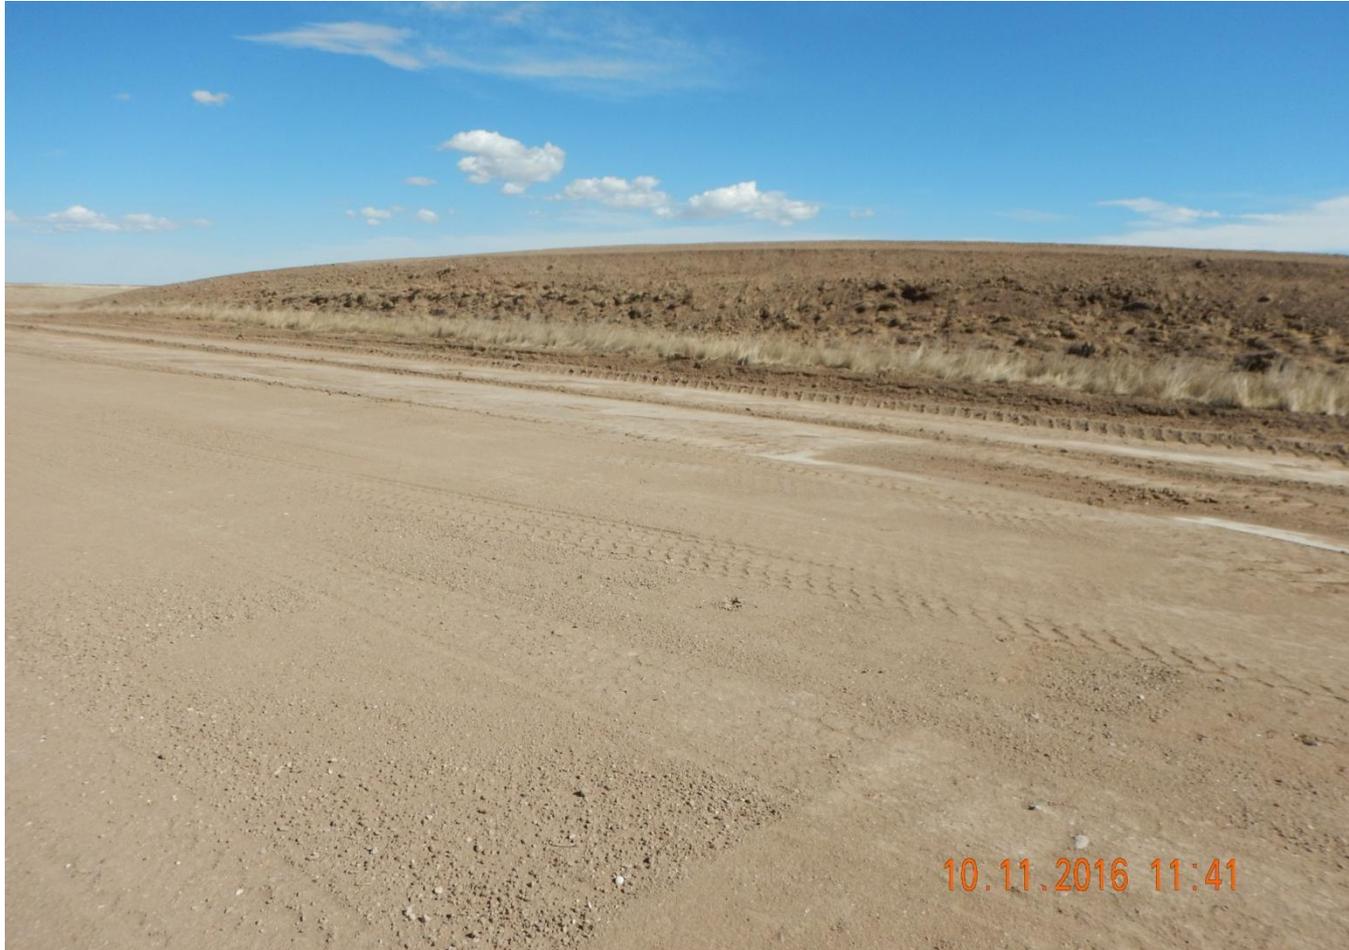
Photo 1. Photo taken from eastern location, facing East, towards topsoil stockpile.

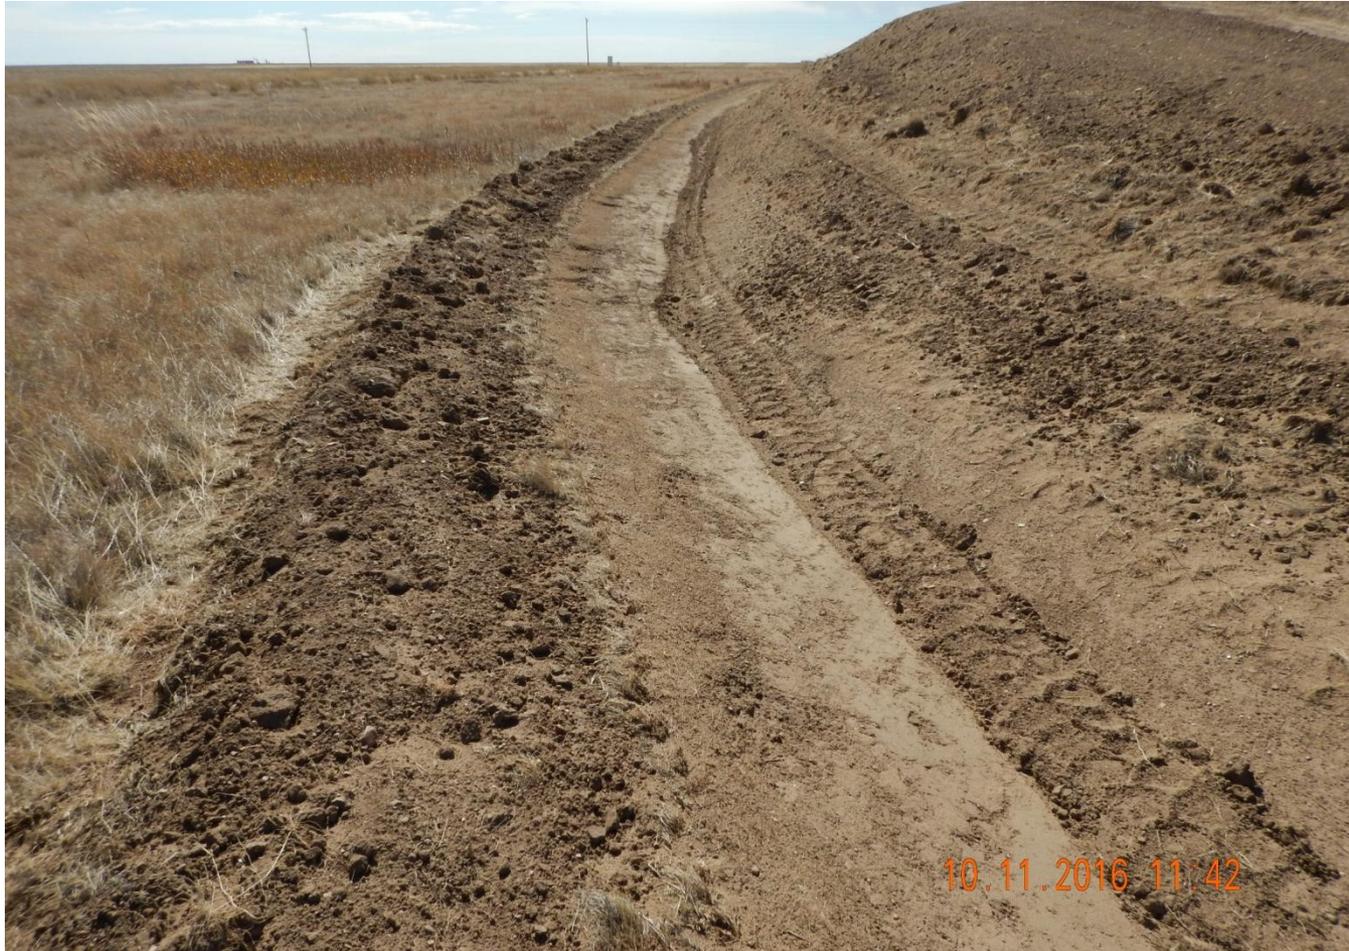
Photo 2. Photo taken from the eastern topsoil pile, facing South. Ditch and berm constructed around outer perimeter of topsoil pile.

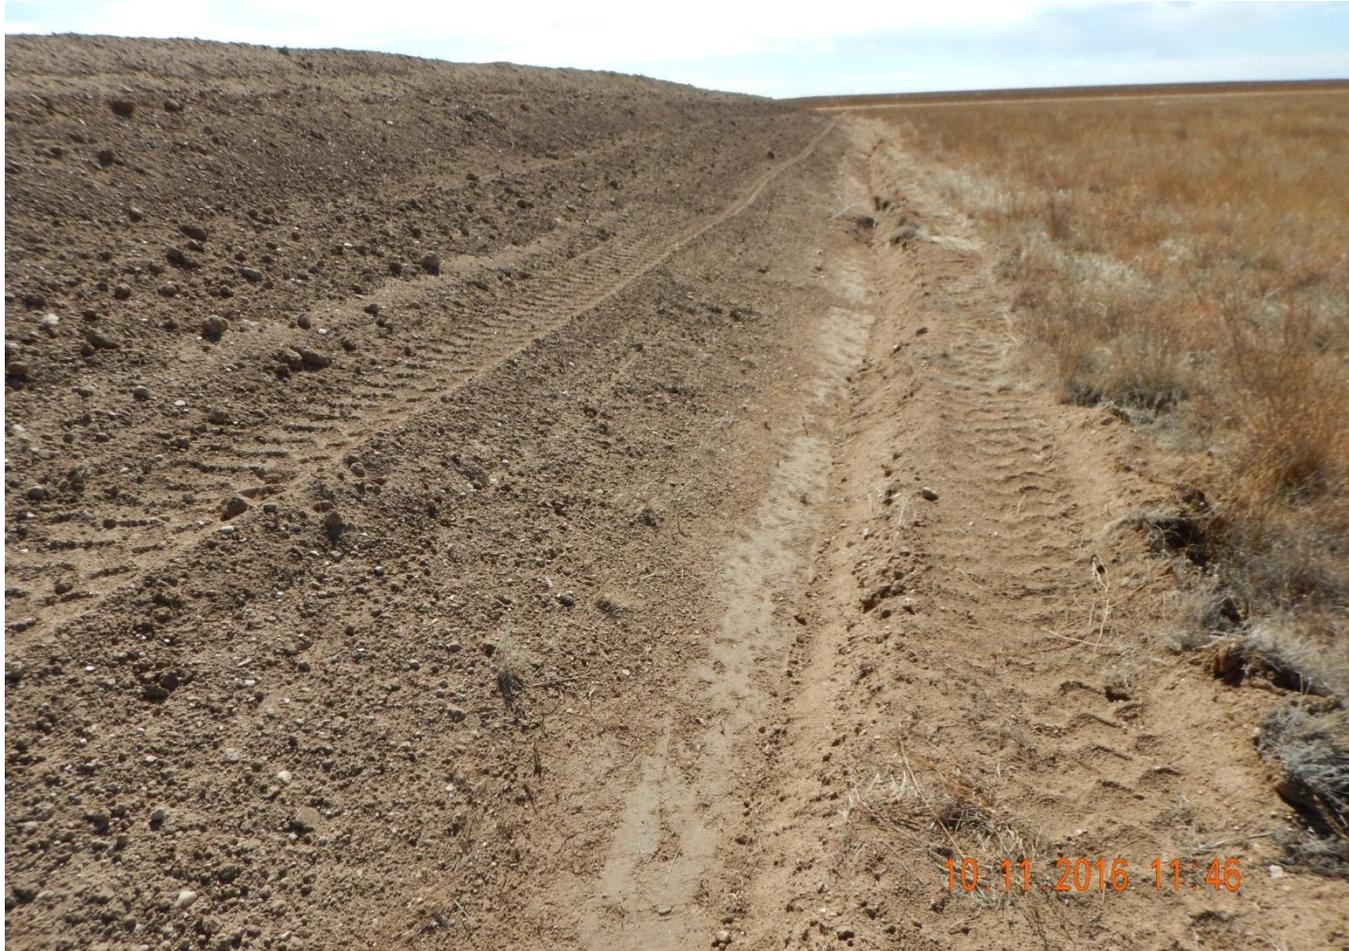
Photo 3. Photo taken from the western soil pile, facing South. Ditch and berm constructed around outer perimeter of subsoil pile. Contractor will re-cut ditch to a wider and deeper depth.

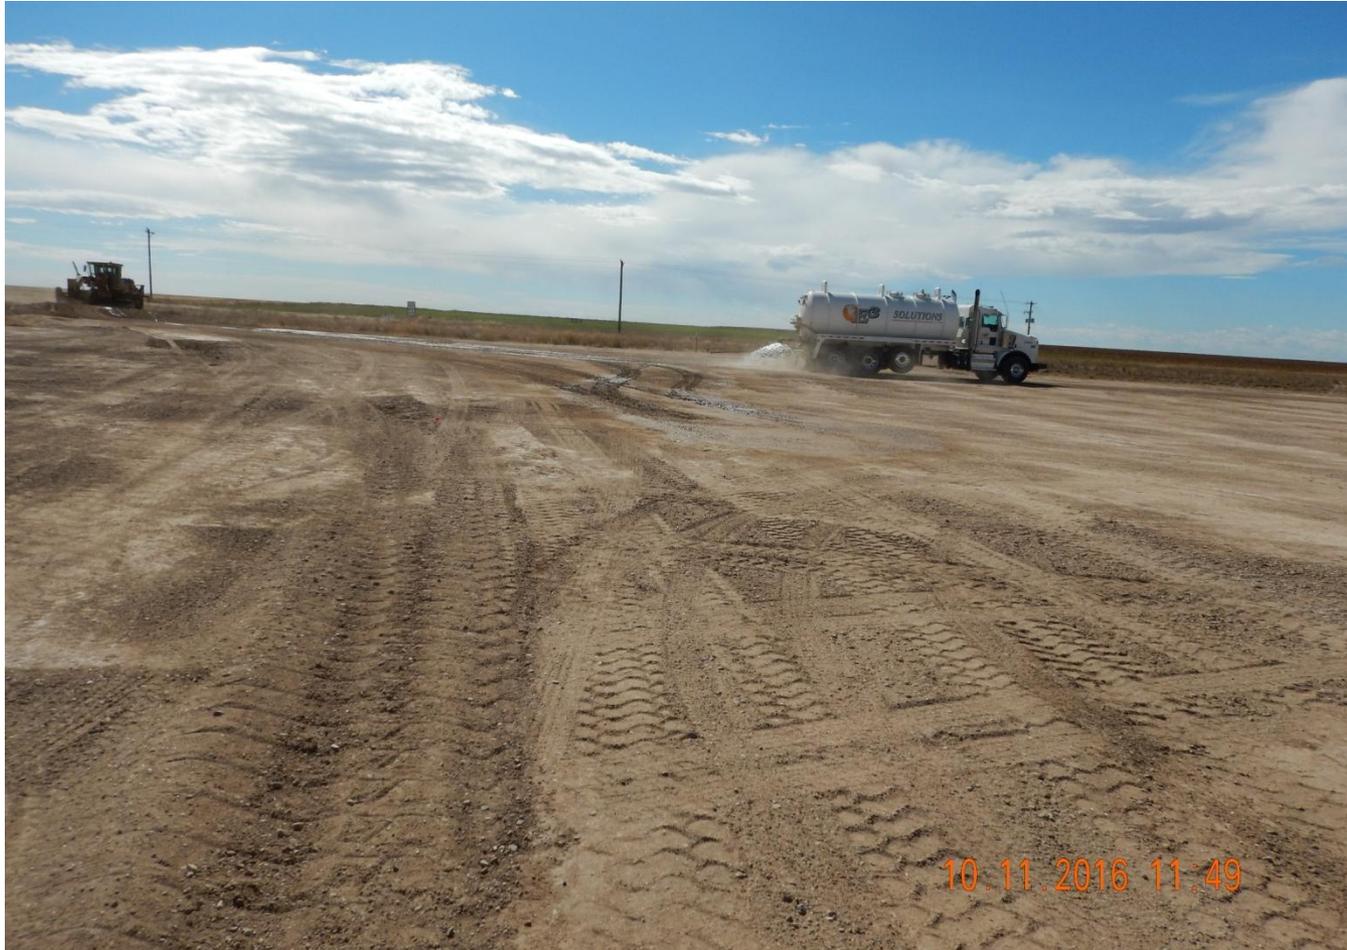
Photo 4. Photo taken from center of location, facing South. Water truck on location to control fugitive dust from operations.
