Final Reclamation Inspection- Overview

Final Reclamation Inspection

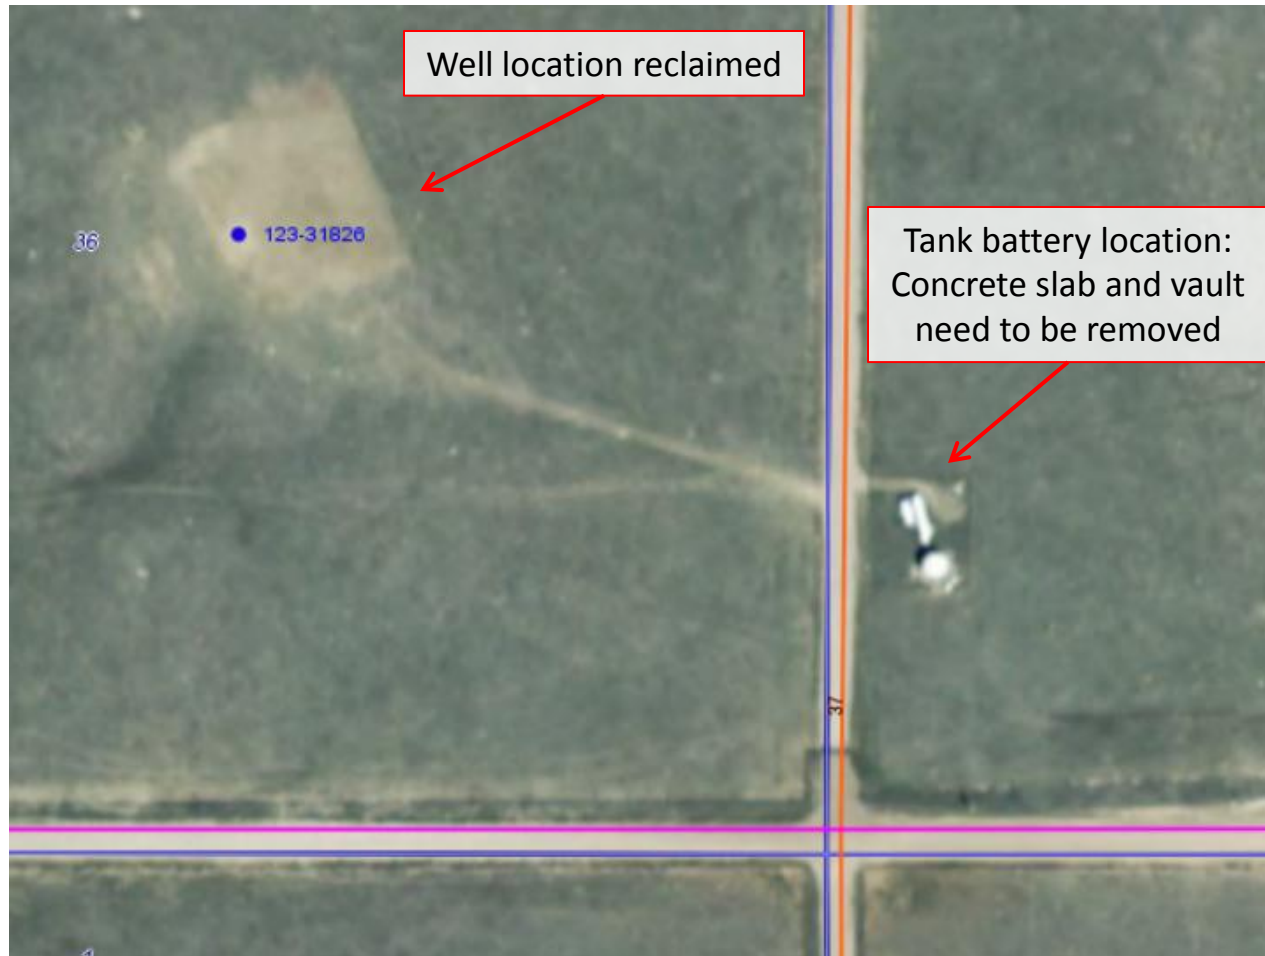
Aerial imagery taken 2011 using COGCC GISOnline, illustrating well location and tank battery location. Well location meets Rule 1004 standards; however, concrete slab and vault need to be removed from tank battery location.

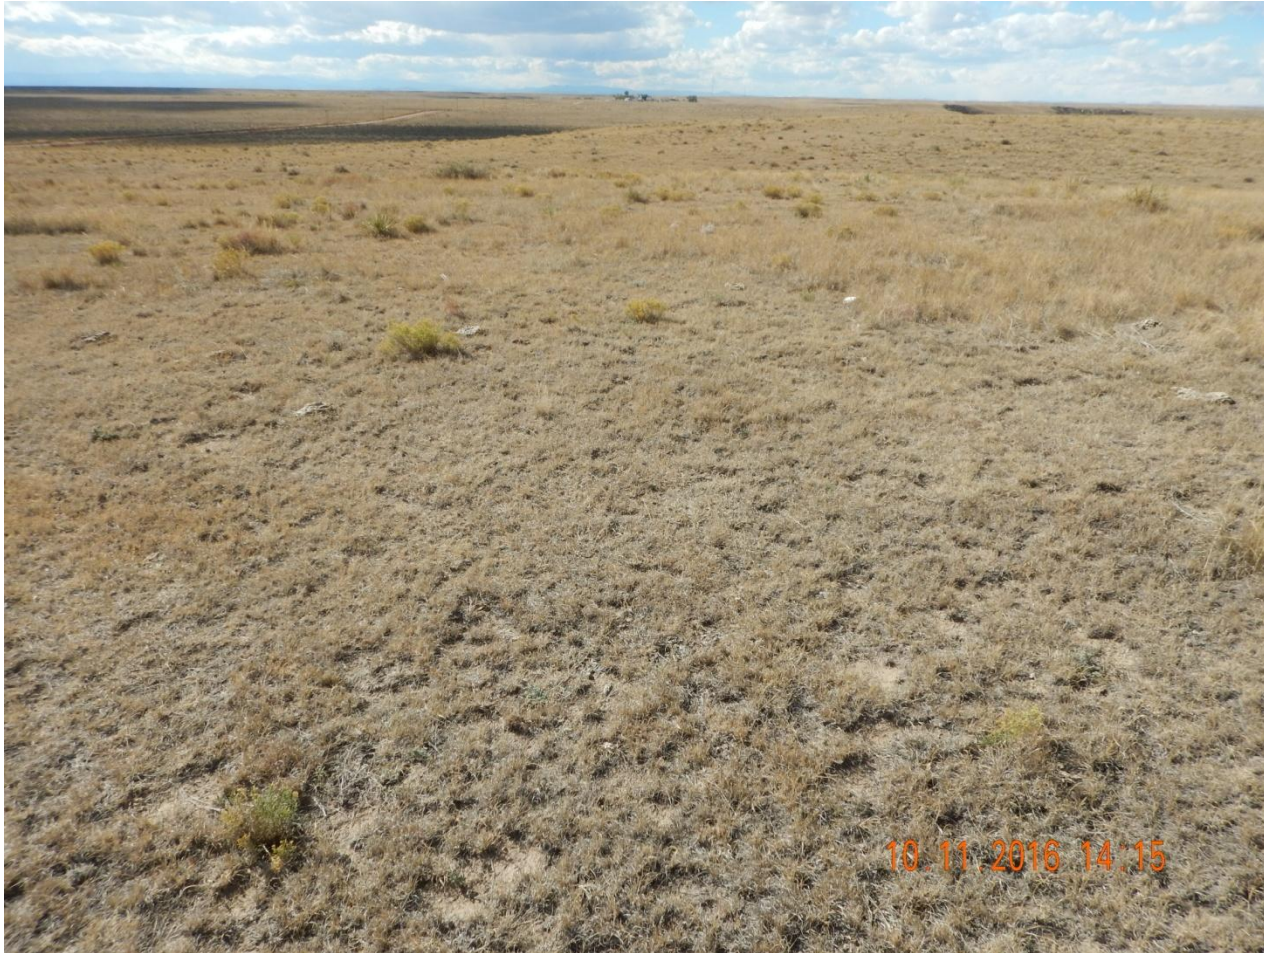
Photo 1. Photo taken from center of location, facing West. No evidence of disturbance. Location appears to be reflective of reference areas.

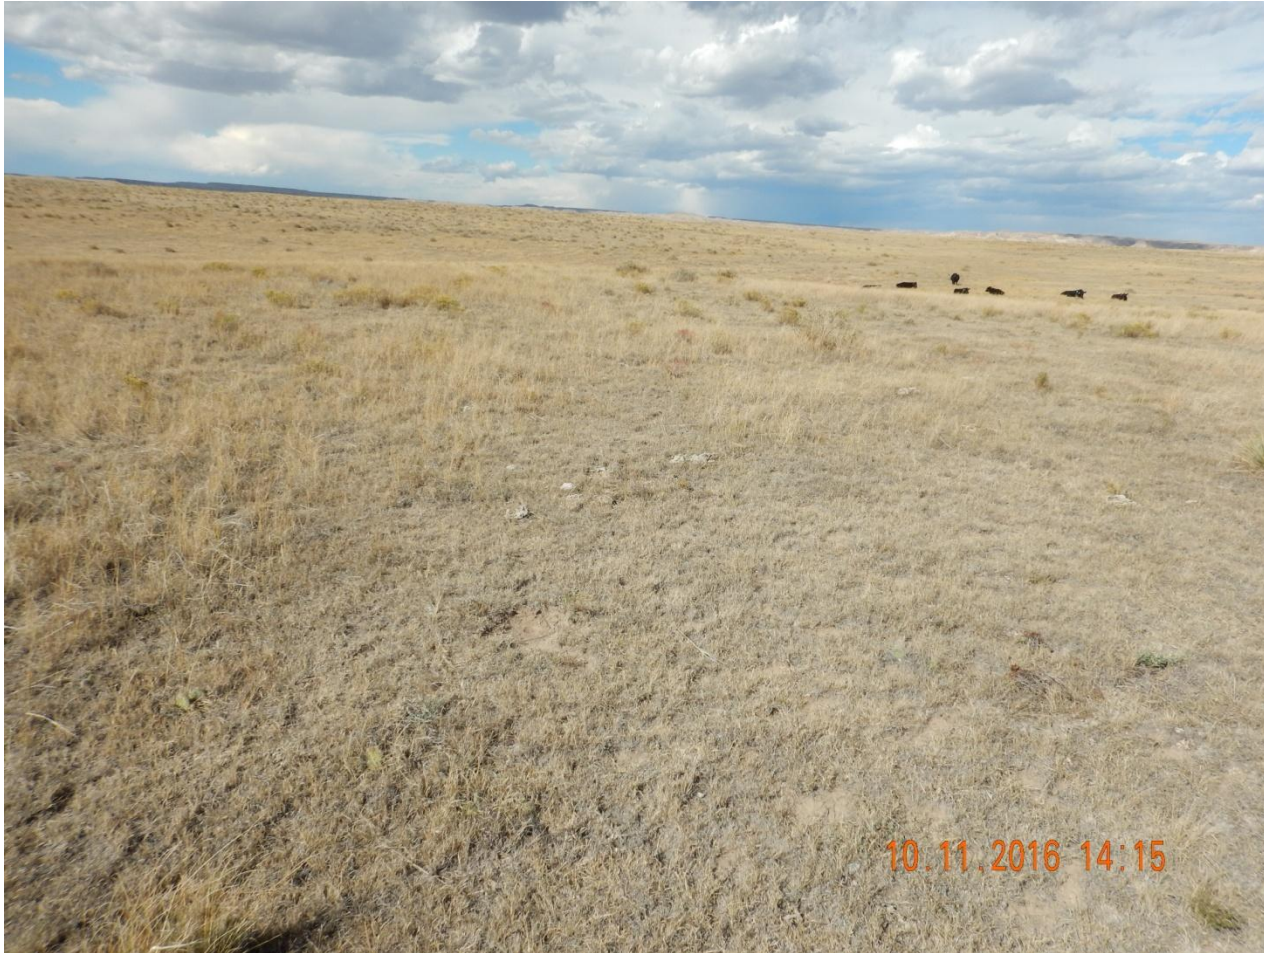
Photo 2. Photo taken from center of location, facing North. No evidence of disturbance. Location appears to be reflective of reference areas.

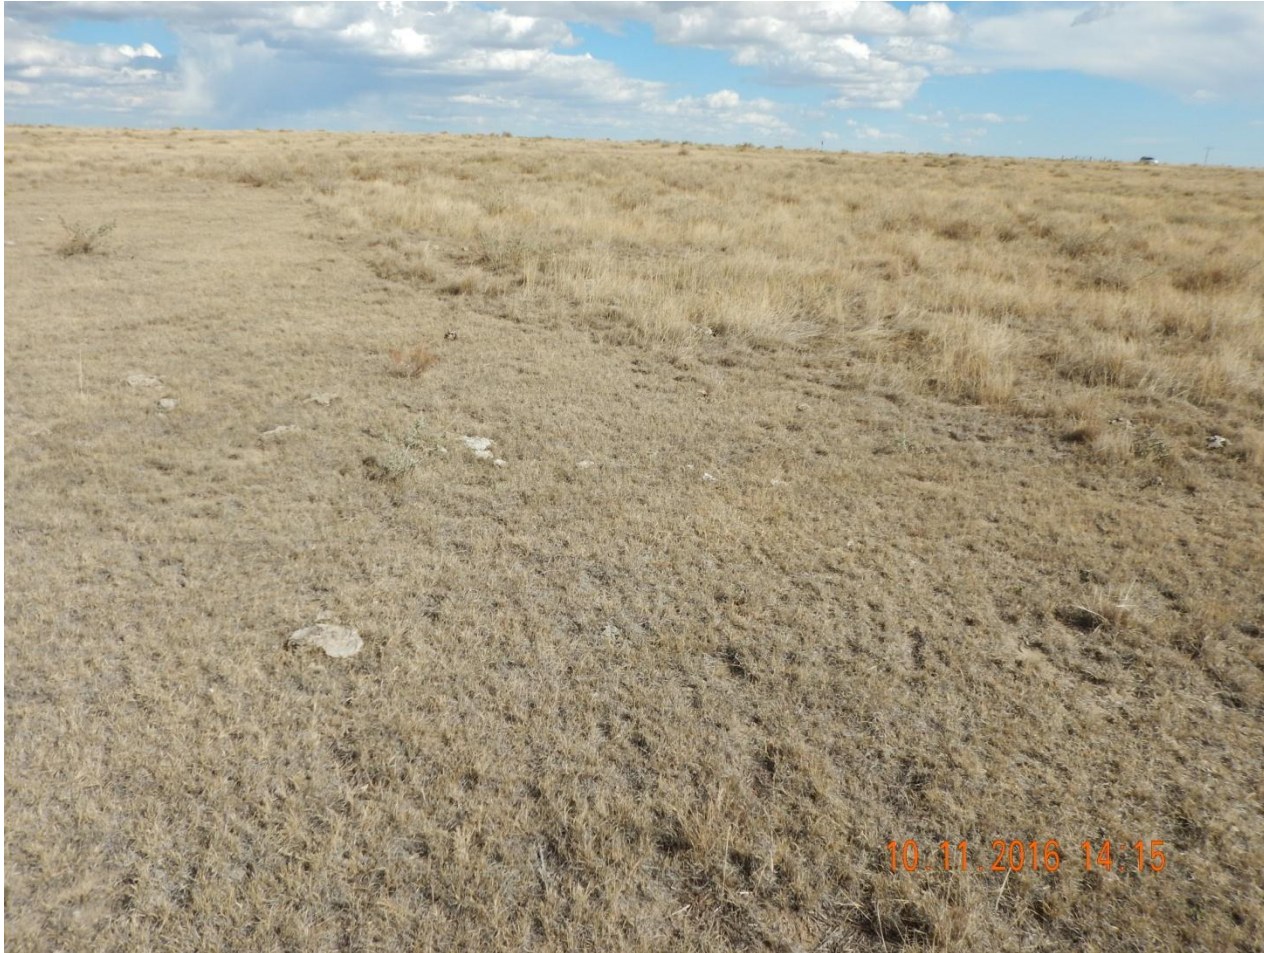
Photo 3. Photo taken from center of location, facing East. No evidence of disturbance. Location appears to be reflective of reference areas.

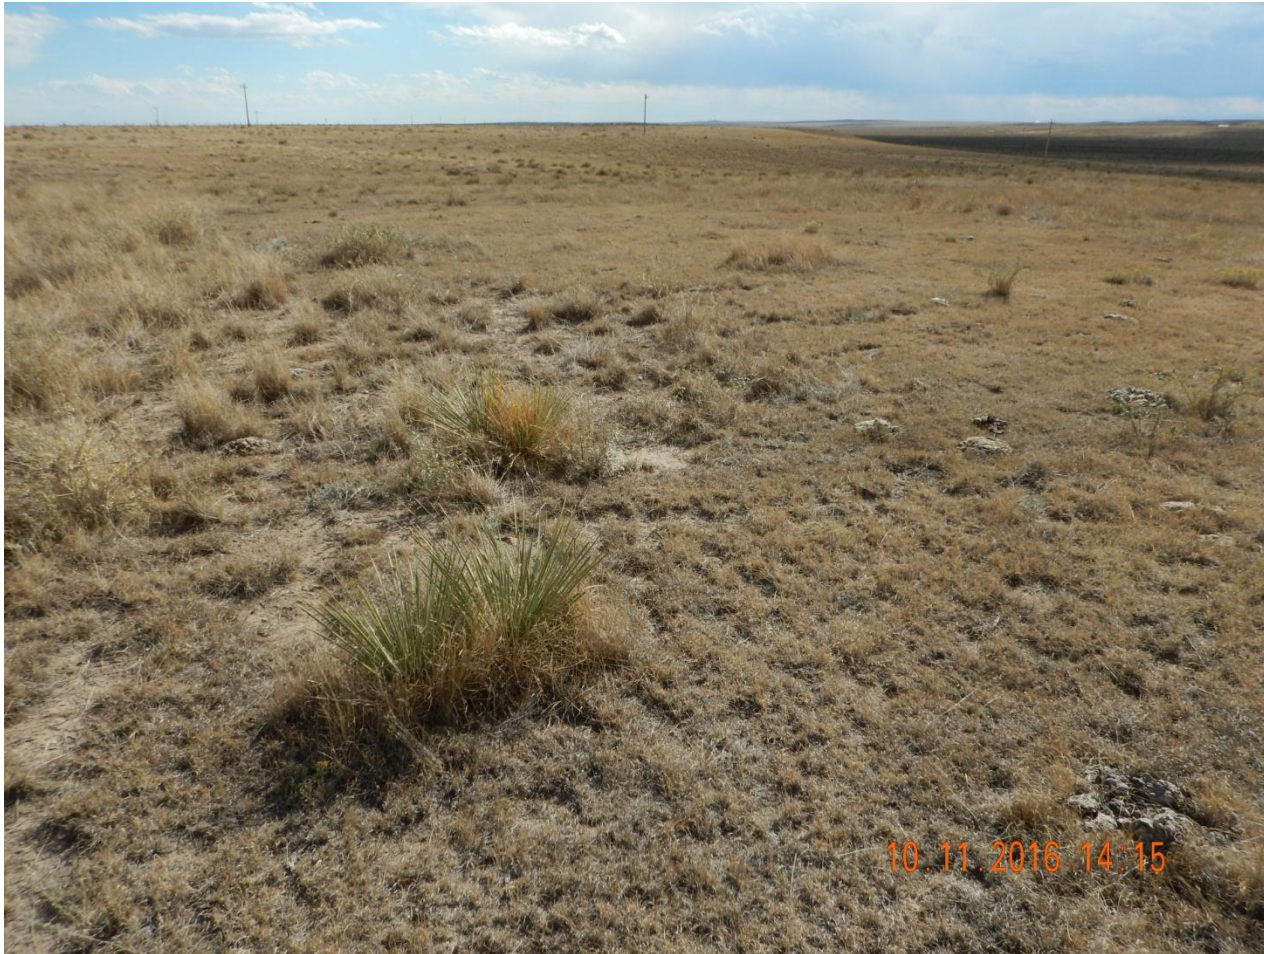
Photo 4. Photo taken from center of location, facing South. No evidence of disturbance. Location appears to be reflective of reference areas.

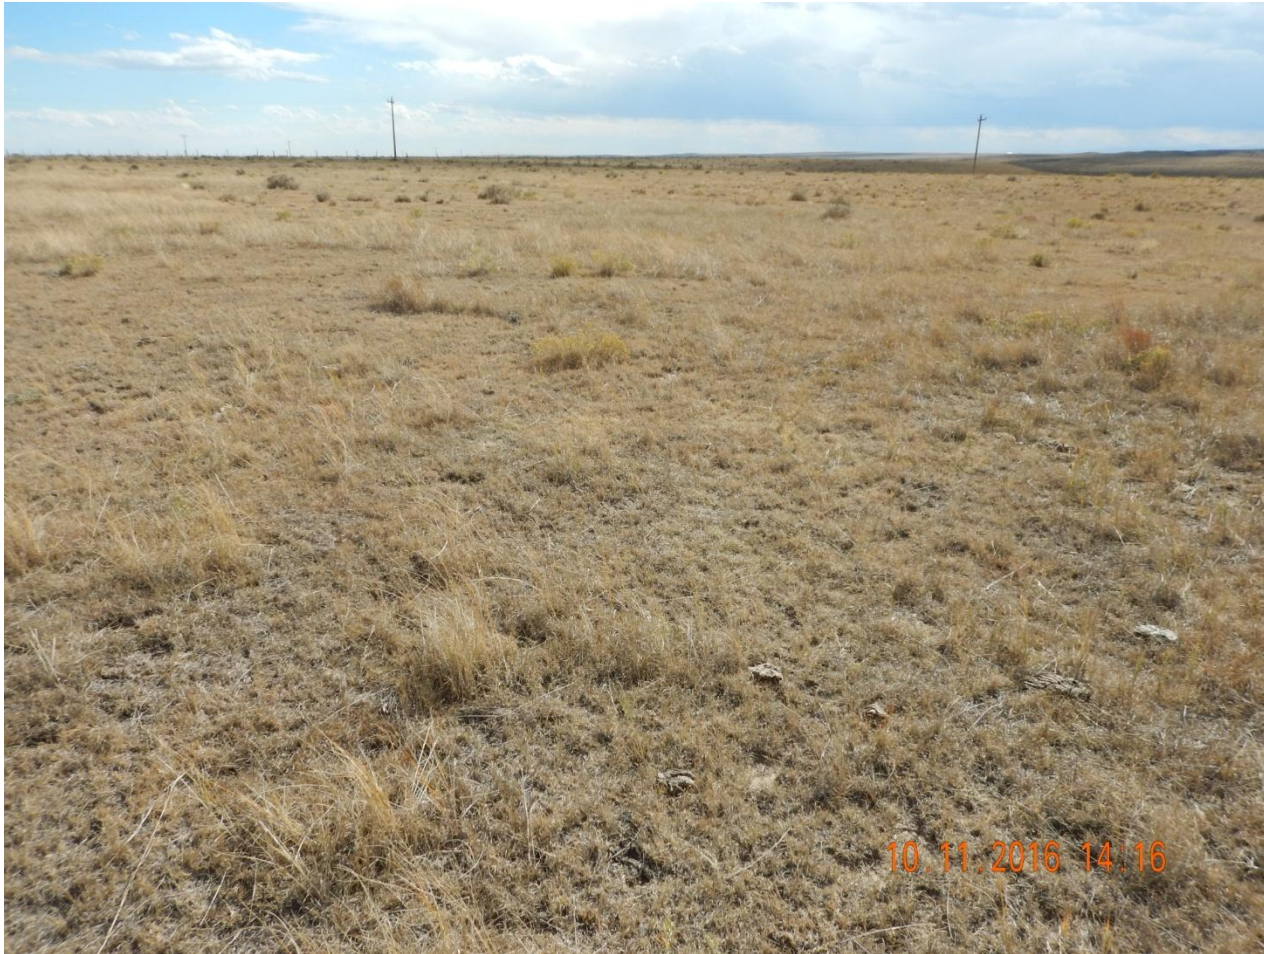
Photo 5. Reference photo taken south of location, facing South. Location appears to be reflective of reference areas.

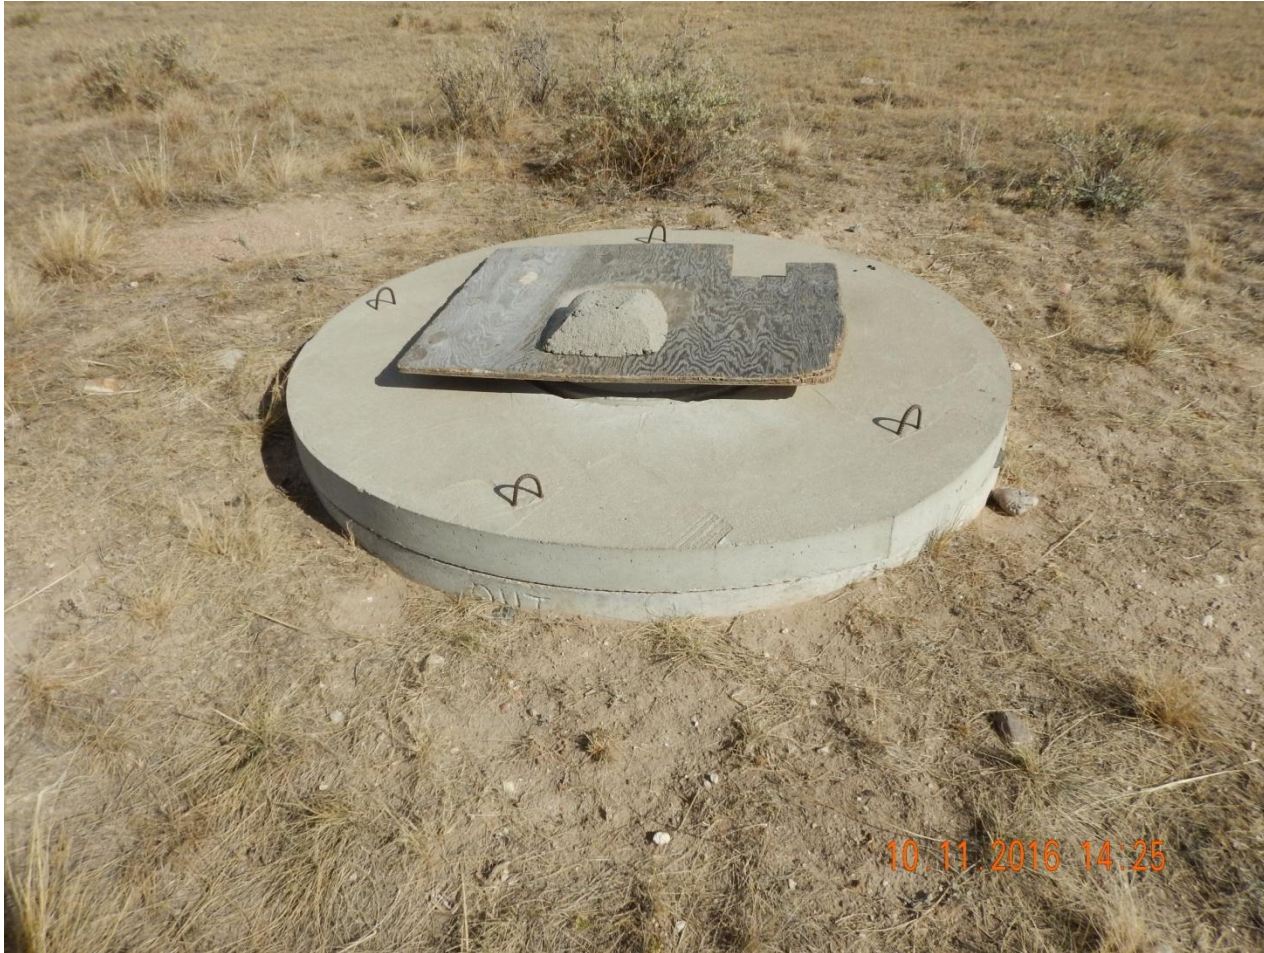
Photo 6. Photo taken from tank battery location. Concrete vault needs to be removed per Rule 1004.

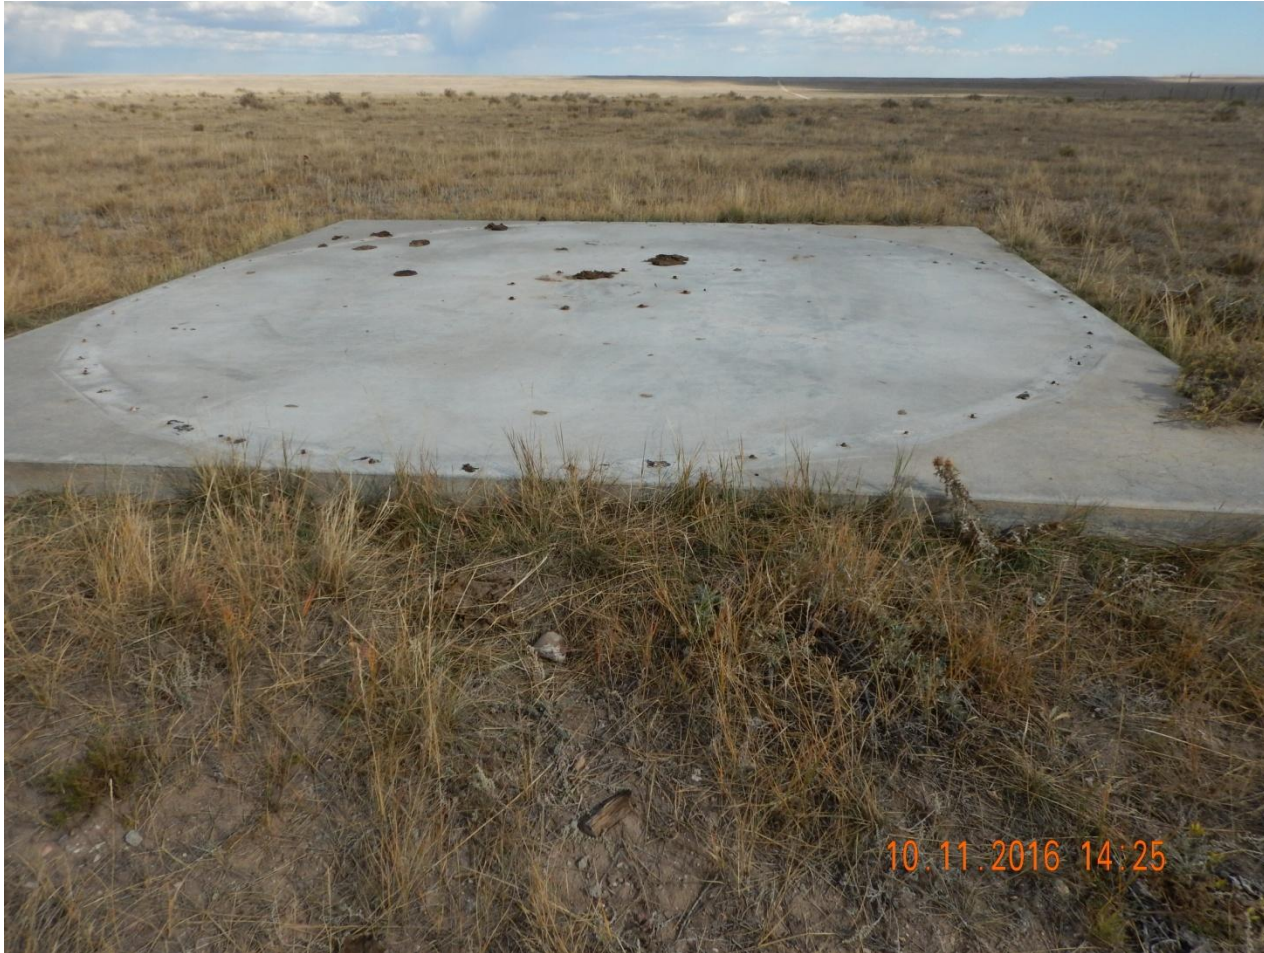
Photo 7. Photo taken from tank battery location. Concrete slab needs to be removed per Rule 1004.
