October 18, 2016

Inspection Photos: Encana PA O`Connell API#045-09353

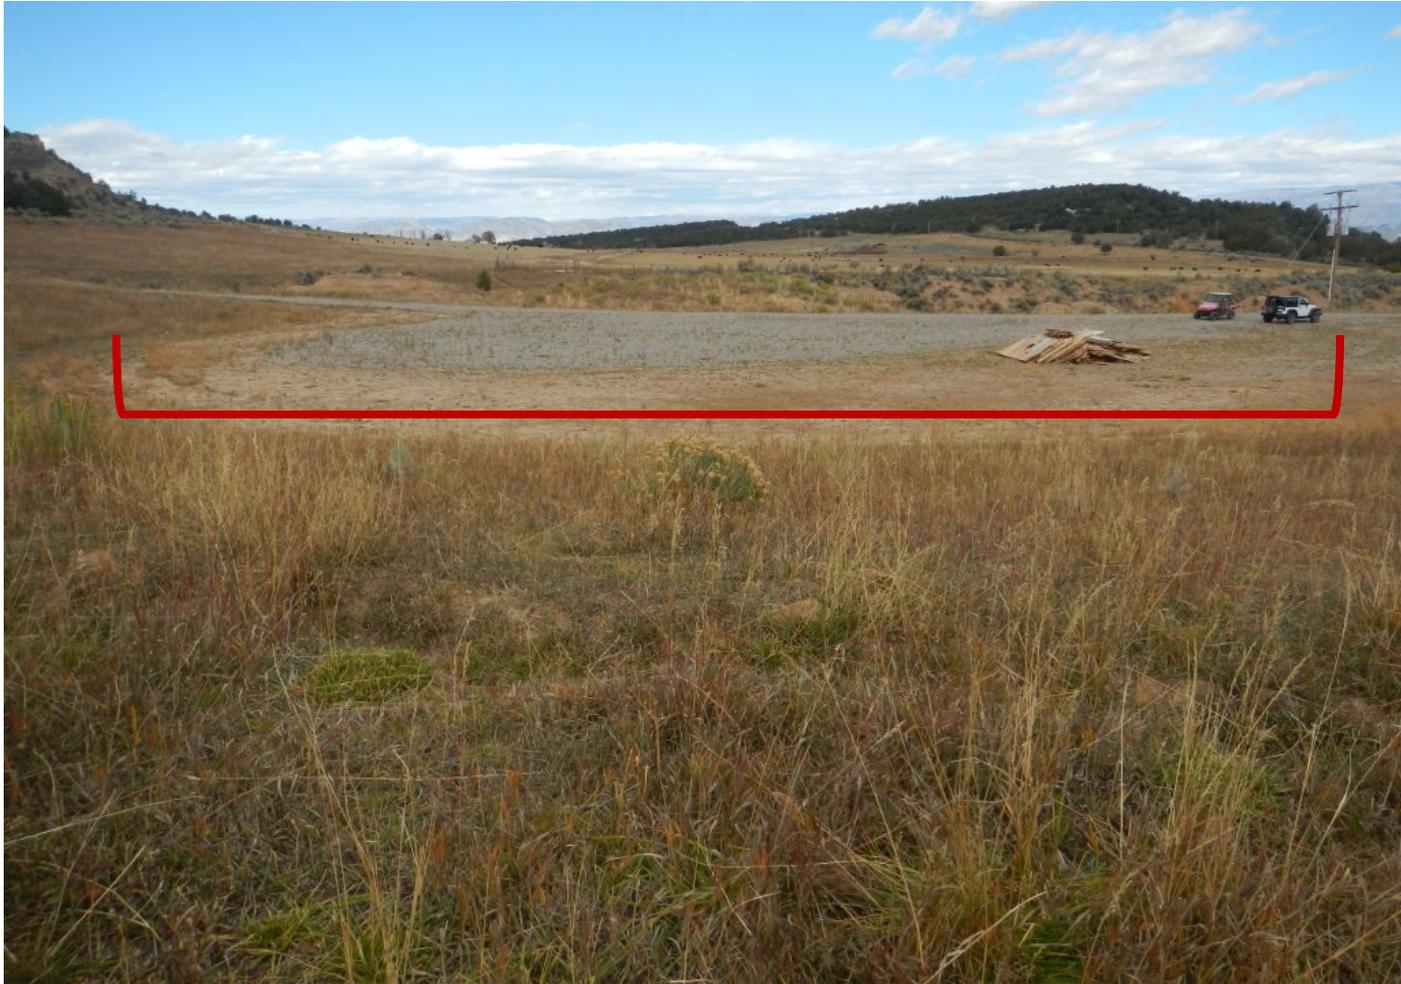
Photo#1: Overview of Location to NW. Red Bracket shows failed Vegetation area.

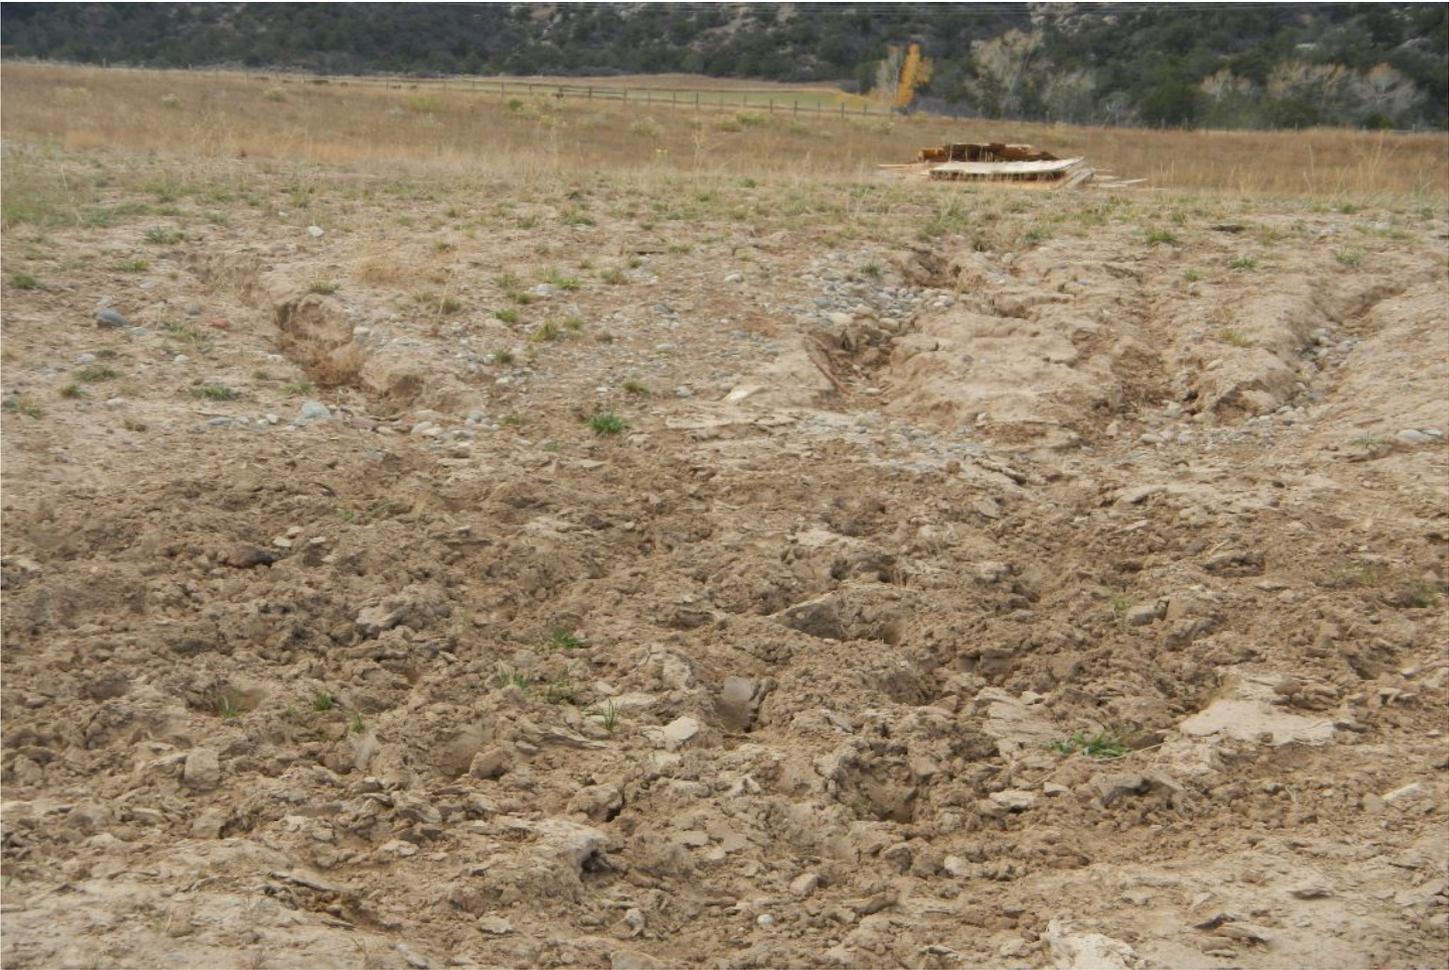
Photo#2: View to SW of erosion commencing in Failed Vegetation area.

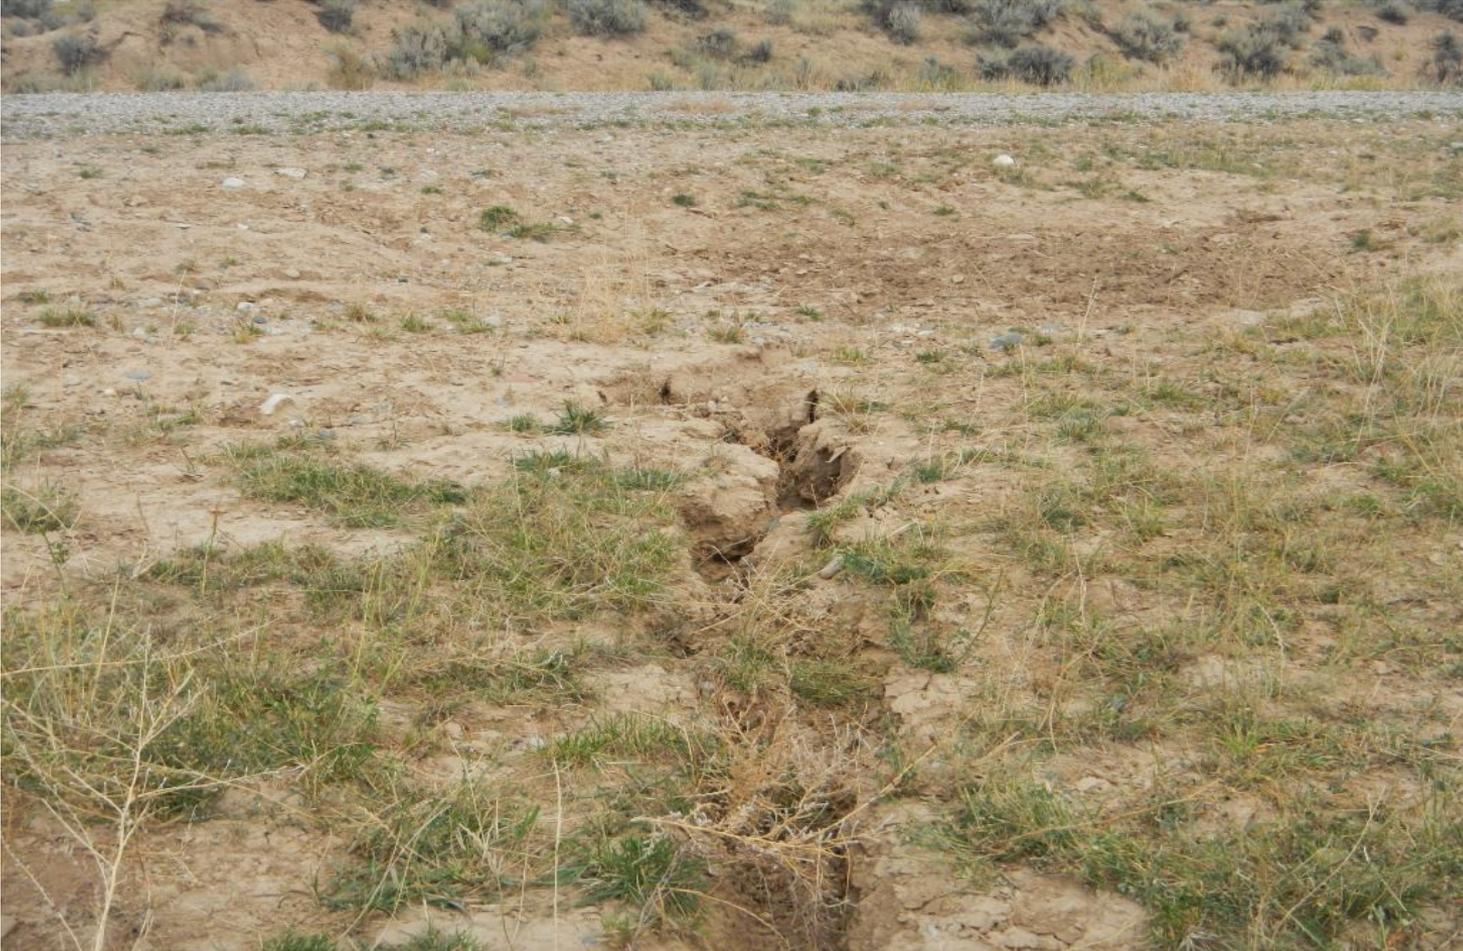
Photo#3: View of SW Path, channeling, pooling, & channeling again to drain into Access Road BMPs.
