# Final Reclamation Inspection

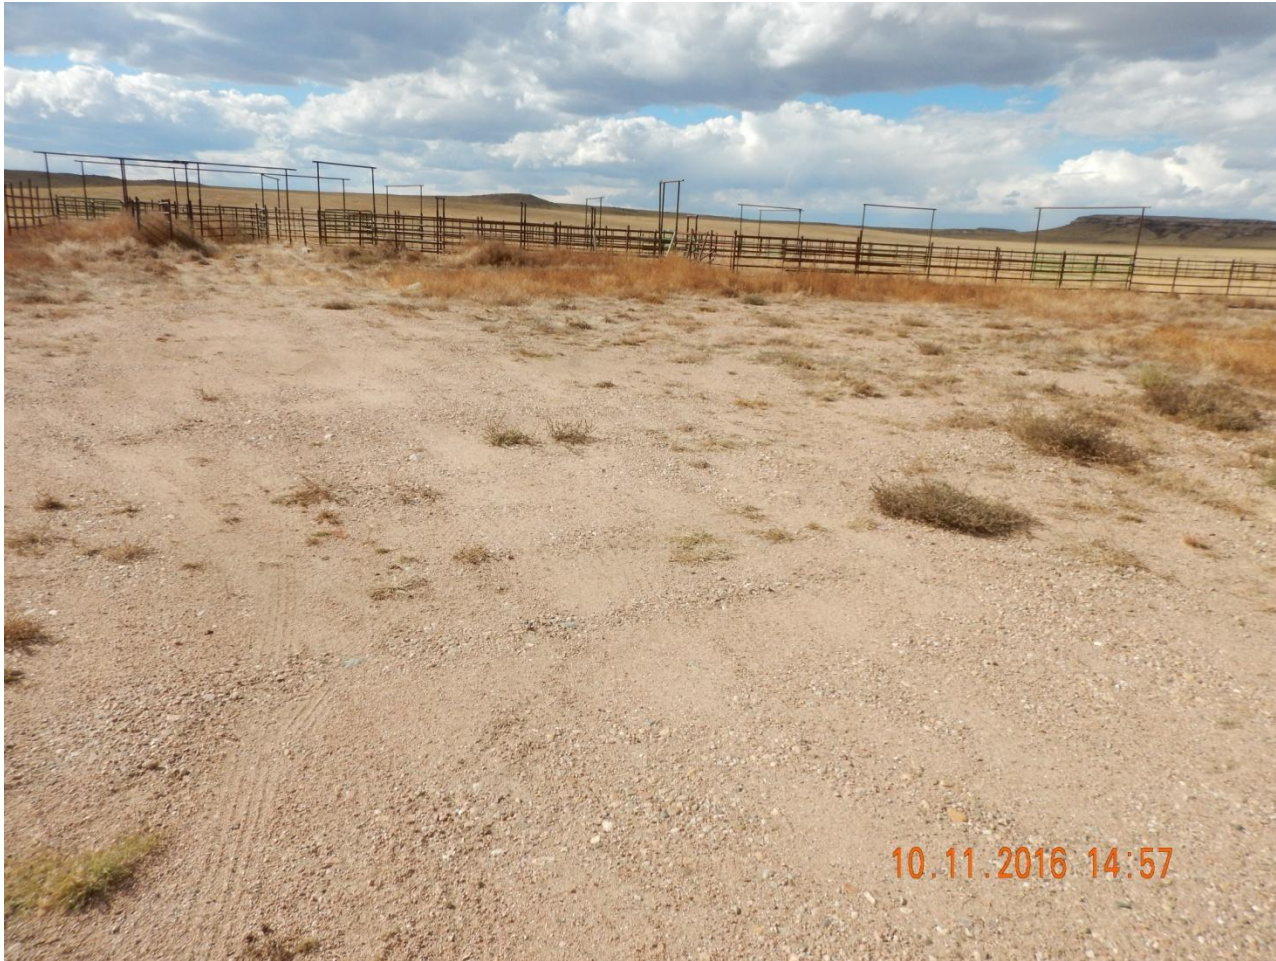
**Photo 1.** Photo taken from east of location, facing West. Landowner is currently using the location for a cattle staging area.

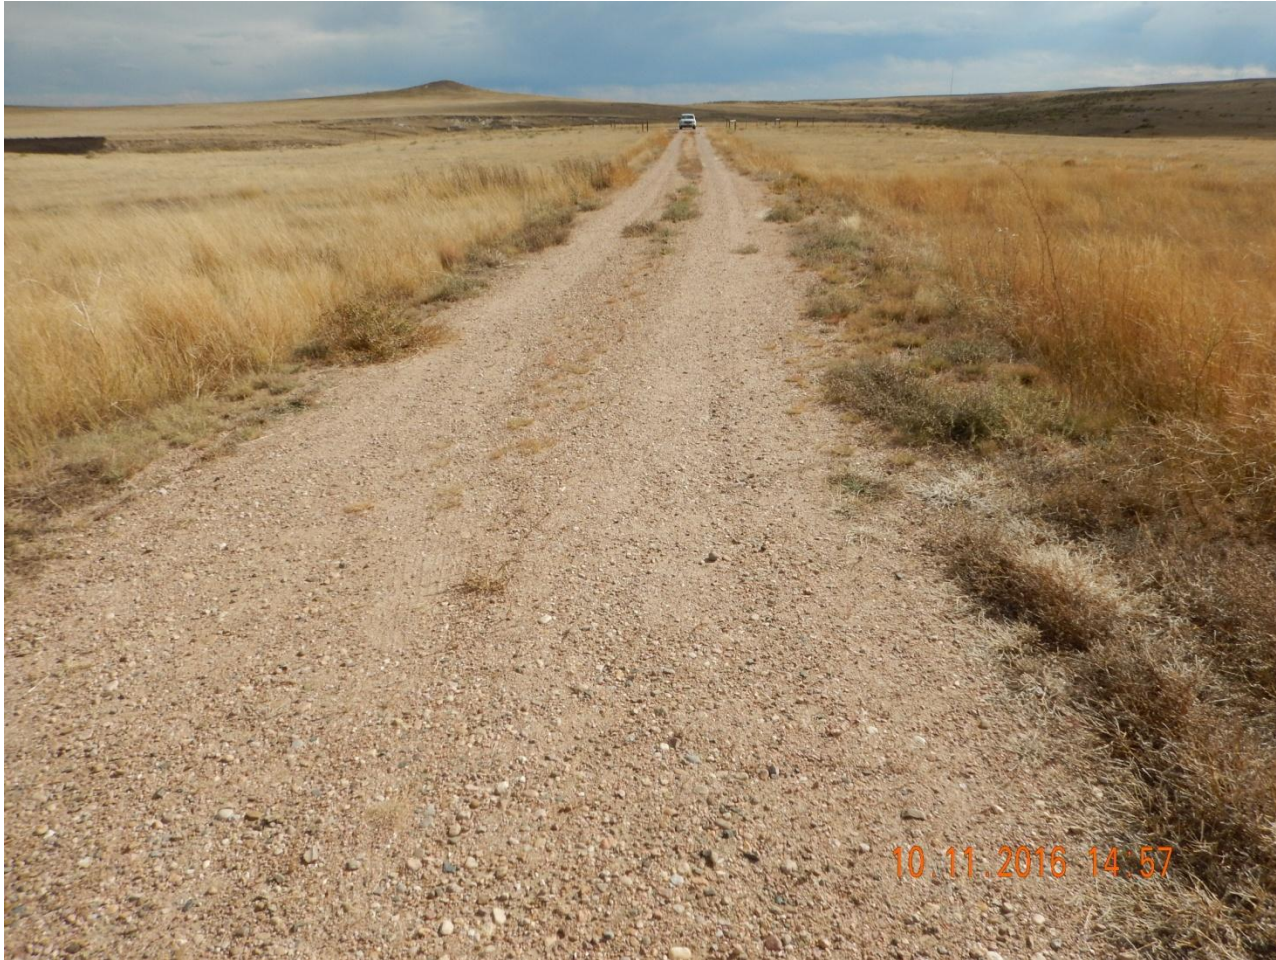
**Photo 2.** Photo taken from northern access road, facing South. Landowner is currently using the location for a cattle staging area.
