Final Reclamation Inspection

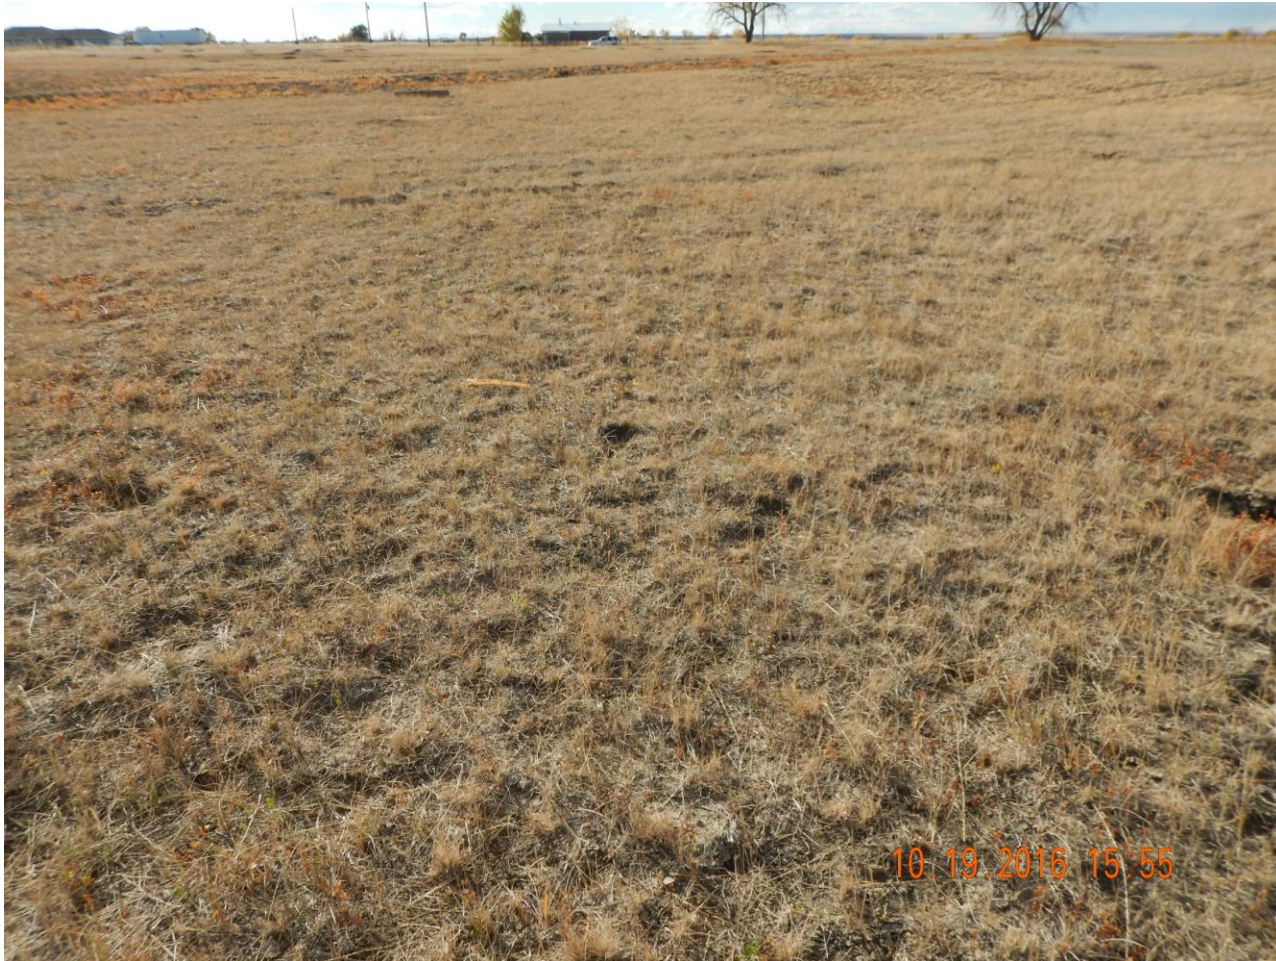
Photo 1. Photo taken from center of location, facing West. No evidence of disturbance. Uniform vegetative growth throughout location. Active prairie dog town near location.

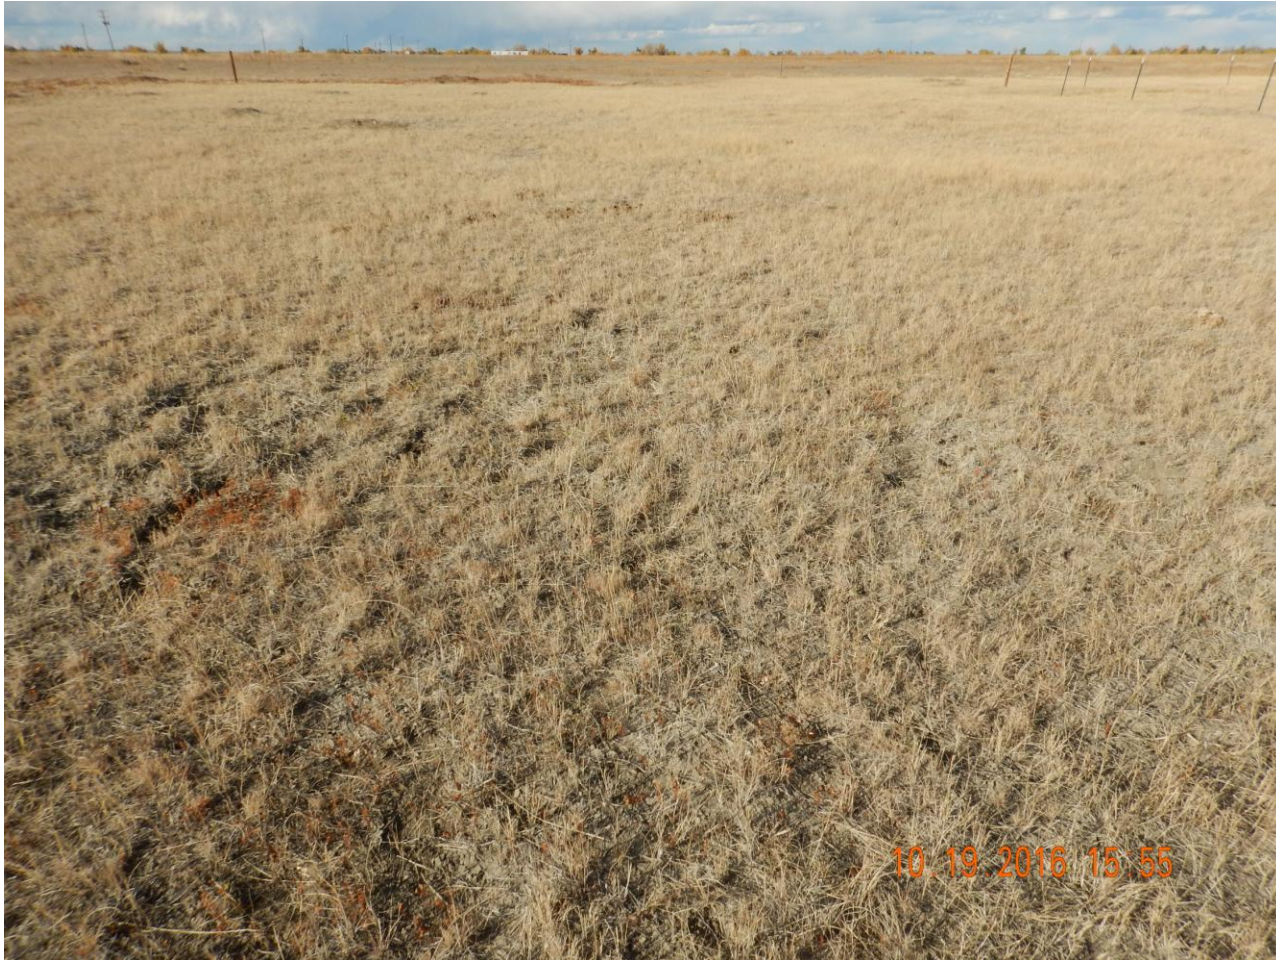
Photo 2. Photo taken from center of location, facing North. No evidence of disturbance. Uniform vegetative growth throughout location. Active prairie dog town near location.

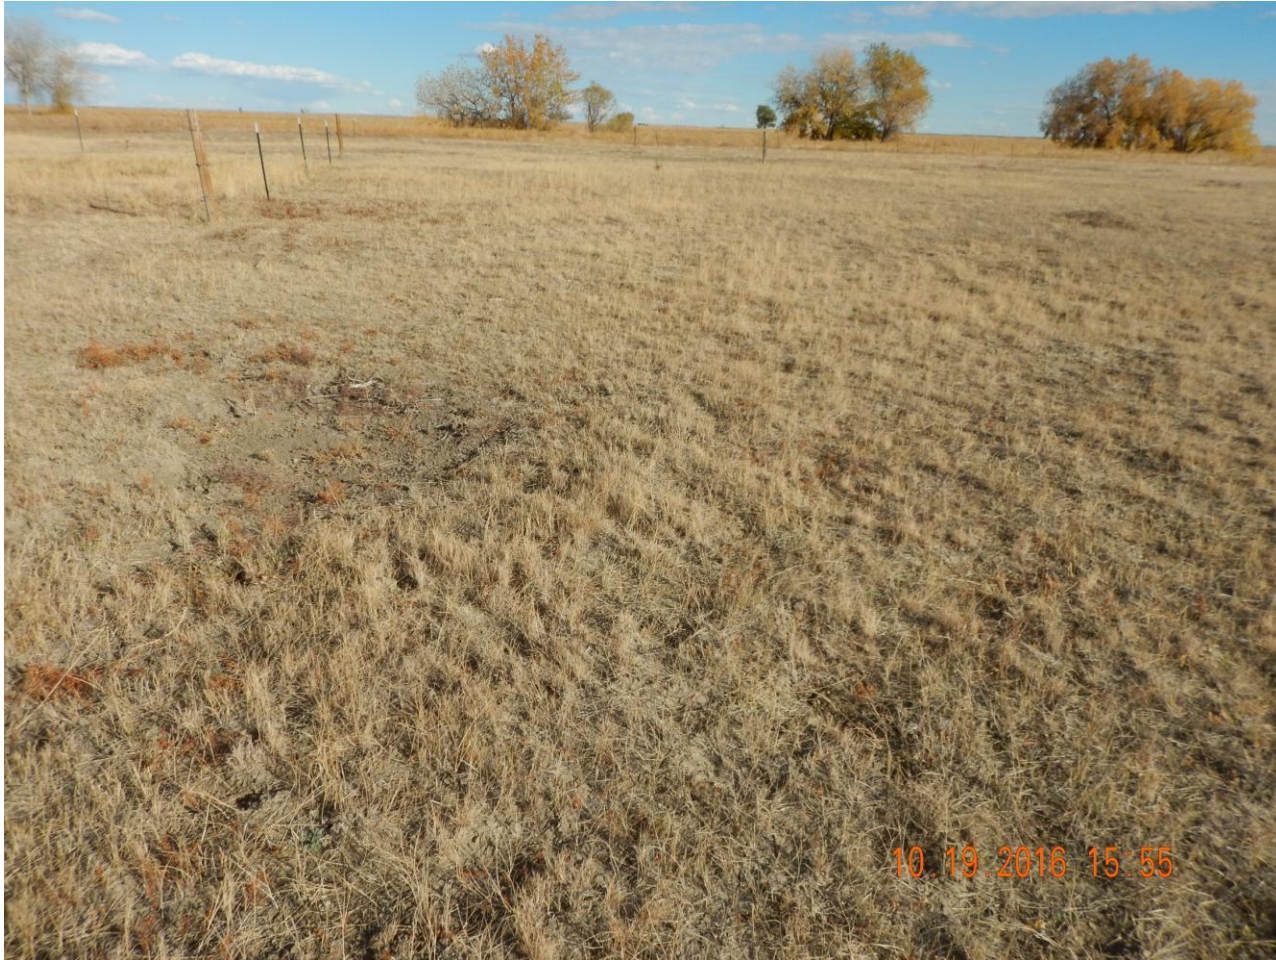
Photo 3. Photo taken from center of location, facing East. No evidence of disturbance. Uniform vegetative growth throughout location. Active prairie dog town near location.

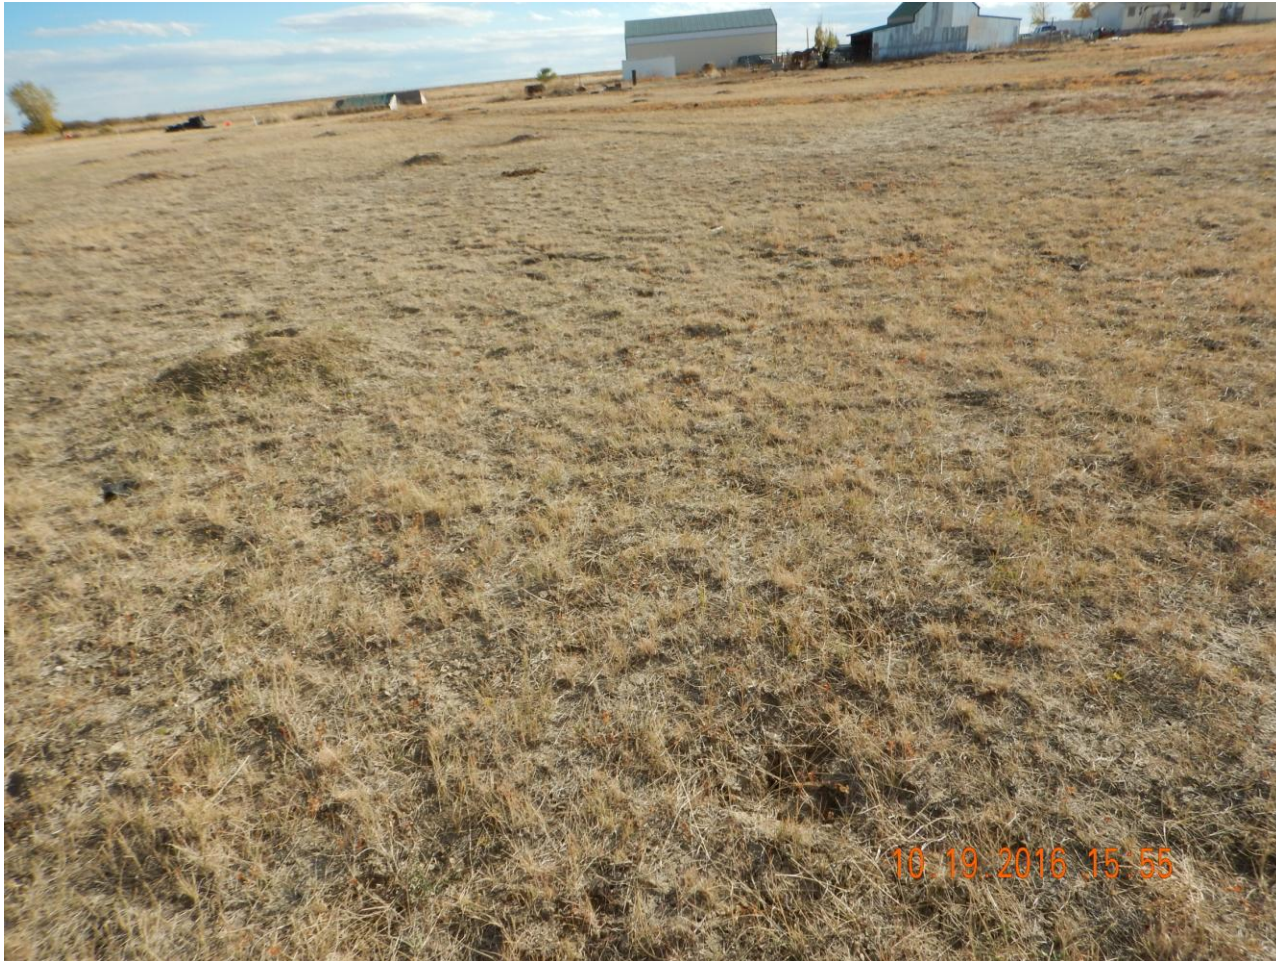
Photo 4. Photo taken from center of location, facing South. No evidence of disturbance. Uniform vegetative growth throughout location. Active prairie dog town near location.

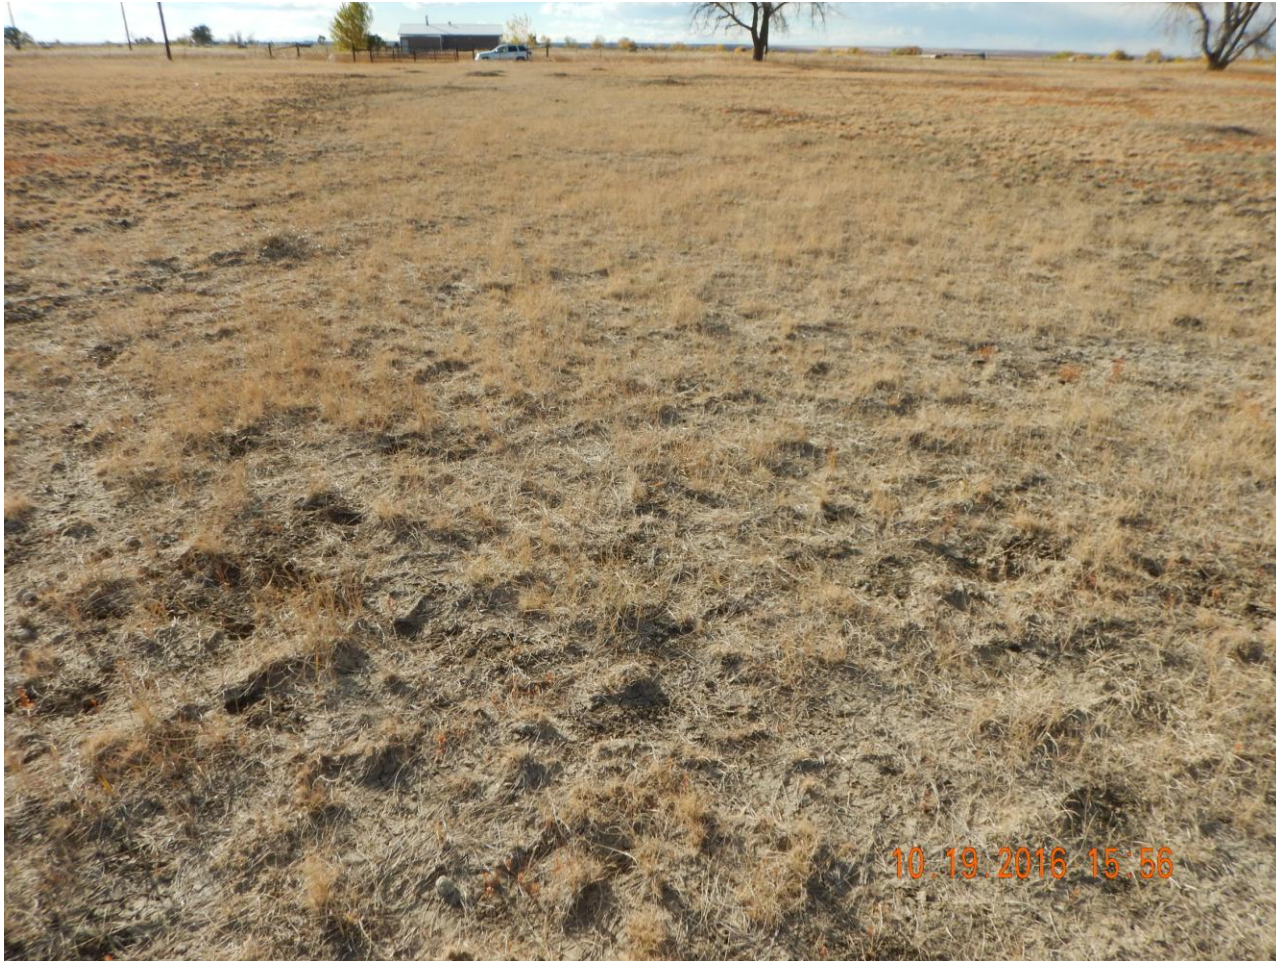
Photo 5. Reference photo taken North of location, facing West. Location appears to be reflective of reference areas. Active prairie dog town near location.
