Interim Reclamation Inspection

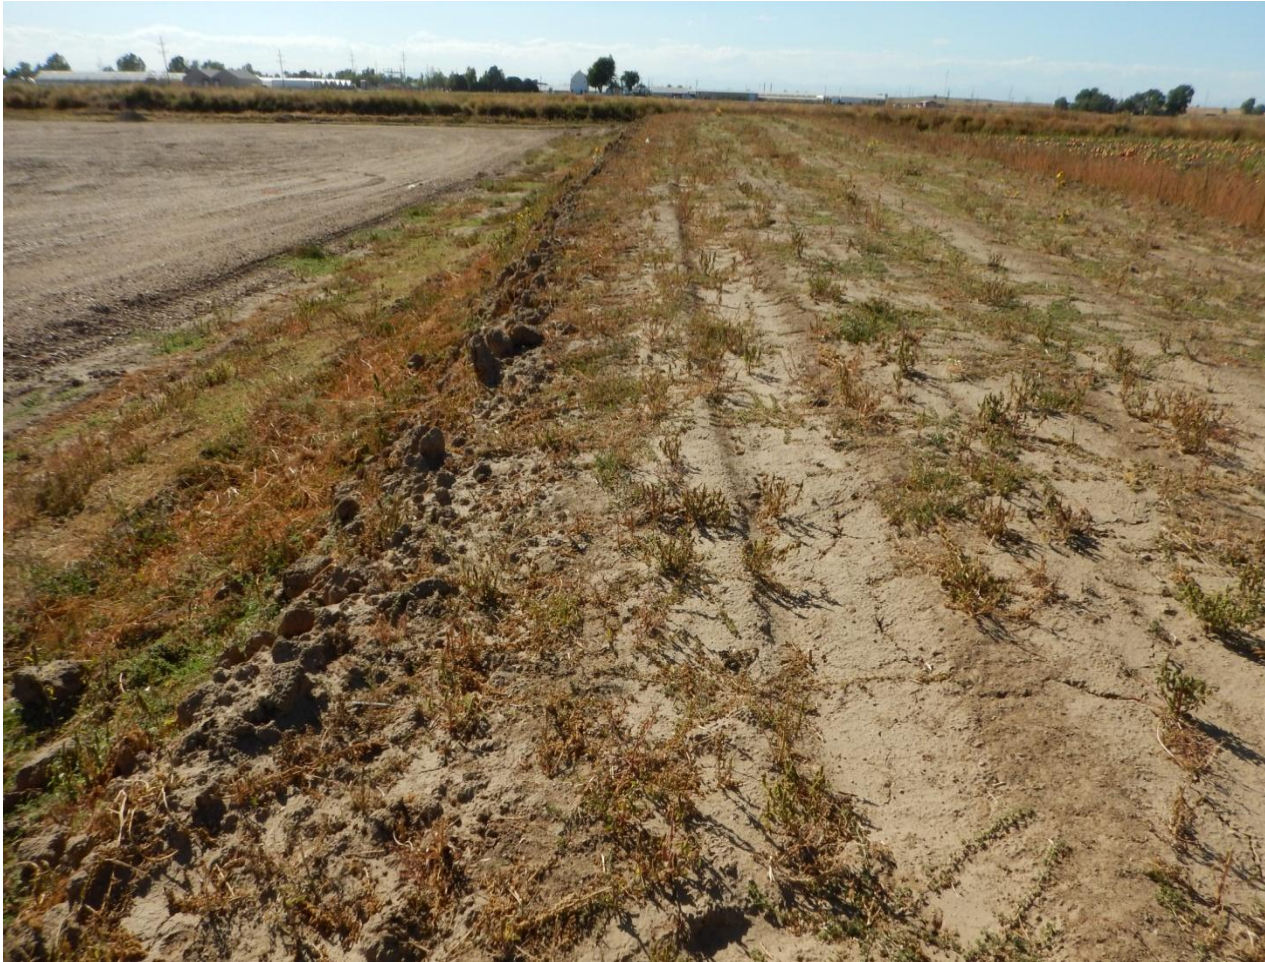
Photo 1. Photo taken from the eastern topsoil stockpile, facing West. Topsoil stockpile was mowed but undesirable weed species are growing on topsoil stockpile.

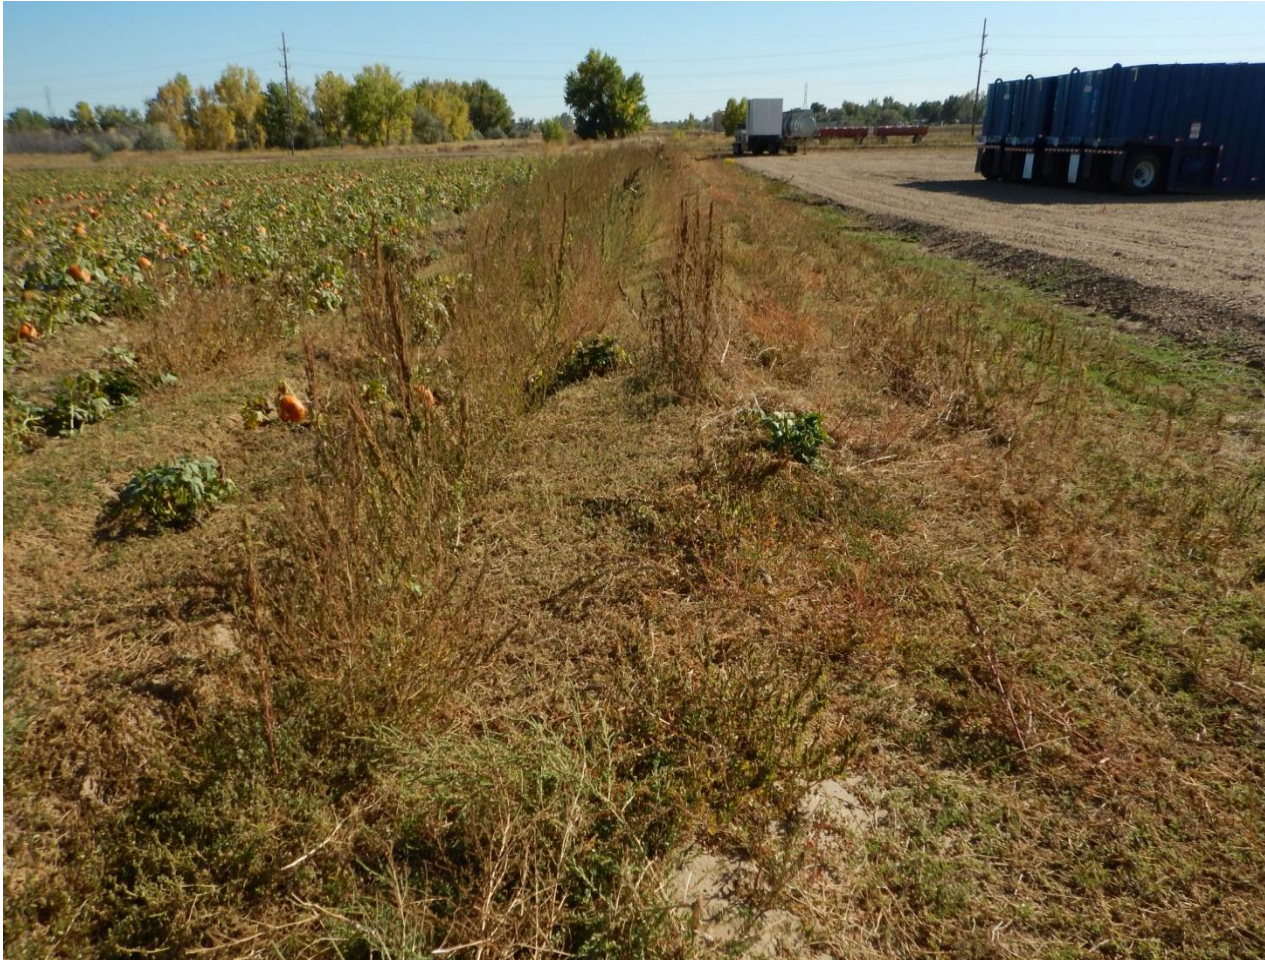
Photo 2. Photo taken from the eastern location, facing South. Perimeter was mowed up to the first stormwater ditch but the second stormwater ditch was not mowed.
