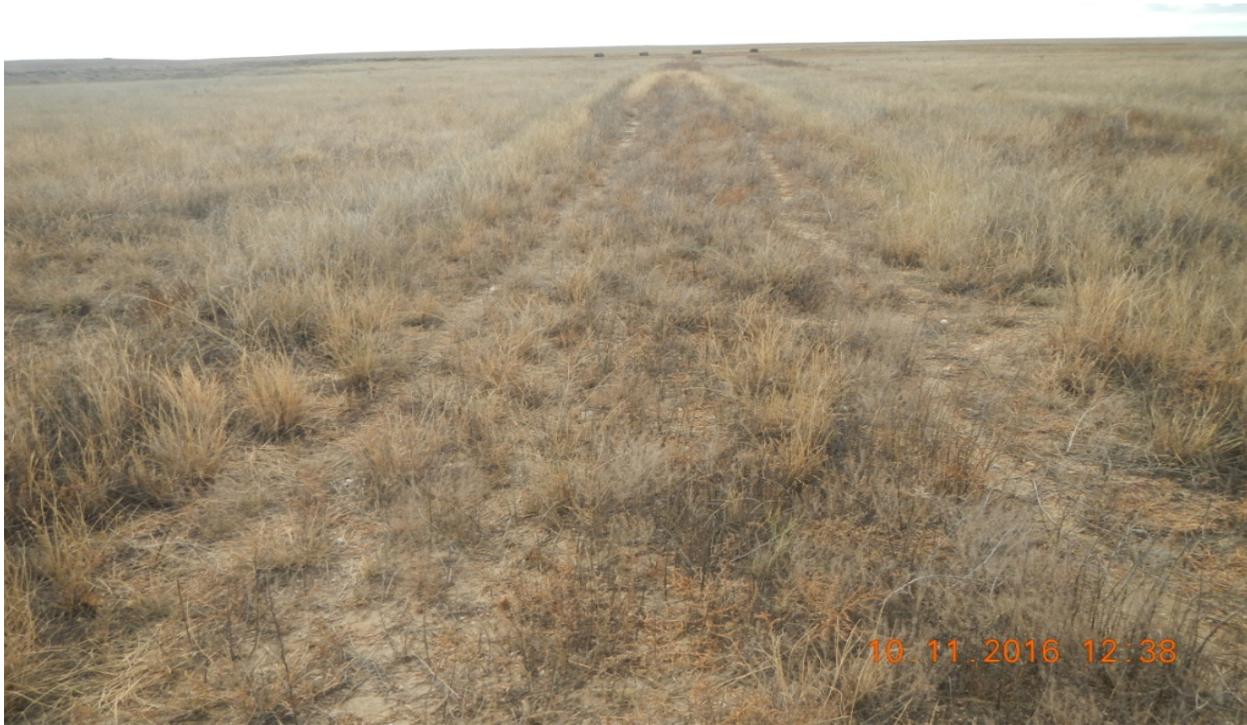
photo 1: Facing south along the access road toward the location. The brown vegetation in center of the road is undesirable weed growth.

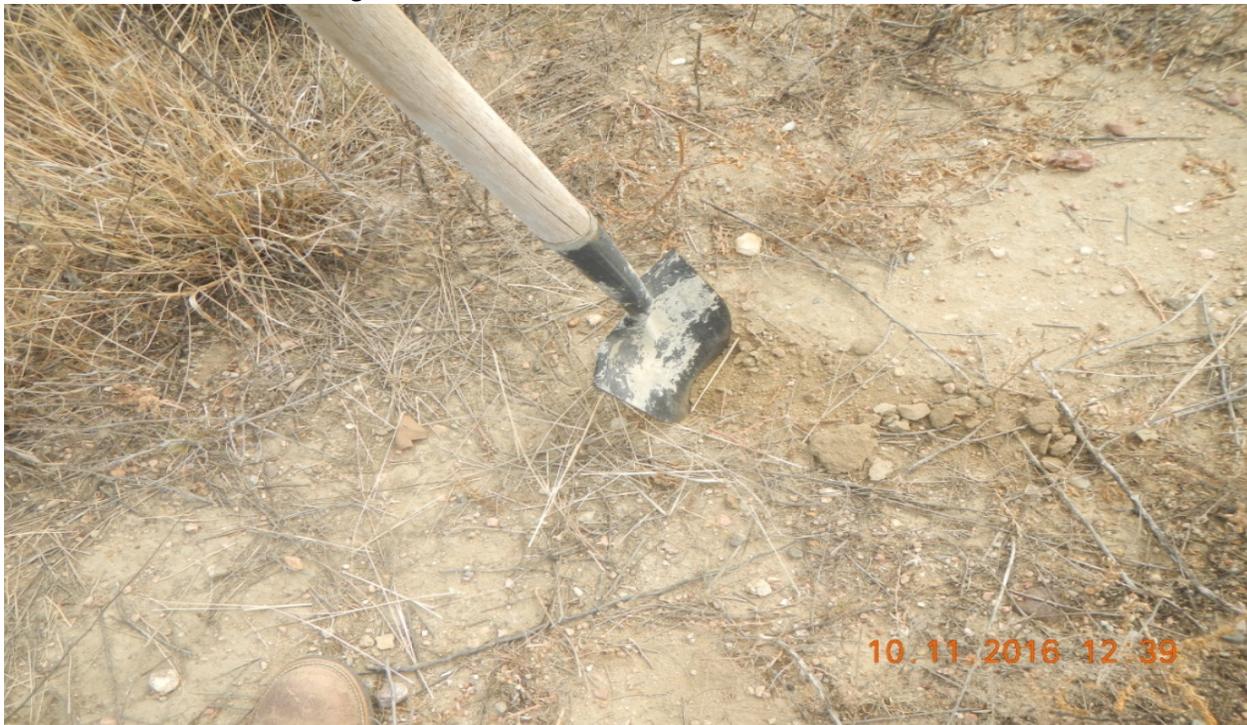
photo 2: Areas along the access road seemed to have soil compaction issues.

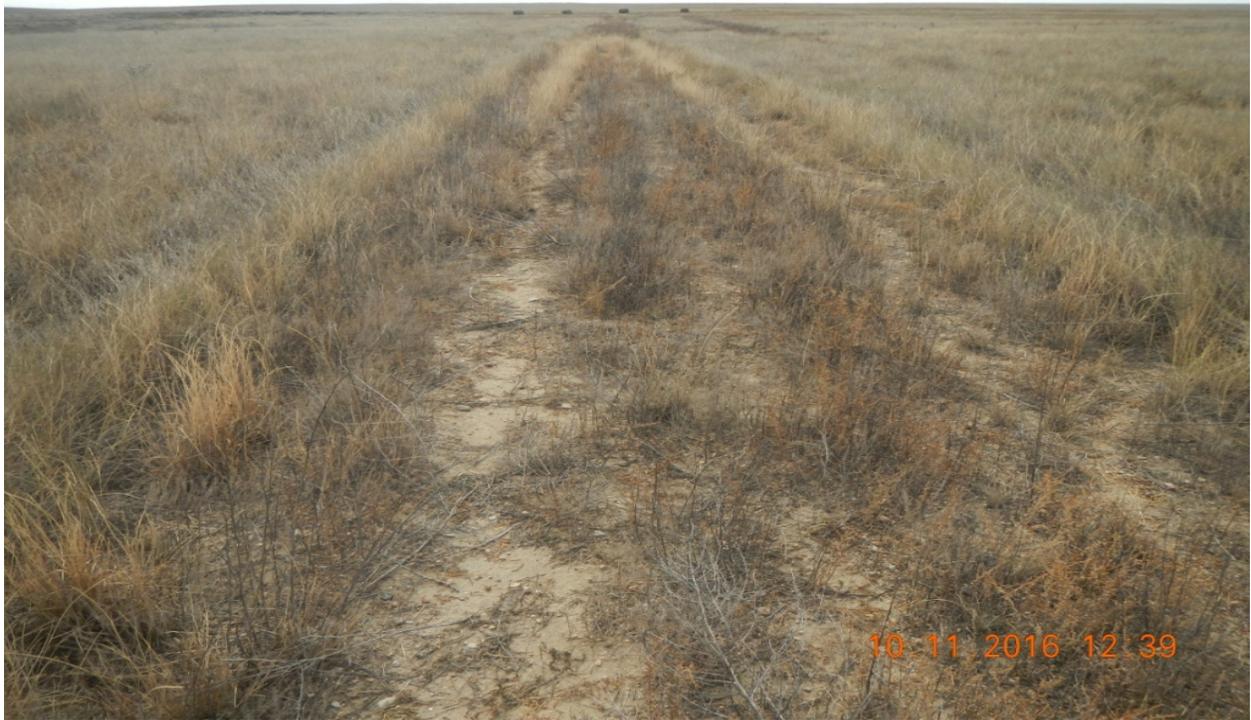
photo 3: Facing south along the access road toward the location. The brown vegetation in center of the road is undesirable weed growth.

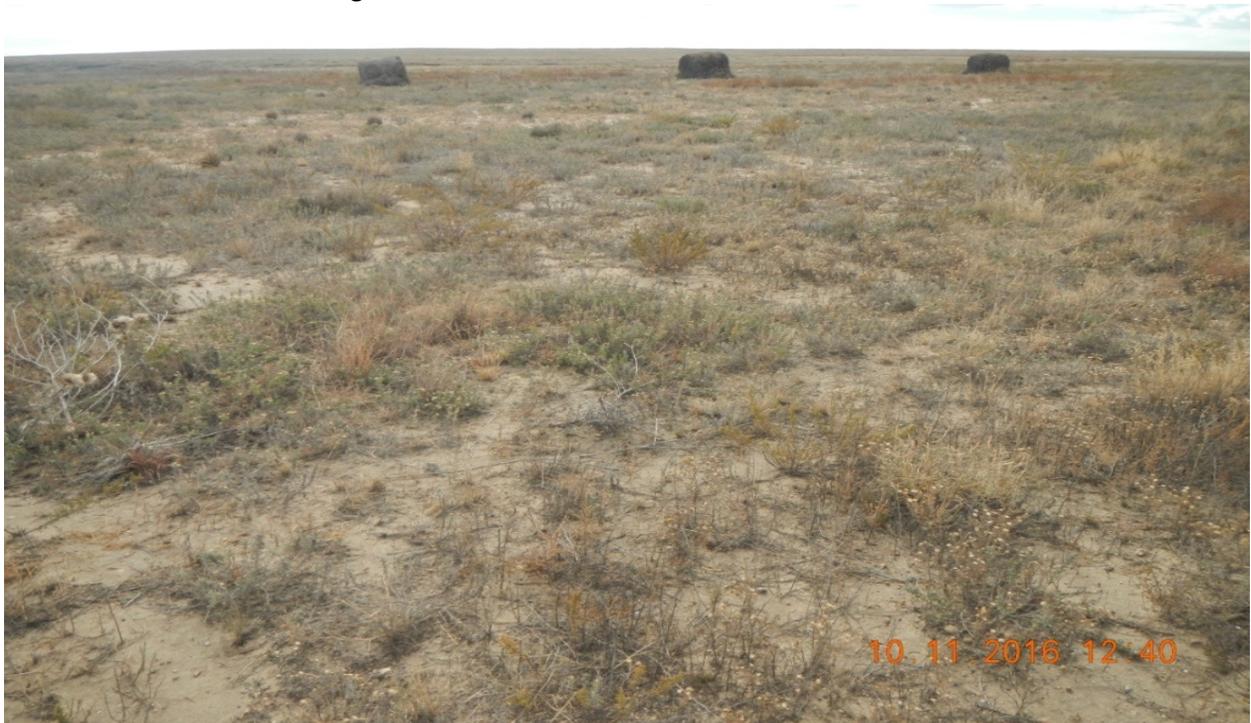
photo 4: Facing south toward the location. The round bales remain at the location.

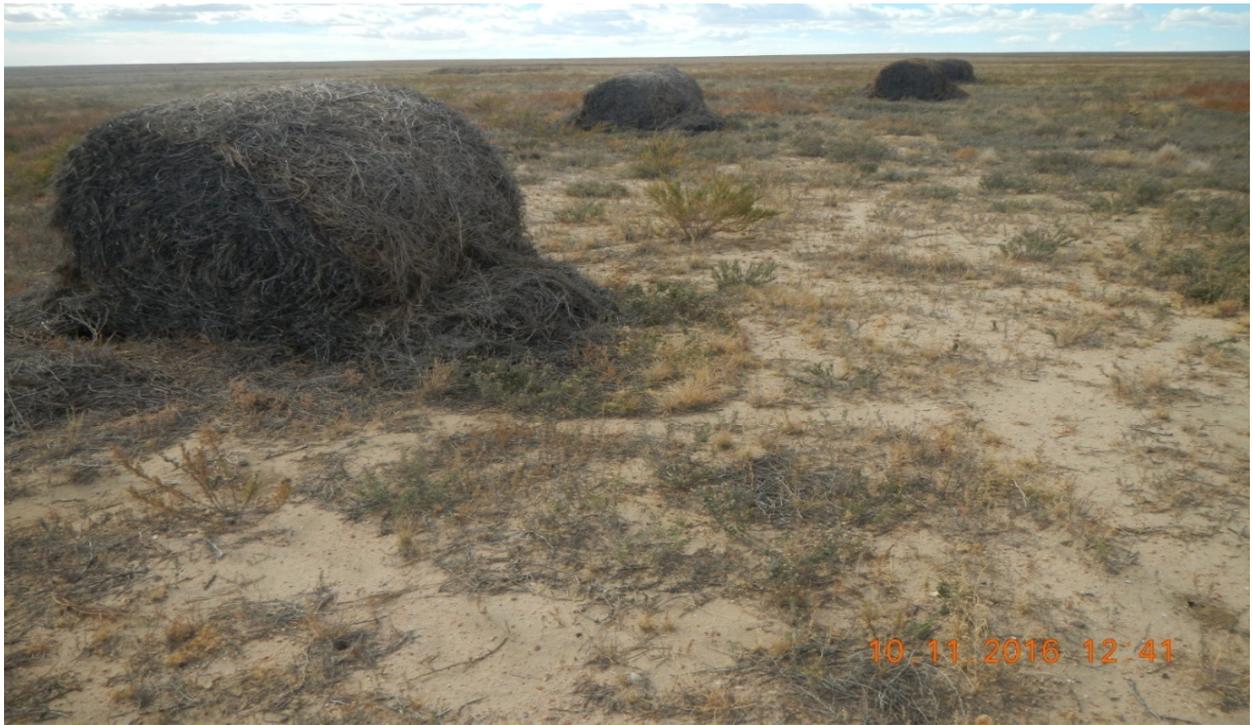
photo 5: The round bale debris remains at the location.

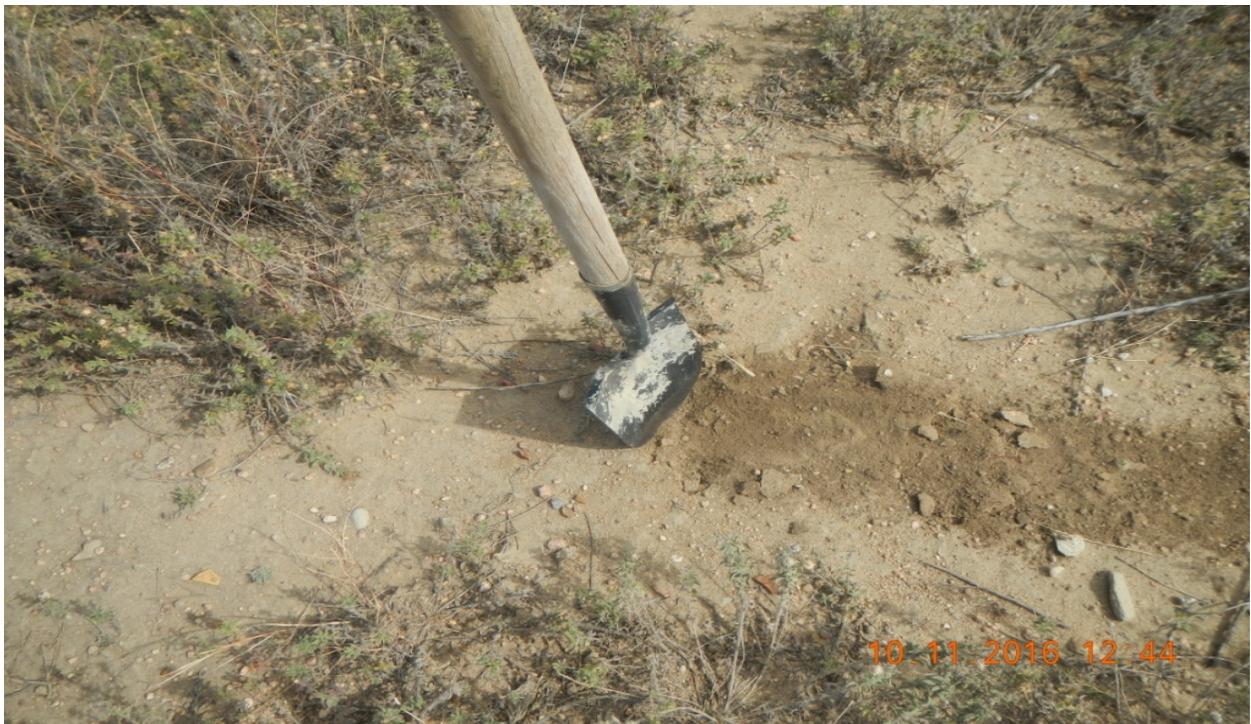
photo 8: There are areas at the location which seem to have compacted soils.
