October 27, 2016

Inspection Photos: Vanguard Dixon Federal Loc#425891

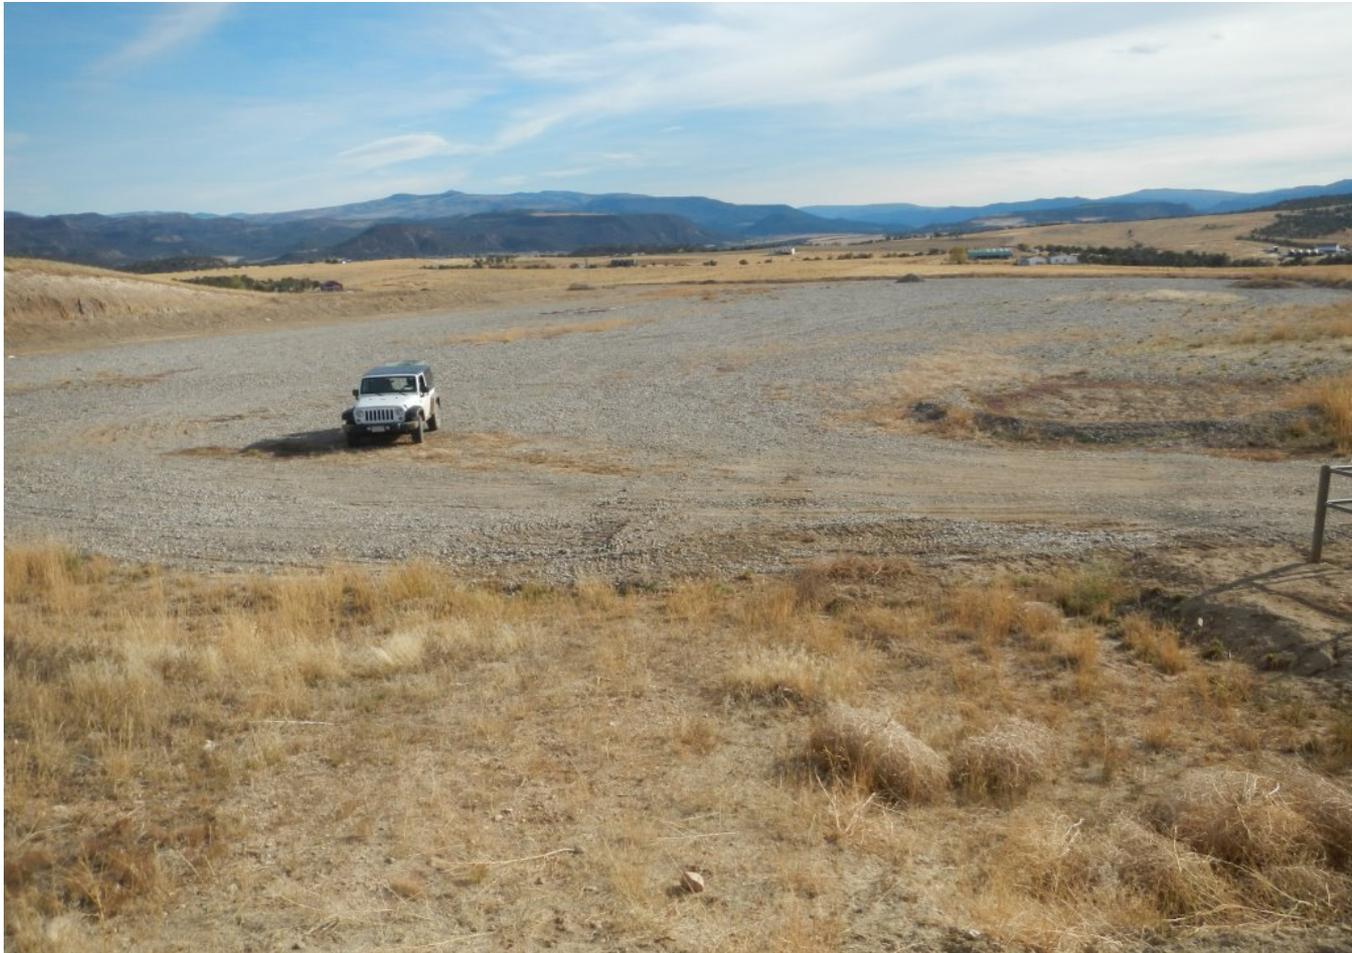
Photo#1: Overview of Location to South.

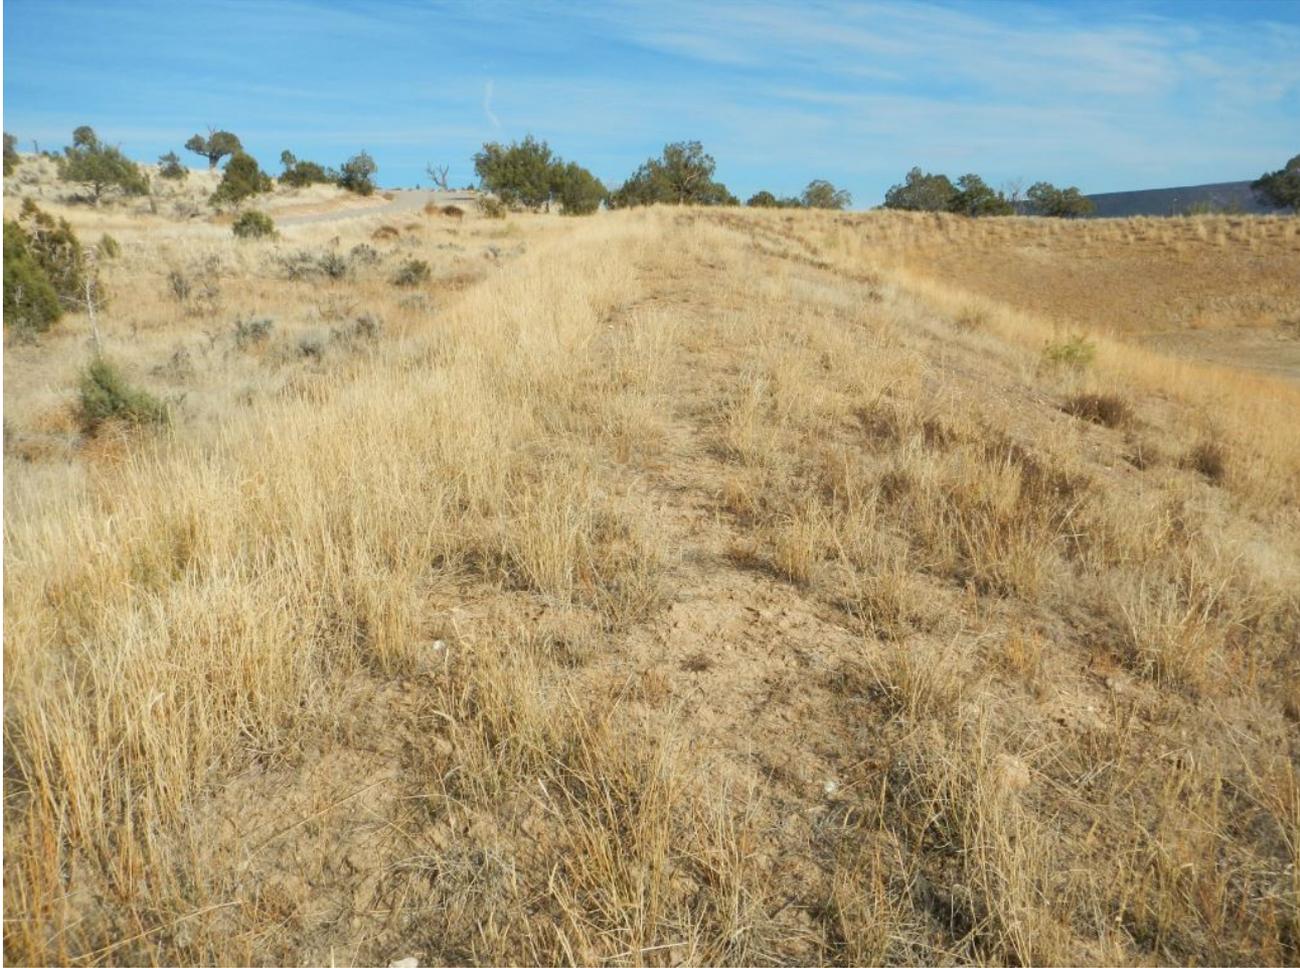
Photo#2: View of Interim Vegetation on North Berm facing East.

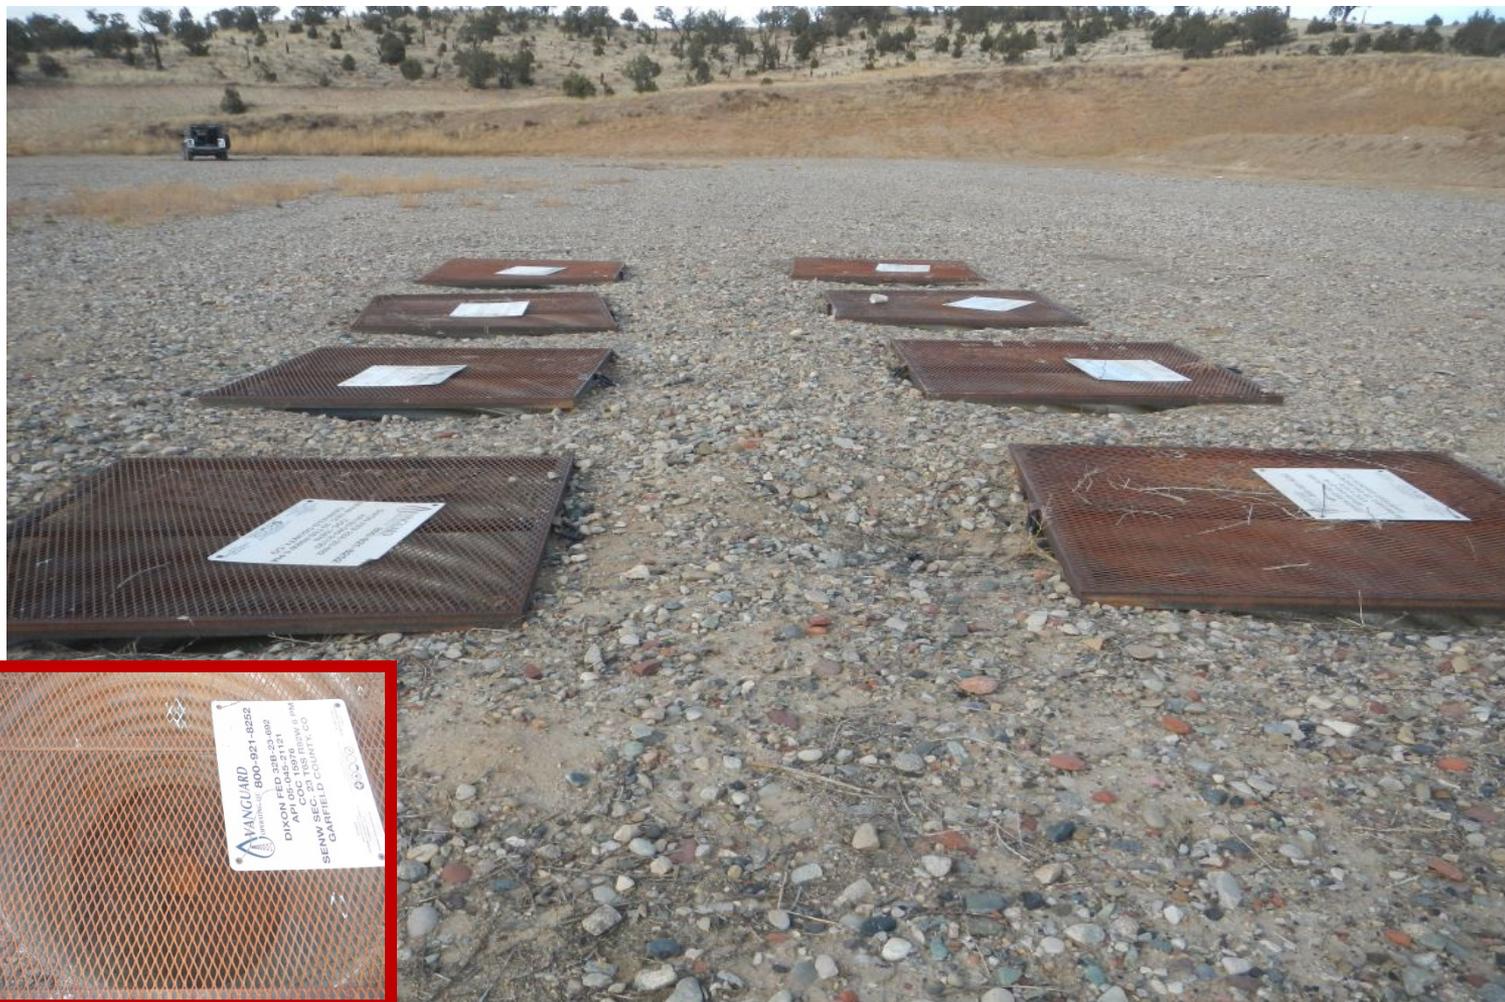
Photo#3: Eight Wells on Location have been P&A'd; Insert; view of Plated welded on Cut off Casing.

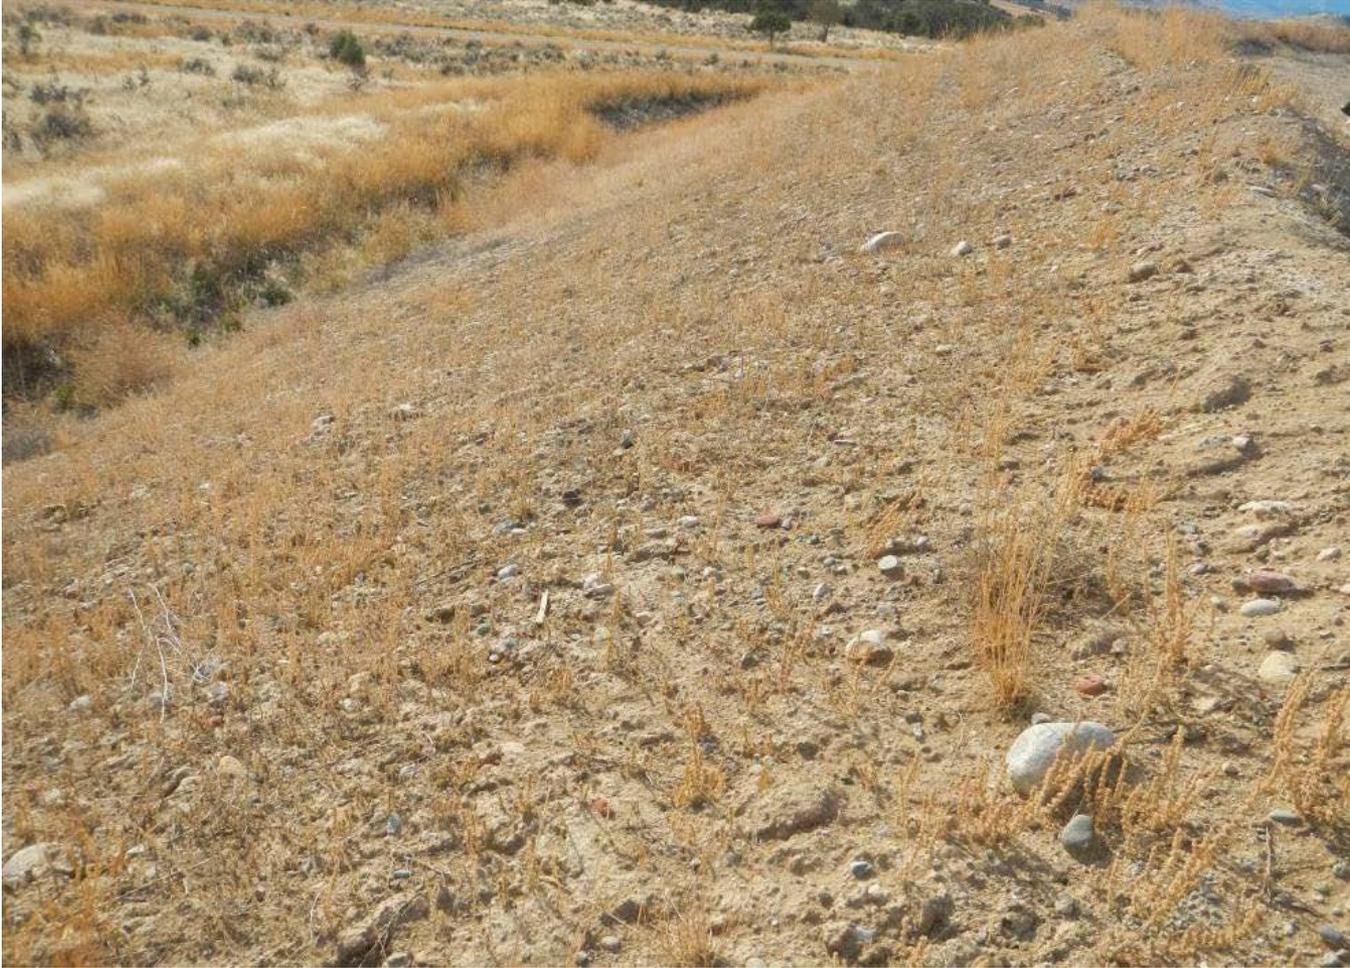
Photo#4: Vegetation on Fill Slope at South end of Location is Sparse..

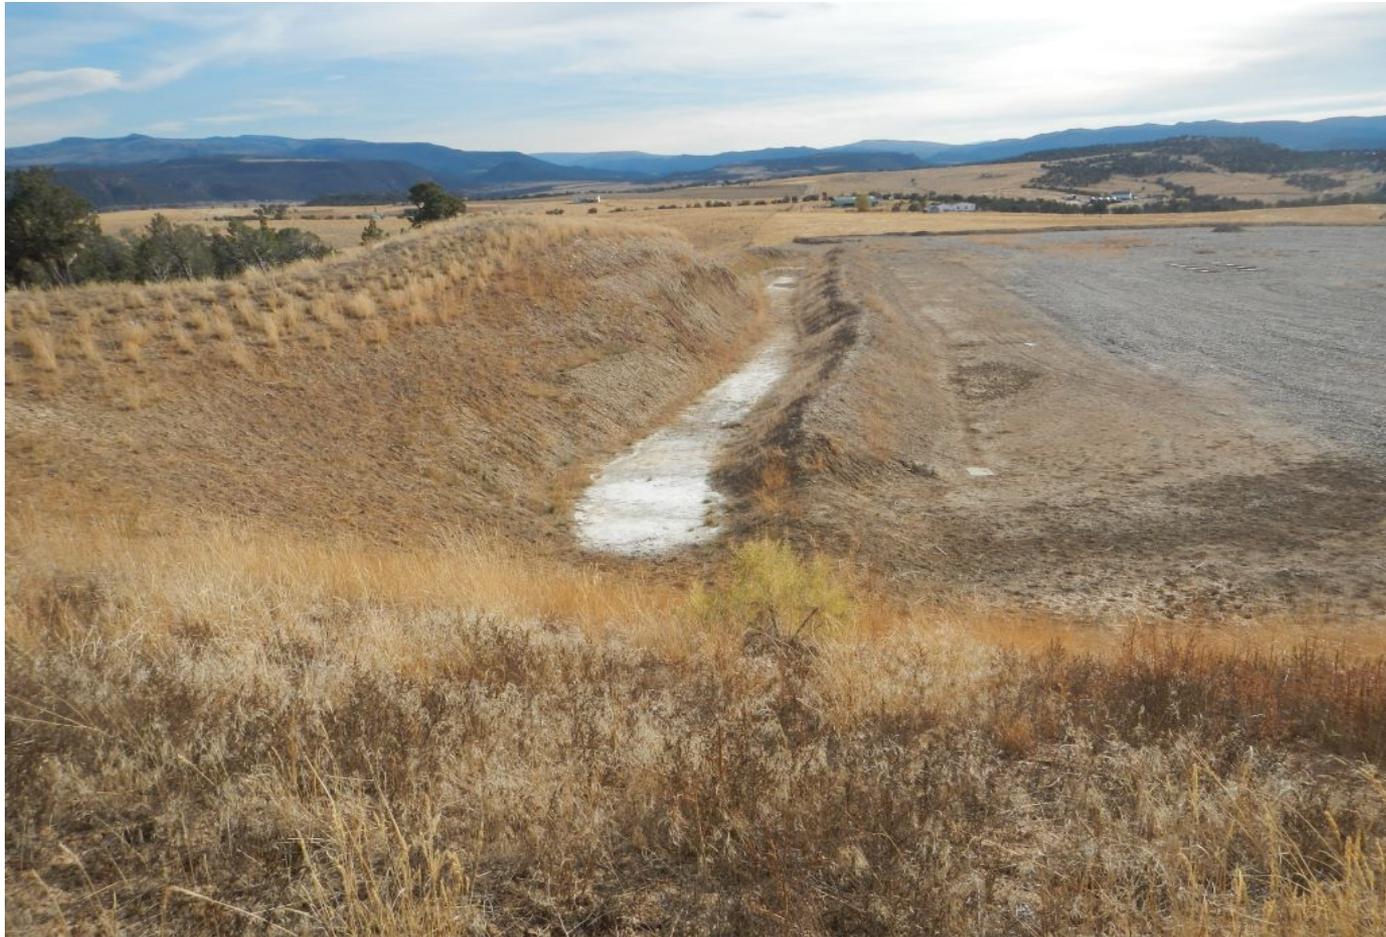
Photo#5: View along Cut slope at East Side of Location to South.

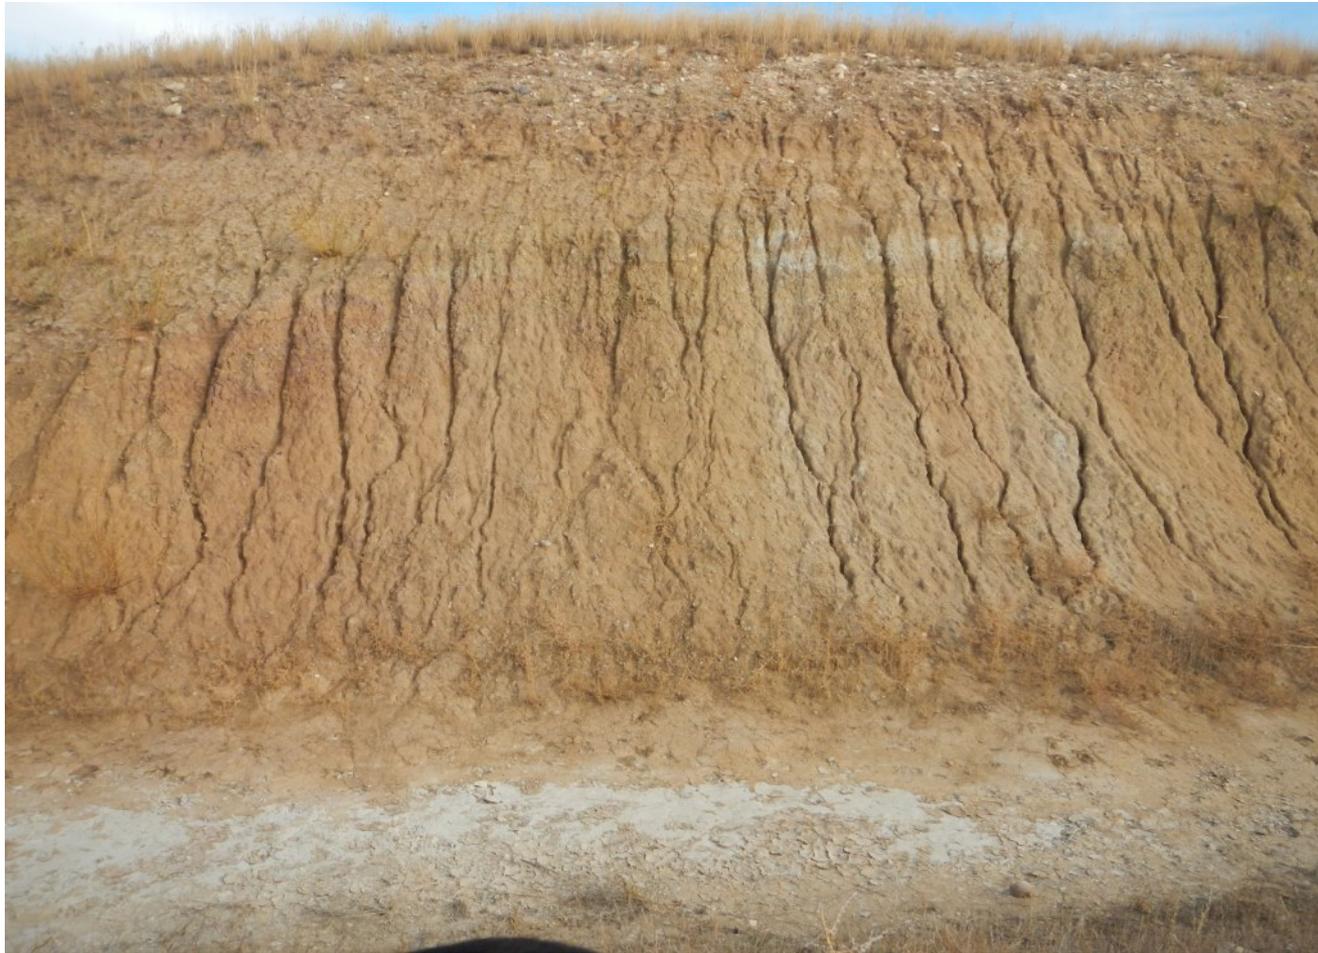
Photo#6: Rill Erosion is occurring on Cut Slope.

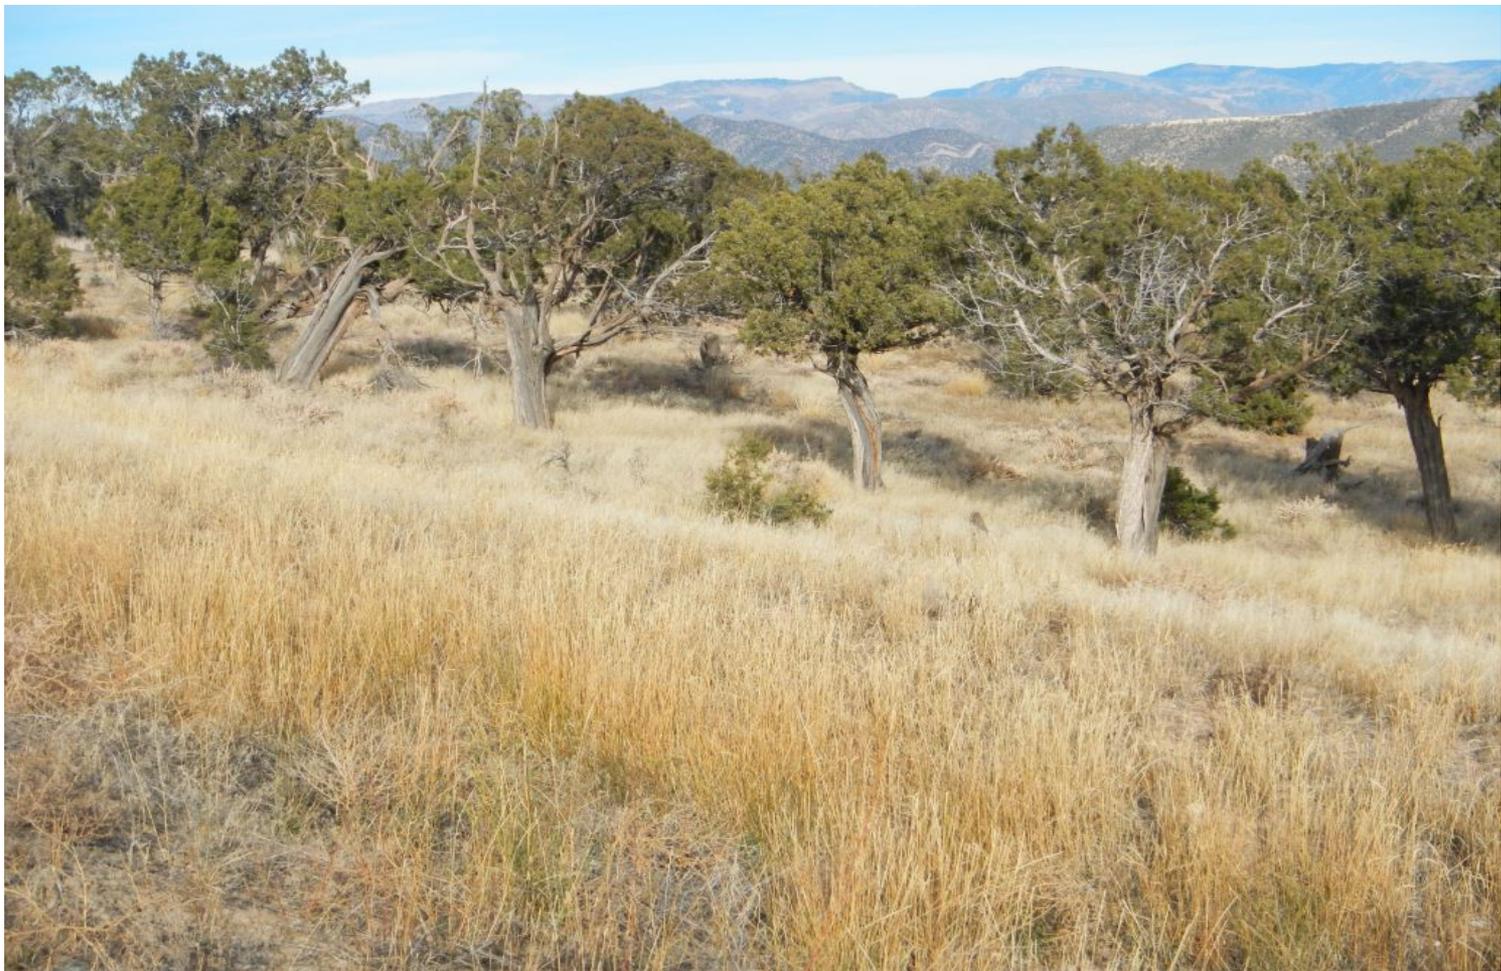
Photo#7: View of Reference Area Vegetation.
