Interim Reclamation Inspection- Overview

Aerial imagery taken September 2015 using COGCC GISOnline database, illustrating KPK and Kerr McGee shared tank battery location in relation to a corrective action to fix a portion of the access road that was widened by an operator.

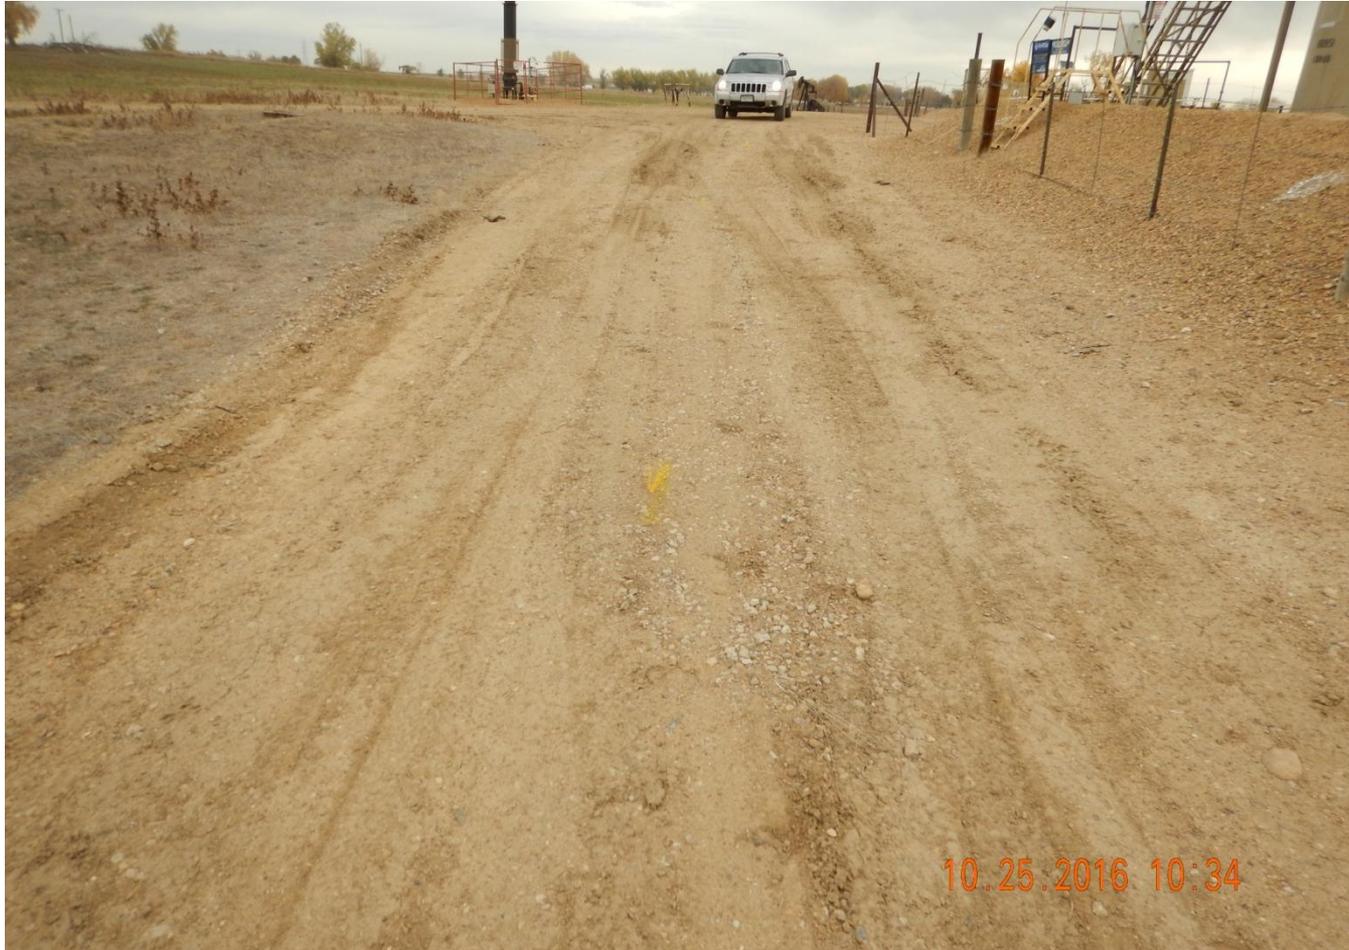
Photo 1. Photo taken west of the batteries, facing North. Corrective actions to repair ruts have been performed.

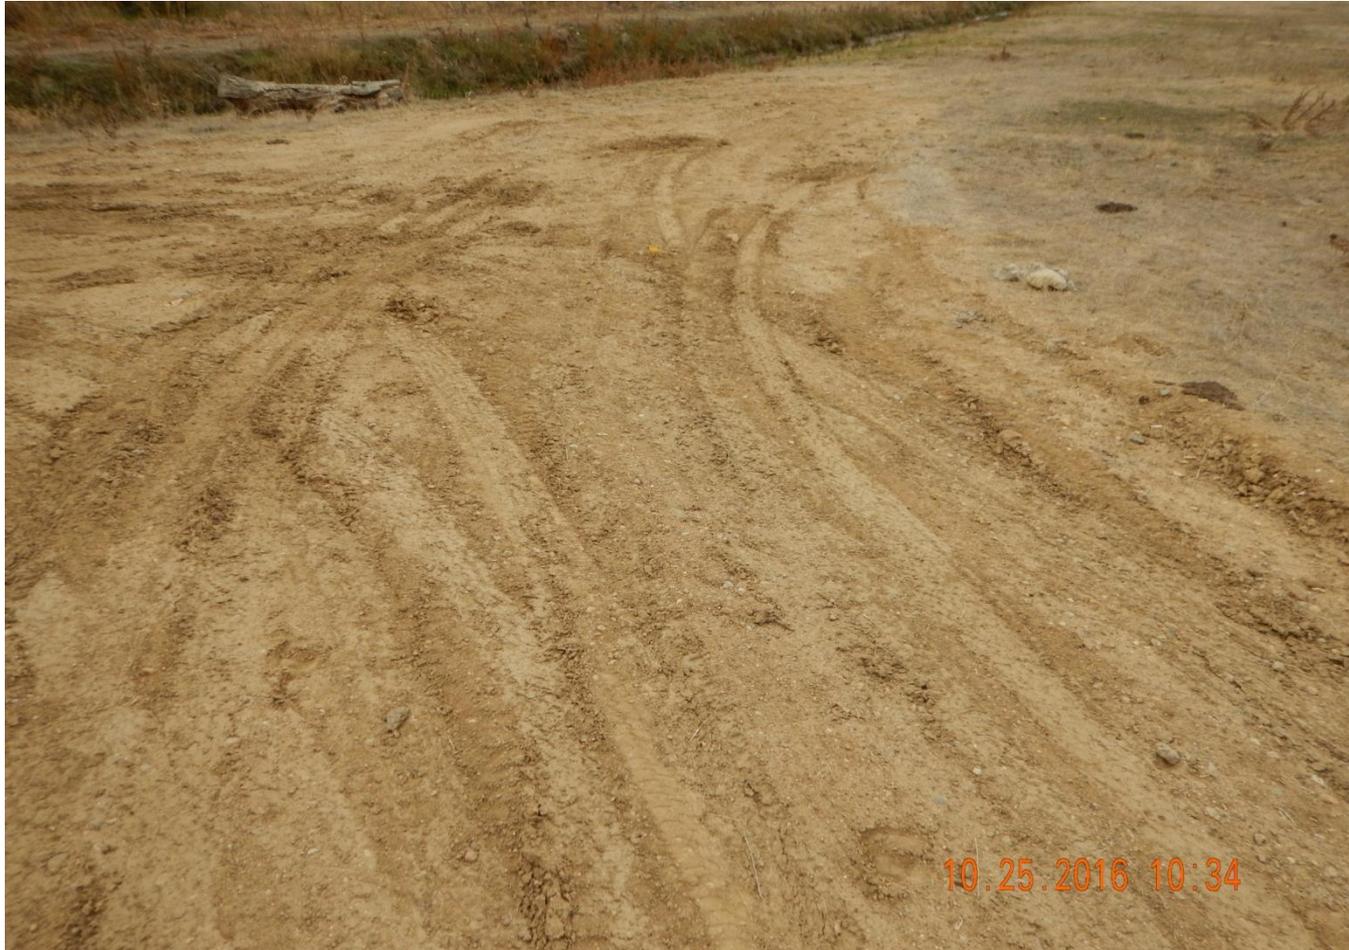
Photo 2. Photo taken west of the batteries, facing South. Corrective actions to repair ruts have been performed.

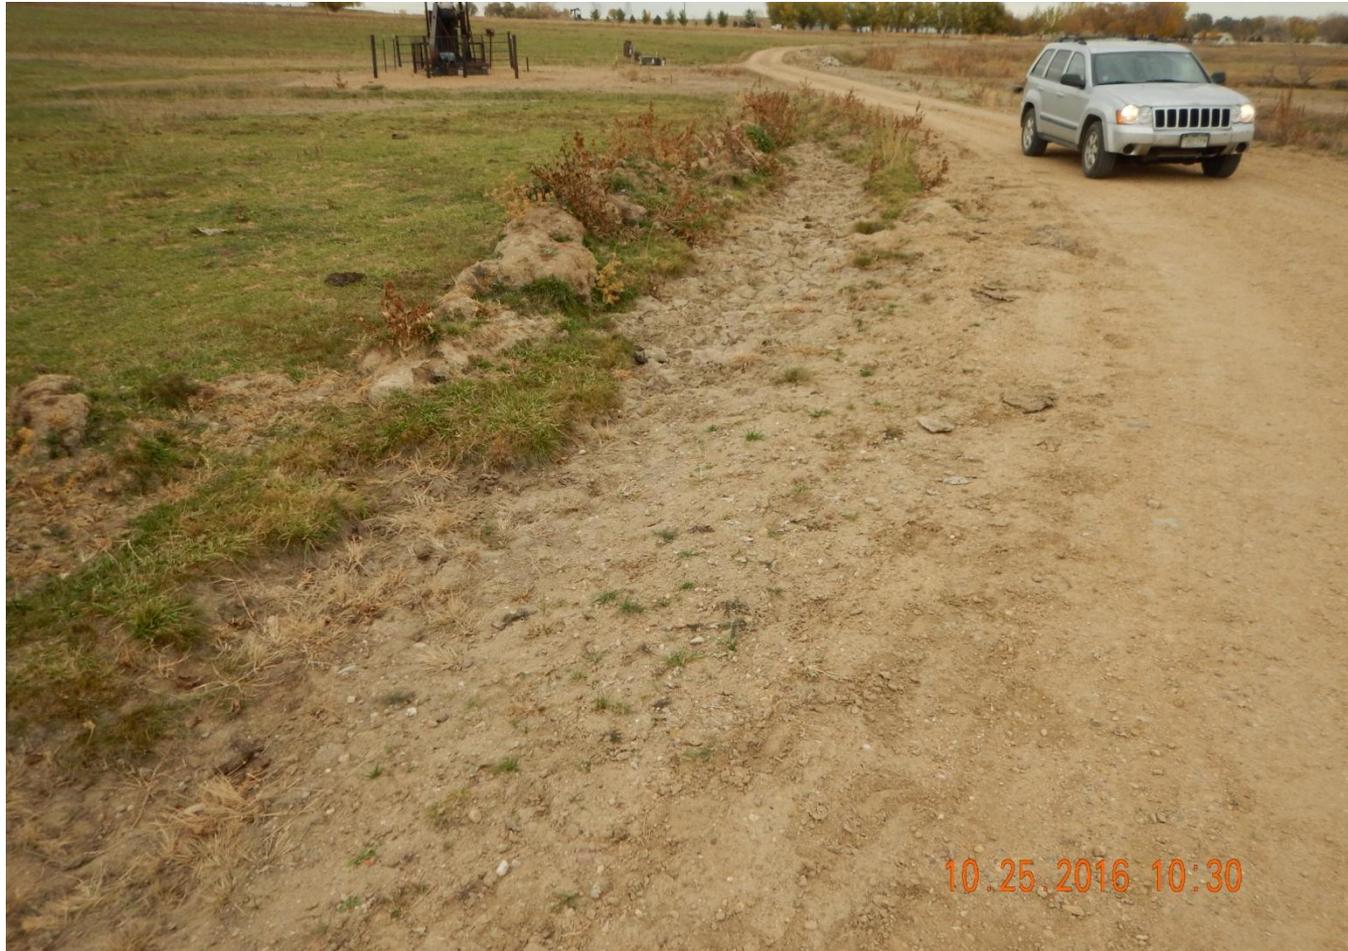
Photo 3. Photo taken north of the shared tank battery location, facing North along the access road. Need to repair access road that was widened by an operator and re-seed any portions that are disturbed during this process.
