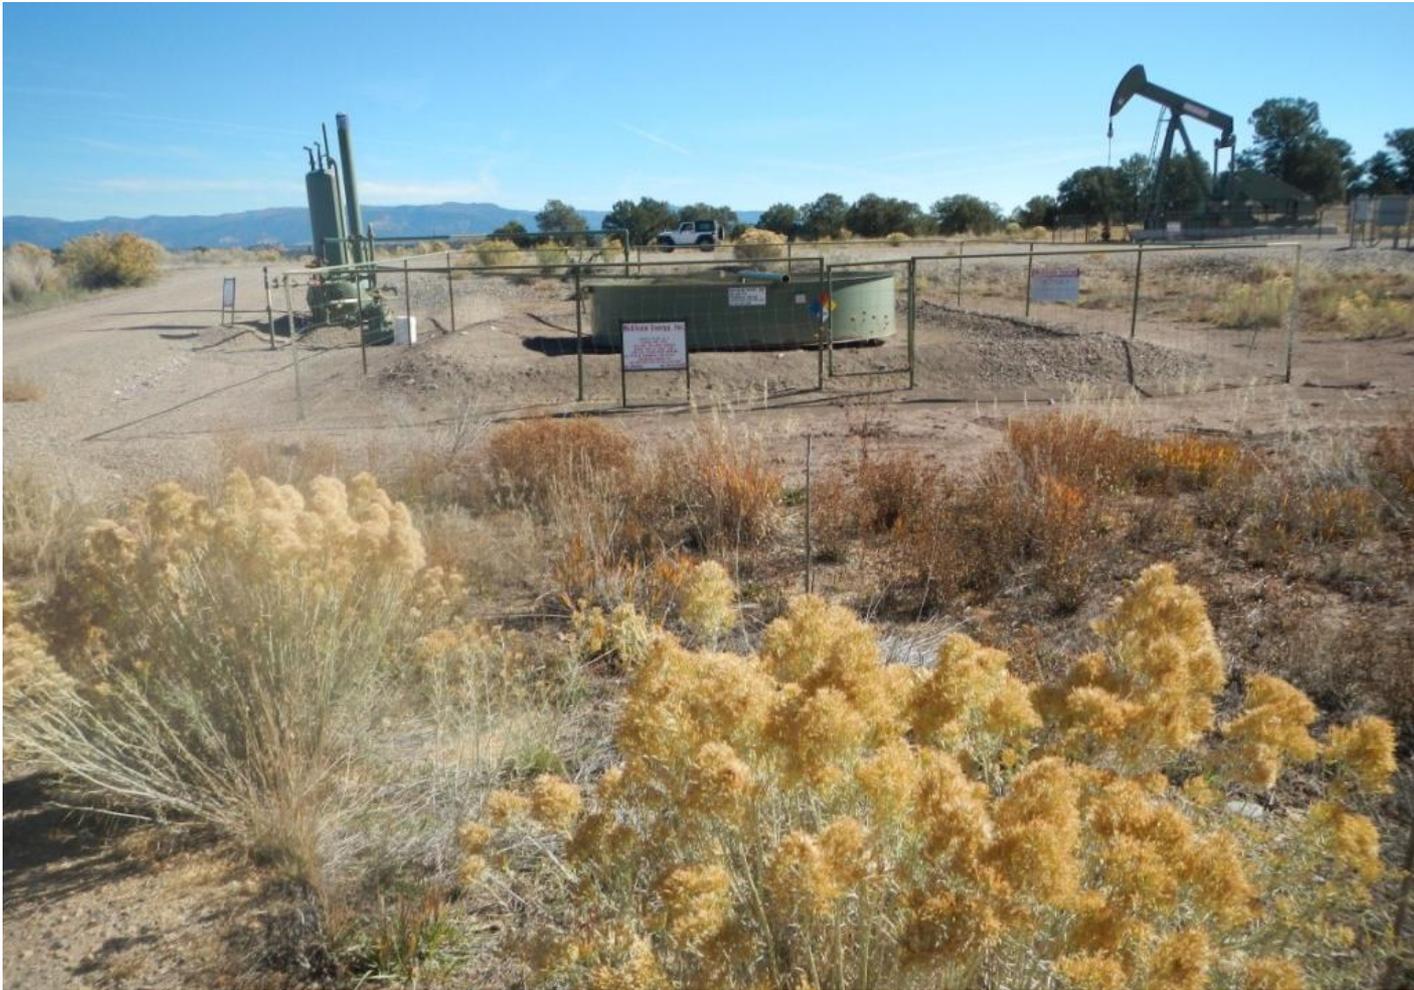
Photo 1. View of the project area from the western edge facing eastward.

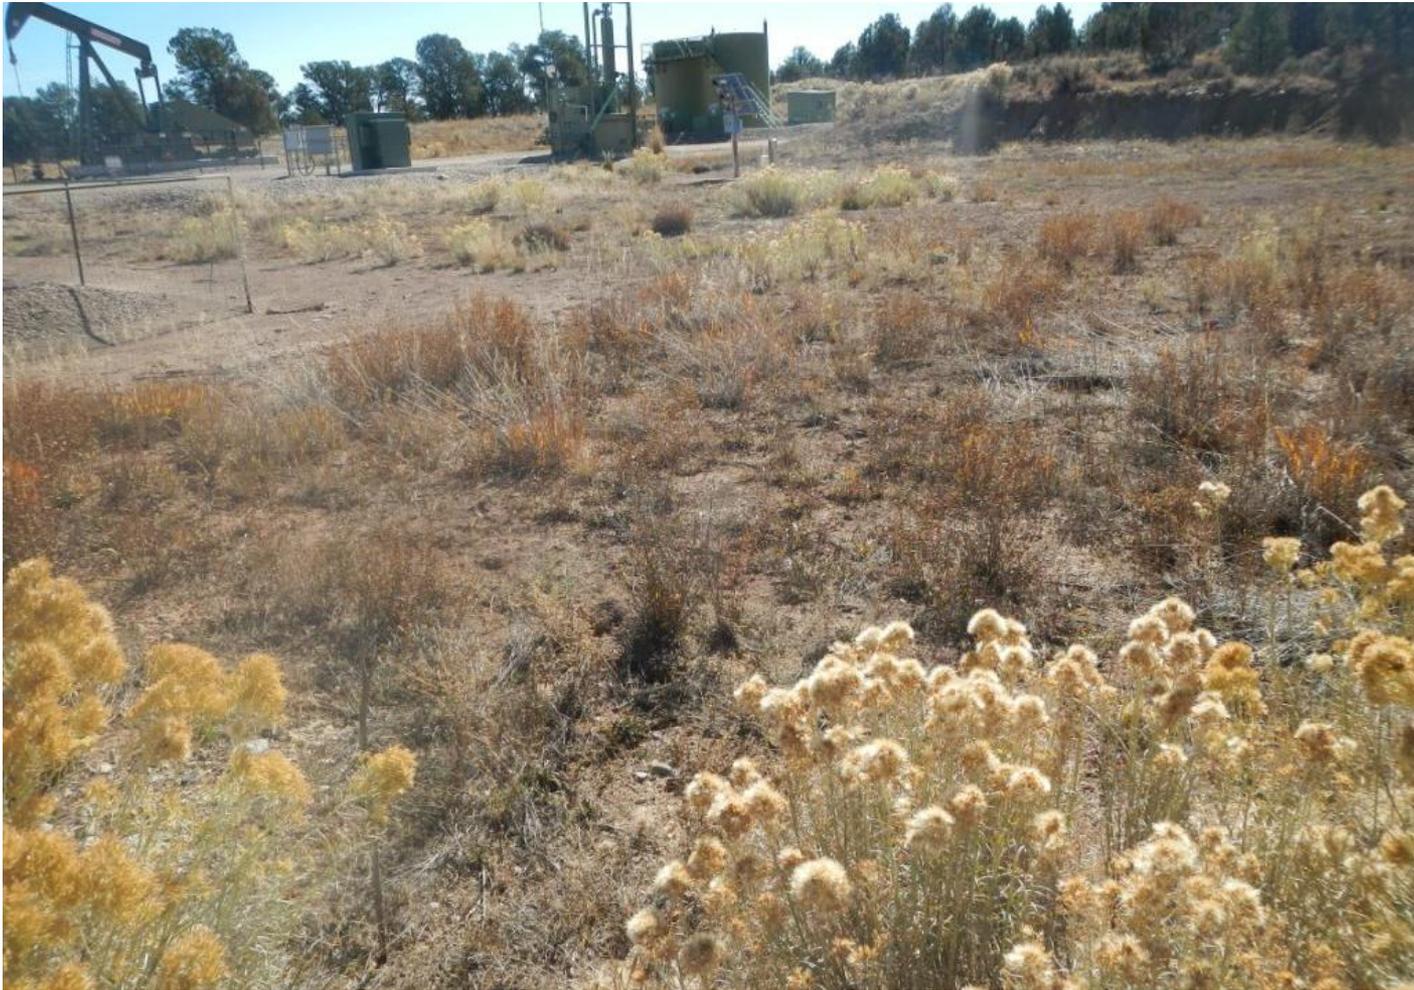
Photo 2. View of the southeastern portion of the project area from the northwestern edge facing southeastward. Revegetation is progressing with perennial species such as smooth brome (*Bromus inermis*), crested wheatgrass (*Agropyron cristatum*), and rubber rabbitbrush (*Chrysothamnus nauseosus*)

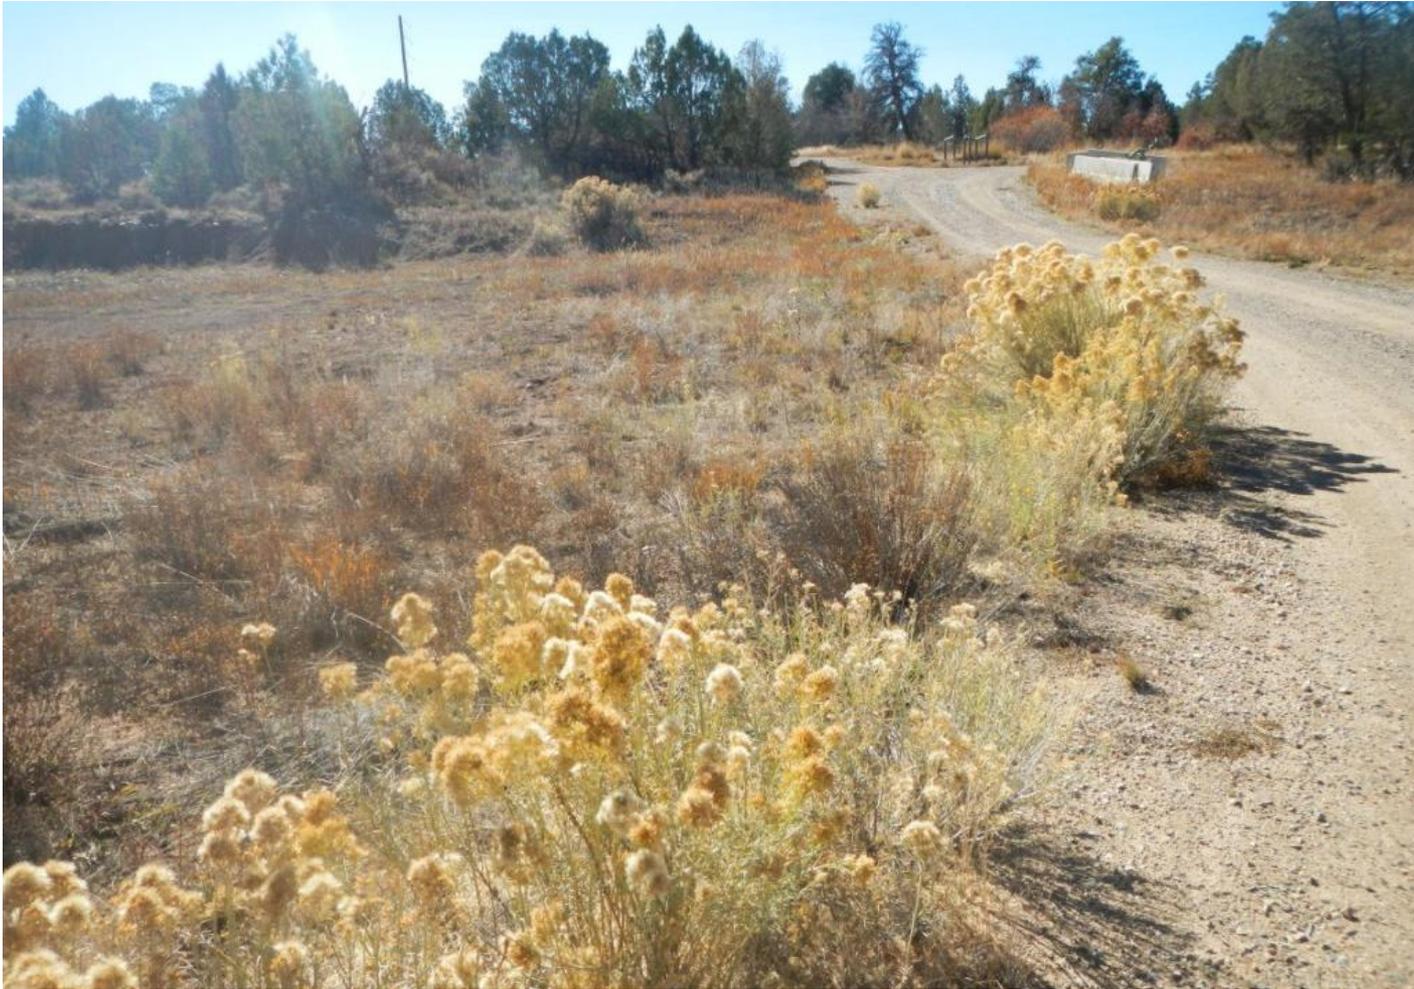
Photo 3. View of the western portion of the project area from the northwestern edge facing southward.

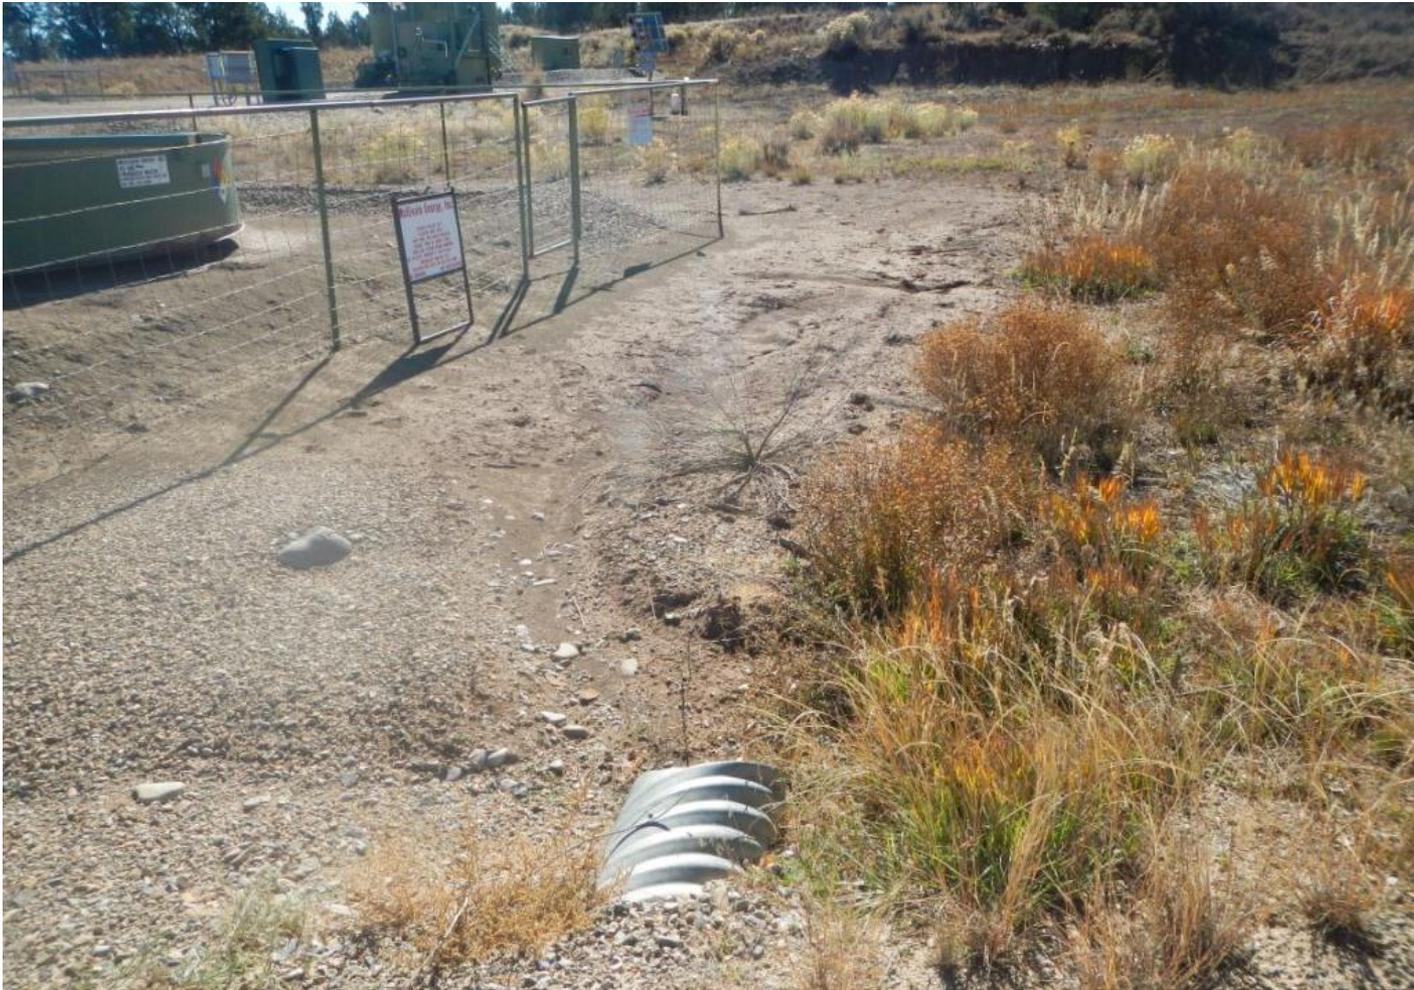
Photo 4. View of area where stormwater flows enter culvert and it appears sediment is carried with it.

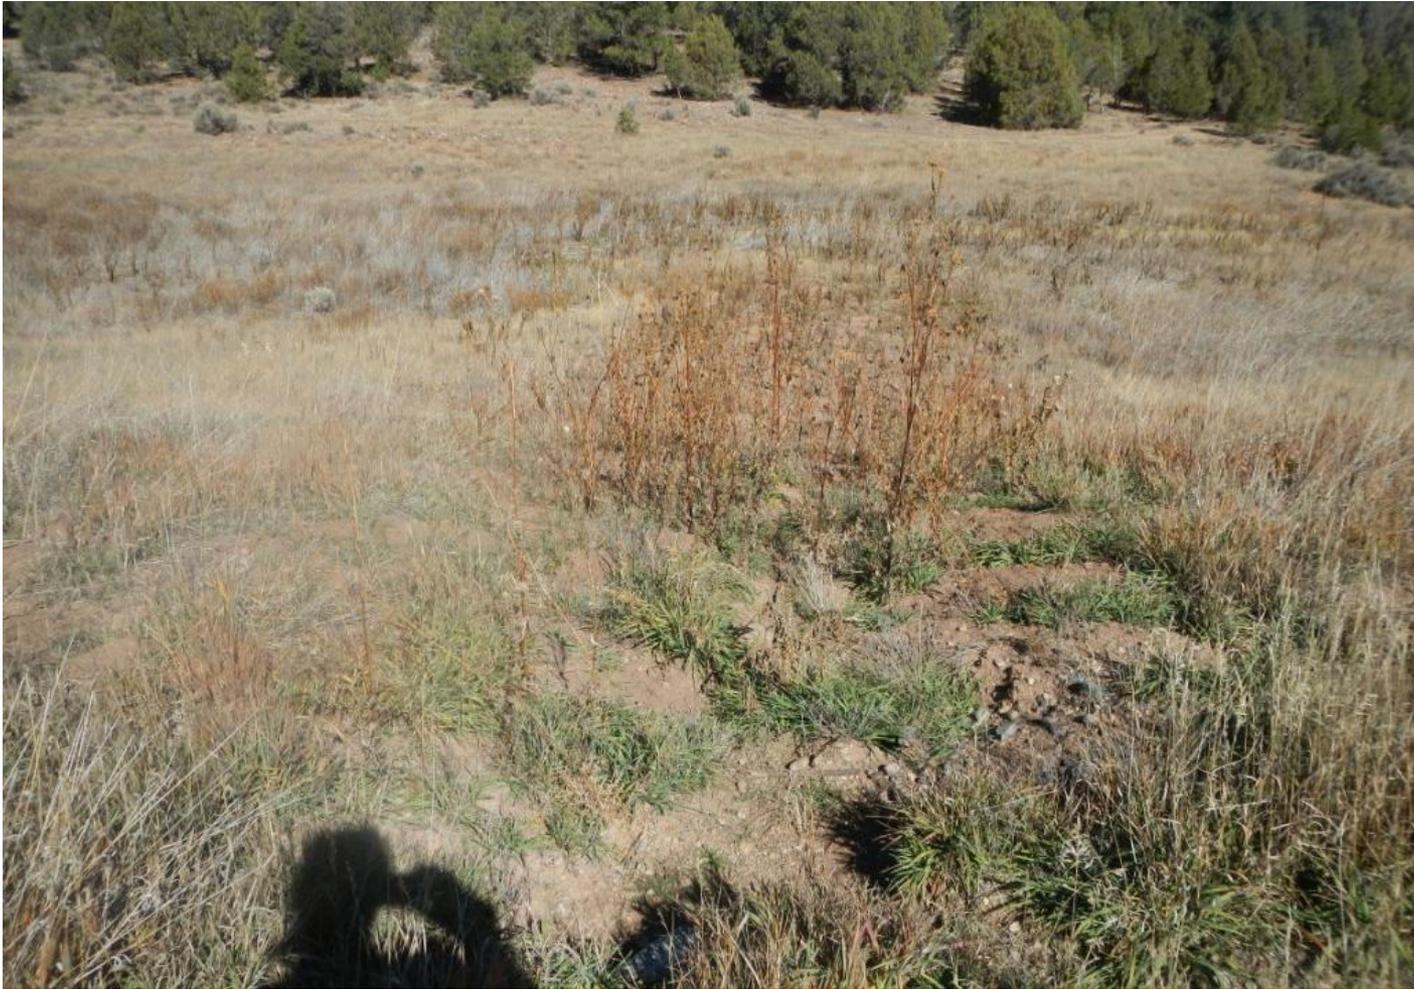
Photo 5. View of the outlet from the culvert shown in Photo 4, where it appears sediment debris from the culvert is being discharged outside of the project area and damaging vegetation.
