Construction and Stormwater Inspection

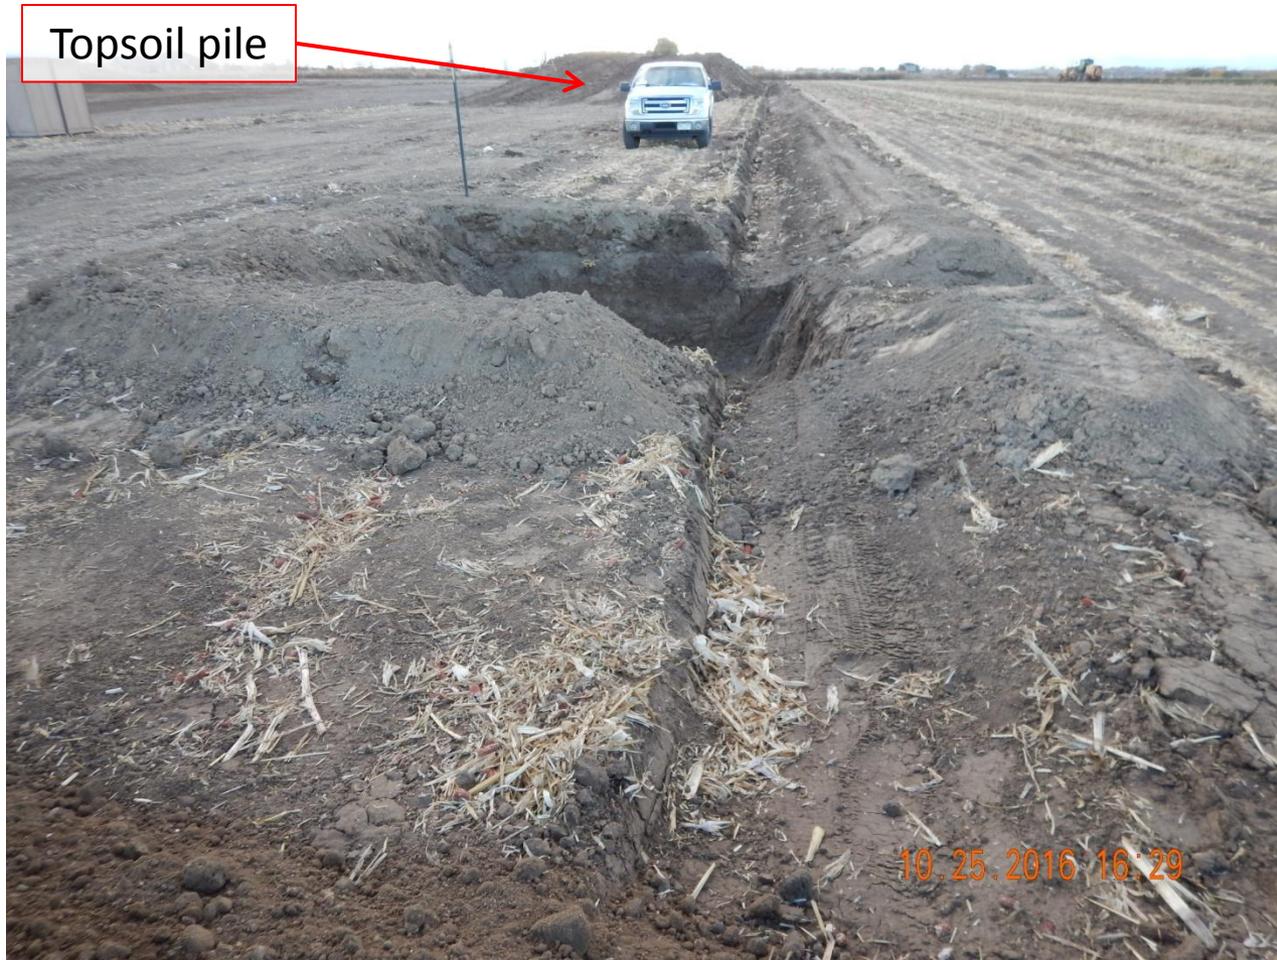
Photo 1. Photo taken from northeastern corner of perimeter, facing West. Sediment trap installed which will be stabilized per the contractor. Topsoil pile stored along northern location. Ditch and berm constructed around outer perimeter of the location.

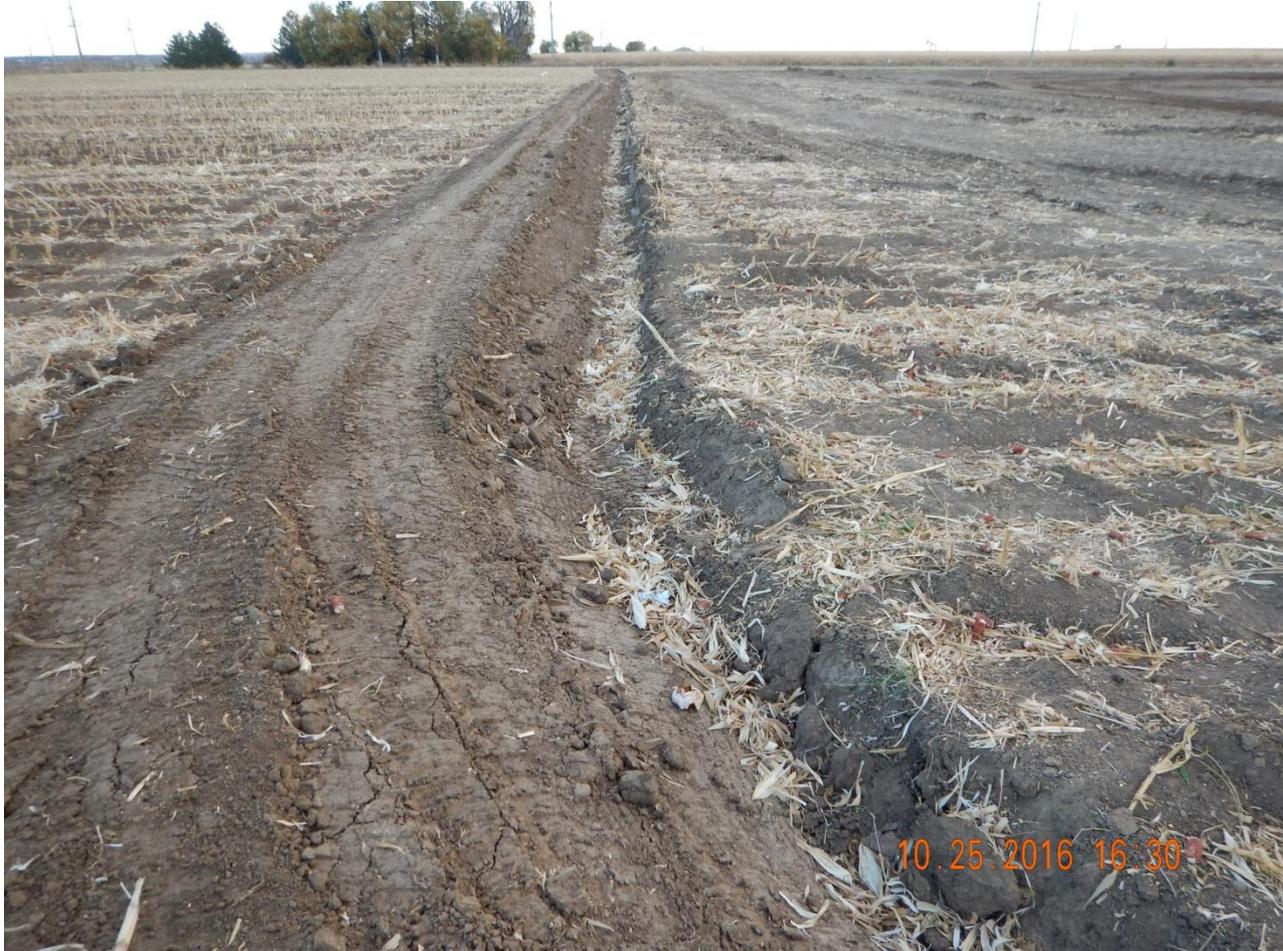
Photo 2. Photo taken from northeastern corner of perimeter, facing South. Ditch and berm constructed around outer perimeter of the location.

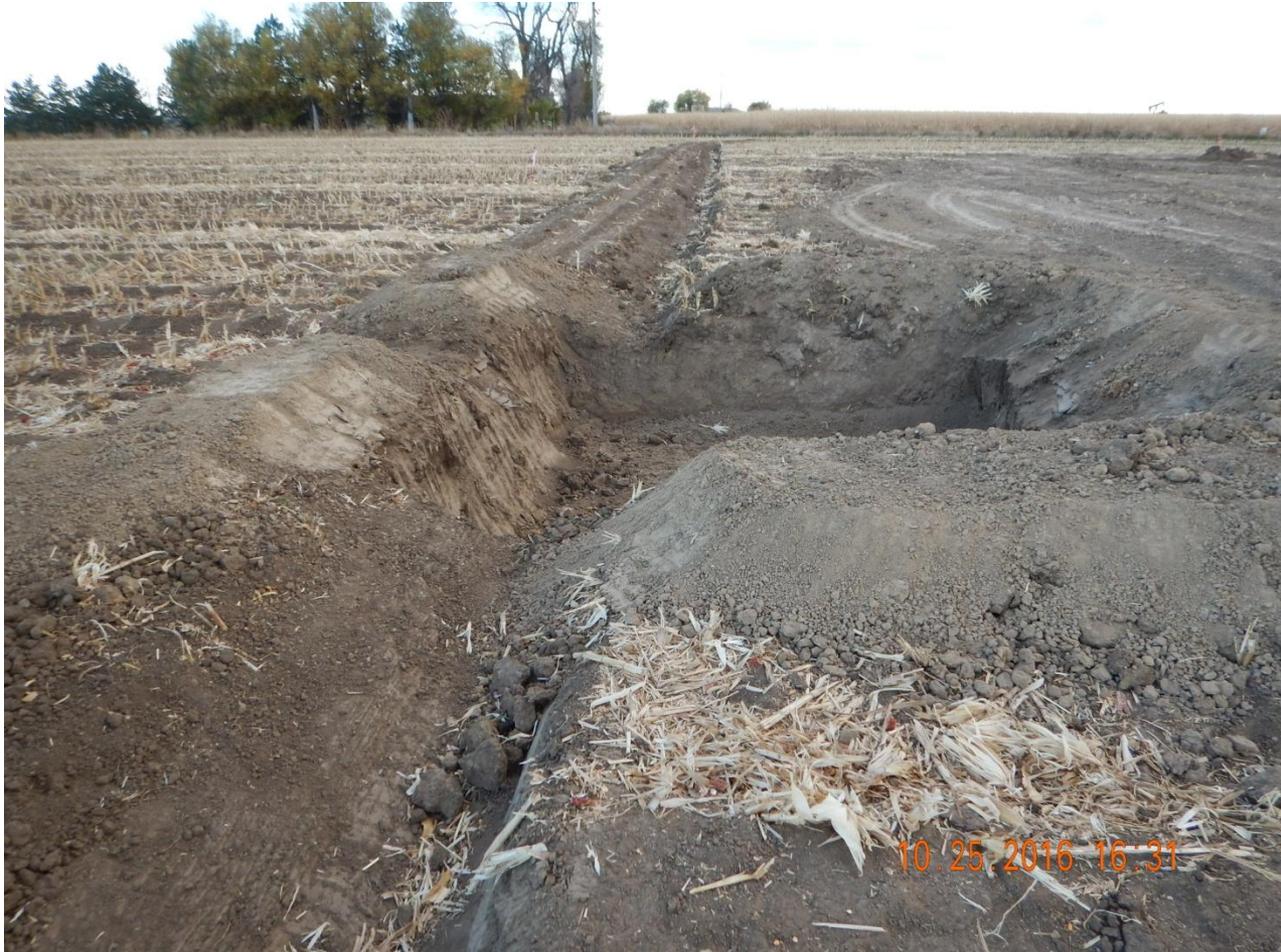
Photo 3. Photo taken from eastern perimeter of the location, facing South. Sediment trap installed which will be stabilized per the contractor. Ditch and berm constructed around outer perimeter of the location.

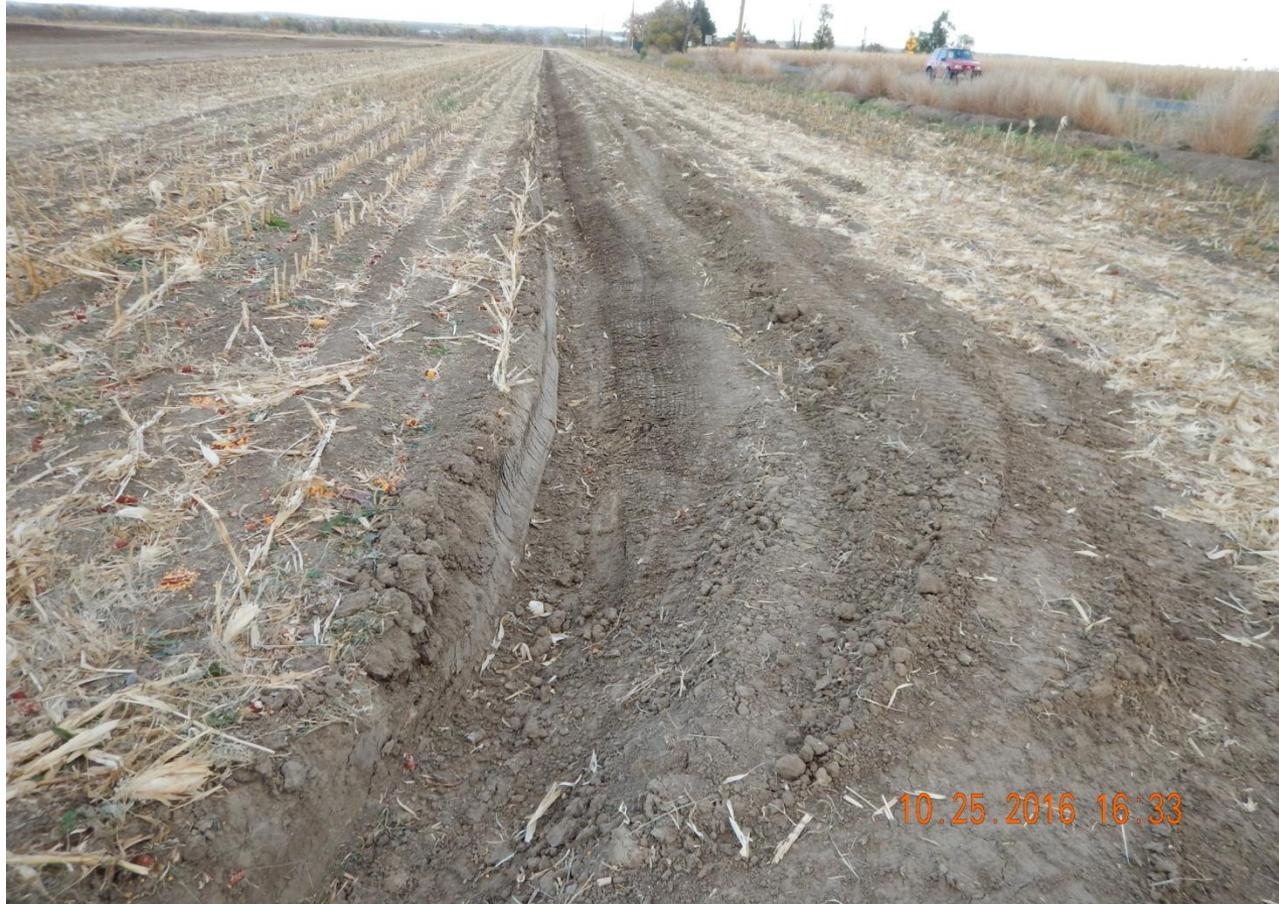
Photo 4. Photo taken from southwestern corner of perimeter, facing East. Ditch and berm constructed around outer perimeter of the location.

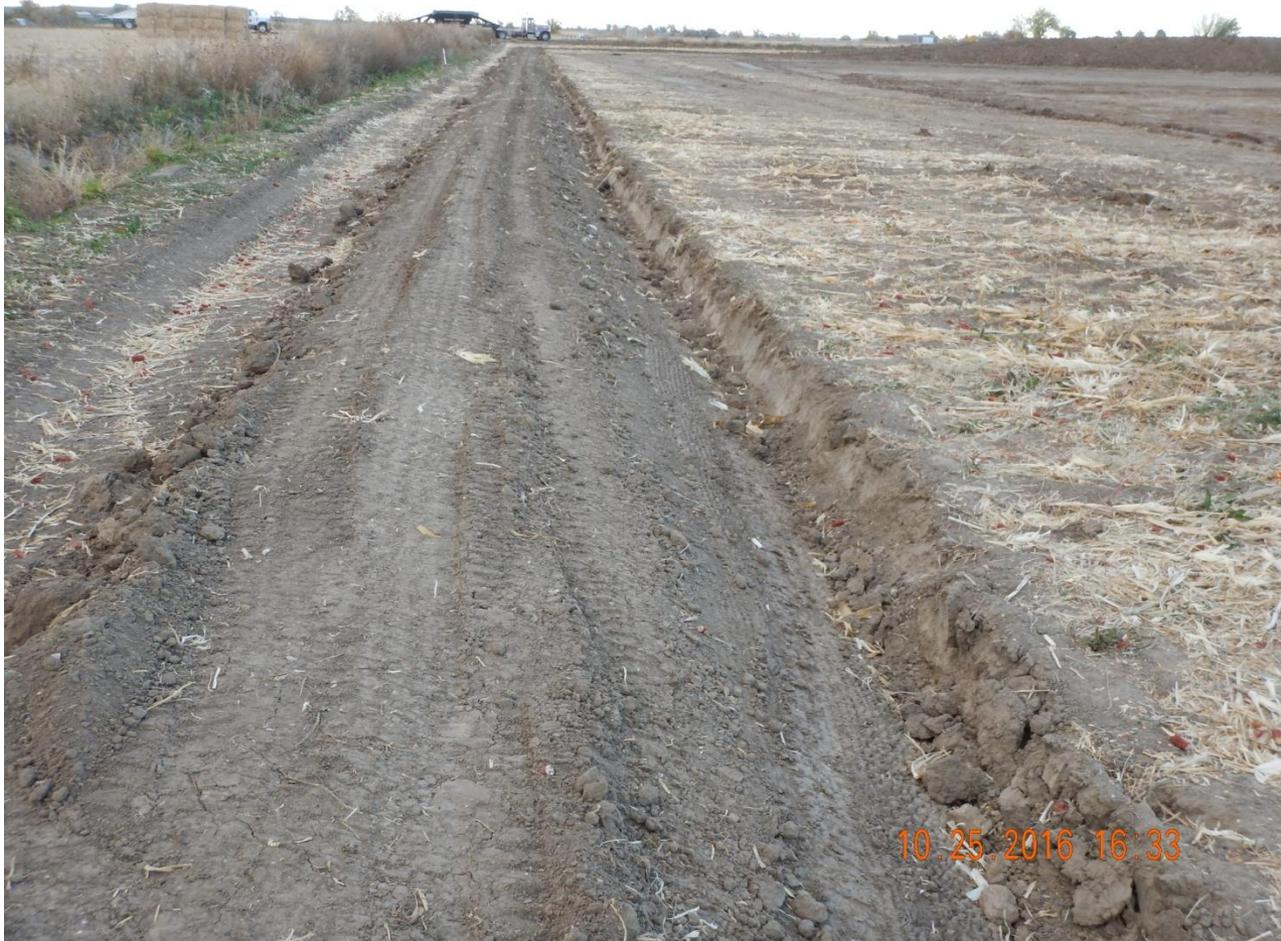
Photo 5. Photo taken from southwestern corner of perimeter, facing North. Ditch and berm constructed around outer perimeter of the location.

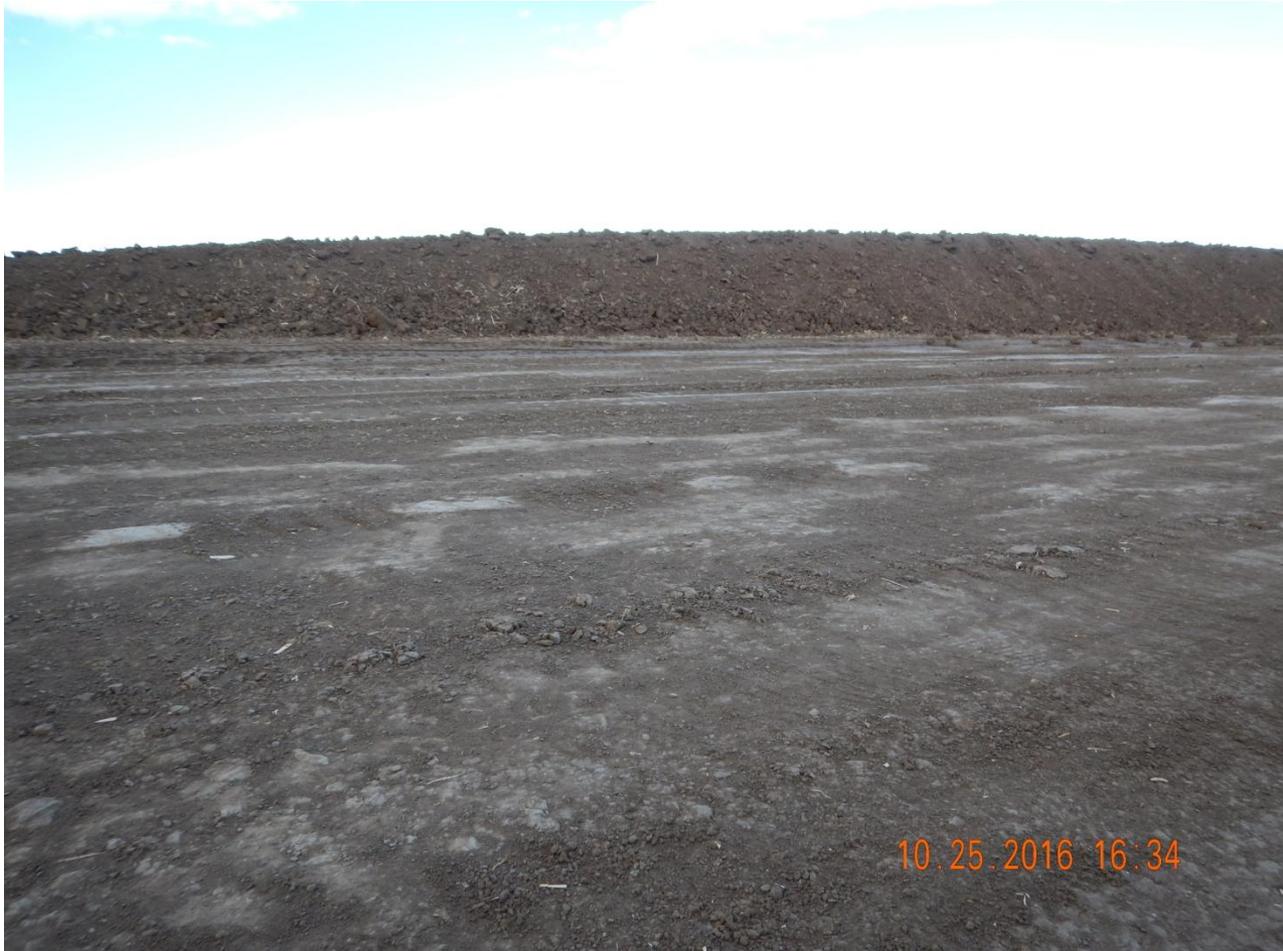
Photo 6. Photo taken from northern location, facing North, toward topsoil pile.
