## Construction and Stormwater Inspection

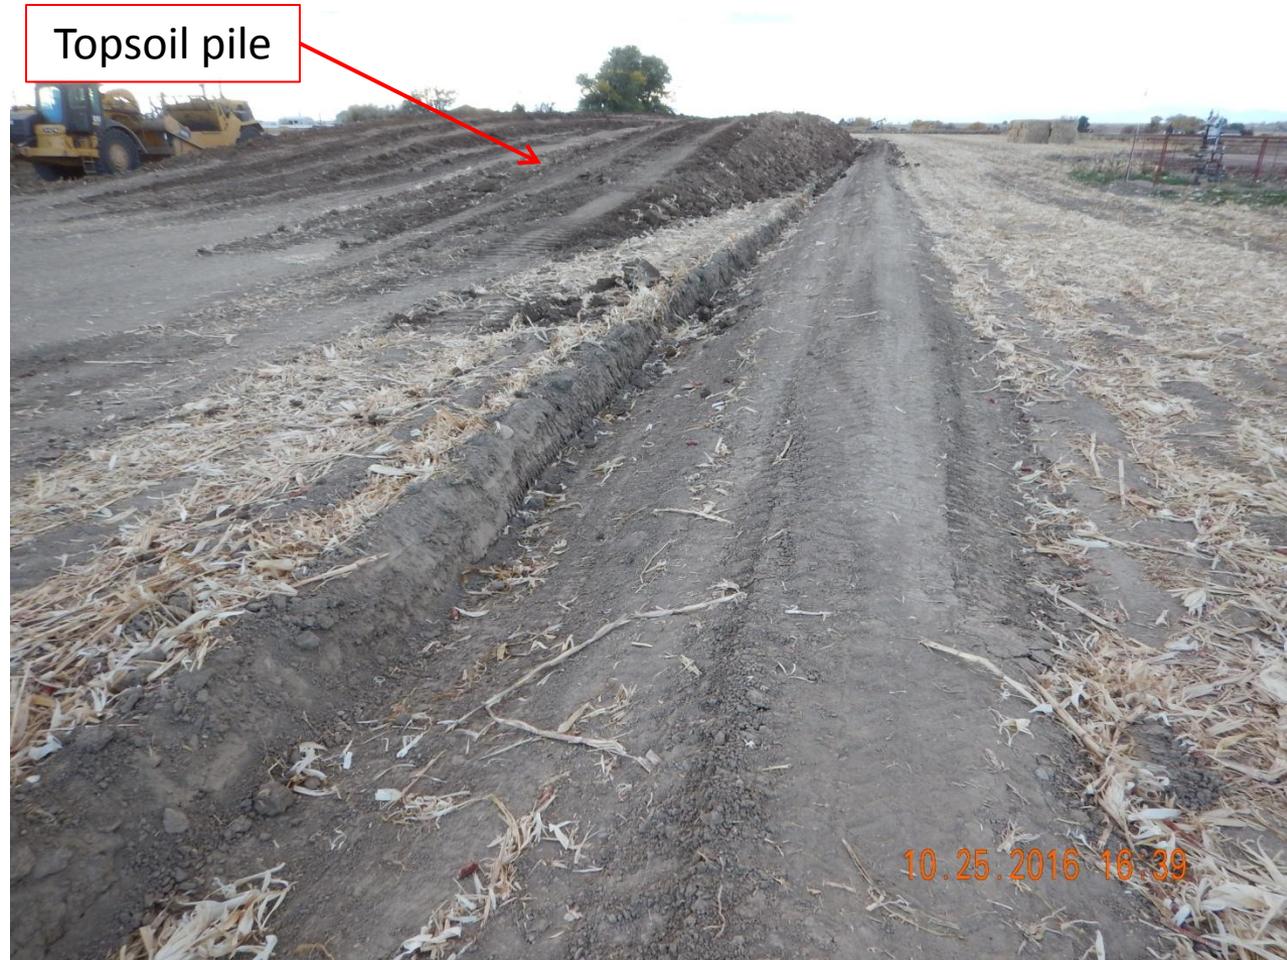
**Photo 1.** Photo taken from northern perimeter of location, facing West. Topsoil salvage IN-PROCESS and being stored along northern location. Ditch and berm constructed around outer perimeter of the location.

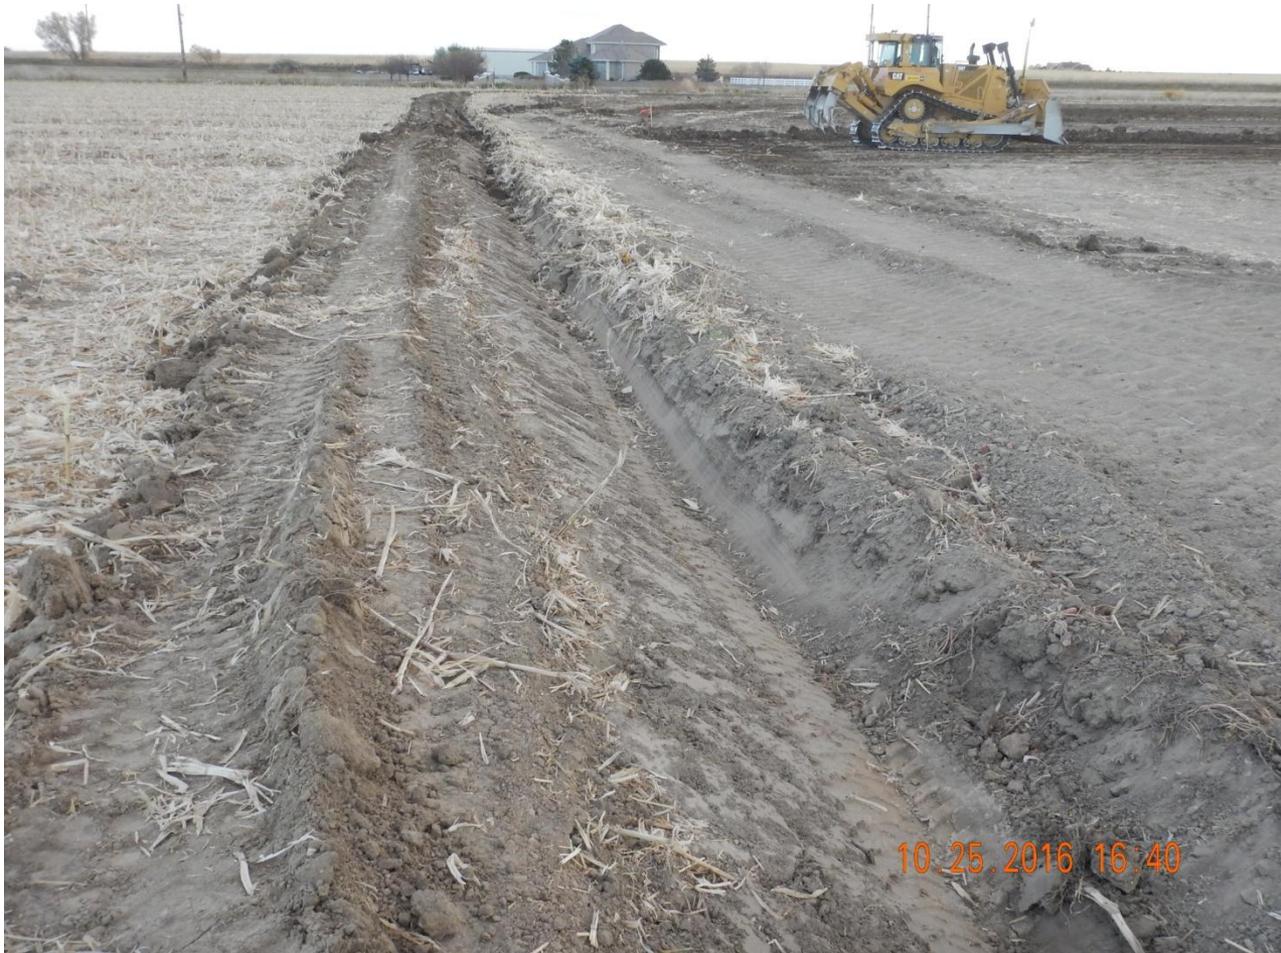
**Photo 2.** Photo taken from eastern perimeter of location, facing South. Ditch and berm constructed around outer perimeter of the location.

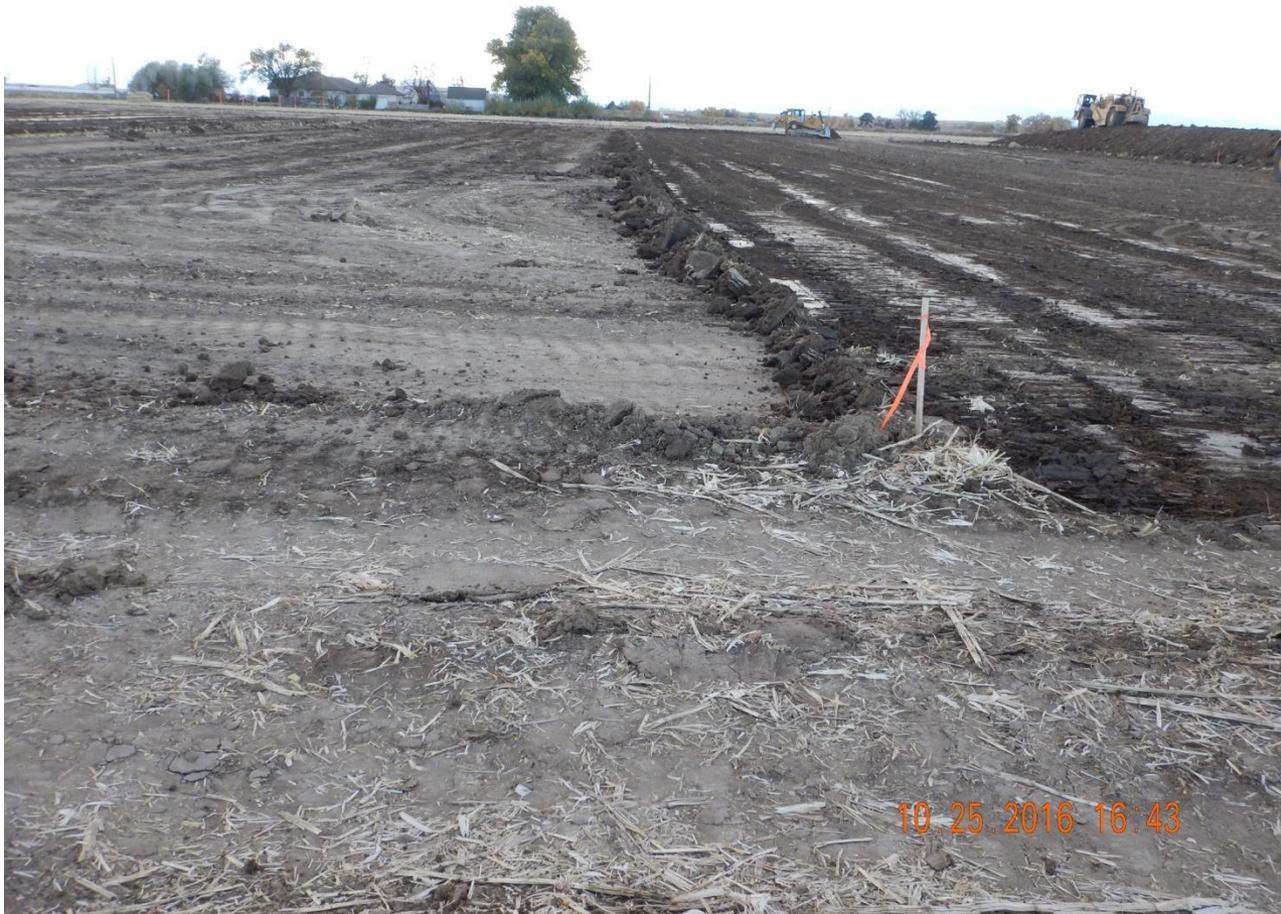
**Photo 3.** Photo taken from eastern perimeter of location, facing West. Topsoil salvage IN-PROCESS.

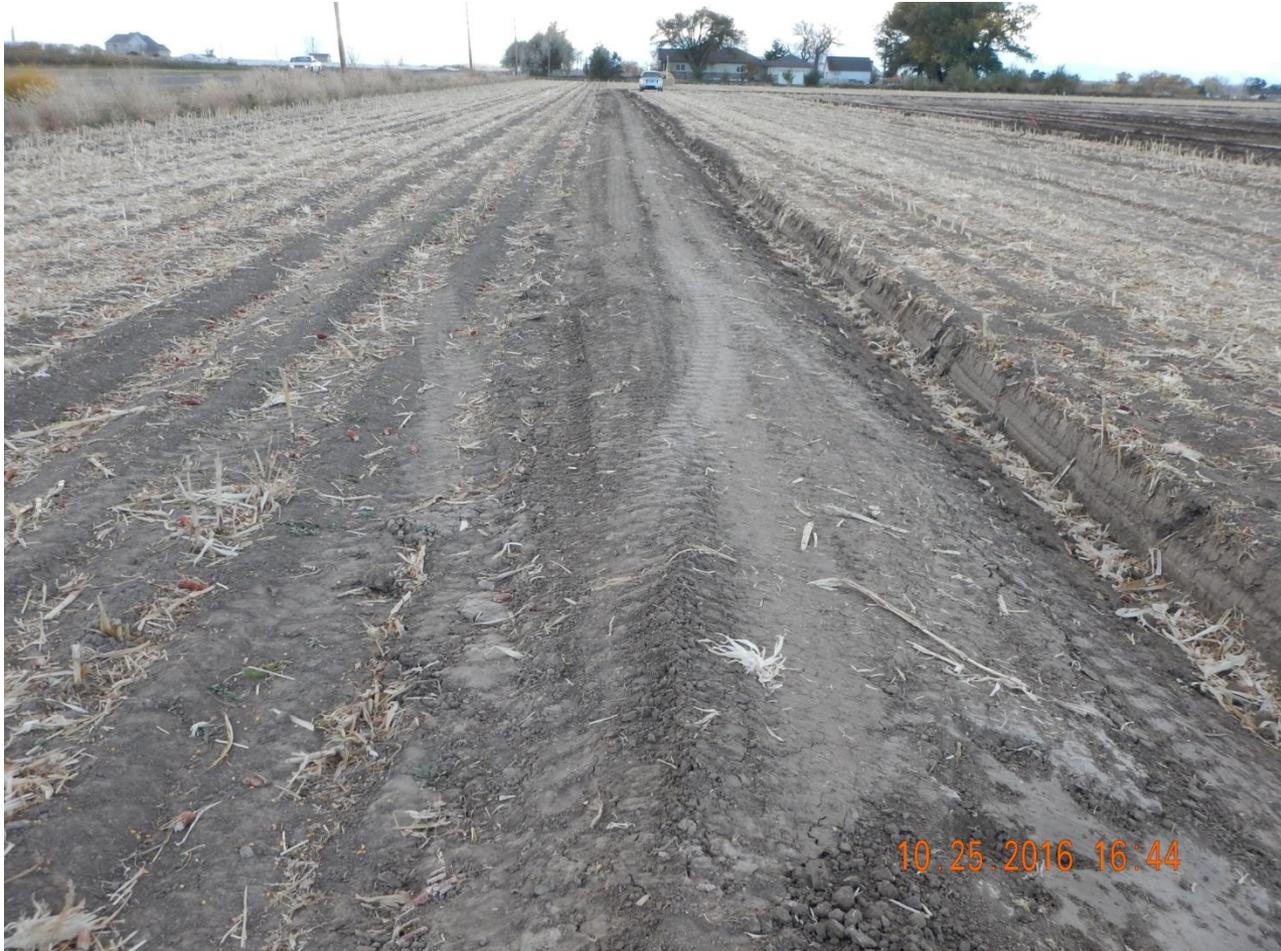
**Photo 4.** Photo taken from southern perimeter of location, facing West. Ditch and berm constructed around outer perimeter of the location.

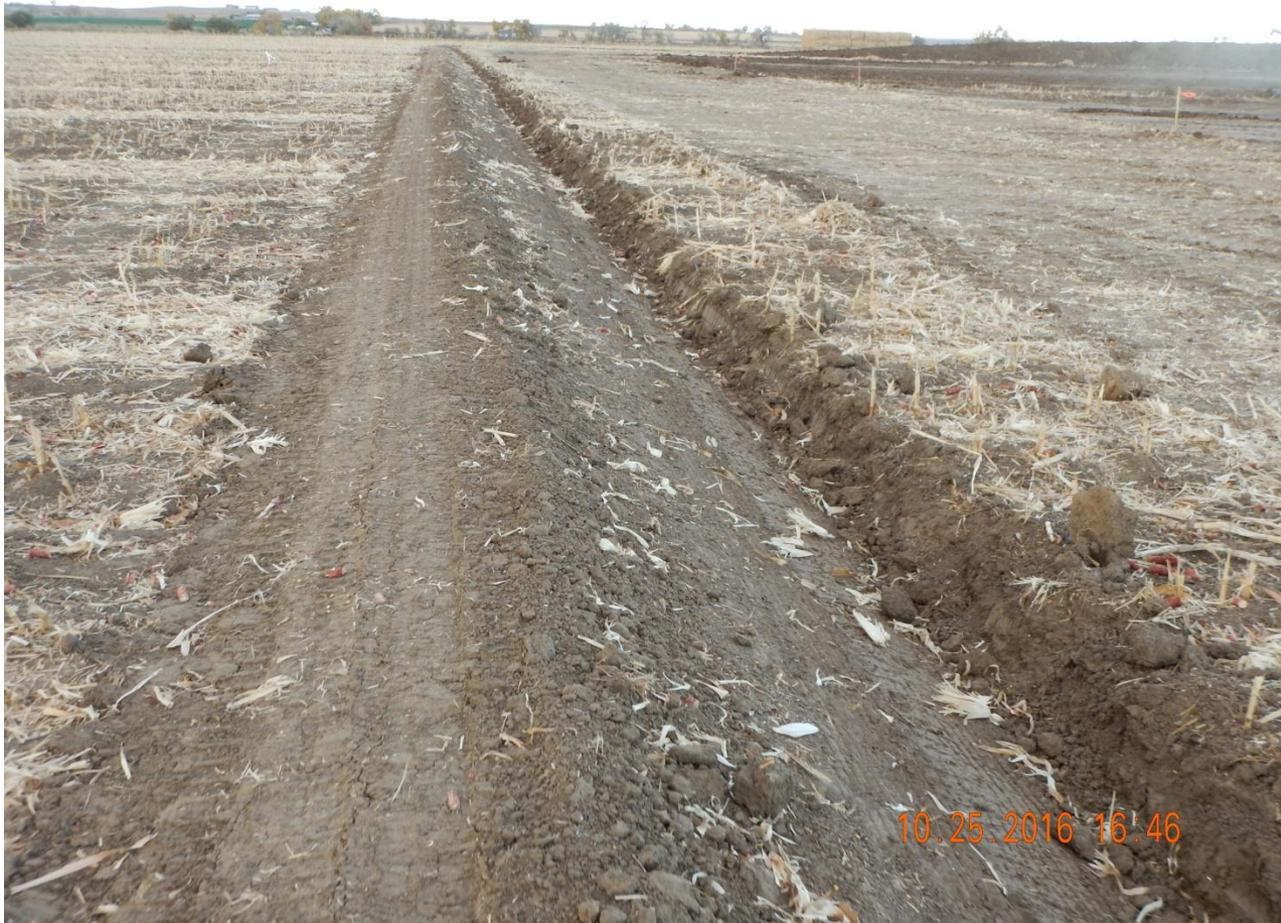
**Photo 5.** Photo taken from western perimeter of location, facing North. Ditch and berm constructed around outer perimeter of the location.
