Final Reclamation Overview- Summary of corrective actions

Final Reclamation Inspection

COLORADO
Oil & Gas Conservation
Commission
Department of Natural Resources

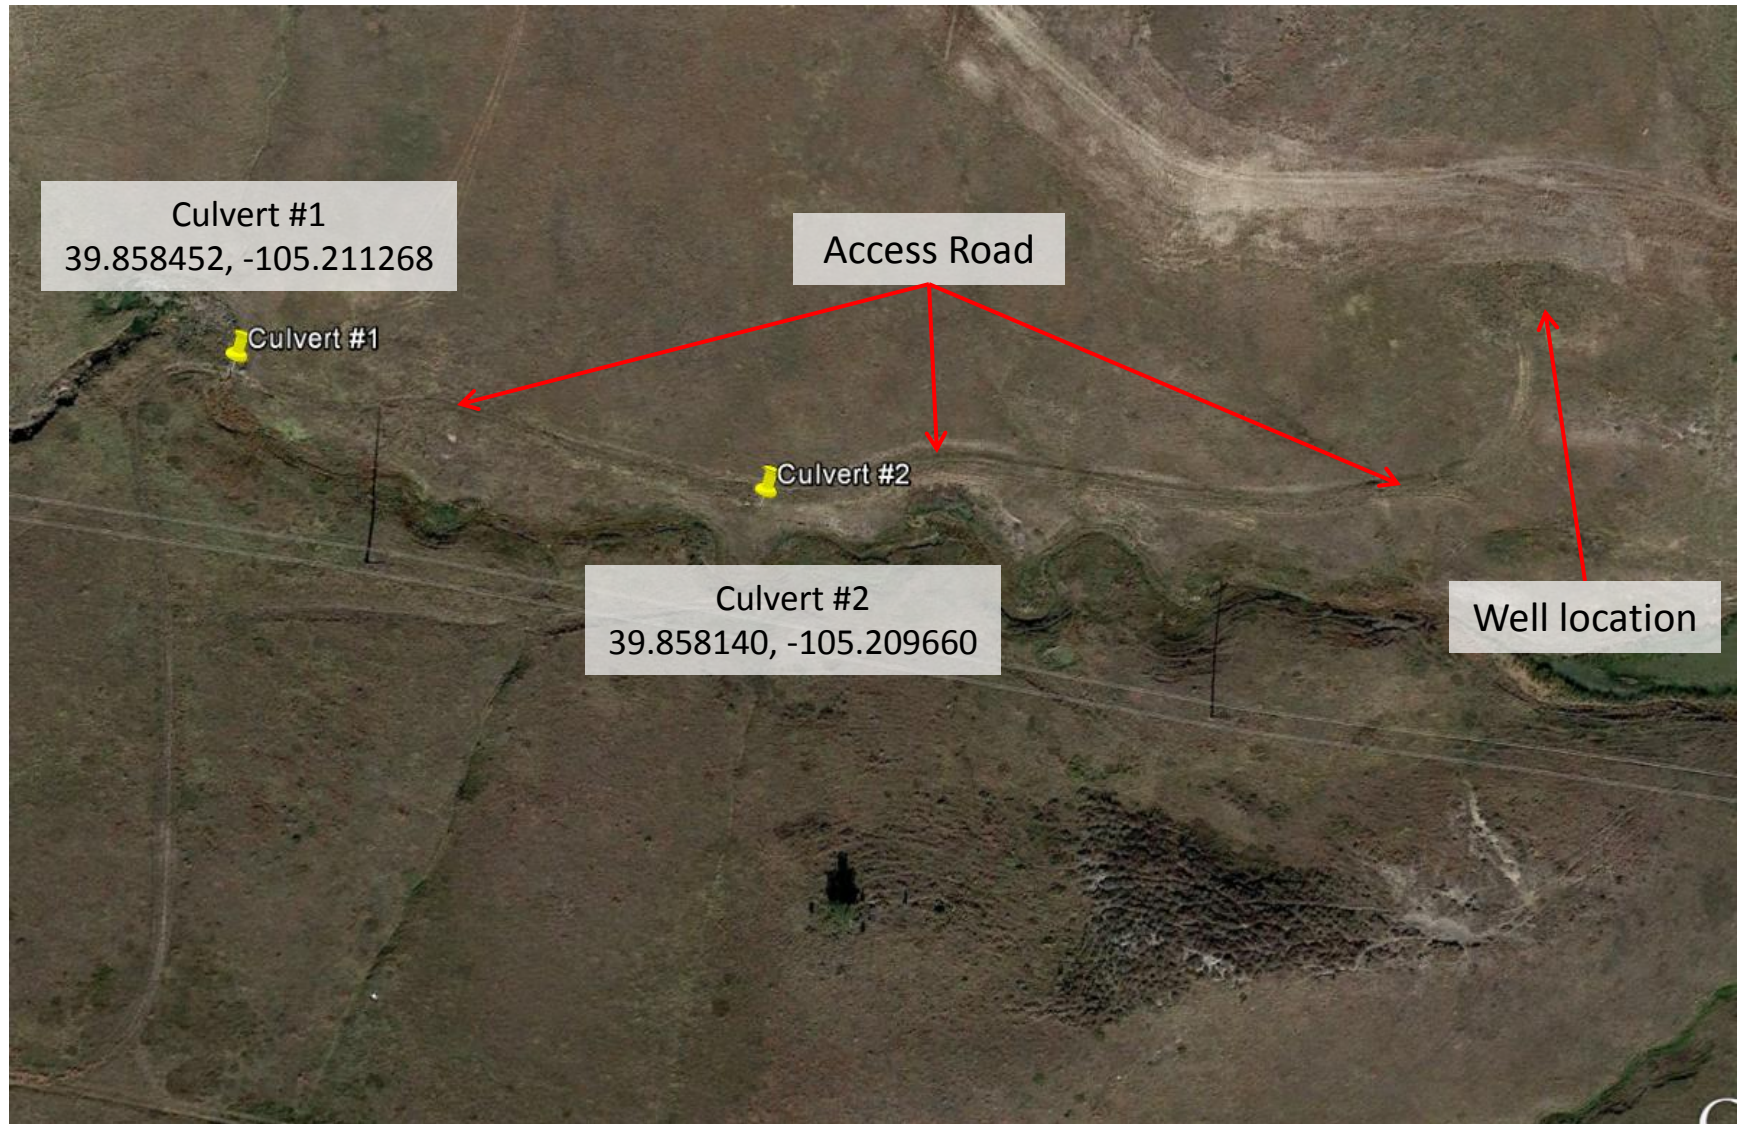
Google Earth aerial imagery taken 10/9/2015 illustrating area of interest. The access road, starting from Culvert #1 to the well location and the well location itself, has a Colorado List B noxious weed that needs to be controlled. In addition, erosion needs to be controlled around the drainage by Culvert #1 once the culvert has been removed. Culverts #1 and #2 shall be removed from the access road. Refer to the following photos taken on 9/8/16 for more information.

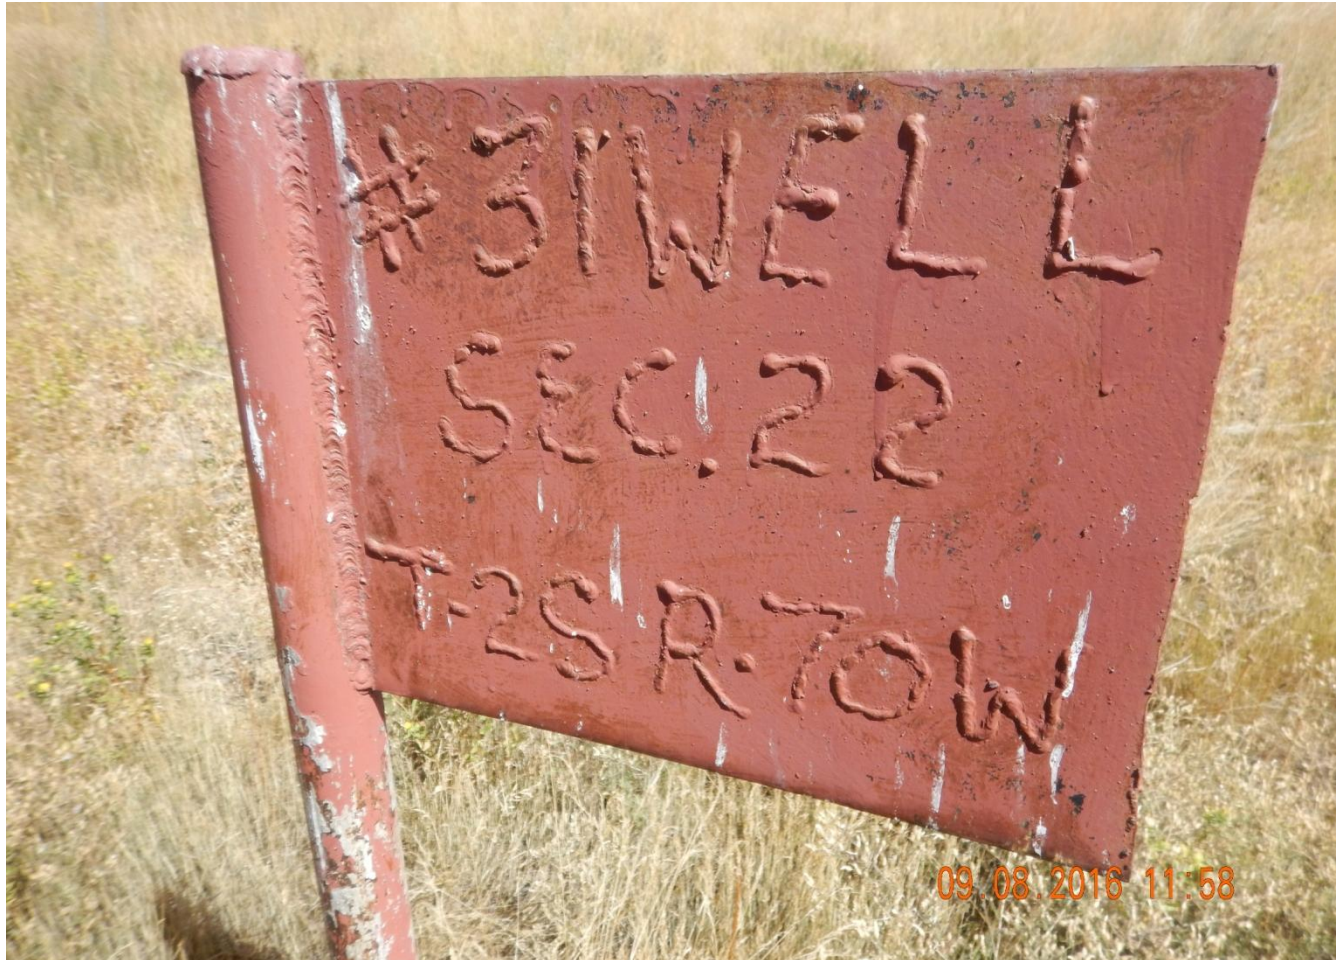
Photo 1. Photo taken of well sign at approximate center of well location.

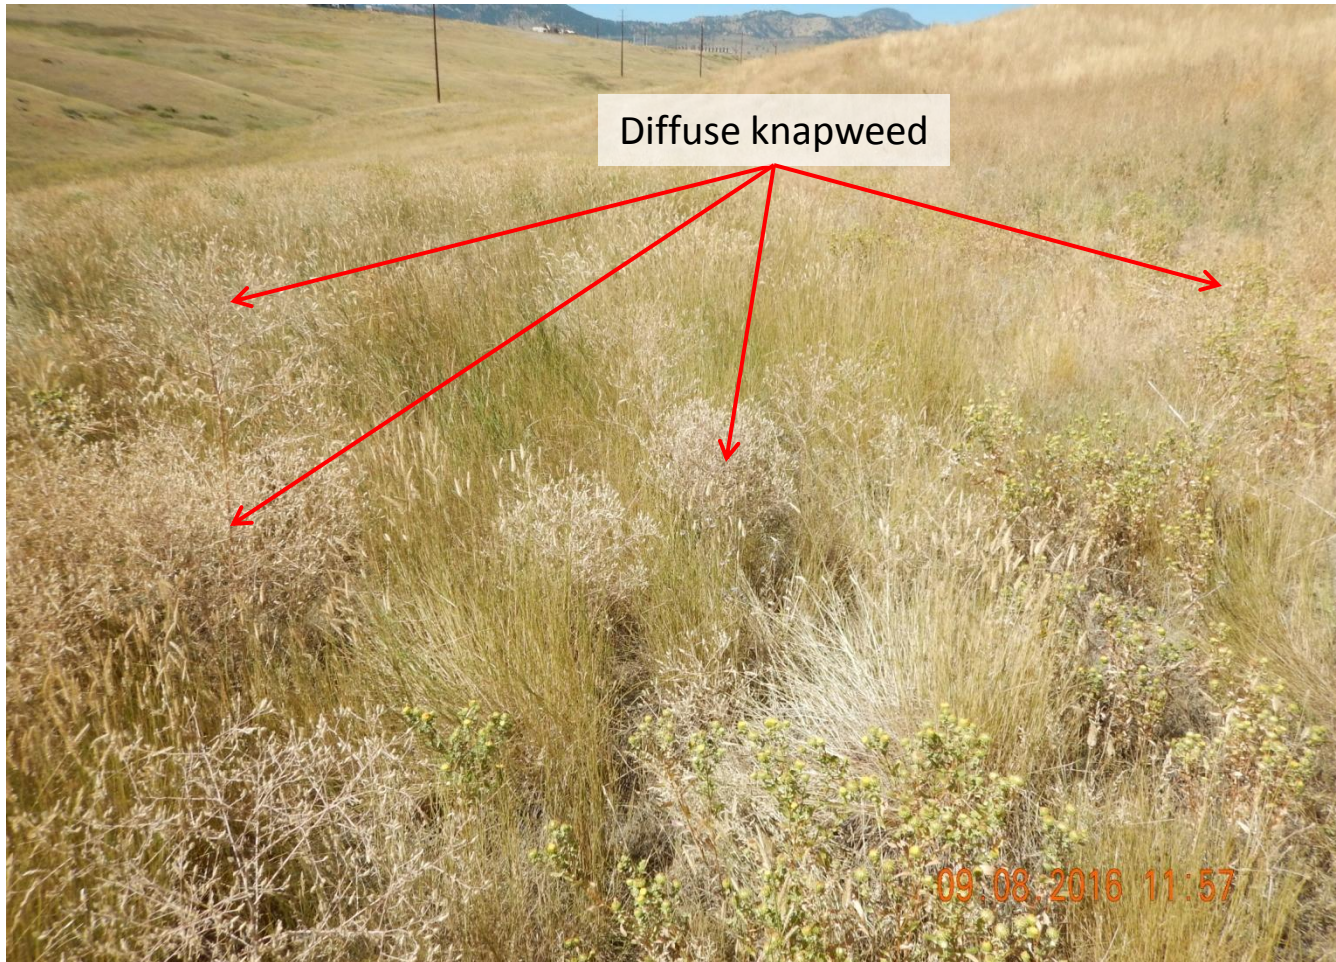
Photo 2. Photo taken from approximate center of location, facing West. Perennial vegetation has established at location but the location is inundated with a Colorado List B noxious weed, Diffuse knapweed (*Centaurea diffusa*).

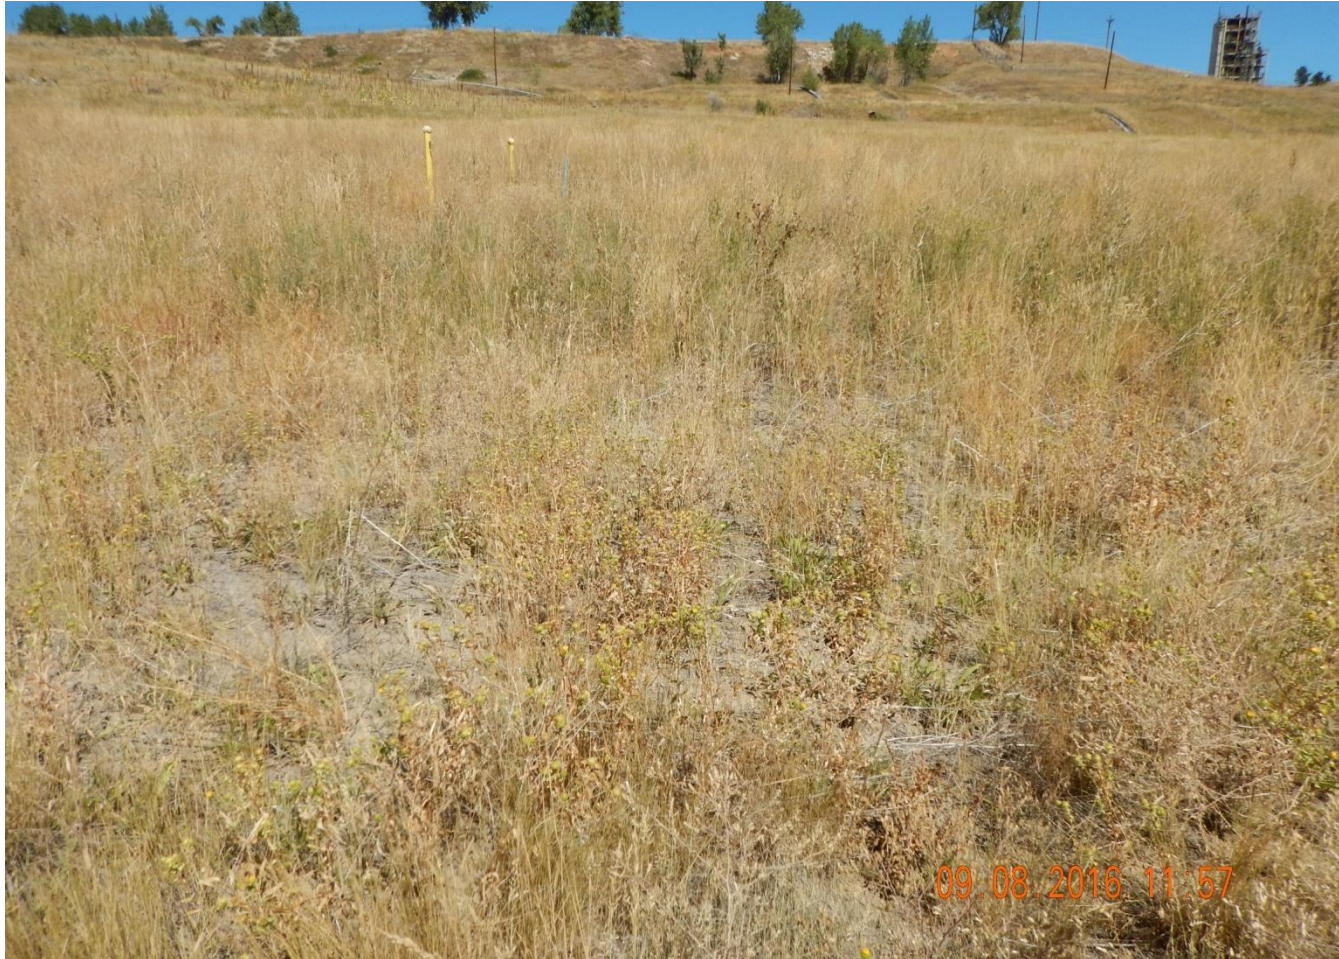
Photo 3. Photo taken from approximate center of location, facing North. Perennial vegetation has established at location but the location is inundated with a Colorado List B noxious weed, Diffuse knapweed (*Centaurea diffusa*).

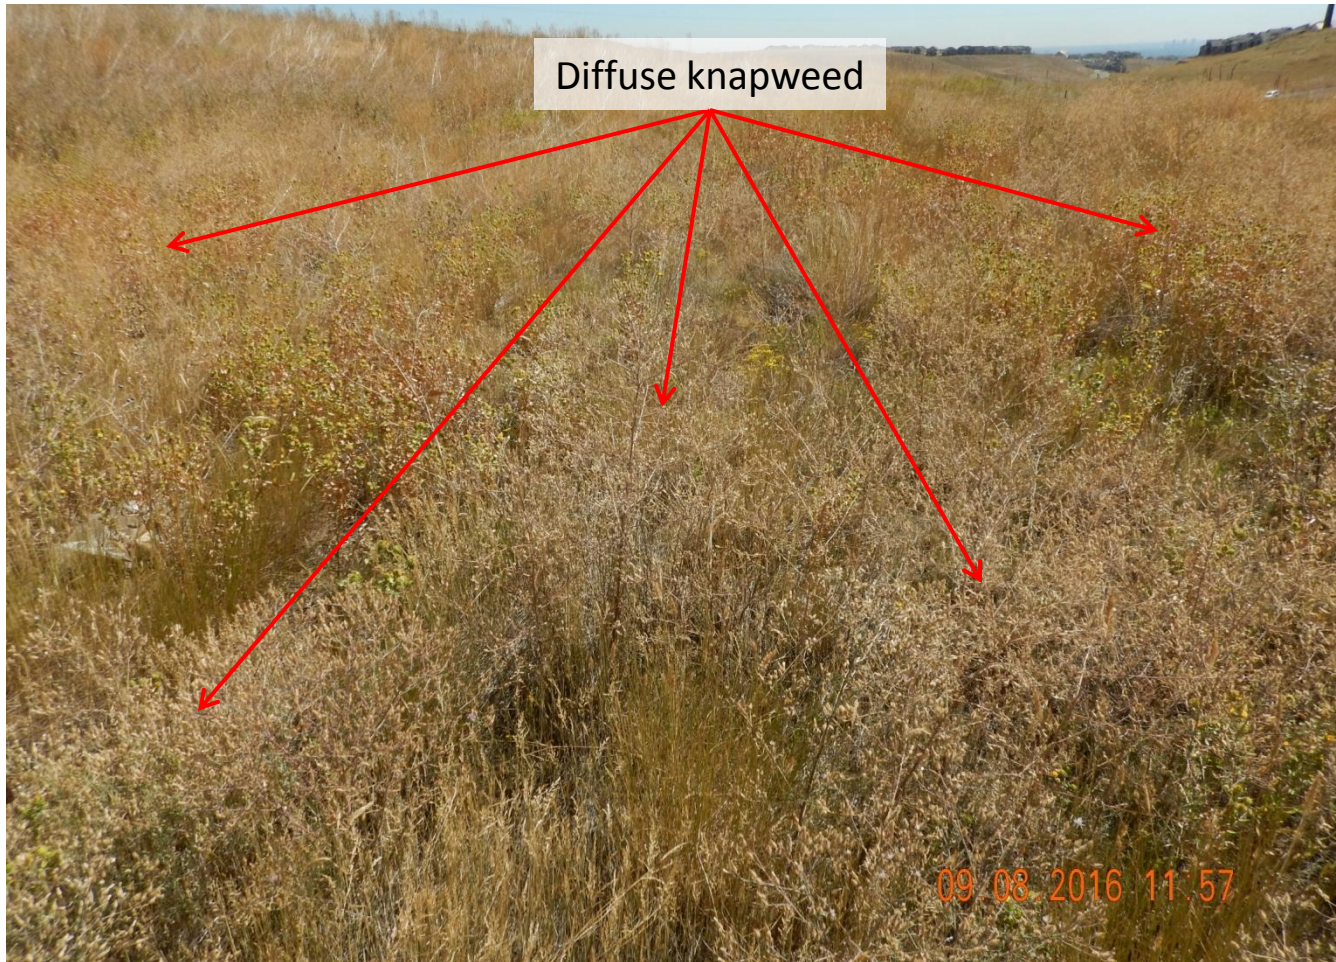
Photo 4. Photo taken from approximate center of location, facing East. Perennial vegetation has established at location but the location is inundated with a Colorado List B noxious weed, Diffuse knapweed (*Centaurea diffusa*).

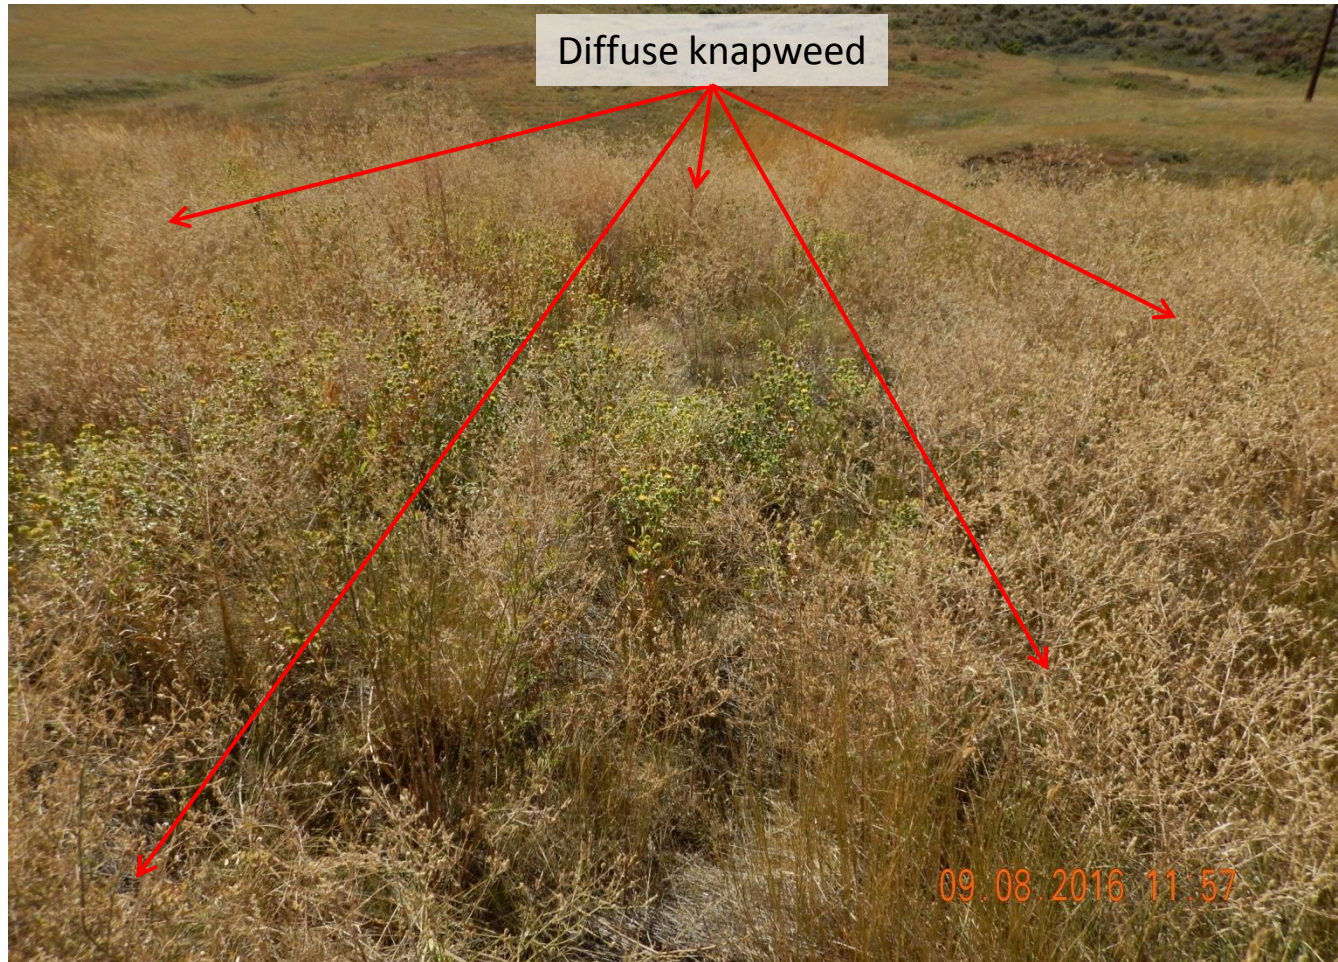
Photo 5. Photo taken from approximate center of location, facing South. Perennial vegetation has established at location but the location is inundated with a Colorado List B noxious weed, Diffuse knapweed (*Centaurea diffusa*).

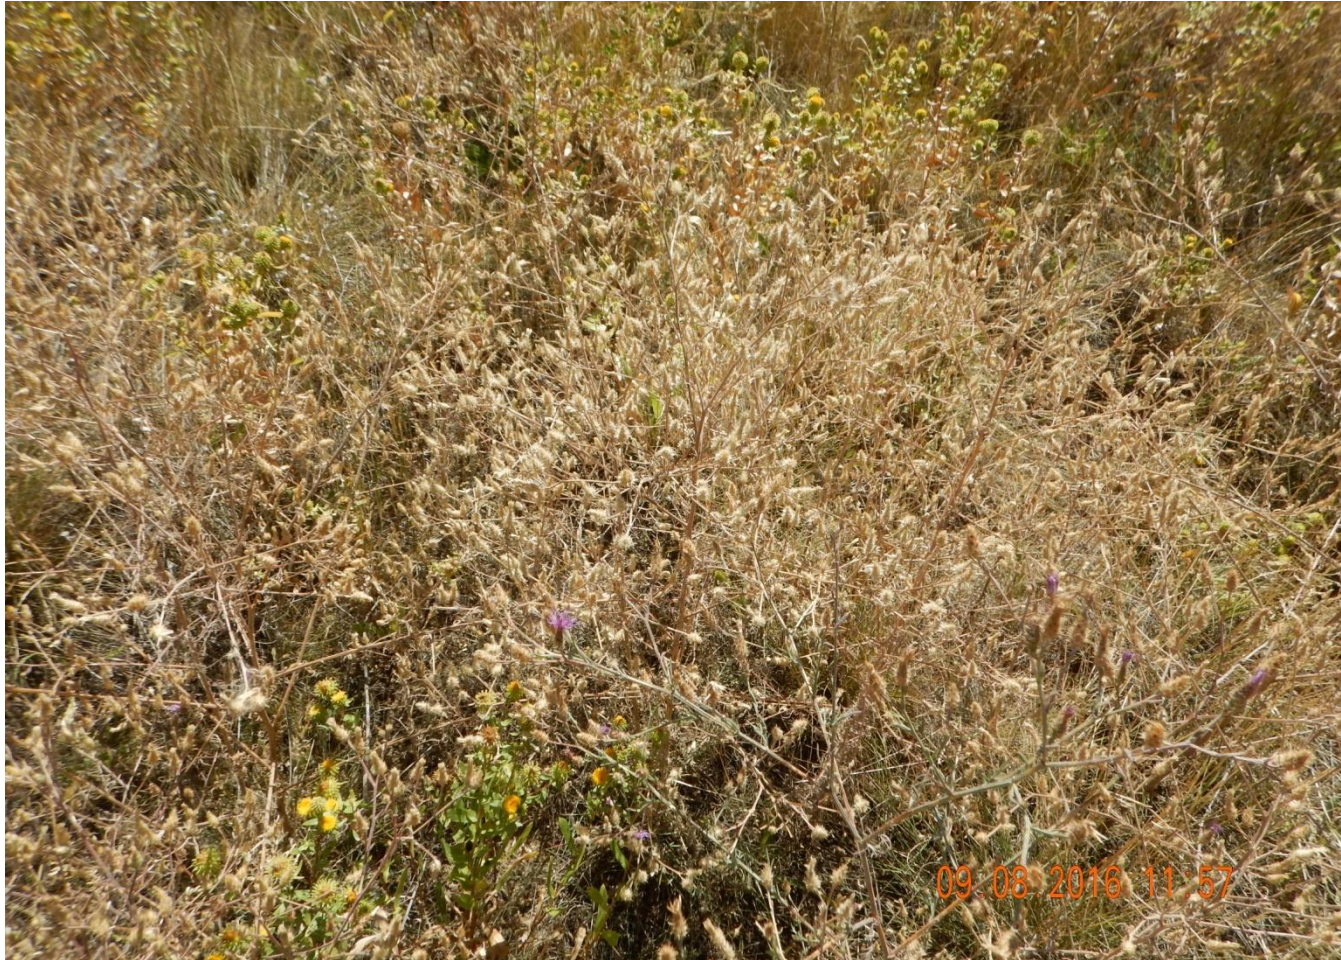
Photo 6. Close-up photo taken of Diffuse knapweed.

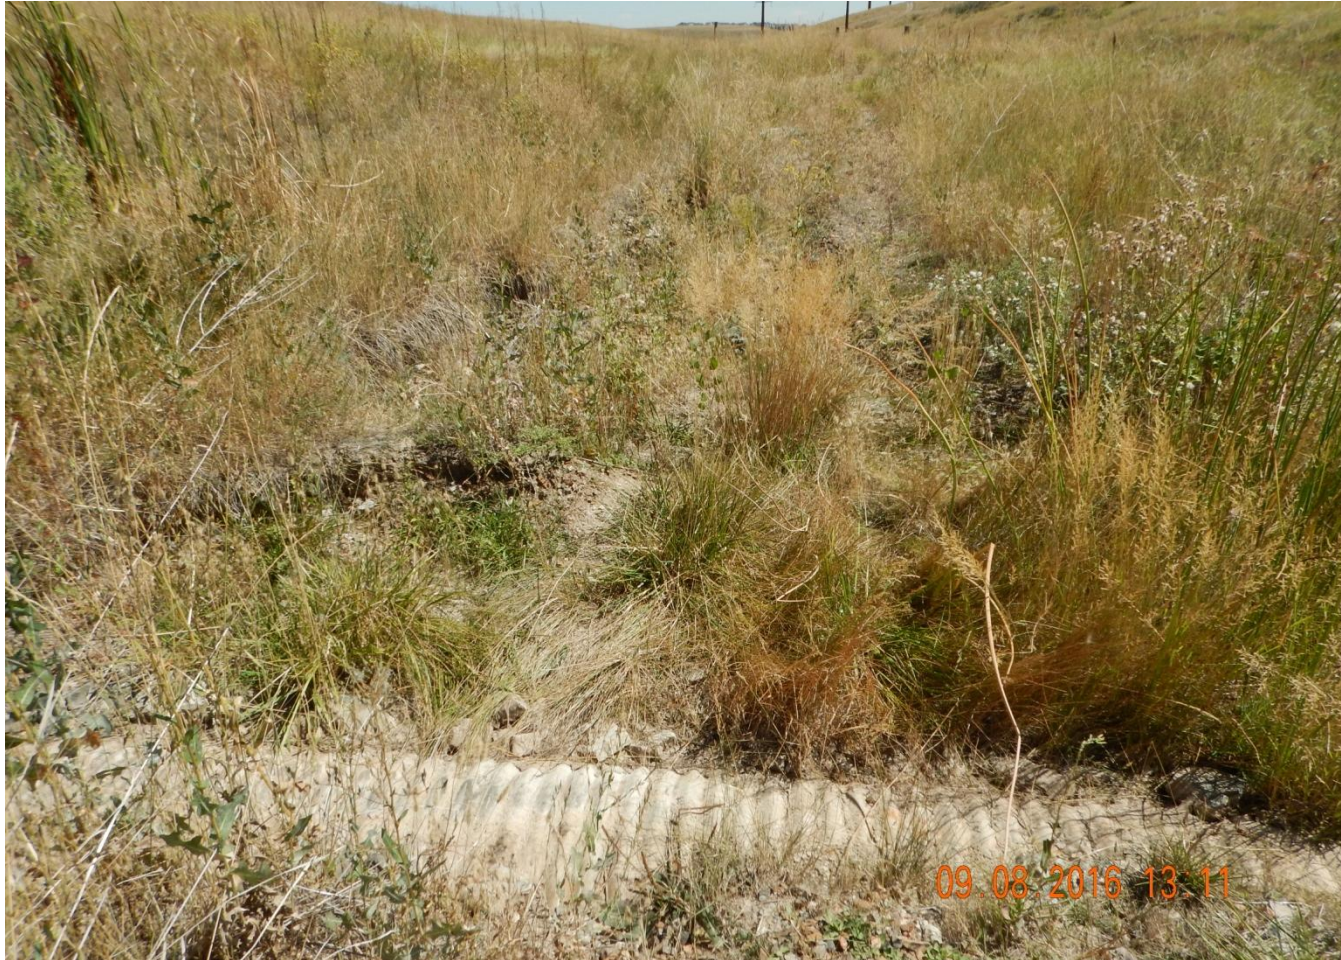
Photo 7. Photo taken from Culvert #1, facing East. Culvert needs to be removed to establish natural flows, need to remove gravel used to arm the culvert and reseed with native, perennial vegetation that is representative.

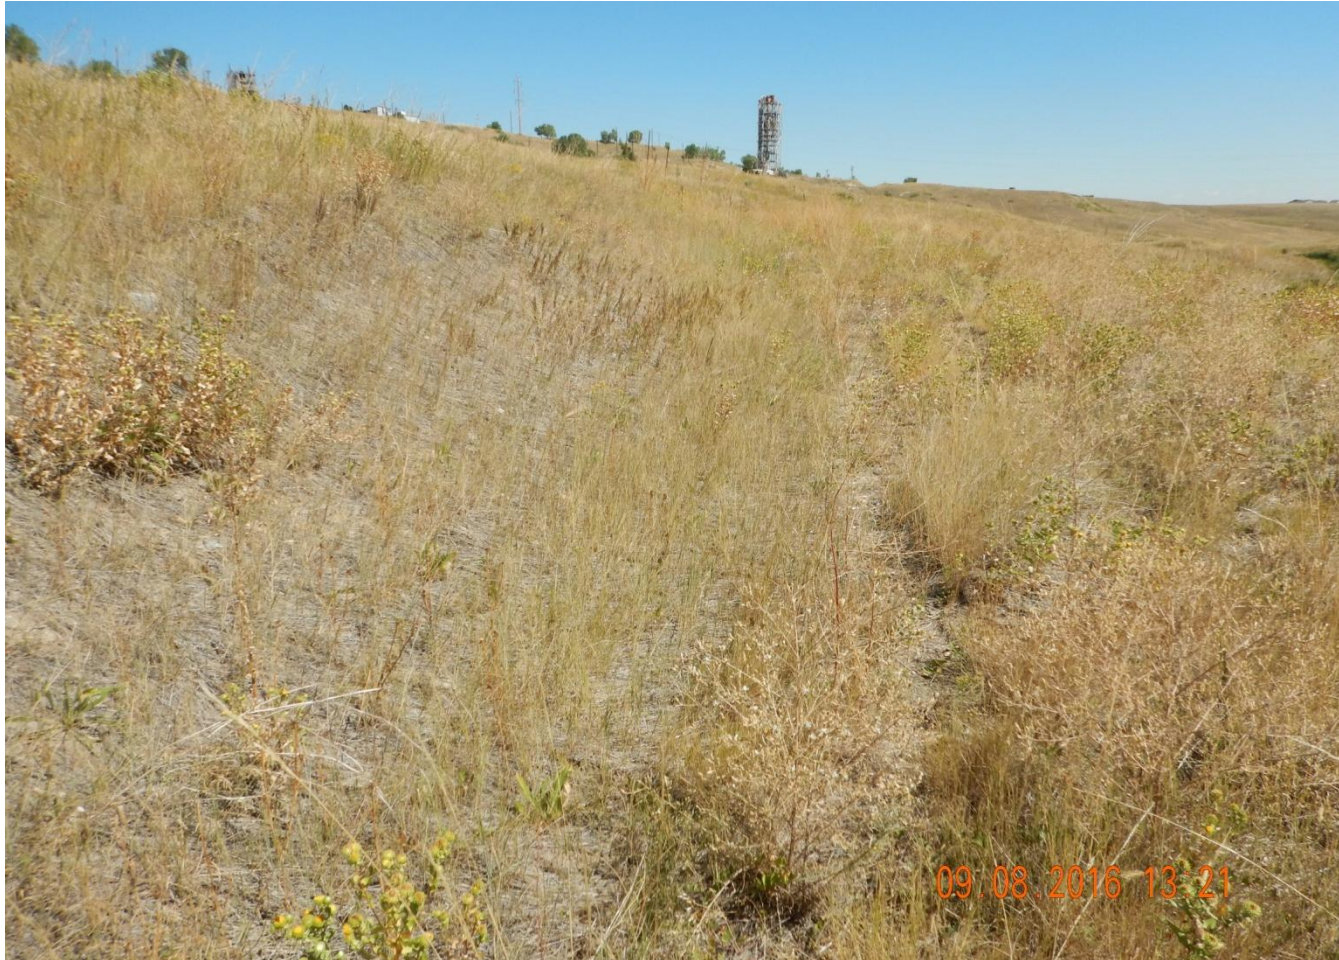
Photo 10. Photo taken along the access road, facing East. Diffuse knapweed and a few individuals of Spotted knapweed were observed throughout the entire access road.
