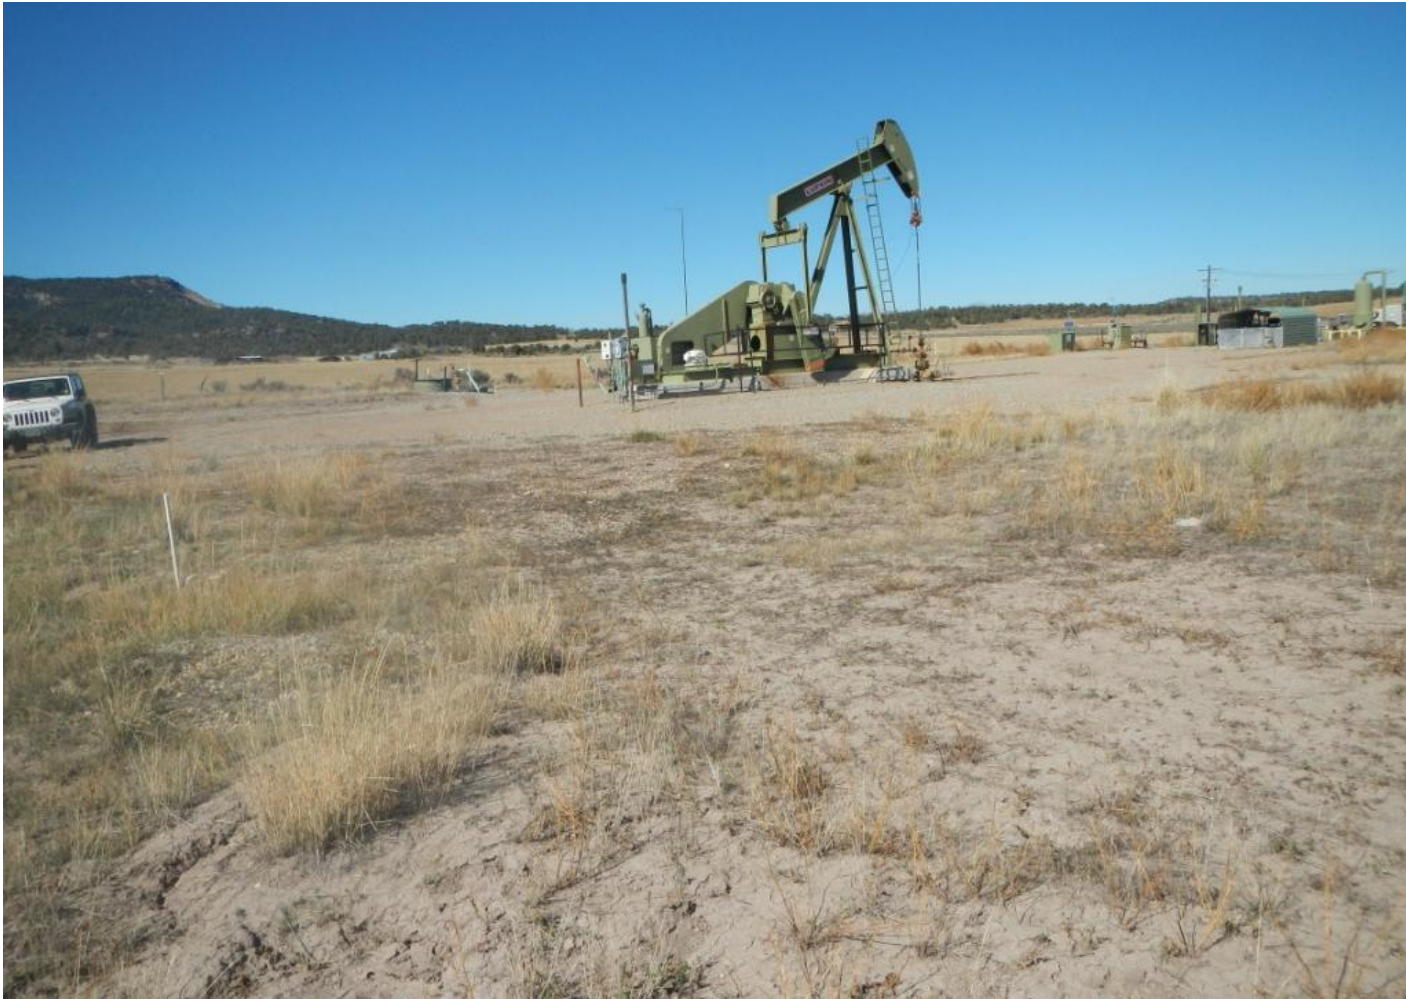
Photo 1. View of the southern portion of the project area from the southeastern corner facing center toward the well.

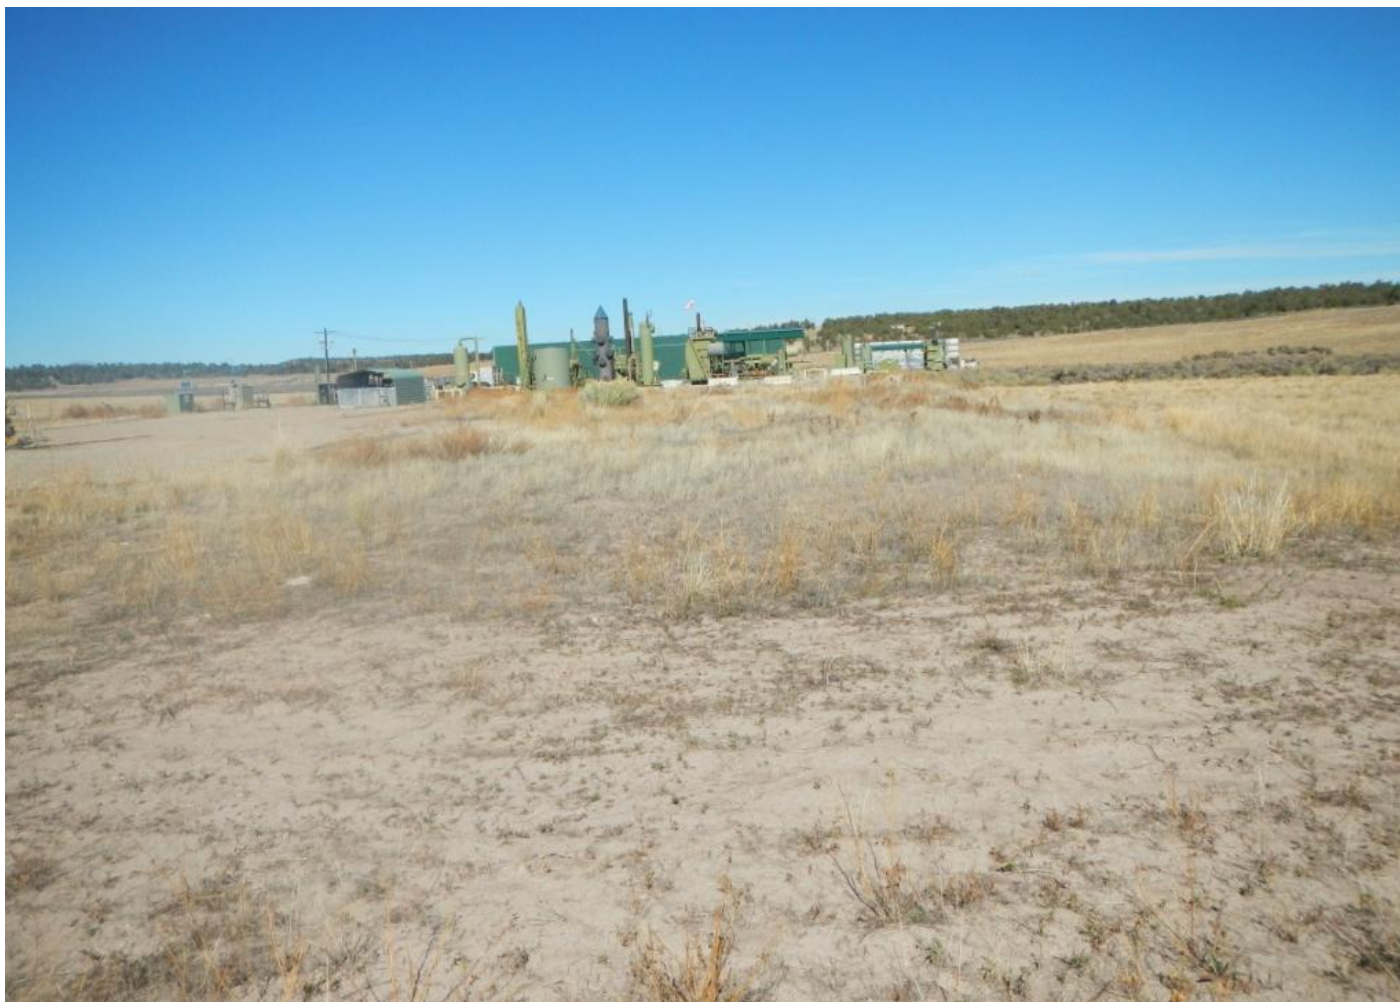
Photo 2. View of the eastern portion of the project area from the southeastern corner facing northward.

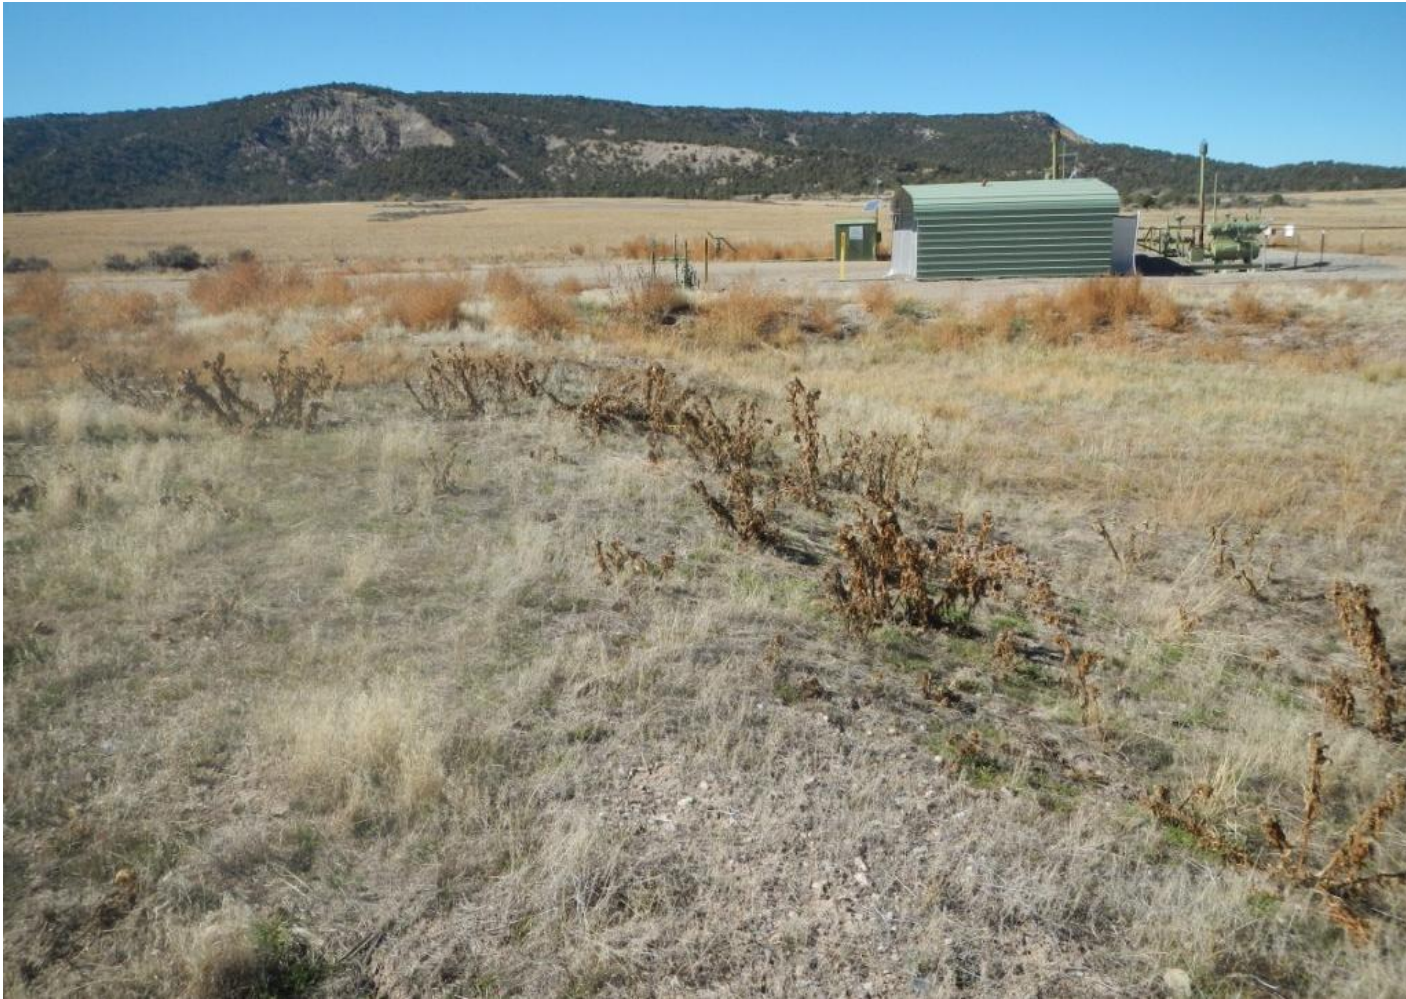
Photo 4. View of the northern portion of the project area from the northeastern edge facing westward. Musk thistles (*Carduus nutans*) from the 2016 growing season grew to maturity and are senescing.

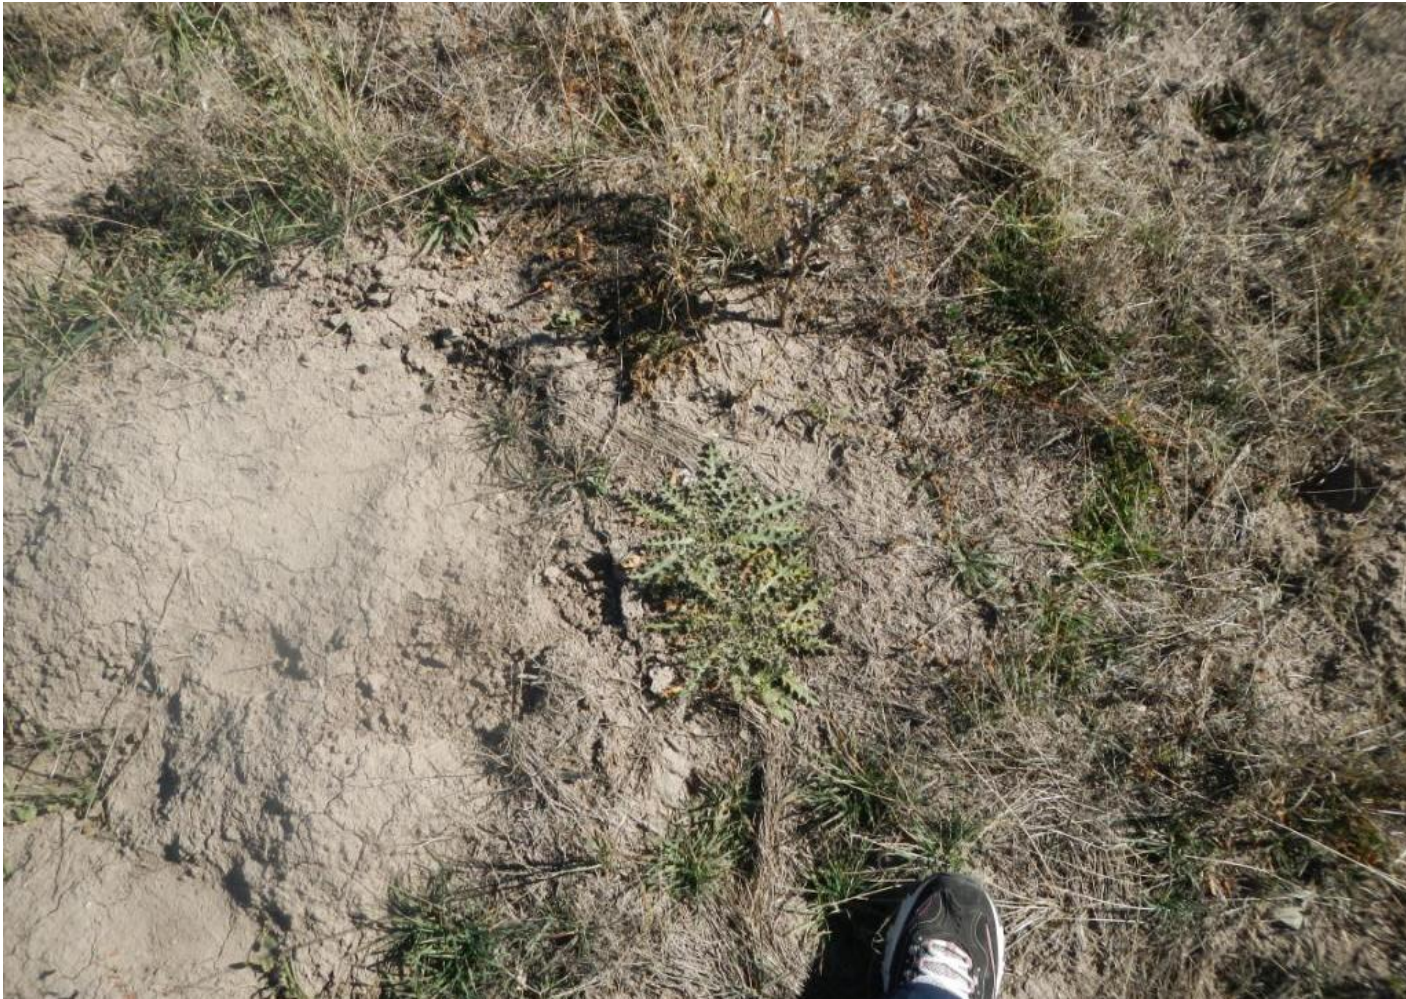
Photo 5. View of musk thistle rosettes in the eastern portion of the project area.
