November 2, 2016

Inspection Photos: Laramie Energy McClung Loc#335048

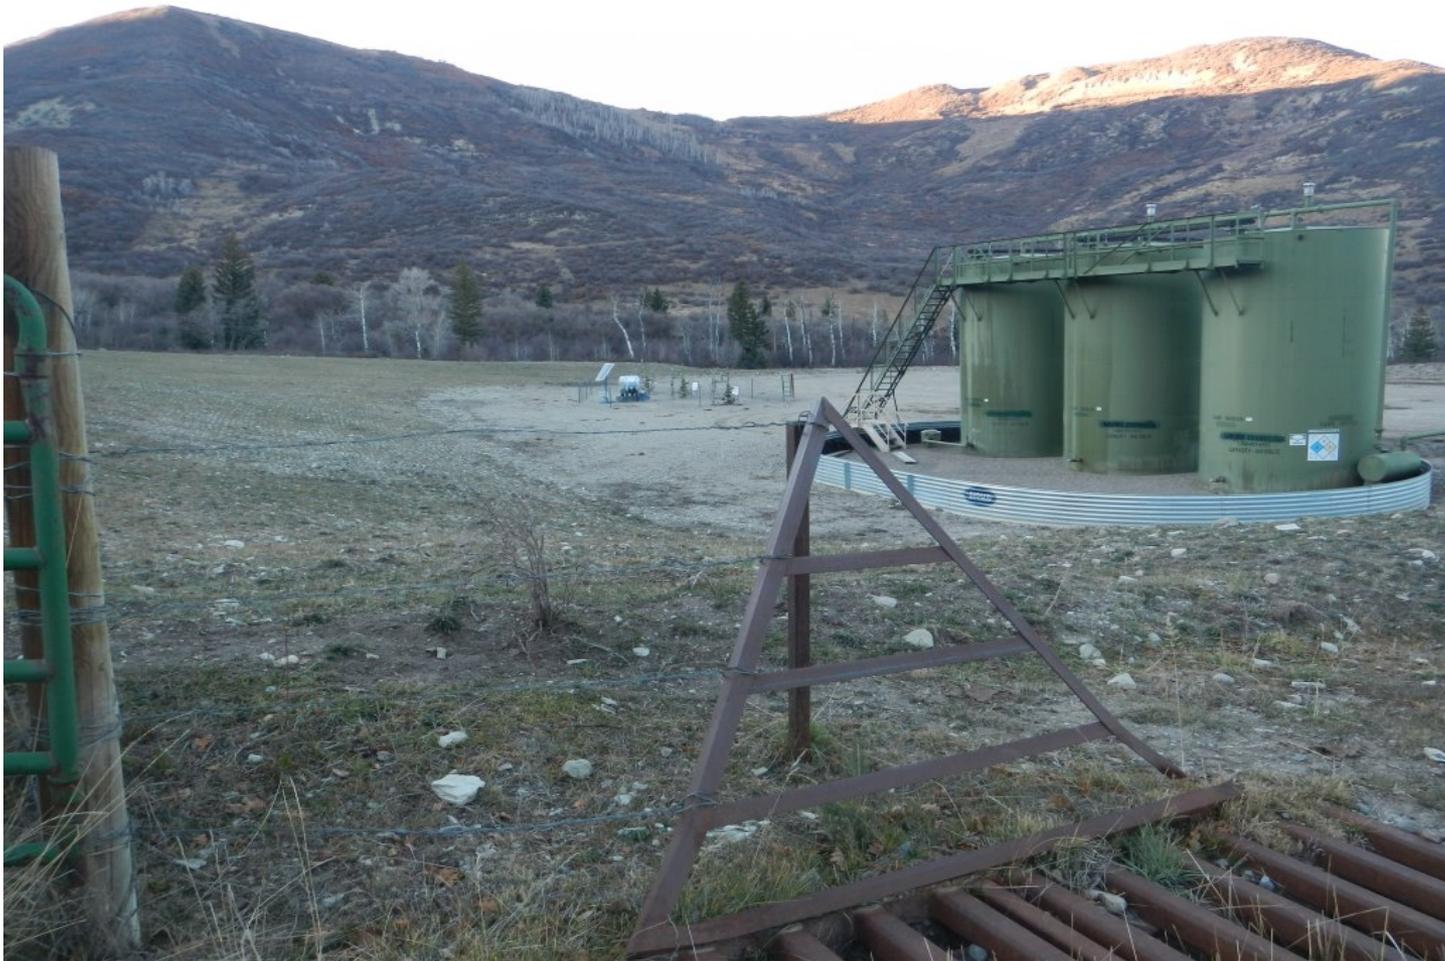
Photo#1: View of Location from entry to West.

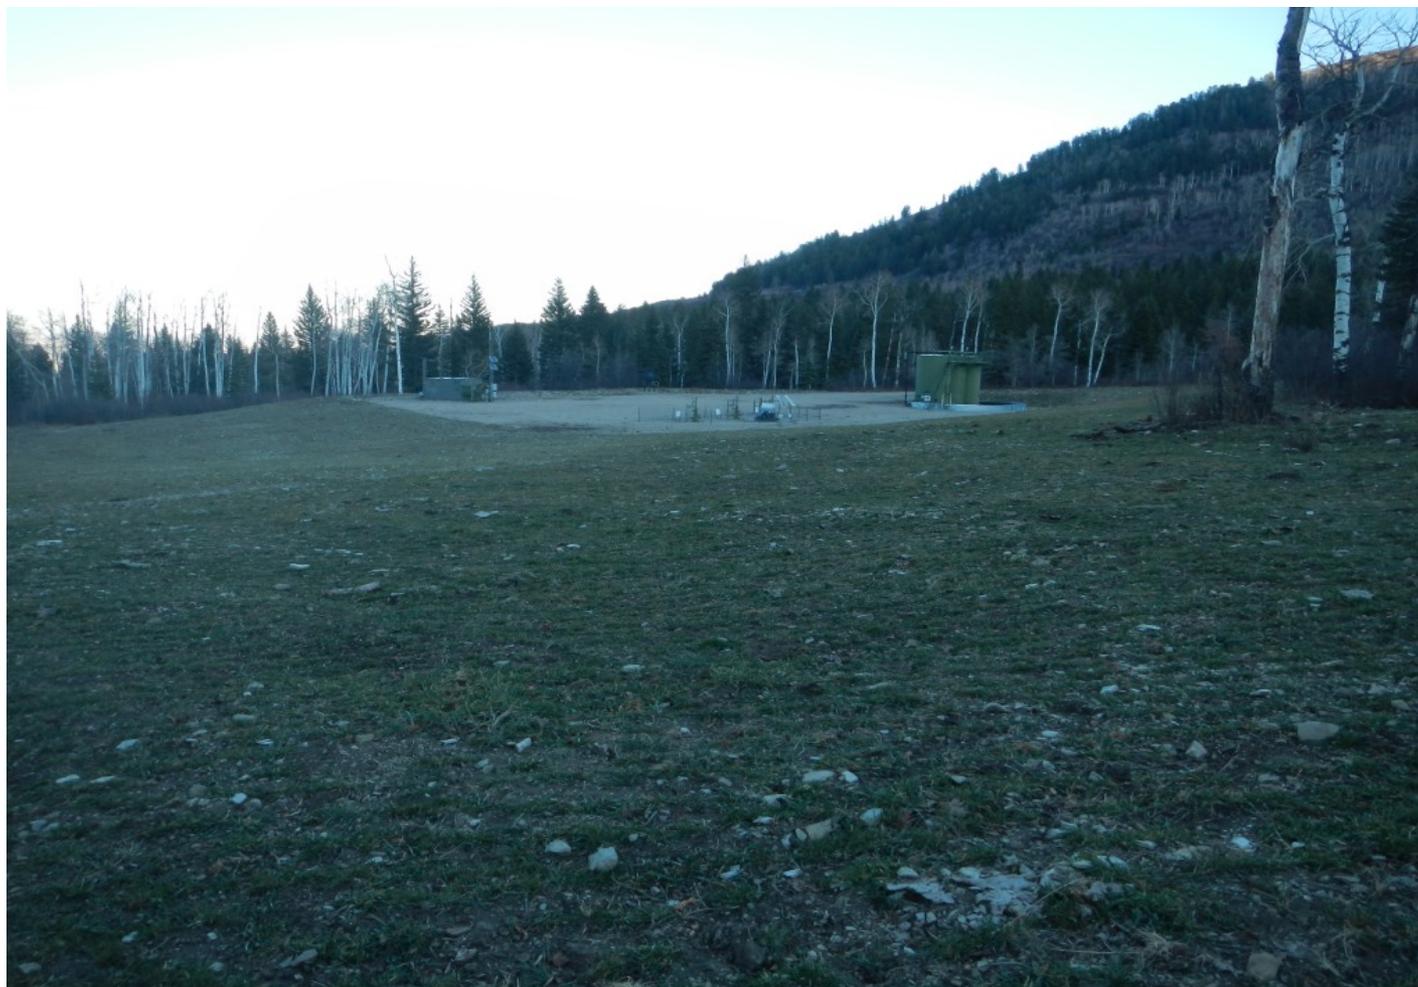
Photo#2: View of Location to east showing reduced footprint and new Interim Reclamation.

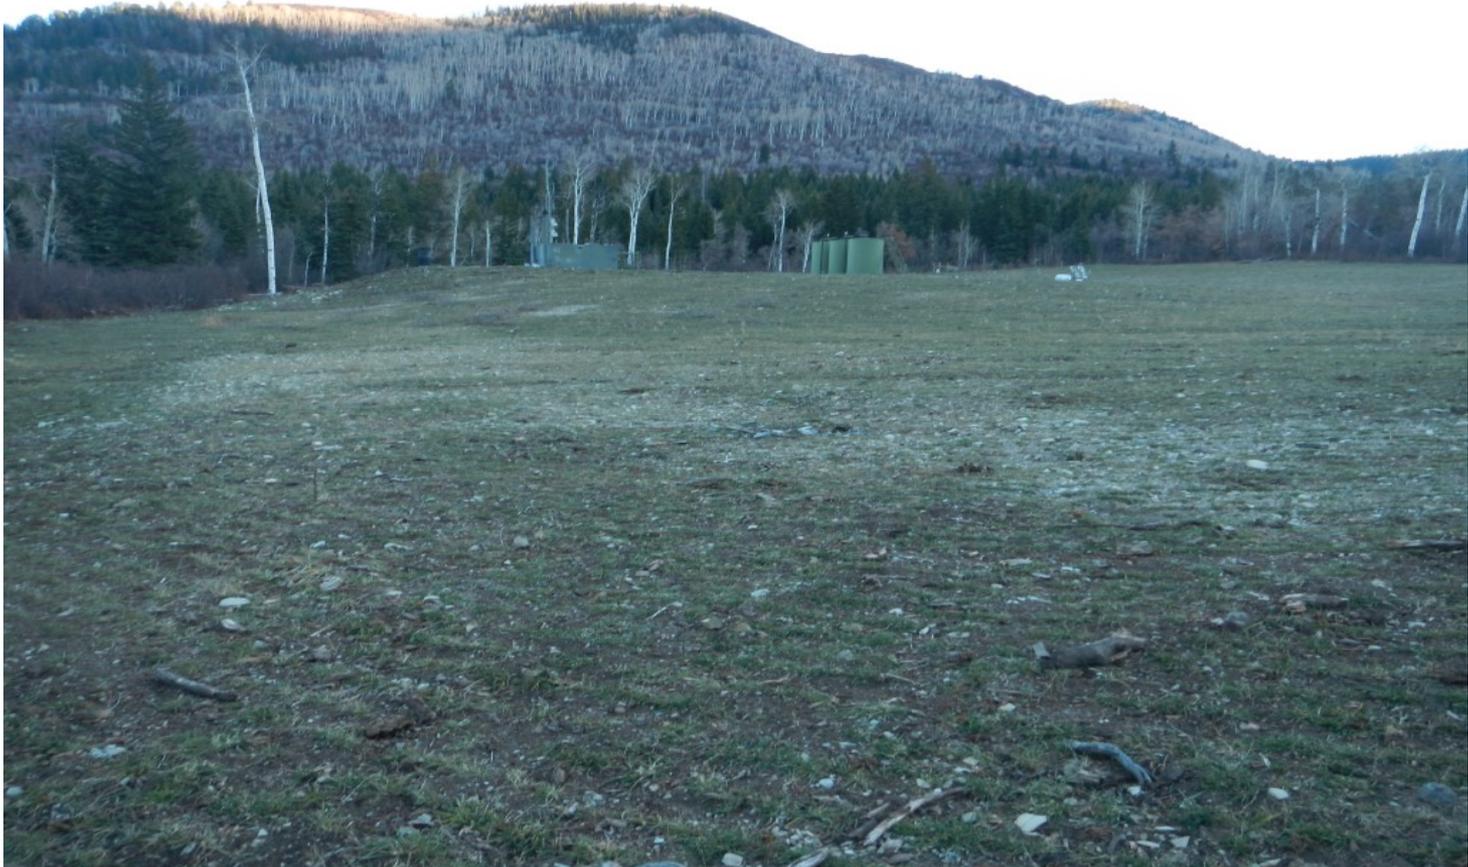
Photo#3: View of Location to South, showing successful germination in new Interim Reclamation areas.

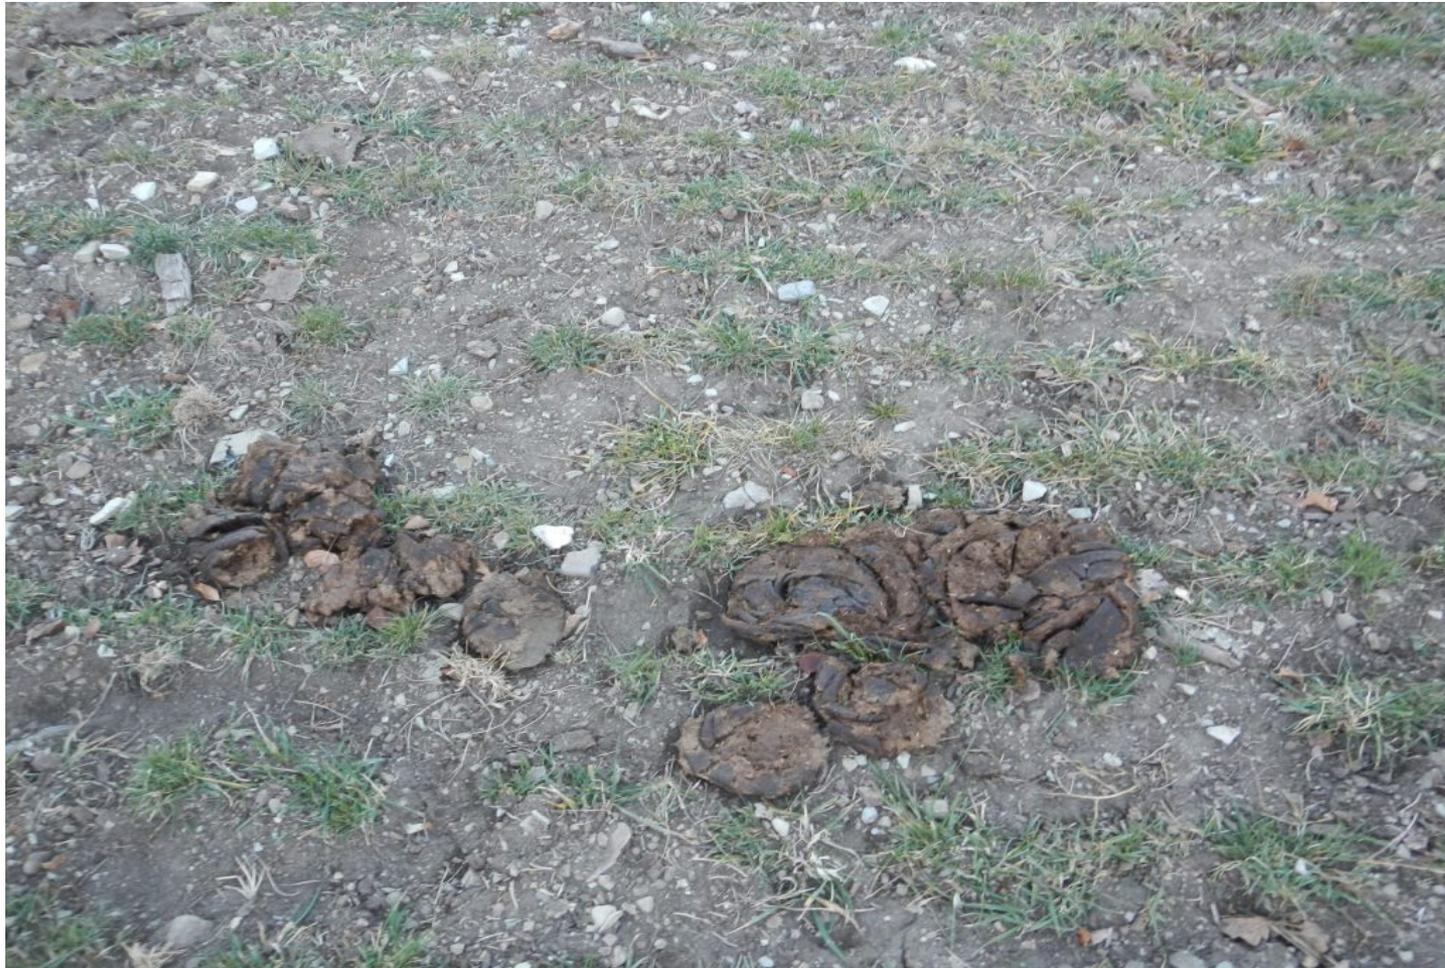
Photo#4: Close up view of ground conditions; overgrazing of first year plants.

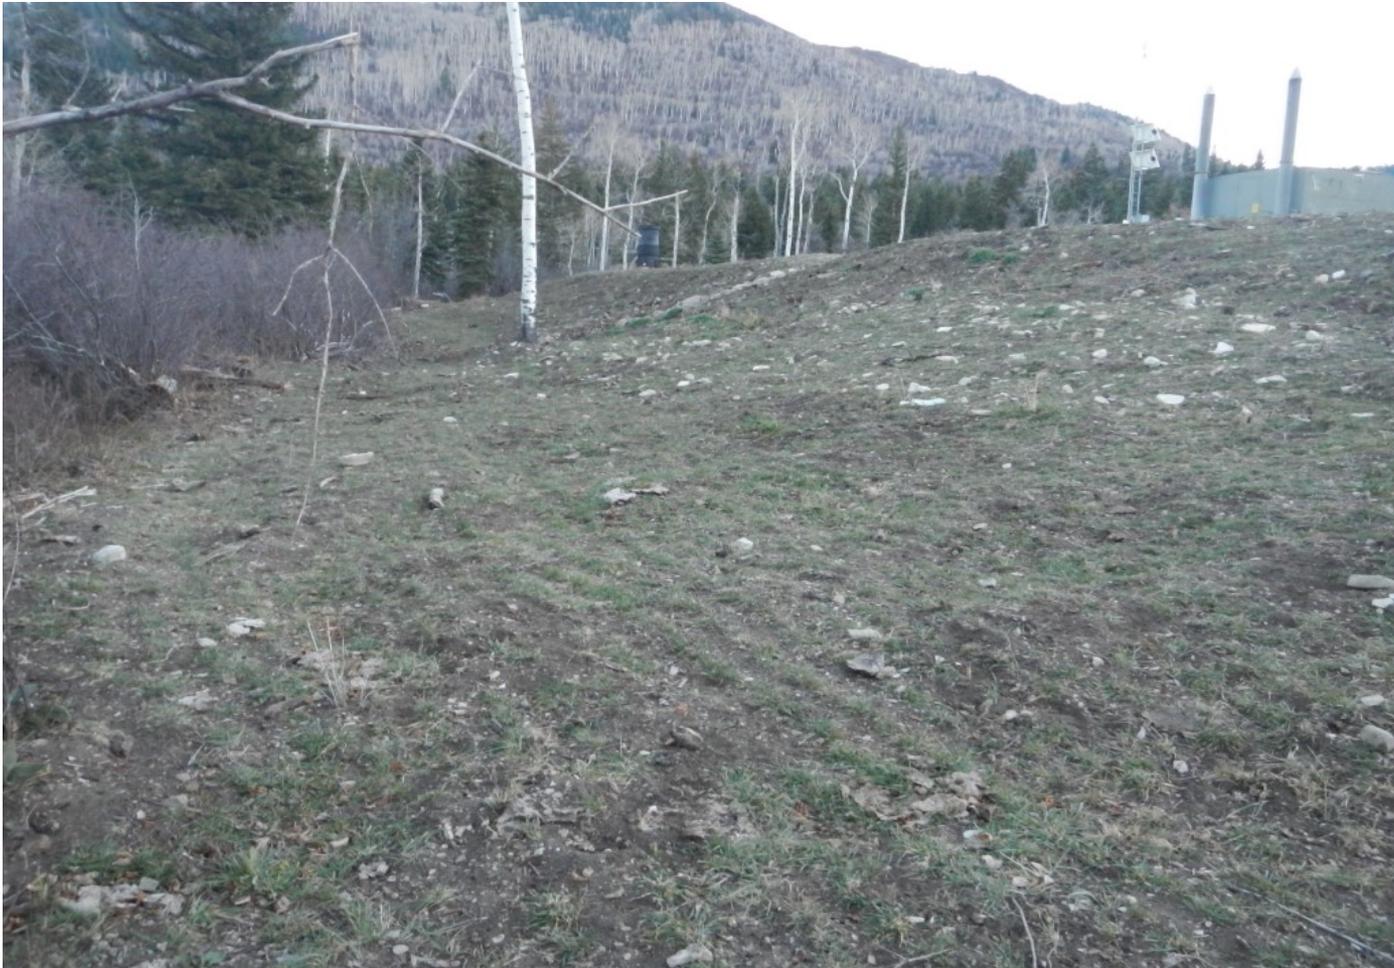
Photo#5: Grazing of newly seeded areas is retarding vegetation establishment, exposing soil & rock which will lead to erosion issues.
