November 3, 2016

Inspection Photos: Laramie Gunderson Loc#334494 Interim

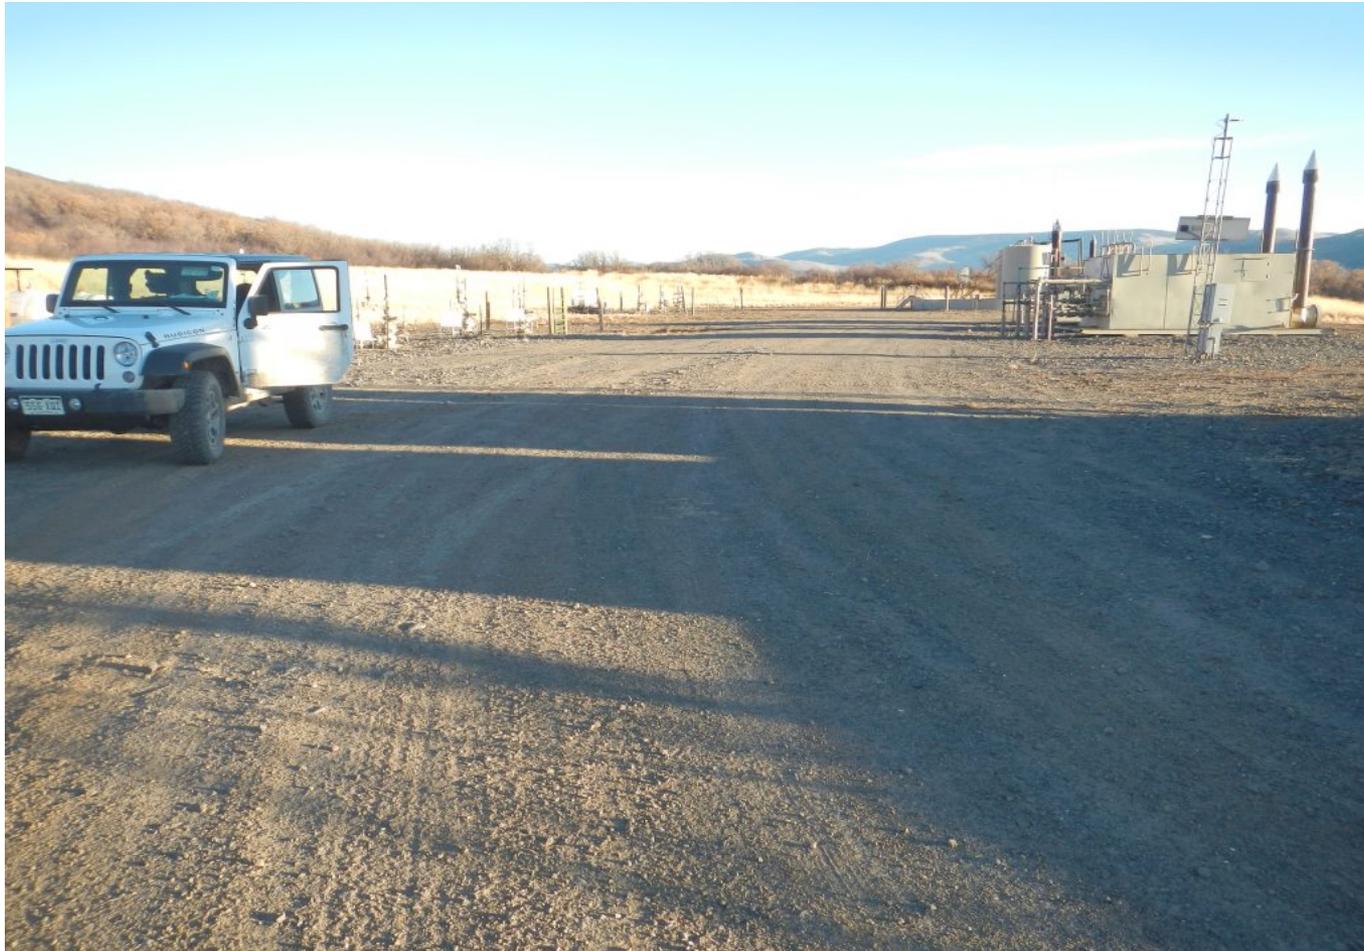
Photo#1: Overview of Location from Entry to South.

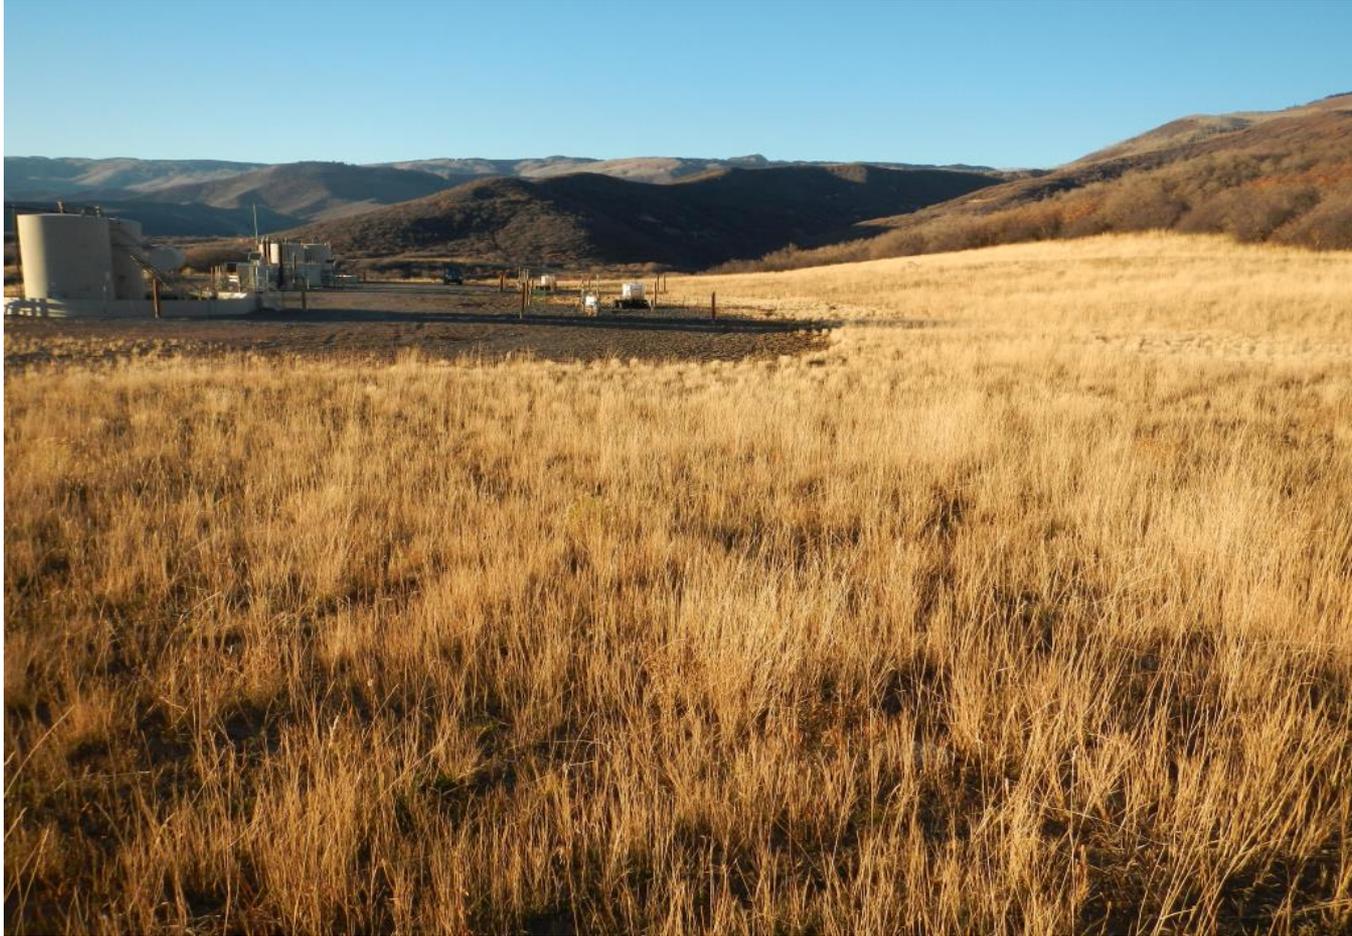
Photo#2: Interim areas are well Vegetated

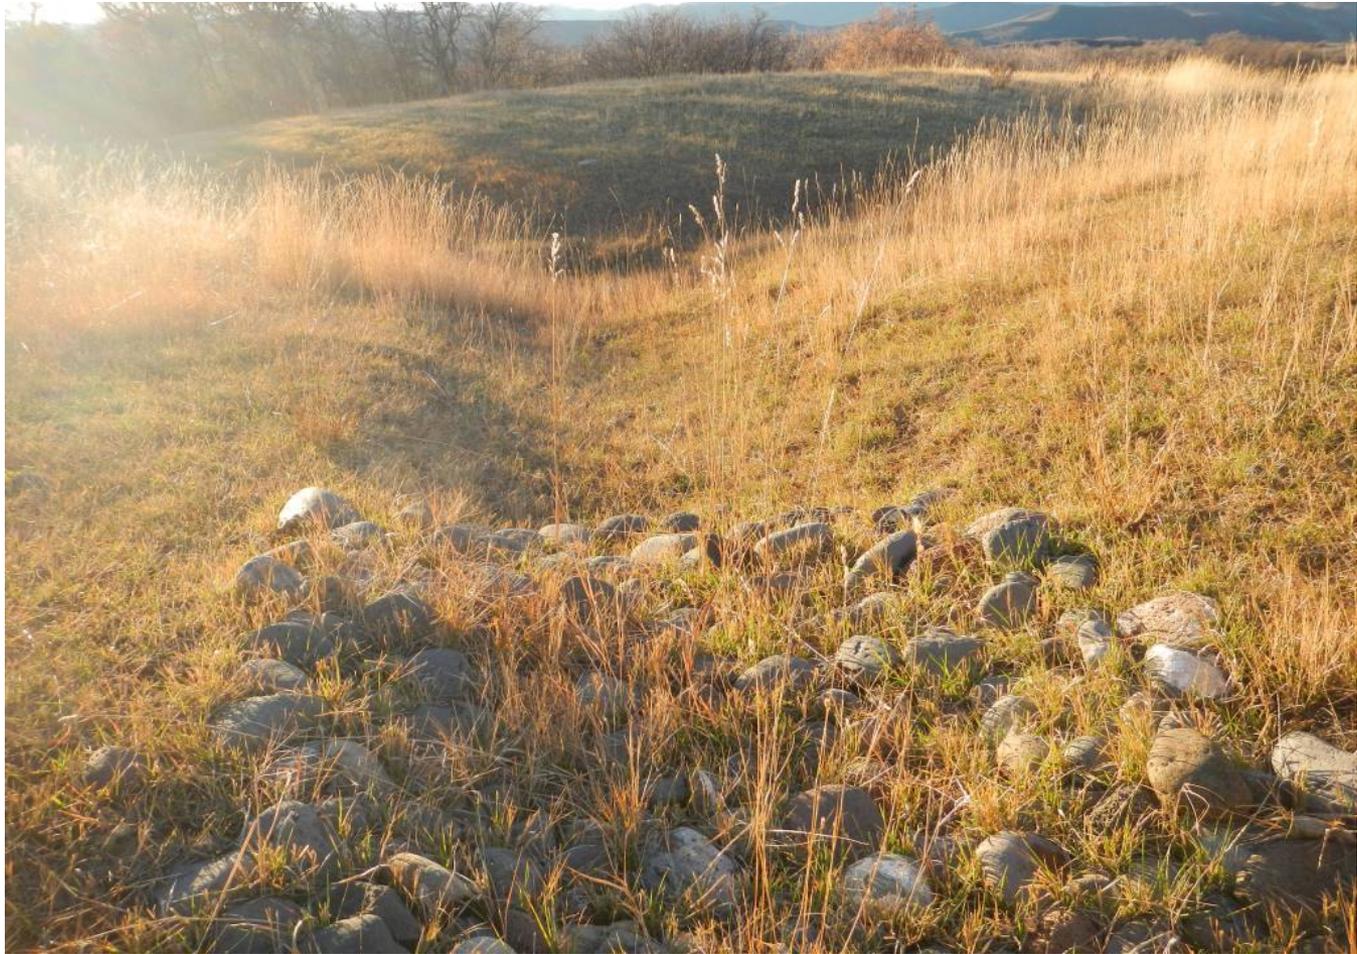
Photo#3: Location is Stable and has no Soil migration Concerns.
