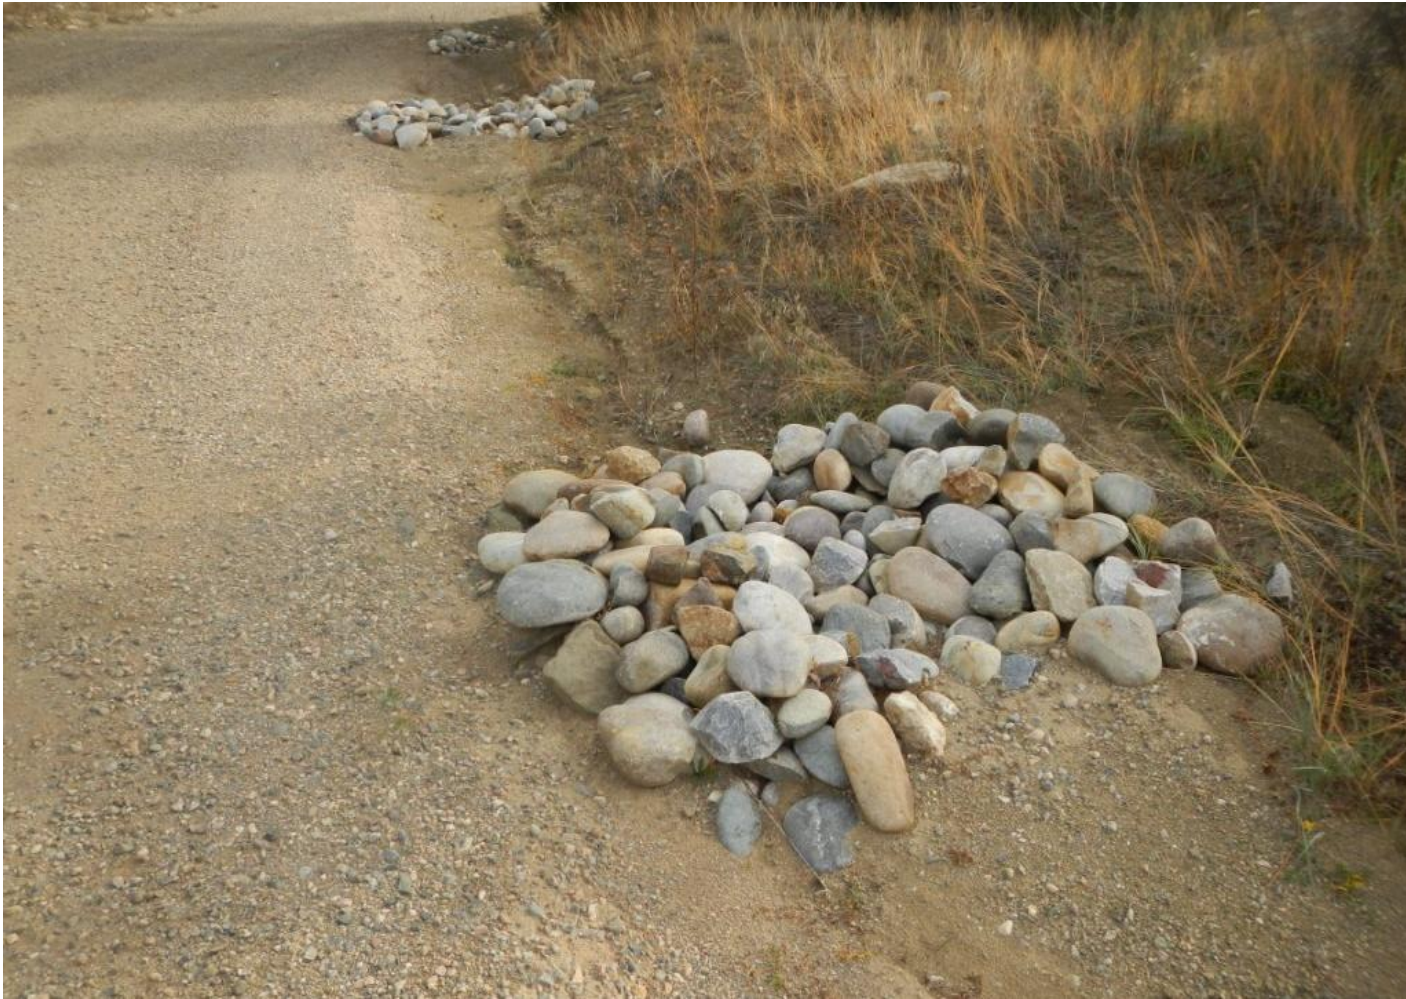
Photo 1. View of rock check dams on eastern edge of access that need maintenance.

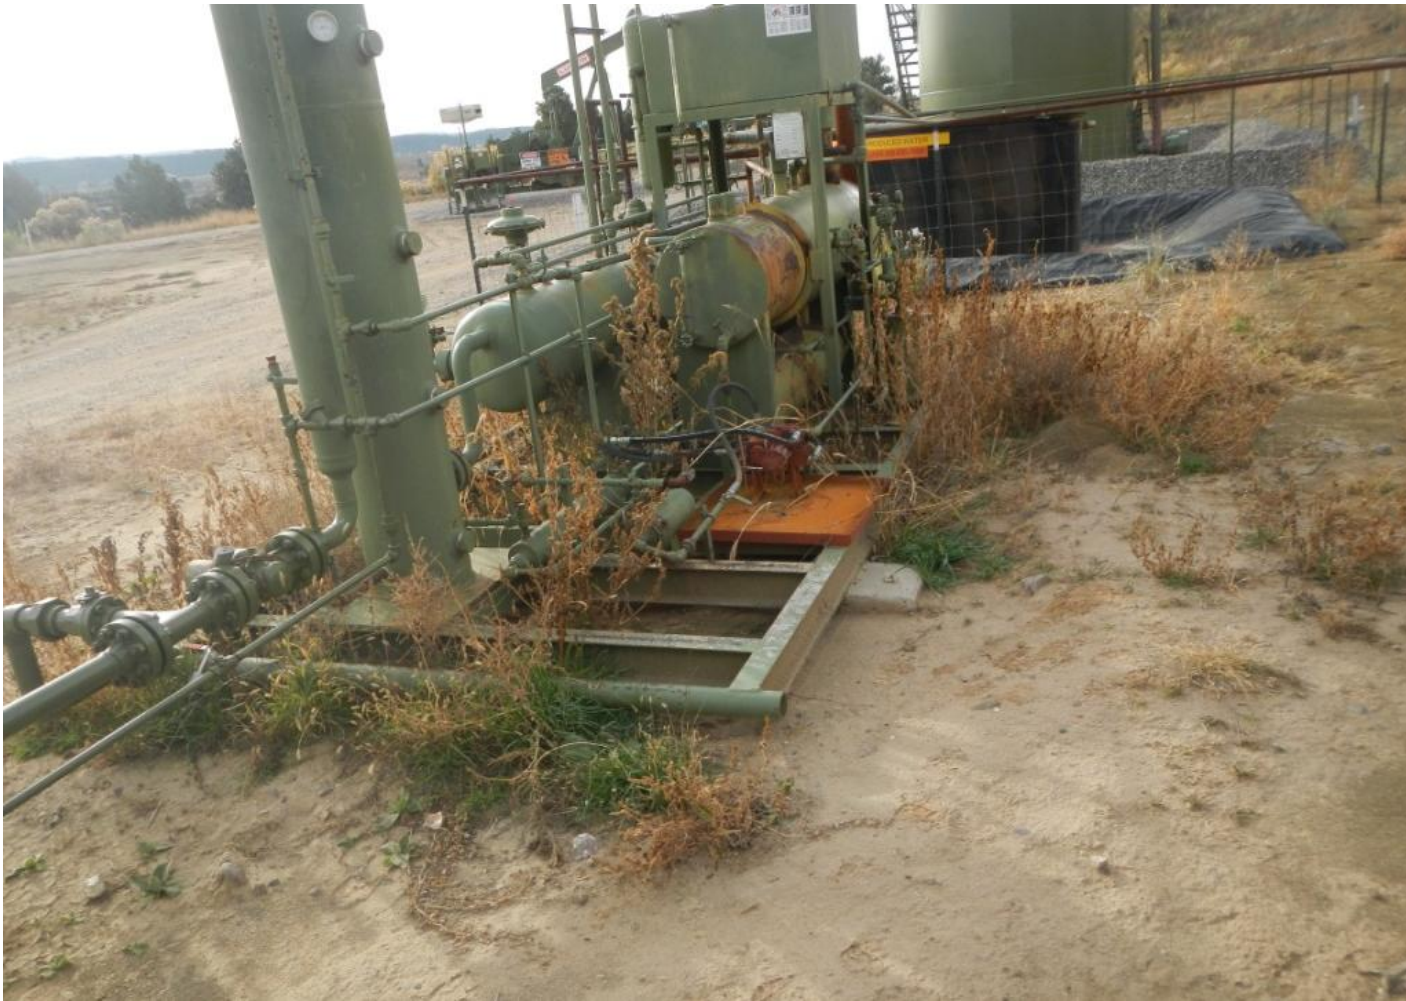
Photo 2. View of weeds growing around fired equipment that need to be removed.

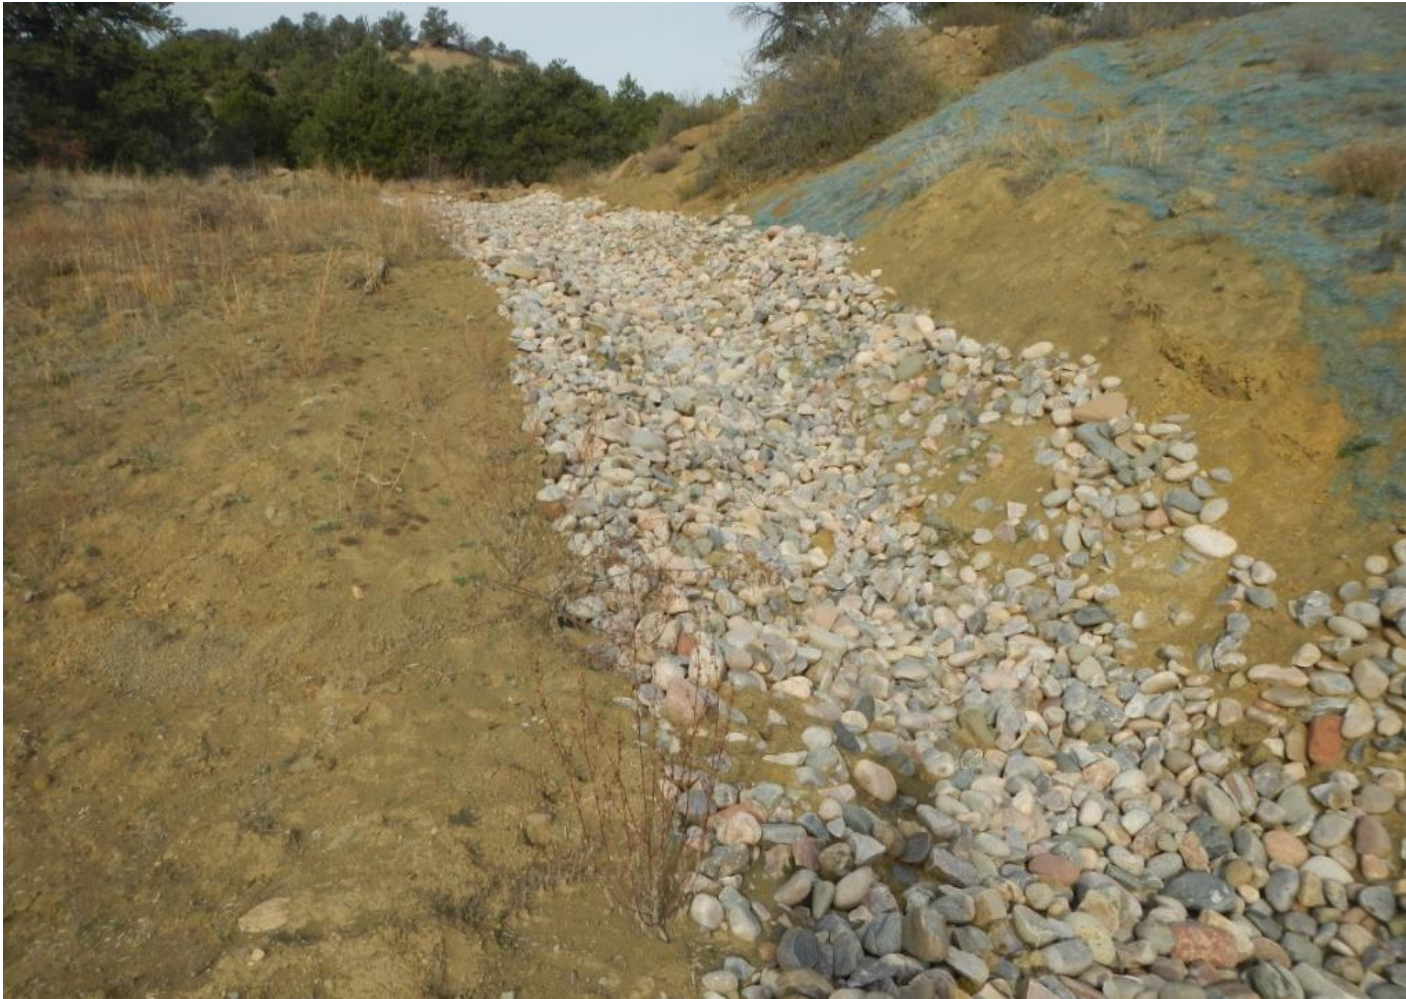
Photo 3. View of stormwater controls in the eastern portion of the project area. Appears to be functioning at this time.

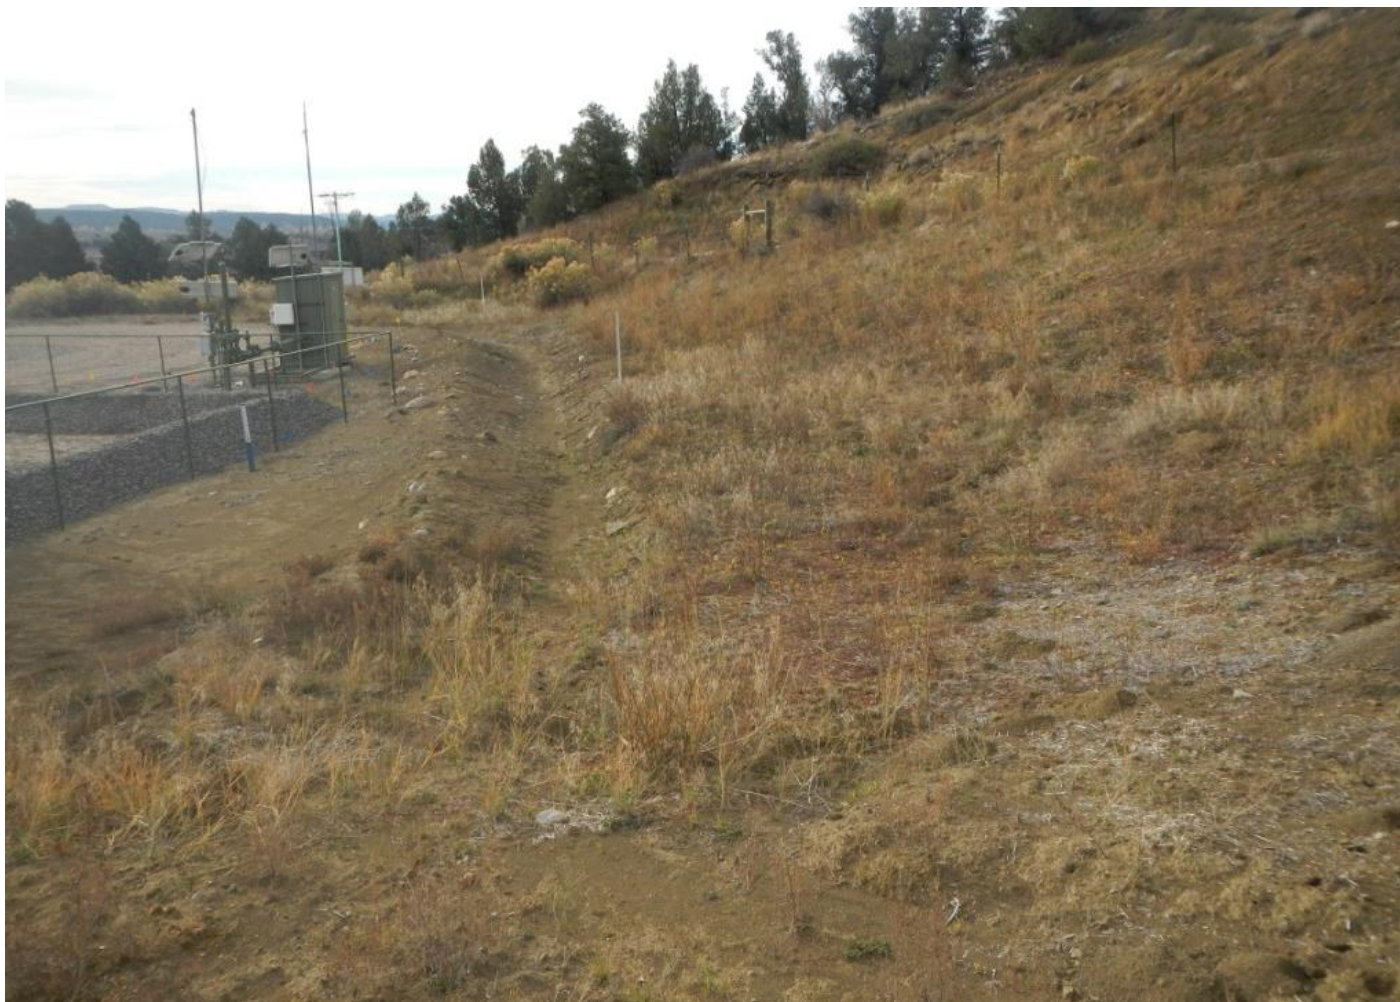
Photo 4. View of the southeastern portion of the project area. Revegetation is progressing on this slope and diversion is in good condition.

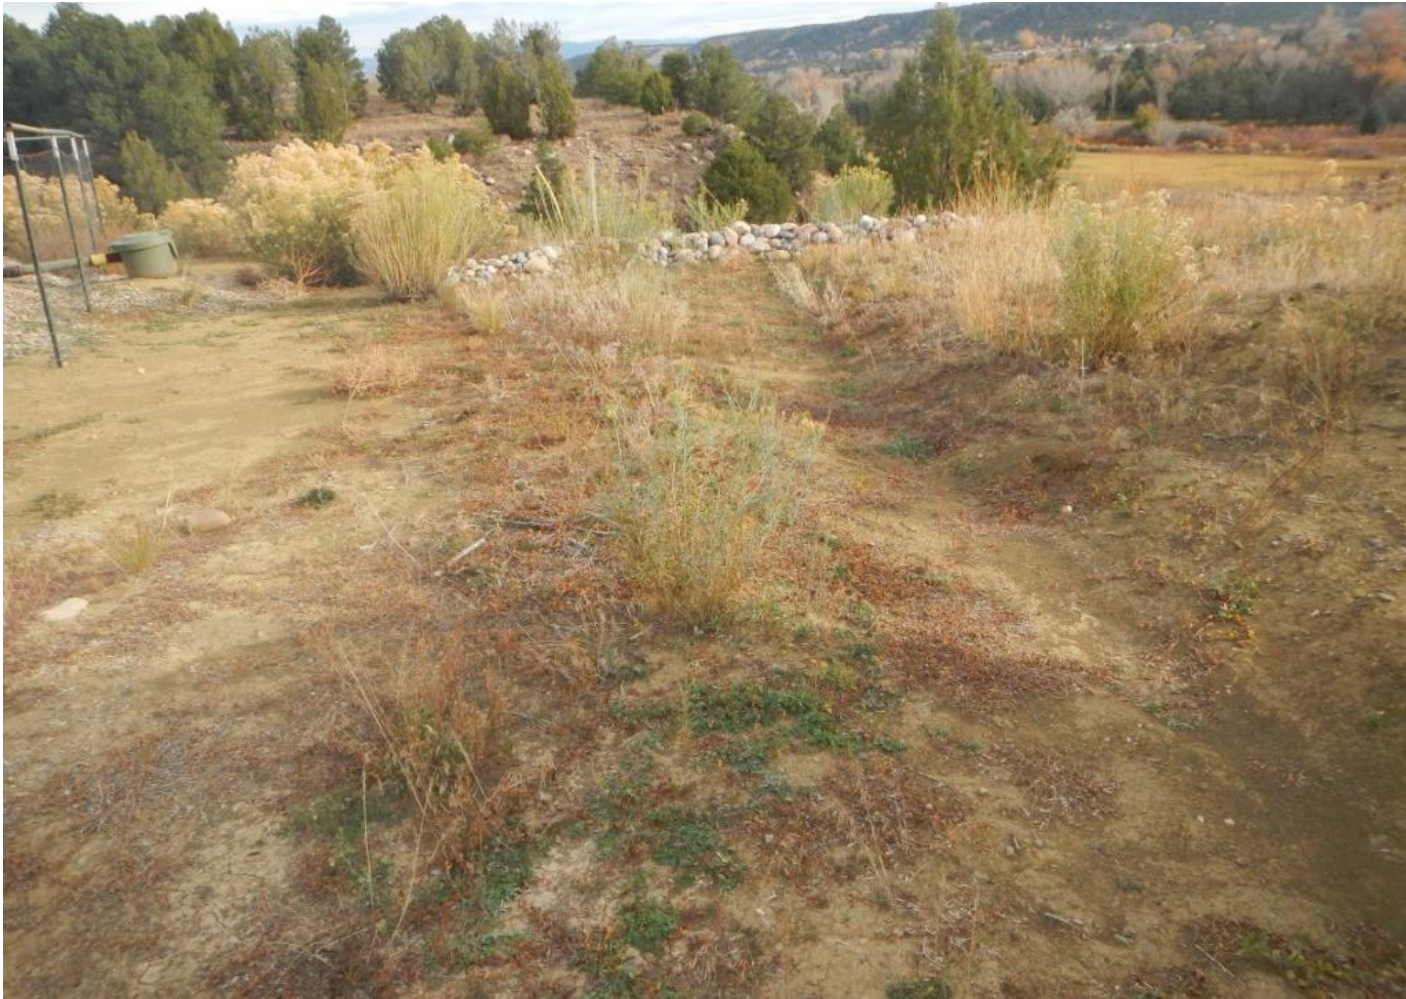
Photo 5. View of stormwater controls in the northeastern portion of the project area in good condition.

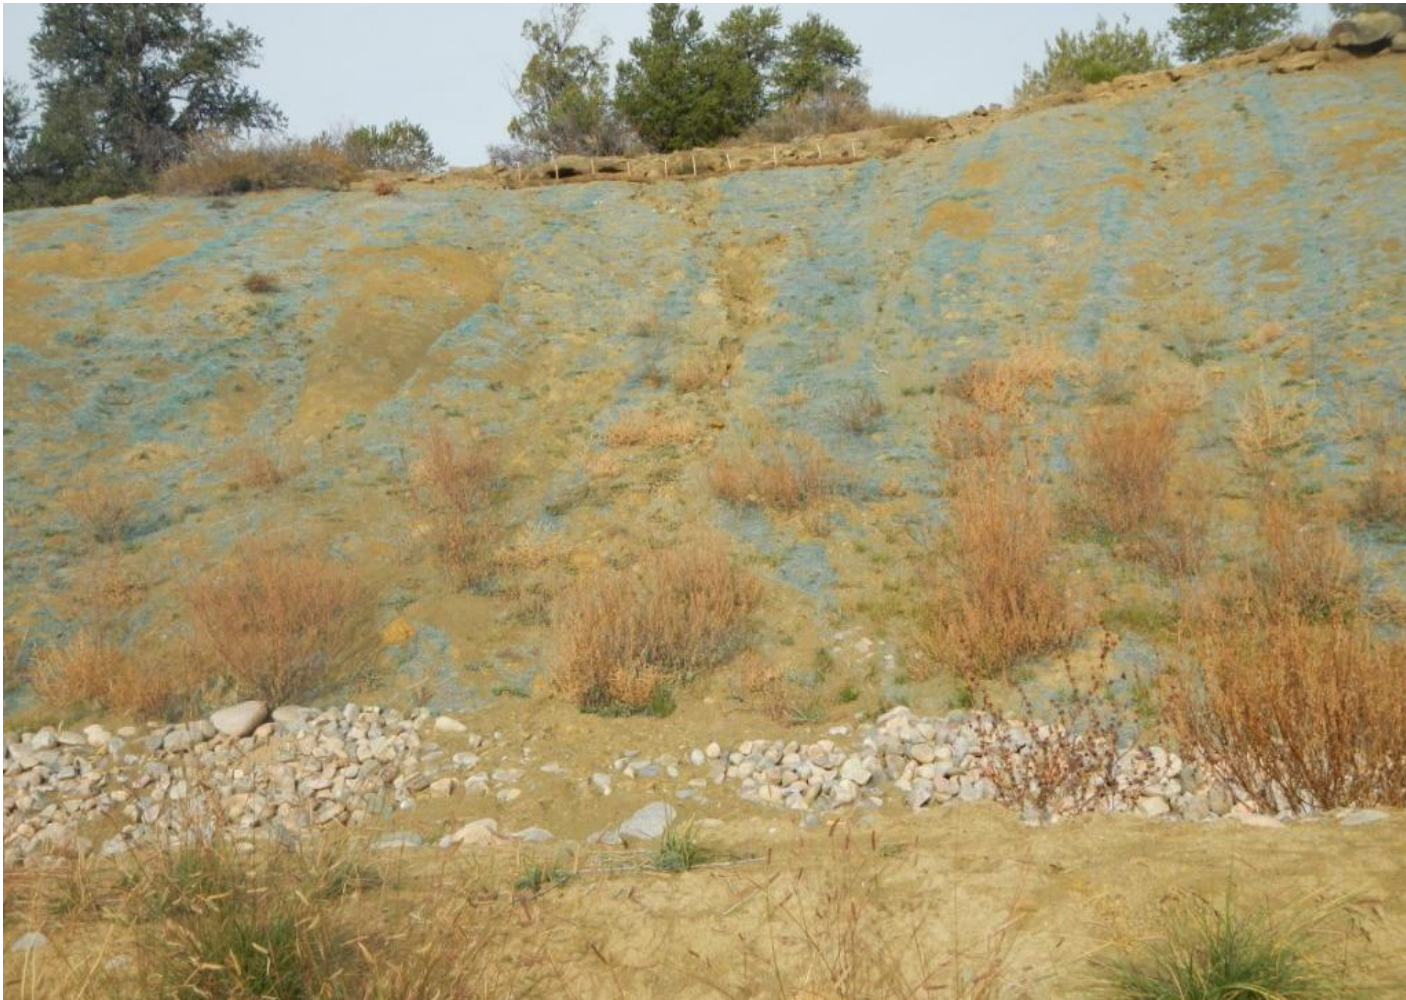
Photo 6. View of the northwestern portion of the project area. Revegetation is sparse on the slope. Stormwater erosion is occurring beneath the wattle at the top of the slope. This area needs maintenance and likely further stabilization to prevent further erosional channeling.
