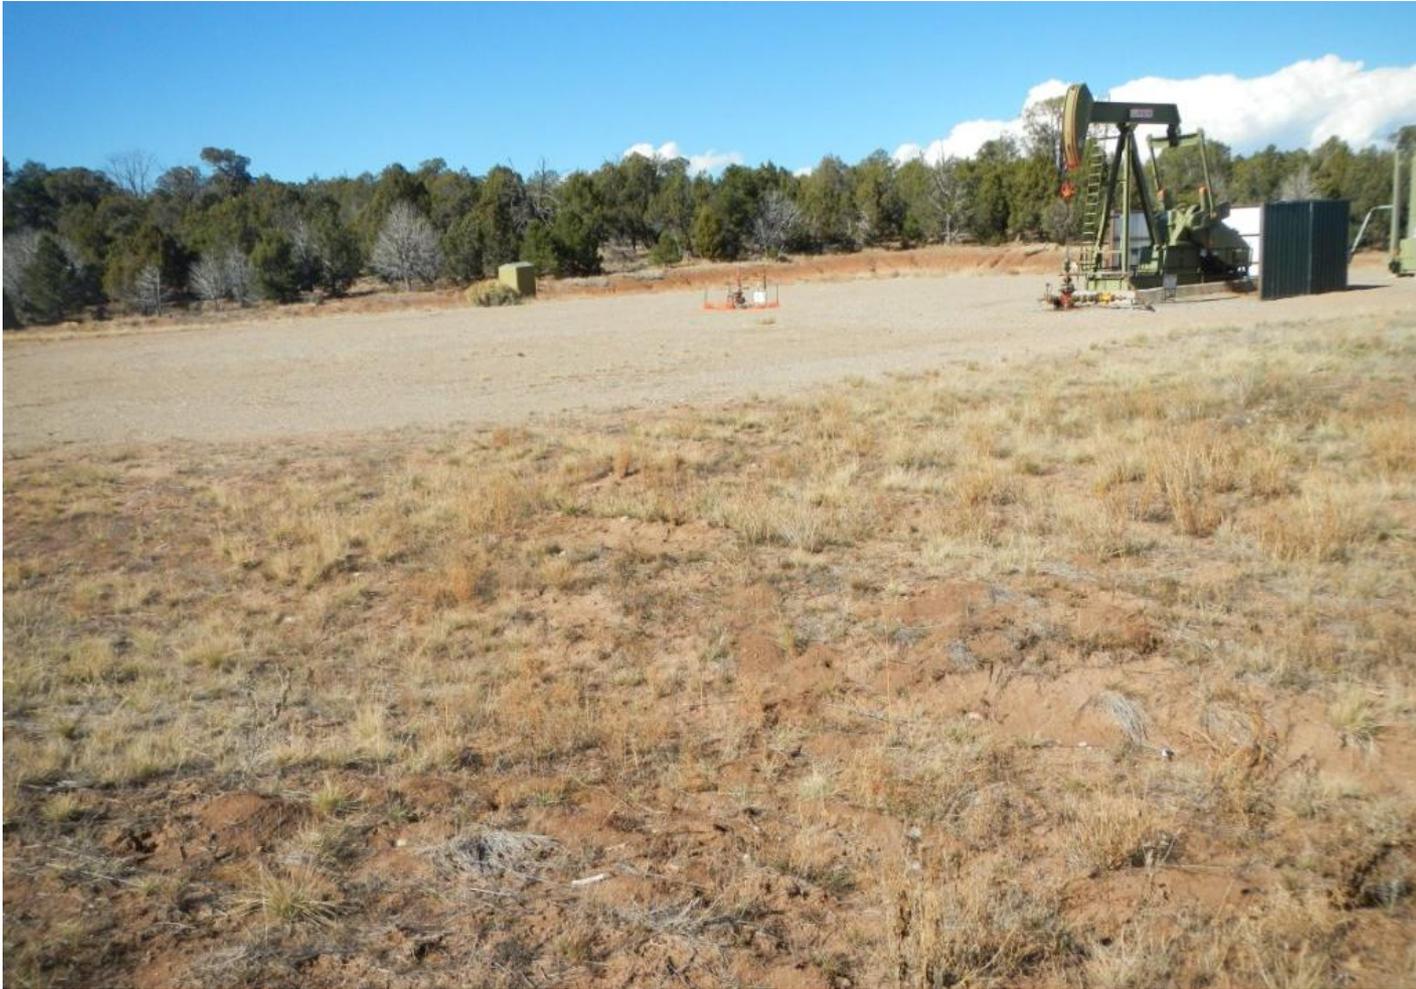
Photo 1. View of the project area from the southeastern corner facing center.

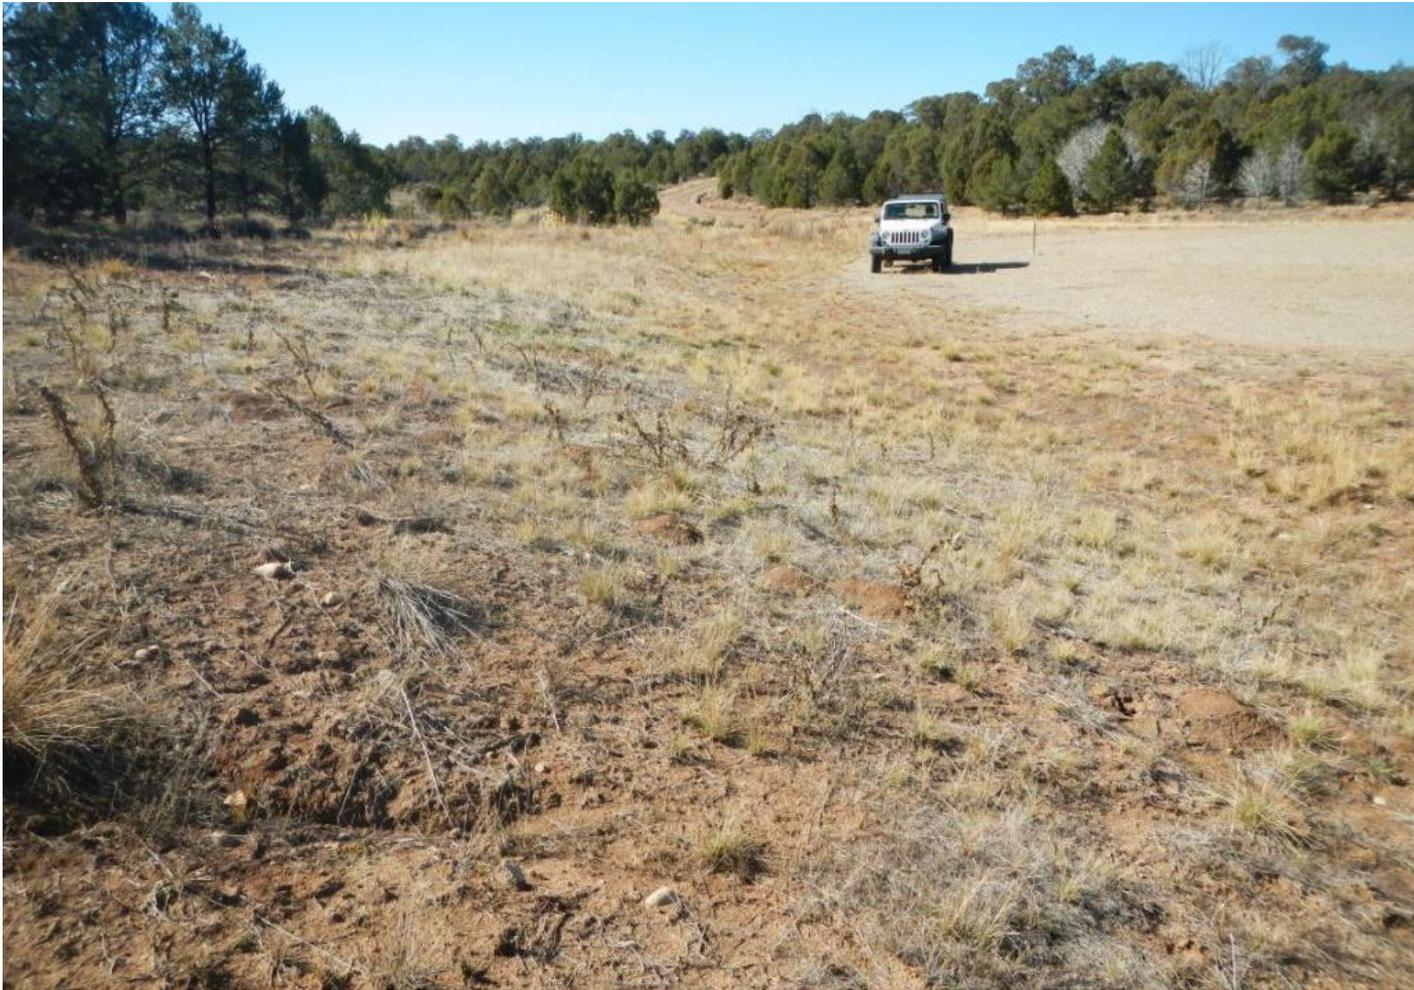
Photo 2. View of the southern portion of the project area from the southeastern corner facing westward.

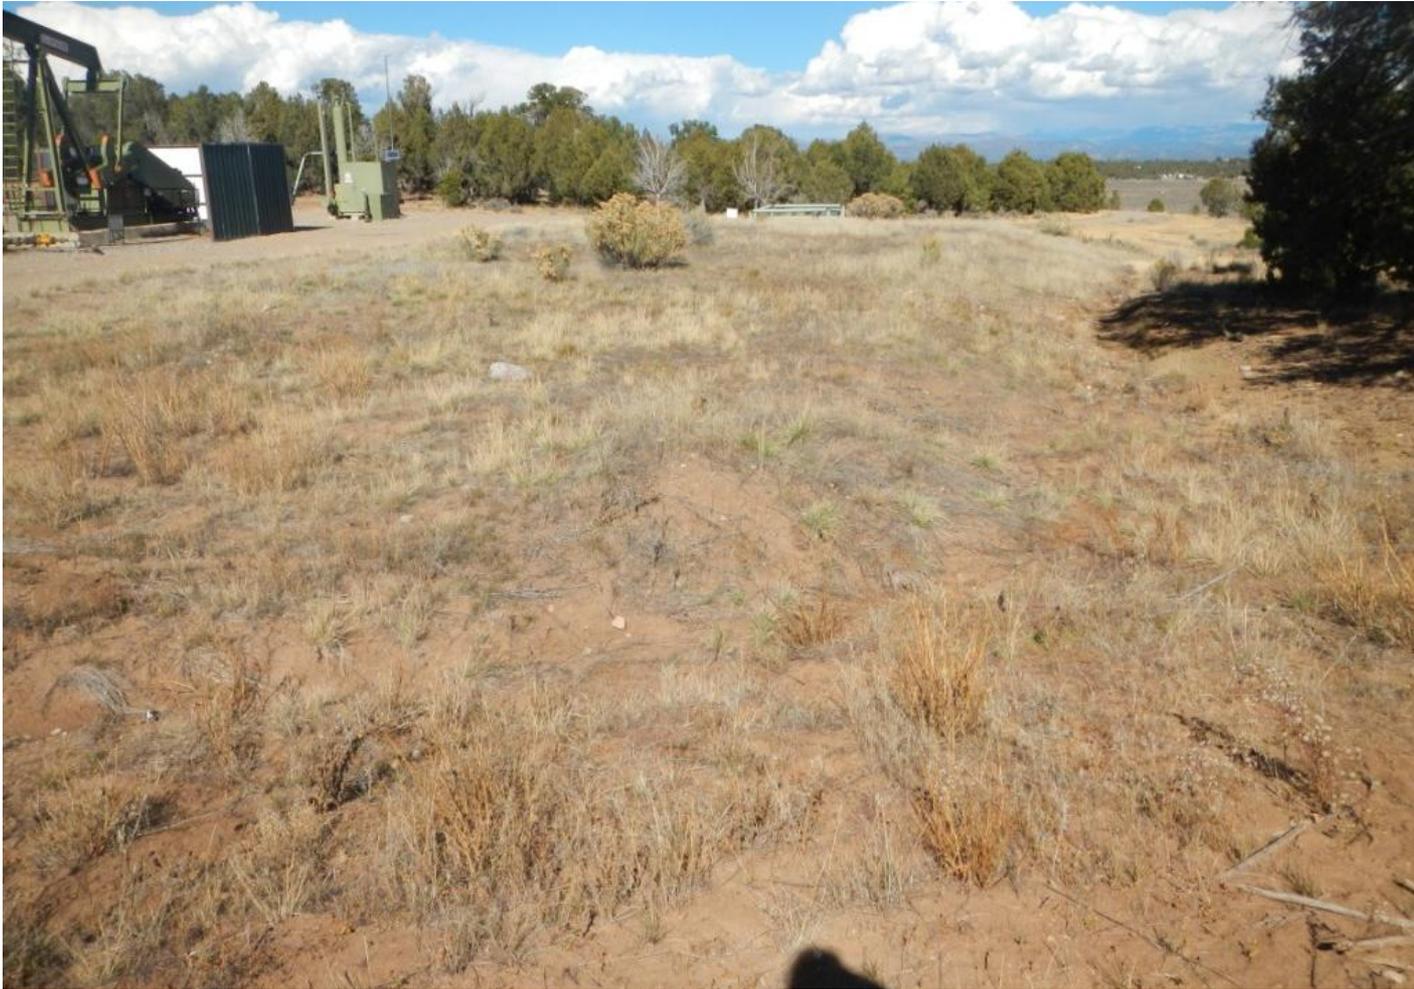
Photo 3. View of the eastern portion of the project area from the southeastern corner facing northward.

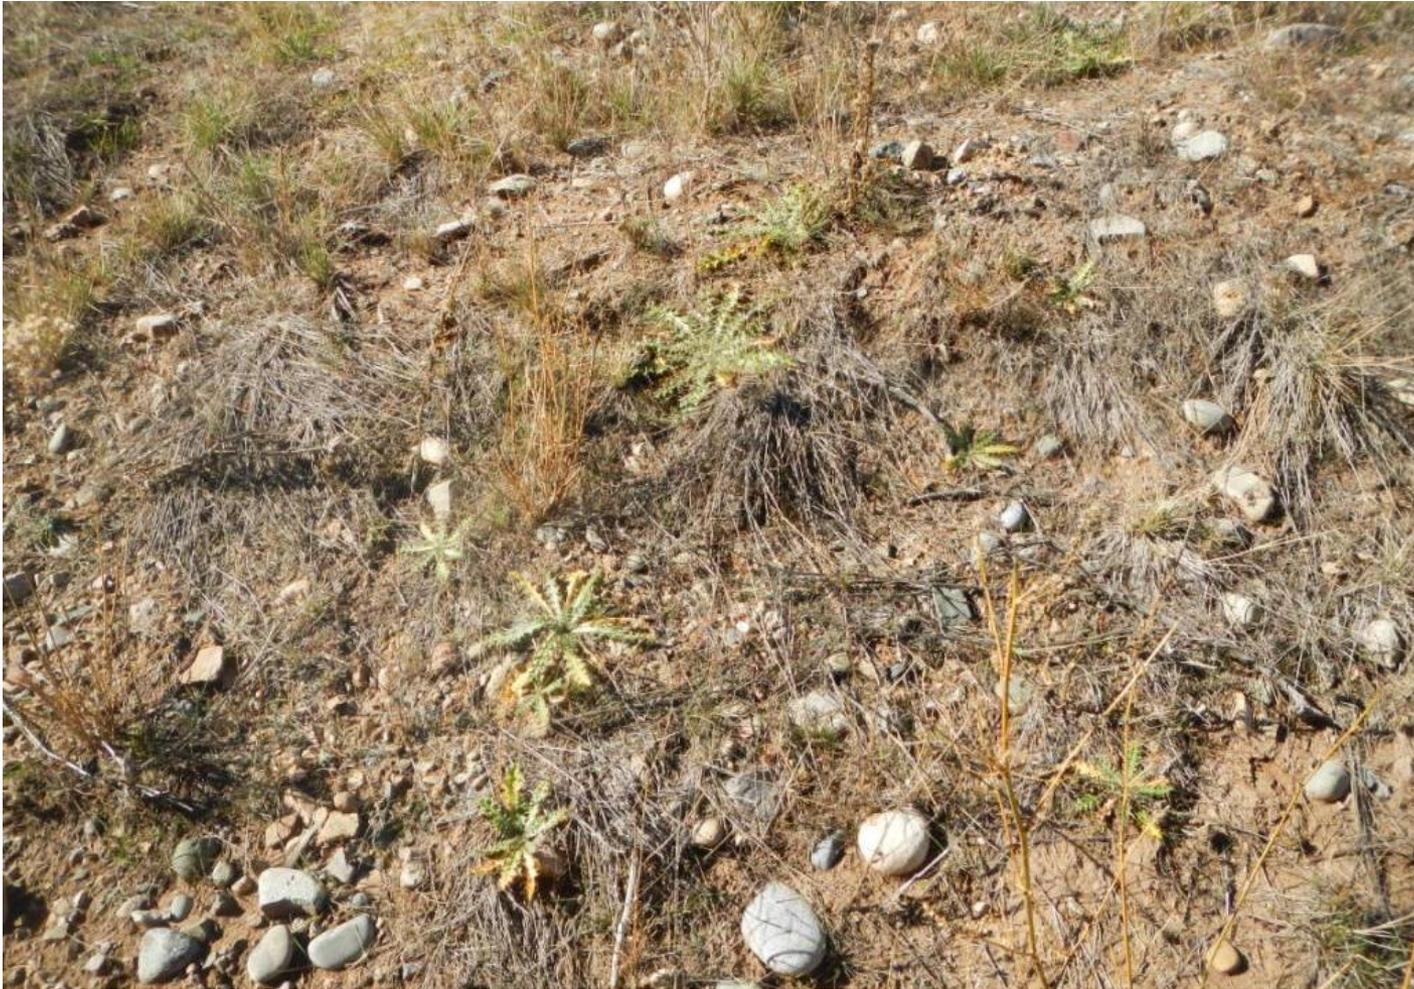
Photo 4. View of musk thistles (*Carduus nutans*) growing within then southeastern portion of the interim reclamation area.

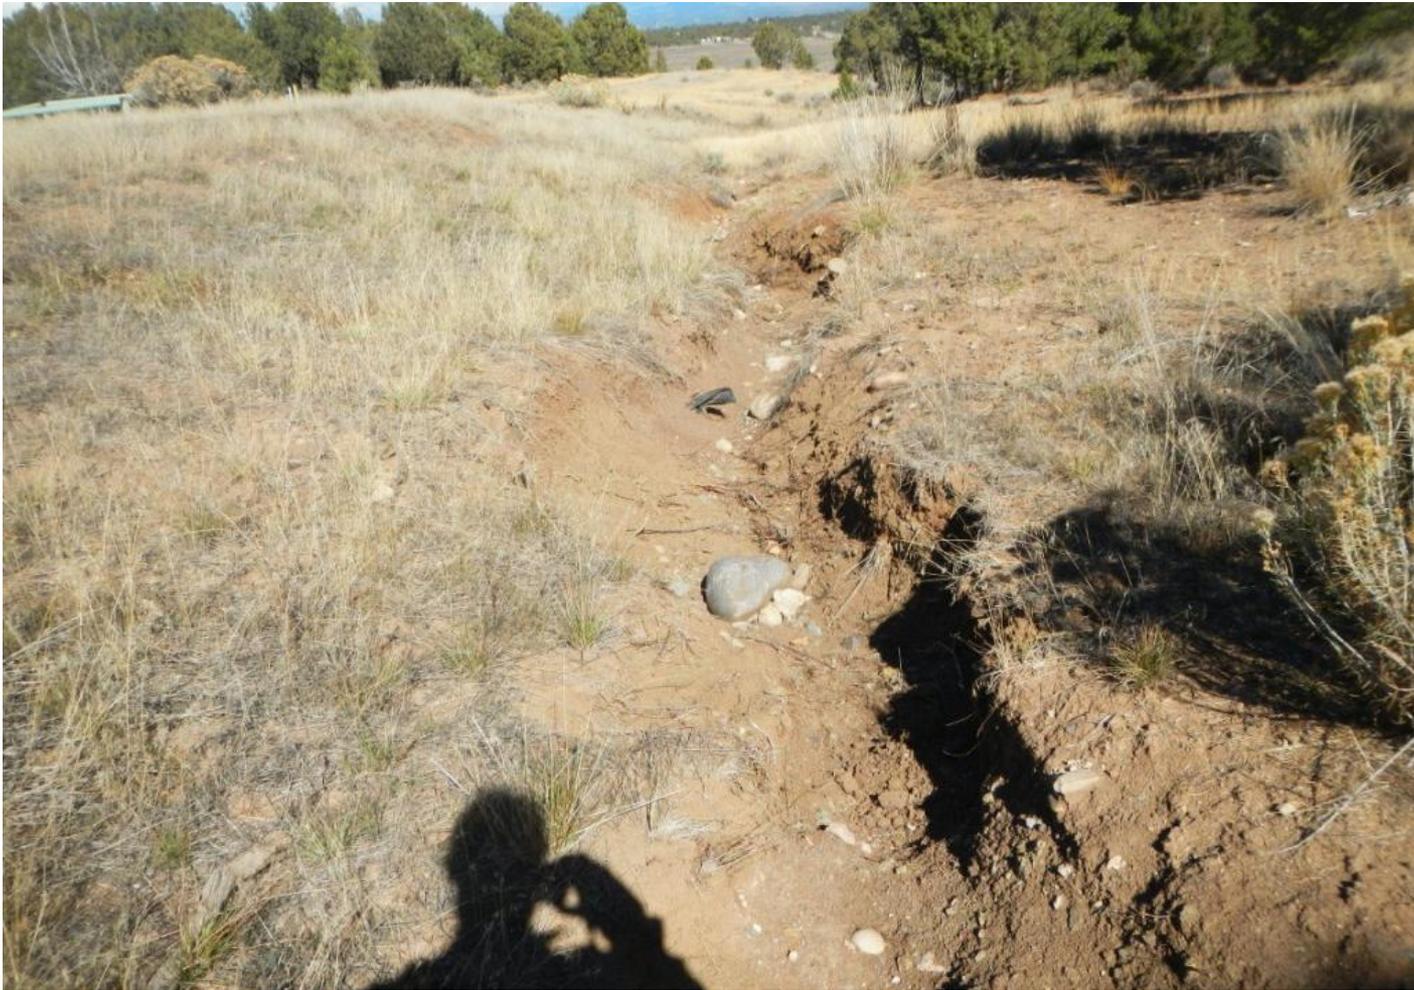
Photo 5. View of erosional channel that is approximately 2 to 3 feet wide and deep forming along the western edge of the project area.

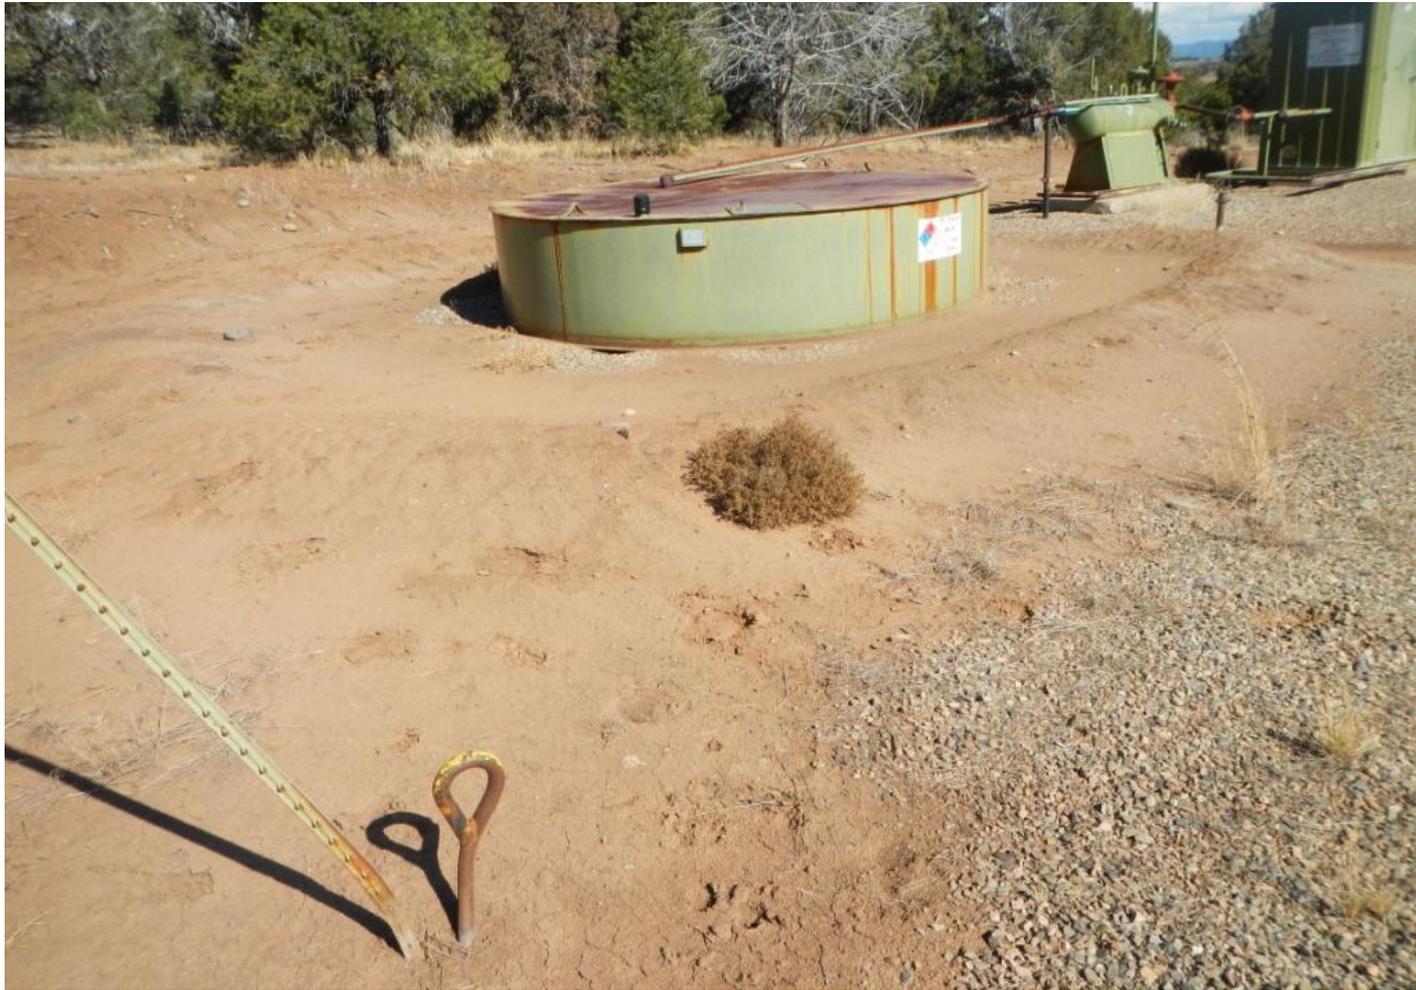
Photo 6. View of tank berm that is no longer functioning.

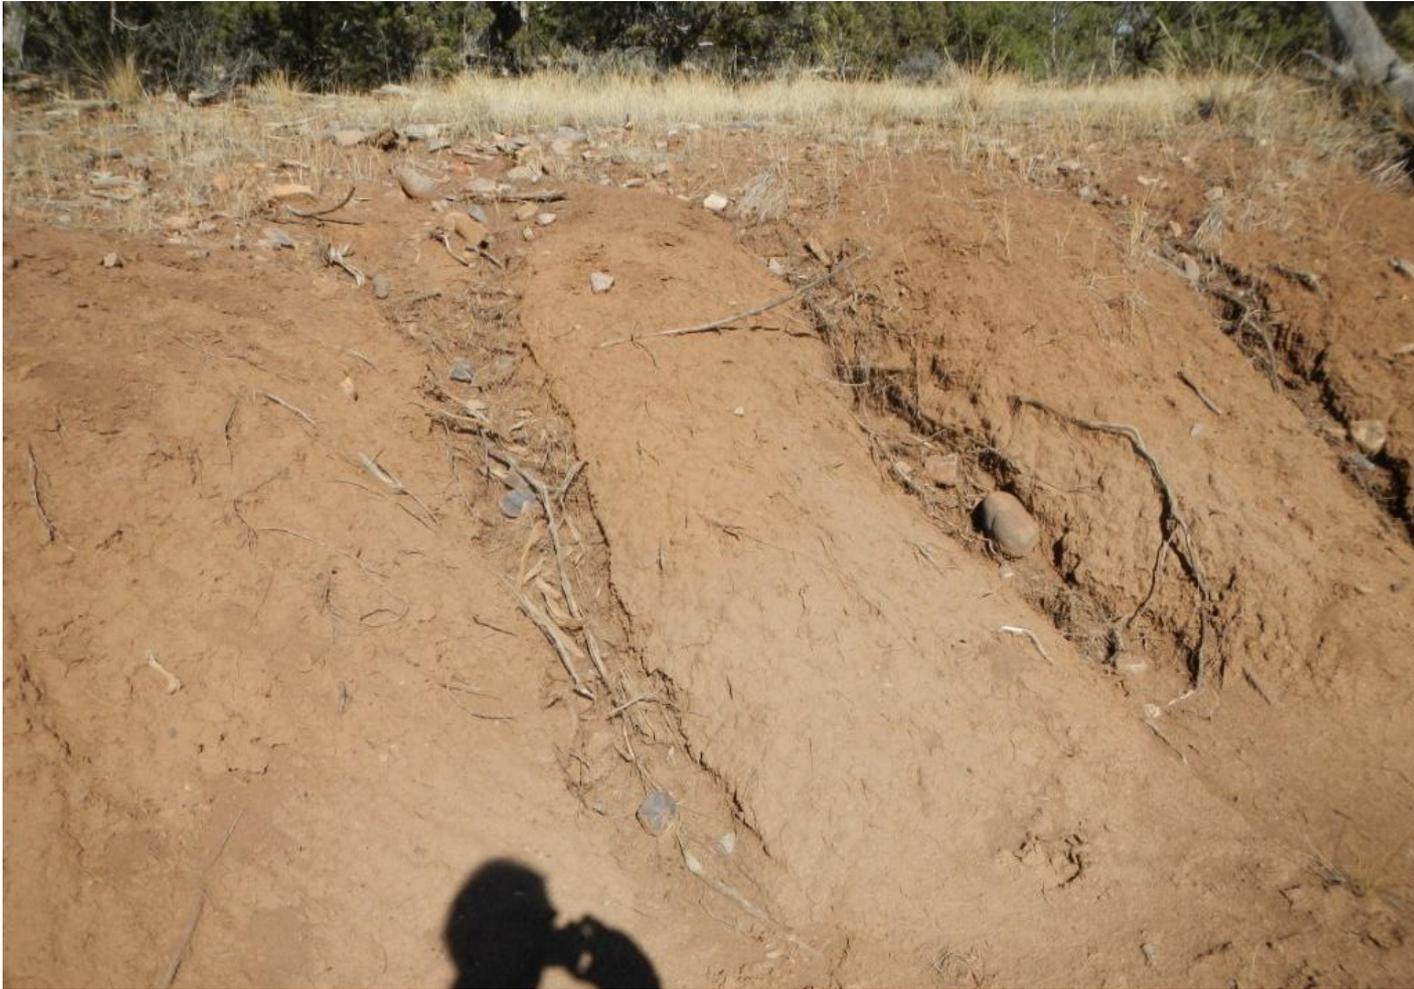
Photo 7. View of erosion exposing roots from adjacent vegetation within the eastern edge of the well pad cut-slope. Stormwater flows are eroding cut-slopes from stormwater run-on and slopes need to be stabilized.
