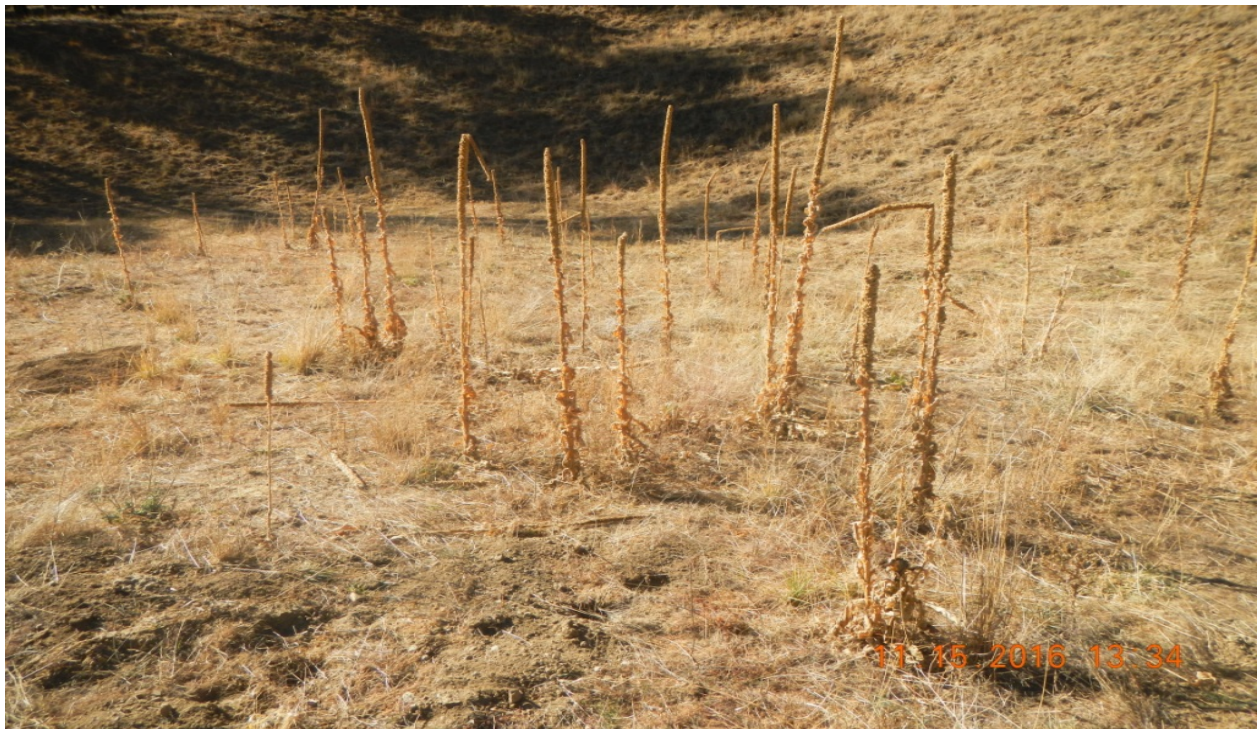
**photo 6:** There is a patch of noxious weeds (Common mullein) at the northwest side of the location.

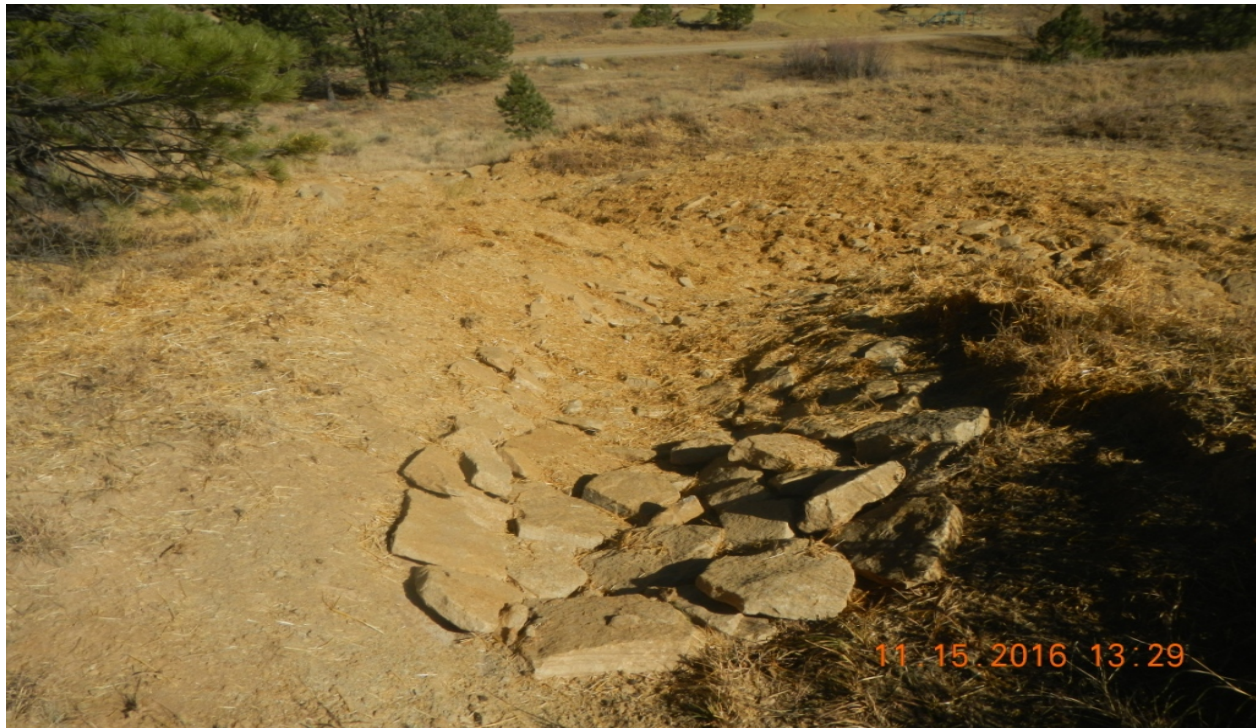
**photo 7:** Rock rip/rap has been placed at the north side of the location.
