Stormwater Inspection

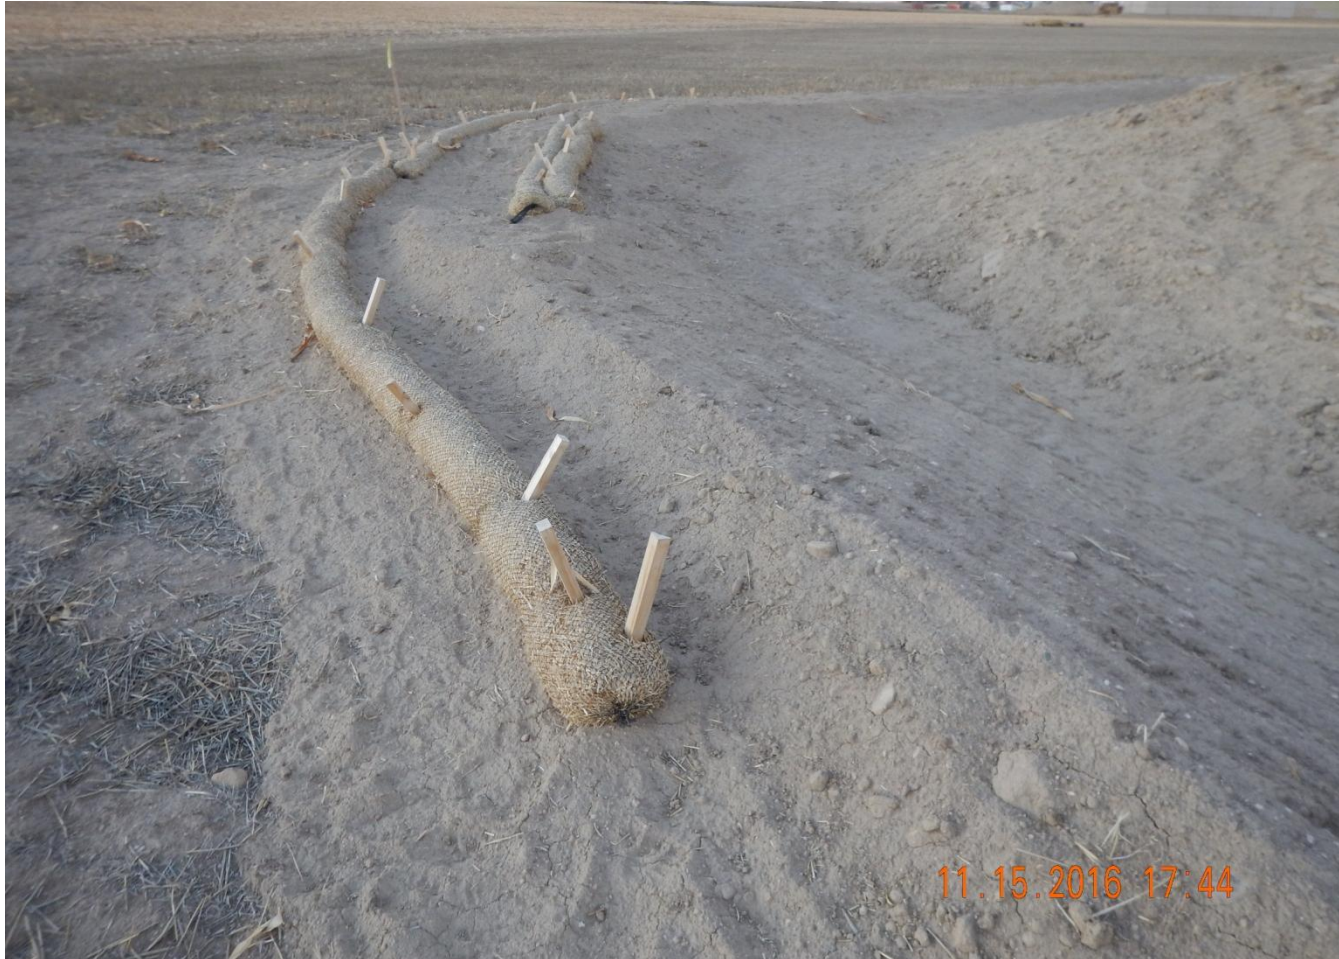
Photo 1. Photo taken from the western location, facing North. Installed wattles along the potential discharge point.

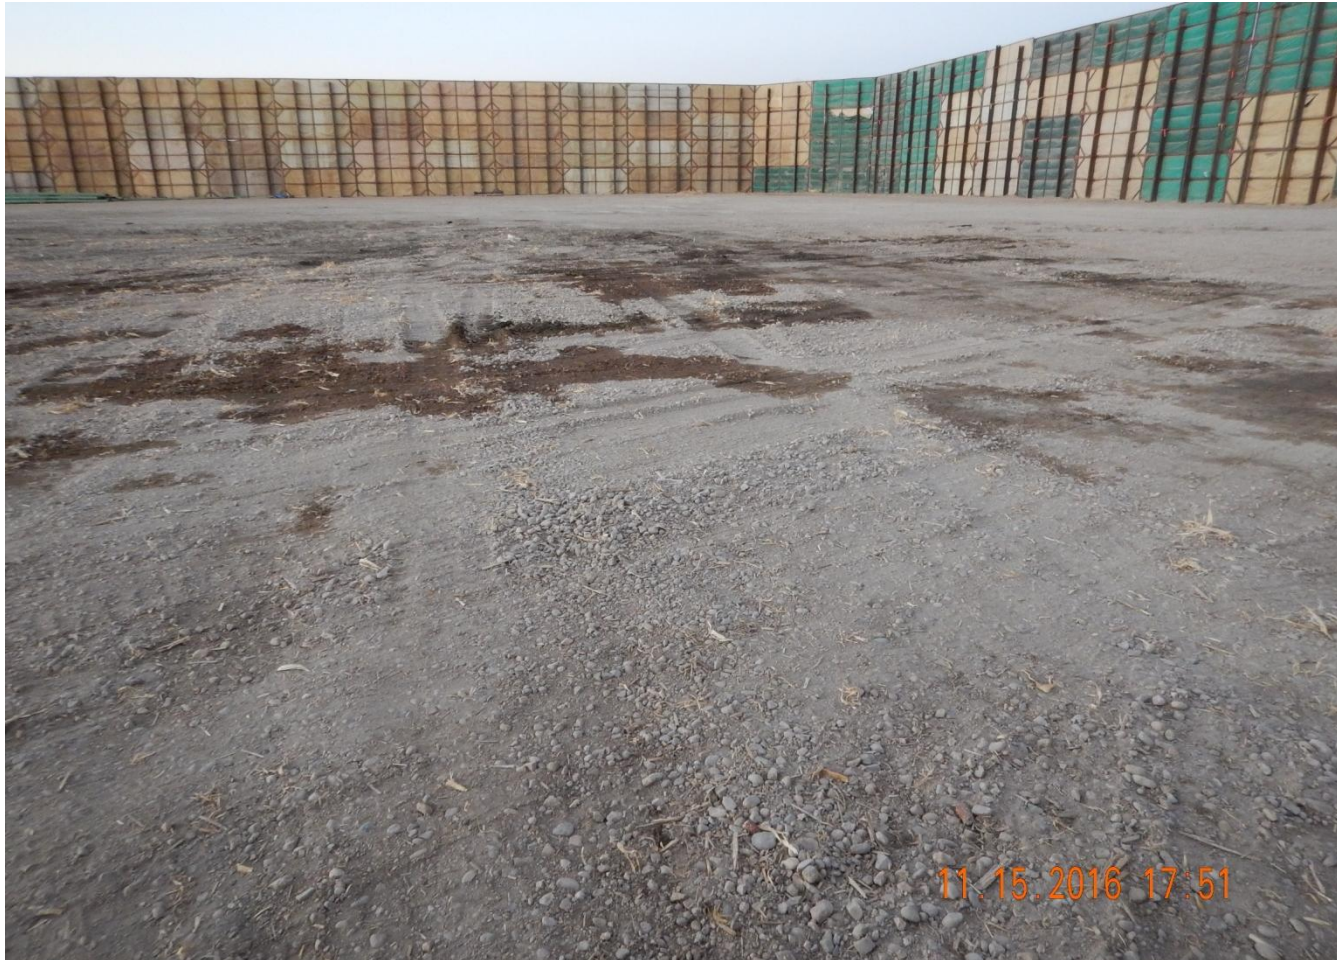
Photo 2. Photo taken from the approximate center of the location, facing North. Additional spills were observed outside of this photo, throughout the location. Control and contain spills/releases and clean up per Rule 906.a.

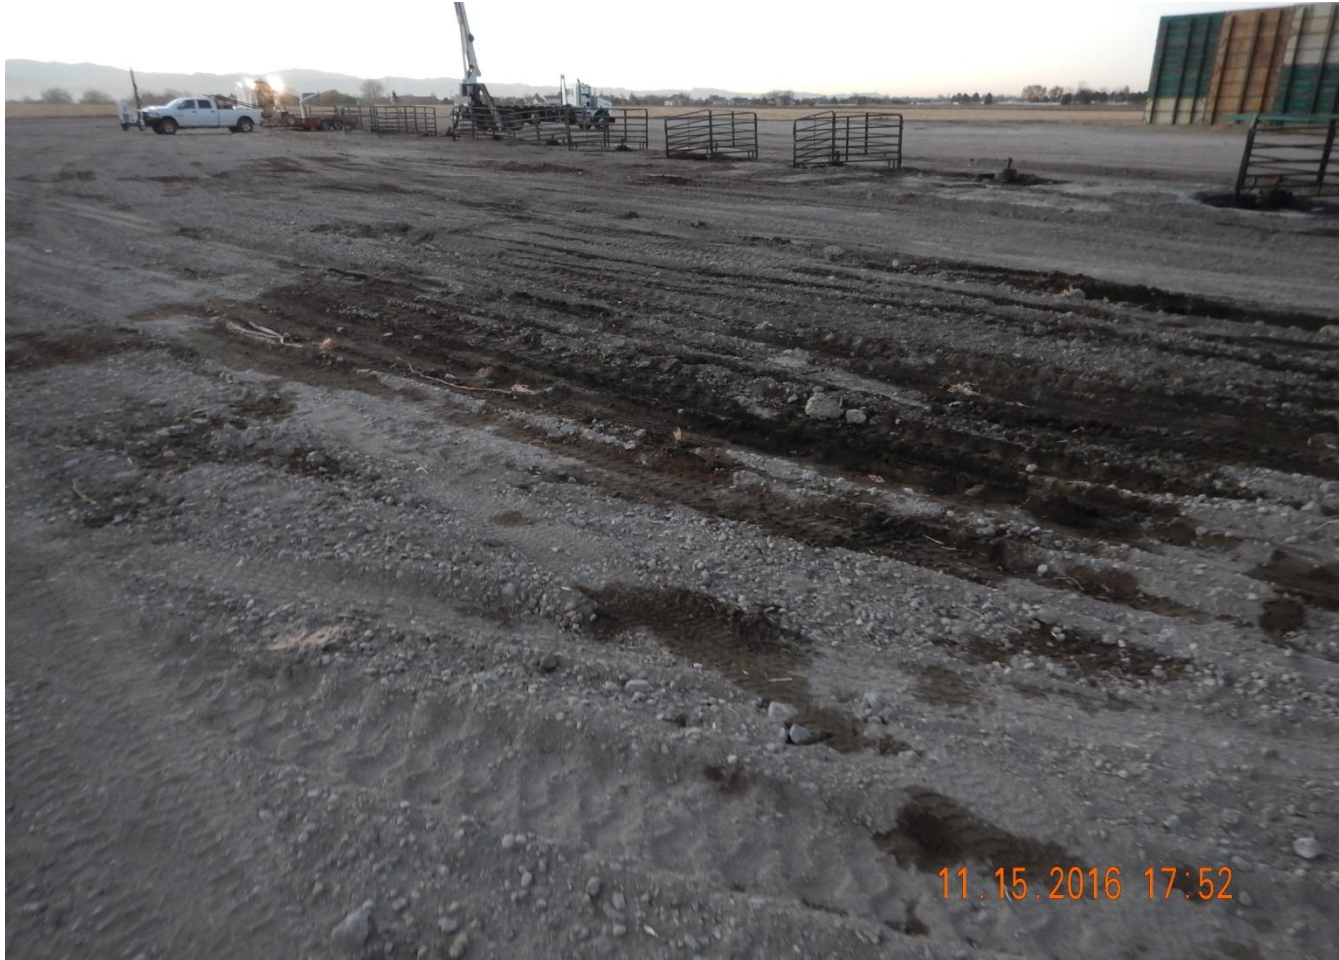
Photo 3. Photo taken from the approximate center of the location, facing Northwest. Additional spills were observed outside of this photo, throughout the location. Control and contain spills/releases and clean up per Rule 906.a.
