Final Reclamation Inspection

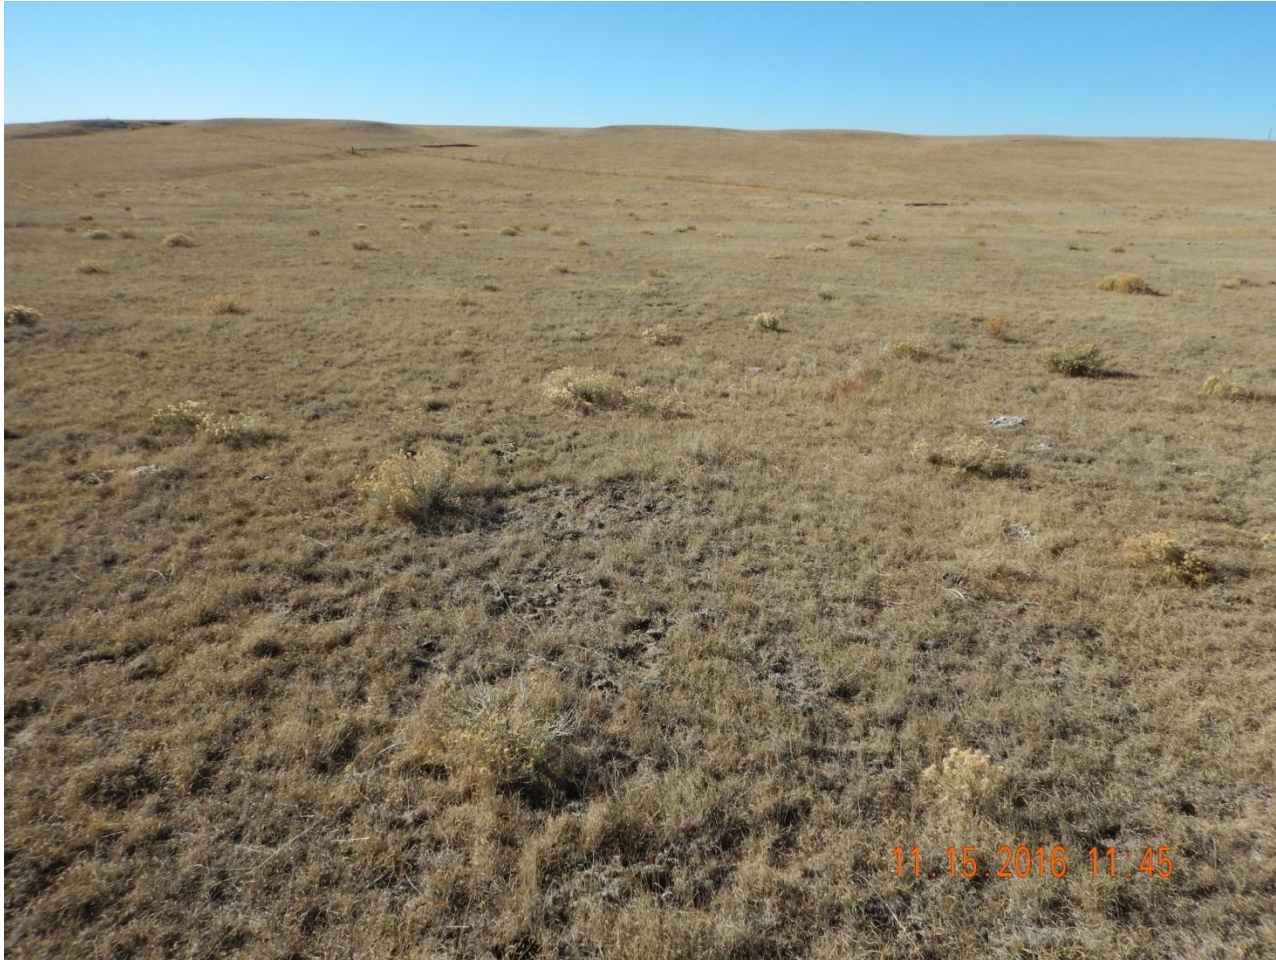
Photo 1. Photo taken east of location, facing Southwest. Does not appear the well was constructed at the proposed location based off field observations.

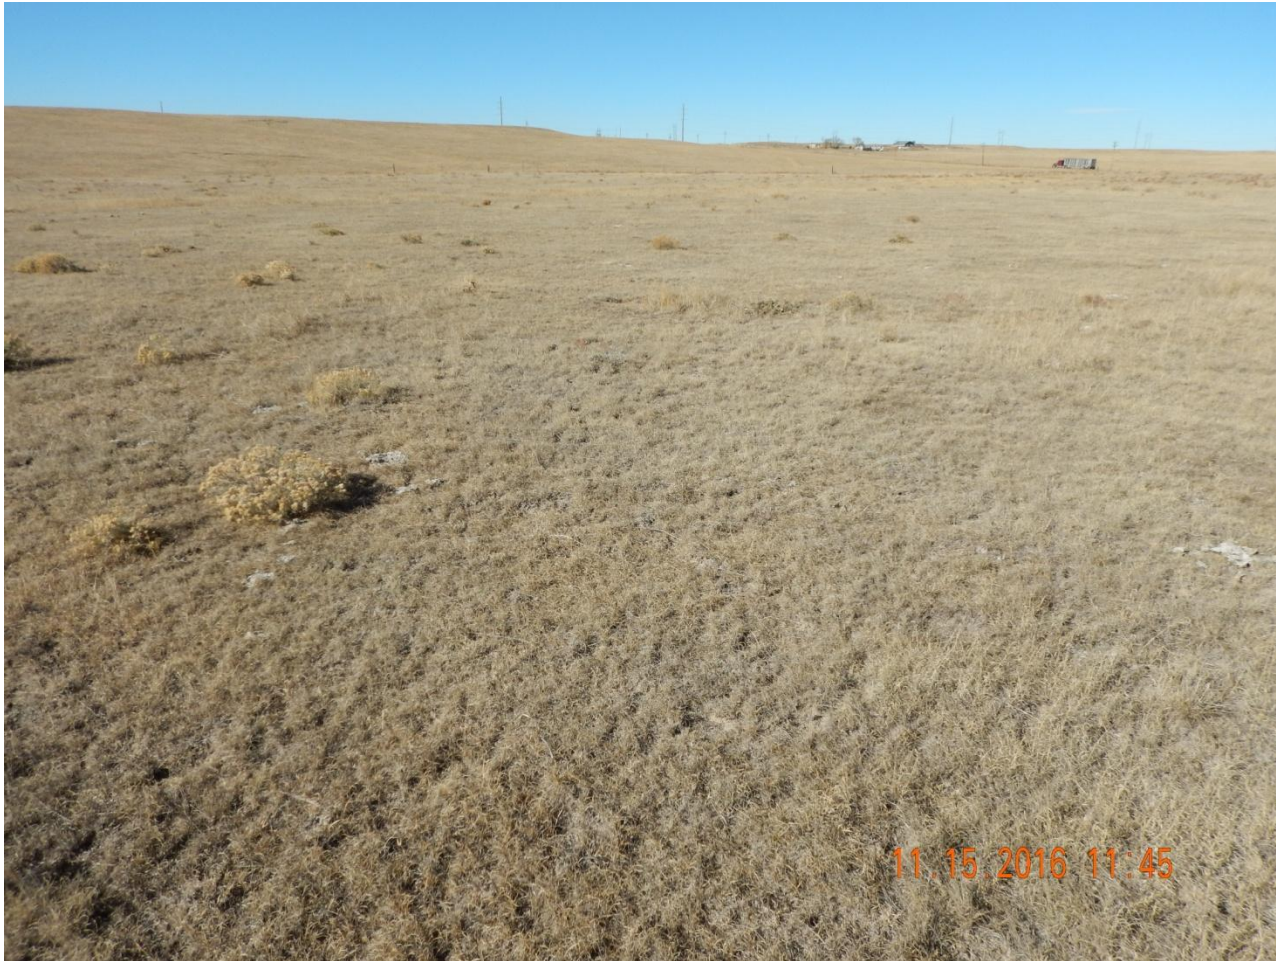
Photo 2. Photo taken east of location, facing Northwest. Does not appear the well was constructed at the proposed location based off field observations.
